1.0 INTRODUCTION

This report describes the Turkey Point Unit 3 containment dome, delamination of the dome concrete during post tensioning of tendons, the subsequent investigation and analysis of this phenomena, and the repair and test program. When about two thirds of the dome tendons had been tensioned, it was noted that concrete cracking and sheathing filler leakage was developing and that in some areas of the dome, the concrete felt springy when walked on. The dome was struck with a sledge hammer and, in some areas, it sounded as if it were hollow. The concrete was locally removed in some of these areas and shallow (approximately 1/2" to 4") delamination planes were found running almost parallel with the surface, but eventually intersecting it. A full investigation was begun to determine both the extent and cause of the delaminations, and to cover the following:

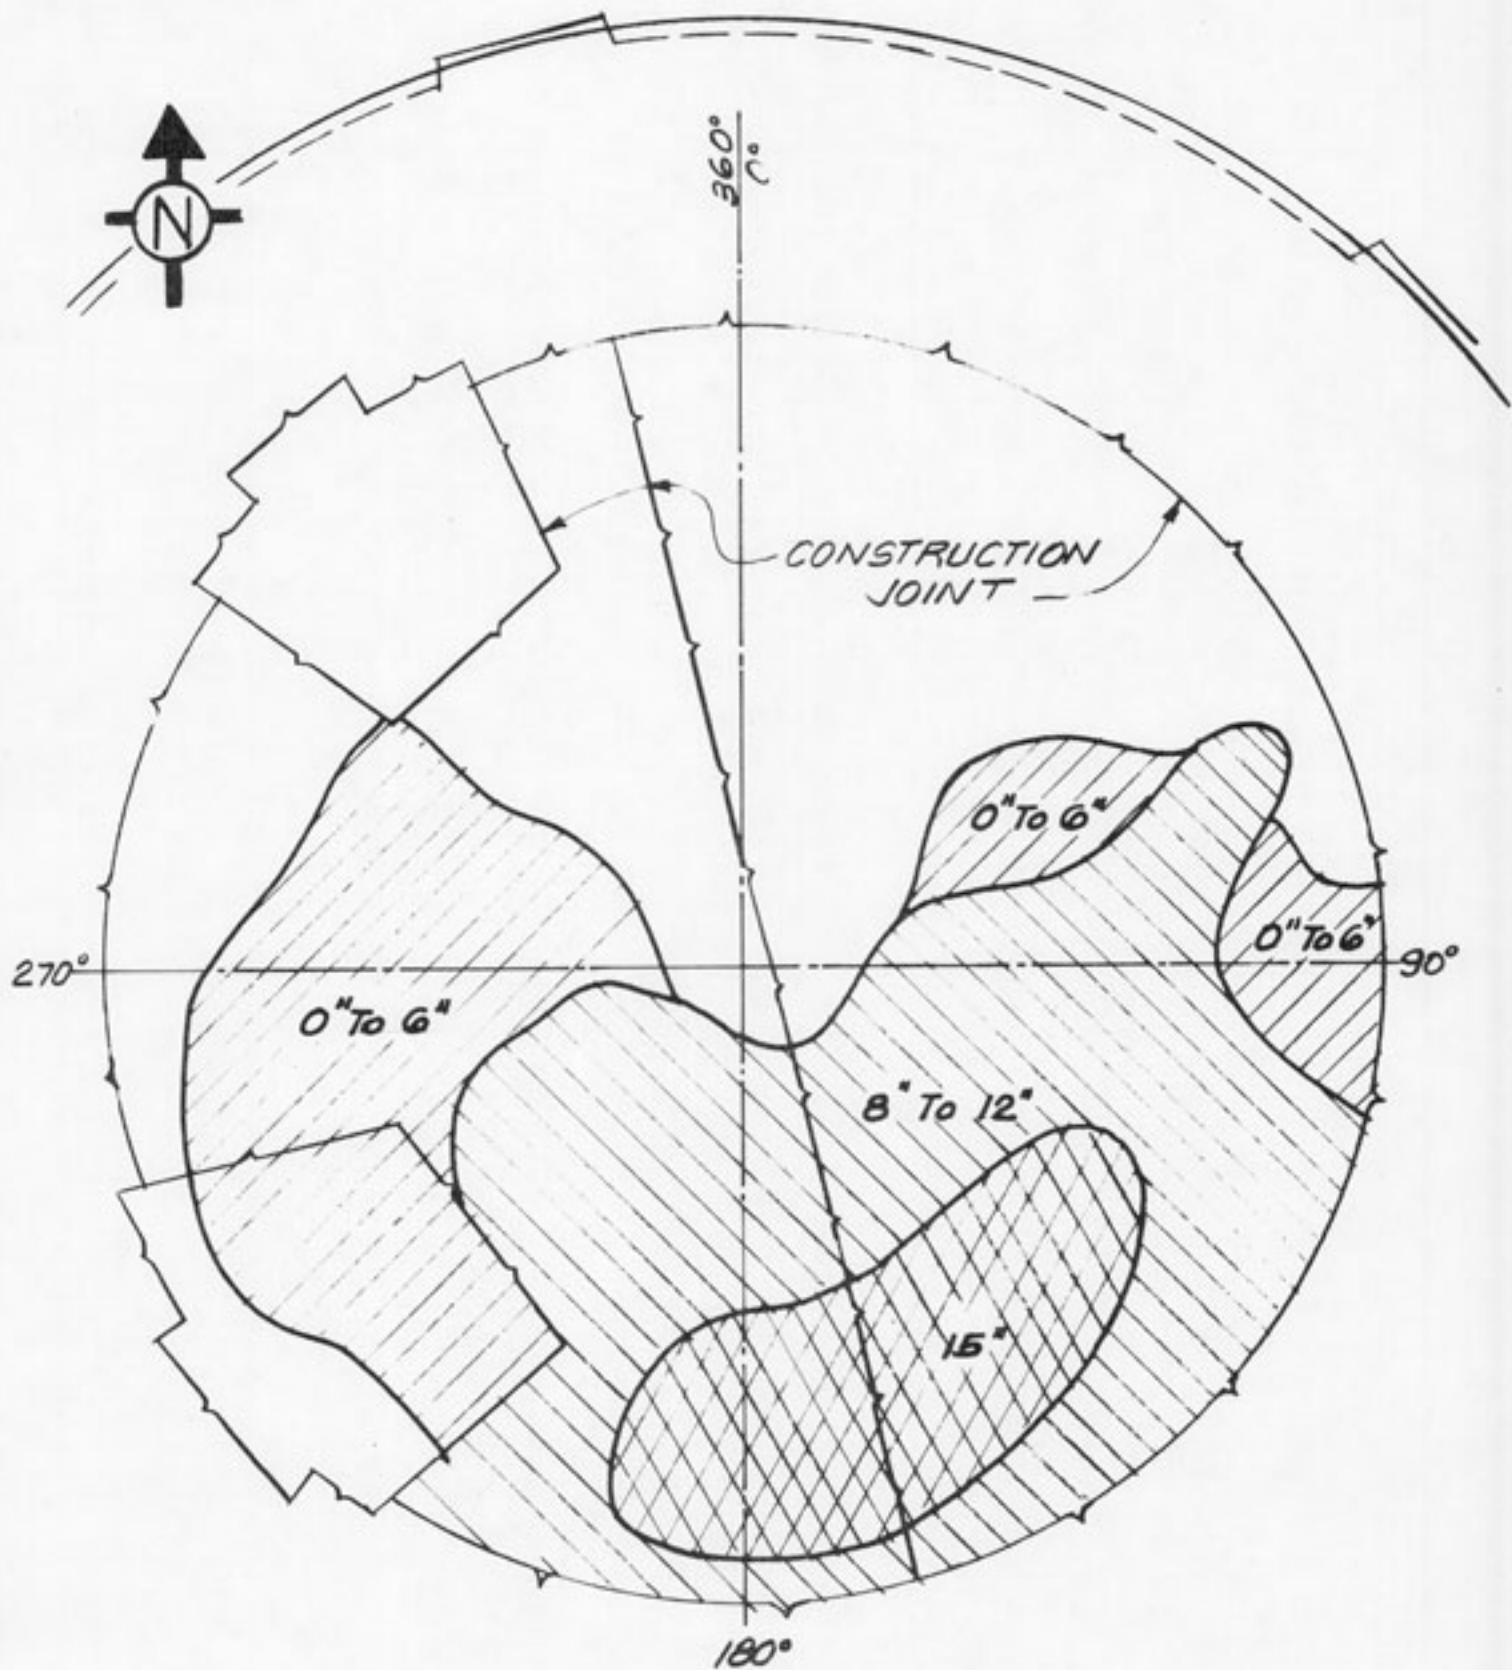
FIG. 3-2

CONTOURS OF DEEPEST
DELAMINATIONS

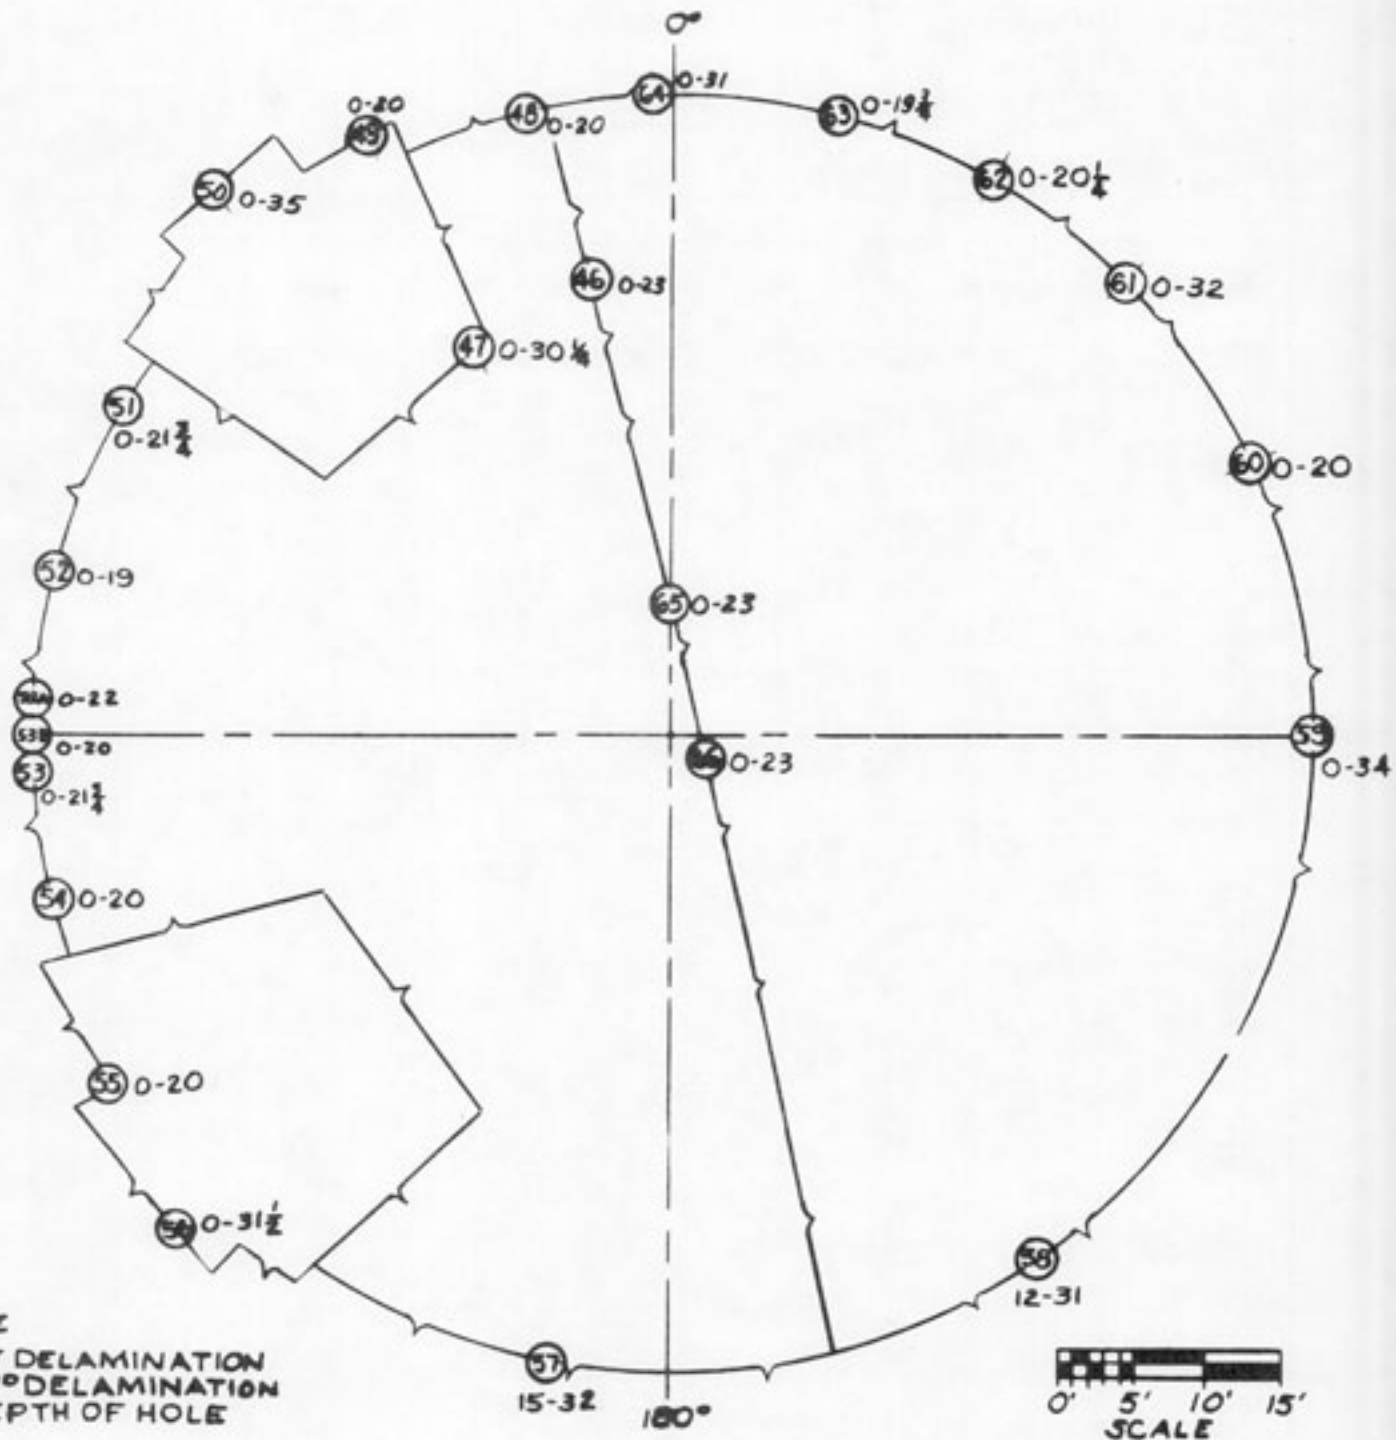
FIGURE 3-21

- (3) Construction joints - Figures 3-21, 3-28 and 3-29 show conditions found at construction joints during concrete coring and removal. At the south side of the meridional construction joint, grease was found on the vertical surfaces in a band varying from about 3" to 6" or more in width. The band started approximately 10' from the apex and was approximately 25 feet in length. A portion of the band is shown on Figure 3-28. Voids were found, with the ~~worse~~ voids located in the joints for the ventilation blockouts. There was evidence of lack of concrete consolidation in the north-west blackout.

CORING ON CONSTRUCTION
JOINT

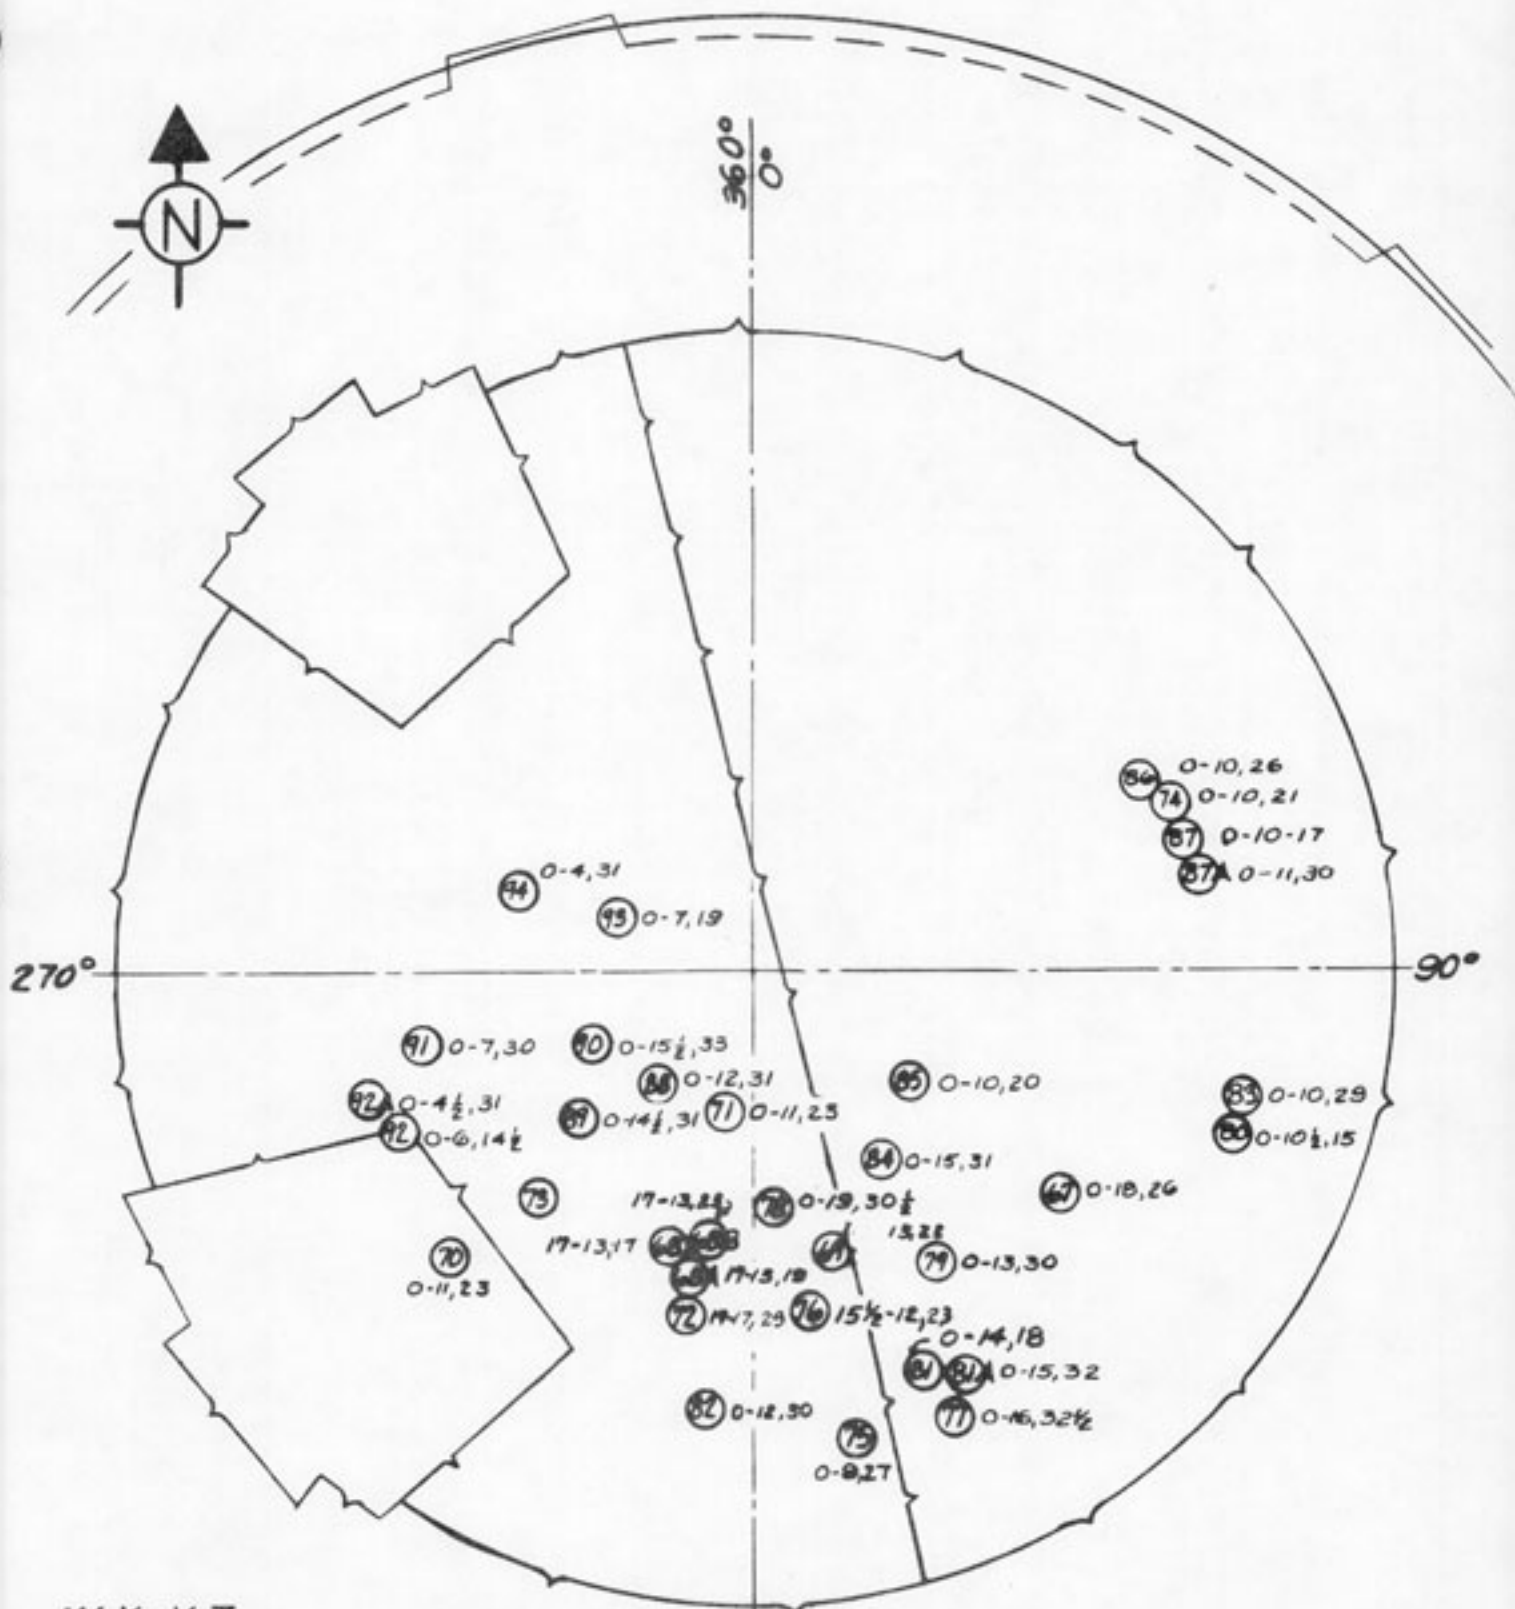
FIGURE 3-22

CORING AFTER
CONCRETE REMOVAL

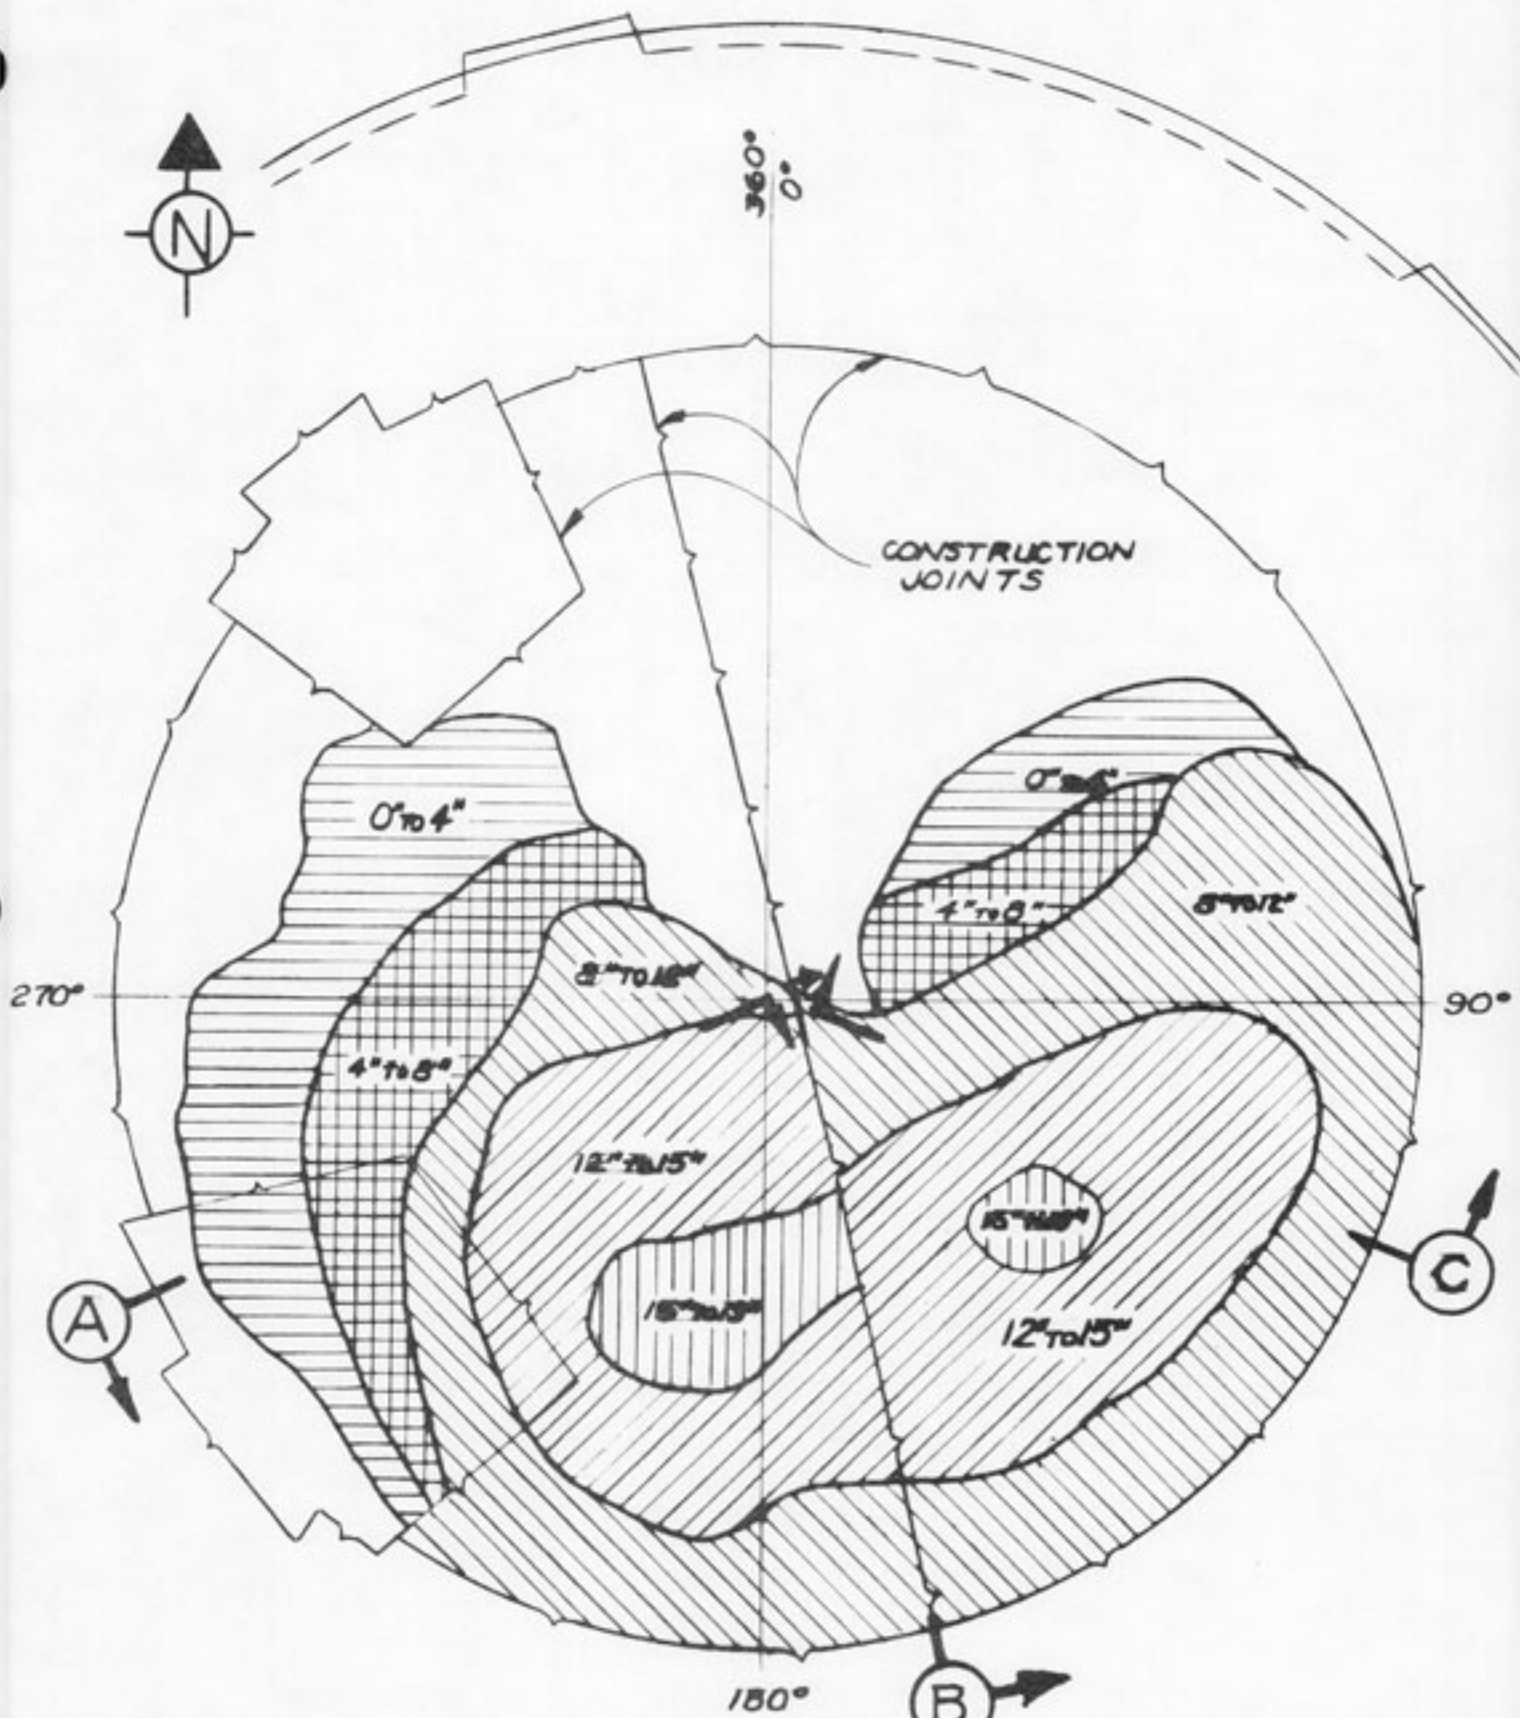
FIGURE 3-23

CONTOURS OF DEEPEST
DELAMINATIONS
VERIFIED BY CONCRETE
REMOVAL AND CORING

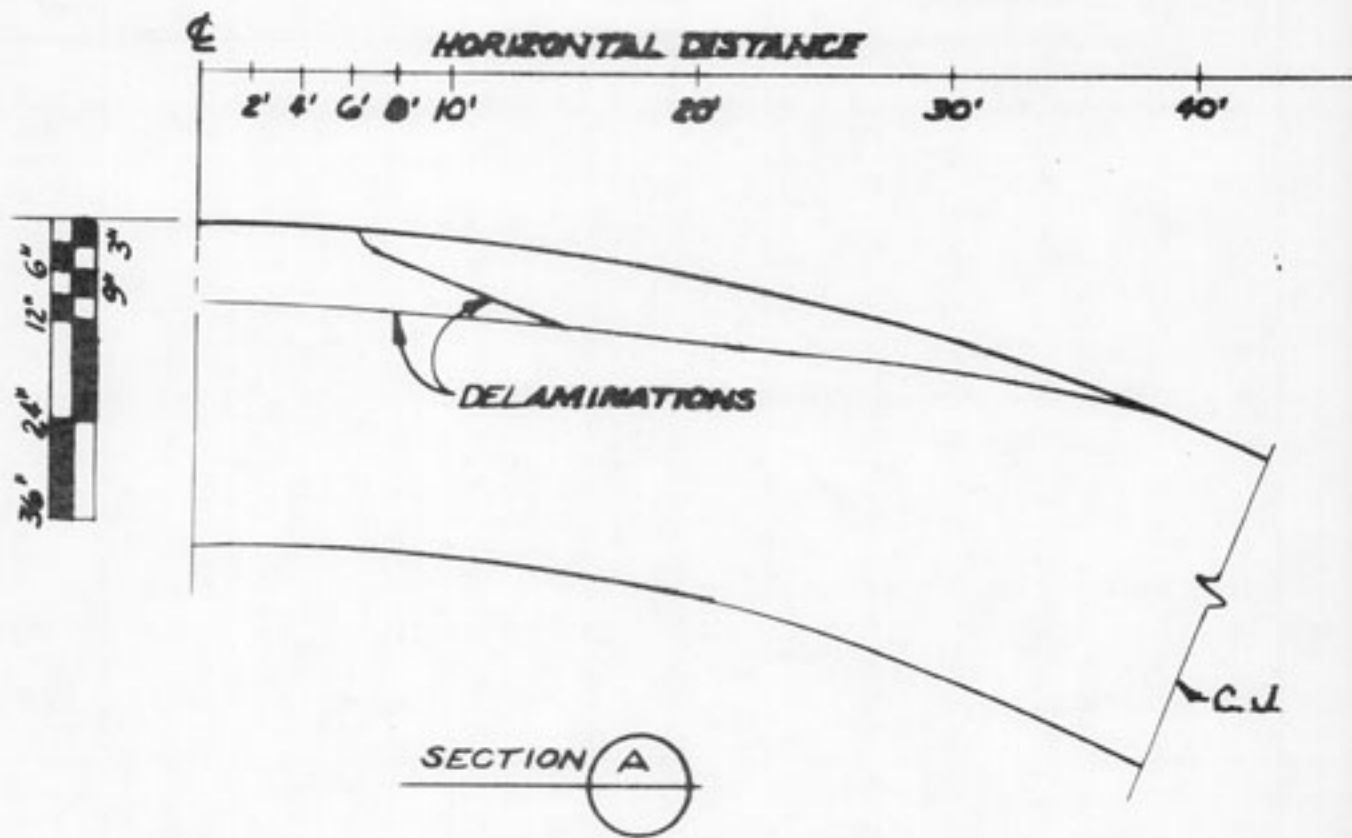
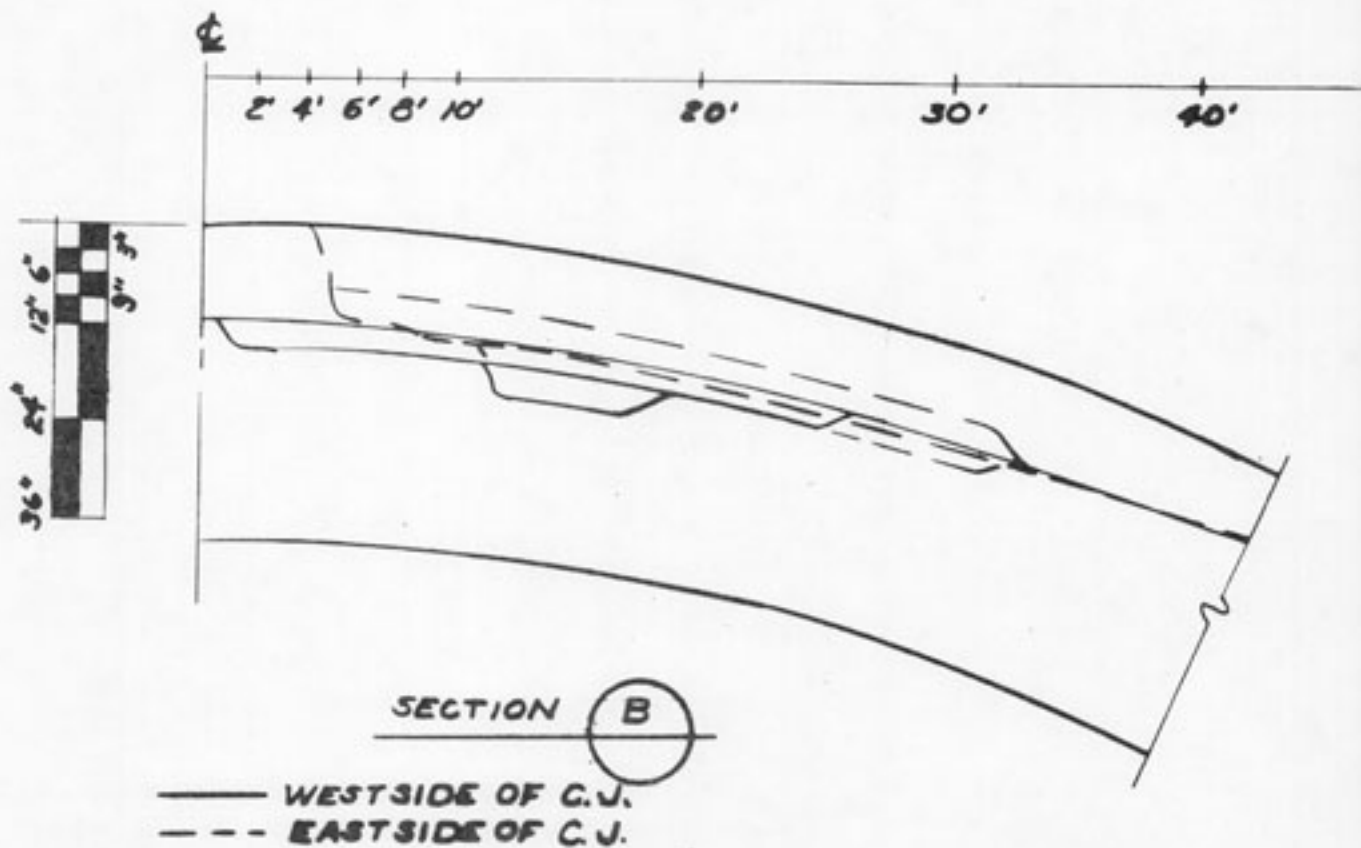
FIGURE 3-24

SECTION SHOWING
 DELAMINATIONS

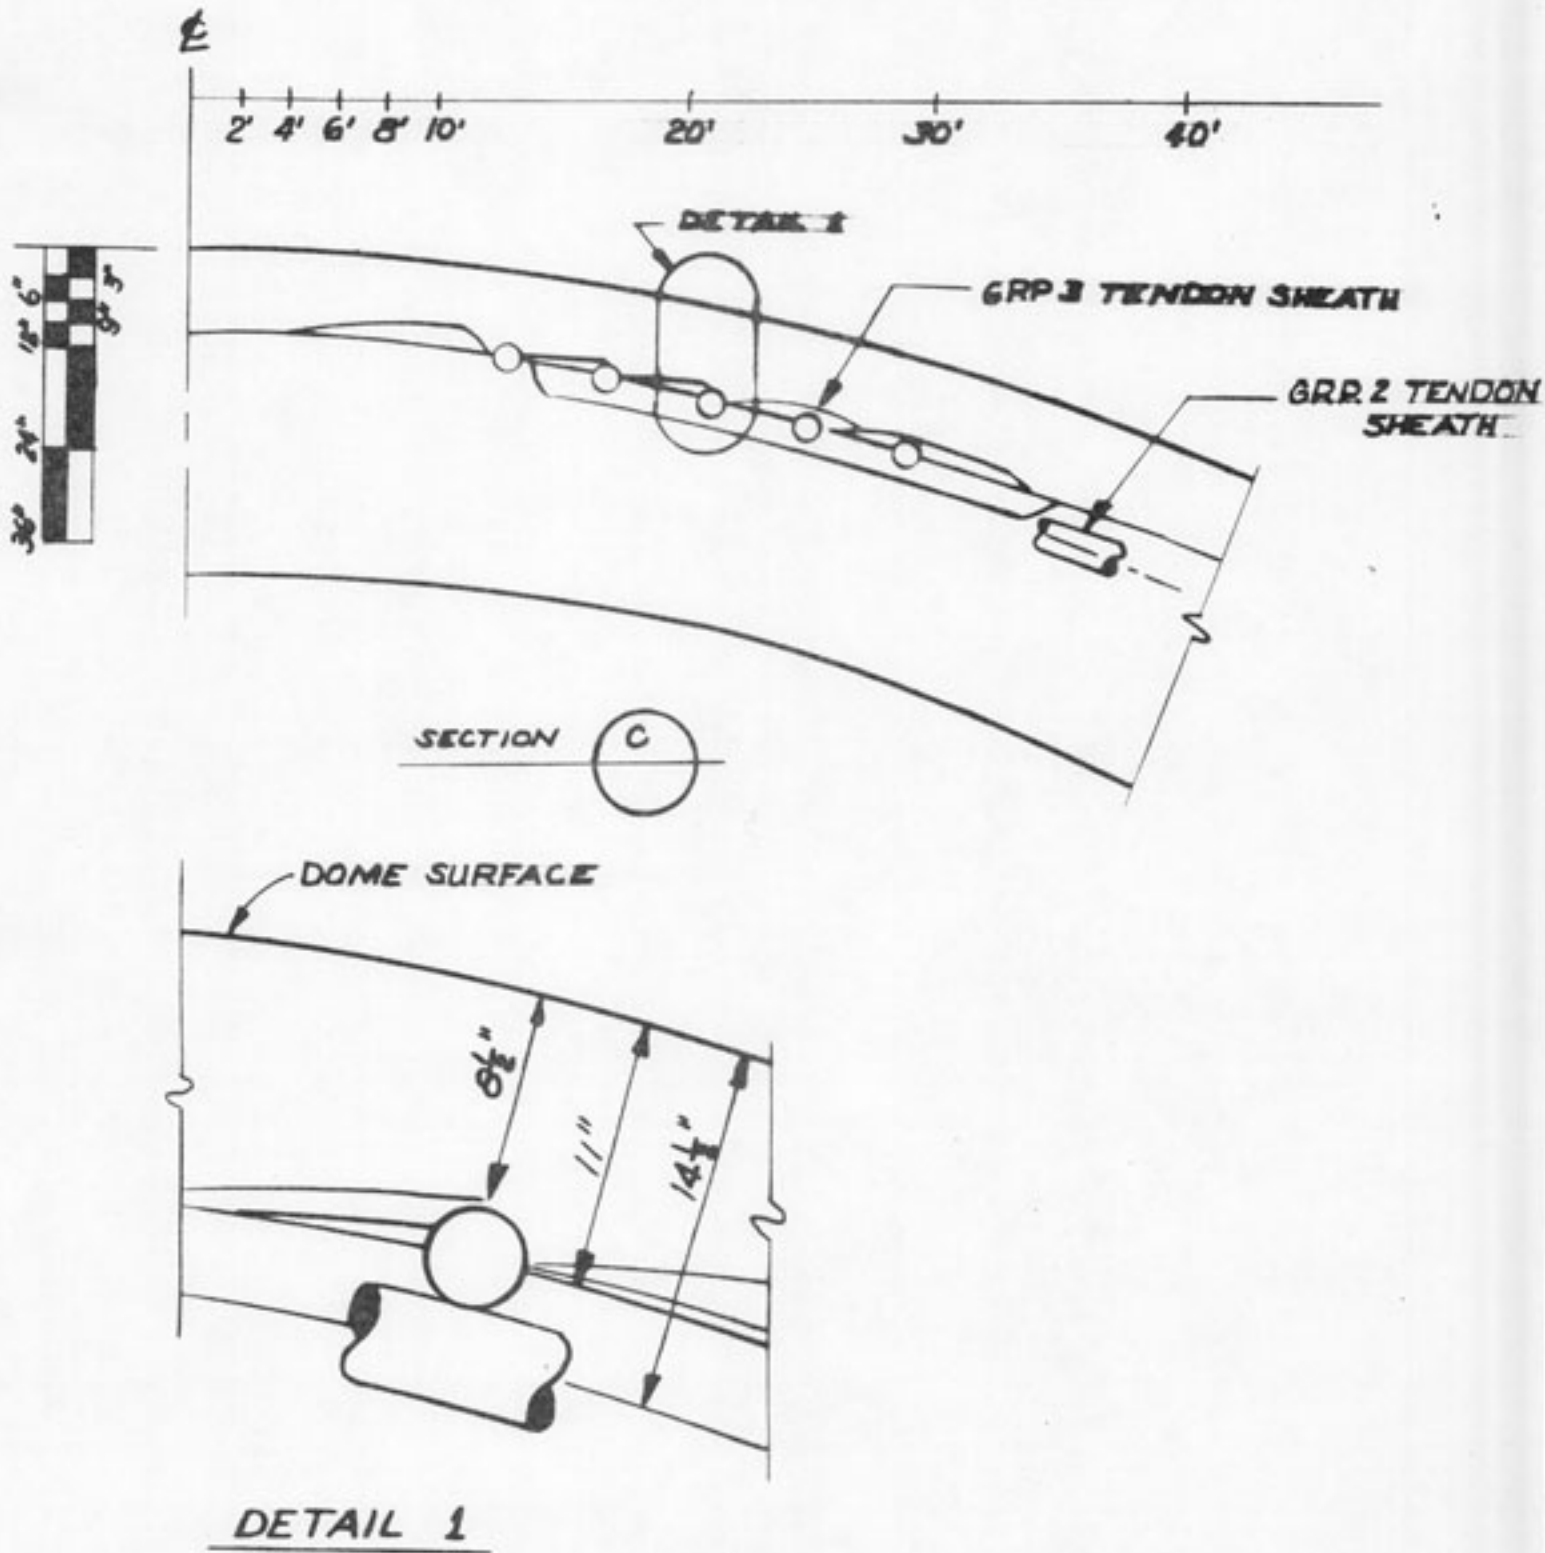
FIGURE 3-25

SECTION SHOWING DELAMINATIONS

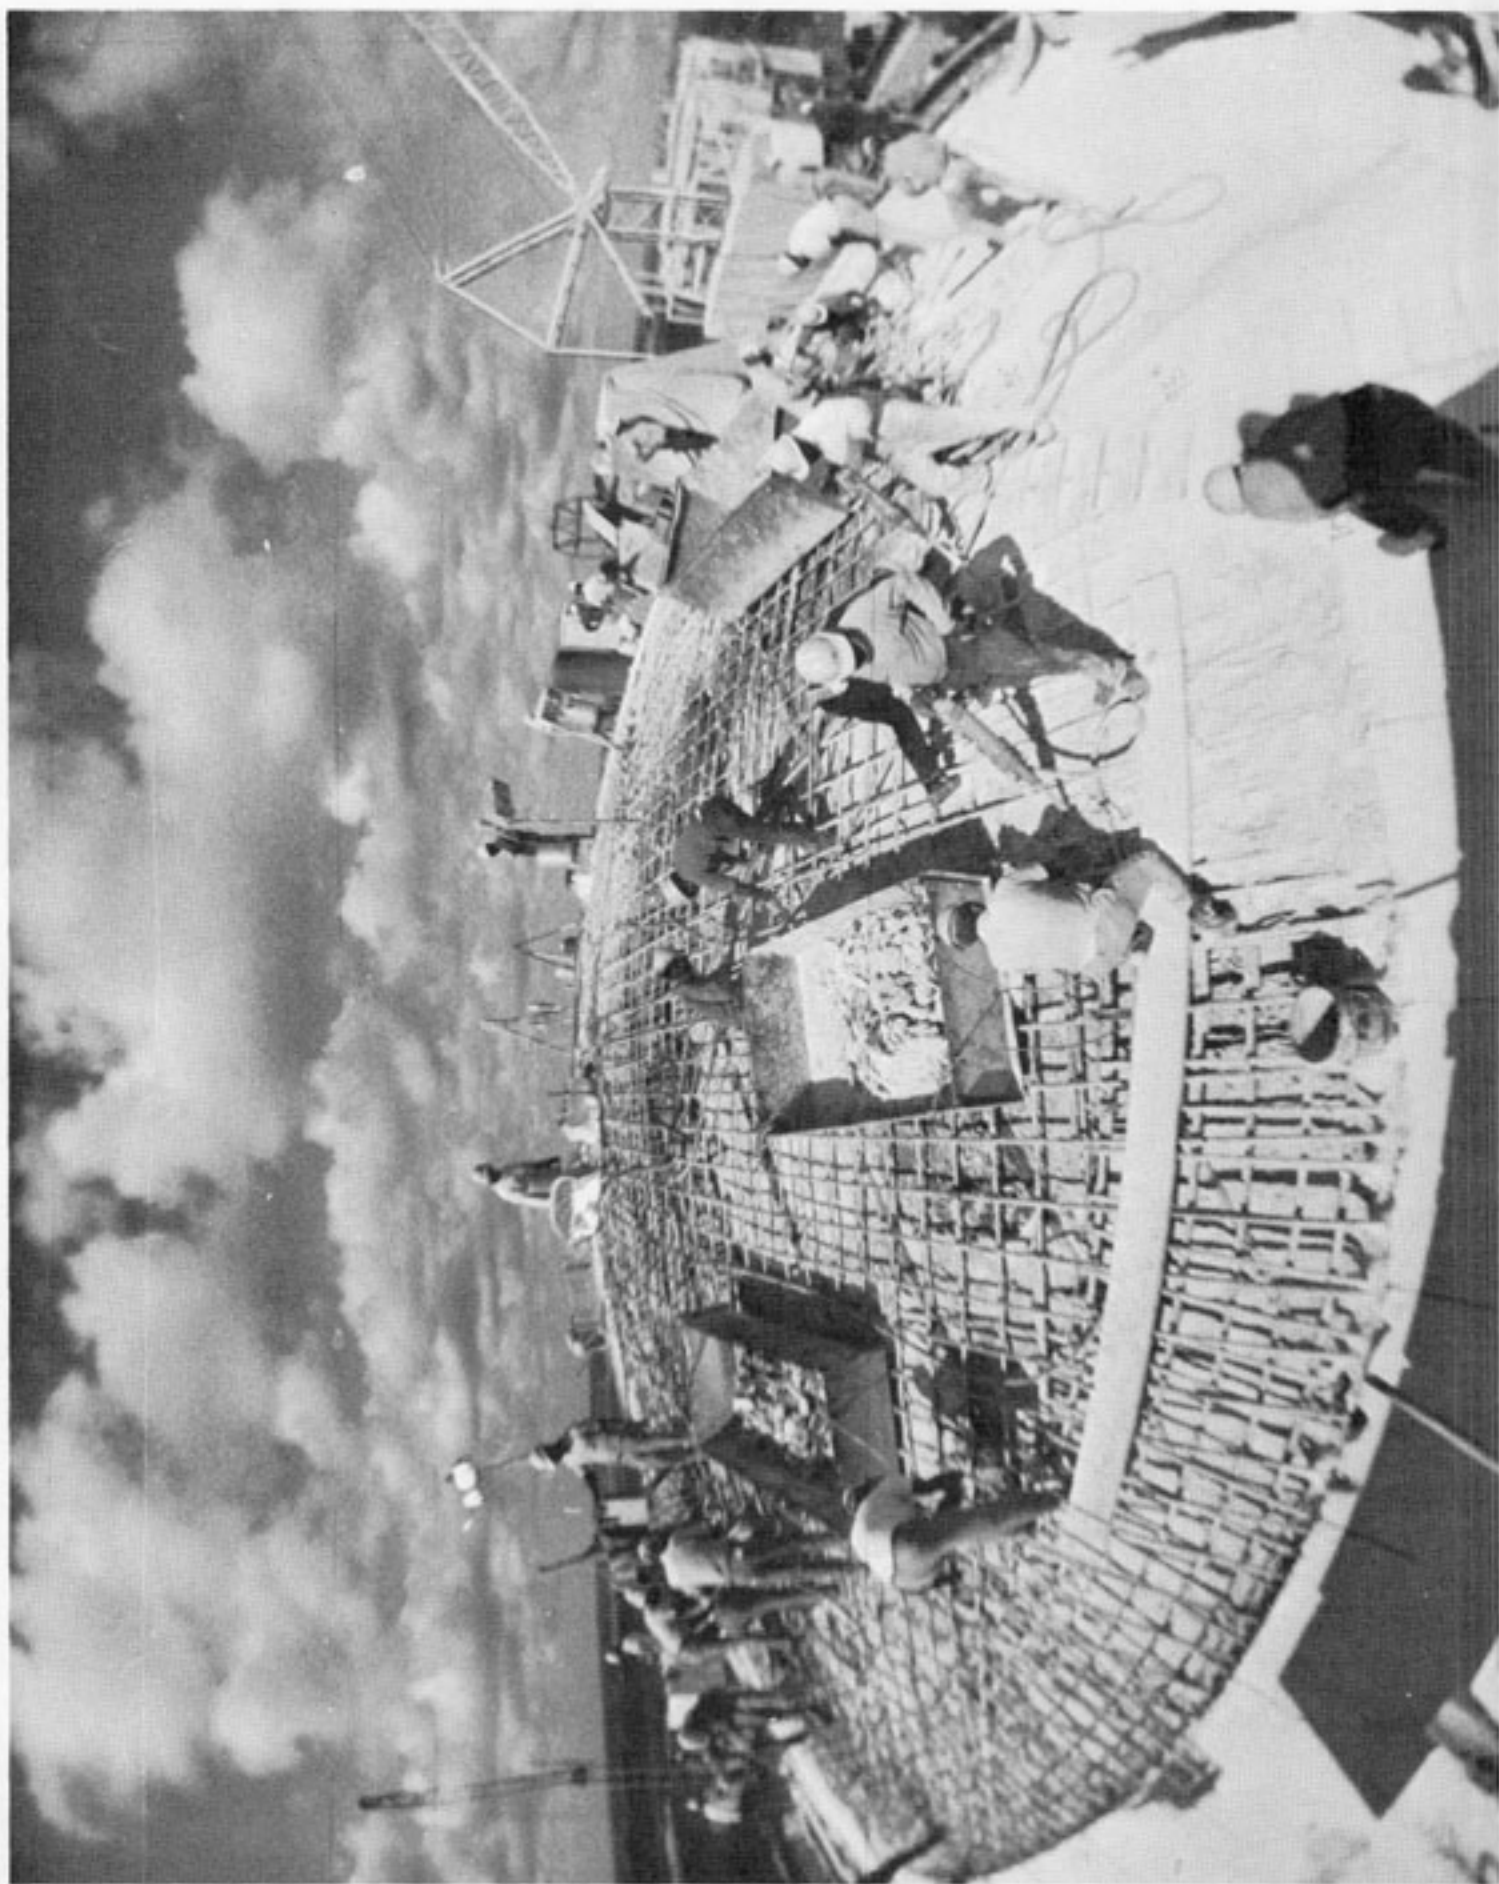
FIGURE 3-26

EAST SIDE OF DOME
DURING CONCRETE REMOVAL

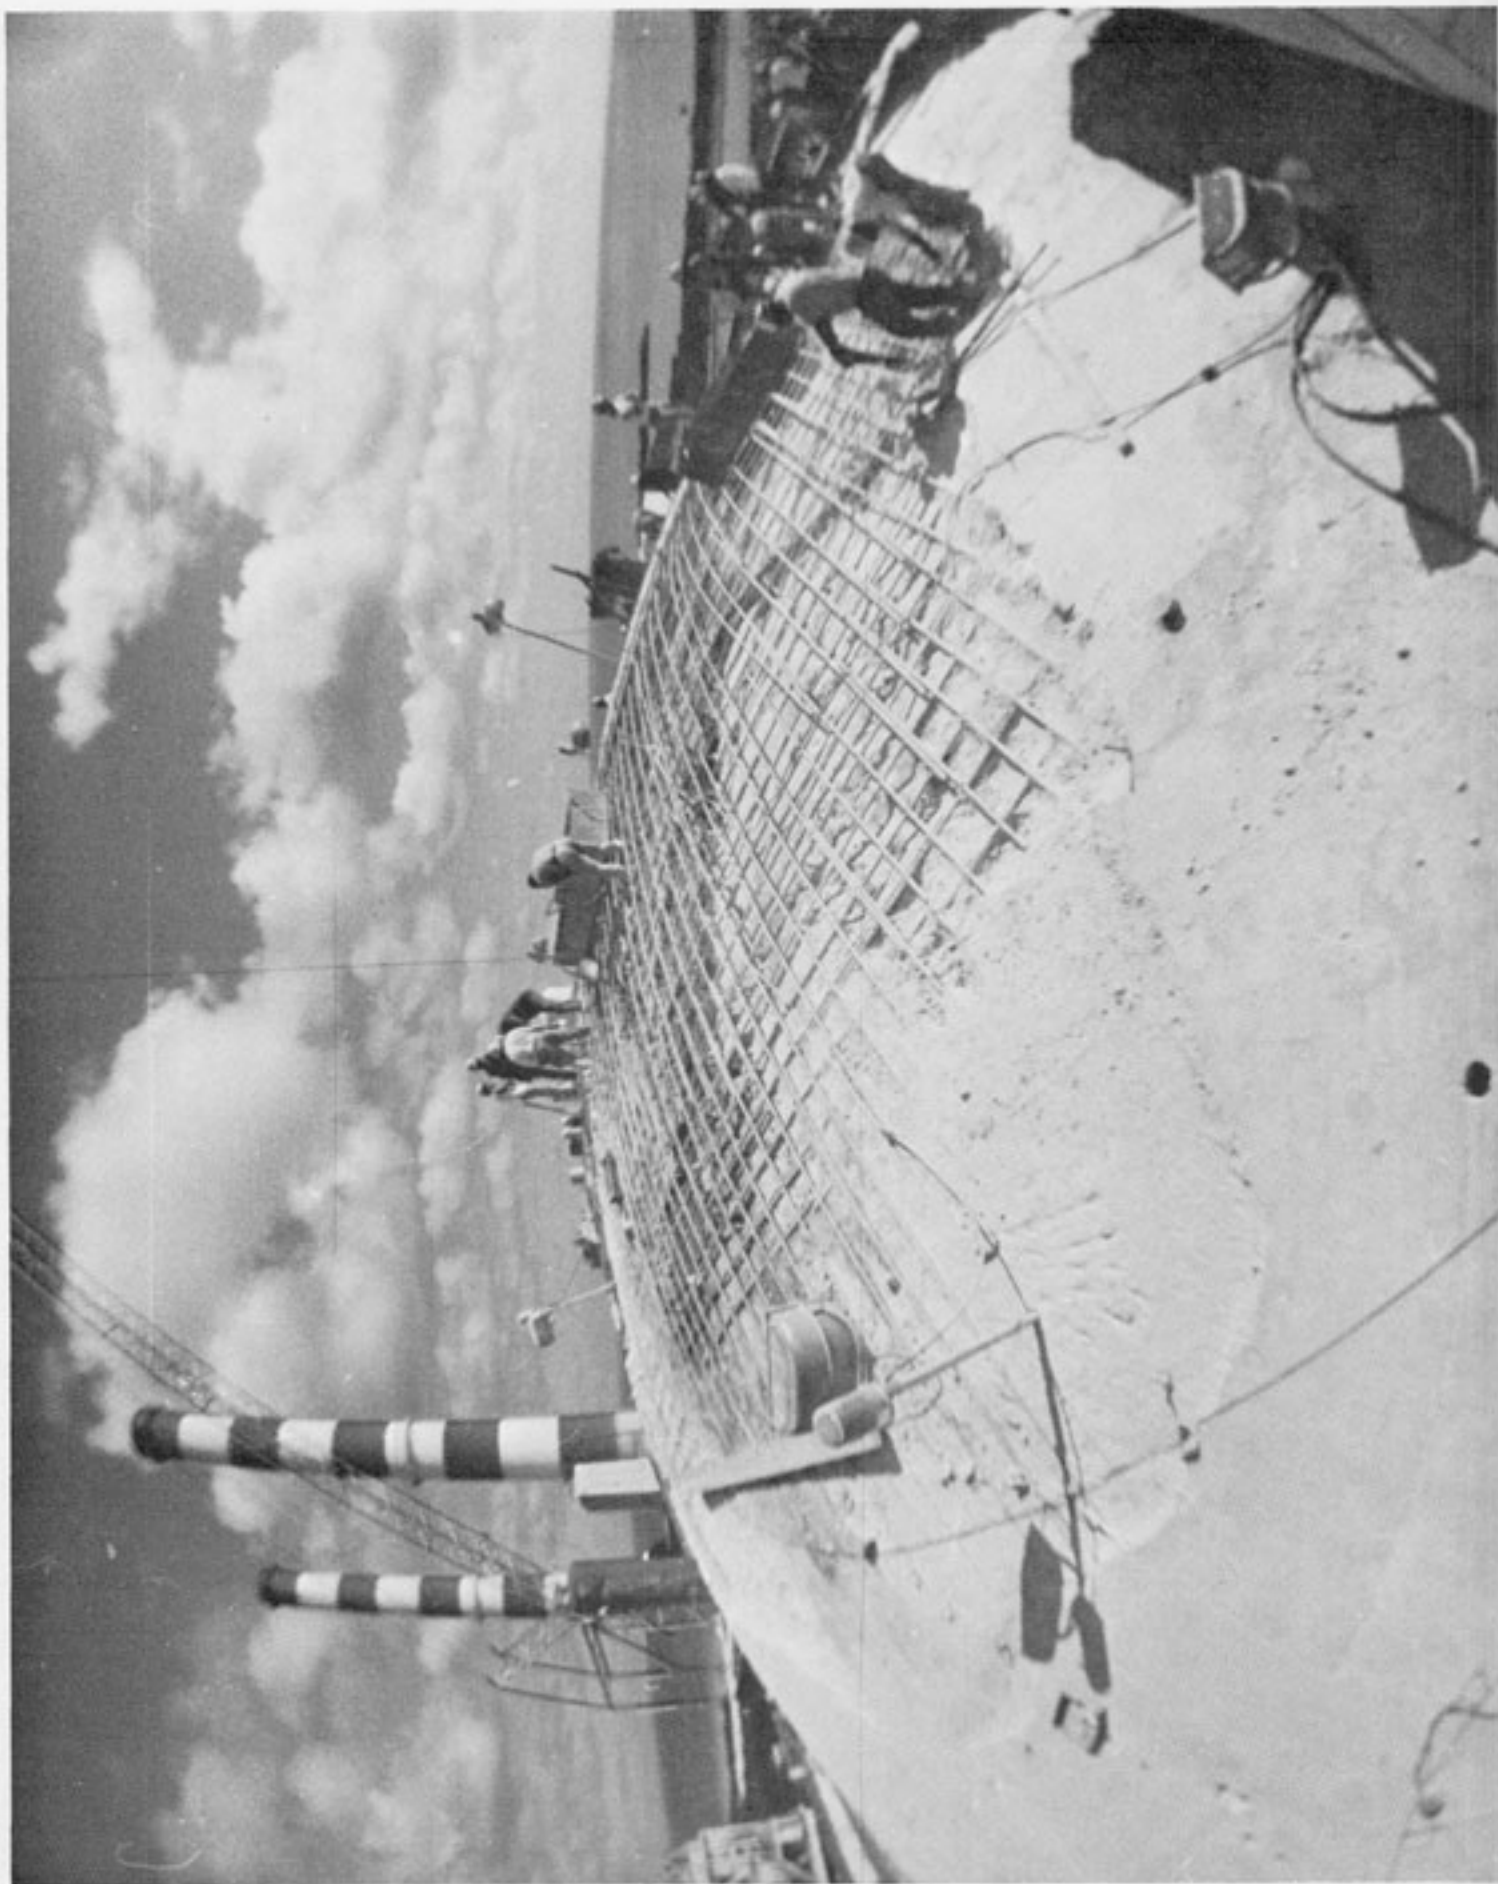
FIGURE 3-27

WEST SIDE OF DOME
DURING CONCRETE REMOVAL

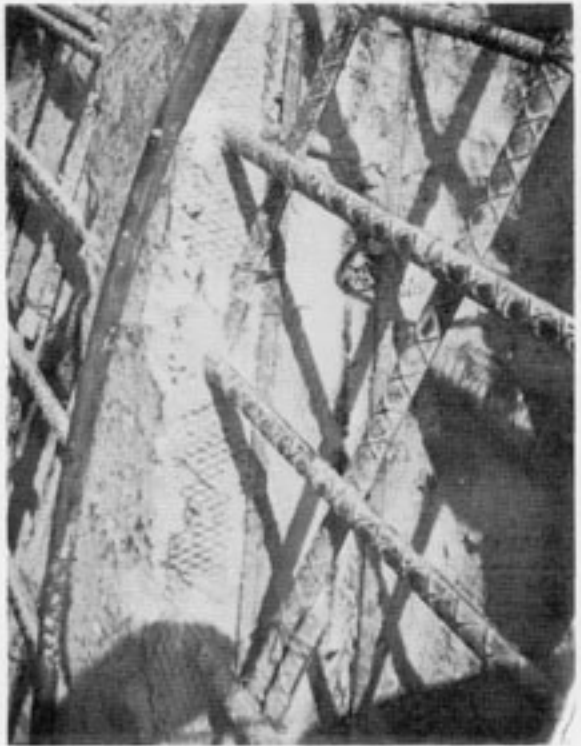
Meridional construction joint 15'-20' south of apex to a depth of 18".

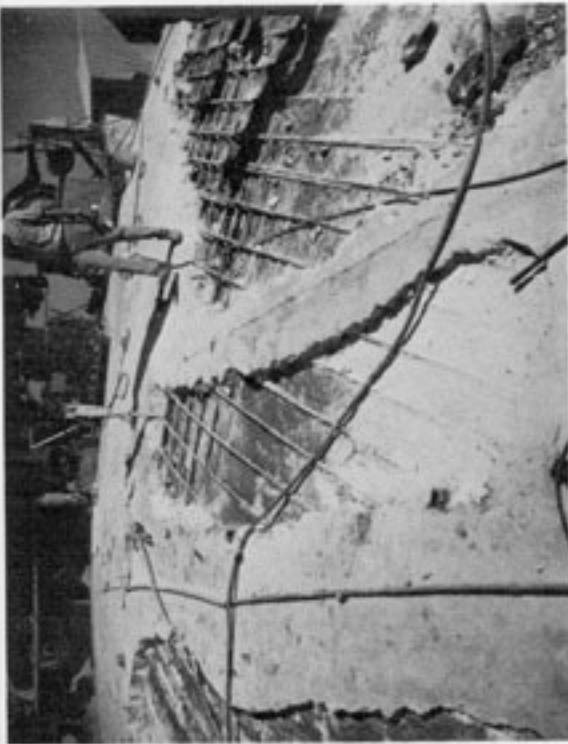
West side of dome in region of azimuth 256°. Note grease stain on delamination and outcropping.

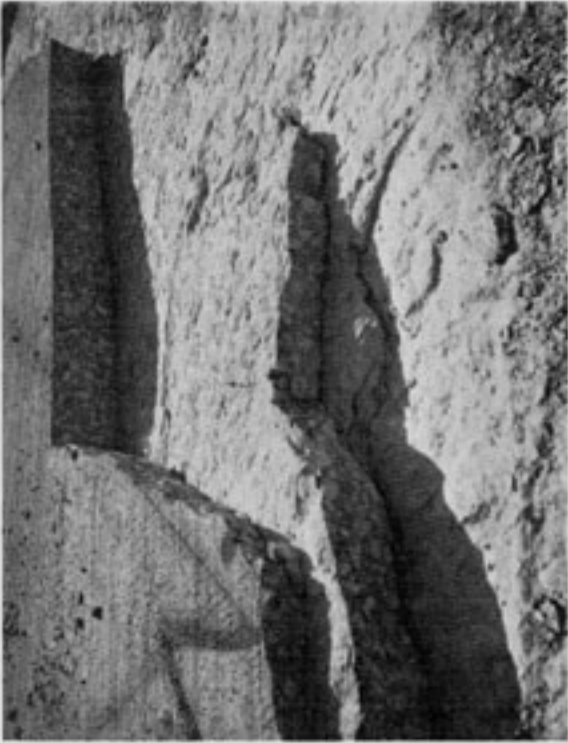
Multiple delaminations at azimuth 316° and radius 8'.

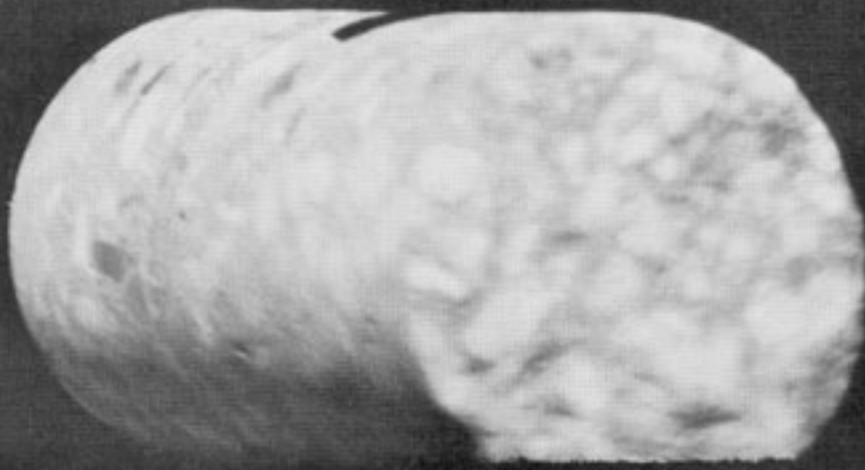
CORE REMOVED FROM DOME DELAMINATED SURFACE ON BOTTOM OF SPECIMEN

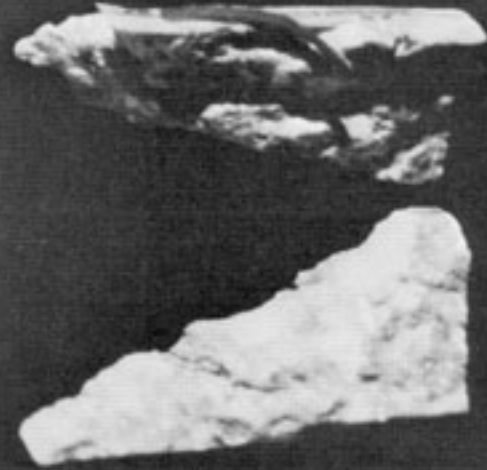
FINAL COMPRESSION FAILURE WEDGES FORMED IN MULTIPLE PLANES

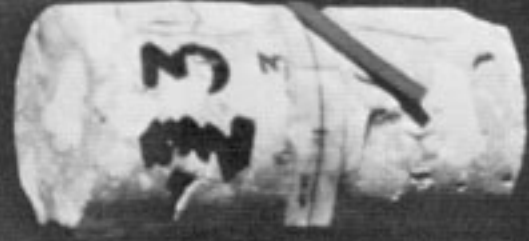
INITIAL COMPRESSION FAILURE VERTICAL CRACKING

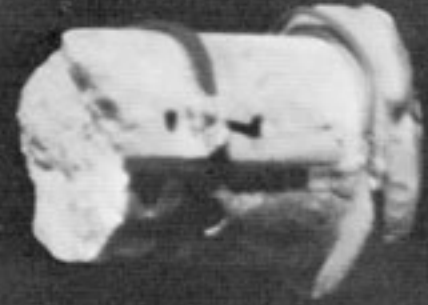
TENSION FAILURE
