1.0 INTRODUCTION

This report describes the Turkey Point Unit 3 containment dome, delamination of the dome concrete during post tensioning of tendons, the subsequent investigation and analysis of this phenomena, and the repair and test program. When about two thirds of the dome tendons had been tensioned, it was noted that concrete cracking and sheathing filler leakage was developing and that in some areas of the dome, the concrete felt springy when walked on. The dome was struck with a sledge hammer and, in some areas, it sounded as if it were hollow. The concrete was locally removed in some of these areas and shallow (approximately 1/2" to 4") delamination planes were found running almost parallel with the surface, but eventually intersecting it. A full investigation was begun to determine both the extent and cause of the delaminations, and to cover the following:

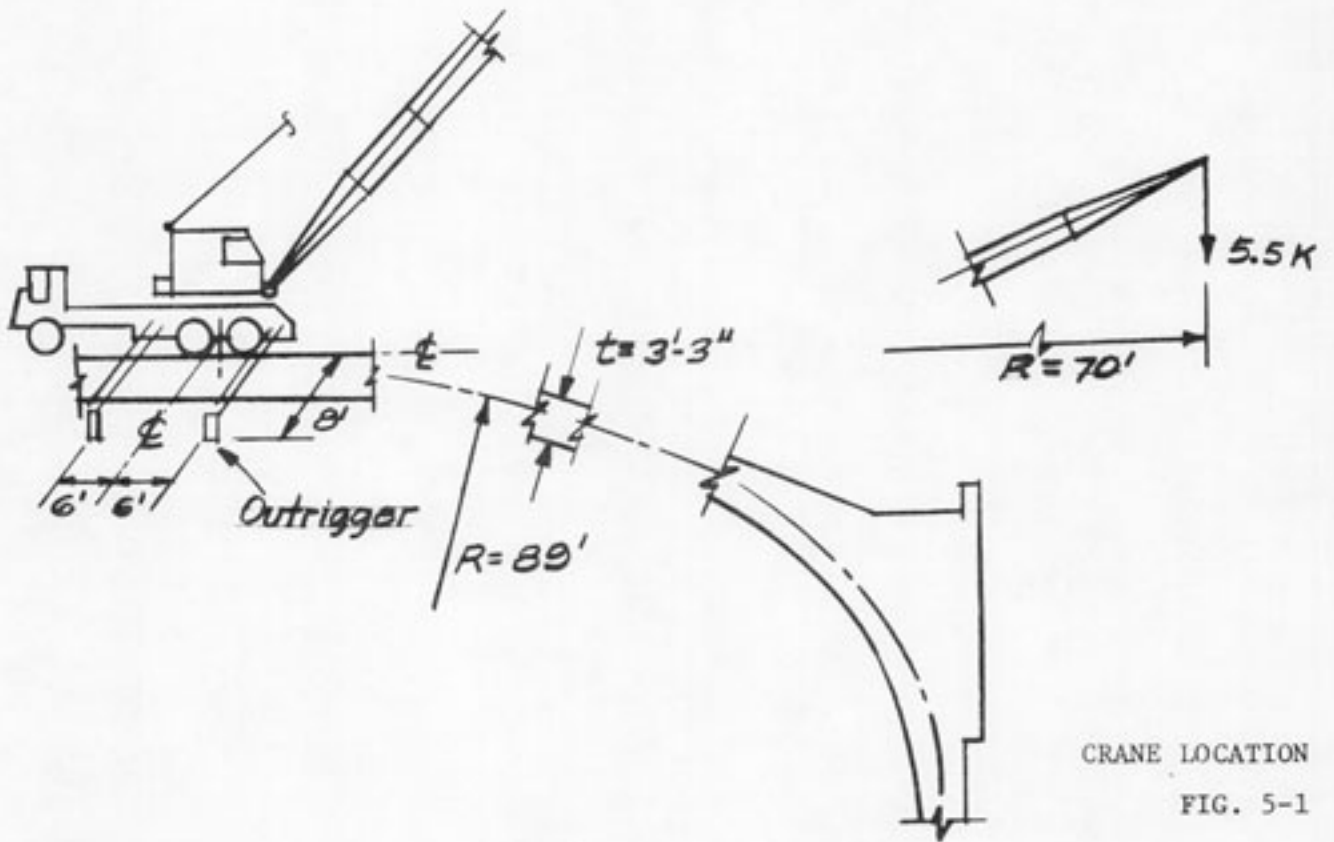
CRANE LOCATION
FIG. 5-1

Due to the low magnitude of the calculated stresses the crane is not considered a significant contributor to delamination causes.

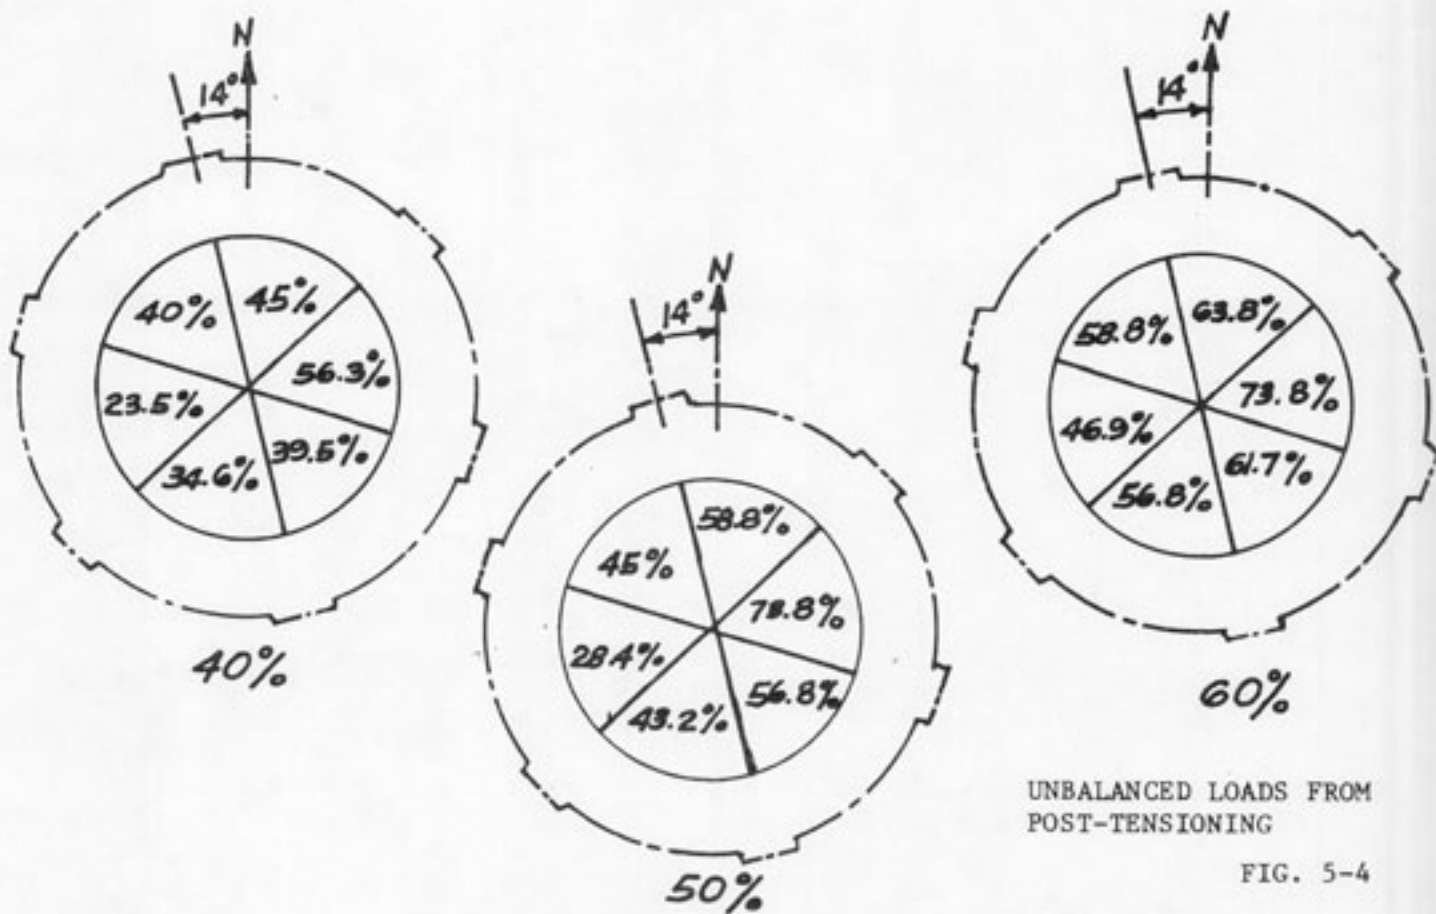
FIG. 5-4

In the first part of the analysis the structure was loaded with the unbalanced load resulting when post-tensioning was 50% complete as shown in Figure 5-4. Due to the assumed boundary conditions all the forces at the construction joints acted through the center of the section with no eccentricity. The stresses resulting at the outer surface from this loading condition are shown on Figures 5-15 and 5-16 for the meridional and circumferential directions. The peak meridional stress is - 1420 psi (compression) and the peak circumferential stress is - 1220 psi.
