UNITED STATES
DEPARTMENT OF THE INTERIOR
GEOLOGICAL SURVEY

THE EFFECTS OF PLUGGING A DEEP ARTESIAN WELL ON THE
CONCENTRATION OF CHLORIDE IN WATER IN THE WATER-
TABLE AQUIFER AT HIGHLAND ESTATES, LEE COUNTY, FLORIDA

D. H. Boggess

Open-File Report

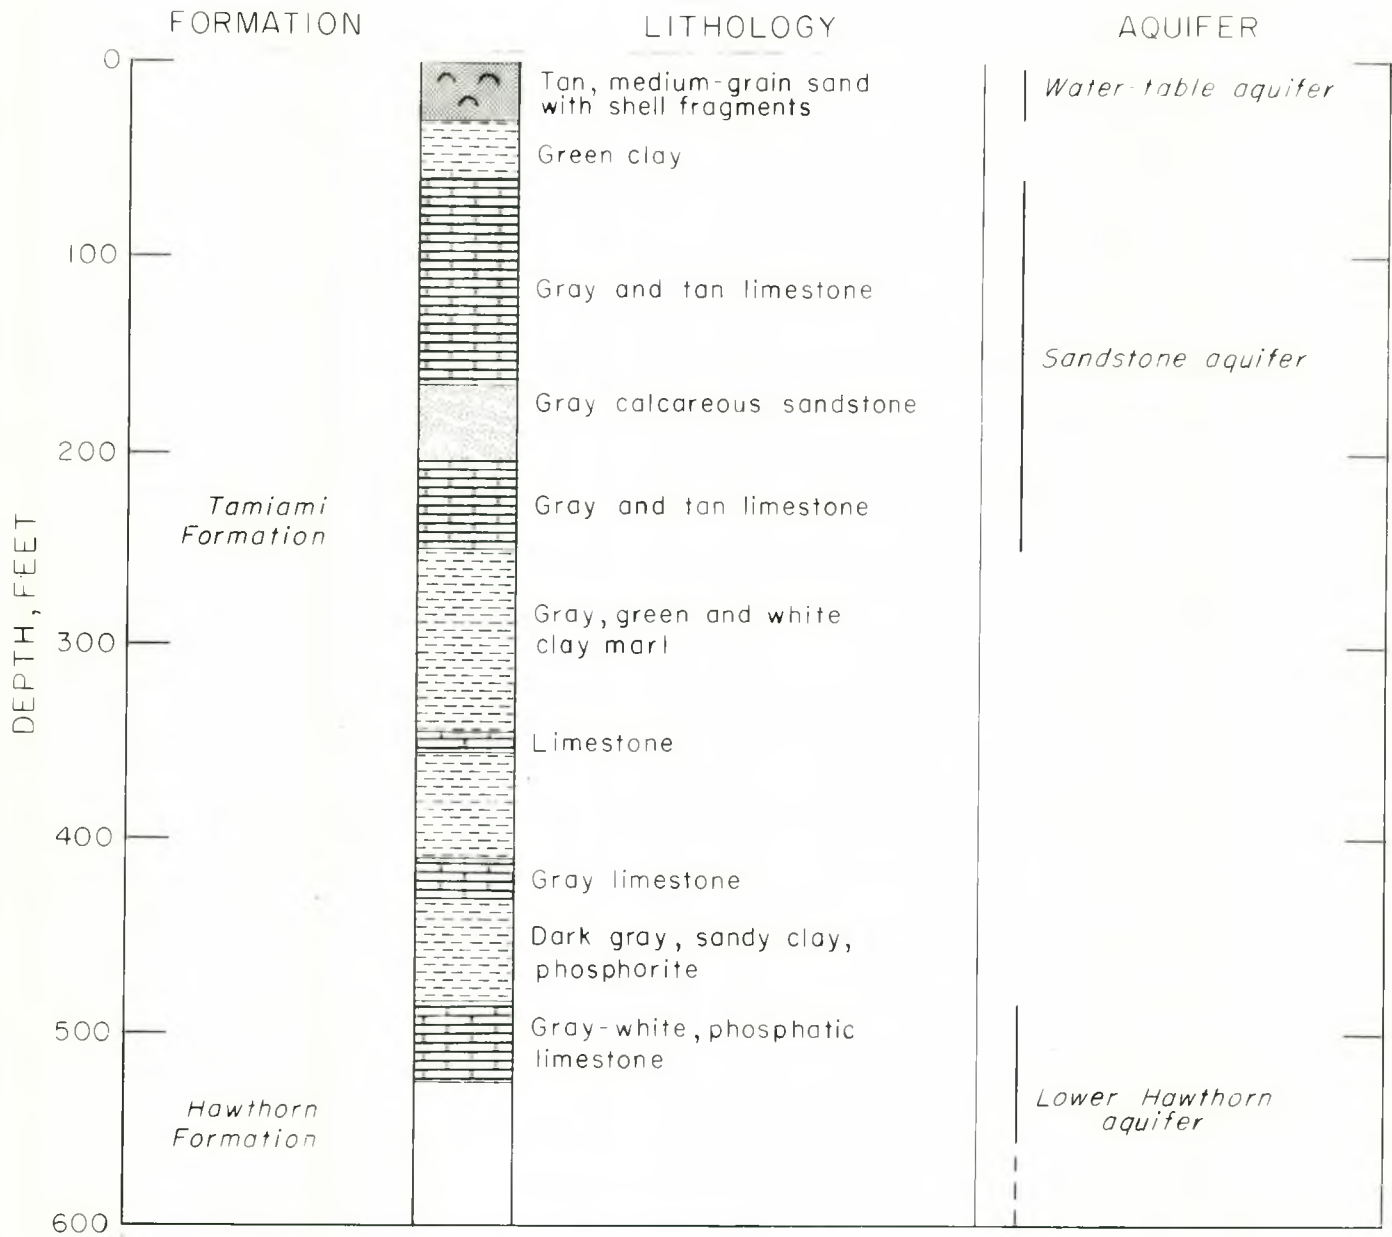
The uppermost water-bearing unit that underlies Highland Estates is called the water-table aquifer. It consists of tan colored medium sand and some shell fragments (fig. 2). It extends from the land surface to a depth of about 30 feet. The aquifer is recharged directly by rainfall. The water table fluctuates from 2 to 6 feet below the land surface (6-10 feet above sea level) during the rainy season and from 9 to 10 feet (2-3 feet above sea level) during the dry season. The chloride concentration in water from the aquifer generally ranges from 20 to 40 mg/l (milligrams per liter).

Figure 2.--Composite log of formations, lithology, and aquifers underlying Highland Estates.

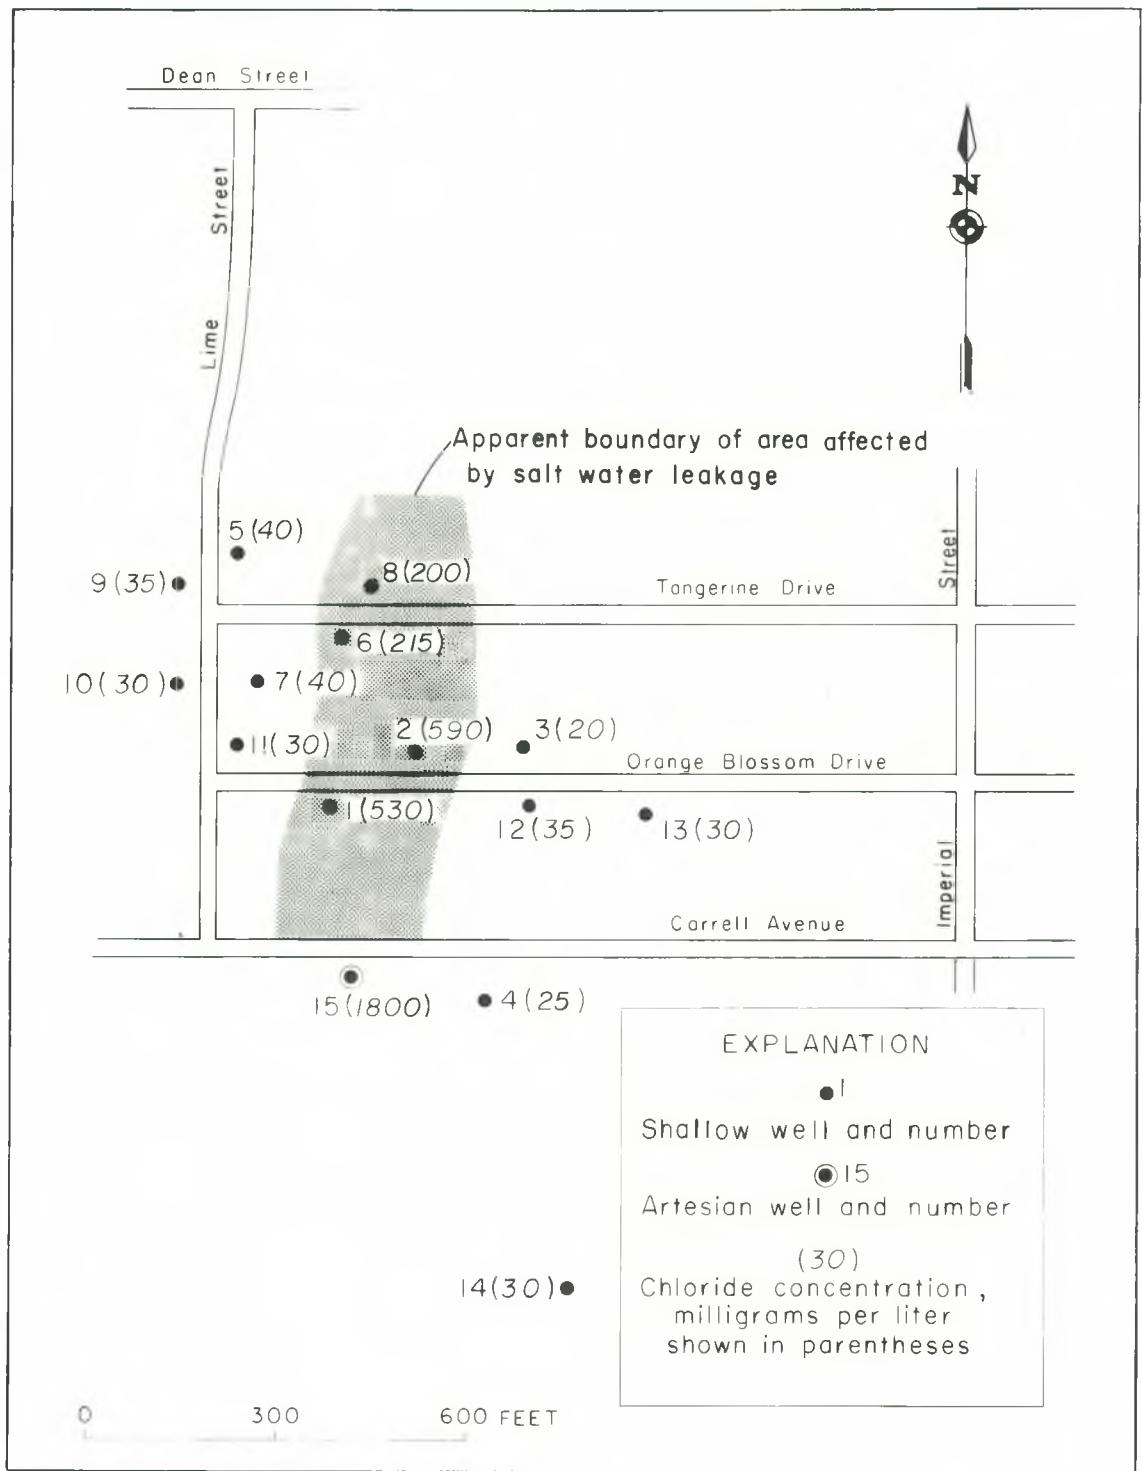
Figure 3 shows the location of 15 wells in the Estates and the chloride content in water samples collected from them on January 28, 1968. Except the samples from well 15, all were from wells 20 to 25 feet deep constructed in the water-table aquifer. As shown on figure 3, chloride concentrations in water from the shallow wells ranged from 25 mg/l in well 4 to 590 mg/l in well 2. Four shallow wells, numbers 1, 2, 6, and 8, aligned northward, yielded water much higher in chloride than from similar wells in adjacent areas.

Figure 3.--Map showing location of wells at Highland Estates and chloride concentrations in water on January 24, 1968.

Well 15, south of well 1 and along the same general alignment (fig. 3), contained water with a chloride concentration of 1,800 mg/l. This well apparently tapped the lower Hawthorn aquifer at depths below 485 feet as evidenced by the high artesian head, 19.4 feet above land surface. The depth of the well could not be determined because of blockage within the well bore. Geophysical logs run on the upper part of the well indicated that the casing extended to a depth of only 80 feet.

The metal casing of well 15 was badly corroded particularly where the casing was leaking. The control valve on top of the casing, installed in 1961 to prevent flow from the well, was closed. The ground around the well was wet, although no standing water was evident. Upon opening the control valve, the well flowed about 5 gpm.

The unusual distribution of higher chloride concentrations in wells 1, 2, 6, and 8 along the relatively narrow path north of well 15, probably resulted from local variations in the permeability of the sediments comprising the water-table aquifer. Most likely the path of intruding saline water marks the direction of the hydraulic gradient and the subsurface location of an accumulation of shell detritus or other material of high permeability that is similar to beds formed by wind and wave action along present shore lines.

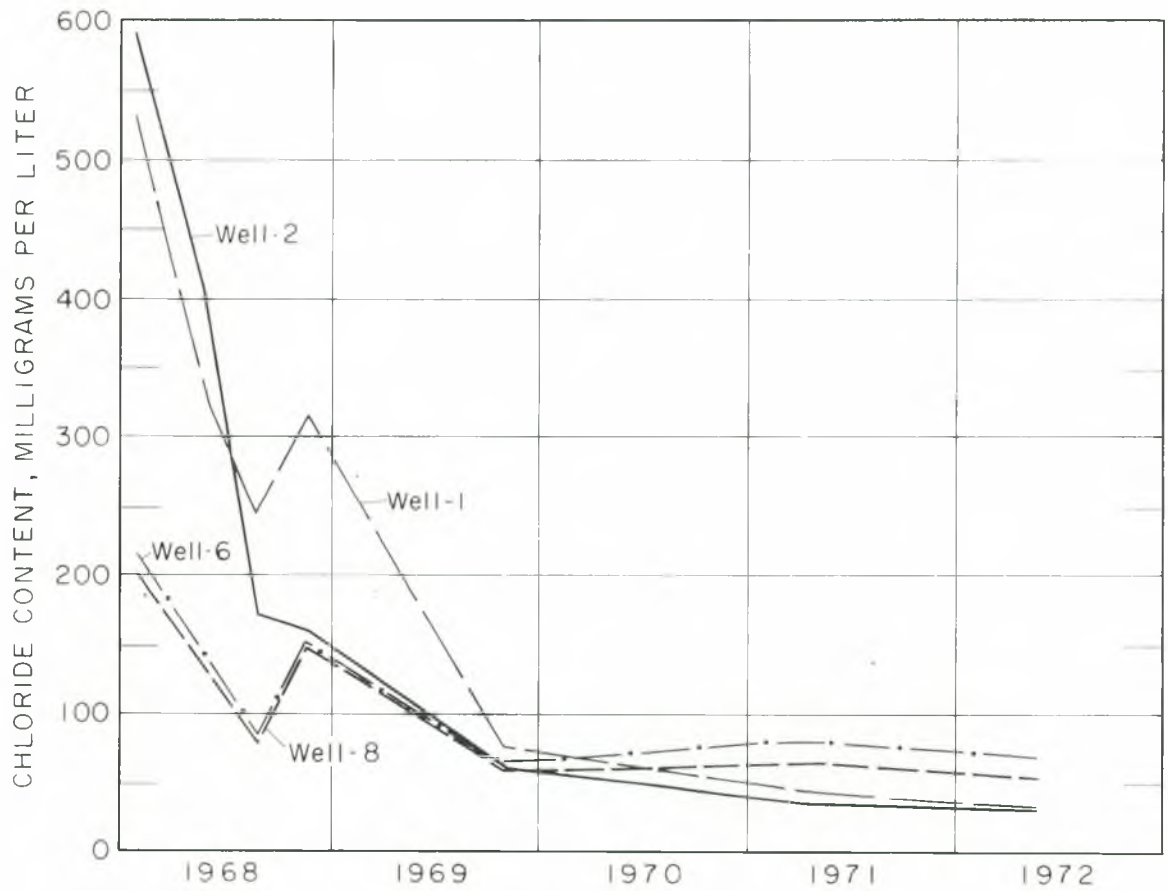
After well 15 was plugged, the chloride content of water from wells 1 and 2, about 270 and 370 feet from well 15, decreased 180-200 mg/l by May 1968 as shown in figure 4. The chloride content continued to decrease until August when the total reduction was 285 mg/l in well 1 and 420 mg/l in well 2. The chloride content of water from wells 6 and 8, about 540 and 620 feet from well 15, decreased 120-130 mg/l over the same period. The reduction in chloride concentrations probably was related in part to the dilution and flushing of saline water from the aquifer by rainfall which began in May.

Analyses made in November 1968, after this initial period of decreasing concentrations, indicated that chloride in water from wells 1, 6, and 8 had increased by 65-70 mg/l. This probably represents residual contamination from saline water that had gained access to the aquifer before well 15 was plugged.

Figure 4.--Variations in chloride concentrations in wells 1, 2, 6, and 8, 1968-72.

By October 1969, about 20 months after well 15 was plugged, the chloride content of water from wells 1, 2, 6, 8 was less than 80 mg/l, indicating a decrease of 452 mg/l in well 1; 528 mg/l in well 2; 151 mg/l in well 6; and 140 mg/l in well 8. Additional observations in April 1971 and May 1972 indicated some variation in chloride content in wells 6 and 8, but a continued decrease in wells 1 and 2.

On February 15, 1968, well 15 was plugged under the supervision of H.J. Woodard and C.R. Sproul of the Florida Department of Natural Resources. A water-cement mixture containing about 16 bags of cement was pumped into the well during the plugging operation. This stopped all visible leakage from the well at or near the surface and no further leakage has been noted.

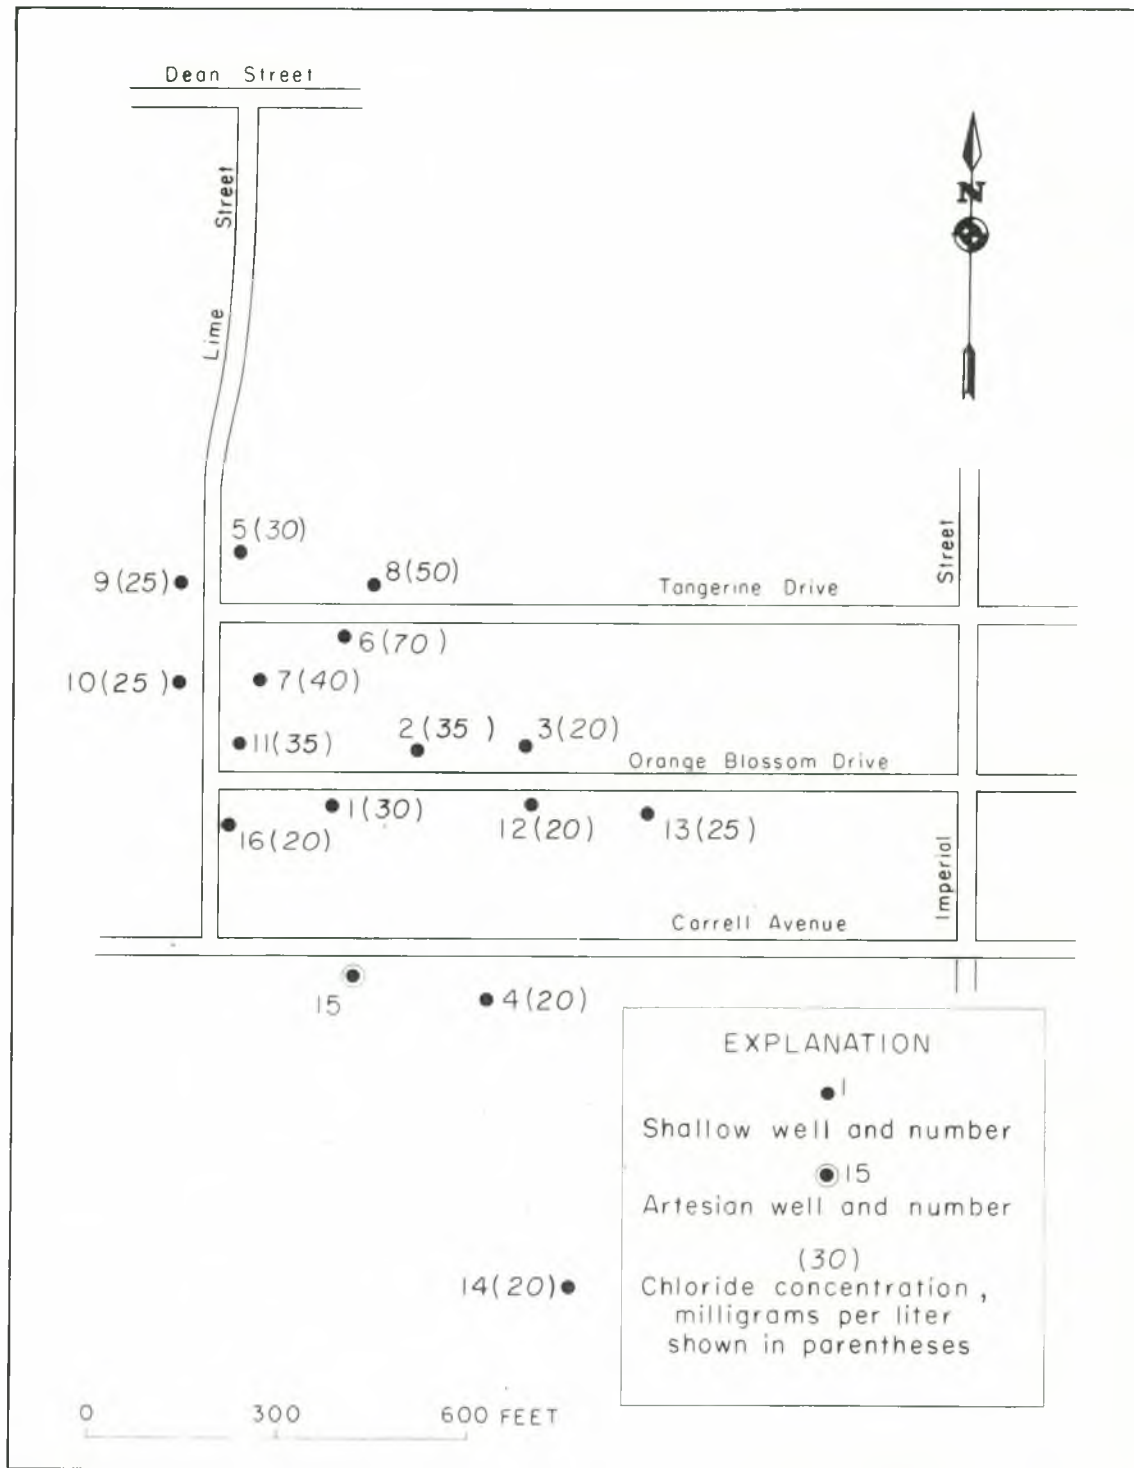
All except one of the wells sampled in January 1968 were sampled again in May 1972, more than 4 years after plugging well 15. The chloride analyses are shown in figure 5. Water from wells 1 and 2, formerly most affected by leakage of saline water from well 15, contain chloride within the normal range in water from other wells in the water-table aquifer. Wells 6 and 8 showed some residual effects of the saline water which entered the aquifer earlier.

The results of this brief investigation provides reliable evidence that surface discharge and subsurface leakage from well 15 were the primary sources through which saline water entered the water-table aquifer at Highland Estates. The results further indicate that rainfall will, in time, dissipate most of the effects of the saline water, provided the conduit remains tightly sealed.

Figure 5.--Map showing chloride concentrations in wells at Highland Estates on May 24, 1972.
