INTERIM FINAL DRAFT REPORT
ON
EMBANKMENT FAILURE
FLORIDA POWER & LIGHT COMPANY
MARTIN PLANT COOLING RESERVOIR

April 1980

South Florida Water Management District
West Palm Beach, Florida

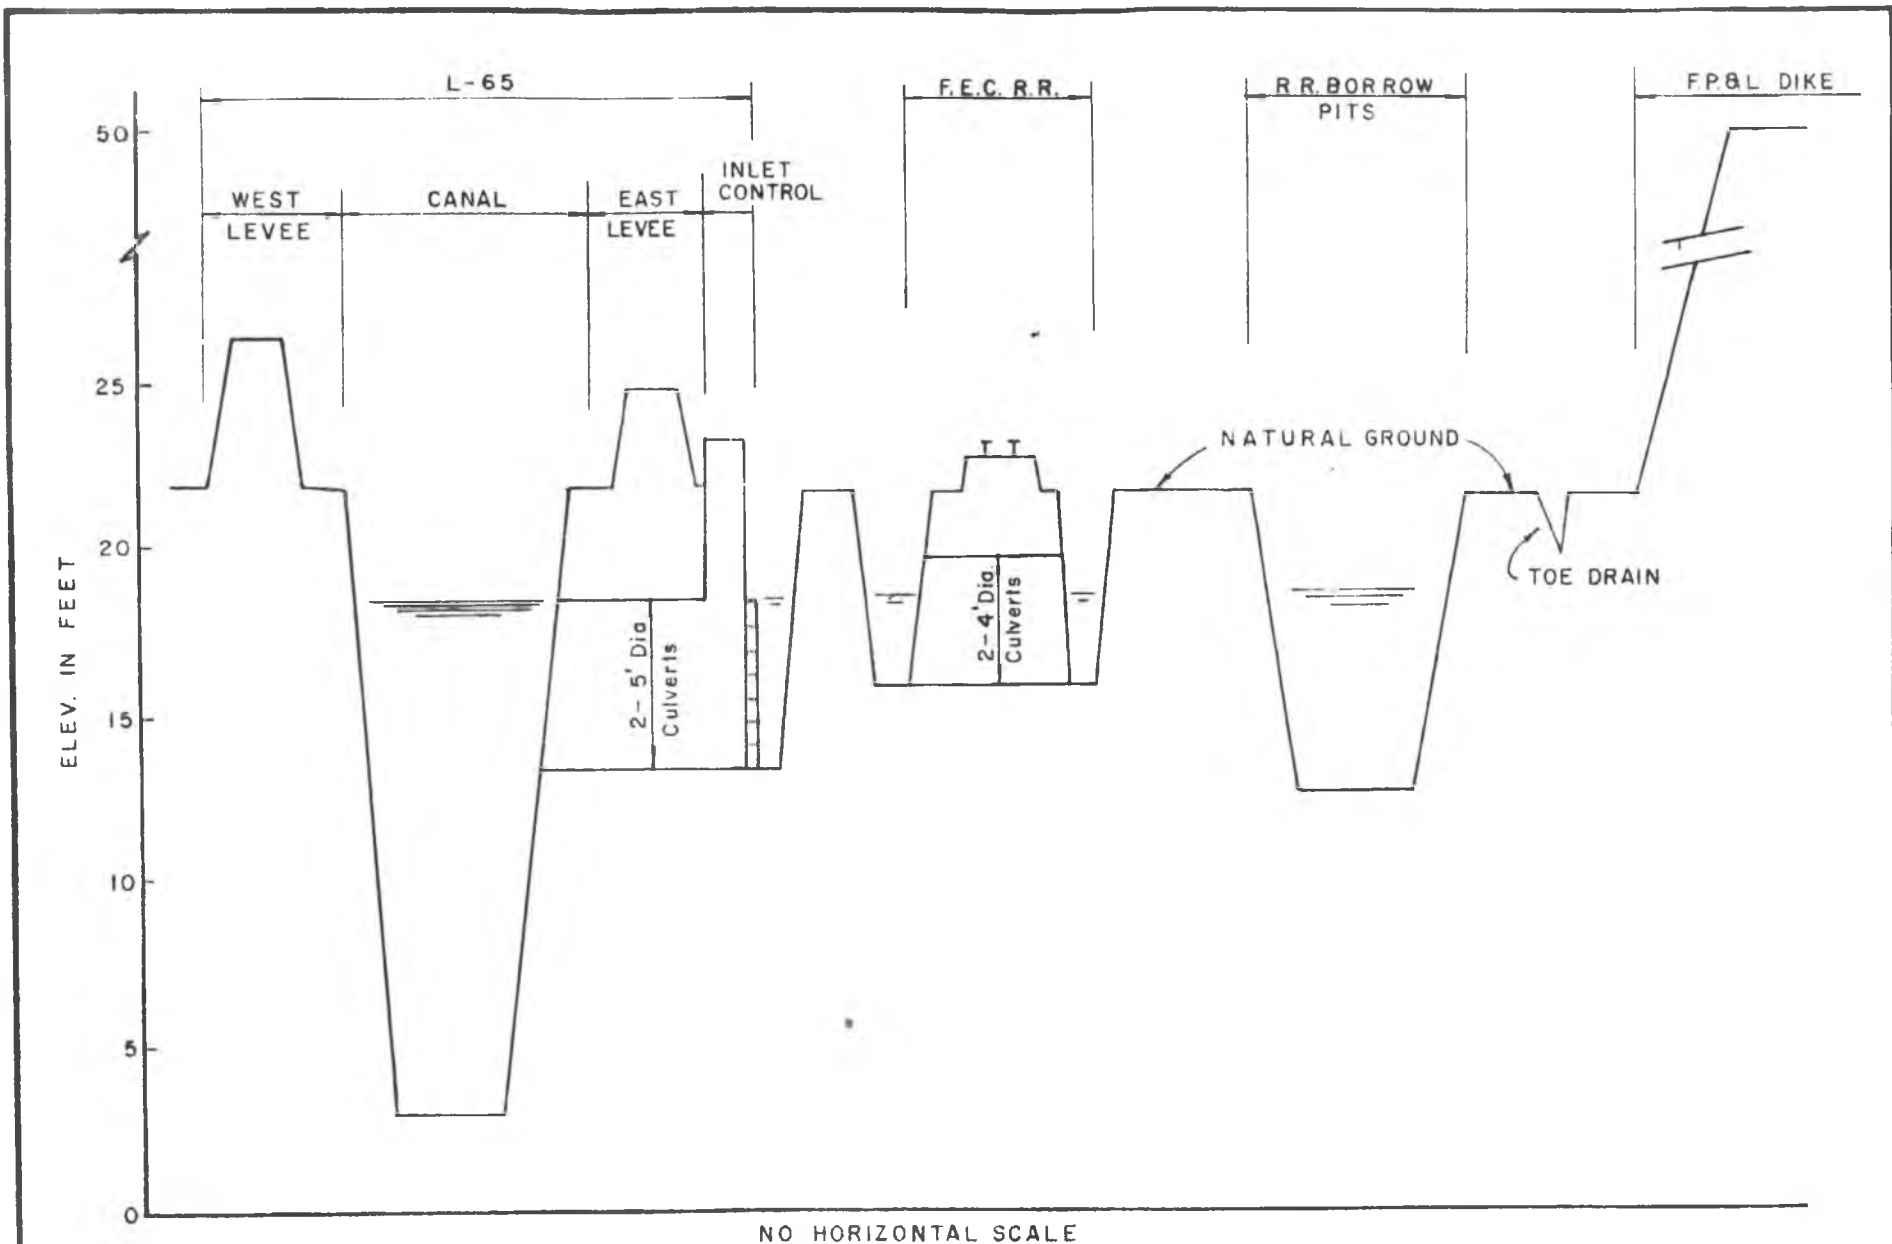
Figure 1-3

DIAGRAMATIC PROFILE IN BREACH AREA

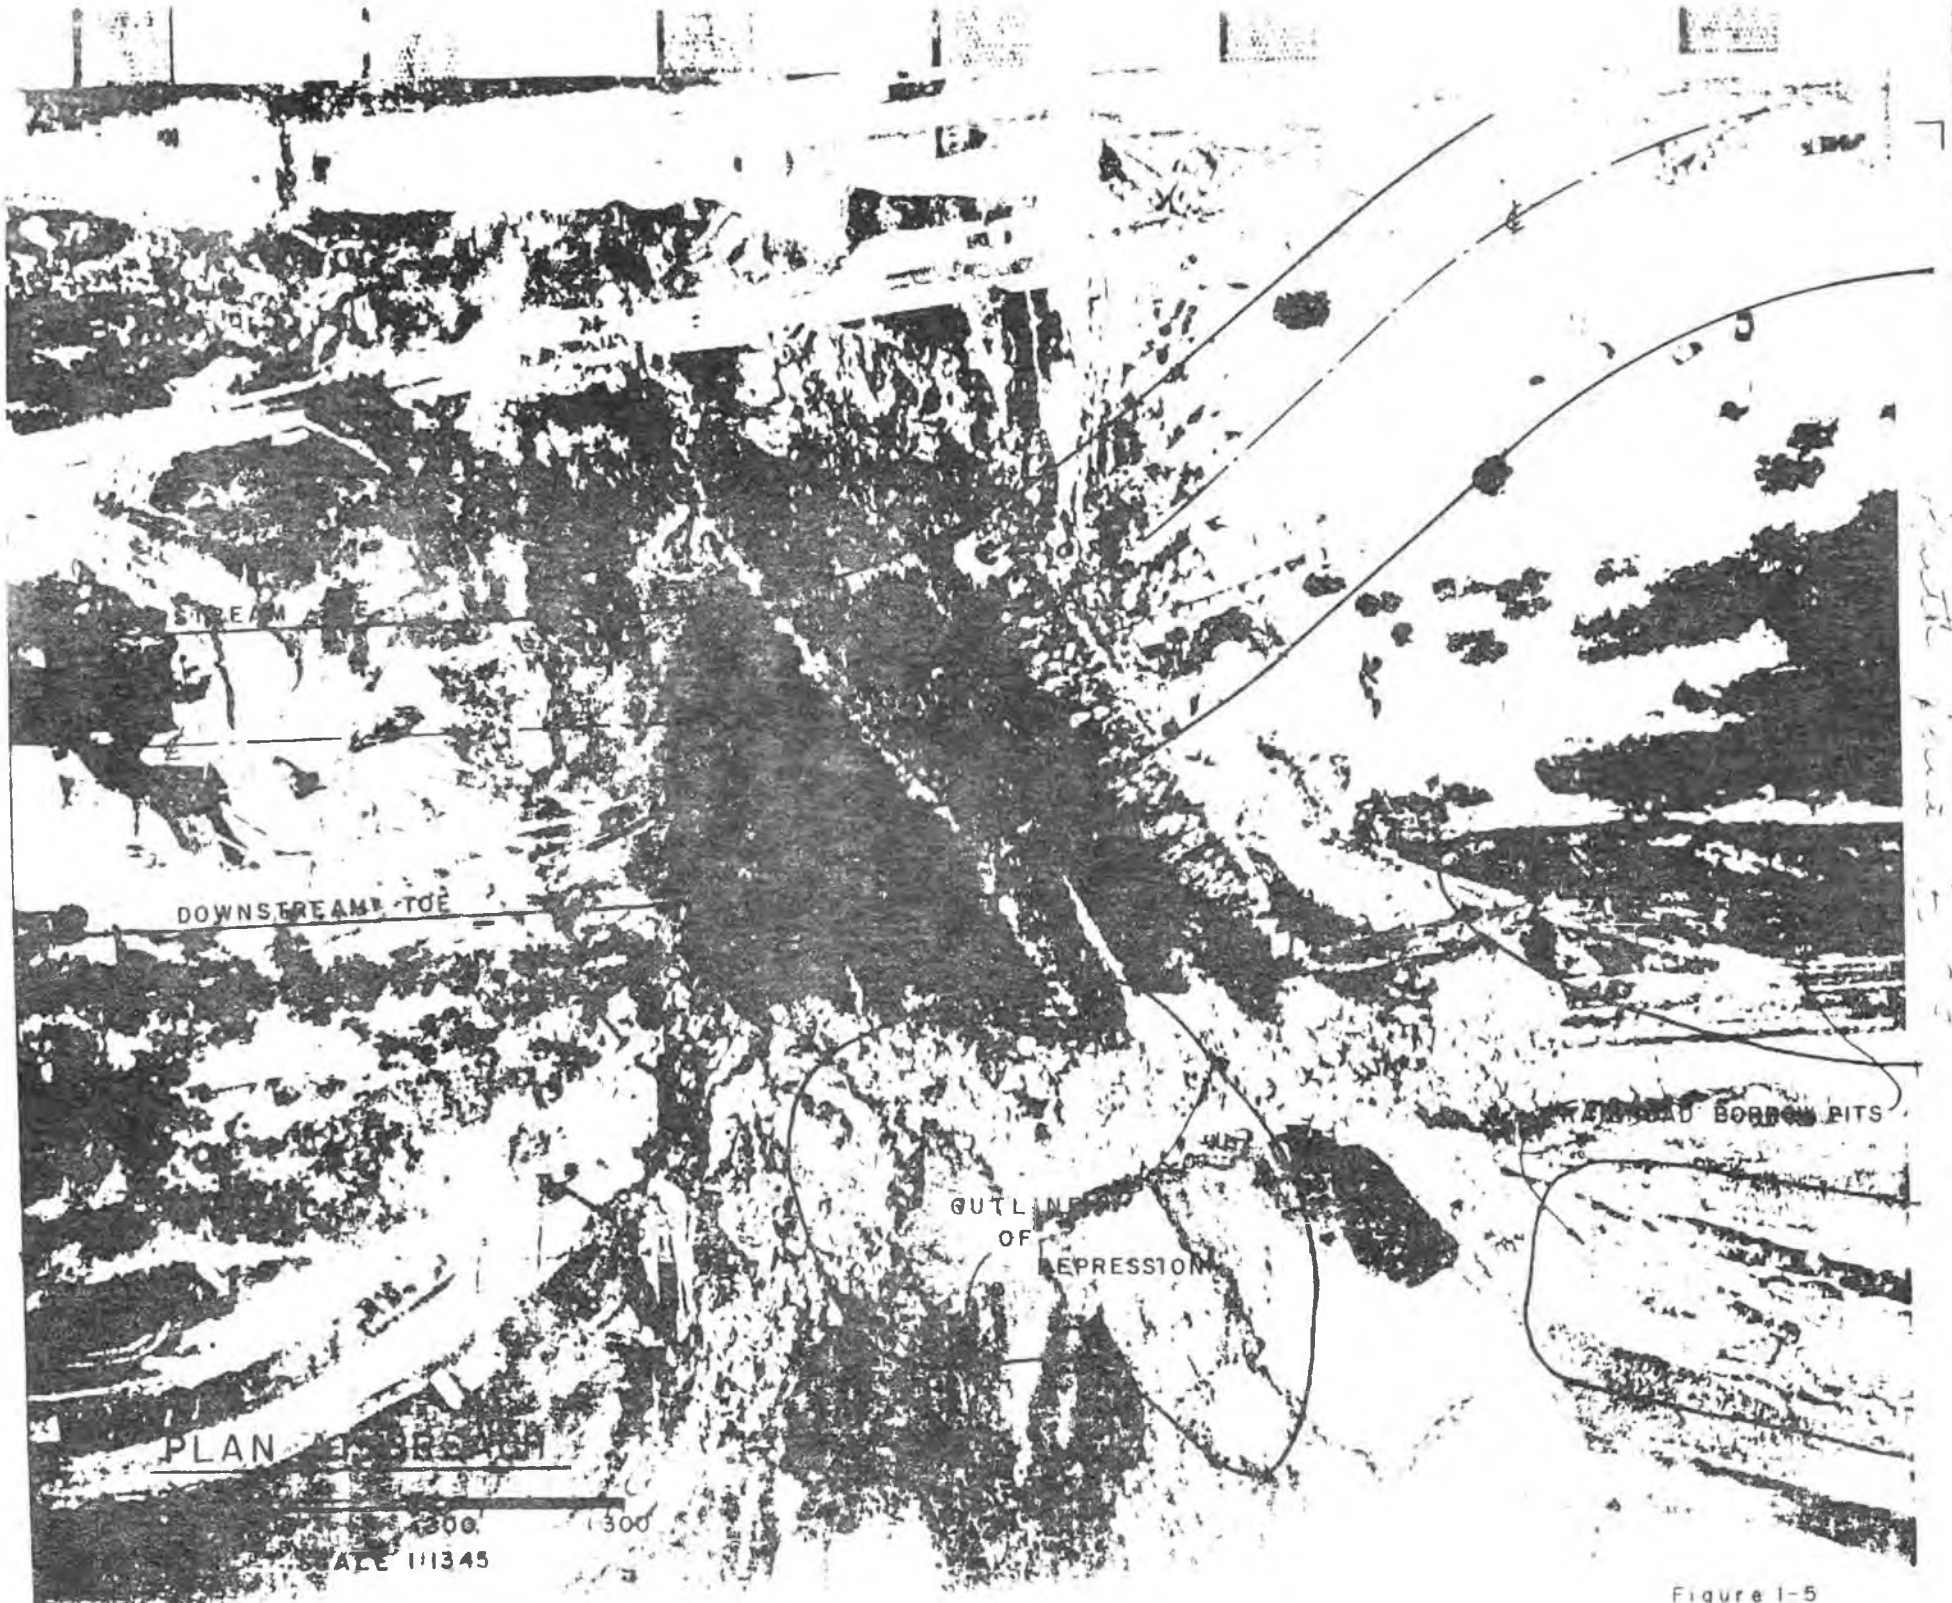
Figure 1-5

450 feet wide (parallel to the dike) by about 700 feet long (perpendicular to the dike). See Fig. 1-5. The deepest part of the scour hole was located in the center and west of the breach. This deepest hole was also rectangular in plan, 190 feet wide by 400 feet long. The invert of this hole was at elevation -7 feet at the east end; it sloped upward to an elevation of about +4 feet at the west end. Surrounding this deep scour hole a dark brown silty sand stratum was uncovered at about elevation 0 to +4. All material above this stratum was eroded away in the scour area. A vertical section along the embankment center line through the breach was U-Shaped, about 600 feet across the top, with vertical faces from natural ground to the embankment crest.

The soil cement slope protection collapsed in place, ending in a heap along the embankment alignment except in the very center of the breach. See Fig. 1-5. In this location a gap was left in the remnants of soil cement, about 10-15 feet wide. The soil cement as it fell into its final resting place broke into large random sized slabs on an average of 6 feet x 6 feet. Each slab was about 6 inches thick, the original thickness. On each side of the center gap in the soil cement, the remaining pieces were moved about 40 feet to the west. A few large slabs about 5 feet square were deposited roughly 300 feet below the embankment and numerous smaller pieces (1+ feet square) were carried as far downstream as the railroad.

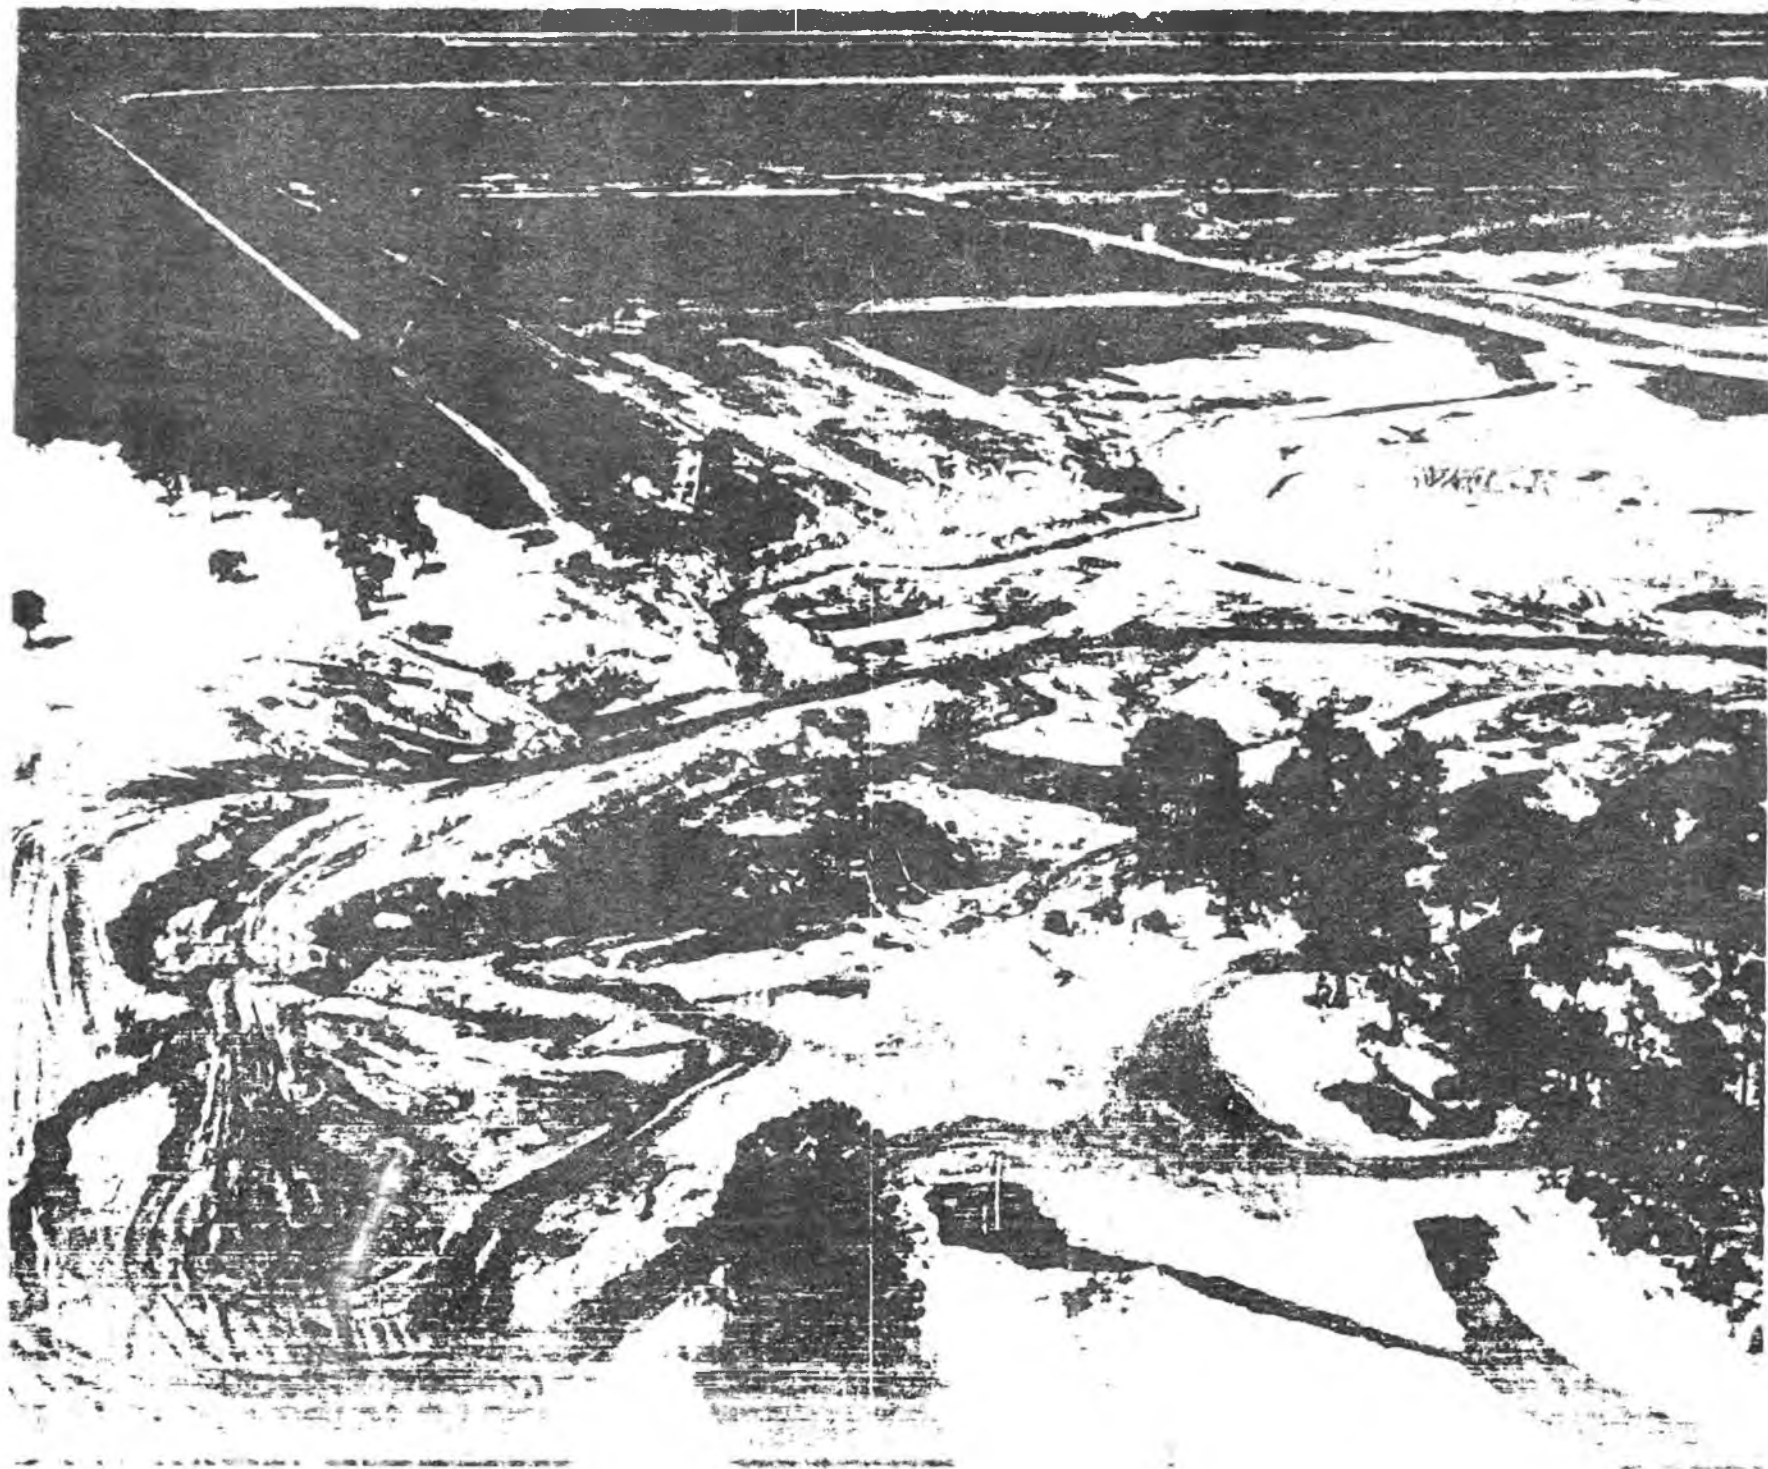
6. Photos taken by special flights from District aircraft which enabled this committee to monitor progress of the initial stages of breach area repair. See Figure 5-11 .

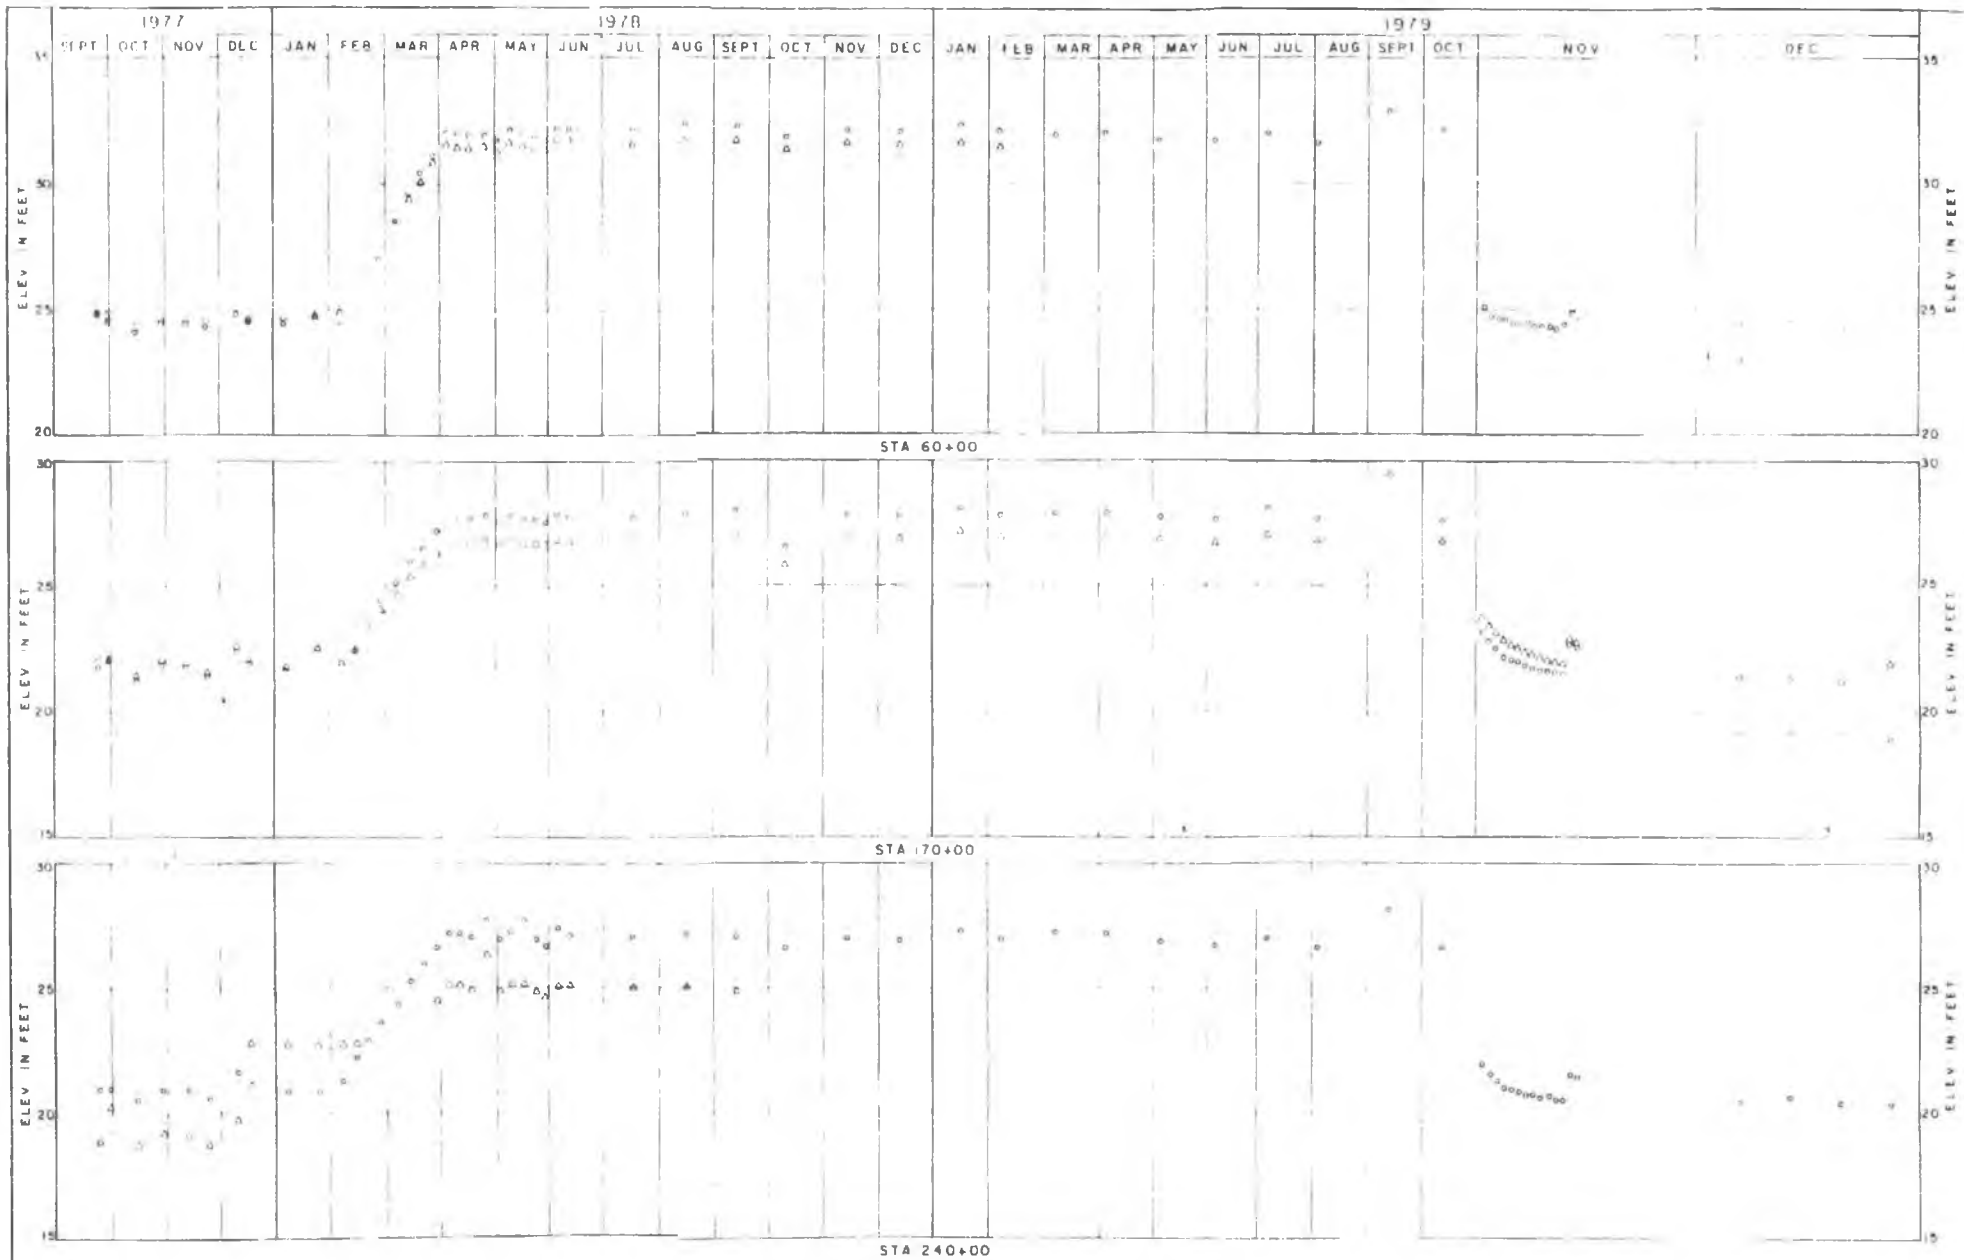
3. The D and E piezometers were plotted for their entire period of record and are shown in Figure ^{5-12A & 5-12B}. An inspection of pairs of piezometric heads reveals what can be considered to be anomalous conditions. For example, the potentiometric gradient from transect to transect changes. That is, in some transects the water level above the shell is higher than water levels measured below the cemented shell. Thus the gradient would be in a downward direction. This can be seen in the D & E piezometers at station 460+00. Conversely, at all other stations (60, 170, 240, 370, 670, 800) the water levels measured in the deep piezometer (E) stand higher than water levels measured in the shallow wells (D). In this latter situation the potentiometric gradient can be considered to be in an upward direction. The reason for this change in potentiometric gradient most probably relates to subtle changes in permeability of the various soil layers in the vicinity of the piezometers and the position of the regional hydraulic gradient.

4. The direction of the gradient does, however, take on meaning when evaluated in terms of probable causes of failure. One of the theories that had been proposed suggests that a downward gradient could drive the very fine sand overlying the shell into the underlying open fabric of the shell rock; and, by degrees, sediment would be removed by upward "stoping" and deposited in the shell until finally the reservoir embankment could be breached and failure could occur. The mechanics of such a

failure mechanism must take into account the differential head between these two formations. Obviously, the greater the head in a downward direction, the higher the velocity and thus the better the ability to transport the sand grains from their in-situ position into the shell rock. Continuing this line of reasoning, one must recognize that there is a minimum velocity (time travel relationship) where the forces available are insufficient to move the sand grains. Further detail concerning this mechanism is covered elsewhere in this report.
