PRELIMINARY REPORT ON
RAINSTORM OF APRIL 23-26, 1982

Steve Lin

Water Resources Division
Resource Planning Department
May 6, 1982

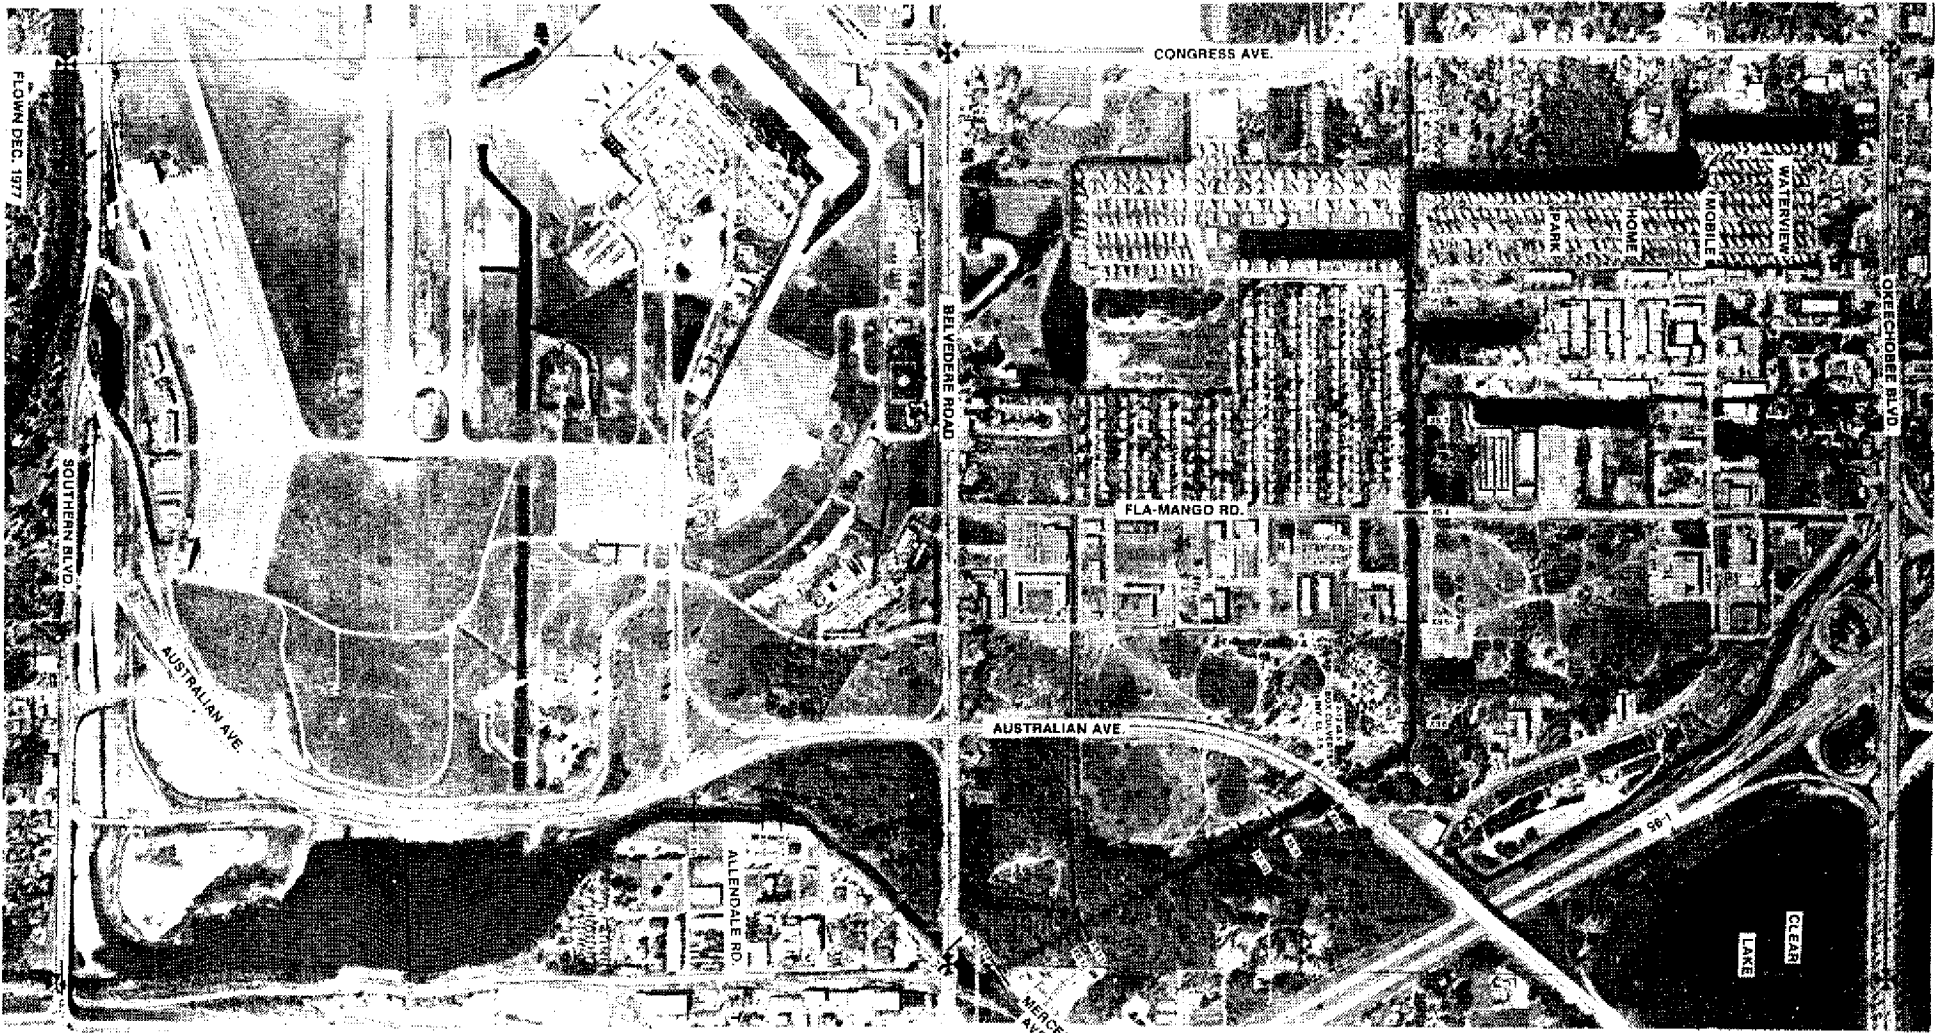
The following high water marks (refer to Figure 3A for locations) were surveyed on April 29, 1982 as compared to the high water marks for the March 28-29, 1982 and September 17-18, 1960 rainstorms.

It should be noted that the high water mark at the Australian Avenue Bridge crossing the stub canal was 0.4 feet higher than at Waterview Mobile Home Park during this rainstorm. This has been checked twice to be sure that the water level did approximate this elevation at Australian Avenue. The possible explanation for this is that water must have spilled over the spillway from Clear Lake into the stub canal downstream of Australian Avenue during this rainstorm, together with discharge from the Palm Beach Lakes south area. This amount of water may have caused a momentary backwater to this site long enough to leave a high water mark.

The historic high water mark in the area of Waterview Mobile Home Park, about 15.00 ft msl, resulted from the September 17-18, 1960 rainstorm. This compares to 13.50 ft msl and 11.22 ft msl from the March and April 1982 rainstorms. This mobile home park did not exist prior to 1962. The rainfall for September 17-18, 1960 was 8.79 inches as reported by Palm Beach International Airport which was about 0.4 inch less than the heavy rainstorm of 1982.

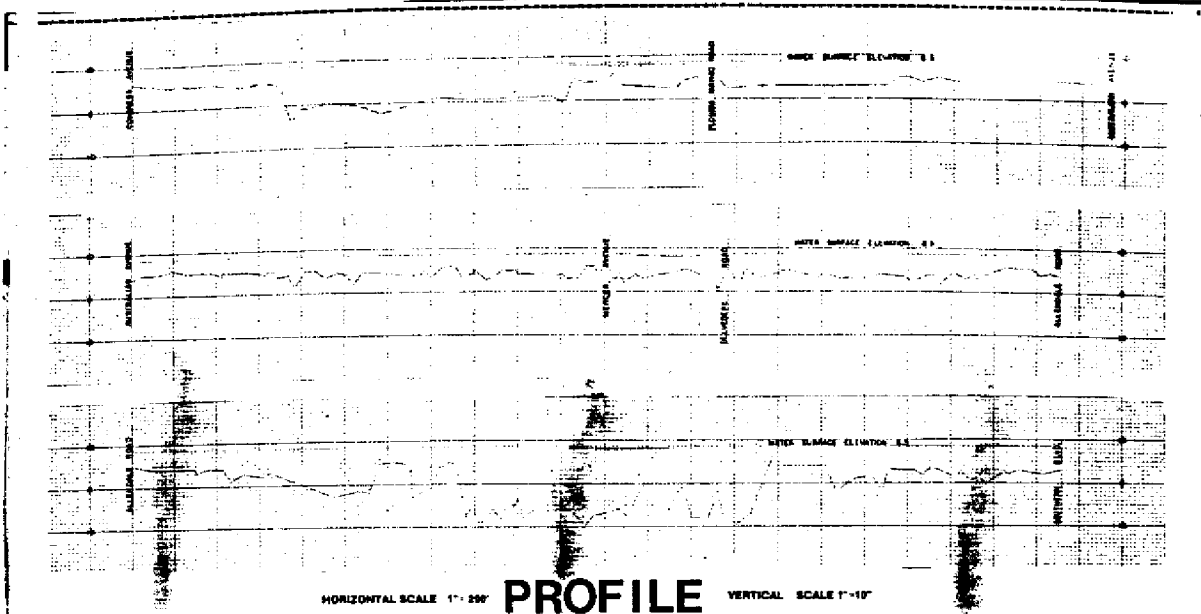
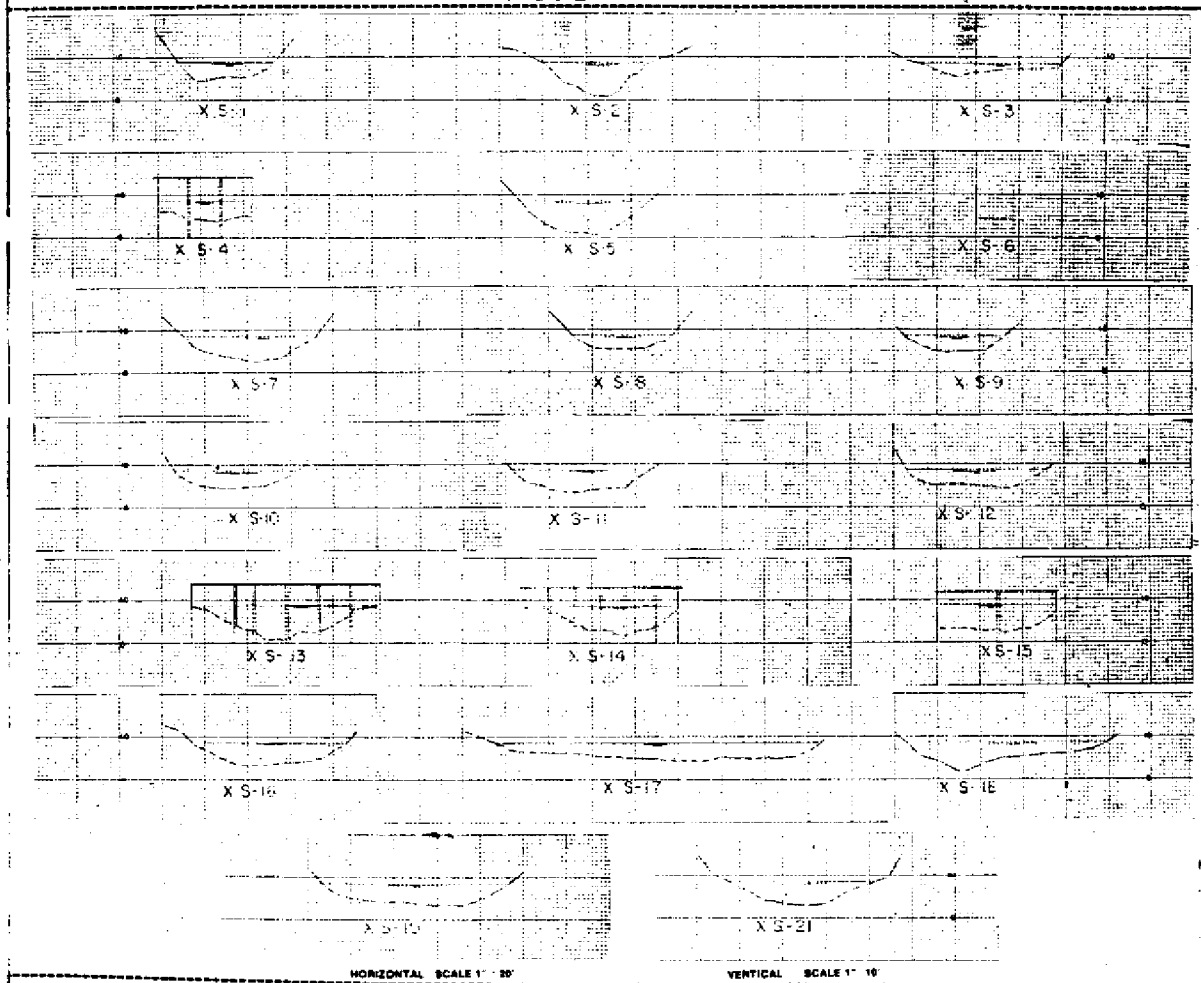
Figure 3B

- c). Inadequate channel capacity - The existing cross-section of the Stub Canal in the reach between Australian Avenue and the downstream reach of Belvedere Road has been shoaled due to sedimentation. The expansion and construction in the area, especially the industrial park, has

increased the erosion problem in the area. The existing cross-section no longer can handle its design capacity. The survey of the channel cross-section along the Stub Canal is shown in Figure 3B.

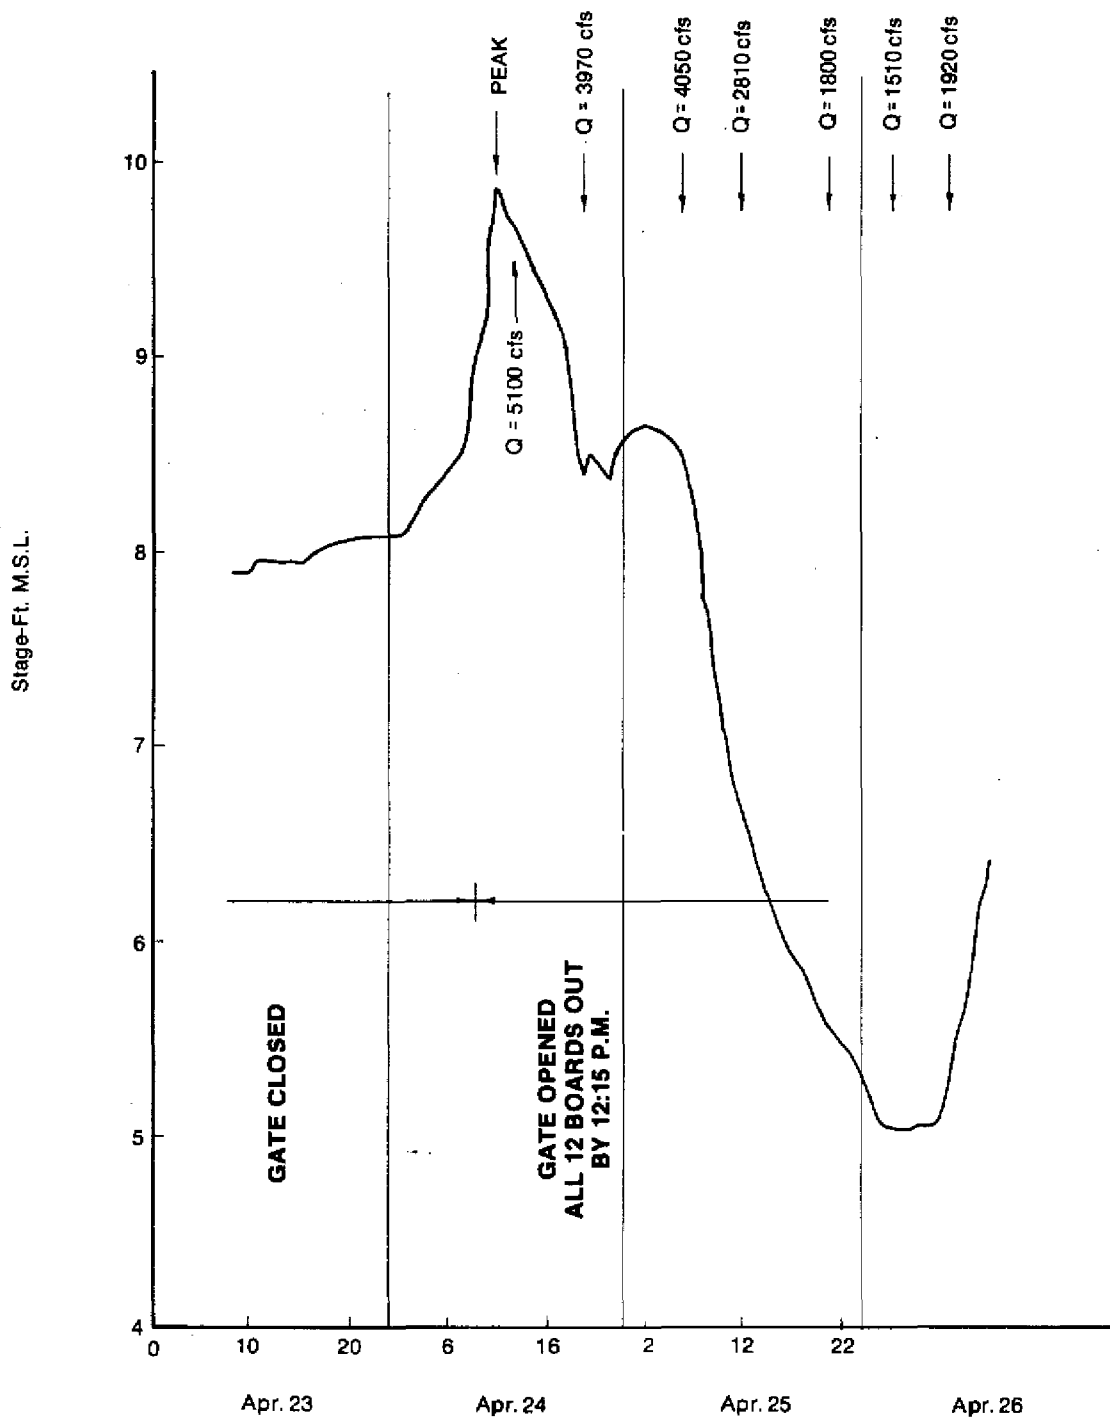
Figure 4 HOURLY STAGE HYDROGRAPH AT PALM BEACH LOCK DURING RAINSTORM OF APRIL 23-26, 1982

1. Palm Beach Lock - Figure 4 shows the hourly stage hydrograph during this rainstorm. The gate on the lock was closed until 9 AM April 24, 1982 and opened on automatic at 9:15 AM. The headwater stage was at 8.98 ft msl. At the same time, the service crew was on the way to pull the boards. The crew started pulling boards at ±11 AM and finished at ±12:15 PM. At 12:15 PM the structure was full open, all boards out, and the stage at the lock reached its peak (9.88 ft msl). The peak discharge at the lock was at 5100 cfs with an average flow, during April 24, 1982, at 4200 cfs. The peak stage was about 0.80 feet less than last month's rainstorm. The peak stage in the West Palm Beach Canal at the District's Field Station was 10.58 ft msl (at ±12 noon April 24, 1982). The high water mark at the Summit Boulevard crossing of the West Palm Beach Canal was 10.23 ft msl. In other words, due to the operation of the system and the rainfall from this event, stages in the system were about one foot below the high water mark during the March 28-29, 1982 rainstorm. The boards in the lock were pulled out more quickly than during the March storm, which took over five hours of effort during the night of March 28-29, 1982.

The boards in Palm Beach Lock were pulled out at 12:15 PM April 24, 1982. A peak stage of 9.88 ft msl at the lock was reached at 12 noon. This peak was the second highest stage since 1960 and also the second highest stage in this dry season. The return frequency of this stage is about one in 11 to 12 years. The peak stage at Summit Boulevard and the District's Field Station are 10.23 ft msl and 10.58 ft msl, respectively. These readings are about one foot lower than last month's readings (March 28-29, 1982 storm).

The events of March and April have vividly demonstrated the inadequacy of this antiquated structure, which is not responsive to the needs of an urban watershed. The replacement structure, S-155, is under contract by the Corps of Engineers.

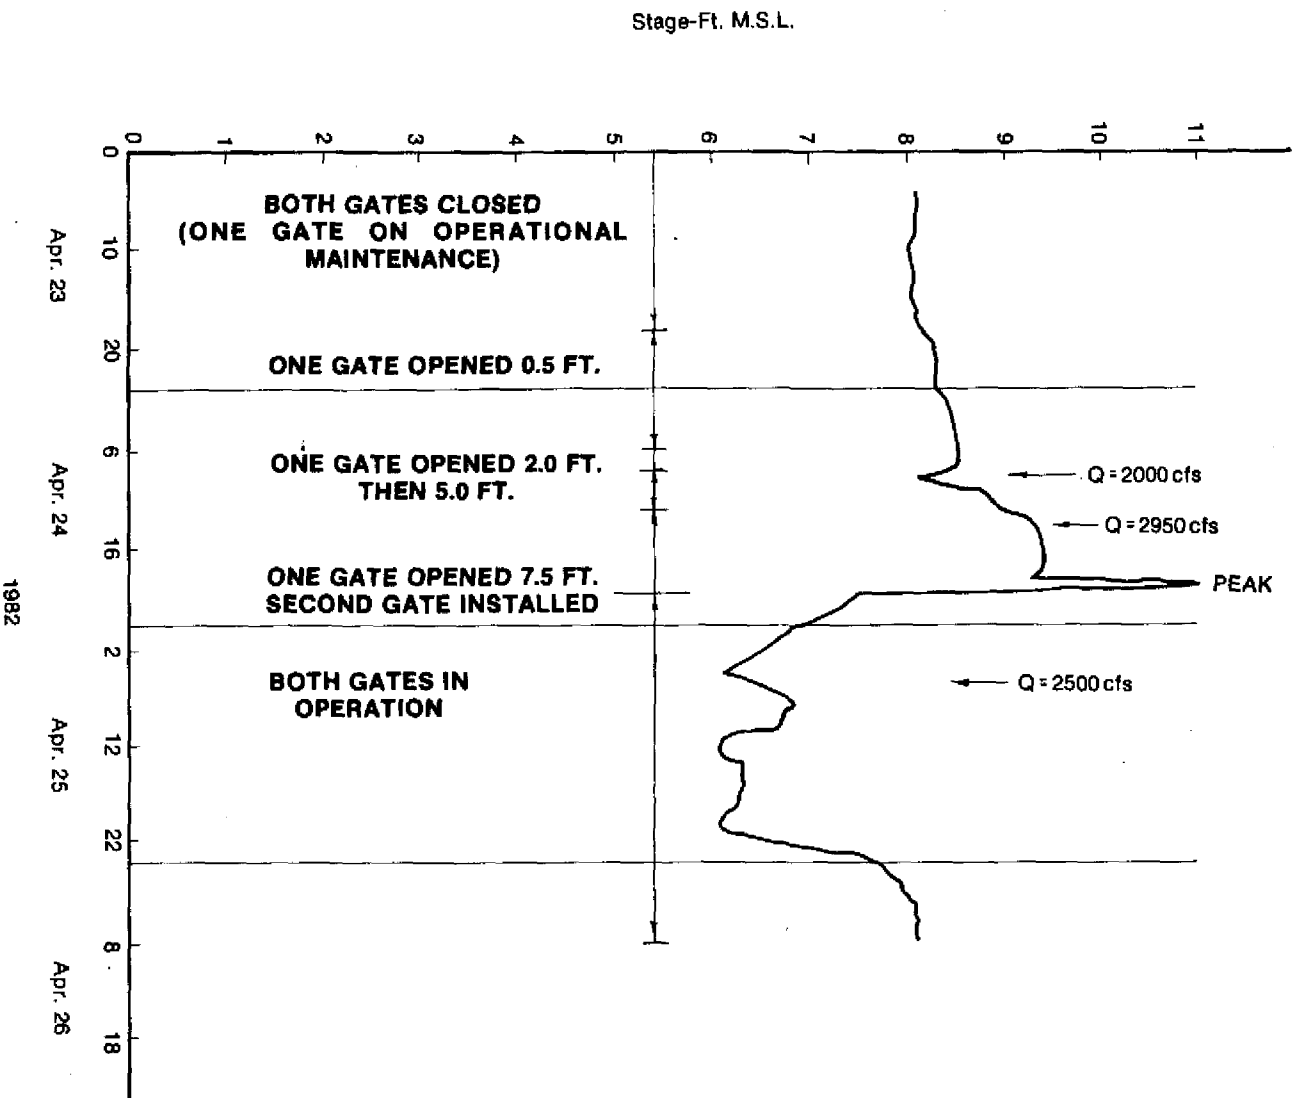
Figure 5 HOURLY STAGE HYDROGRAPH AT S-41 HEADWATER DURING RAINSTORM OF APRIL 23-26, 1982

Figure 5 shows the hourly stage hydrograph at S-41 headwater during this rainstorm. As briefly mentioned previously, one of the main gates on this structure was undergoing maintenance. Therefore only one gate was in operation until 8 PM April 24, 1982, when the second gate was put back in service. The stage reached a short term peak of 10.94 ft msl at 8 PM April 24, 1982. Reinstallation of the gate was prompted by a forecast of 80% chance of rainfall. The stage rose from 9.32 to 10.94 in 30 minutes, due to the need to close the gate on the structure to reinstall the second gate for service. The stage

dropped to 7.94 ft msl at 8:30 PM right after both gates on the structure were open full. The headwater stage was at 9.32 ft msl for several hours between 2 PM and 8 PM April 24, 1982 due to only one gate being in operation. This represents the actual storm peak. This may have provided less hydraulic head availability for the drainage from the secondary system in the area. However, the high water stage in John Prince Park at the Congress Avenue crossing of Lake Worth Drainage District Lateral Canal 14 was about 10.15 ft msl, which was about 2.20 feet below the high water mark caused by the March 28-29, 1982 storm. It is interesting to note that the discharge during the night and early morning of April 24-25, 1982 was 2500 to 3000 cfs, comparable to the 2500 cfs discharge later in the day with both gates in operation. The possible explanations are restriction of inflow from the secondary drainage system, and much less rainfall this time than last month.

One gate at S-41 was undergoing maintenance at the West Palm Beach Field Station and was out of service until 8 PM April 24, 1982. A forecast of 80% rainfall probability prompted reinstallation of the gate. The peak headwater stage resulting directly from the storm was 9.3 ft msl and occurred prior to the installation. During installation of the second gate, a short term peak stage of 10.94 ft msl resulted from the need to briefly close the remaining gate. The effects of the brief peak were not severe.

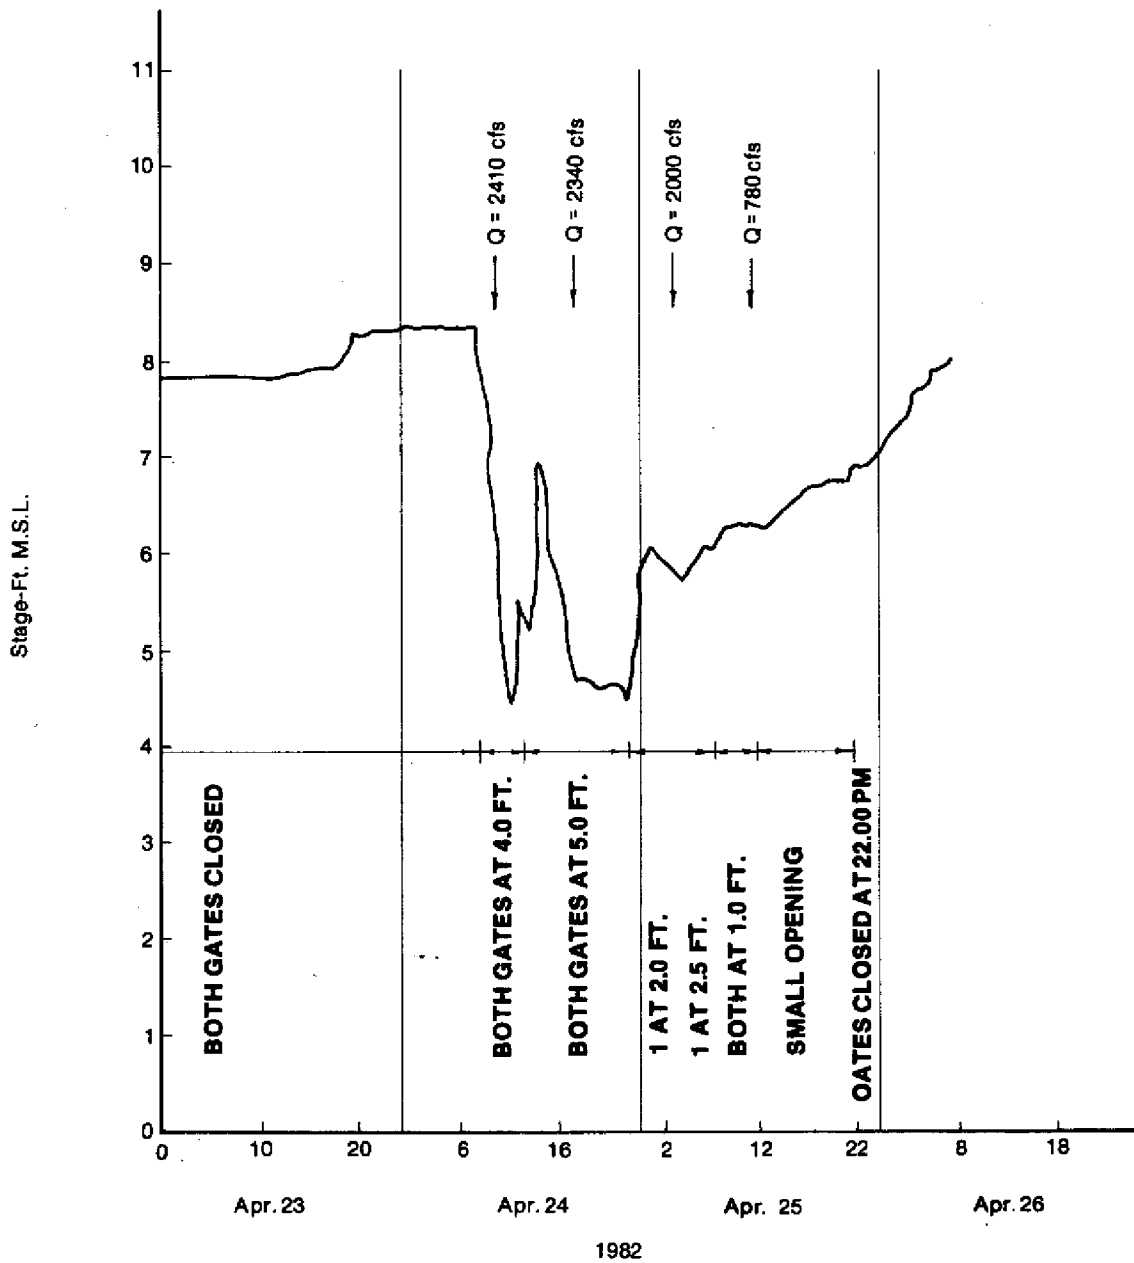
3. S-40 - This structure maintains and drains the C-15 Basin which covers the City of Delray Beach. Figure 6 shows the hourly stage hydrograph at S-40 headwater during the rainstorm. Both gates were in operation during this rainstorm. The stage was maintained between 4.5 and 8.0 ft msl during this storm. The flooding in some streets and homes was due to inadequate secondary or tertiary drainage system capacity, maintenance, or operation.

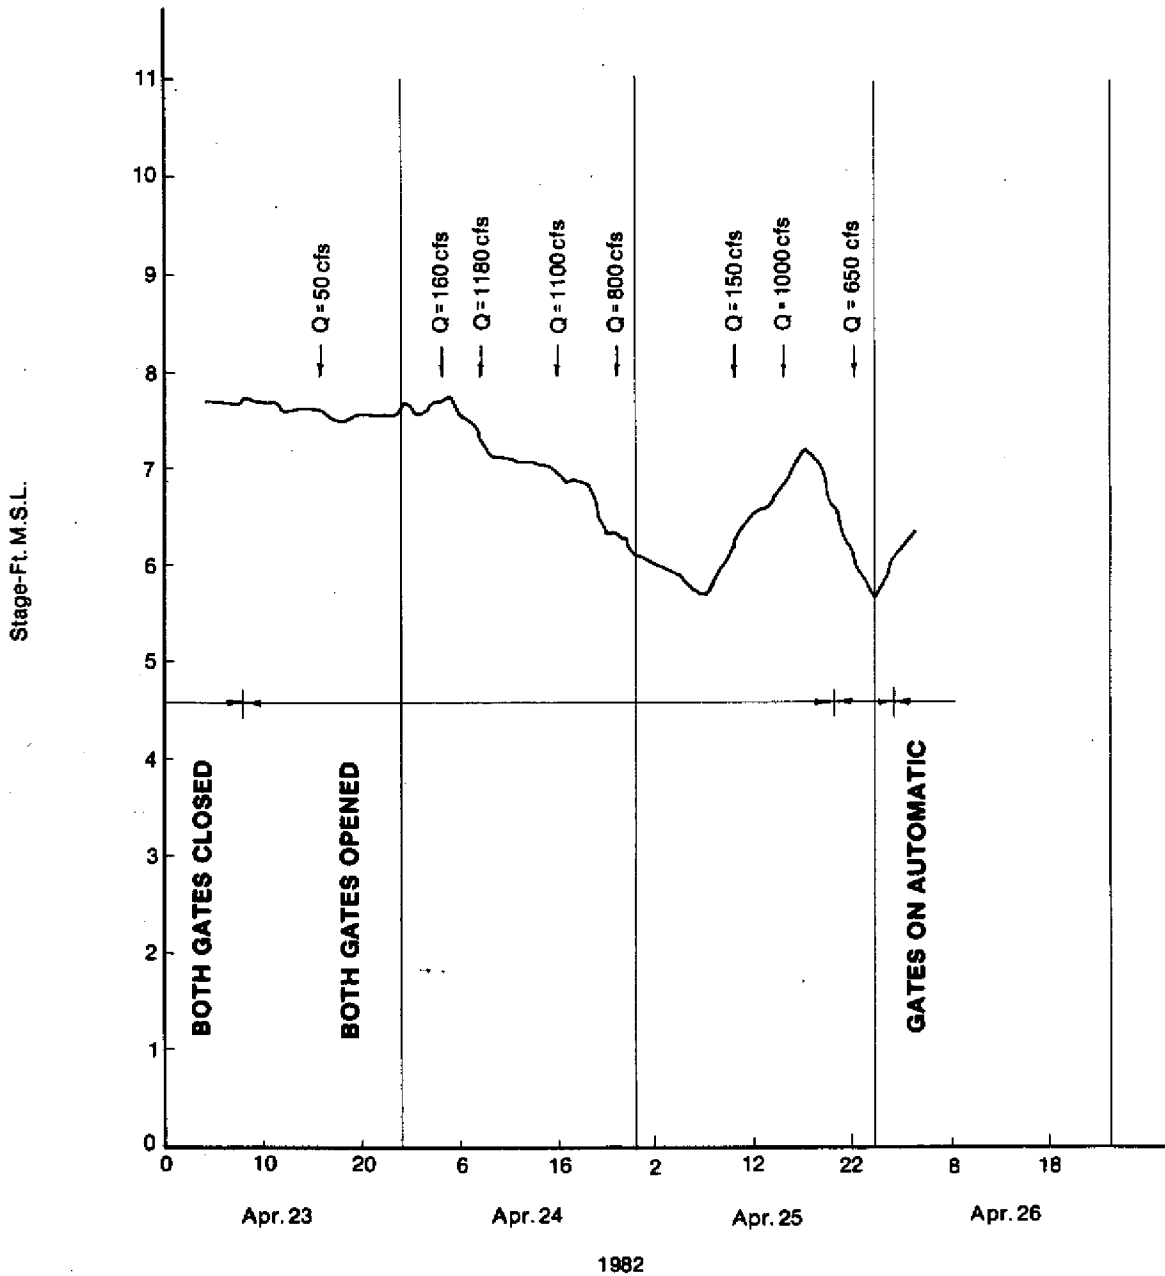
Figure 7 HOURLY STAGE HYDROGRAPH AT S-44 HEADWATER DURING RAINSTORM OF APRIL 23-26, 1982

4. S-44 - This structure maintains stages and drains the C-17 Basin. This basin received 5 to 8 inches of rainfall with intensive rainfall at the upstream portion of the basin. Figure 7 shows the hourly stage hydrograph during this rainstorm. The stage was maintained between 5.7 and 7.7 ft msl during the rainstorm. One death was reported to be the result of a flooded street and canal draining into C-17 across Palm Beach Lakes Boulevard. A sheetpile wier located downstream of 45th Street (West Palm Beach) in C-17 is suspected to have resulted in a backwater condition and is under investigation by the District.

This structure was able to handle the discharge from the C-17 Basin without difficulty. The intense rainfall in the southern portion of this basin resulted in significant flooding. An existing sheetpile weir, which maintains dry season waterlevels, may have caused a backwater condition and is under investigation by the District.

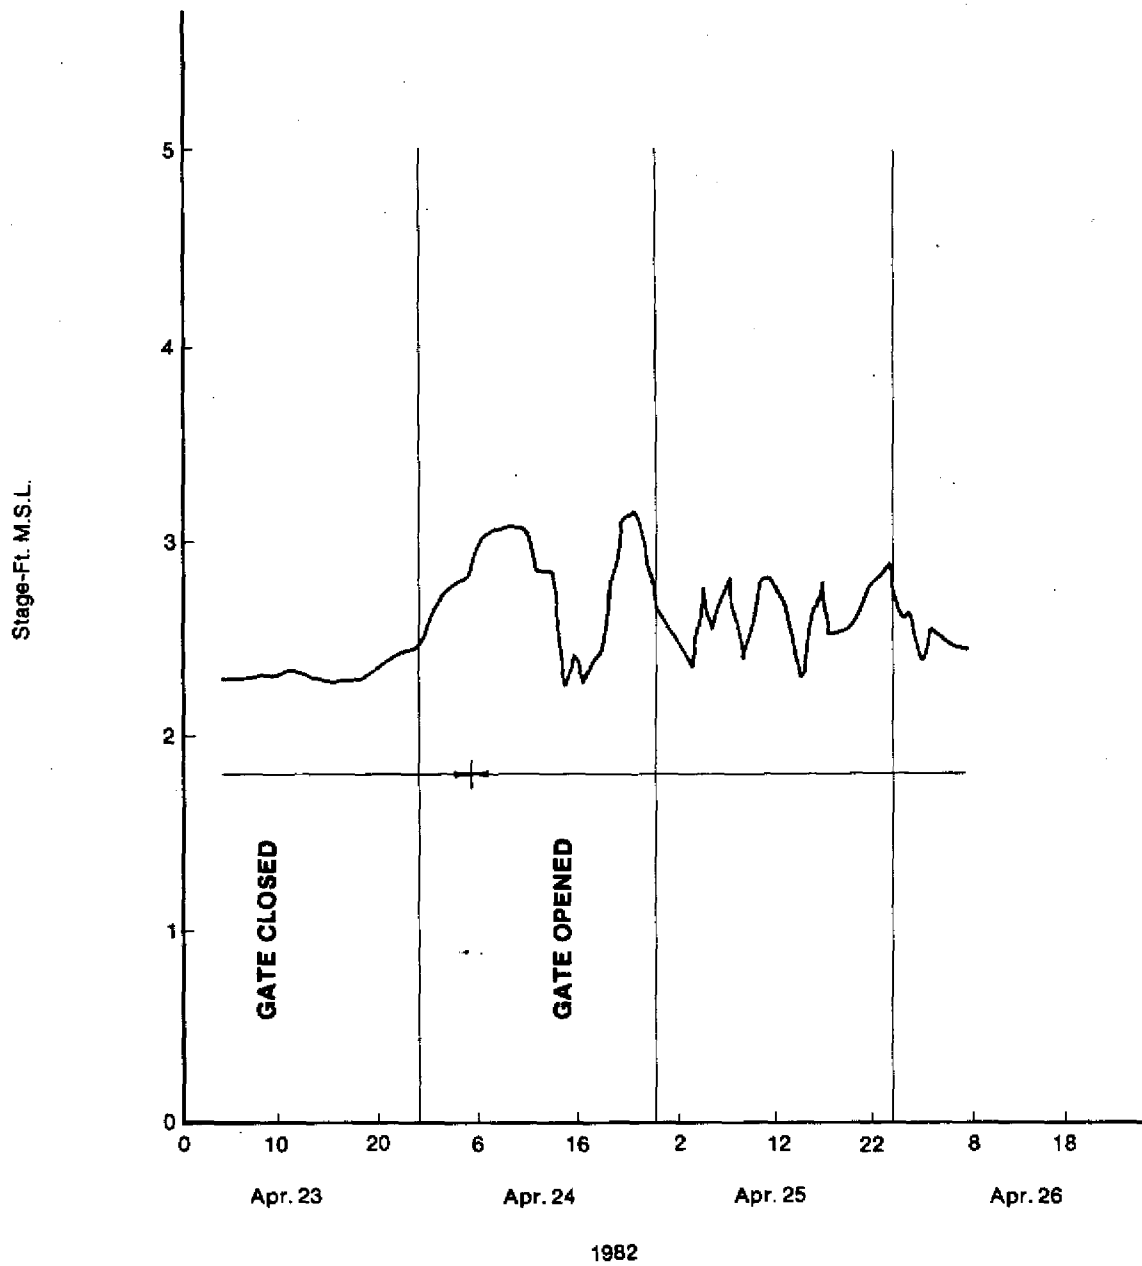
5. S-26 - This structure, located in the City of Miami at the 36th Street crossing of the Miami canal, is a reinforced concrete, gated spillway, with discharge controlled by two cable operated, vertical lift gates. Operation of the gates is automatically controlled to maintain the optimum headwater elevation of 2.50 ft msl. As mentioned previously, the rainfall in this area was reported to be 8.99 inches at Miami International Airport and 8.75 at the District's Miami Field Station. The operation of S-26 has a direct and indirect impact on the area's drainage. Figure 8 shows the hourly stage hydrograph at S-25 headwater during this rainstorm. The gates were operated at 5 AM April 24, 1982 when stage reached 2.80 ft msl. The stage at this structure was maintained between 2.25 and 3.12 ft msl. The stage reached slightly over 3.0 feet in two periods: one at 6 AM through 11 AM April 24, 1982 and one between 9 PM and 11 PM April 24, 1982. No severe flooding was reported in this basin, although golfball-size hail was observed.
