**REPORT OF  
RAINFALL EVENT,  
SEPTEMBER 22-25, 1983  
NORTH AND WEST  
PALM BEACH COUNTY**

**South Florida Water Management District**

**October 1983**

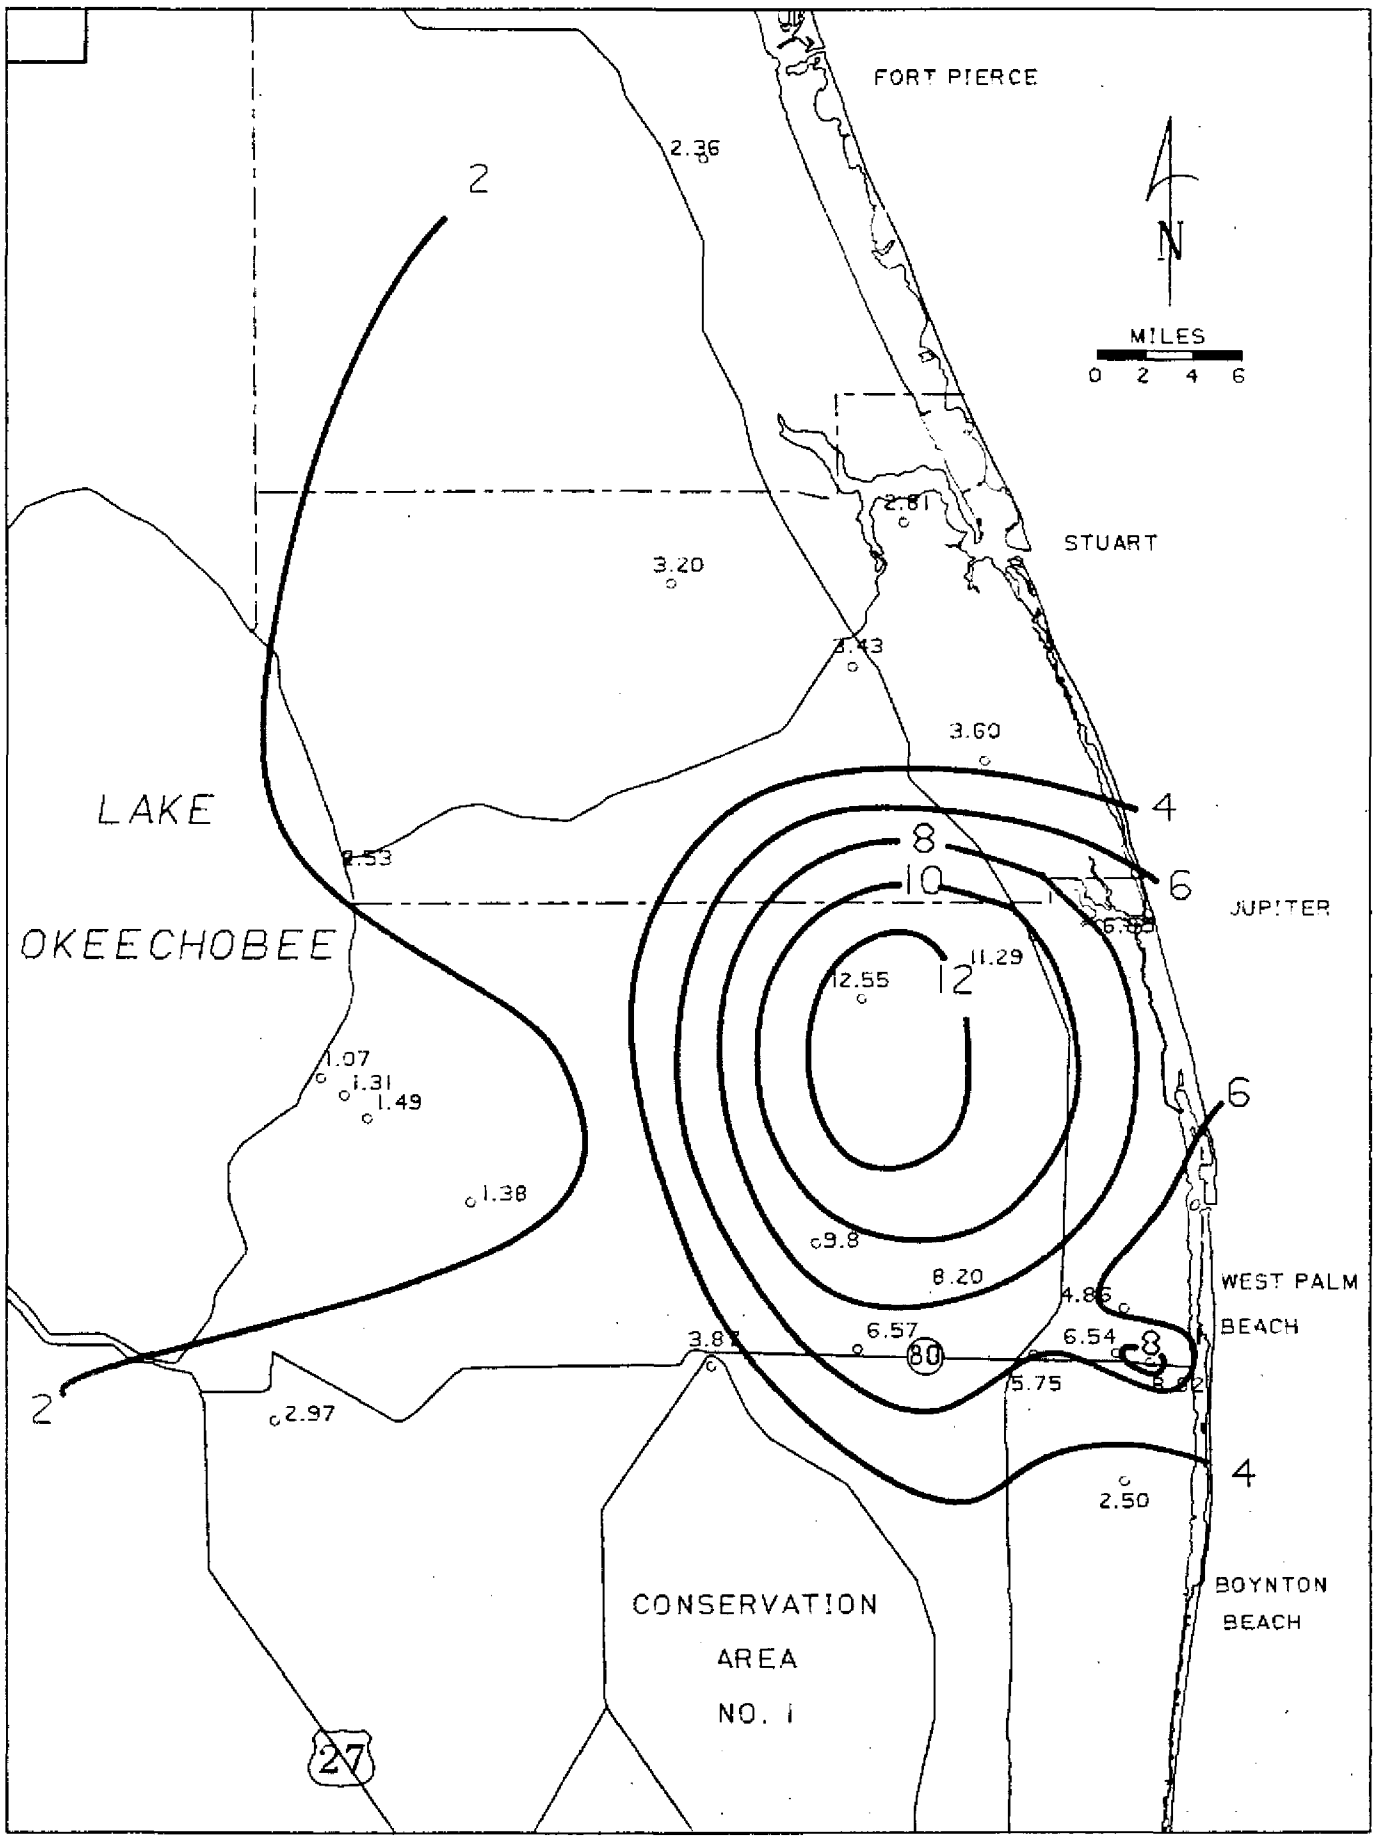
FIGURE 1  
 ISOHYETAL MAP OF SEPTEMBER 22 - 25, 1983 STORM  
 IN PALM BEACH AND MARTIN COUNTIES

Figure 1 shows the isohyetal map of rainfall distribution resulting from this rainstorm in St. Lucie, Martin, and Palm Beach counties. C-18 basin received a total rainfall of 8 to 12.55 inches during this storm event. This is equivalent to a return frequency between 1 in 10 and 1 in 25 years. The 9.5 inches of rainfall recorded at Pratt & Whitney on September 24 is equivalent to a 1 in 25 year return frequency. Even though this event was not a record rainfall for the area, it was, however, more intense and covered a larger area than the rainstorm of November 8-9, 1982. (See Figure 2.)

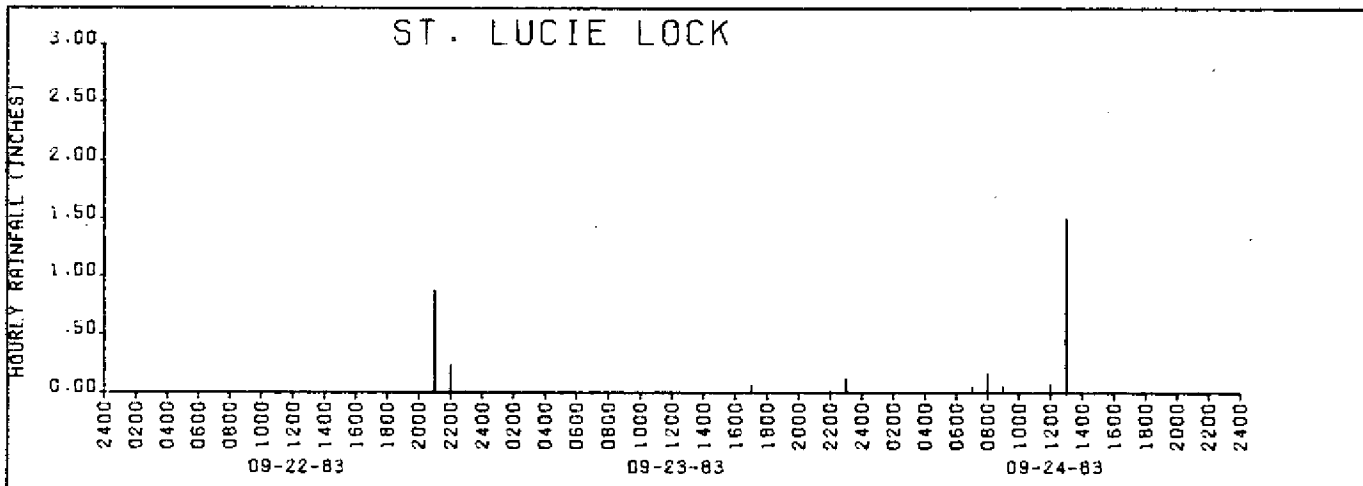
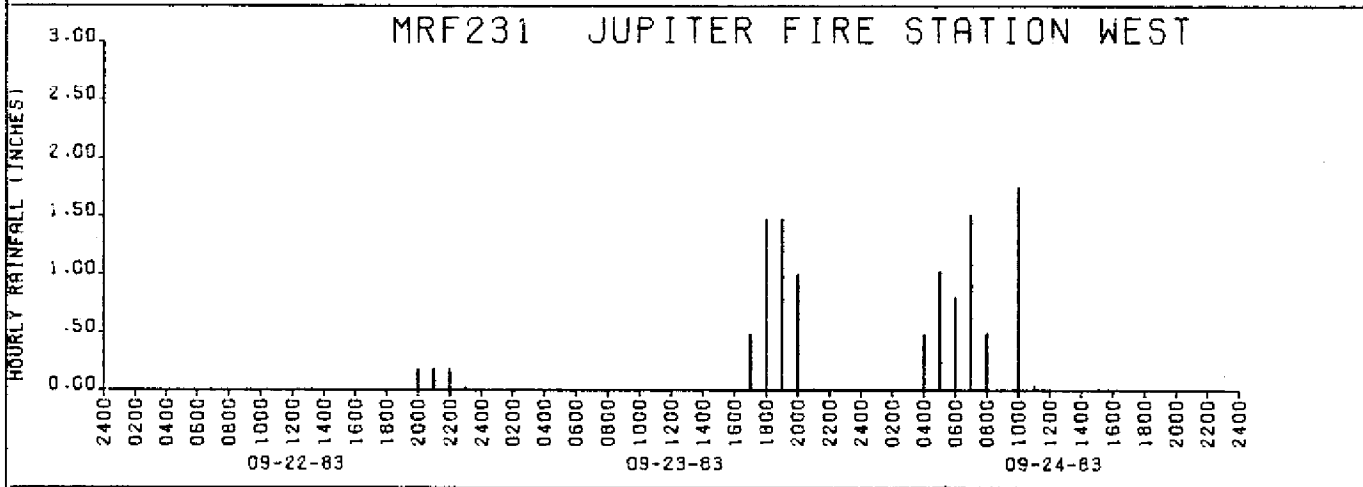
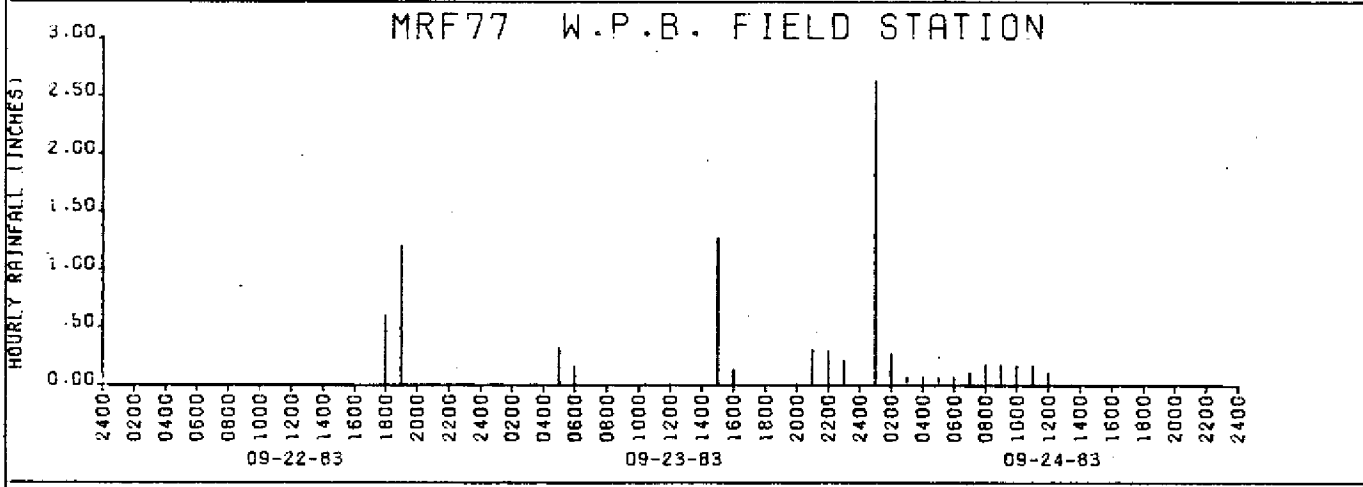
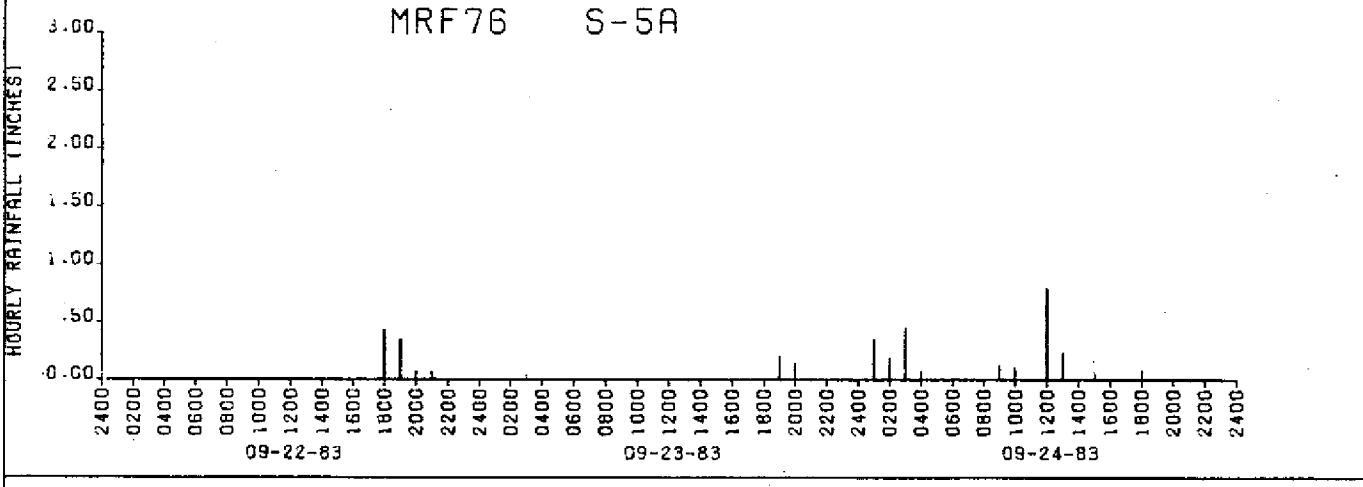
FIG. 3 RAINFALL EVENT 9/22/83/-9/24/83

The hourly rainfall distribution at four recording stations in the affected area is shown in Figure 3. They are the St. Lucie Lock, Jupiter Fire Station West, West Palm Beach Field Station, and S-5A. The spatial and time variation in rainfall intensity at these four locations is apparent. For example, at the St. Lucie Lock, the rainfall occurred primarily in two separate periods and at the Jupiter Farms area on three separate periods ranging from the evening hours of September 23, and the morning hours of September 24.

There were four separate periods of rainfall recorded at the West Palm Beach Field Station. The most intensive rainfall occurred at 1800 and 1900 hours of September 22; 1500 hours, September 23, and 1 a.m. September 24. The rainfall was then fairly steady throughout the entire morning of September 24.

The rainfall recorded at S-5A was much less in intensity and occurred in four separate periods also.

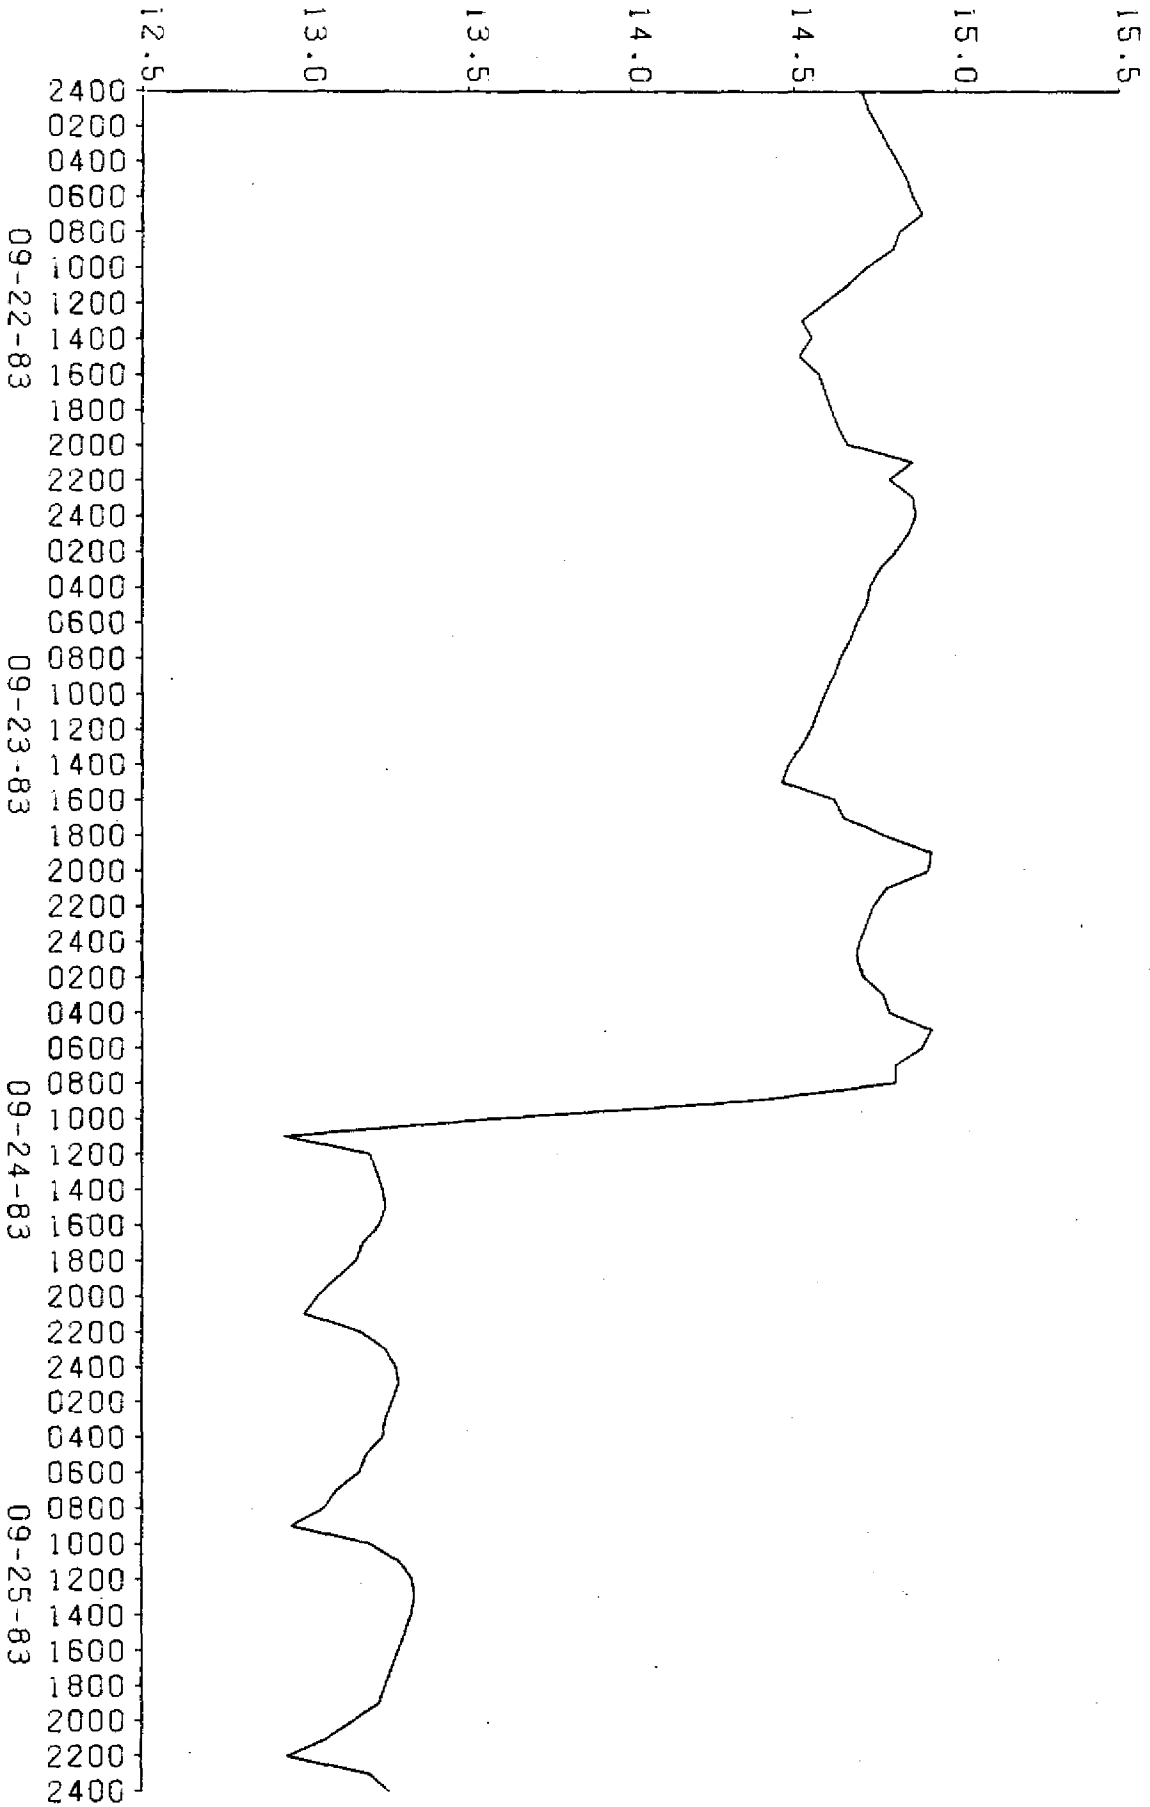
FIG. 4 HOURLY STAGE READINGS AT S-46 HEADWATER

On Saturday morning, September 24, 1983, after a heavy rainfall, the downstream stage at the weir was 18.2 ft, consequently, S-46 was placed on the lower setting at 8:30 a.m. Before this change, the structure discharge, though still rising, had reached 2,250 cfs. After the change, the discharge rose to 4,300 cfs, and then gradually decreased to 2,055 cfs by 11:30 a.m. on Monday, September 26. At that time the stage at the weir had dropped below the crest (17.1 ft) so S-46 was returned to the normal 14.5 to 15.0 ft setting. (See Figure 4 for hourly stage hydrograph at S-46).

This change resulted in the gates closing for about an hour as the canal refilled, rising from 13.25 to 15.0 ft. Thereafter, the gates again opened and initially discharged 1,800 cfs. The gate gradually closed and the discharge had fallen to about 600 cfs by Thursday morning, September 29.

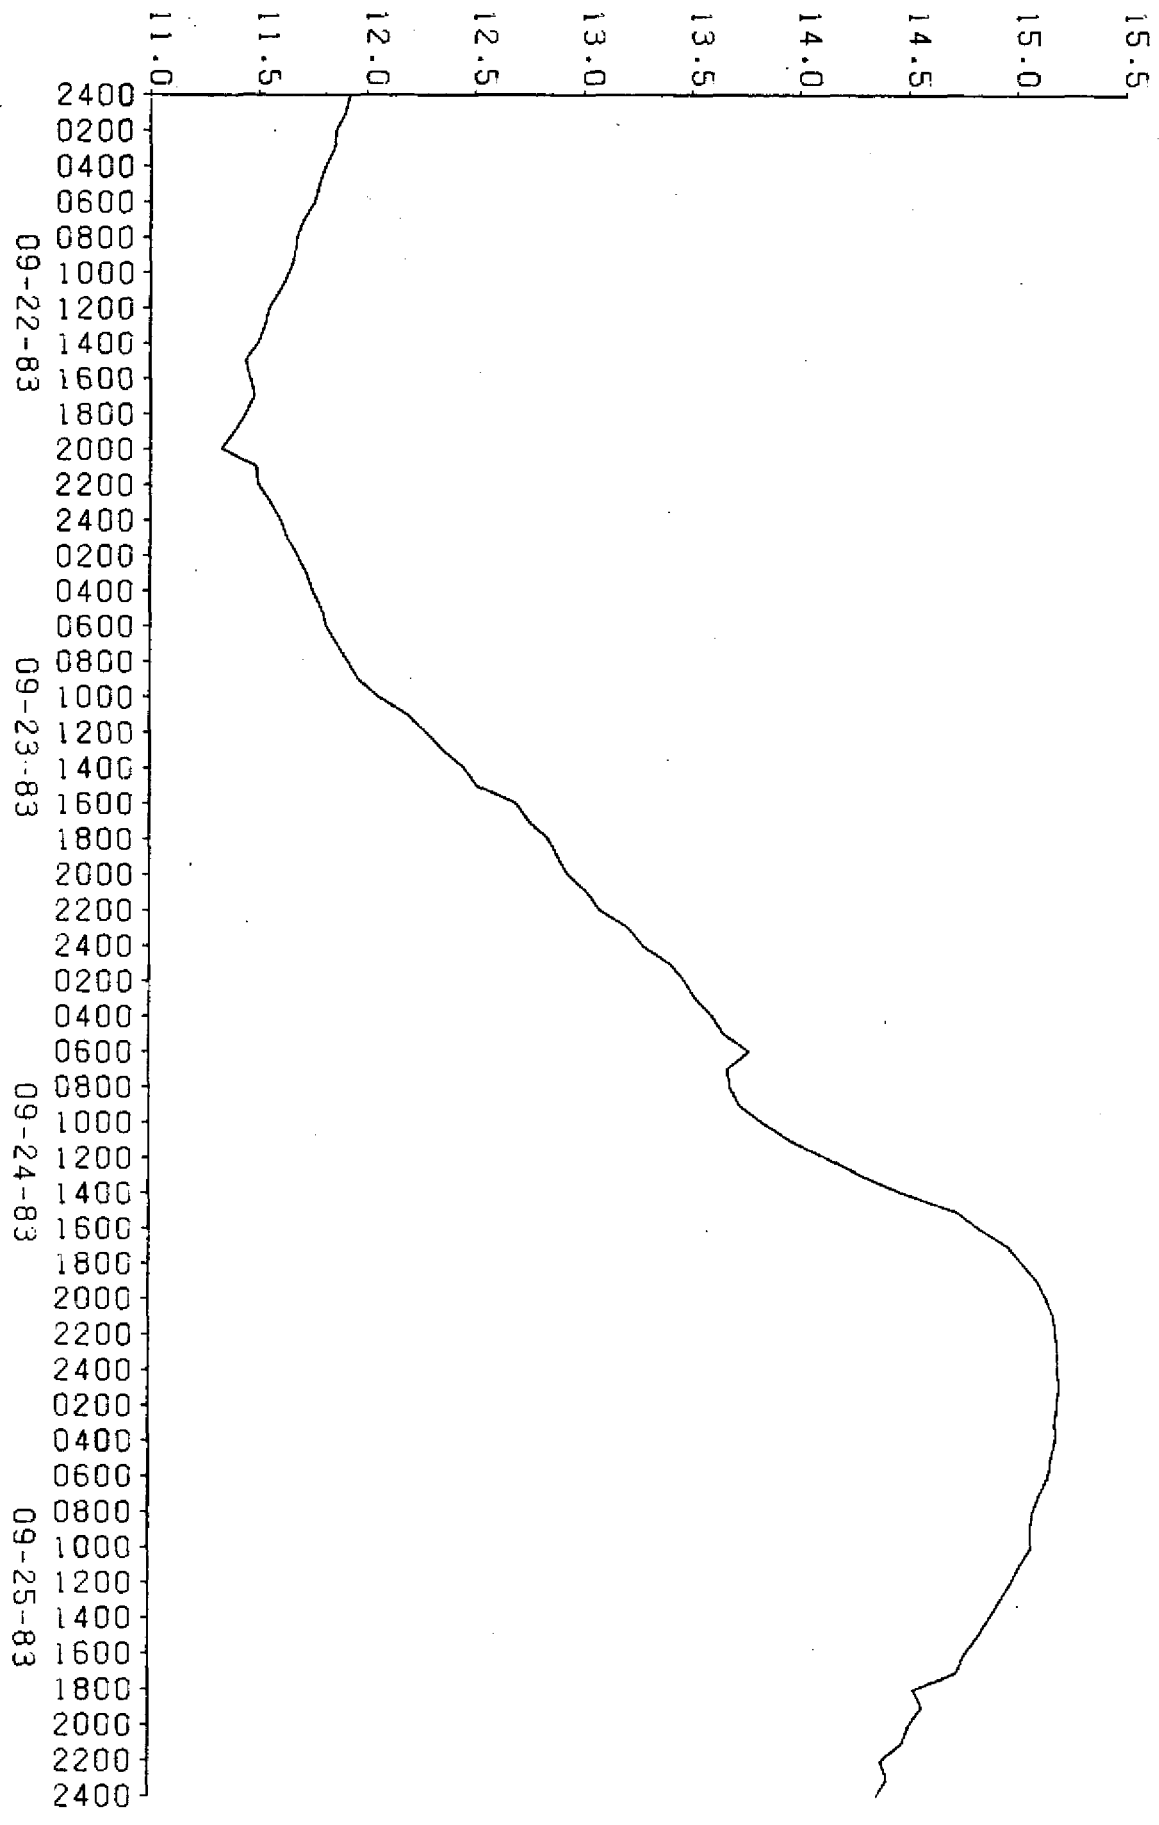
FIG. 6 HOURLY STAGE READINGS AT S-5AE

Flow through the structure could not be determined because the upstream staff gage was submerged, but visual observations indicated little or no flow through the structure as water levels were the same on both sides. The hourly stage hydrographs recorded at S-5AE and Wellington Road (see Figures 6 and 7) indicated that the water level in C-51 might be peaked at this structure.

Heavy gravity and especially pumped inflow into C-51 raised the level in that canal to a very high level from the period of midnight on the 23rd to midnight on the 25th. The peaked stage at 15.2 (measured at S-5AE) at 1 a.m. on September 25. The stage dropped gradually to about 12 at 9 a.m. on September 27. During this entire period, pumping occurred at S-5A.

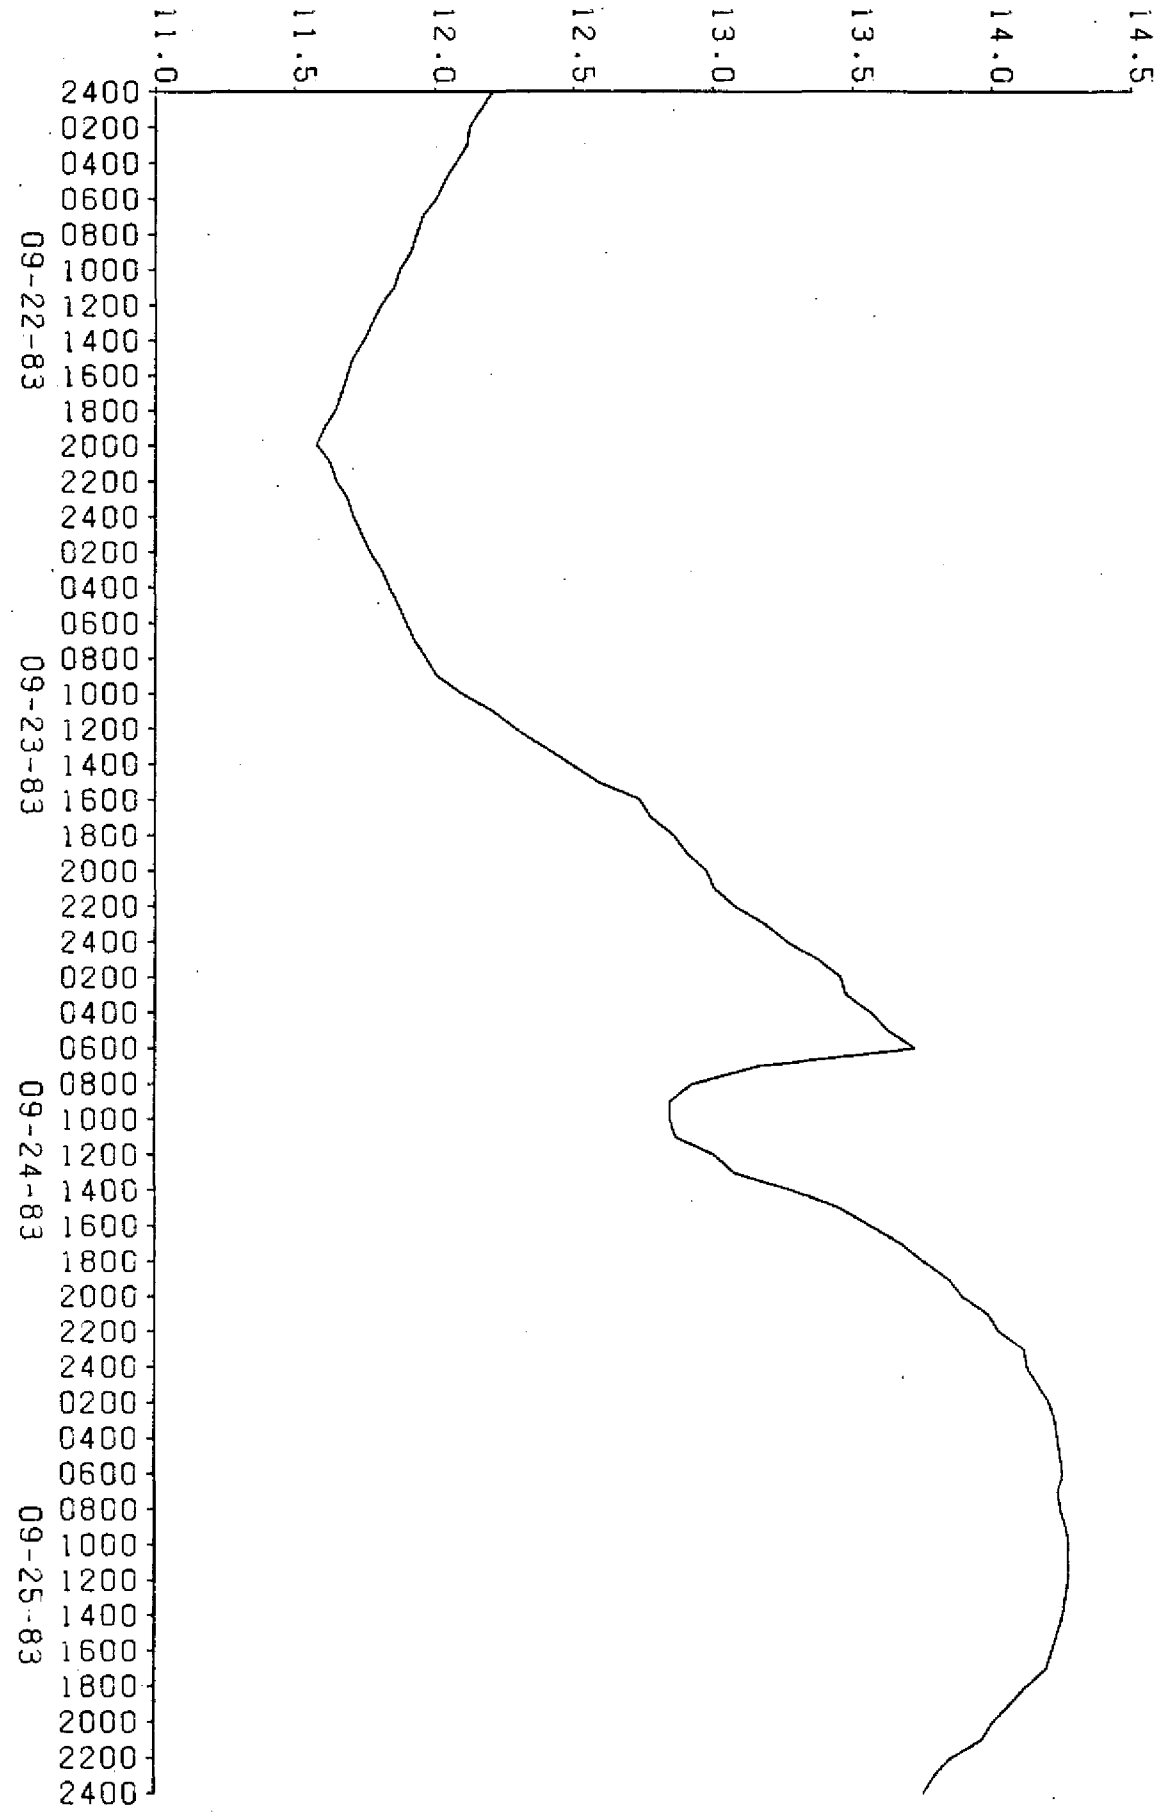
FIG. 8 HOURLY STAGE READINGS AT L8

to the west and was pumped by the District's pumping station S-5A into Water Conservation Area 1. (See Figures 8 and 9 for hourly stage hydrographs at L-8 and S-5AW at State Road 441)

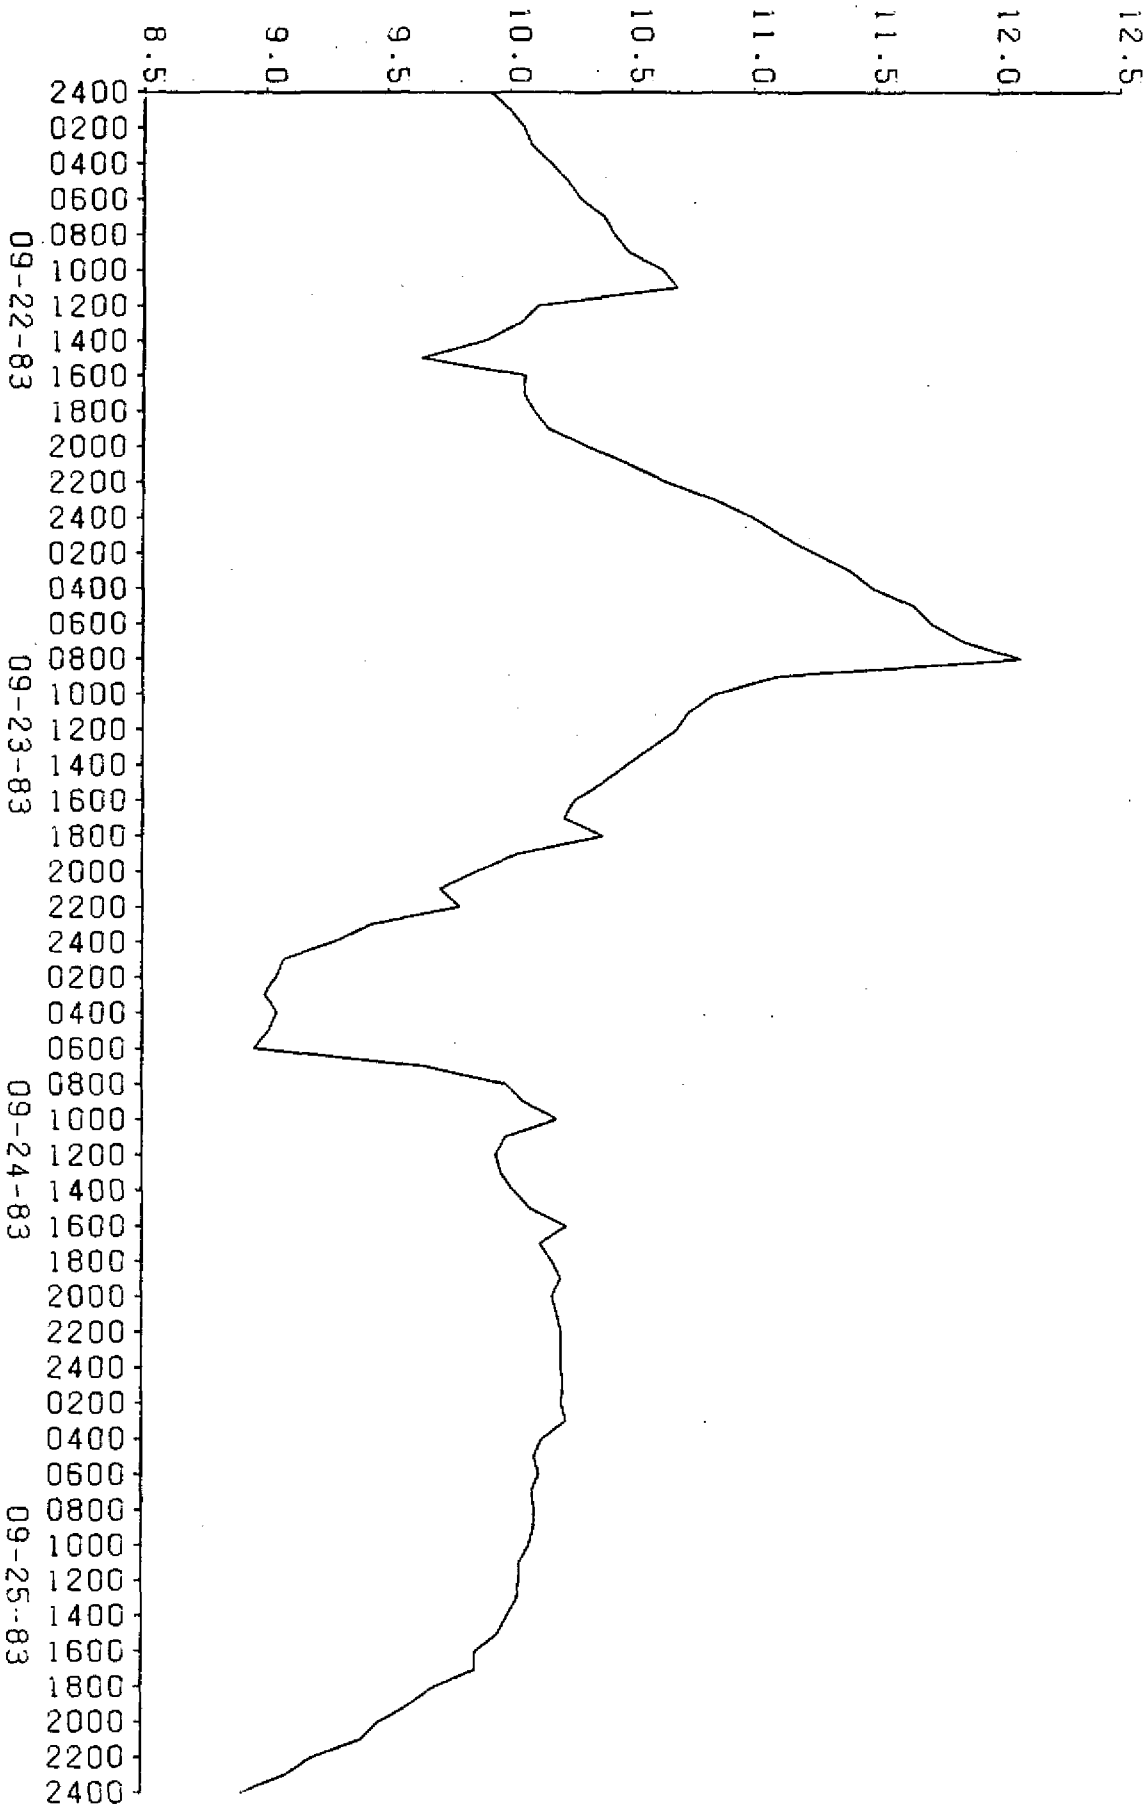
FIG. 9 HOURLY STAGE READINGS AT S-5AM

The operation rationale was to drain L-8 to the east on Friday evening. However, when the head across S-5AE equalized early Saturday, it became apparent that C-51 could not handle the flow; therefore, S-5AW was opened (at 5 a.m.) and as much flow as possible was directed west and pumped by S-5A. Unfortunately, the flow in L-8 limited the discharge flowing westward from C-51, and there does not exist a way to control the L-8 flows. At the peak stage in C-51, the discharge through S-5AE was 650 cfs; and through S-5AW was 1,350 cfs.

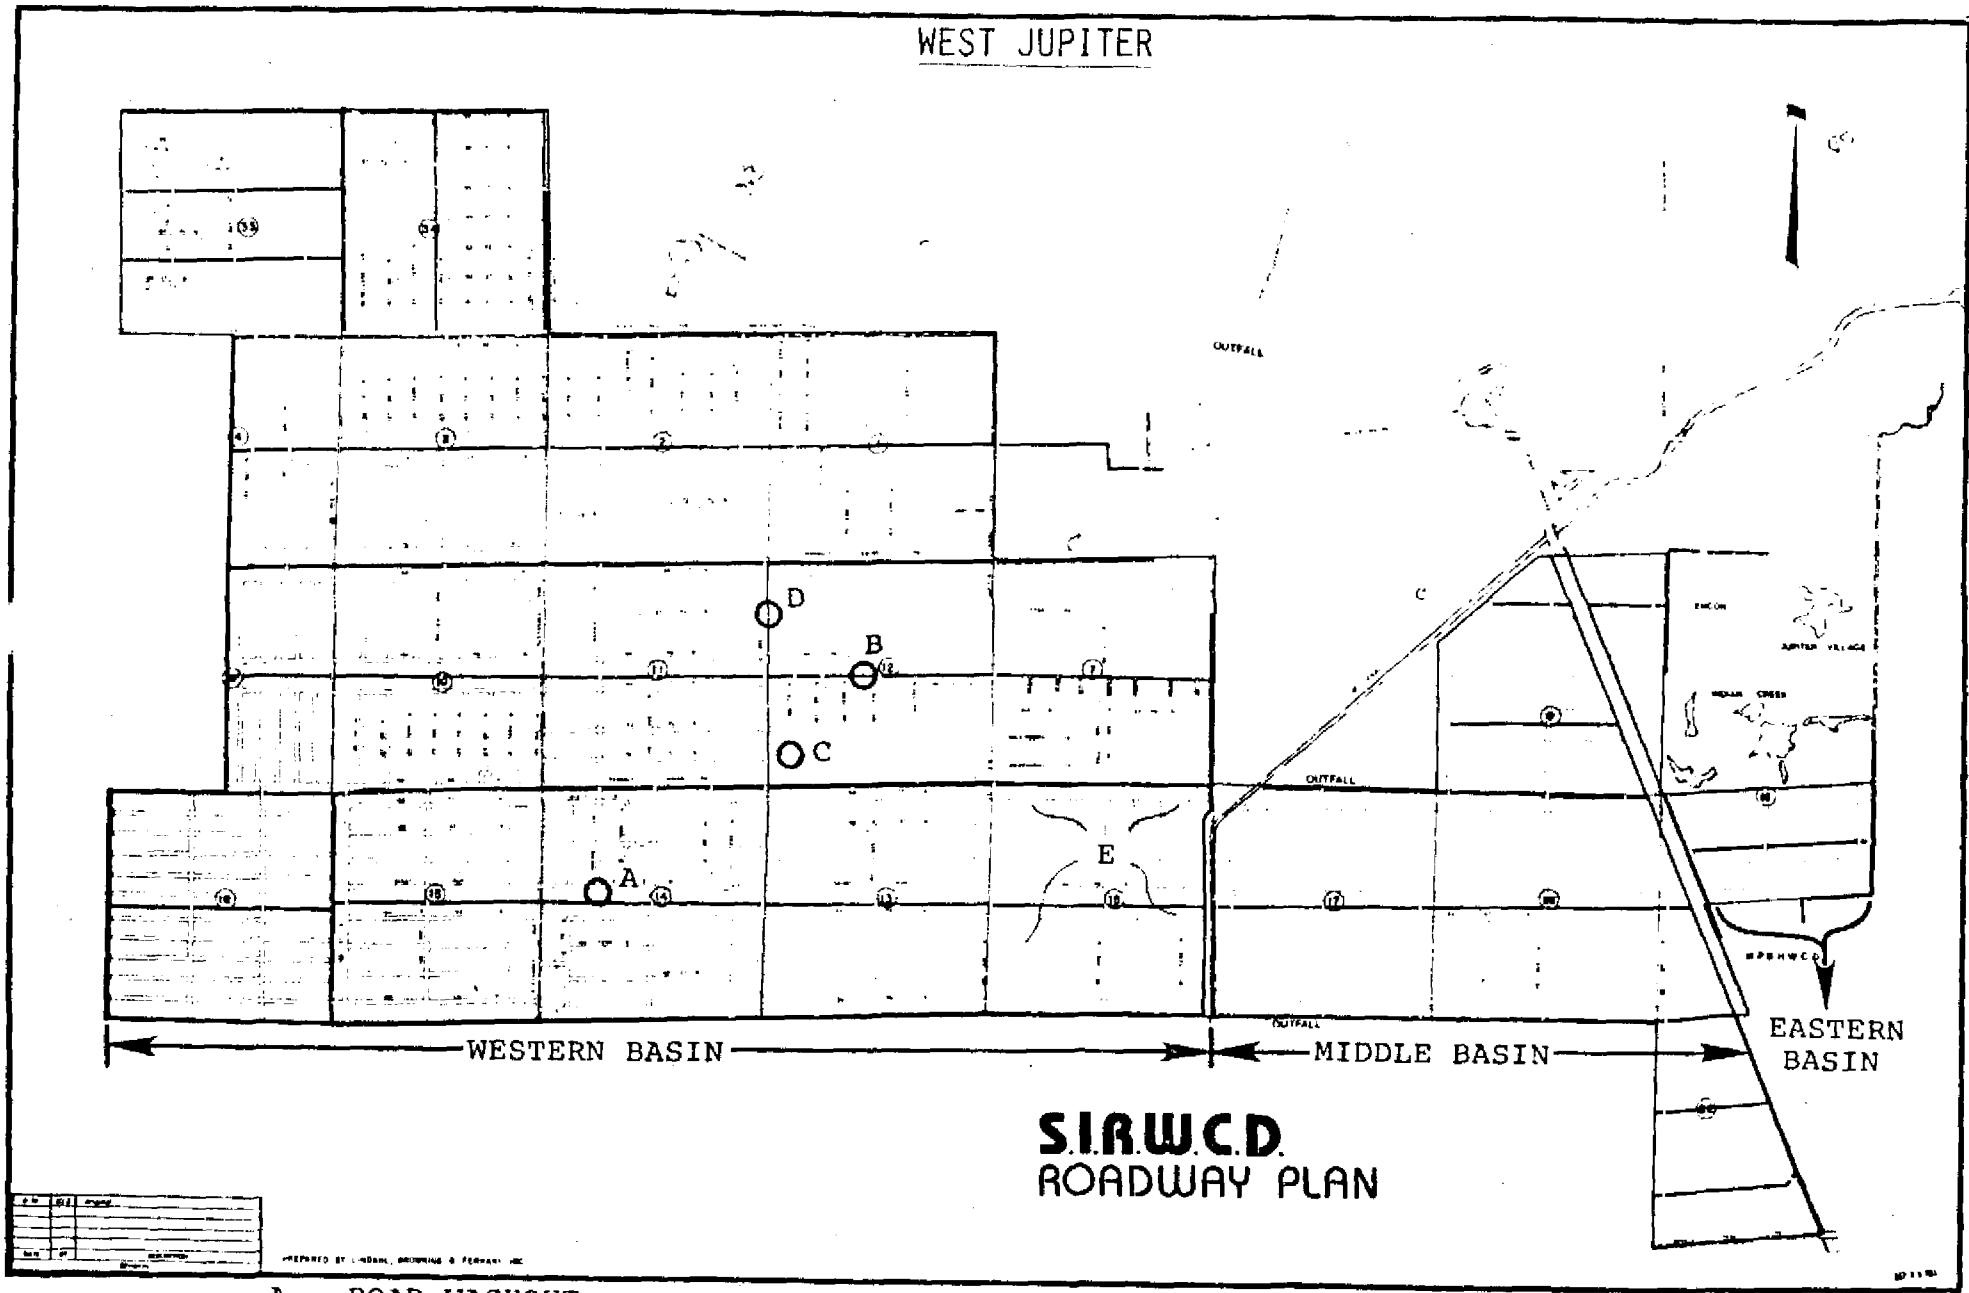
FIGURE 10

District staff inspected the area on Monday, September 26, 1983, (2nd day after the storm) and observed contract repair crews from the South Indian River Water Control District working on restoring road wash-outs and removing ditch "wash-ins". The western half of the western basin was generally dried out with only small pockets of water standing on property. The eastern half of the western basin still had road wash-outs and standing water. (See Figure 10.)

- A - ROAD WASHOUT
- B - ROAD WASHOUT
- C - LOT FLOODING
- D - LOT FLOODING
- E - AREA WITH 18" STANDING WATER
