**PRELIMINARY REPORT OF  
RAINFALL EVENT, NOVEMBER 21-26, 1984  
SOUTH FLORIDA COASTAL AREA**

**South Florida Water Management District**

**December 1984**

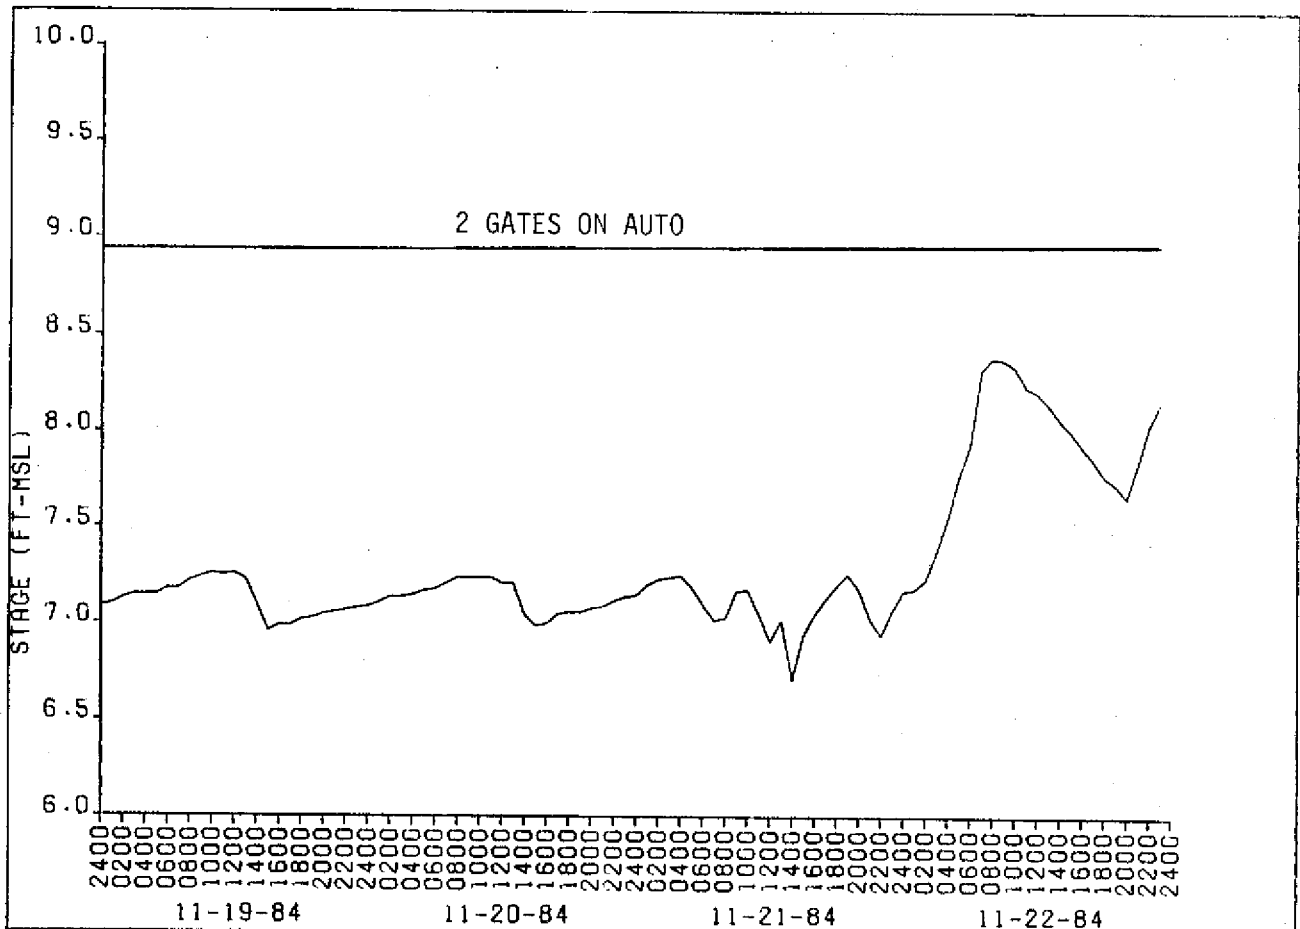
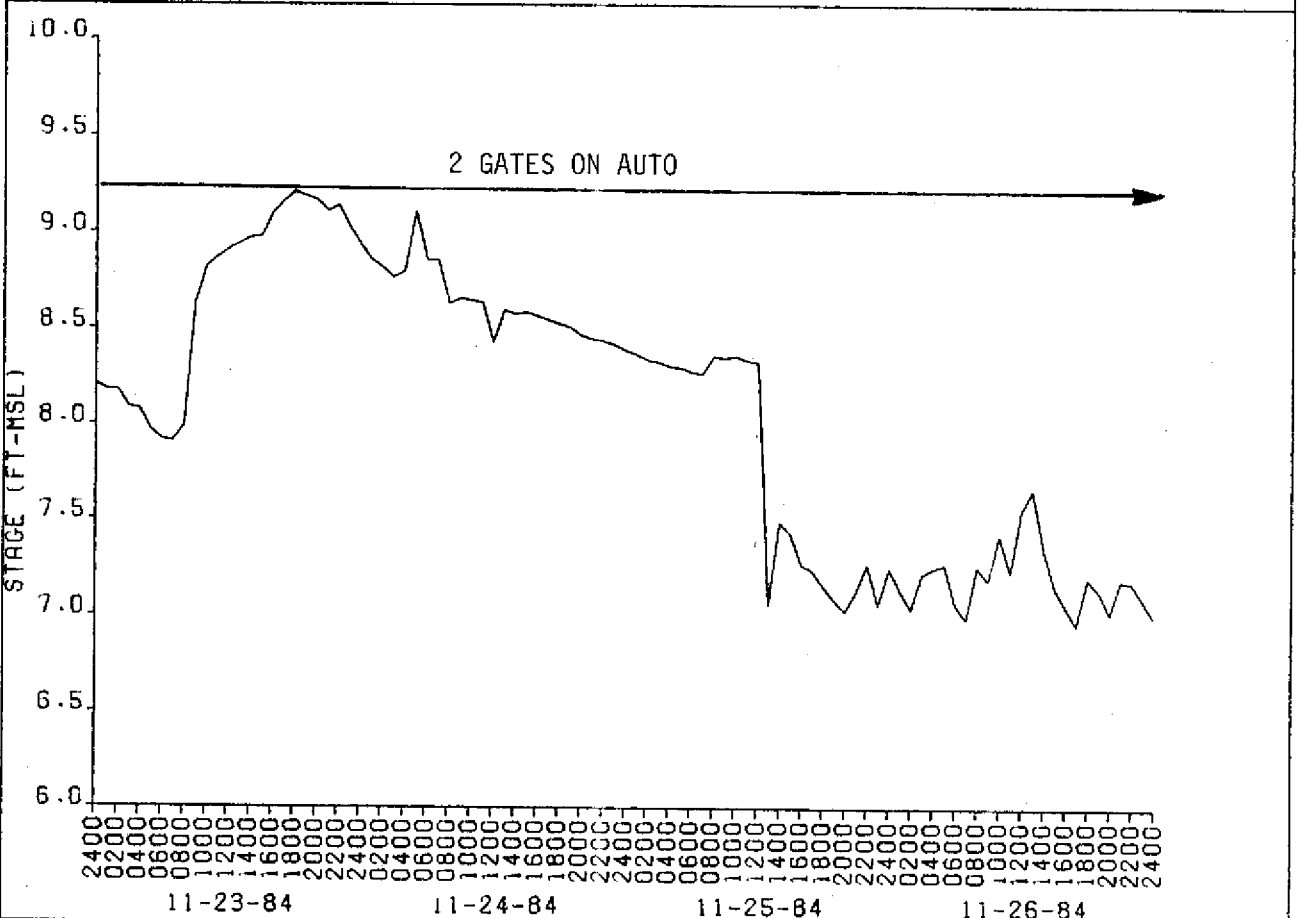
FIG. 10 HOURLY STAGE READINGS AT S-44HW

This structure is a 2-gated, reinforced concrete spillway structure with automatic control. It drains the area of Riviera Beach, Lake Mangonia, the eastern portion of Palm Beach Gardens, Palm Beach Mall, and westward expansion area, and several square miles west of I-95 and south of 45th Street. This area was hit hard by this storm. The gates on S-44 were on automatic control and opened fully at 0300 hours of November 22. The headwater stage was at 7.27 ft msl and reached its peak of 9.21 ft msl at 1740 hours, November 23. The estimated peak flow was about 2250 cfs.

This exceeded its design capacity of 2070 cfs. Figure 10 shows the hourly stage hydrograph with gate operations during this storm period.

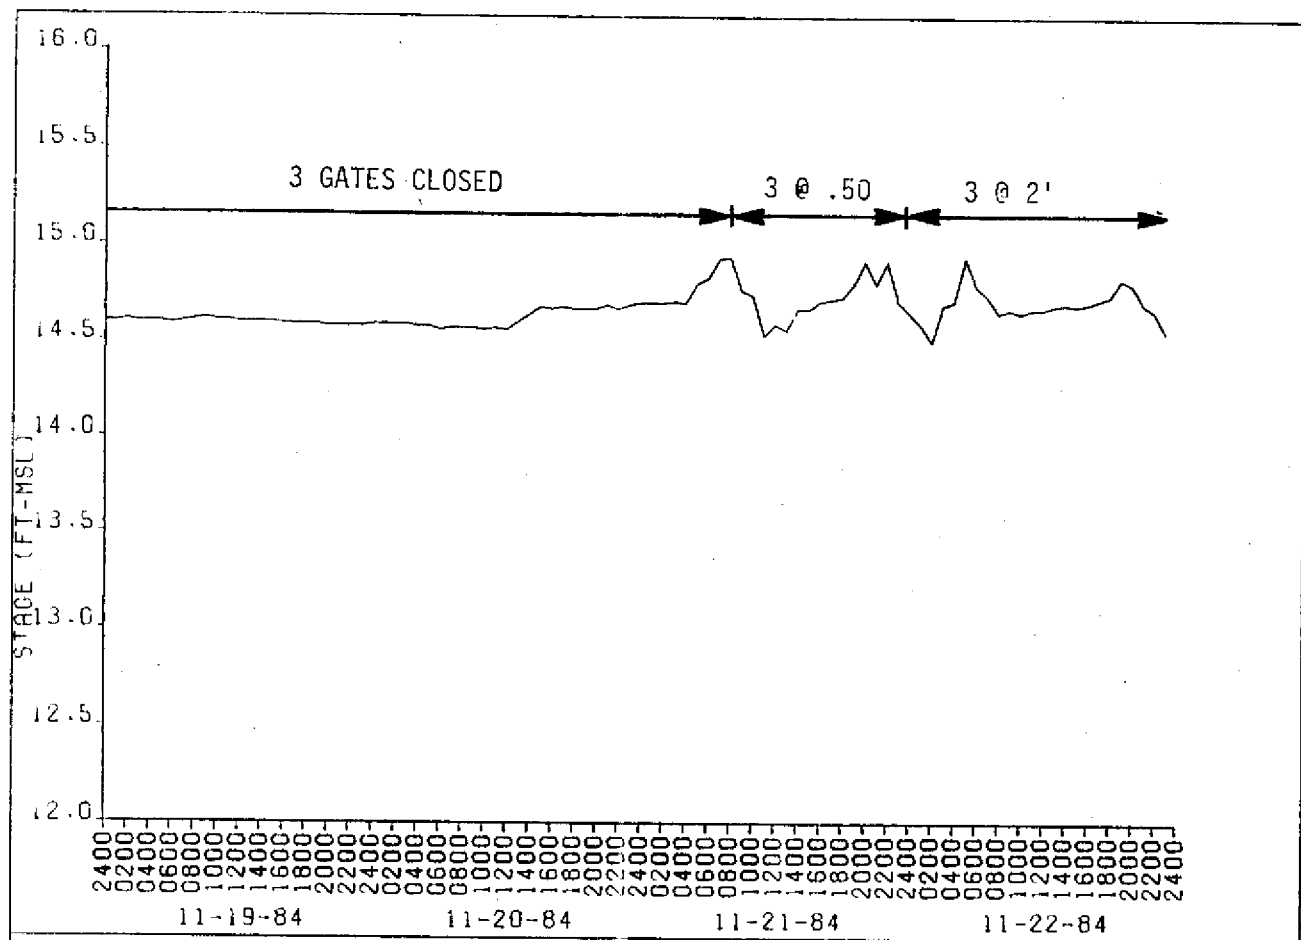
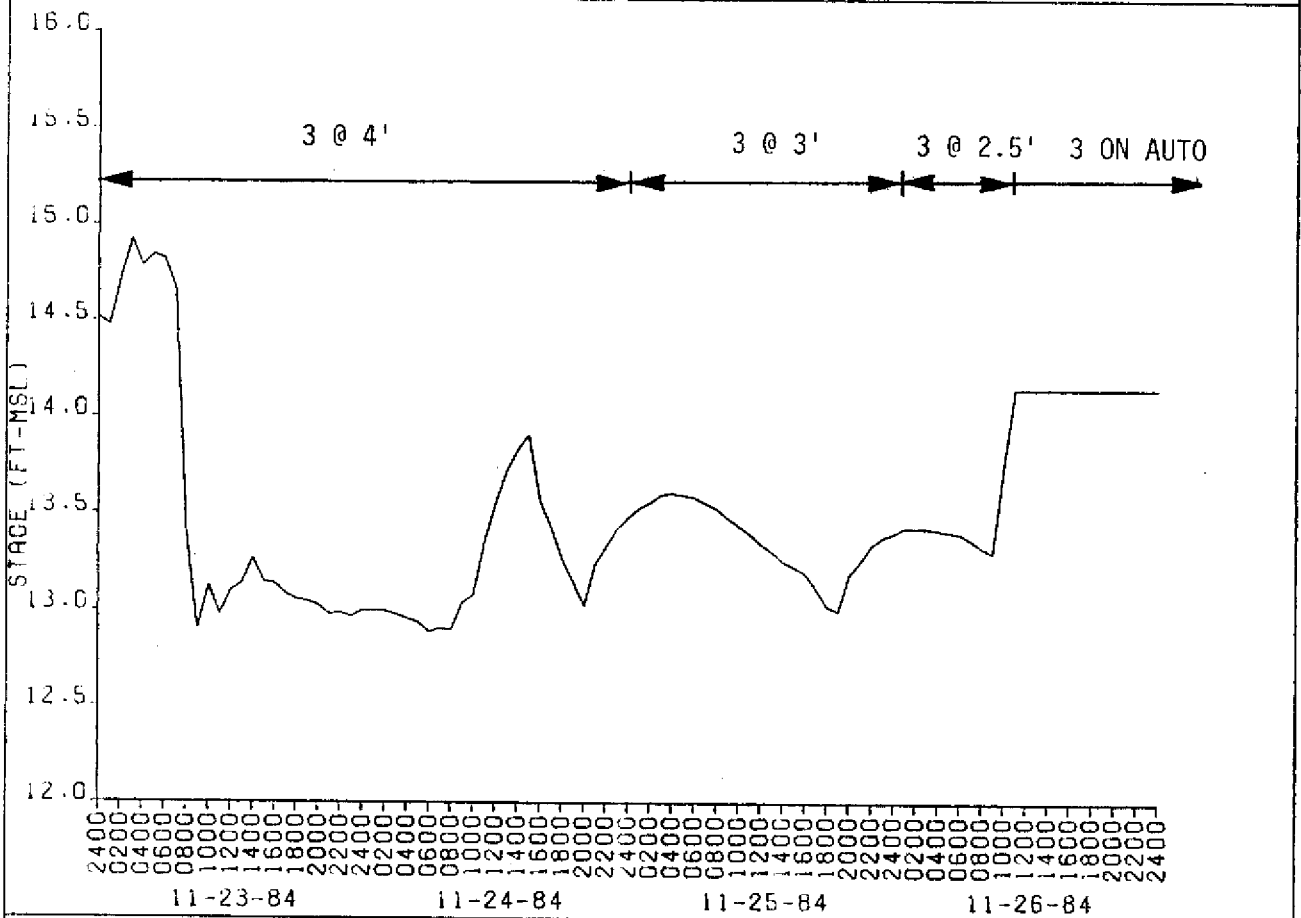
FIG. 11 HOURLY STAGE READINGS AT S-46HW

The gates were on automatic and maintained the headwaters of S-46 at 14.5 ft to 15.0 ft msl. At 0530 hours November 22, the No. 2 gate was not operating properly and was repaired by the District's electrician. The stage was maintained at 14.5 to 15.0 during November 22. At 2200 hours November 22, the upstream and downstream stages at C-18 weir located just north of Beeline Highway bridge, were at 18.6 and 16.0 ft msl respectively. The critical downstream stage at the C-18 weir is 17.6 ft msl. In response to the heavy rainfall along the coast, the S-46 headwater was lowered to 13.0 ft msl in the morning of November 23. The upstream and downstream stages at the C-18 weir were 18.55 and 16.54 ft msl, respectively, at 1123 hours November 23. The gates at S-46 were maintained on manual until 1300 hours November 24. The headwater stage was put back on automatic low setting to maintain stage between 13.0 to 14 ft msl. Figure 11 shows the hourly stage hydrograph with gate operations.

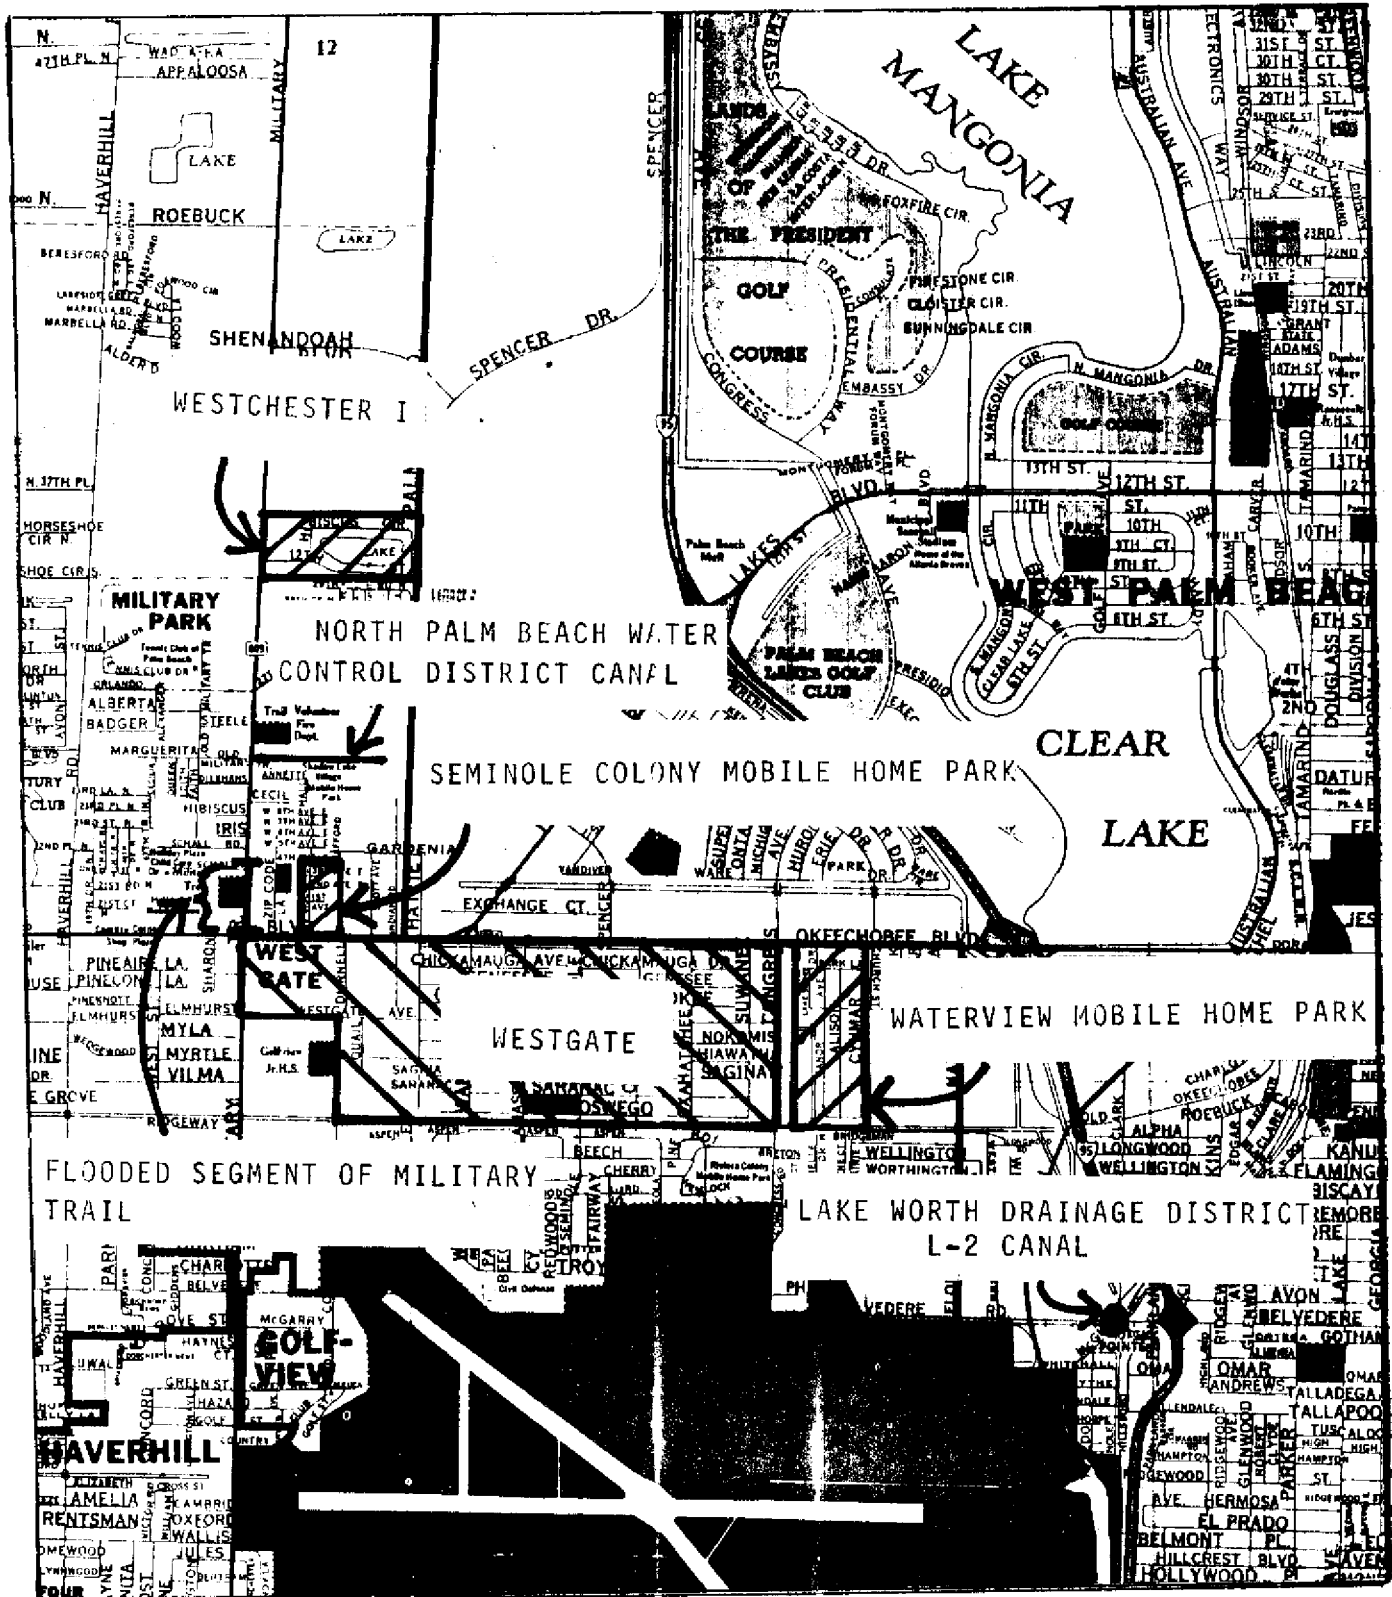
FIGURE 12 LOCATION OF WESTCHESTER I, SEMINOLE COLONY MHP, WESTGATE, WATERVIEW MHP, NPBWCD CANAL, LWDD L-2 CANAL, AND FLOODED SEGMENT OF MILITARY TRAIL

Seminole Colony is located approximately three-eighths of one mile east of Military Trail on the north side of Okeechobee Boulevard. It was inspected at 0907 hours on November 22. Extensive lot and road flooding was observed throughout the project. Water approximately 2 feet deep was observed along the centerline of the entrance road to the park. At least one trailer was flooded. District field representatives were told by residents of Seminole Colony that the mobile home park drains directly into the Northern Palm Beach County Water Control District (NPBCWCD) canal which is located approximately one-half mile north of the park. Locating and inspecting the park's drainage system was not possible due to the areal extent of the flooding. There are several factors which could have contributed to the flooding. The park is at a low elevation relative to a commercial warehouse project under construction, immediately adjacent to Seminole Colony, on the west side. In addition, debris lines indicated that water had sheetflowed from Okeechobee Boulevard north into the project. Finally, the NPBCWCD canal which received water from the project appeared to be at capacity.

Flooding occurred on Military Trail in the vicinity of the Military Trail School, just north of Okeechobee Boulevard. This area was inspected at 0925 hours on November 22. Water extended to the western edge of the northbound lane for a distance of approximately 400 ft. This water was a couple of inches deep and did not prevent traffic from using the roadway.

This canal follows an east-west alignment and drains into the EPB-11 canal. It is located approximately 0.5 mile north of Okeechobee Boulevard and runs along the south side of the Northwood Institute. At 0926 hours on November 22, the canal stage was observed to be about 1 foot below the top of the south bank and was even with the elevation of the north bank. Water was observed to be sheetflowing into the canal through the undeveloped areas along its south bank.

This area was constructed under General Permit No. 81-36, and is located one mile north of Okeechobee Boulevard on the east side of Military Trail. The area was inspected at approximately 0935 hours on November 22. The detention lake stage was over the banks. A water depth of 0.5 foot was measured over the centerline of Woodstock Drive at the entrance to the development. No house pads were flooded; however, the road flooding was extensive. The operation of the development's water control structure could not be evaluated since high water stages in the NPBCWCD system prevented the water from draining.

Waterview Mobile Park is a development located on the south side of Okeechobee Boulevard, approximately 500 feet east of Congress Avenue. This area was inspected at approximately 0955 hours on November 22. The majority of the roads in the project were under water. Several automobiles were flooded. At the time of inspection, water was 1.6 feet deep over the centerline on Manor Avenue. Watermarks indicated that several mobile homes had been flooded hours earlier. The drainage system within Waterview Mobile Park consists of a series of drop inlets, aligned along an inverted road crown, which drains into Lake Worth Drainage District (LWDD) Lateral Canal No. 2 (L-2). At the time of inspection, the water in the L-2 canal was out of its banks.

This canal follows an east-west alignment and is located approximately one-half mile south of Okeechobee Boulevard. This canal eventually drains into C-51. The L-2 canal was inspected at 1023 hours on November 22 at the point where it passes under Belvedere Road. At that time, the stage within the canal was 5.8 feet below the bottom of the electrical conduit on the south side of the bridge. The observed flow was in a southerly direction.

This development is located east of Military Trail, between Belvedere Road and Okeechobee Boulevard. It is bounded on the east by Congress Avenue. This area was inspected at approximately 0900 hours on November 22. General road flooding was observed throughout the entire community. Intersections along Westgate Avenue had water standing 2 feet deep. The roadway and parking lot

of the Westgate Community Center were under water. Several homes in the area were observed to have water inside. The Westgate school grounds were flooded with water to within 1 inch of the floor elevation. Water in the LWDD L-2 canal was flowing with a stage 3 feet below the top of the bank.

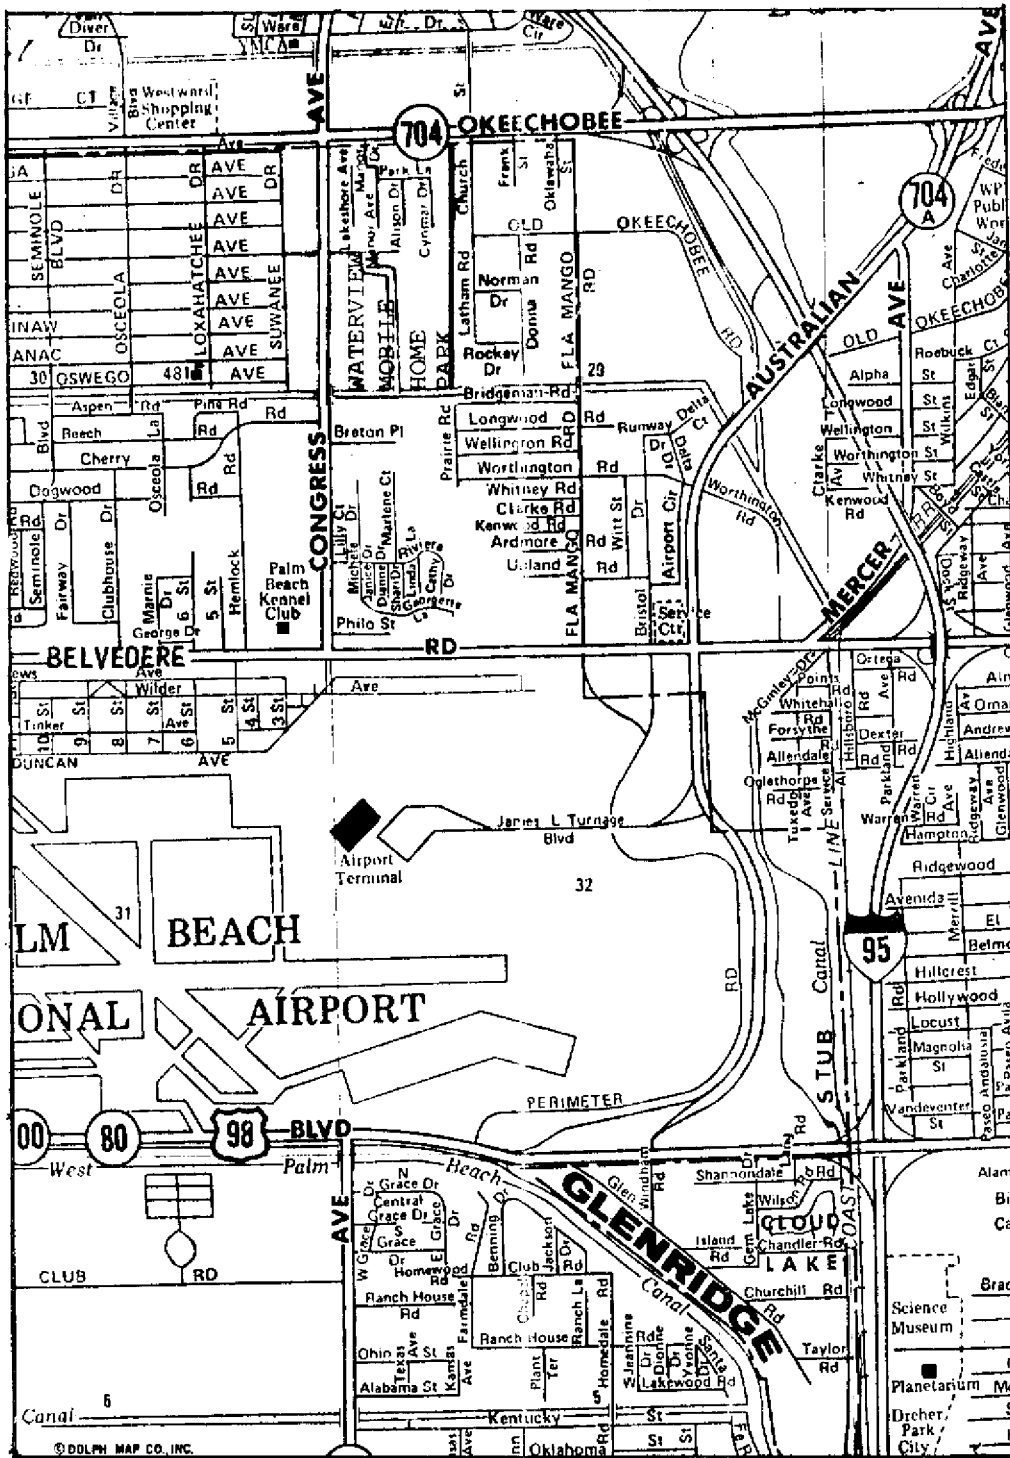
LOCATION OF COMMUNITY OF GLEN RIDGE  
and WATERVIEW MOBILE PARK

The flood stage in Waterview Mobile Park probably was higher than the peak stage during the April 23-26, 1982 rainstorm; however, it was much less than previous storms as shown in Table 3. It should

be noted that the water levels in the West Palm Beach Canal (C-51) were much lower than in previous storms. This was due to the fact that the manually operated Palm Beach lock has been replaced by a more effective and efficient automatic control spillway structure (S-155). It is also important to note that the water level at the structure at the upstream side (north side) of Southern Boulevard was at 11.29 ft msl, and the West Palm Beach Canal was at 8.8 to 9.3 ft msl during the peak hours. This was a head loss of almost 2 feet in a reach of approximately three-quarters of a mile. A preliminary estimation based on available cross sections in this reach, and the high water marks measured during the storm, indicated that there was approximately 1400 cfs of discharge in this reach resulting from this gradient. The flow through the Belvedere Road bridge crossing of the Stub Canal was estimated at  $\pm 850$  cfs and approximately 350 cfs of flow through the bridge at Australian Avenue crossing the Stub Canal. The Stub Canal was designed for 588 cfs which consisted of 250 cfs from Clear Lake and 338 cfs from a 5.2 square mile area to the west. The following factors may have contributed to the excessive runoff.

Glen Ridge is a development near the southwest corner of I-95 and Southern Boulevard. This project was inspected at 1032 hours on November 22. Road flooding was observed in several areas of the development. Several homes appeared to have water inside. Glen Ridge has a drainage system which depends on a pump. At the time of the inspection, District field representatives were told that the pump had been inoperable for about 1.5 hours.

A review of the project system performance during this storm indicated that there were no serious problems encountered. Flooding in the Waterview Mobile Park area was caused by 1) the low elevation of the area (flood prone), 2) rainfall intensity, and 3) increasing runoff due to rapid development in the basin has surpassed the design capacity of the Stub Canal.

In view of the possible adverse impact to the existing C-51 basin, it is not feasible to improve this reach of channel cross-section. Instead, it may be more feasible to consider a small pumping station and a flap gate control culvert to relieve the Waterview Mobile Park from frequent flooding. This would require a levee to protect the park area. Drainage would be to Lateral Canal #2 (L-2) of the Lake Worth Drainage District. The normal stage in L-2 is approximately 8.5 ft msl. The gated culvert should maintain a normal stage inside of the park of less than 9.0 msl. The pump should start up automatically at a stage of 9.5' msl and shut off at a stage of 9.0 ft msl.

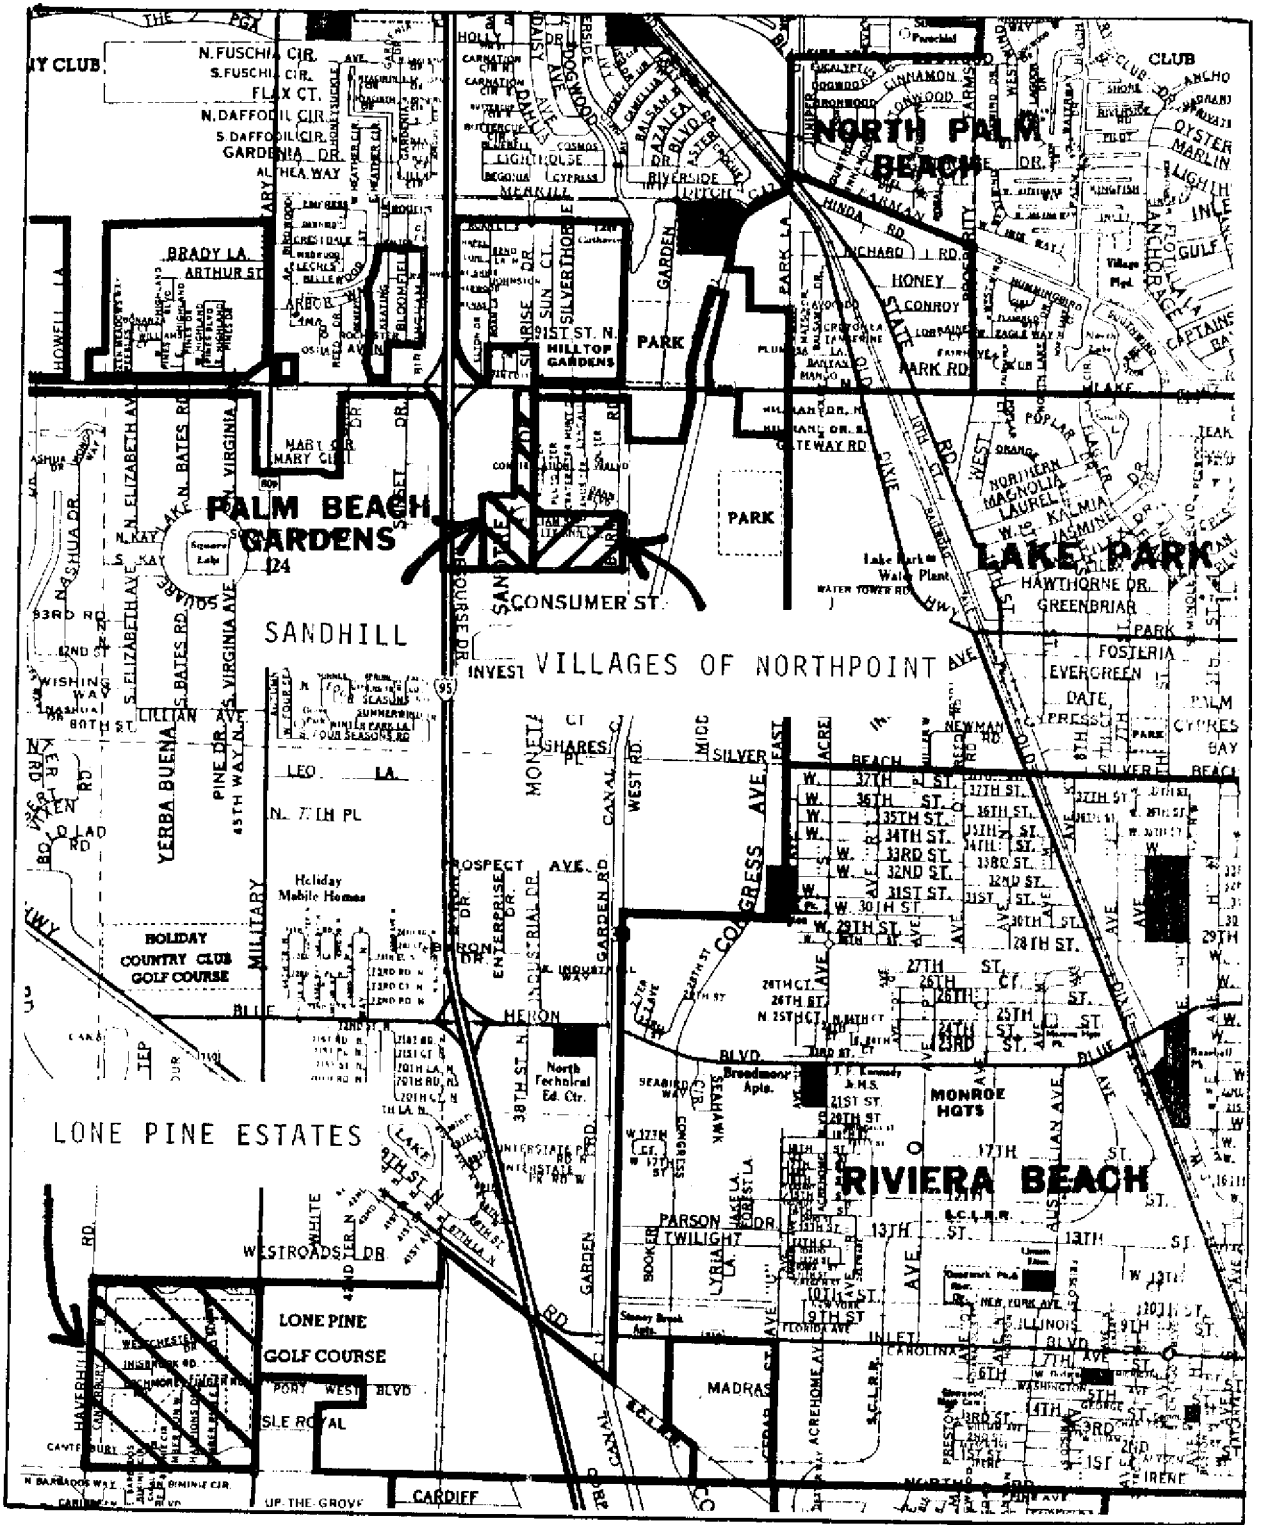
FIGURE 14 LOCATION OF SANDHILL, VILLAGES OF NORTHPOINT AND LONE PINE ESTATES

Sandhill is a development located east of I-95 and south of Northlake Boulevard. It was inspected at 1413 hours on November 23. The project's retention area was not full, and the roads and swales were dry. An additional retention area, which is shared with the Villages of Northpoint, had approximately 0.2 foot of water over its banks.

This development is located just east of Sandhill. It was inspected at 1415 hours on November 23. Flooding was observed along some of the roads. The retention area shared with Sandhill was out of its banks.

This development is located west of Military Trail, north of 45th Street. It was inspected the afternoon of November 23. Flooding was extensive. At least one home was flooded. No discharge to EPB-9 and 10 canals was possible due to high water stages in those canals.

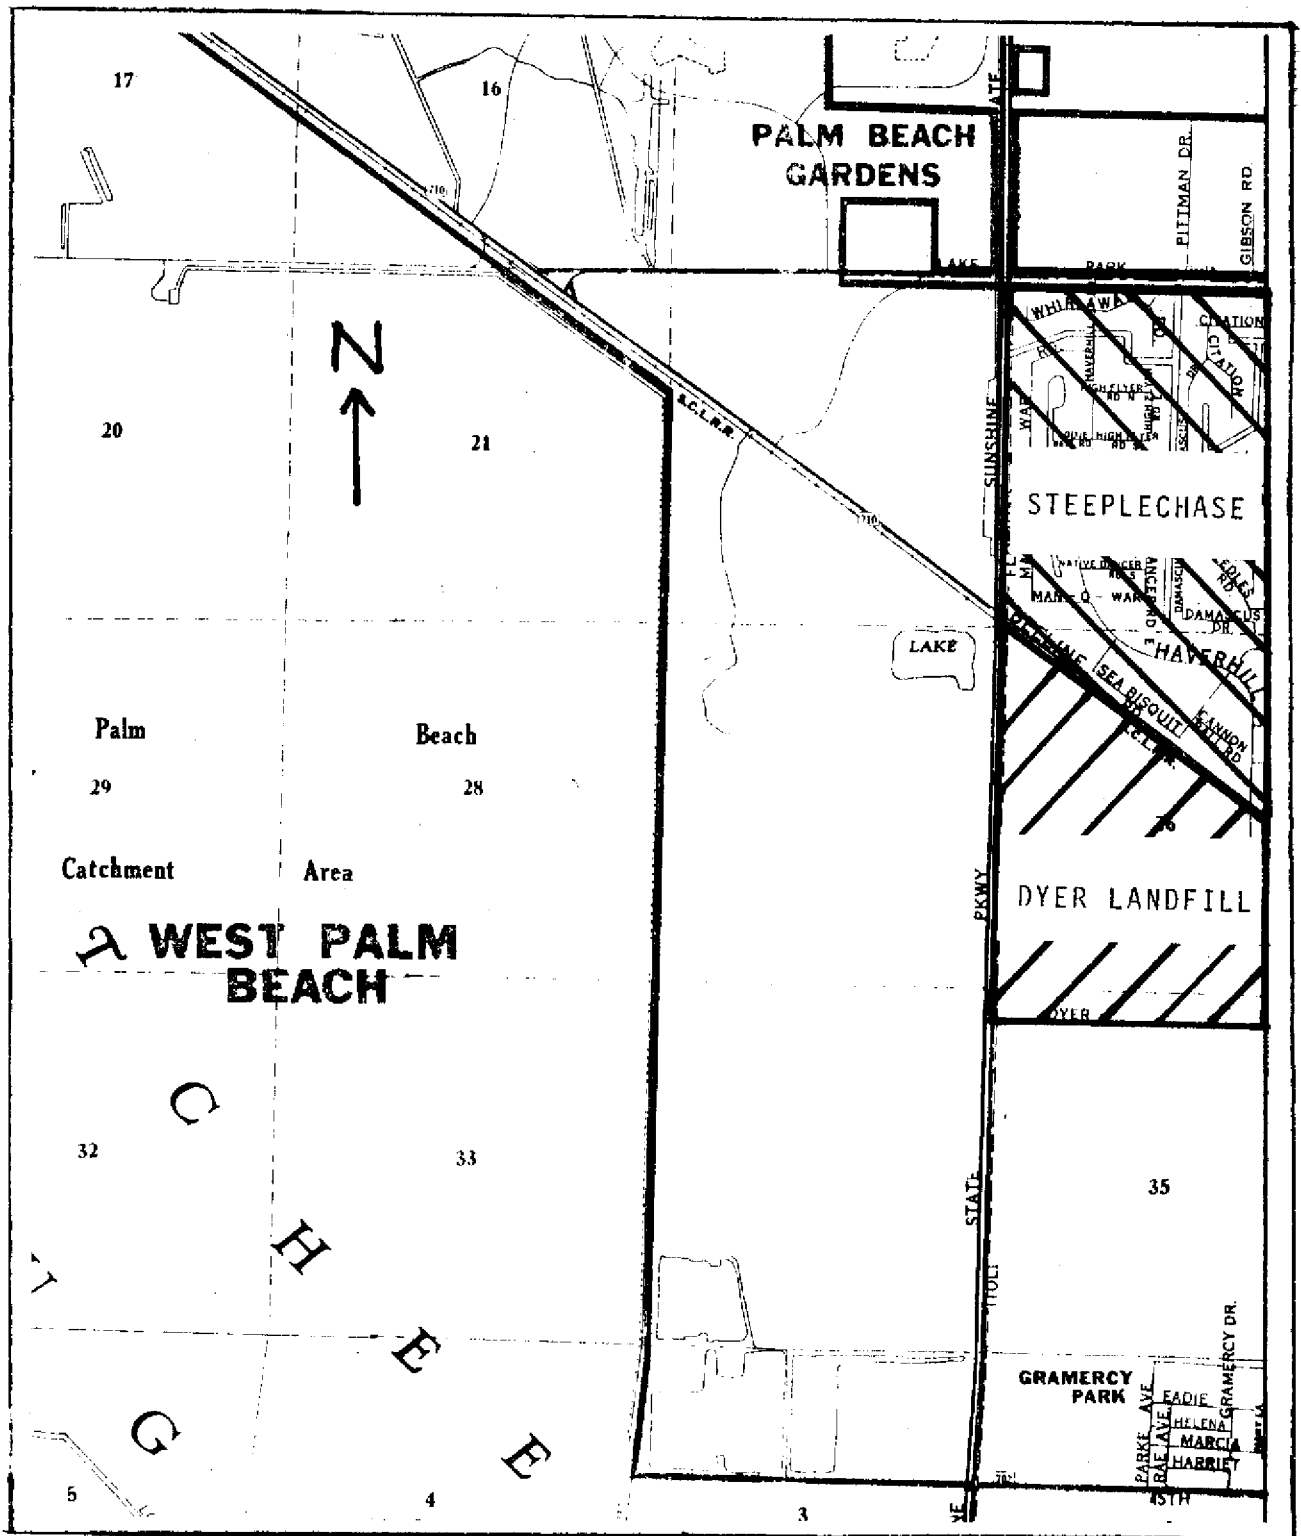
FIGURE 18 LOCATION OF STEEPLECHASE AND DYER LANDFILL

This area is located at the southeast corner of Beeline Highway and Florida Turnpike. It was inspected on the afternoon of November 23. Turbid

discharge was observed at the control structure. The retention area was full. Erosion was occurring on the landfill side slopes. The raw sewage pits appeared to be secure.

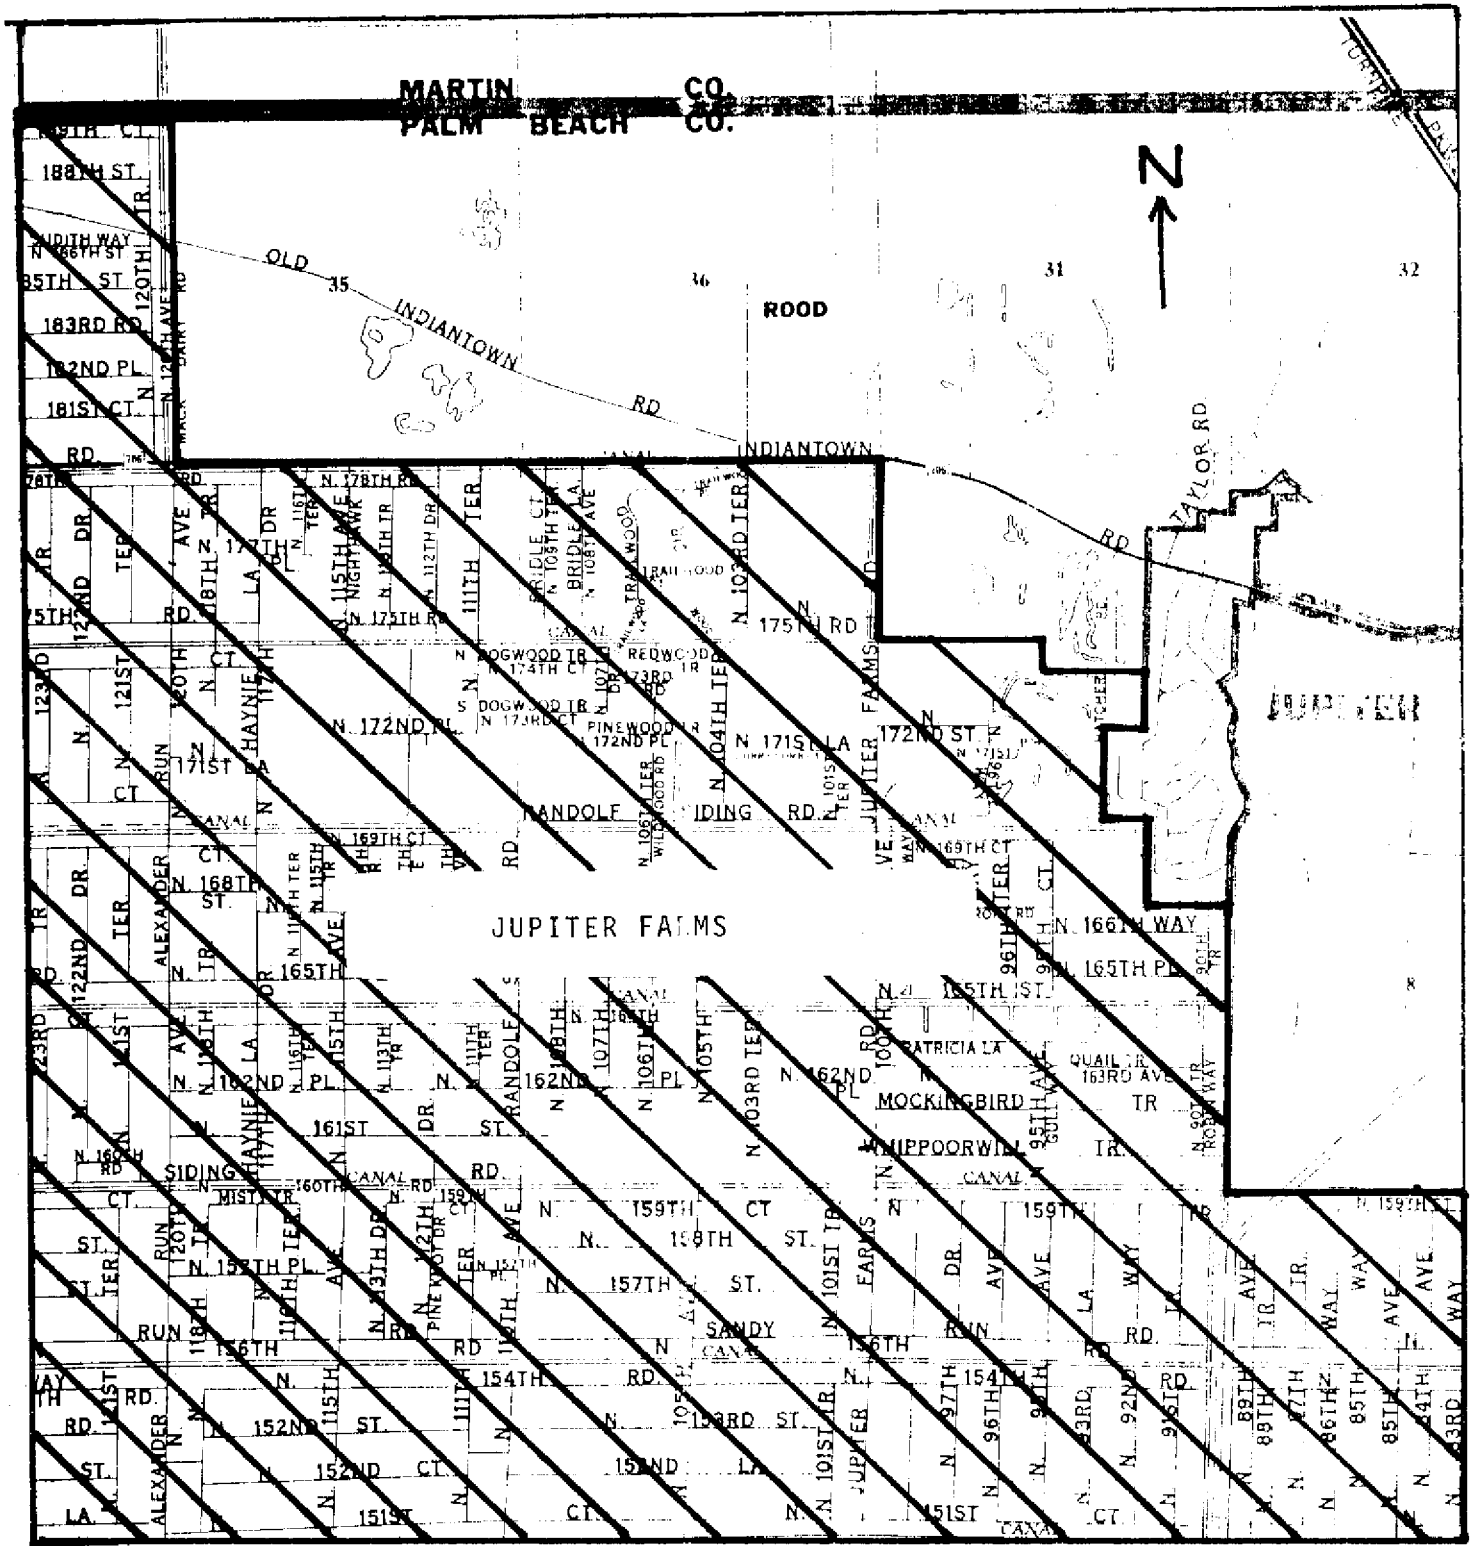
FIGURE 20 LOCATION OF JUPITER FARMS

This community is located south of Indiantown Road and west of the Florida Turnpike. It was inspected on the afternoon of November 23. Most roads were passable. There was standing water in yards and fields.
