STORM EVENT OF OCTOBER 8-10, 1991

December 1991

**South Florida Water Management District
West Palm Beach, FL**

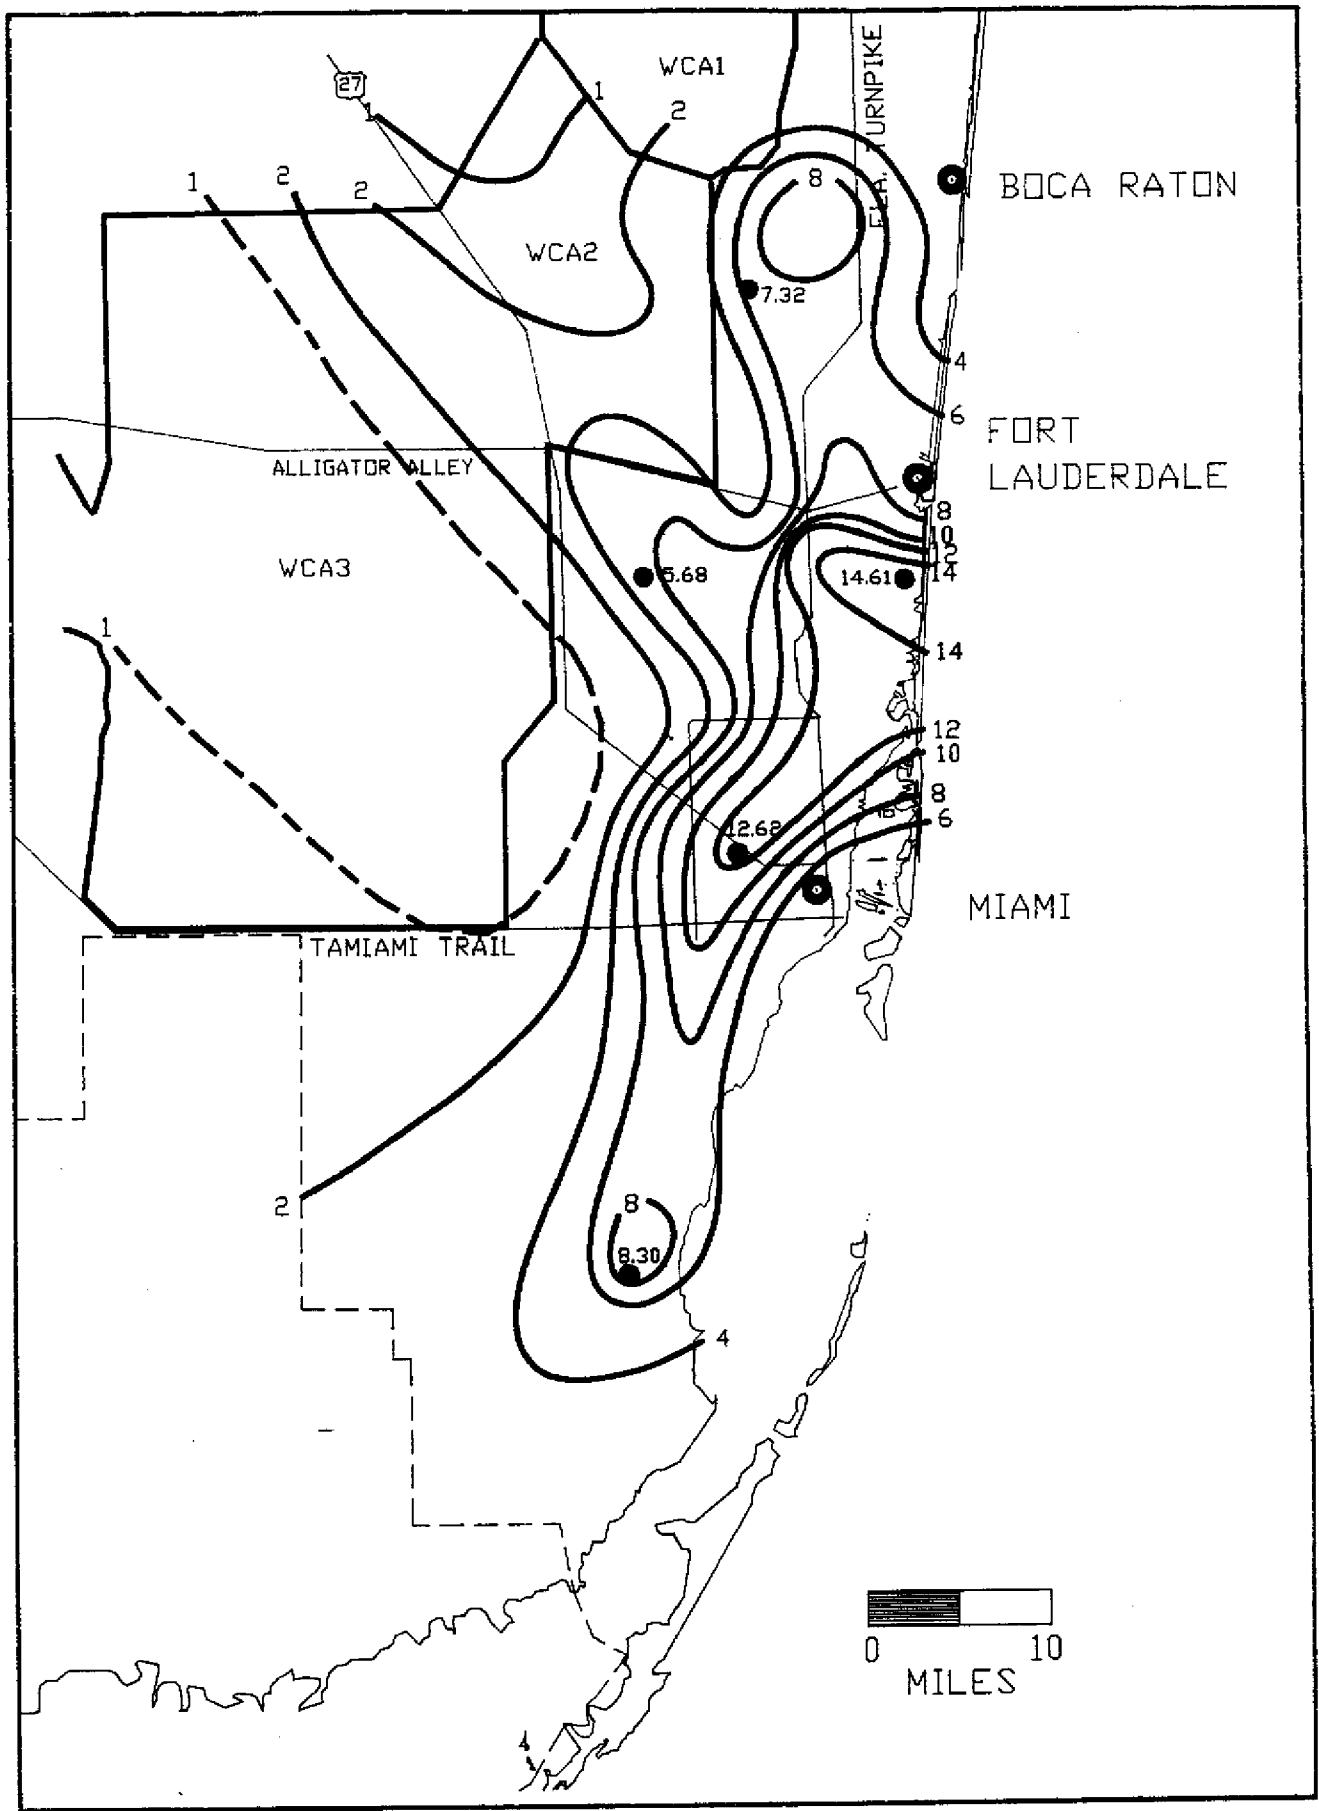
Figure 1. Isohyetal Map of the October 1991 Storm

The spatial distribution of the three-day storm is shown in Figure 1. The isohyets illustrate the areal variation of the storm, and indicate that the heaviest rains occurred near the coast, between Fort Lauderdale and Miami. Recorded rainfall amounts ranged between 0.2 and 15 inches, with the highest three-day total of 14.61 inches accumulated in Hollywood. Miami International Airport received a total of 12.76 inches. Although the major portion of the storm occurred between Fort Lauderdale and Miami, significant amounts of rain fell as far south as Homestead Air Force Base, recording 8.30 inches, and to the north, where Coral Springs received 7.32 inches during the 72-hour period. Rainfall decreased towards the west where less than 16 miles from the coast 5.68 inches were registered at the South Broward Drainage District gage. The locations of the recording stations (Figure A-1) and rainfall amounts used to develop the isohyetal map are presented in Appendix A.

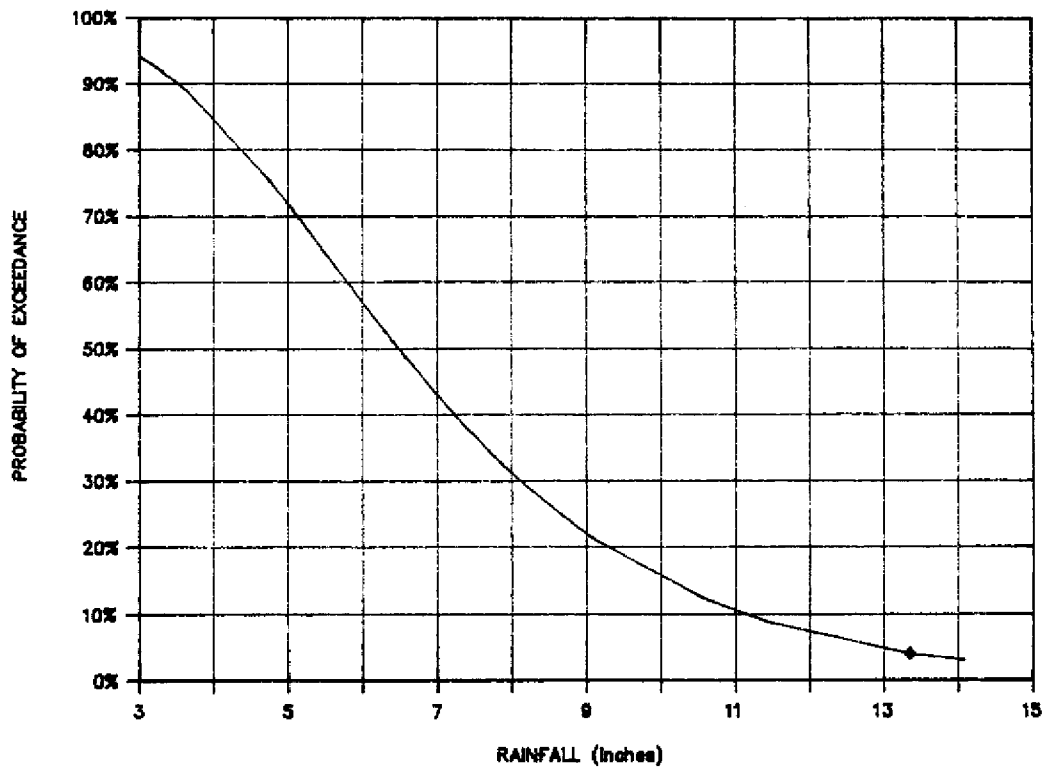
Figure 2. Three-Day Maximum Rainfall Frequency-Gill Realty Station, Broward County

Return periods for three-day rainfall amounts from Gill Realty and Miami International Airport stations were determined from the exceedance probability curves shown in Figures 2 and 3. These curves assume that the historical three-day maximum data follow a Gumbel extreme value distribution. The return period is found by first locating the three-day rainfall value on the Gumbel distribution curve. The ordinate associated with this point is referred to as the probability of that three-day rainfall being equalled or exceeded in any given year at that recording station. The reciprocal of the exceedance probability is equal to the return period of the rainfall depth. The Miami International Airport and Gill Realty gages recorded three-day rainfall depths having a probability of exceedance of approximately 4 percent, or a return period of 25 years. The three-day rainfall return periods for other locations (Table 2) were estimated from the isohyetal maps shown in District Technical Memorandum, Frequency Analysis of One- and Three-Day Rainfall Maxima for Central and Southern Florida, October 1990.

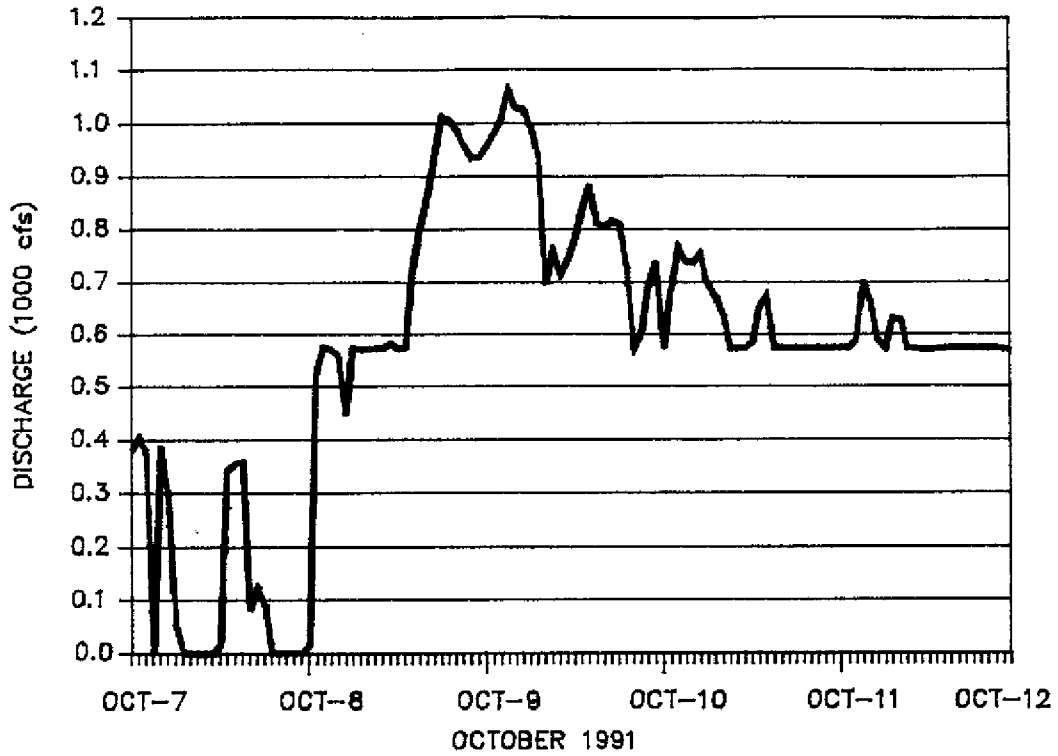
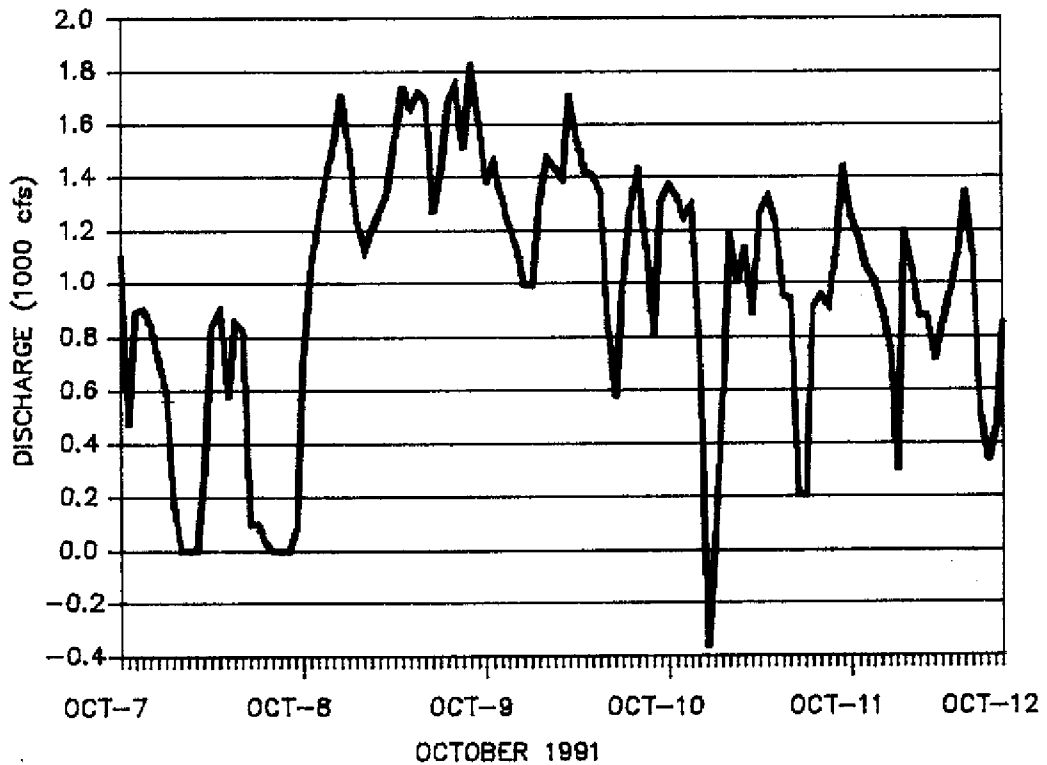
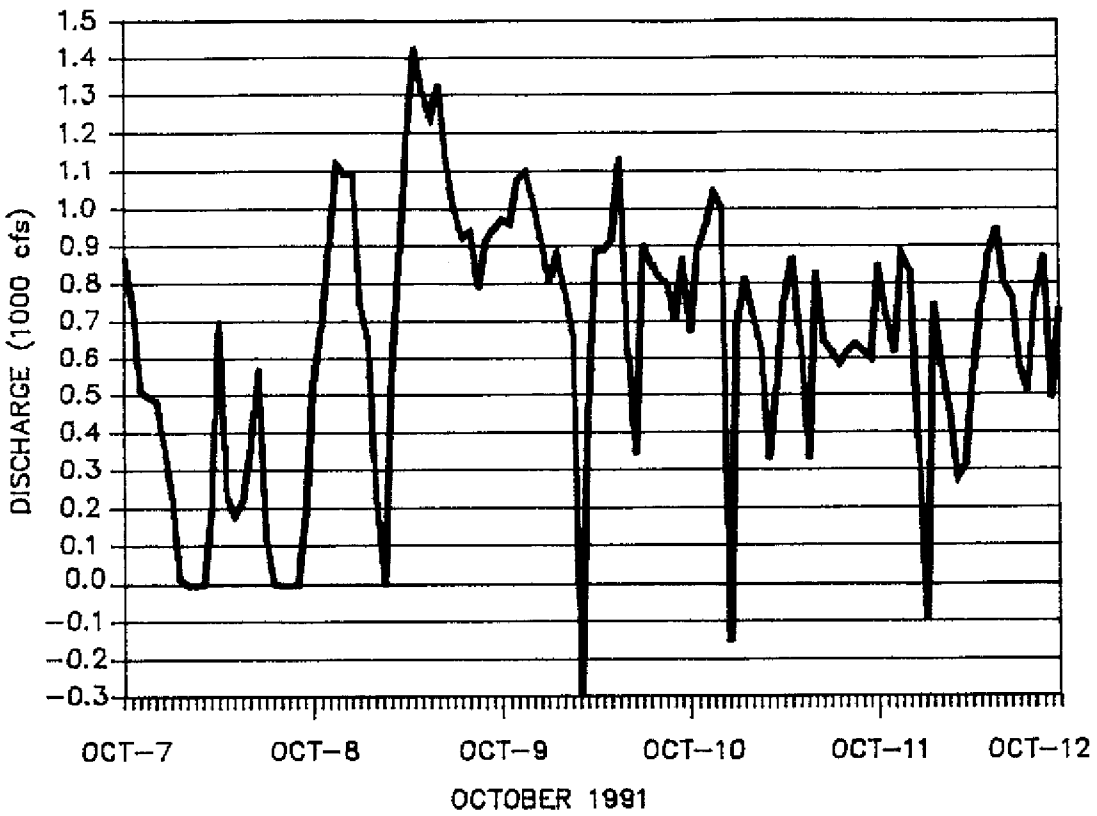
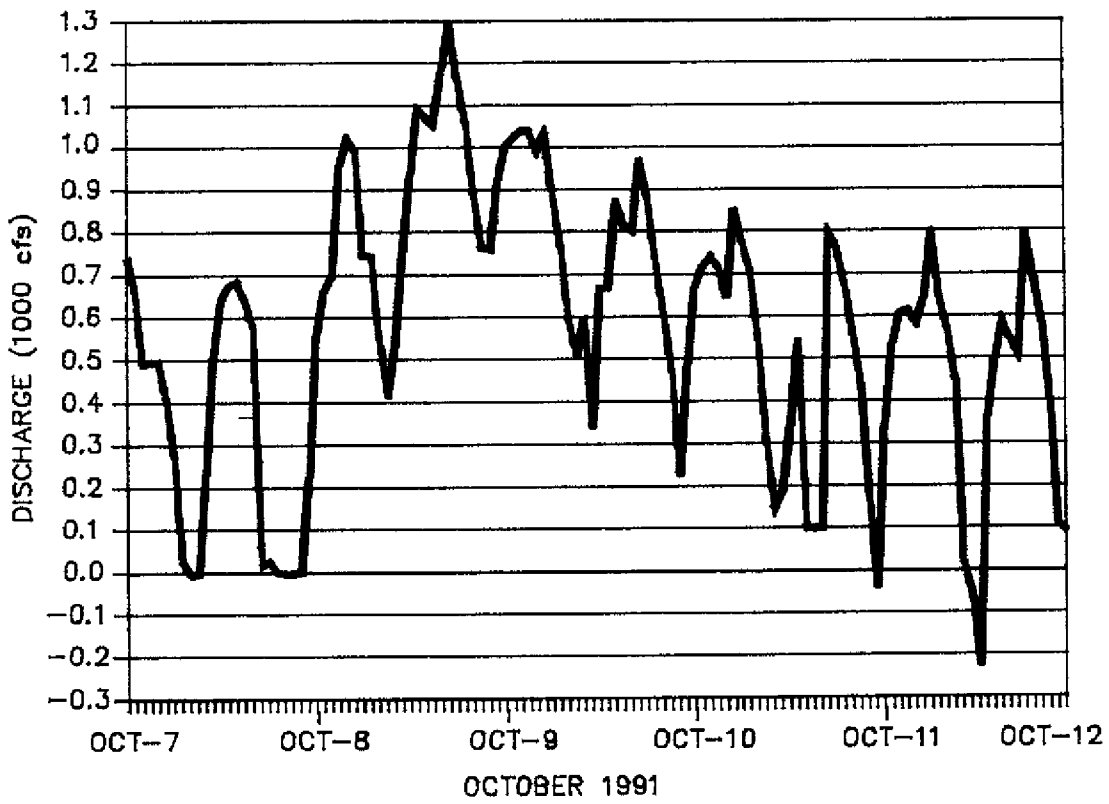
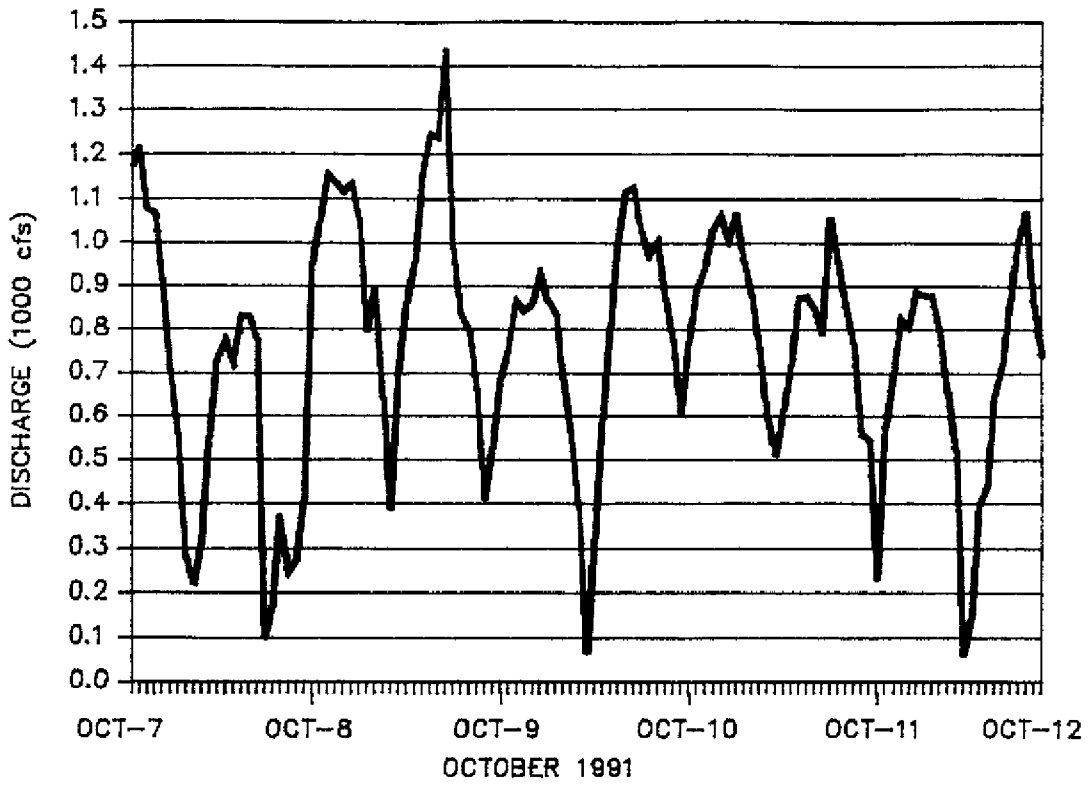
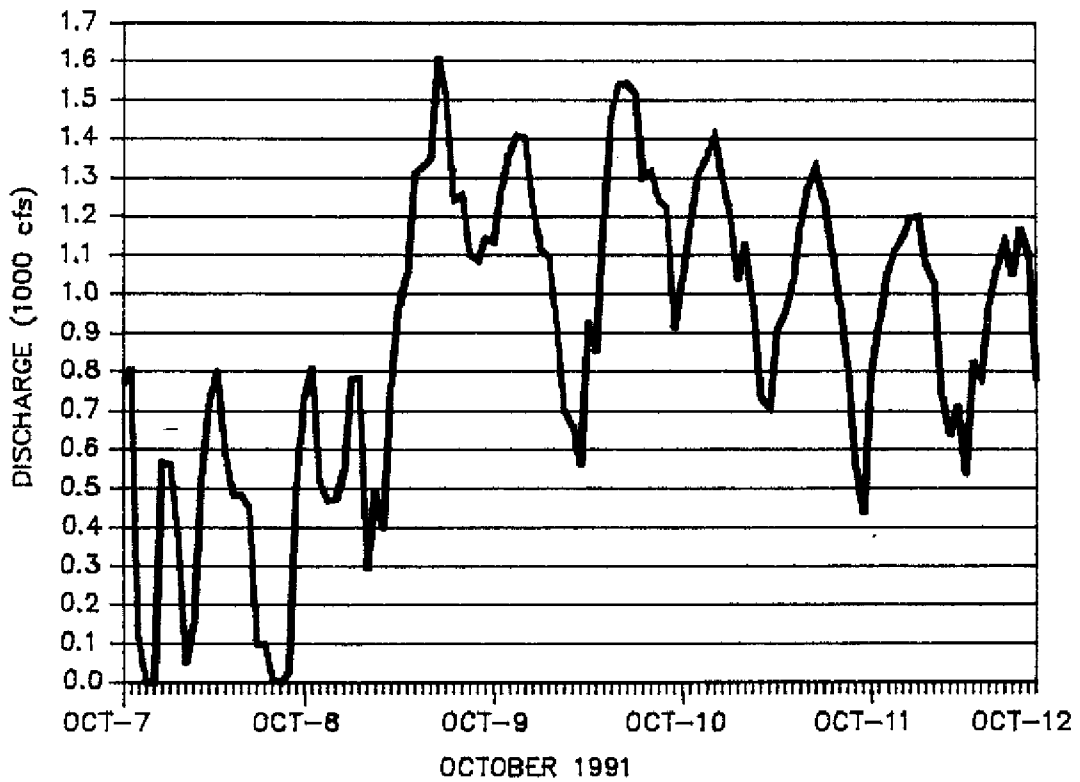
The discharge hydrographs shown in Figures B-21 through B-26 reflect the operations of coastal structures. Normal flood control procedures dictate that coastal areas of Dade County receive priority drainage over the western areas. In conformance with this policy, all discharge moving eastward from the area west of Krome Avenue to C-4 or C-6, was terminated on October 8. This included diversions to the Northwest Wellfield which are normally controlled by Dade County utilities.

Tides during the storm period were unusually high. Strong onshore winds, combined with unusual astronomic conditions, raised water levels seaward of the coastal control structures to severely restrict drainage of stormwater in eastern Dade County. The chronology of events delineating the operations of the control structures is presented in the subsection "Pump and Water Control Structure Operations". The peak discharge and design discharge for selected coastal structures is presented in Table 4. The locations of canals and structures are shown in Figure B-14. Hydrographs of stage and flow at selected sites on major canals in the area affected by the storm are presented in Figures B-15 through B-26.

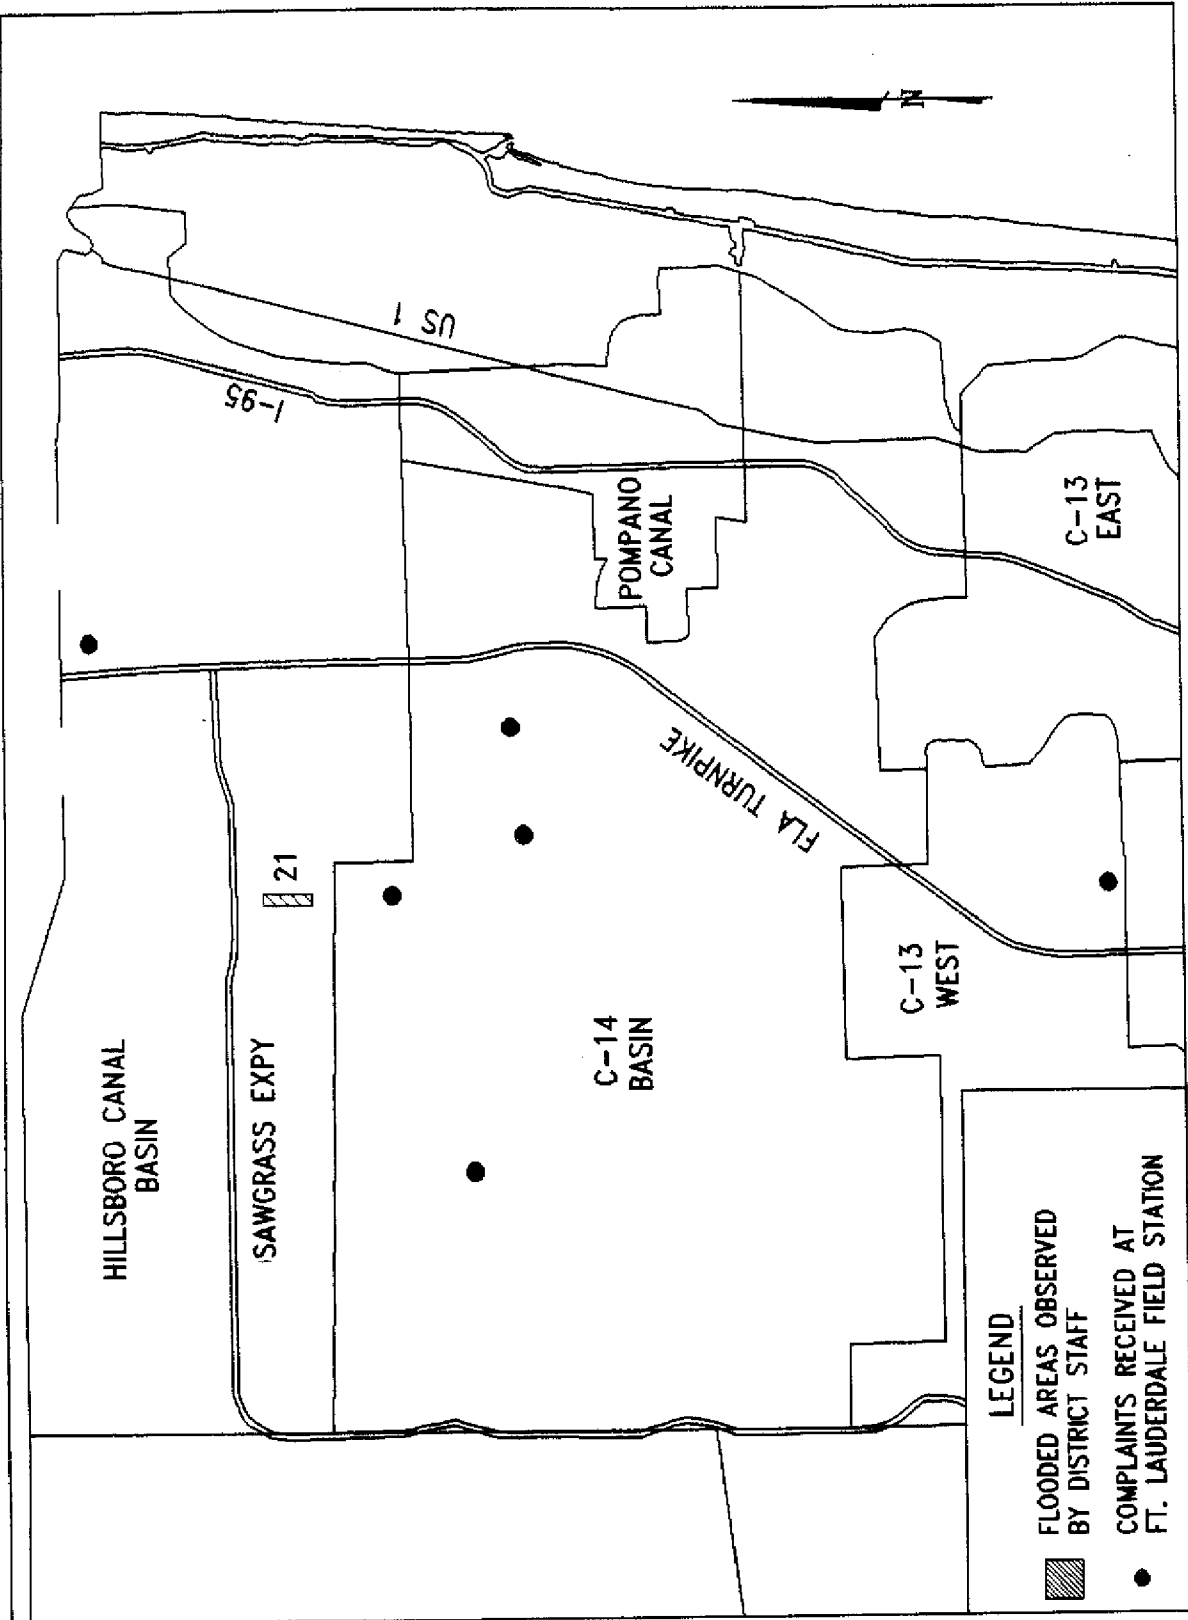
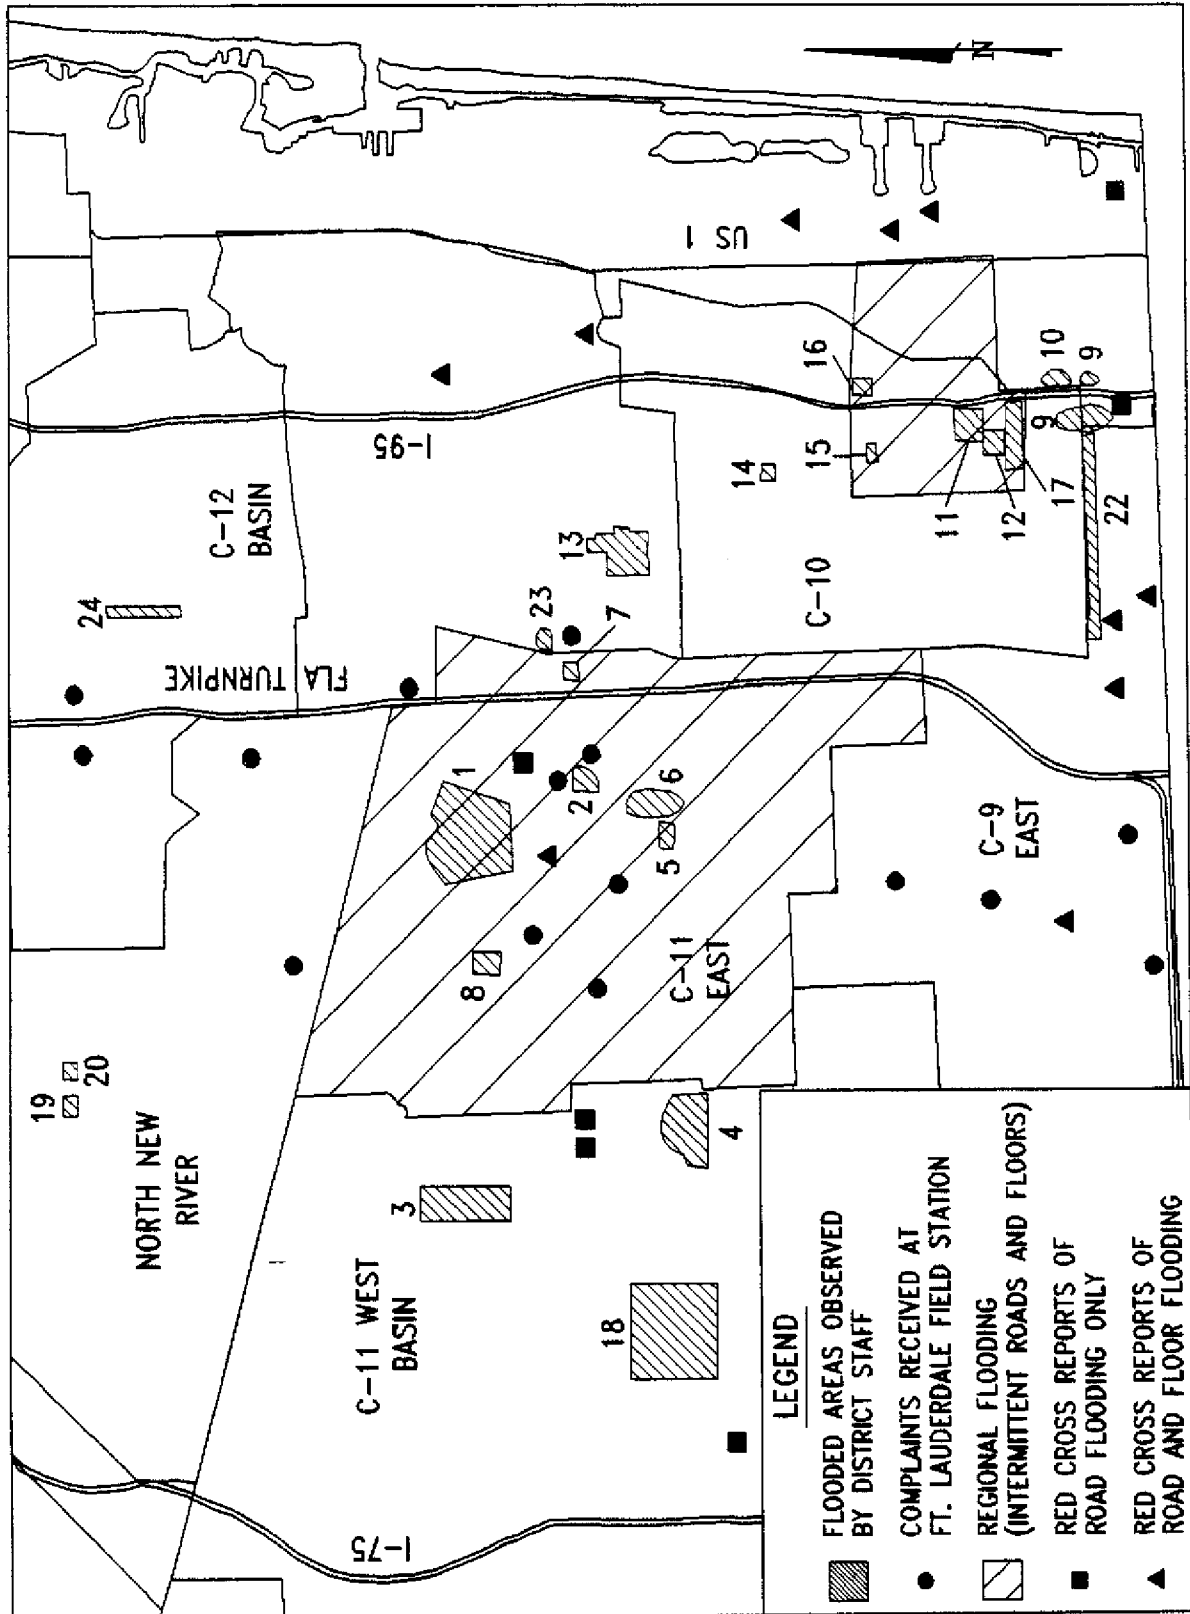
- a. Nova High School/University: Maintenance buildings and green houses were flooded [1].
- b. Emerald Isles Apartments: Parking and air conditioning units flooded to 16 inches [2].
- c. Majestic Groves subdivision: Streets and yards flooded up to building foundations [3].
- d. Little Ranches: Streets flooded [4].
- e. Davie Road and 52nd Street: Streets and floors in lower areas flooded [5].
- f. Davie Road area south of Griffin Road: Streets flooded [6].
- g. Shopping Center at 441 and Griffin Road: Parking lot flooded to 20 inches [7].
- h. SW 30 St/Rolling Hills Golf Course: Streets, yards and golf course flooded from 10 to 12 inches [8].

- r. Sunshine Acres: High water caused drainfield problems [18].
- s. Sunset Strip from NW 91 Avenue to NW 96 Avenue: Street and yard flooded to 6 inches [19].
- t. Pine Island Rd./Sunset Strip intersection: Flooded to 20 inches, street closed [20].
- u. Godfrey Road at Wiles Road: Streets and paddocks flooded to 10 inches [21].
- v. Miramar Parkway east of 441: Street closed due to flooding, depth unknown [22].
- w. Broward Resource Recovery Plant: Water inside of the ash landfill breached the surrounding dike. There was no discharge of water offsite, and the breach was repaired within one day. FDER kept on top of this [23].
- x. NW 39 Avenue from 4 Court to Seventh Street: Streets and yards flooded to 12 inches. Homes flooded to 4 inches [24].

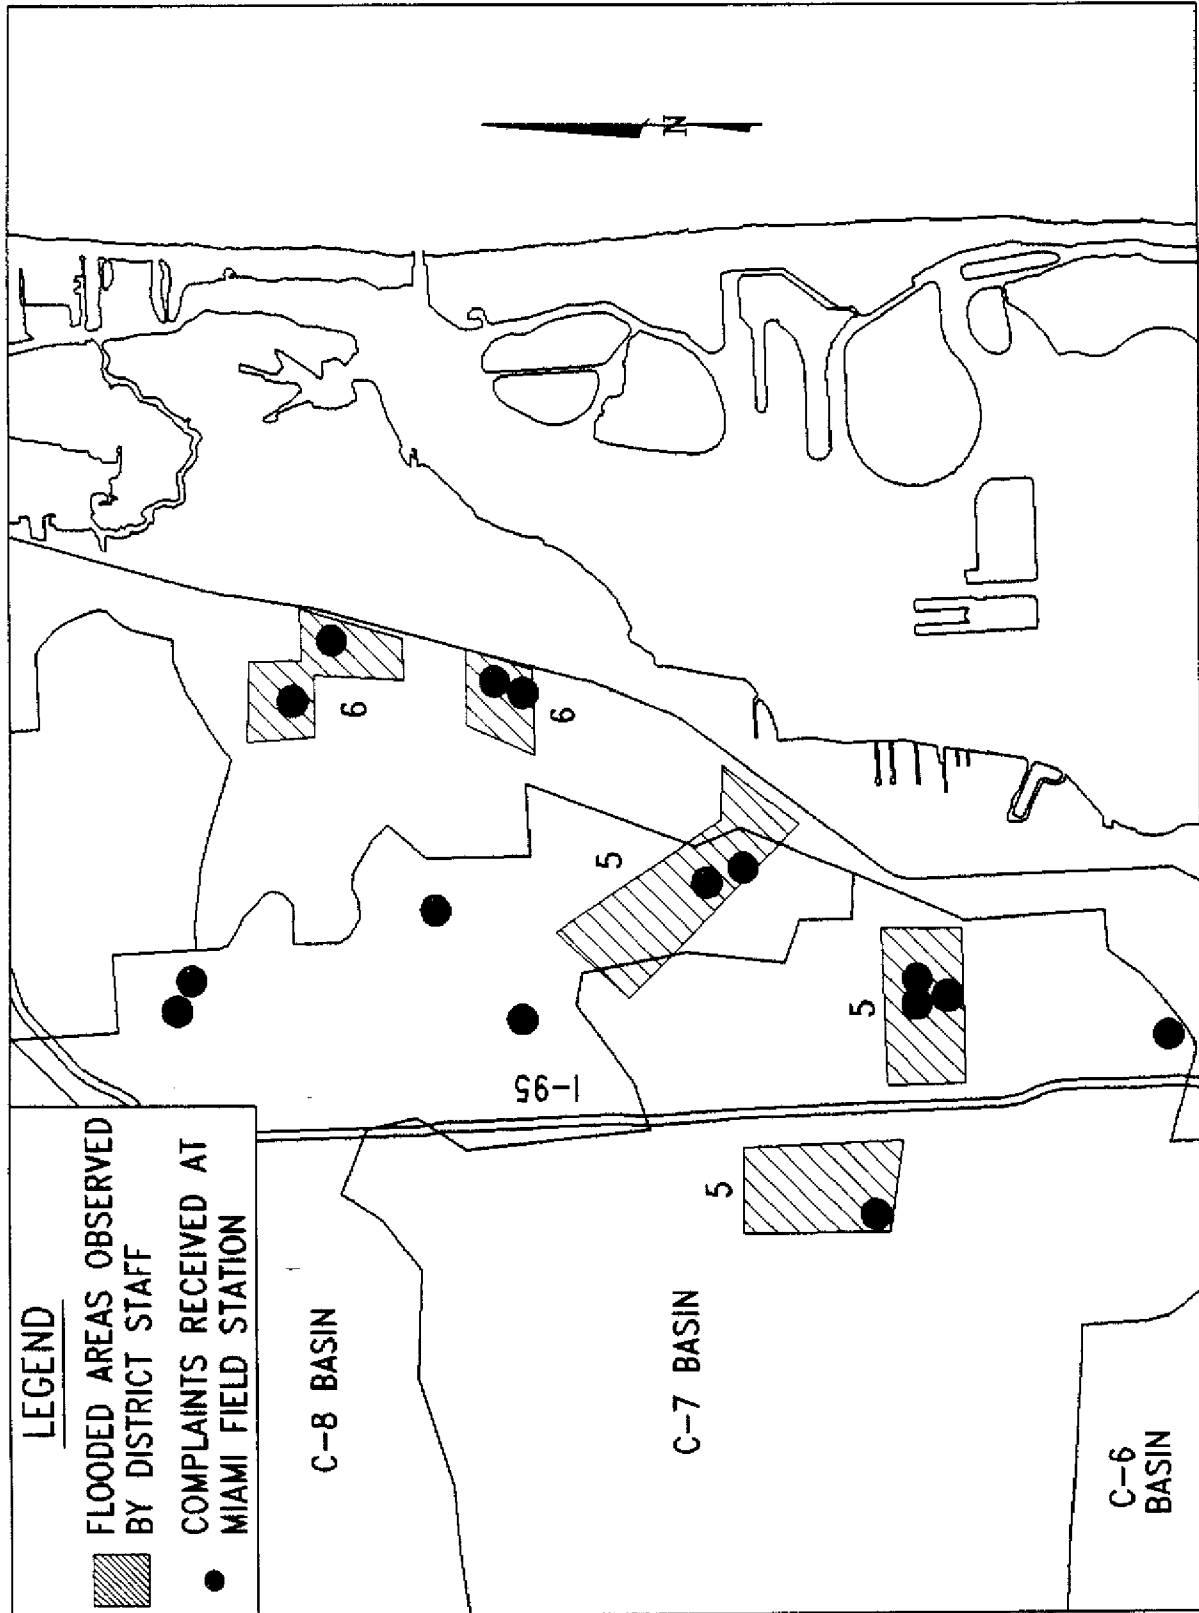
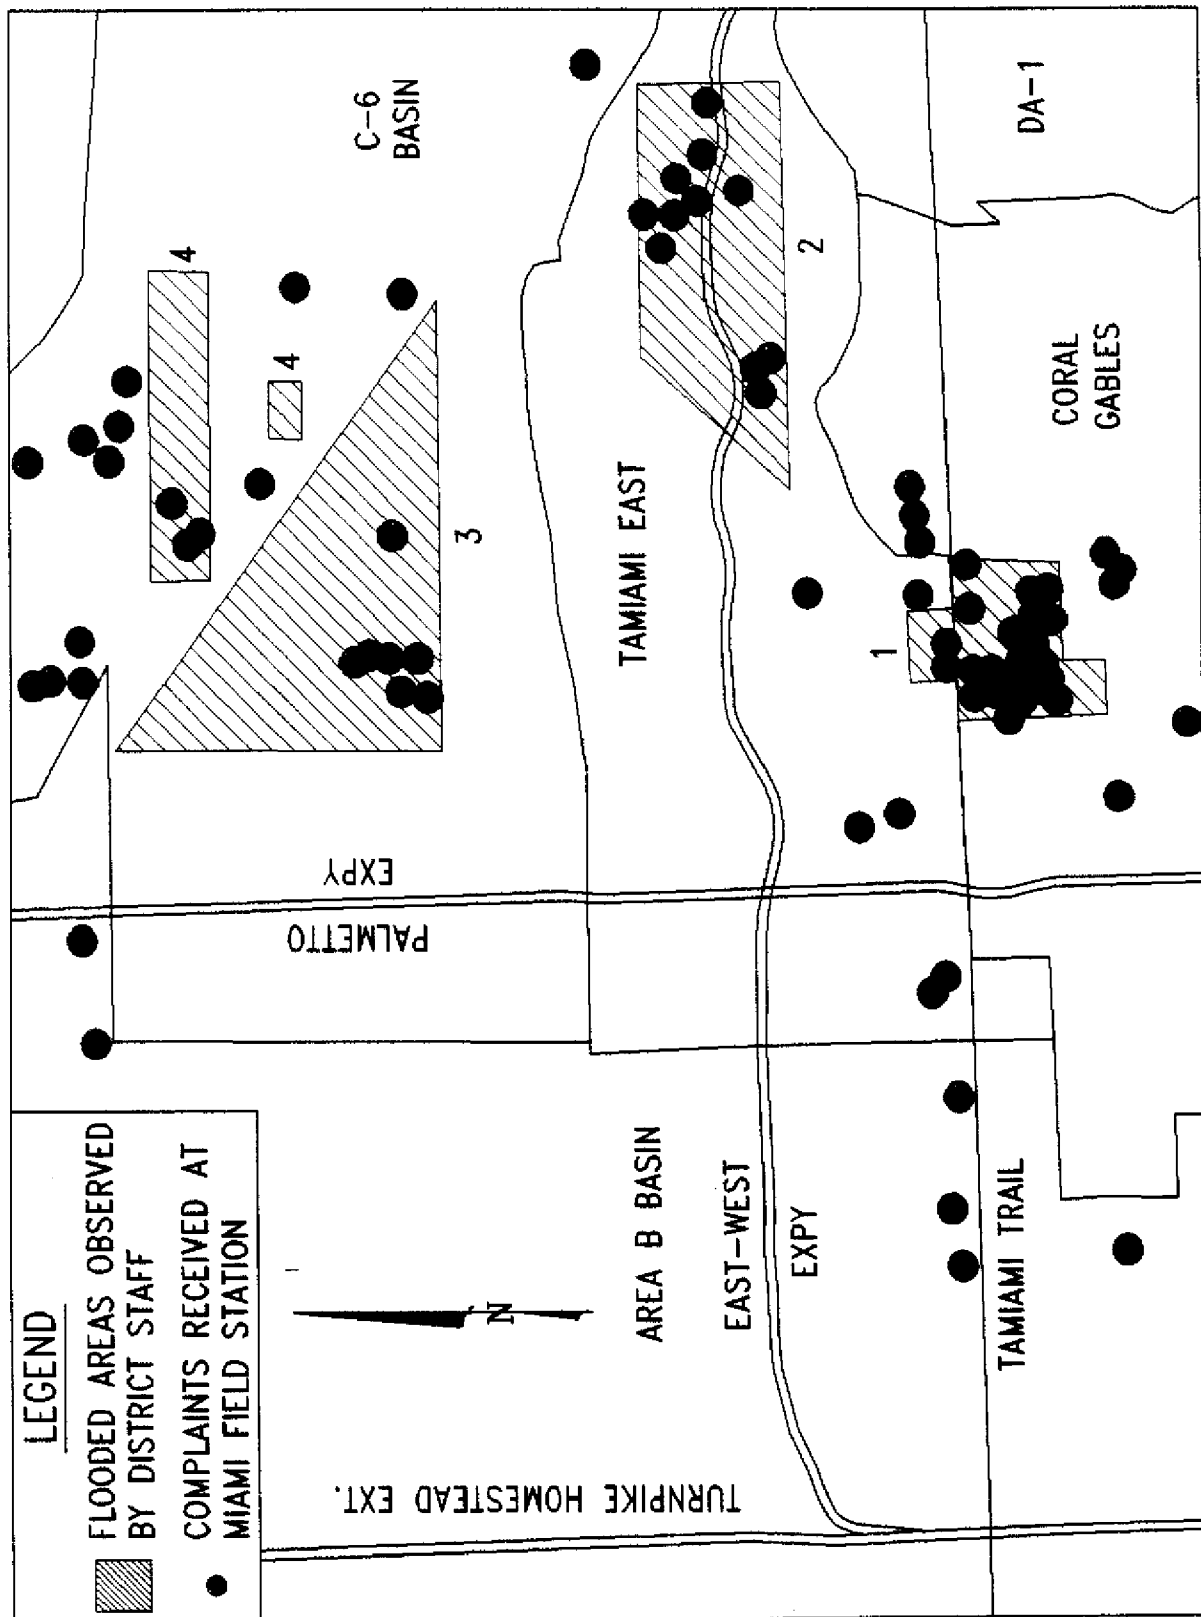
Affected areas of Dade County were observed by Field Engineering staff and Miami field station personnel by helicopter, and flooding was documented on video tape. Additional inspections were performed by Miami station personnel on the ground. Primary areas of documented flooding in Dade County are described below (numbers in brackets correspond to location on figures C-5 and/or C-6):
