WATER QUALITY MONITORING PROJECT FOR DEMONSTRATION OF CANAL REMEDIATION METHODS FLORIDA KEYS

Report of activities: September 7th, 2016

Florida Keys National Marine Sanctuary Steering Committee

Henry O. Briceño, Alexandra Serna, Michael Absten, Sandro Stumpf, James Duquesnel

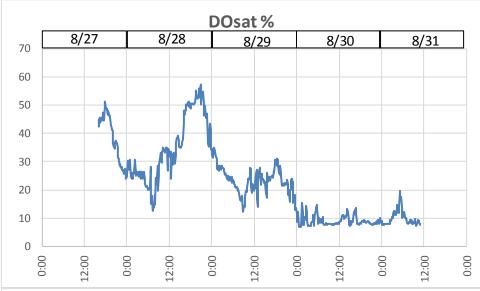
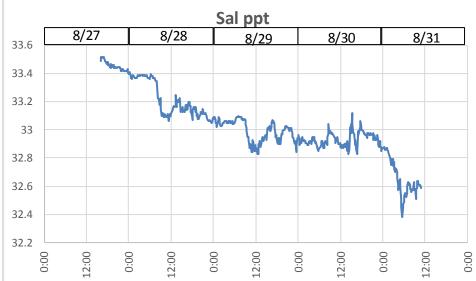
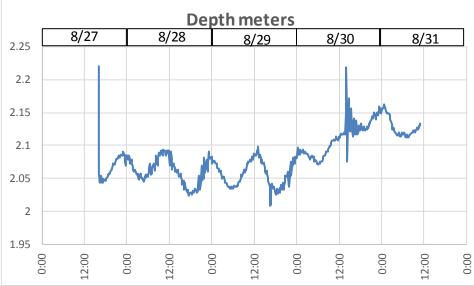
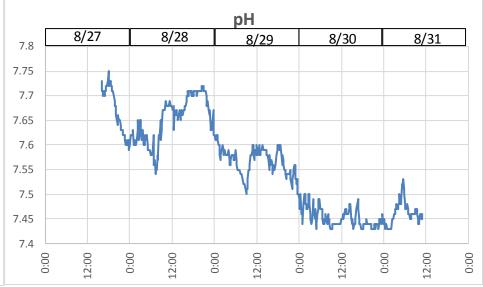
Canal #29. Remediation technology: Backfilling. Completed Jul-15

Pre-rem	ediation	Post-rem	nediation		Above Target
			ır-14	t-14	-16	r-16	g-16	Below Target
			31-Mar	16-0ct	4-Feb	28-Apr	27-Aug	Oxygenation has improved significantly
	Surface	29						in bottom waters of
% Dissolved	water	Control 28						the remediated canal.
Oxygen Saturation	Bottom	29						Bottom DO declined in Aug 2016 due to storm
Sata. atlon	water	Control 28						Hermine.

- Surface waters well oxygenated before and after remediation
- Surveys show increase %DO saturation in shallower new bottom waters after the canal's depth was risen from 35 feet to just 8 feet
- Rain and wind during TS Hermine may have caused a drop in %DOSat

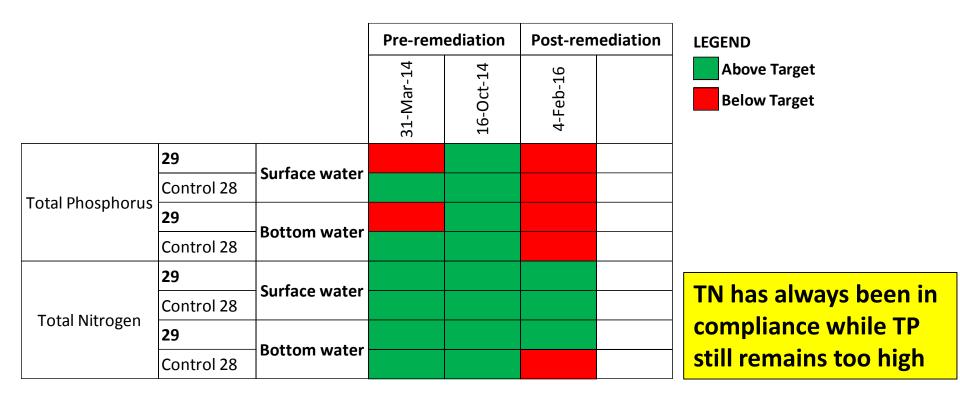
Canal #29. Remediation technology: Backfilling. Completed Jul-15

- Pre-remediation and first post-remediation surveys rendered TP concentrations out of compliance
- Surface and Bottom TN concentrations in compliance in all events before and after remediation

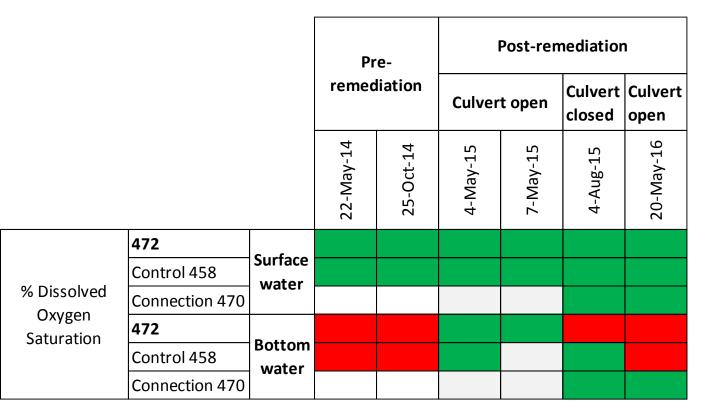
Canal #472. Remediation technology: Culvert installation. Completed May-15 and was closed shortly after, unplugged May-16

Mixed results. No definitive improvement trend for bottom waters after re-opening culvert

- Surface waters well oxygenated during monitoring before and after remediation.
 Heavy seaweed build up observed in late May 2015
- %DO saturation increased in bottom waters of remediated canal when culvert was opened the first time indicating an enhancement of natural tidal flushing

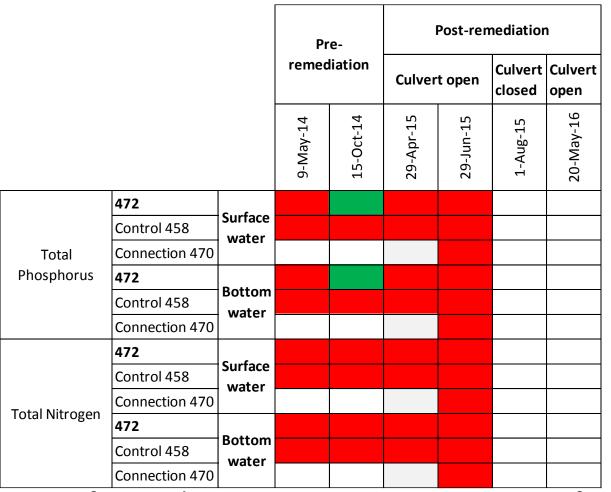
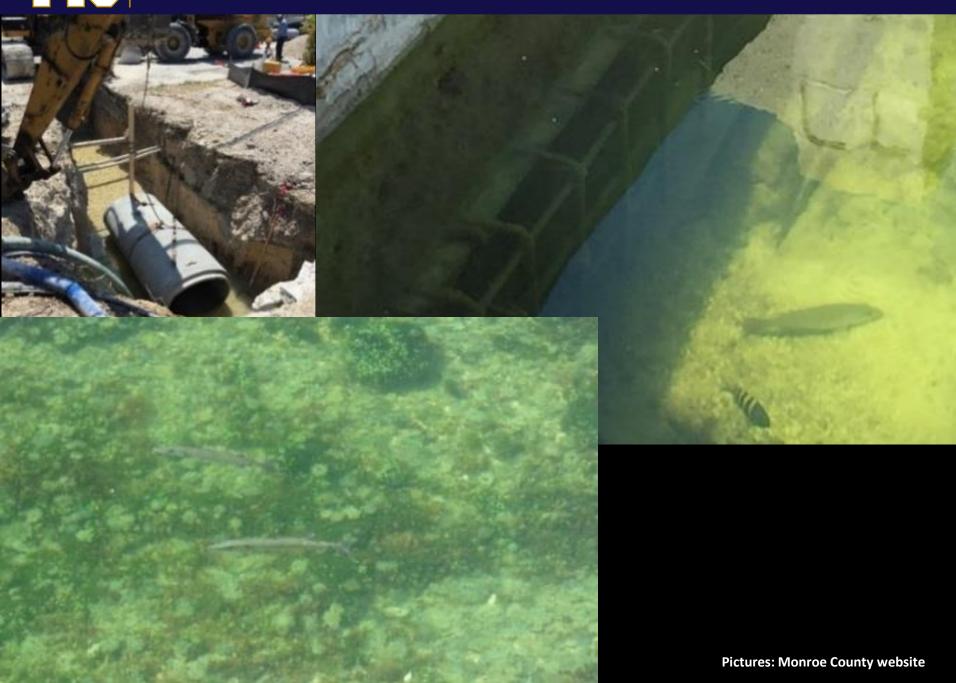
Canal #472. Remediation technology: Culvert installation. Completed

No definitive improvement trend yet. New survey will be performed during Sep 2016

- Surface and Bottom TP concentrations out of compliance in most events before and after remediation
- Pre-remediation surveys rendered TN concentrations out of compliance

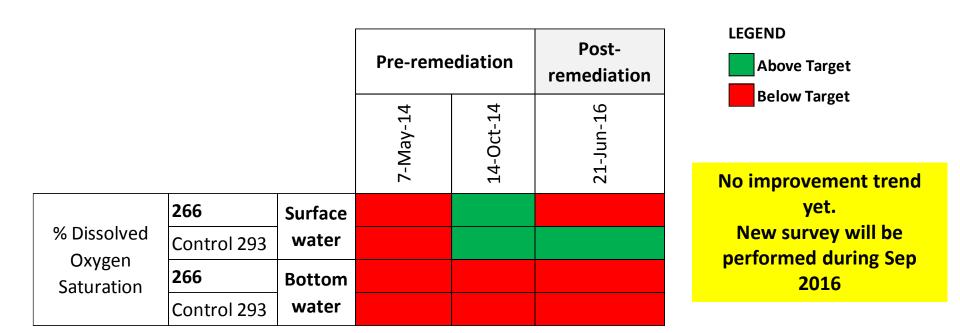
Canal #266. Remediation technology: Weed barrier/organic removal. Completed May-2016

- Pre and post-remediation surveys showed highly variable %DO saturation in surface waters
- Pre and post-remediation surveys rendered %DO saturation in bottom waters out of compliance

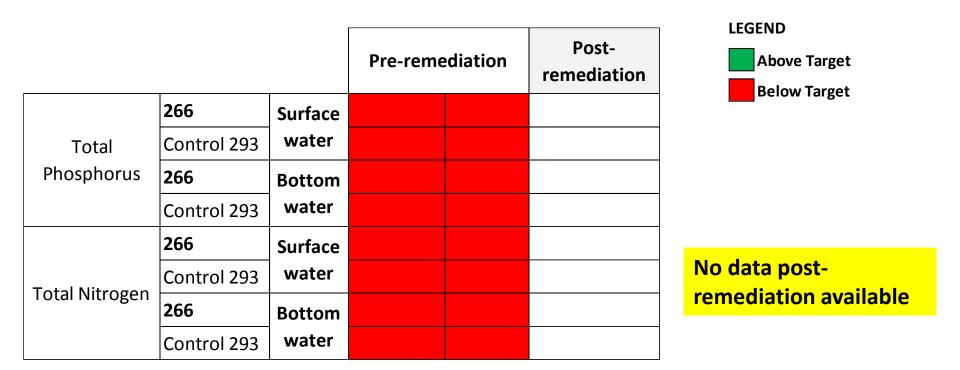
Canal #266. Remediation technology: Weed barrier/organic removal. Completed May-2016

Surface and Bottom waters rendered TP and TN concentrations out of compliance before remediation

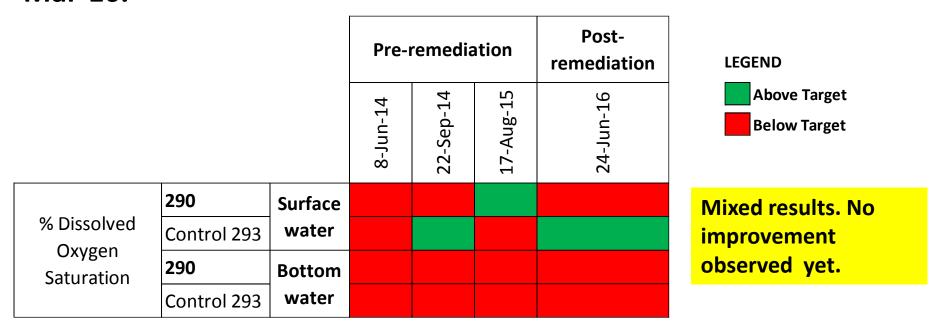
Canal #290. Remediation technology: Organic removal. Completed Mar-16.

- Surface waters do not meet %DO saturation target either in most events during monitoring before or after remediation. Notice that an existing air curtain weed gate owned by the homeowners was reinstalled, but some seaweed has entered the remediated canal
- Vacuum dredging was usd to remove 5 feet of organic muck. Following removal of the muck, a 6-inch sand layer was added to allow for benthic habitat proliferation

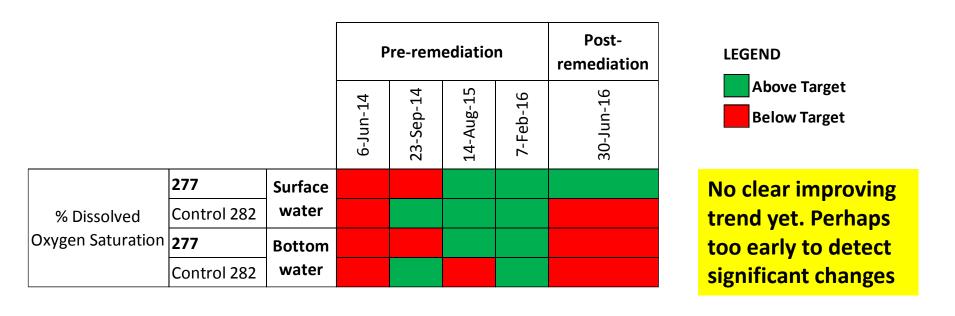
Canal #277. Remediation technology: Culvert installation. 20-Apr-2016

- Surface waters well oxygenated most of the time during monitoring before and after remediation. Water clarity with fish visible at the culvert entrance (MC, Jun 2016), although no differences in turbidity in S/B water has been observed after remediation
- Abundant blue-green algae mats floating on surface (#282) and abundant floating manatee grass present in canal #277
- %DO saturation in bottom waters of remediated canal remains below target values approx.
 2 months after culvert was opened the first time

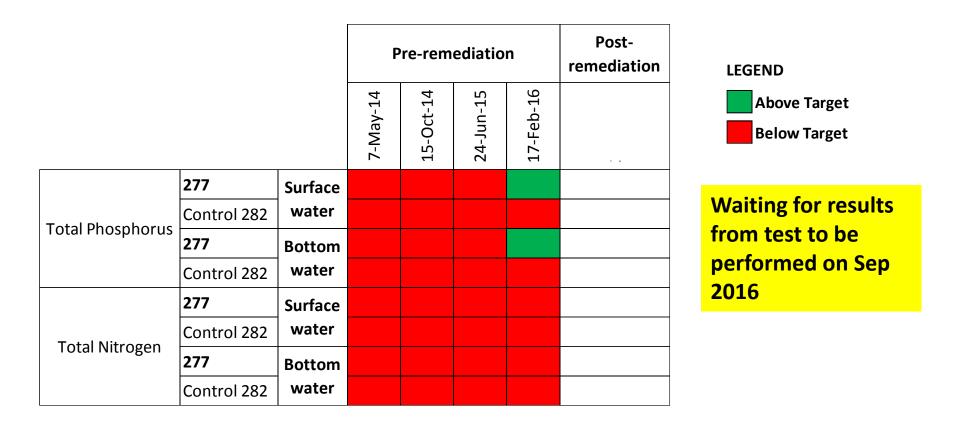
Canal #277. Remediation technology: Culvert installation. 20-Apr-2016

- Surface and Bottom TP concentrations out of compliance in most events before remediation
- Pre-remediation surveys rendered TN concentrations out of compliance

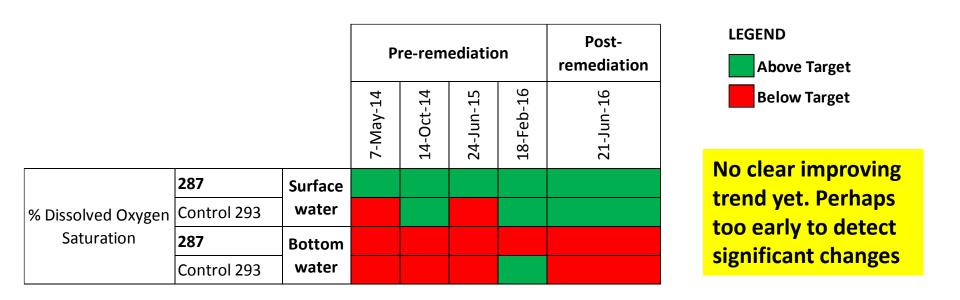
Canal #287. Remediation technology: Weed barrier. Completed Jun-16

- Surface waters well oxygenated during monitoring before and after remediation.
- %DO saturation in bottom waters of remediated canal remains below target values two weeks after the installation of the air curtain weed gate.
 Lots of suspended organic debris, settled on floats and sondes

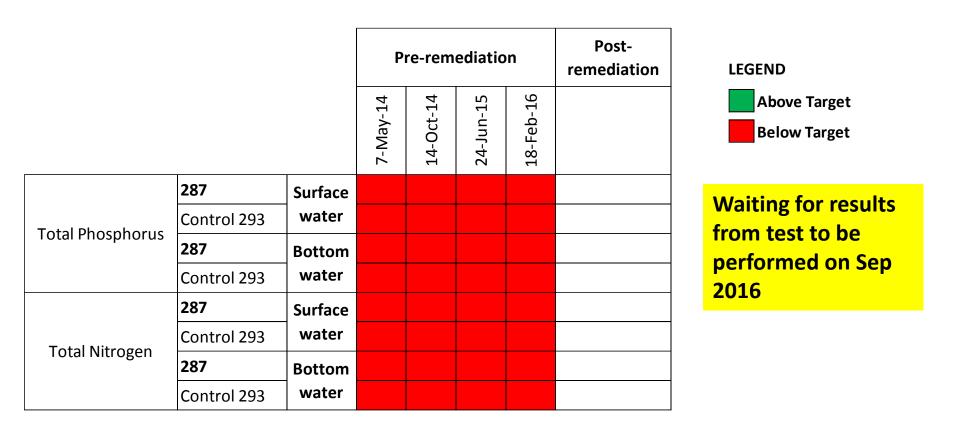
Canal #287. Remediation technology: Weed barrier. Completed Jun-16

Surface and Bottom waters rendered TP and TN concentrations out of compliance before remediation in both, control and treated canal
