FLORIDA MASTER SITE FILE
Site Inventory Form

Site Name Old St. Rose of Lima Rectory 830 == Site No. 8504 820 ==
Address of Site: 313 NE 92 St., Miami Shores, Fla. 33138 905 ==
Instruction for locating NE corner of NE 92 St, & NE 3 Ave. 813 ==

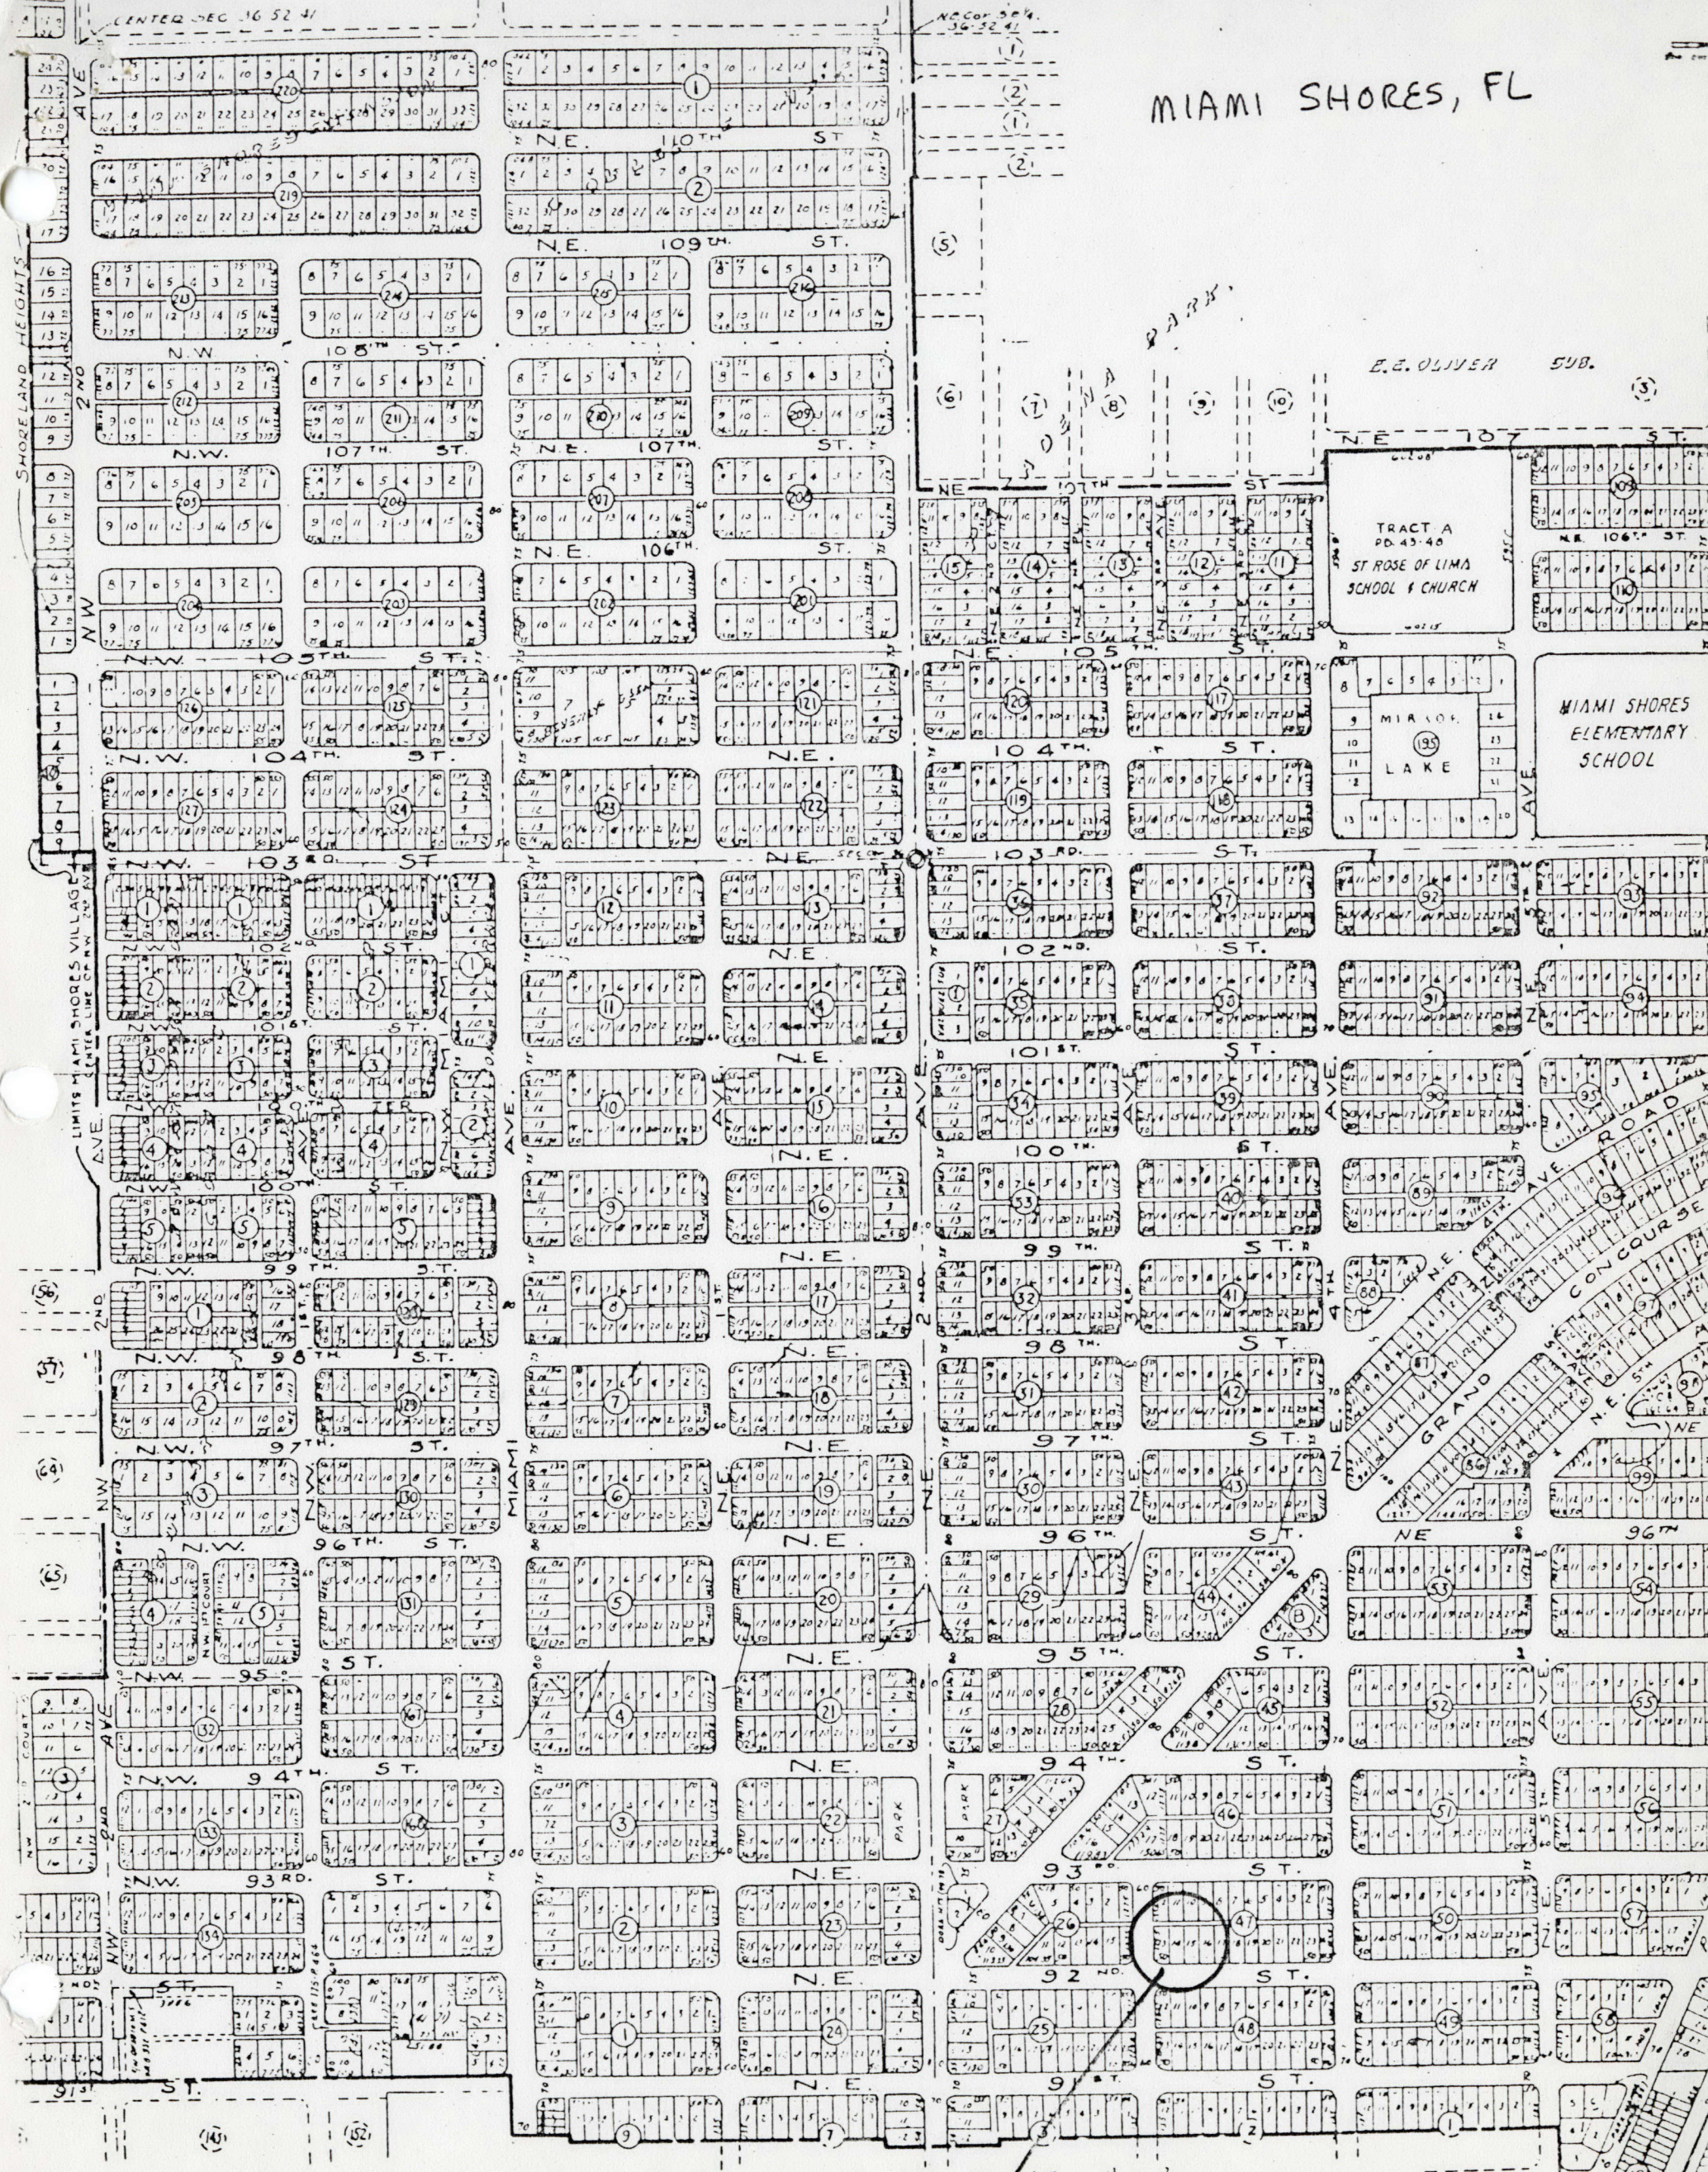
313 NE 92 ST.

Home is a two-story structure of Mediterranean Revival design. There have been numerous additions and alterations to the structure including a single-story wing on W with flat roof and parapet, and narrow horizontal windows. A projecting roof over the entry door (S) is faced with vertical wood siding. Entrance is located in the "L" created by two masses. A sliding glass door fronted by wrought iron grill is on W side of E wing at 45degree angle to entrance.
