# 2000 JUNO PIER MONITORING REPORT

## Volume II - Lighting and Disorientation Report

# **2000 LIGHTING AND DISORIENTATION SURVEYS FOR SOUTH JUPITER AND JUNO BEACH INCLUDING THE JUNO BEACH FISHING PIER**

**Palm Beach County  
Department of Environmental  
Resources Management (ERM)**

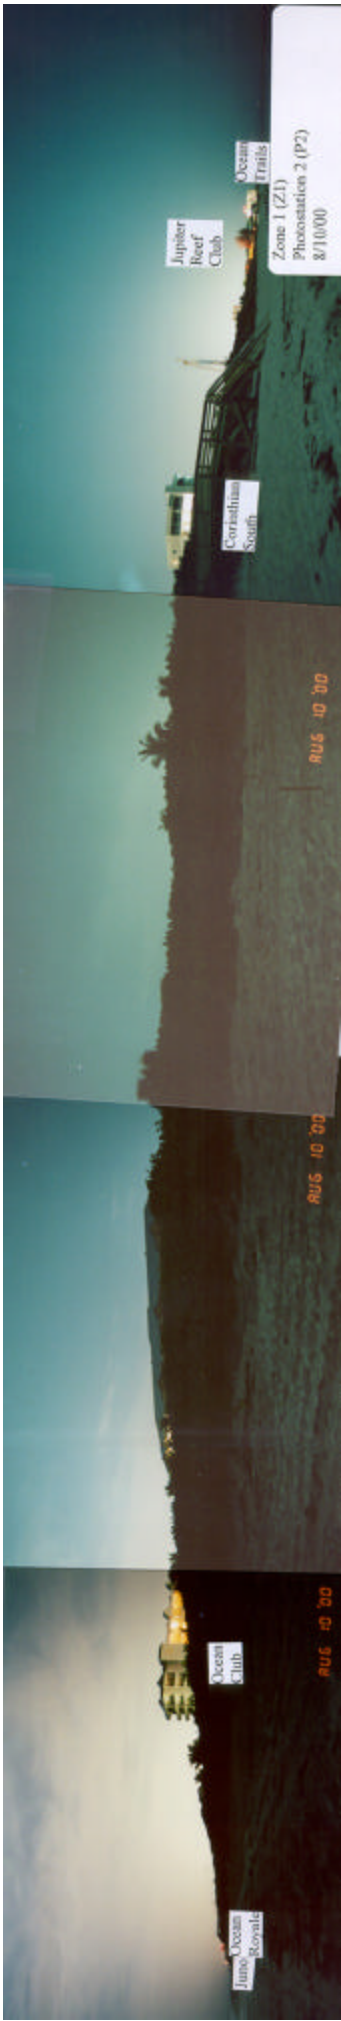
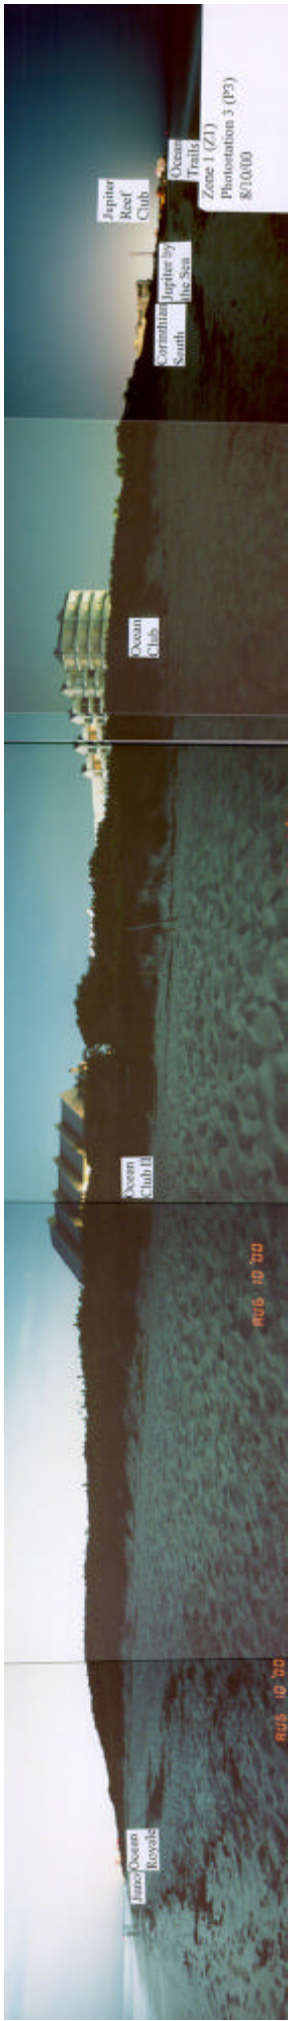
Ocean Trails  
Zone 1 (Z1)  
Photostation 3 (P3)  
801000

Seven sources of light were visible from Zone 1 (Table 1; see photos Z1: P1, P2 and P3). Ocean Trails, Ocean Royale and Juno Beach are outside Zone 1, but are visible from within Zone 1. Ocean Trails Condominium is located approximately 1.6 miles north of Zone 1. Ocean Trails completed lighting modifications several years ago to comply with Palm Beach County's Sea Turtle Protection Ordinance, but continues to be a source of illumination at least as far south as Zone 4.

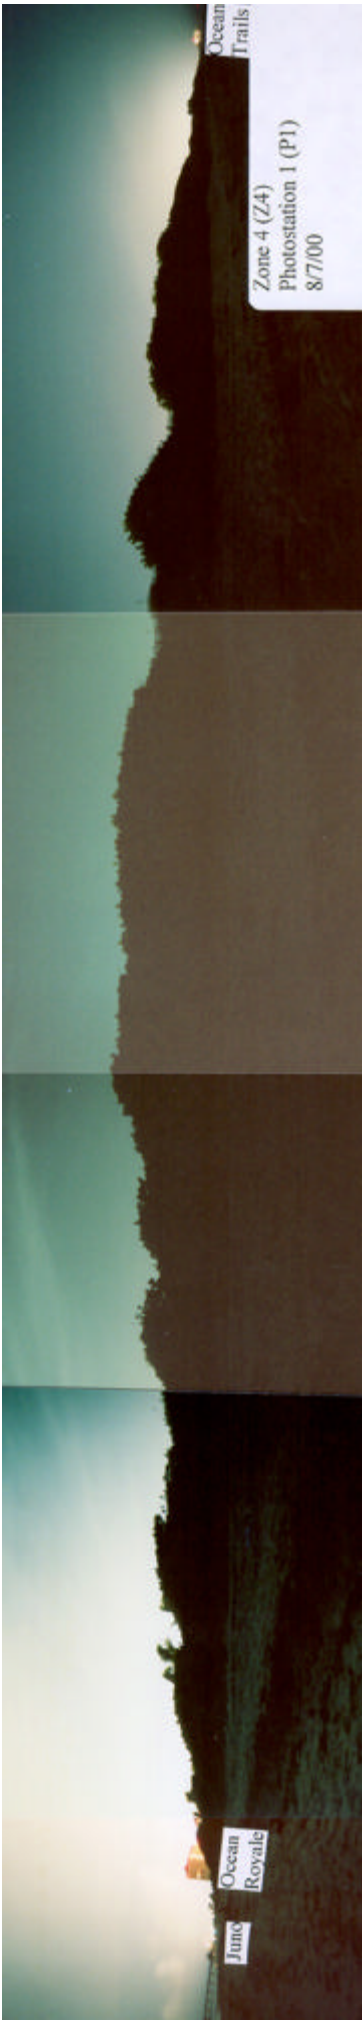
Ocean  
Trails  
Zone 4 (Z4)  
Photostation 1 (P1)  
8/7/00

Five sources of light were visible from Zone 4 (Photos Z4: P1, P2 and P3) (Table 1), and three sources of light were visible from Zone 5 (Photos Z5: P1, P2 and P3). Again, Ocean Trails and the condominiums in the Town of Juno Beach were visible throughout these zones. Both Zones 4 and 5 were relatively bright as compared to the 1999 survey, mostly due to the partial occupancy of Ocean Royale. Zones 4 and 5 are proposed for beach nourishment in November 2000. While not

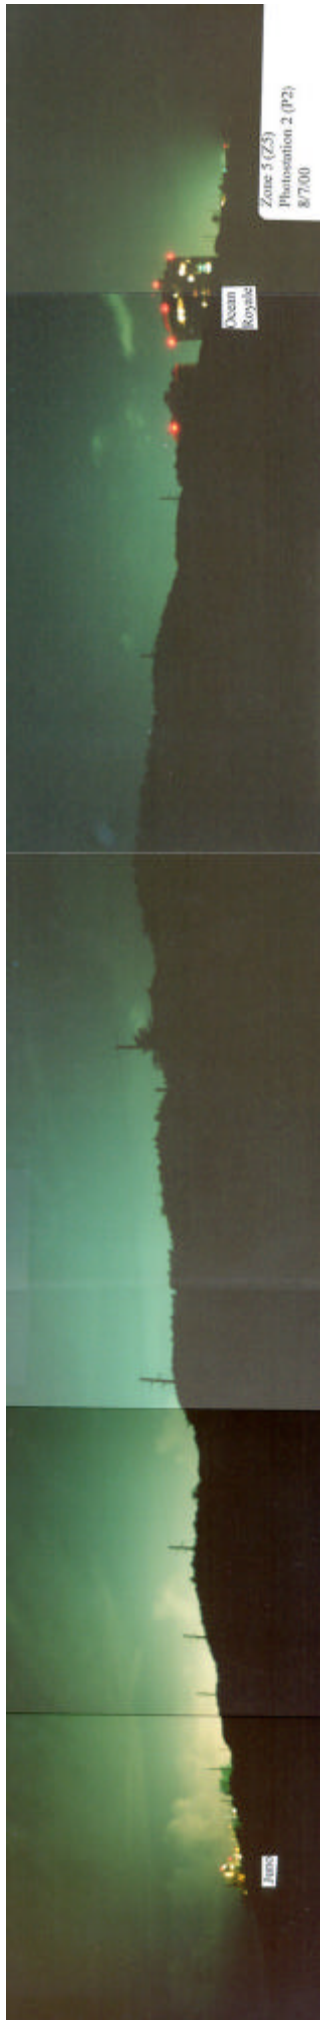
Zone 5 (Z5)  
Photograph 2 (P2)  
8/7/00

The partial occupancy of the north building of Ocean Royale resulted in an increase of 37 lights from 1999. The two twelve story condominium towers are the dominant feature of the landward horizon in the vicinity of the pier and can be observed from Zone 1 south to at least Zone 6. A lighting plan approval was issued by the Town of Juno Beach, but the lights do not yet comply with the approval. The 26 balcony lights on the west side of the north building were clearly visible to the north at least as far as the northern end of Zone 1. These lights, along with the interior lights observed, are the likely source of illumination for three (excluding the three disorientations mentioned above in association with the traffic lights) to six (including the three above) disorientation events in the general vicinity, resulting in the disorientation of approximately 250 to 410 hatchlings (Table 4).

The town has indicated that they will withhold final certificates of occupancy for the project until the lights are modified.

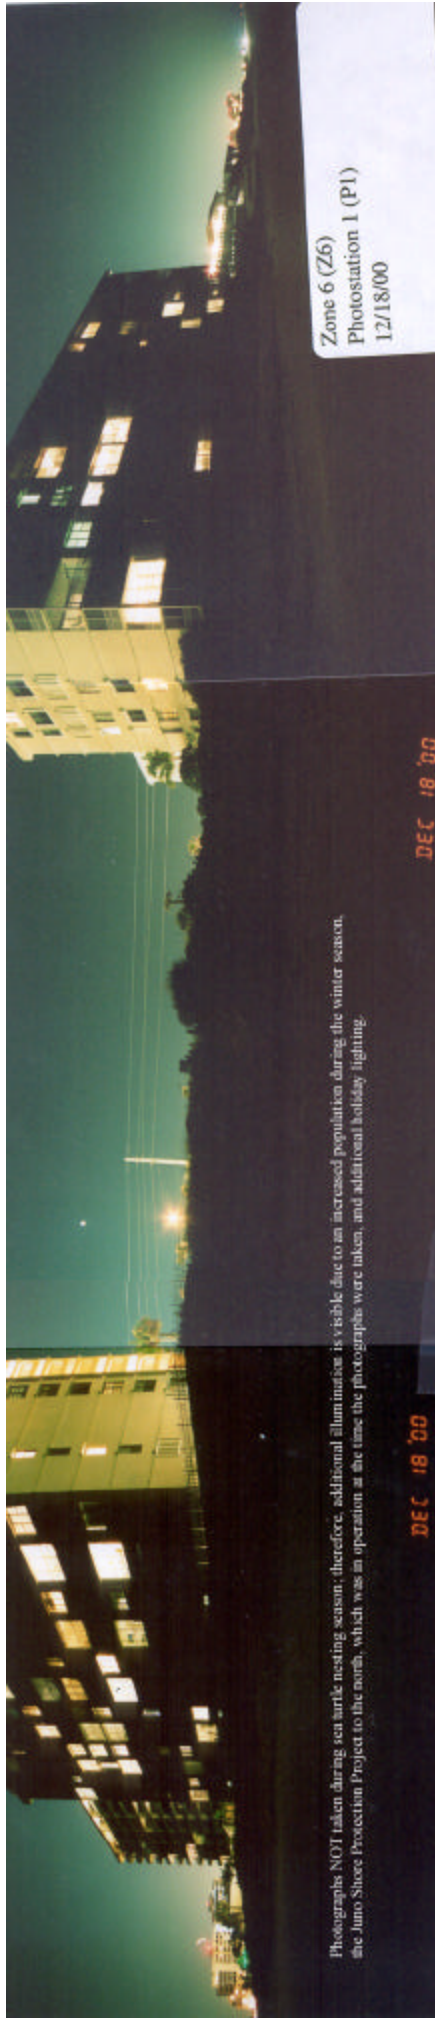
Zone 6 (Z6)  
Photostation 1 (P1)  
12/18/00

Photographs NOT taken during sea turtle nesting season; therefore, additional illumination is visible due to an increased population during the winter season. The Juno Shore Protection Project to the north, which was in operation at the time the photographs were taken, and additional holiday lighting.

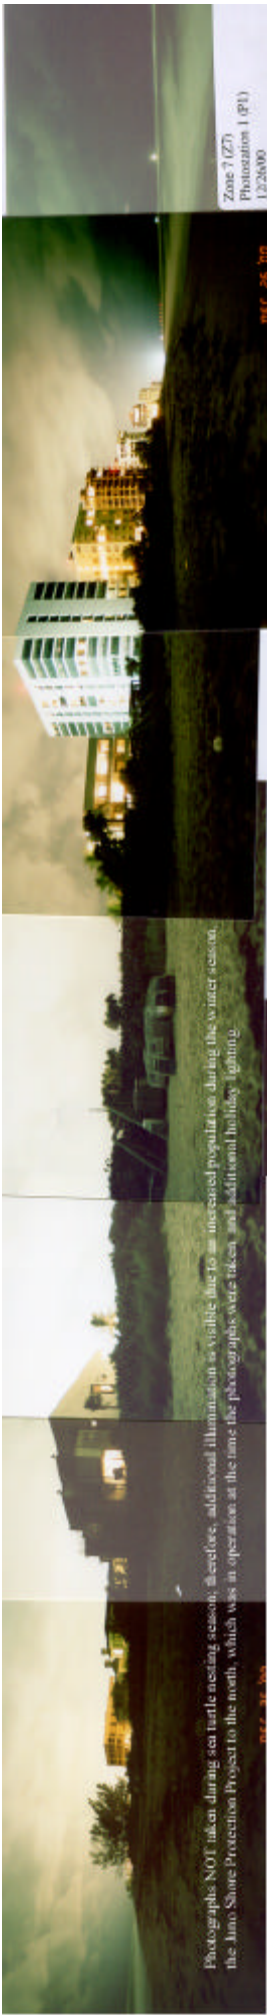
Zone 7 (27)  
Photograph 1 (P1)  
12/26/00

Photographs NOT taken during sea turtle nesting season; therefore, additional illumination is visible due to an increased population during the winter season. The Jiro Shore Protection Project to the north, which was in operation at the time the photographs were taken, and additional highway lighting.

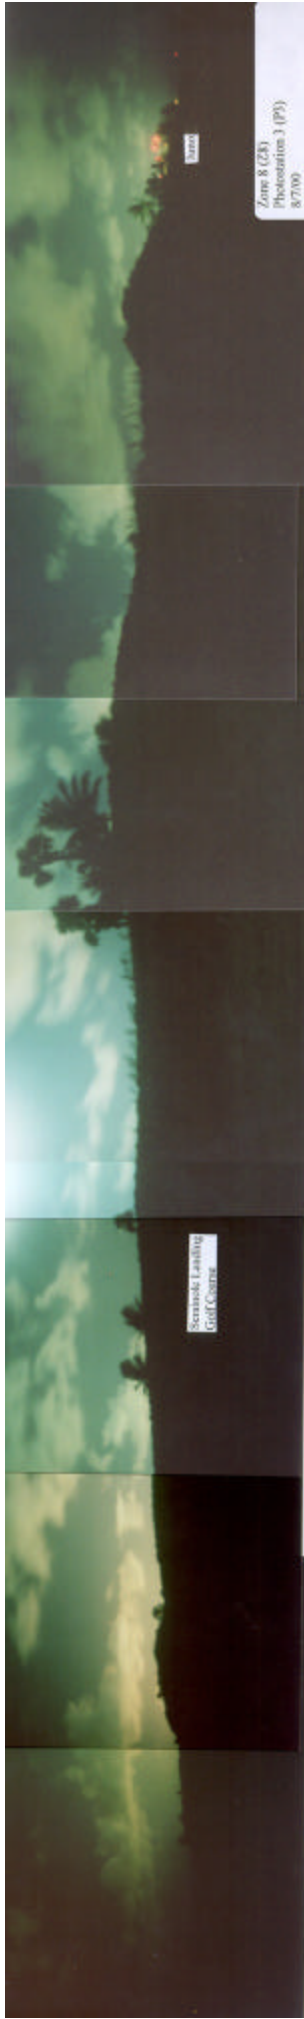
Zone 8 (23)  
Photostation 3 (P3)  
8/7/09

Zone 8 (Photos Z8: P1, P2 and P3) was mostly dark, with only four sources of lights identified within this zone from the scanned photographs. This zone is adjacent to a golf course and the low-rise condominiums in the Town of Juno Beach. The high-rise condominiums located in the Town of Juno Beach to the north was apparent throughout Zone 8. The southern glow, and to some extent the northern glow, were evident from Zone 8.
