Dry Tortugas National Park

Dry Tortugas Light Station

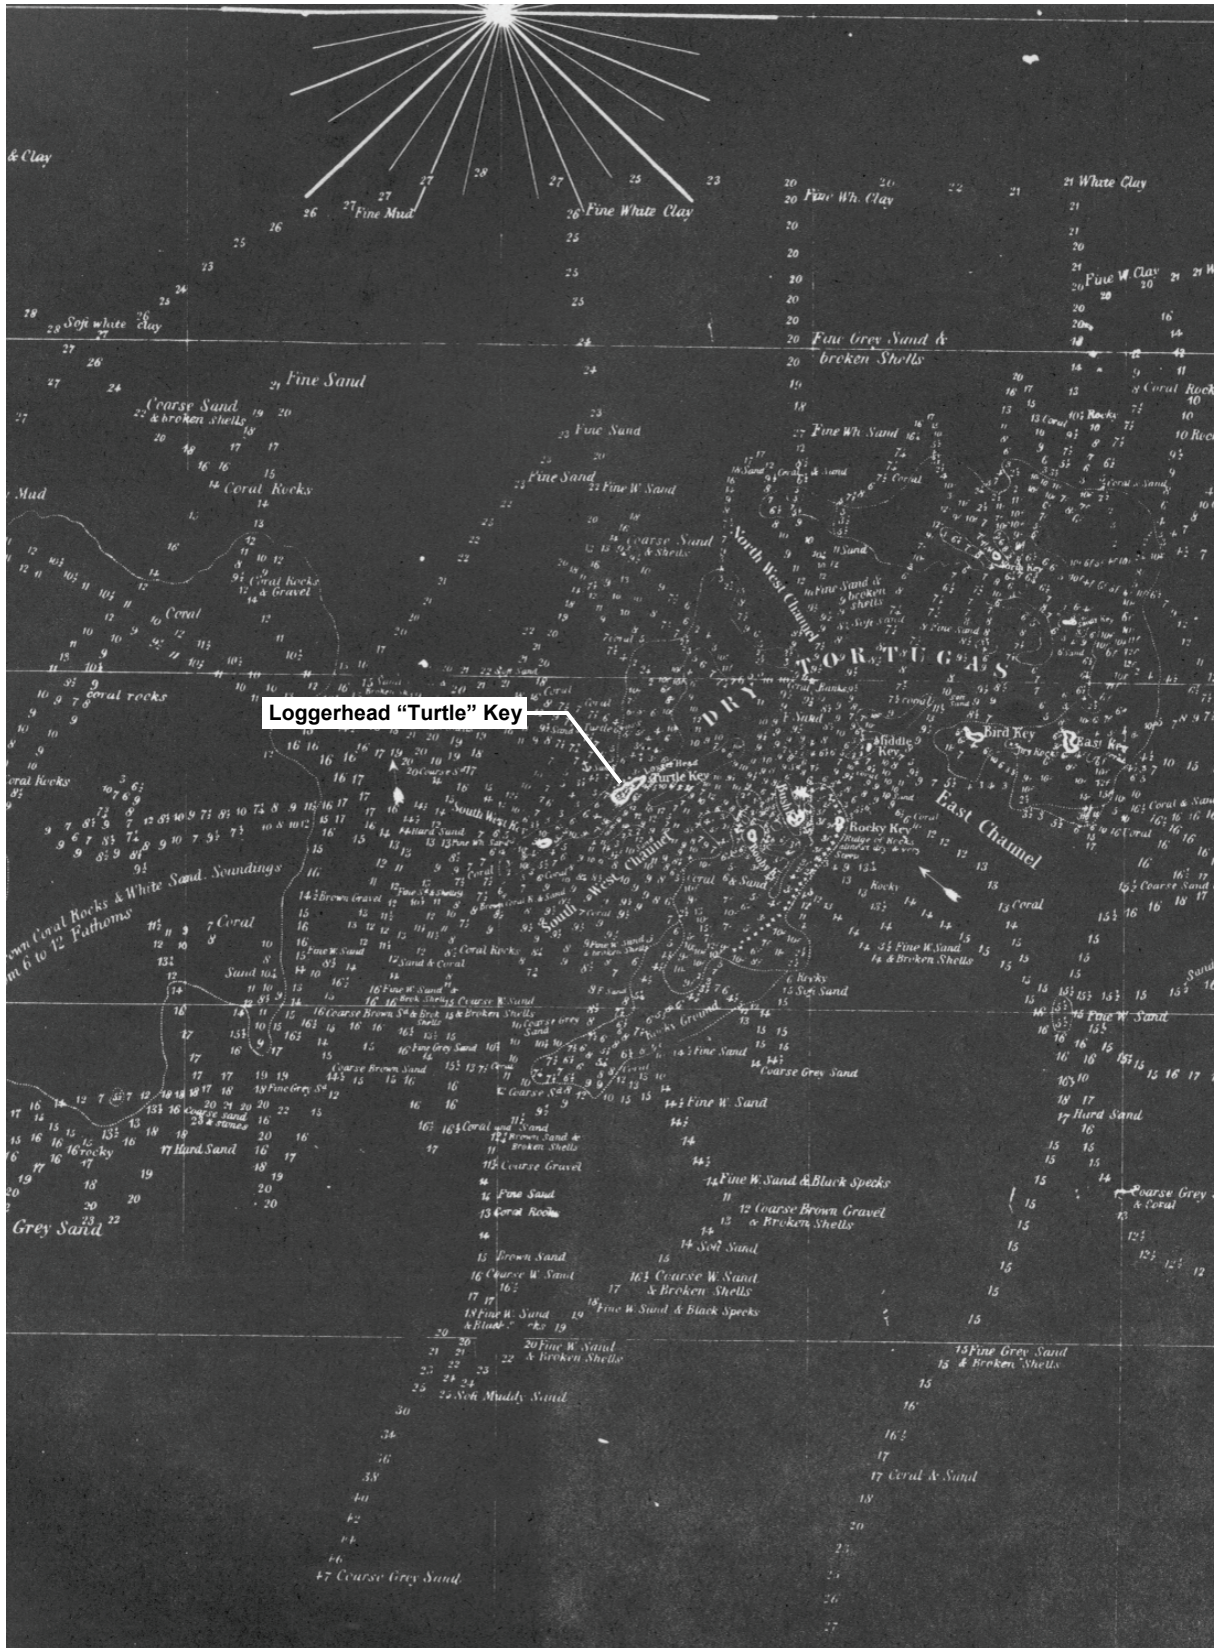
Figure 3. Map produced in 1838 based on Gault's earlier 1773 survey of the Dry Tortugas. Note the map identifies Loggerhead "Turtle" Key.

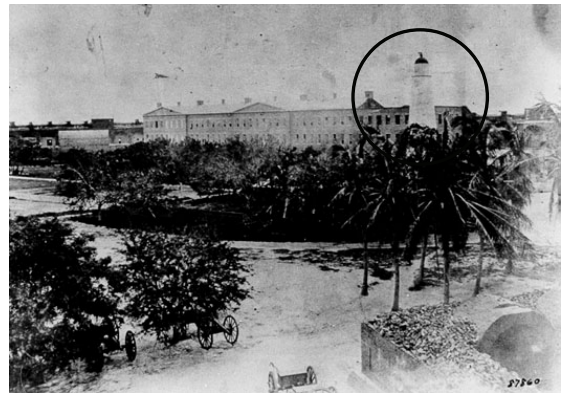
Figure 4. Undated nineteenth century view of Garden Key lighthouse within the parade ground of Fort Jefferson.

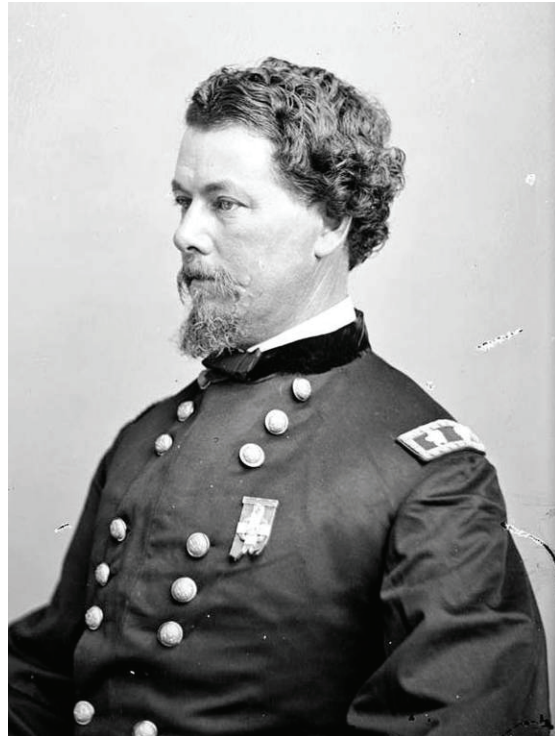
Figure 5. Captain Horatio G. Wright.

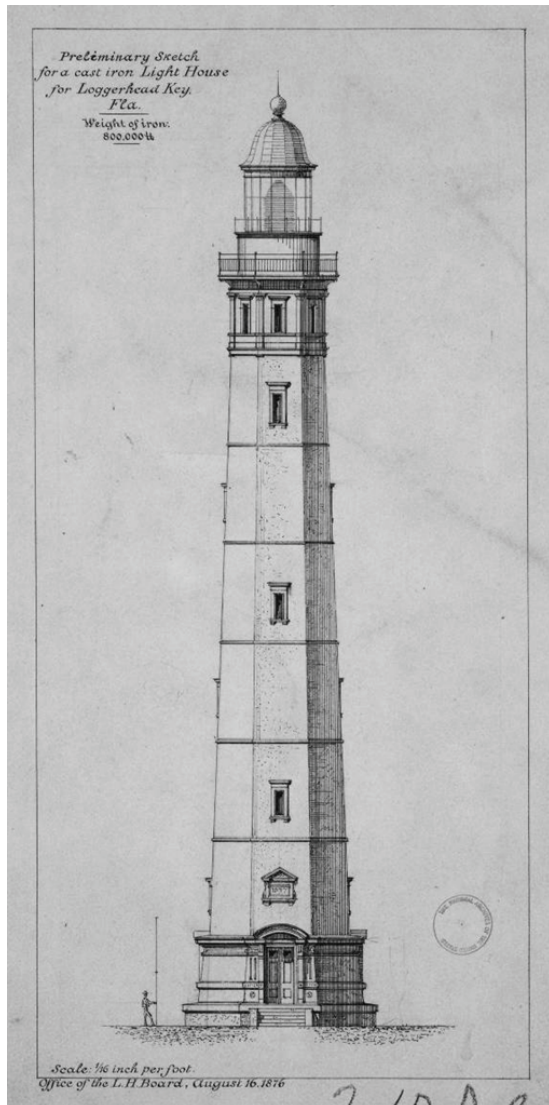
Figure 10. Elevation of iron tower proposed to replace storm-damaged masonry tower

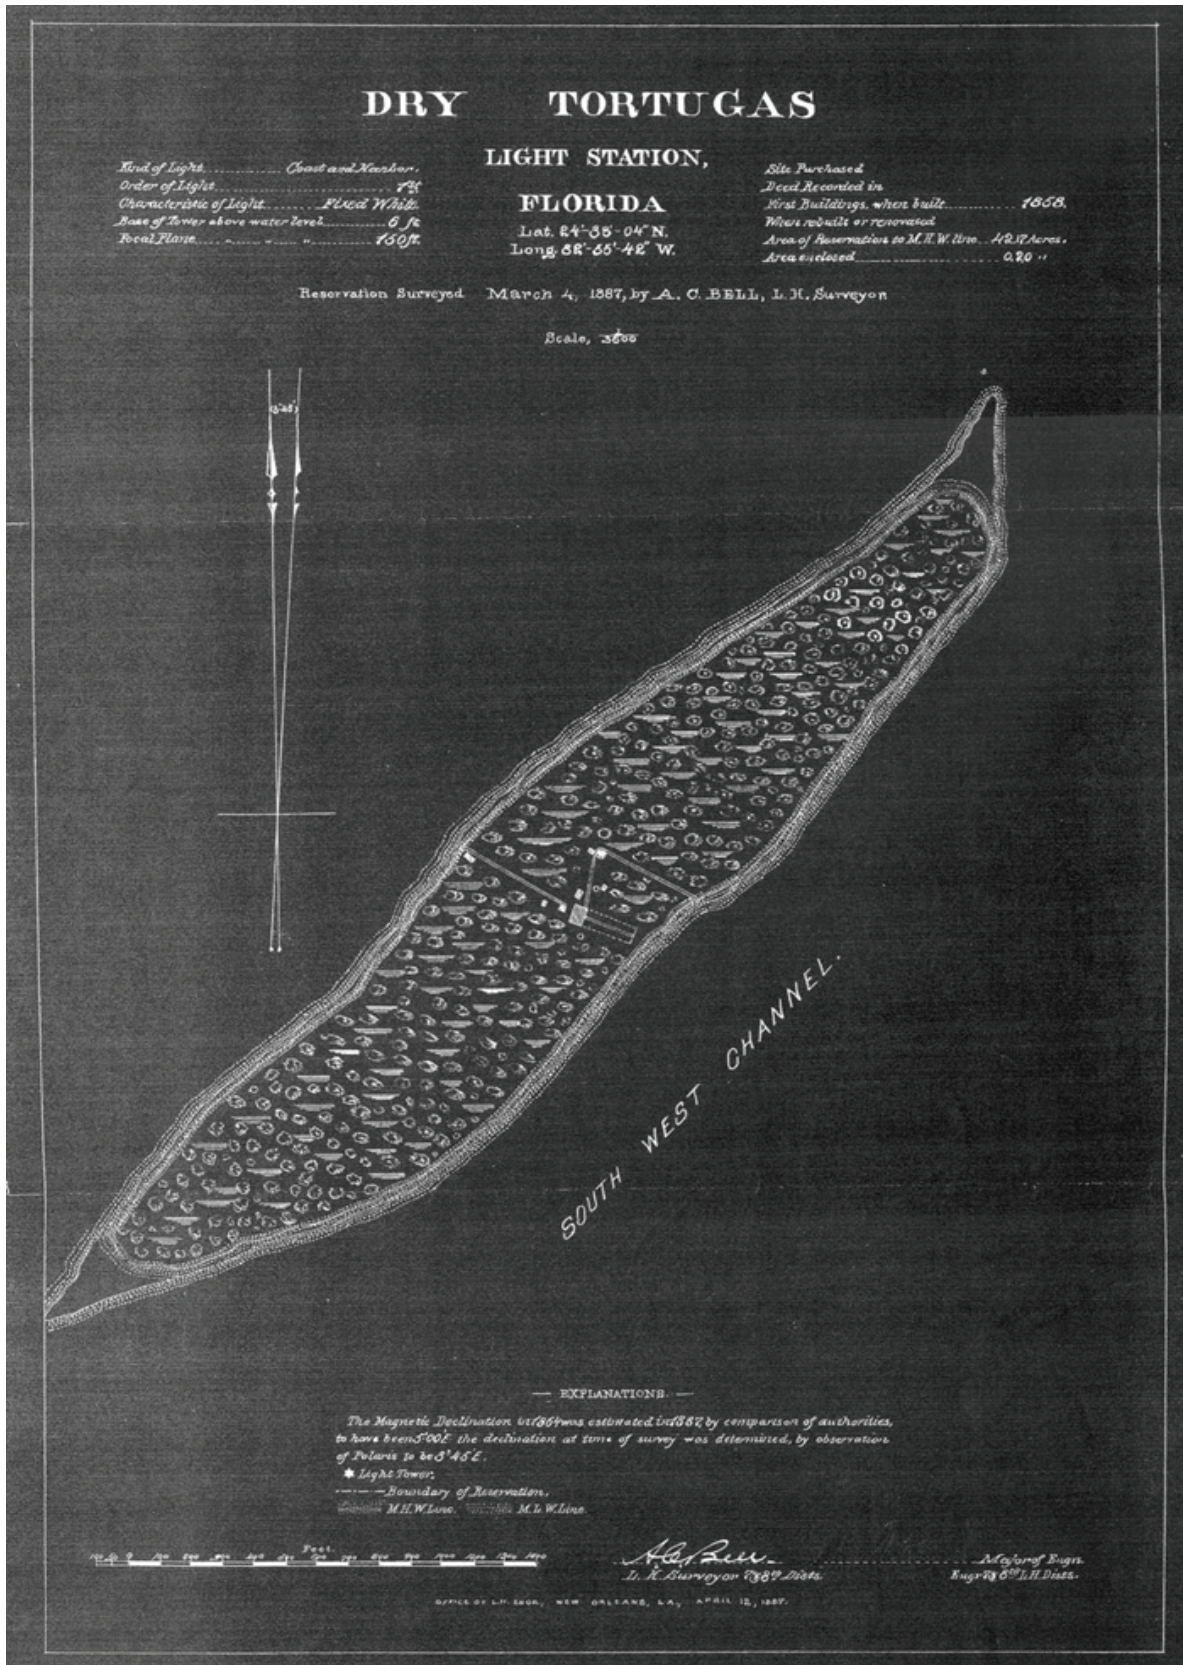
Figure 12. 1887 survey of Dry Tortugas Light Station by A. C. Bell.

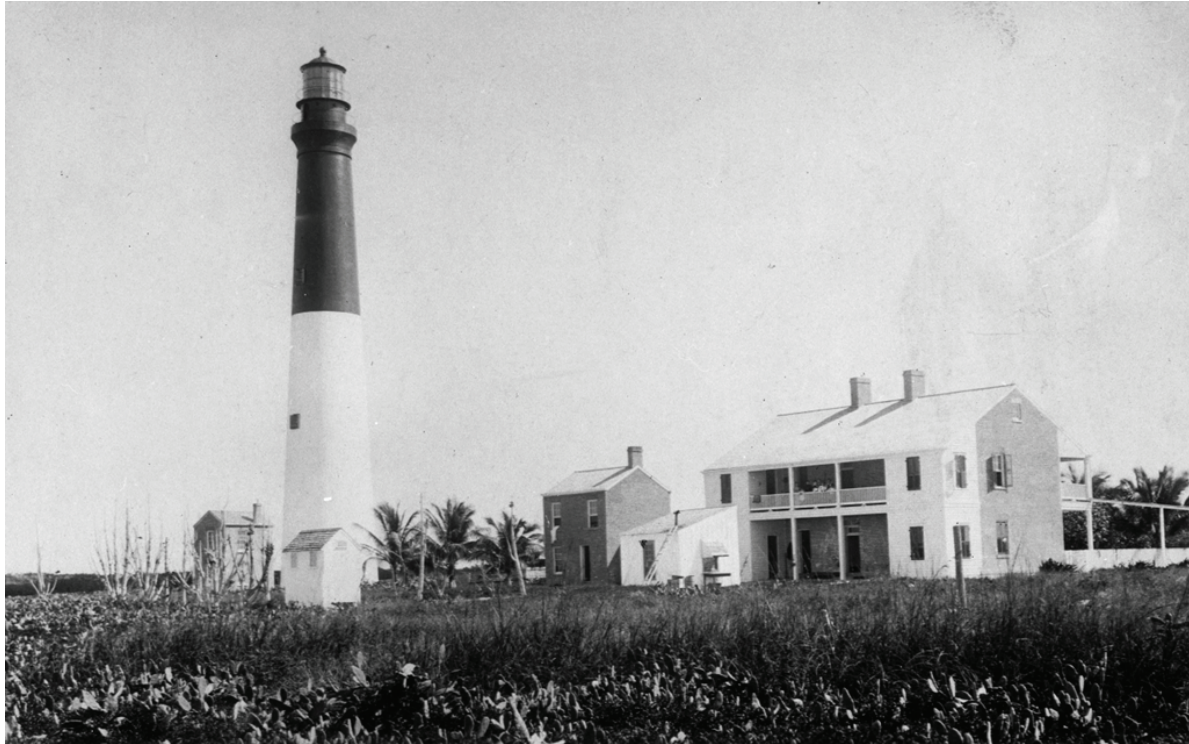
Figure 11. Undated nineteenth-century view of the Dry Tortugas light station looking northeast.

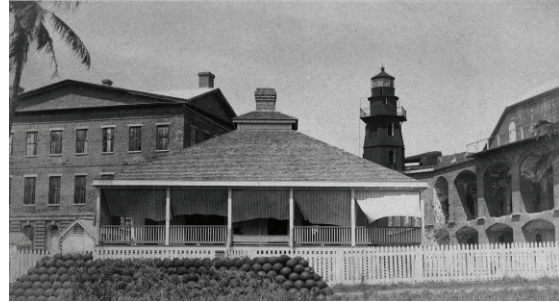
Figure 15. Undated view of the Garden Key Keeper's Residence with the iron lighthouse on bastion C in the distance.

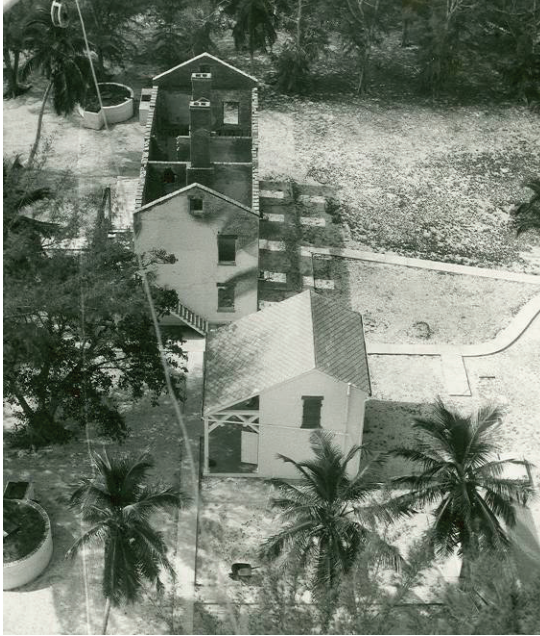
Figure 17. Image taken from the top of the tower showing the burned remains of the original keeper's dwelling.

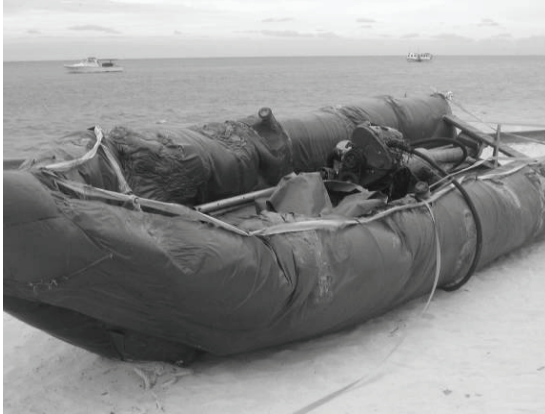
Figure 18. Chug used by Cuban refugees to land at Loggerhead Key in 2008.

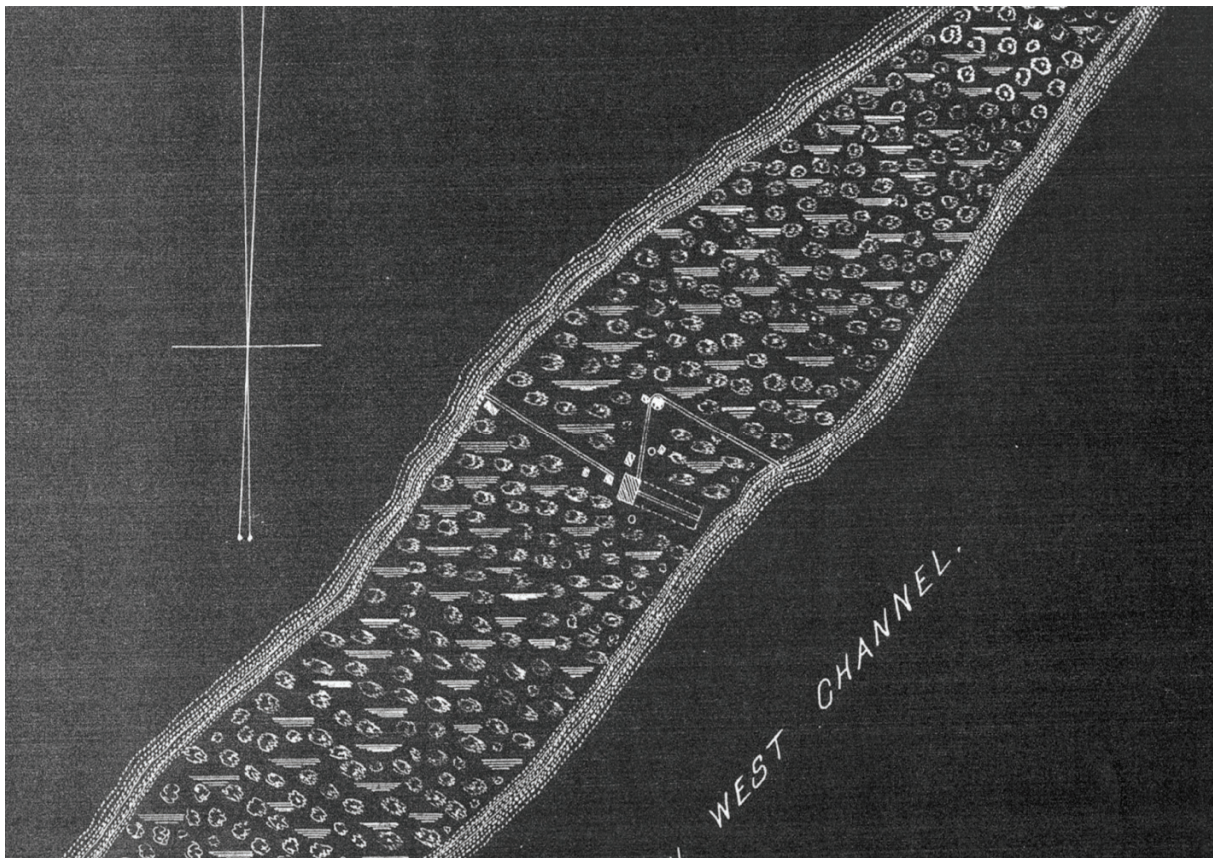
Figure 29. Detail of 1887 Light Station survey showing network of walkways between buildings.

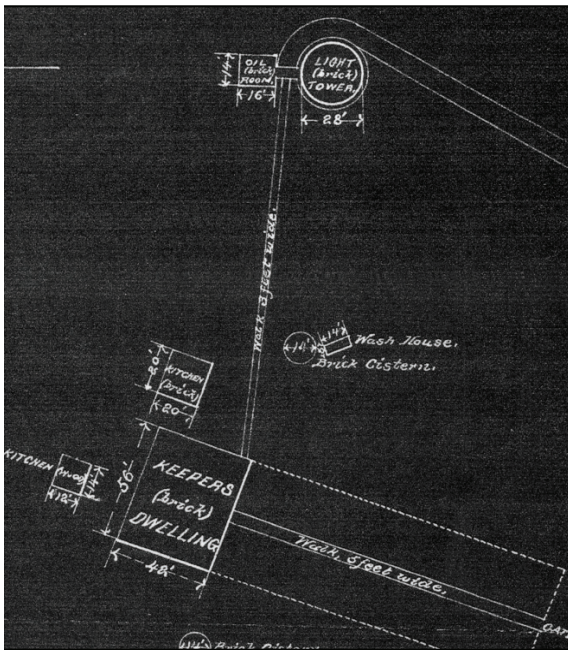
Figure 31. Close-up of 1887 small-scale plan of Light Station showing existing walkways.

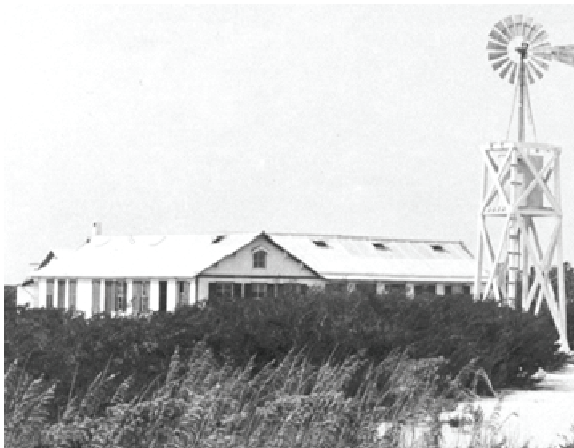
Figures 32. Undated view of Carnegie Institute's main laboratory building.

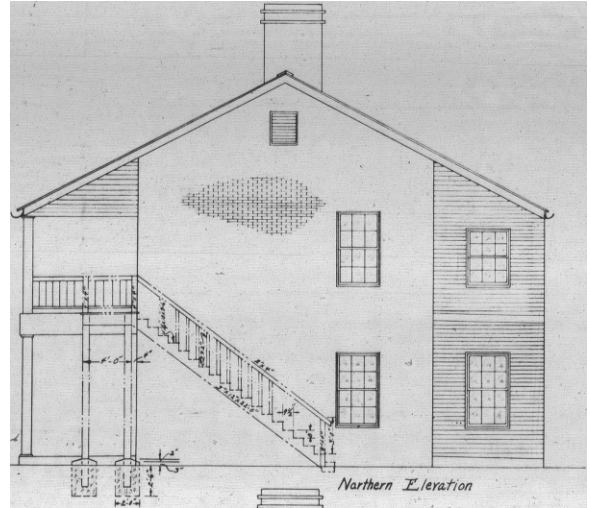
Figure 37. Northern elevation of Keeper's Dwelling from "Repairs & Improvements" to Assistant Keeper's Apartments.

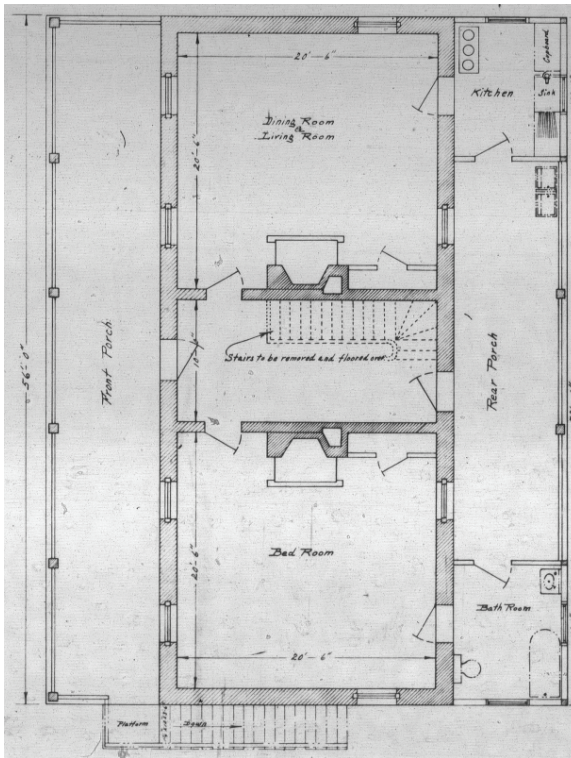
Figure 36. Keeper's Dwelling floor plan from "Repairs & Improvements" to Assistant Keeper's Apartments.

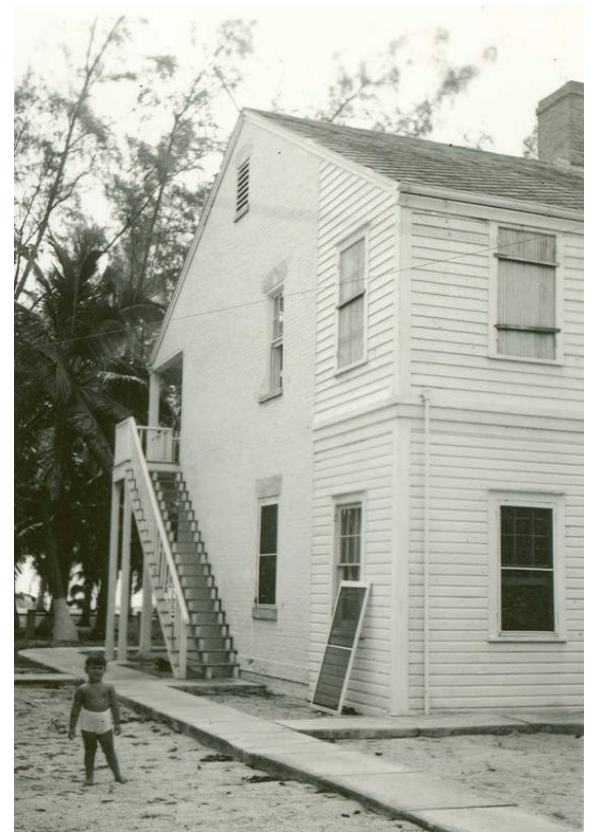
Figure 38. Undated photo (Ca. 1941) of exterior stairway at north elevation of Keeper's Dwelling.

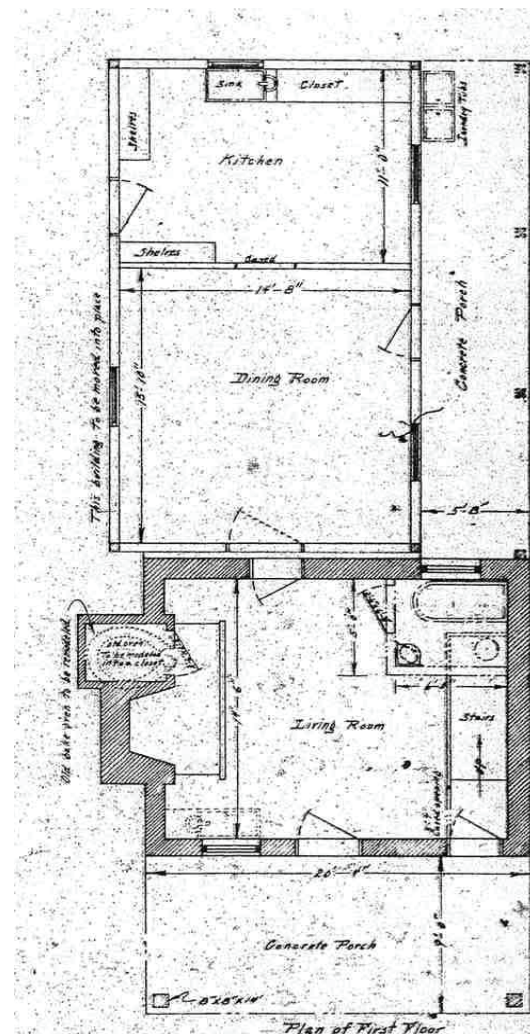
Figure 41. Close-up of Kitchen floor plan from 1922 "Repairs & Improvements" to Assistant Keeper's Dwelling.

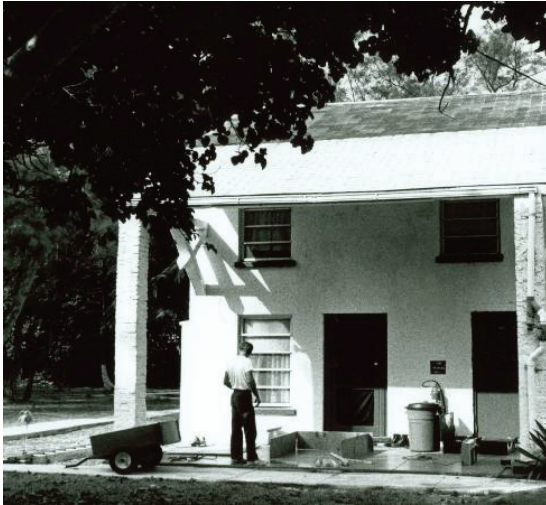
Figure 42. Undated photo of Kitchen with brick columns.

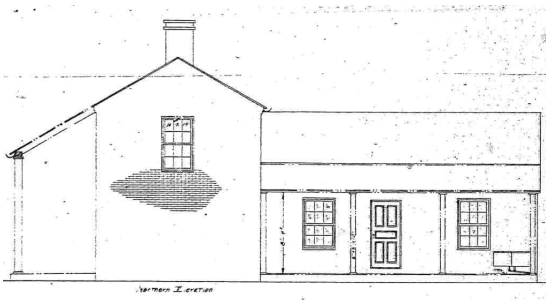
Figure 43. Northern elevation from 1922 "Repairs & Improvements" to Assistant Keeper's Dwelling.

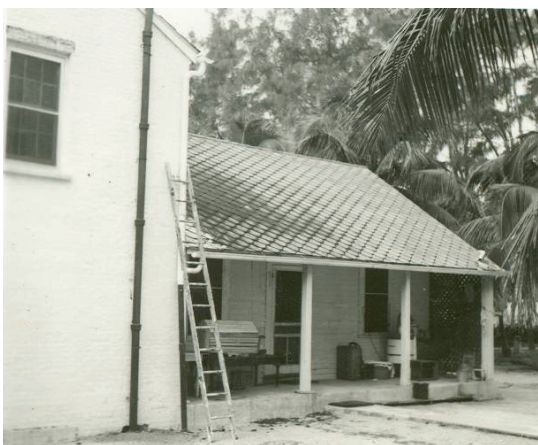
Figure 44. Ca. 1941 photo of kitchen/dining room attached to rear of original Kitchen Building.

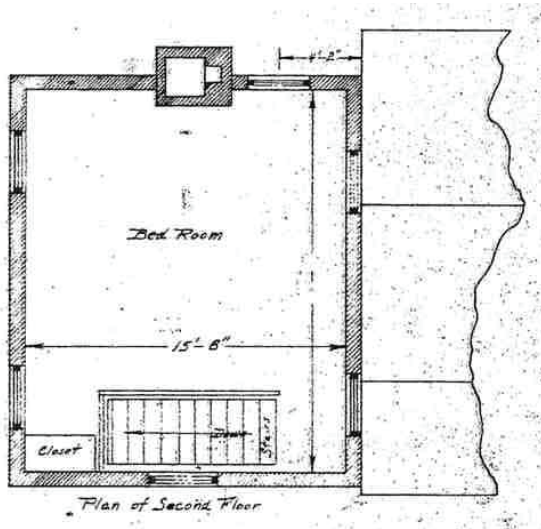
Figure 45. Second floor plan of Kitchen building from 1922 "Repairs & Improvements" to Assistant Keeper's Dwelling.

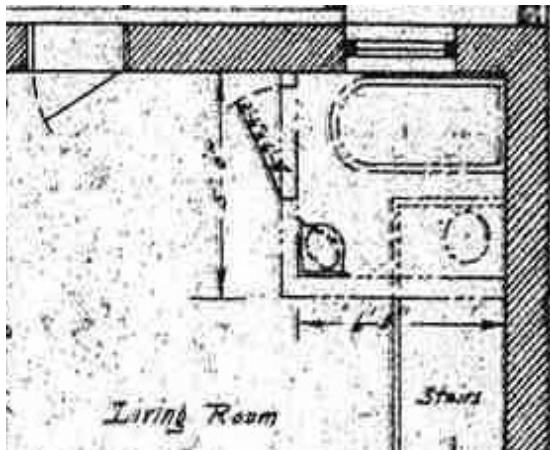
Figure 46. Close-up of bathroom on Kitchen floor plan from 1922 "Repairs & Improvements."

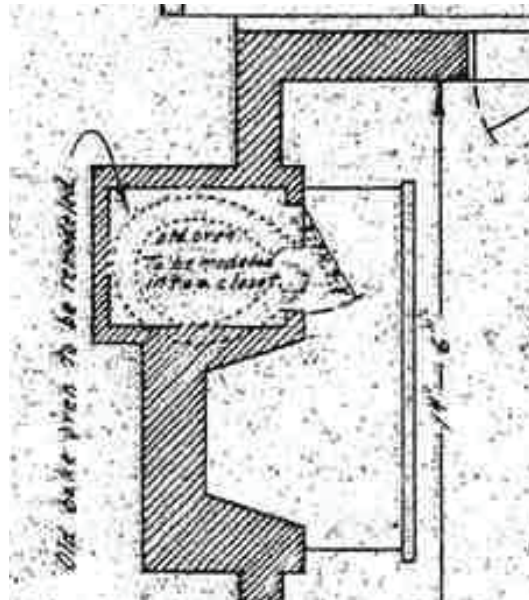
Figure 47. Close-up of brick oven on Kitchen floor plan from 1922 "Repairs & Improvements."

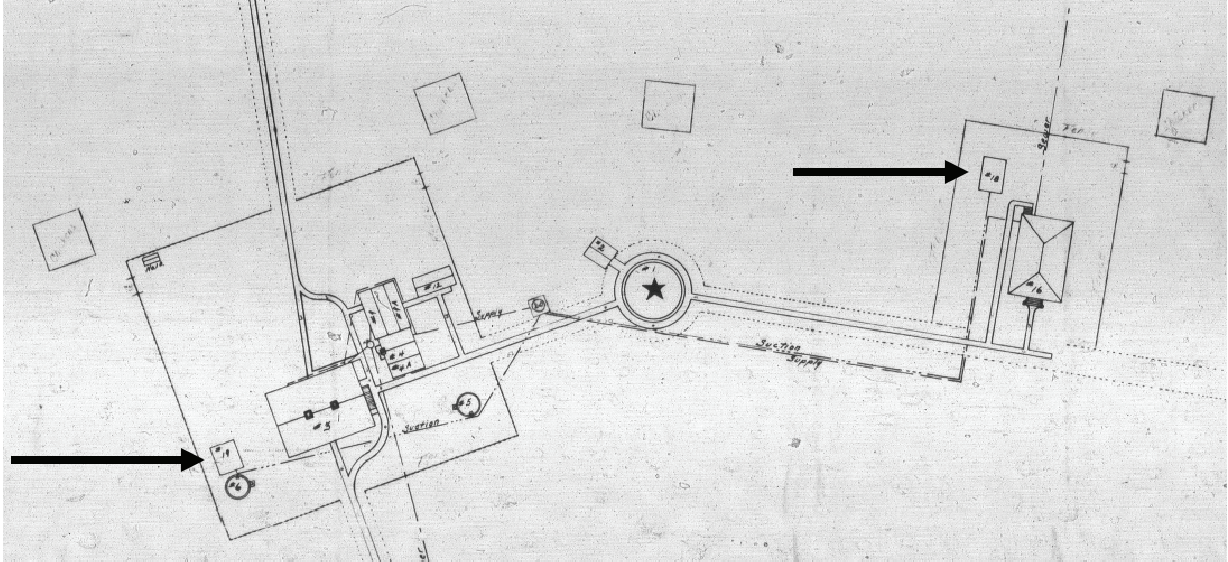
Figure 48. Close-up of 1925 Station site plan showing location of concrete cisterns.

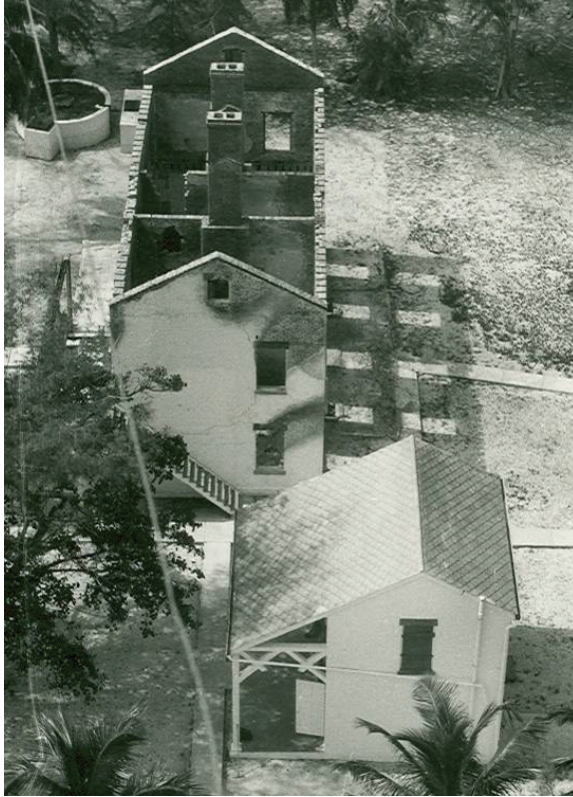
Figure 67. Undated view of fire damaged Keeper's Dwelling.

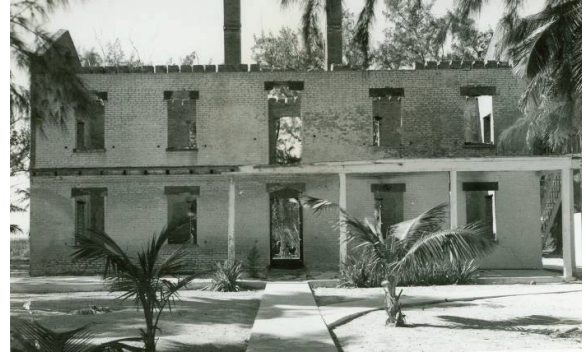
Figure 68. Undated view of Keeper's Dwelling façade showing fire damage.

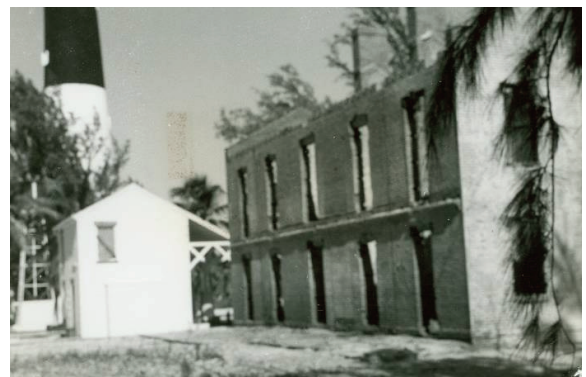
Figure 69. Undated oblique view of Keeper's Dwelling showing fire damage.

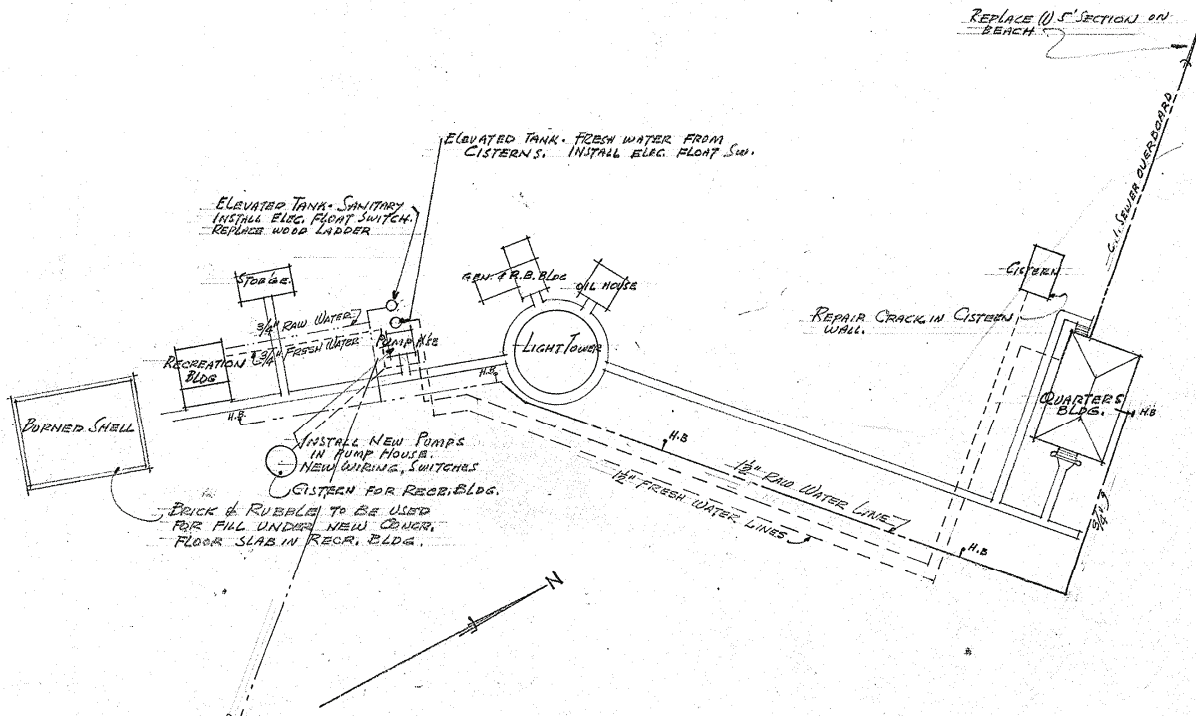
Figure 70. Close-up of Plot Plan from 1951 "Improvements to Sanitary Facilities" project.

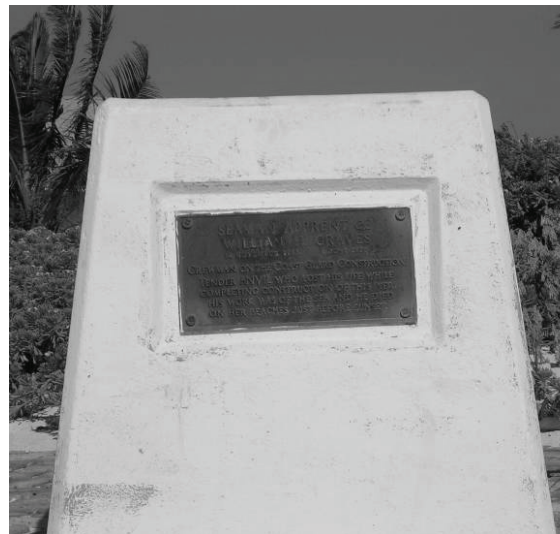
Figure 74. Monument to Seaman Graves.

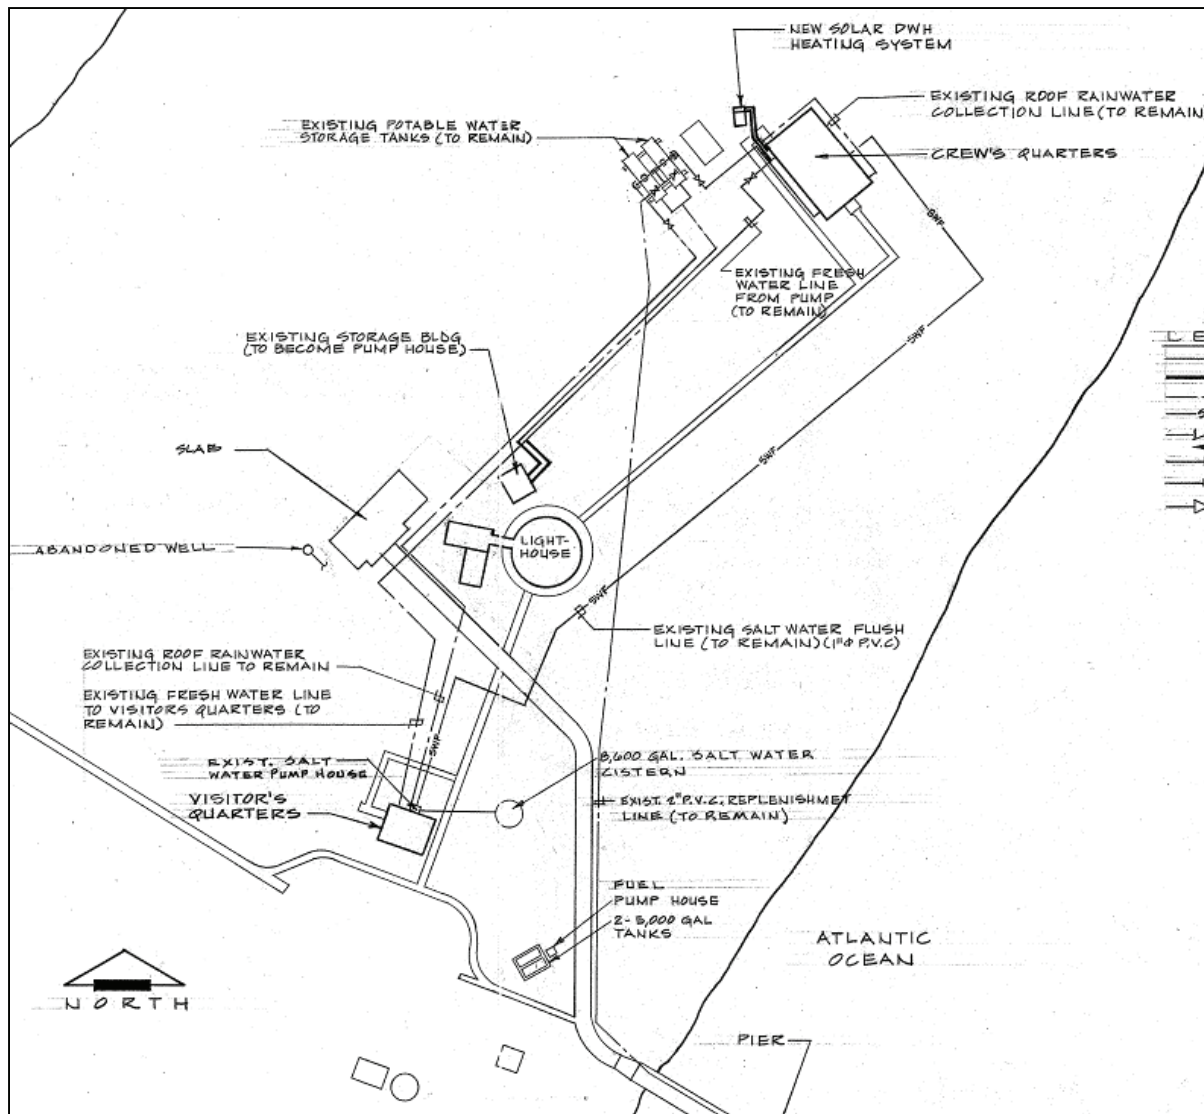
Figure 76. Close-up of 1985 "Dry Tortugas Rehabilitation New Potable Water Plot Plan & Details."

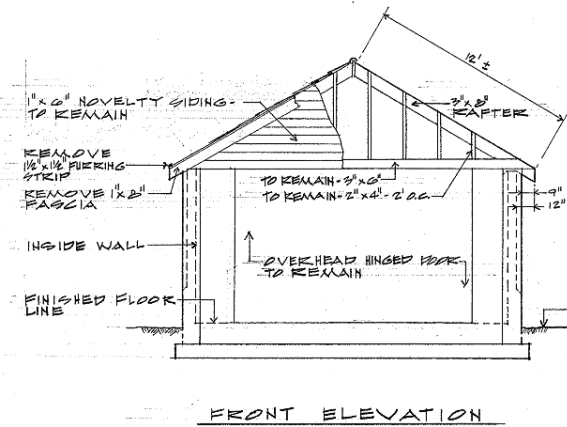
Figure 77. Close-up of front elevation from Boat House "Existing Roof Plan & Elevations."

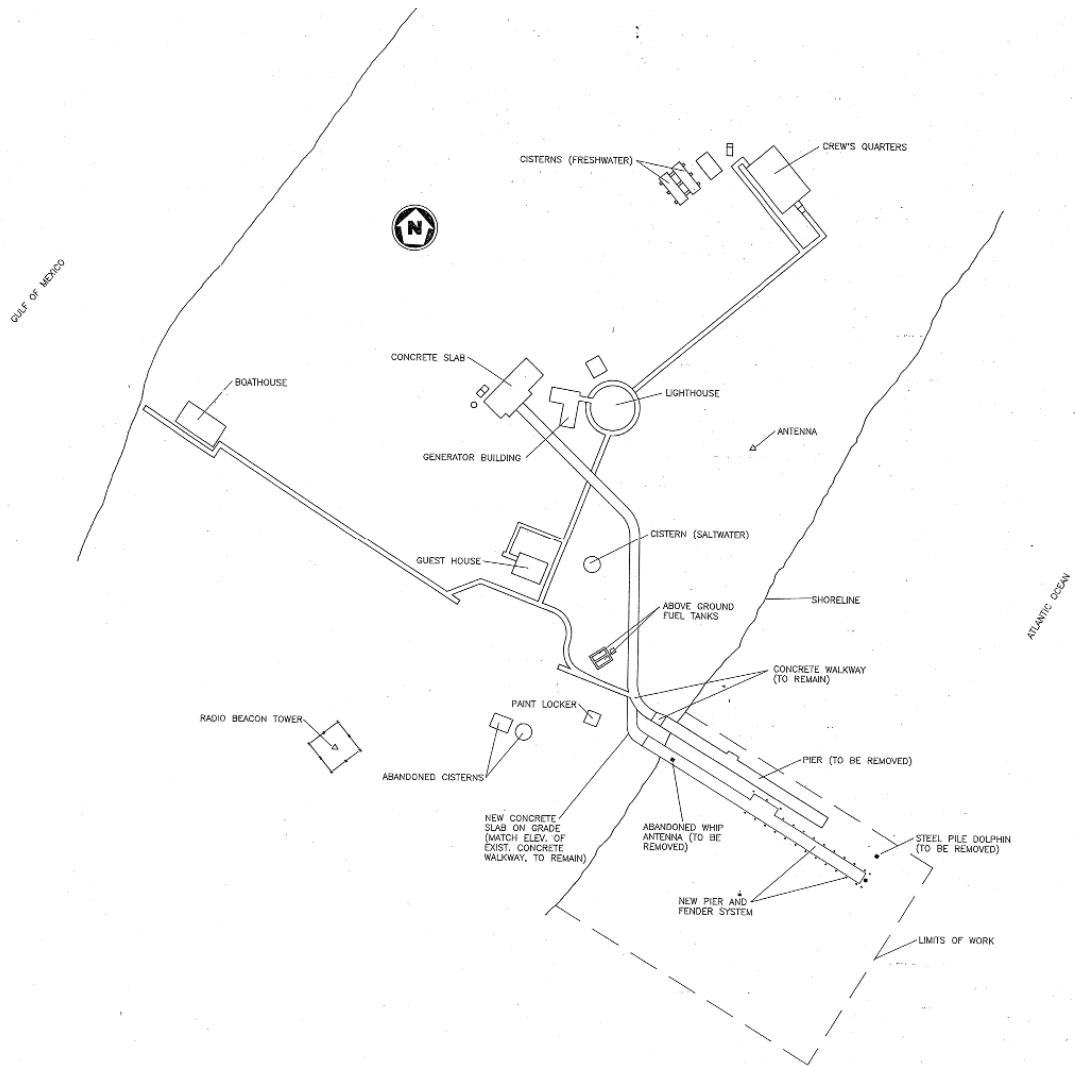
Figure 78. Close-up of 1993 "General Plot Plan" to "Replace Pier."

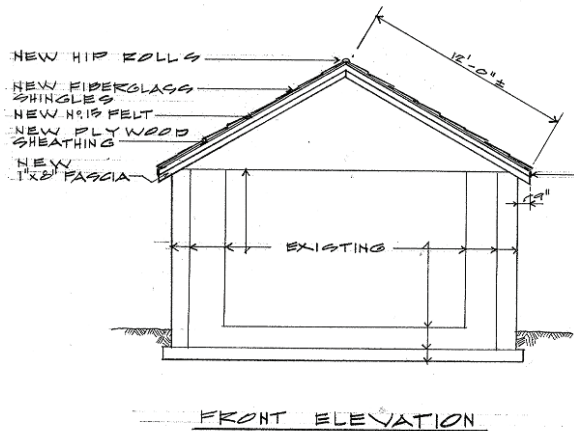
Figure 79. Close-up of front elevation from Boat House "New Roof Plan & Elevations."

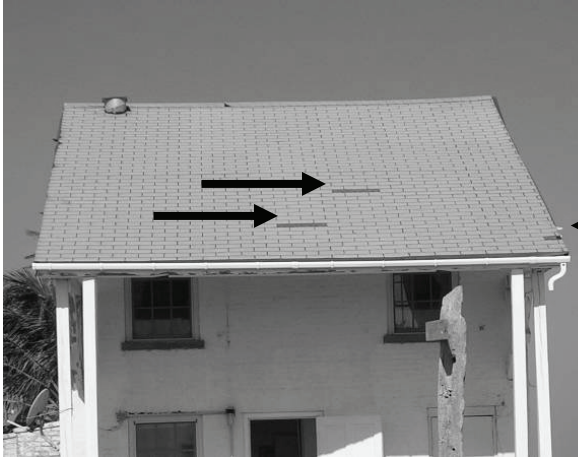
Figure 80. Missing shingles on front gable.

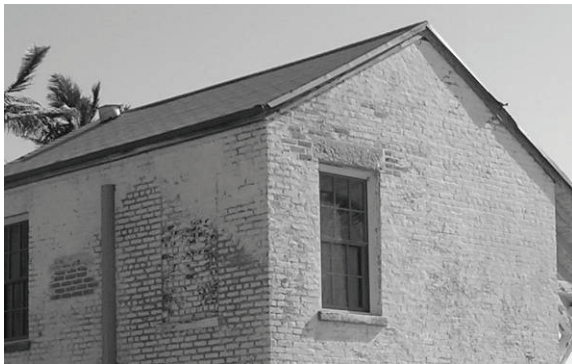
Figure 81. Damaged flashing at rake board.

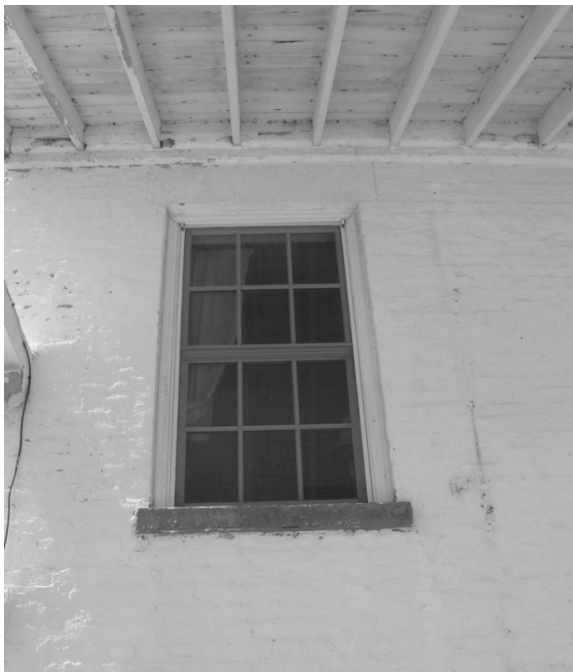
Figure 84. Deteriorated mortar at cornice on east elevation.

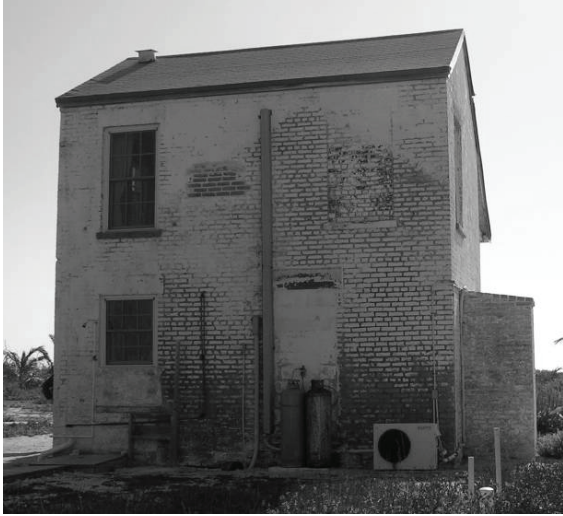
Figure 85. West (rear) elevation of Kitchen Building. Note the ghosting left by the Kitchen/Dining Room addition that was removed after the 1945 fire.

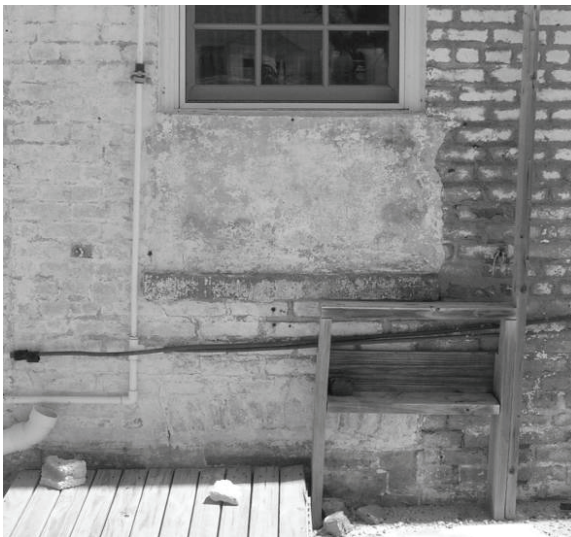
Figure 86. Outline of brick segmental arch at north side of west elevation.

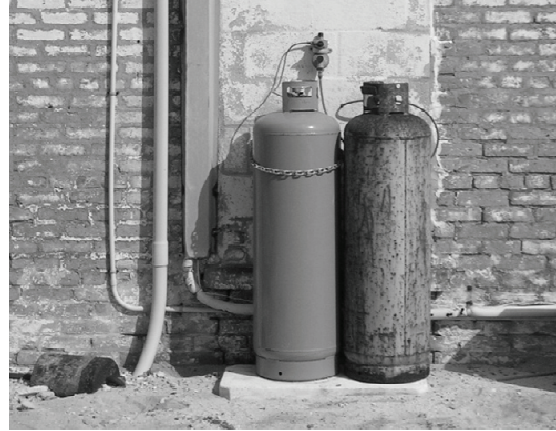
Figure 87. New and rusted propane gas tanks at west elevation.

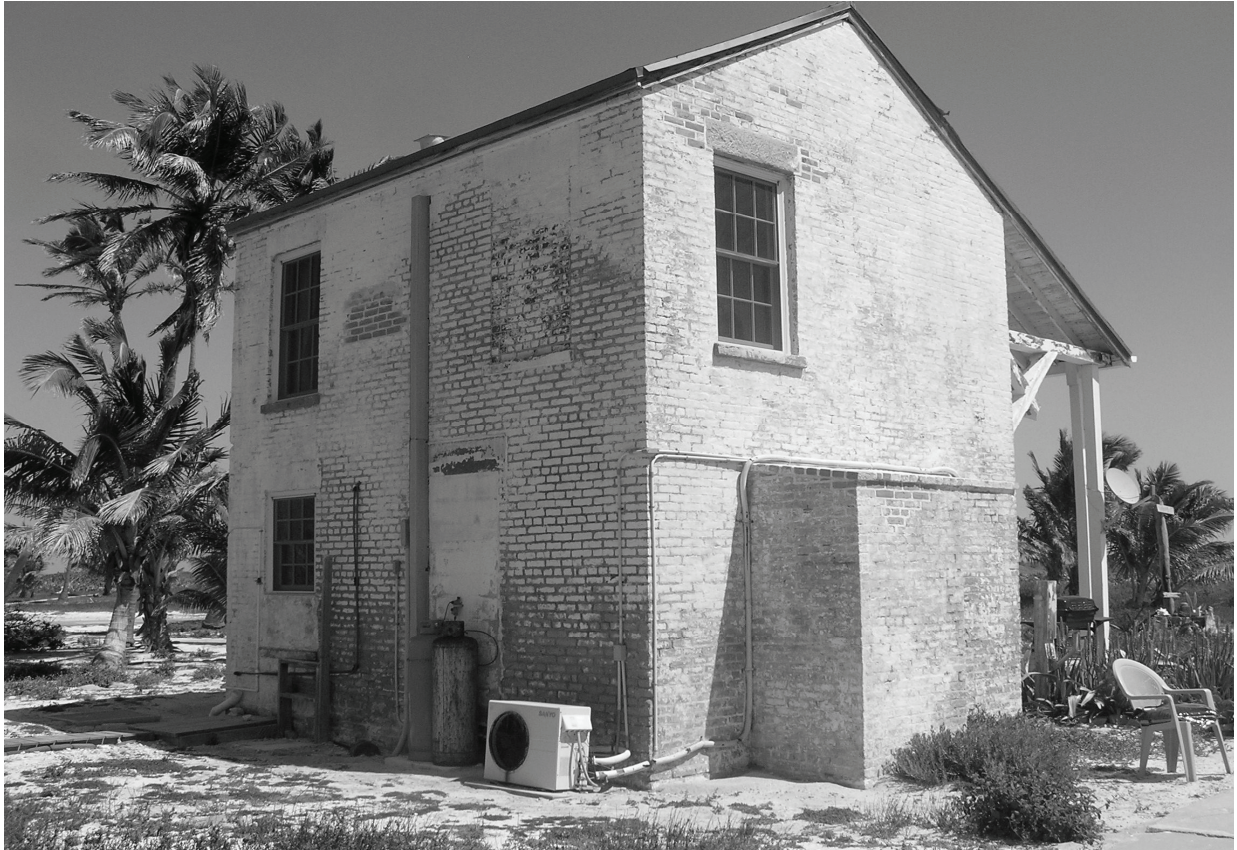
Figure 88. Conditions sketch for west elevation.

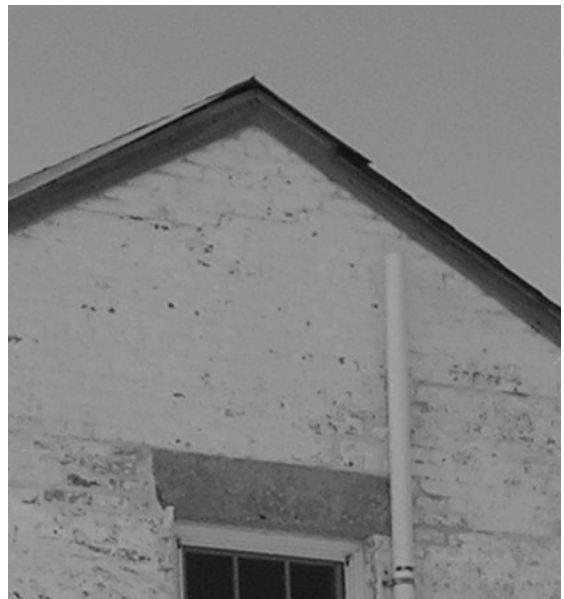
Figure 89. Areas of previous repairs.

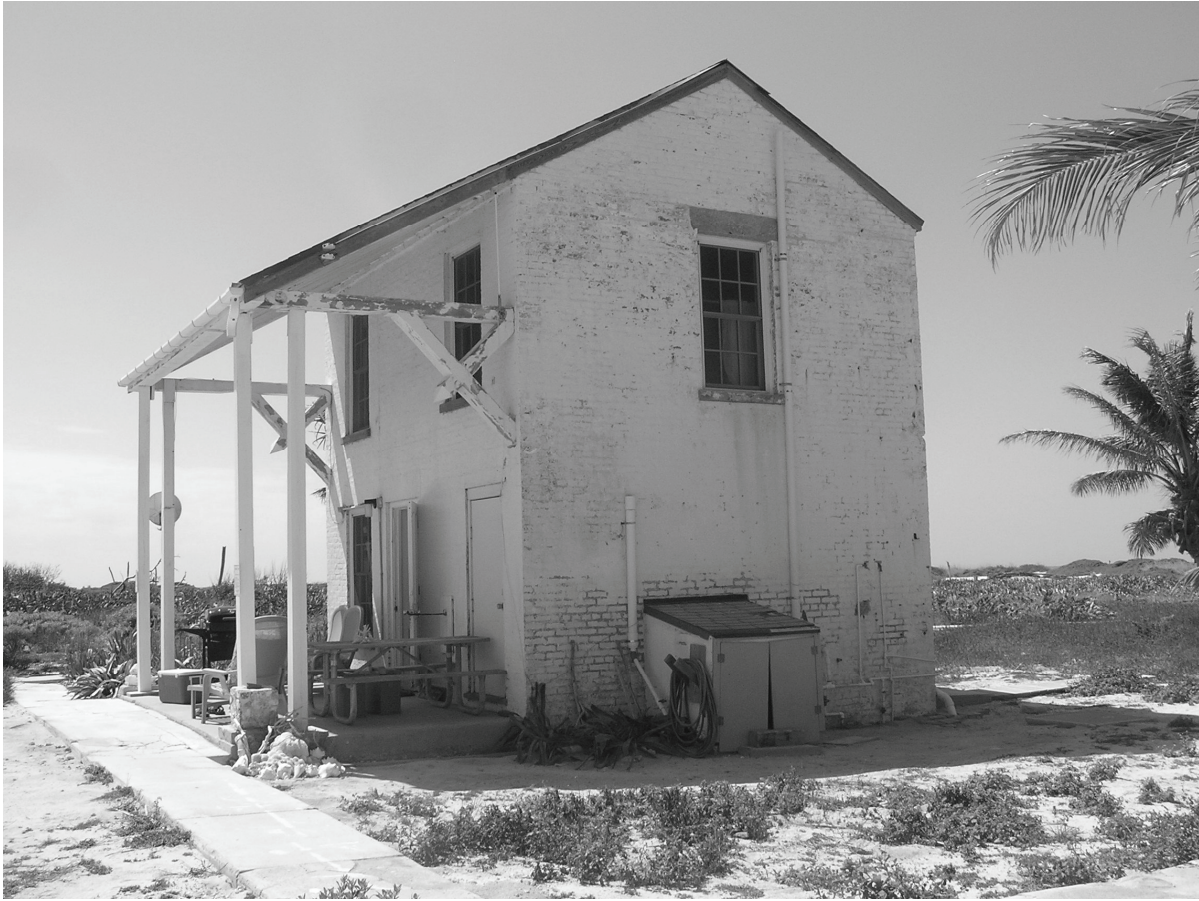
Figure 90. North elevation of Kitchen Building.

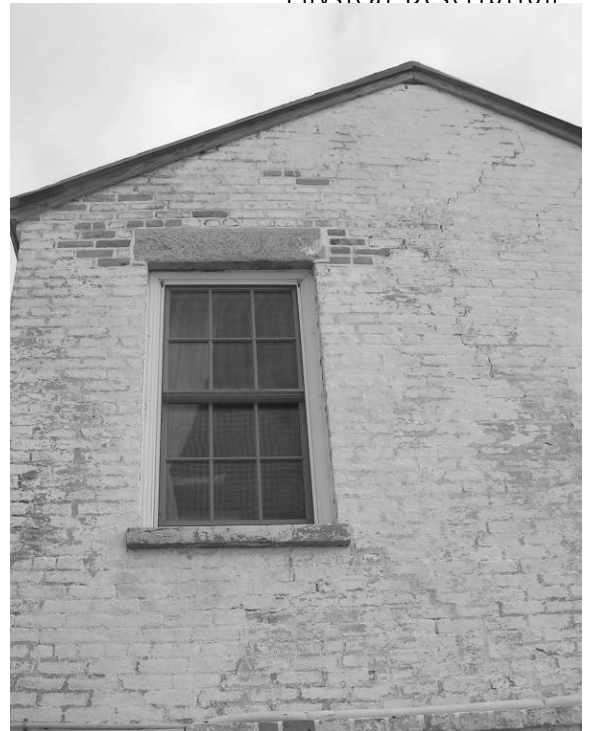
Figure 93. Several cracks emanate from a central location. It is possible that this damage may have been caused by a tree or other projectile hitting the building during a storm.
