Dry Tortugas National Park

Dry Tortugas Light Station

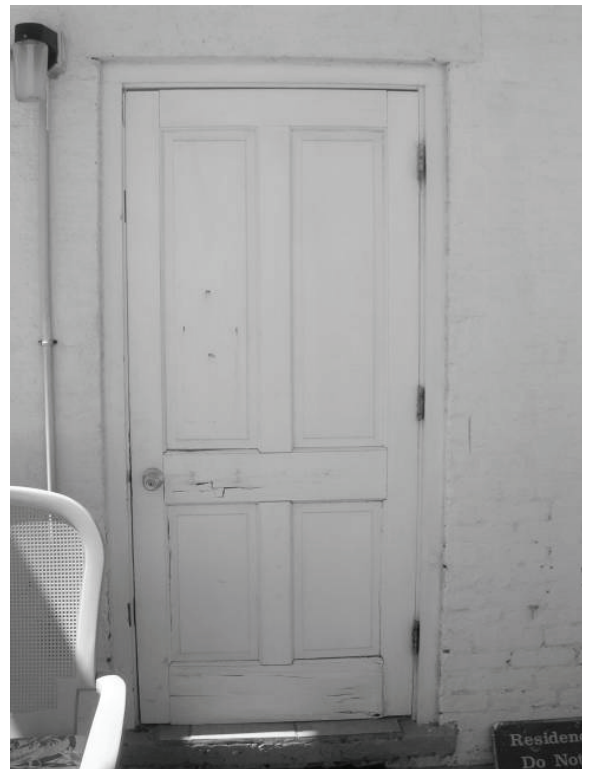
Figure 94. Exterior face of front door with cracking.

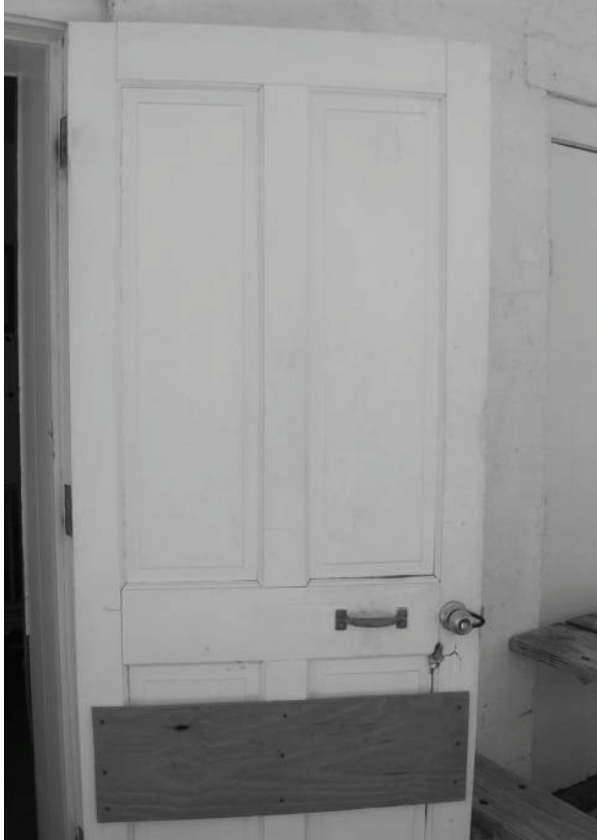
Figure 95. Interior face of front door with cracks and ¼” plywood brace.

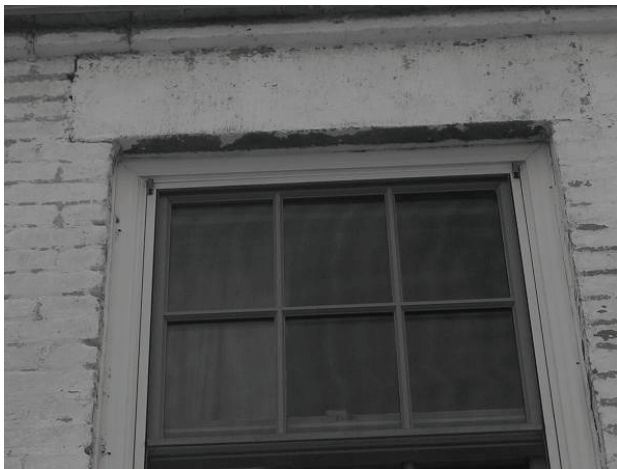
Figure 96. Typical condition of painted concrete window lintels.

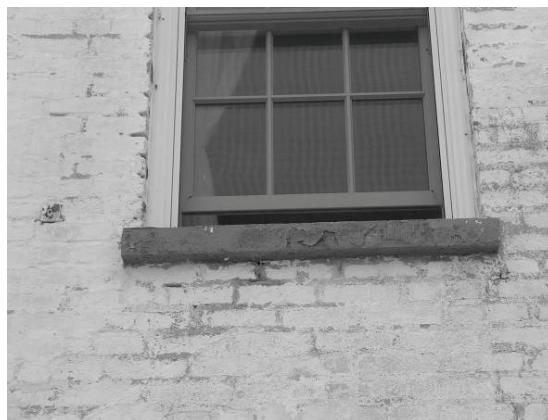
Figure 97. Typical condition of painted concrete window sills.

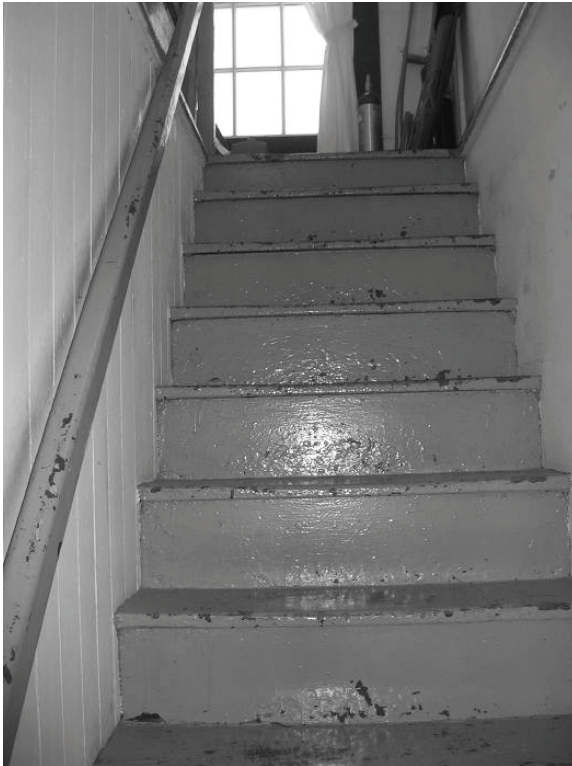
Figure 102. Wood stairs and railing in Kitchen Building.

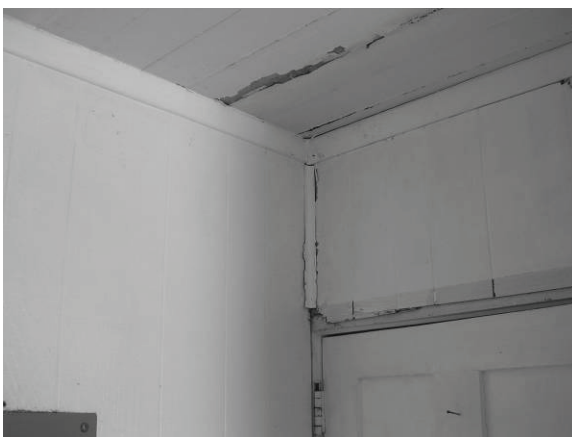
Figure 103. Deteriorate ceiling finish and wall boards above bathroom door.

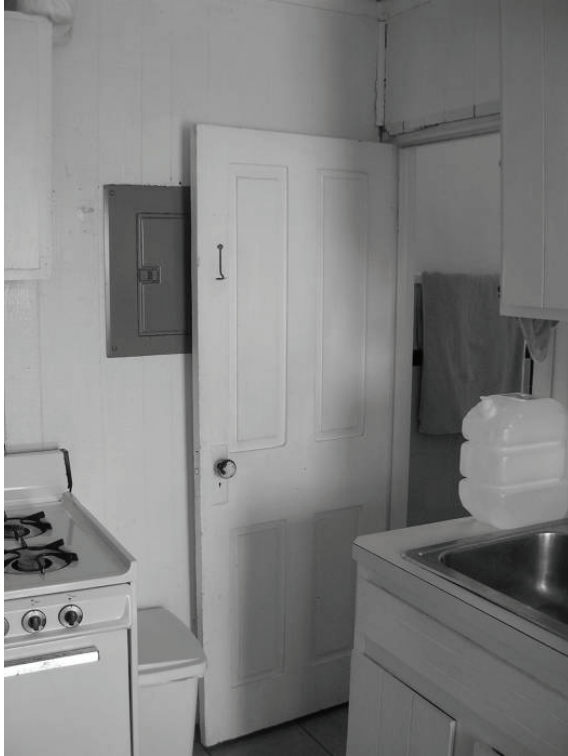
Figure 104. View of bathroom door and entry facing north.

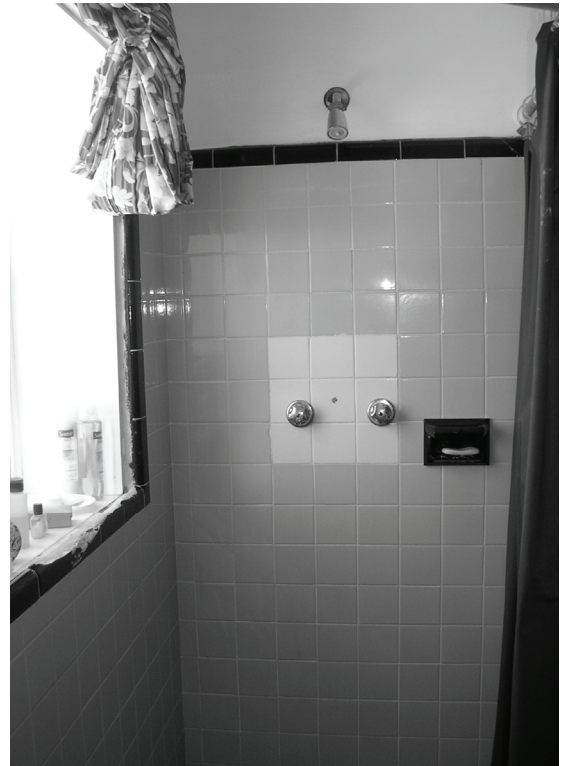
Figure 106. View of ceramic tile at shower and window. Damaged tile at window edge.

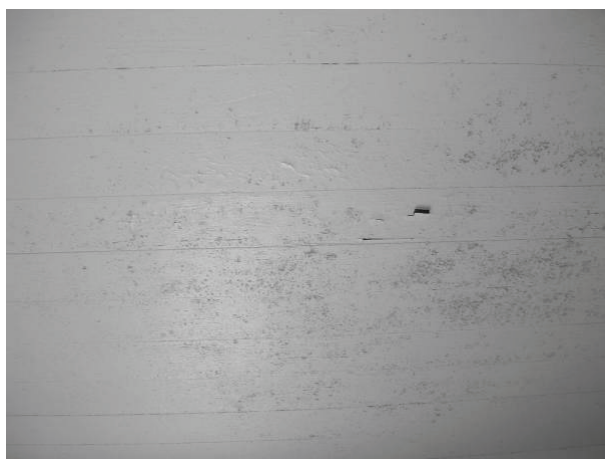
Figure 116. Deteriorated paint finish at the second floor ceiling.

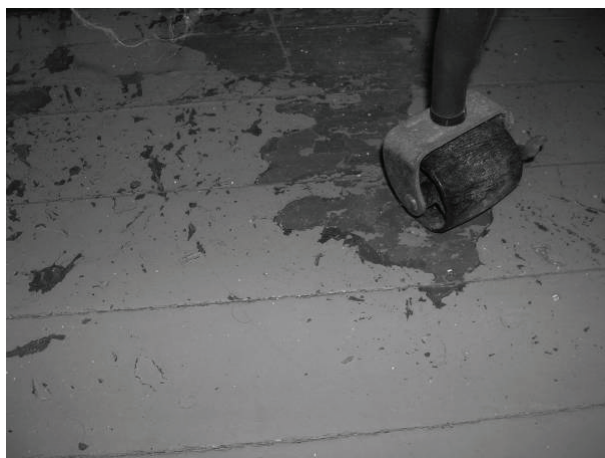
Figure 117. Deteriorated floor finish at the floor on second floor.

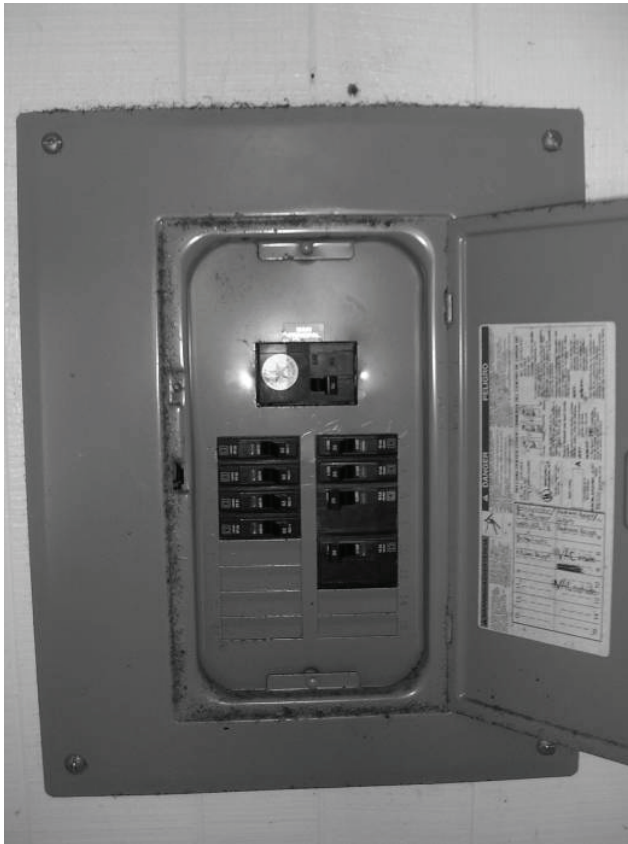
Figure 118. Close-up of eight-circuit distribution panel at Kitchen Building.

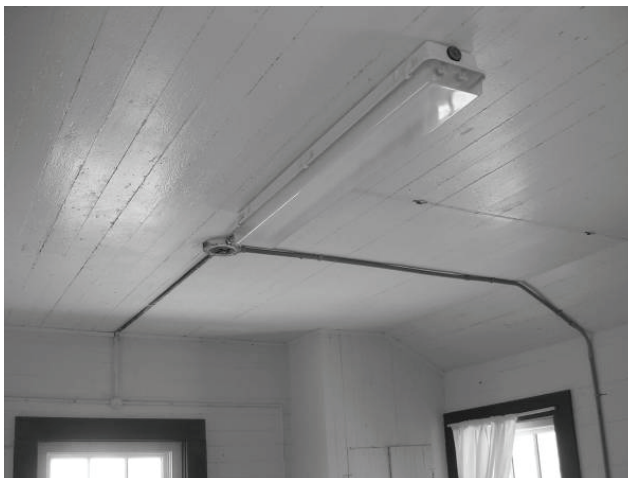
Figure 119. Fluorescent light fixture and rigid metal conduit at second floor.

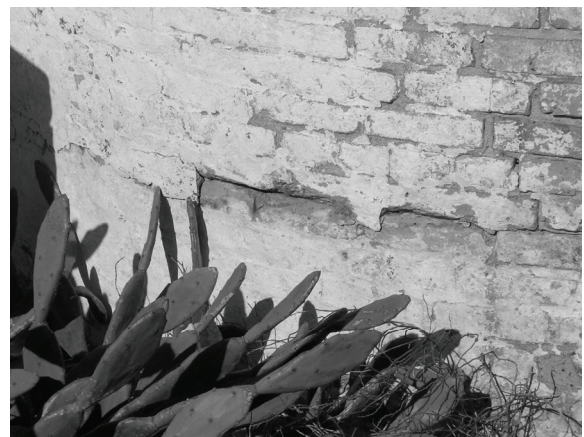
Figure 126. Deteriorated mortar joints and bricks at lower courses of south brick cistern.

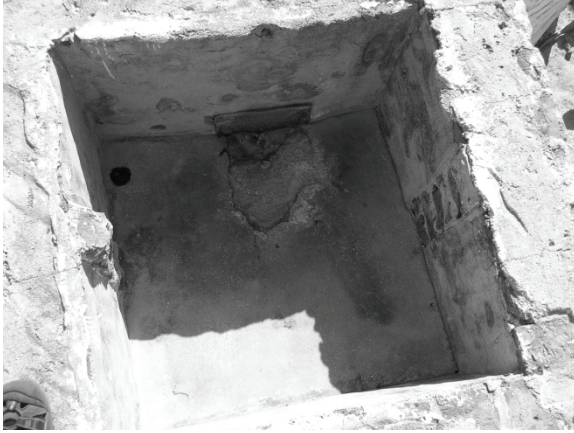
Figure 127. View of intake box at south brick cistern.

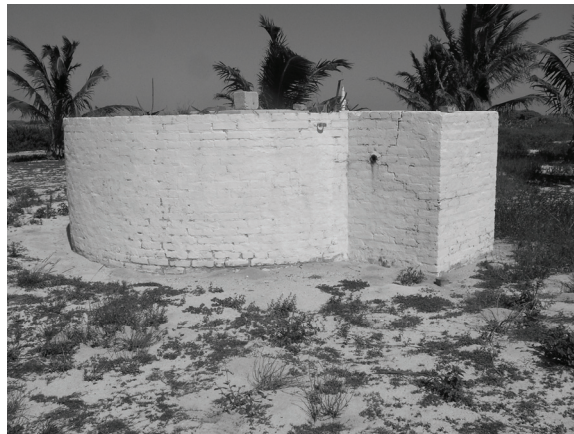
Figure 128. Cracks at intake box of south cistern.

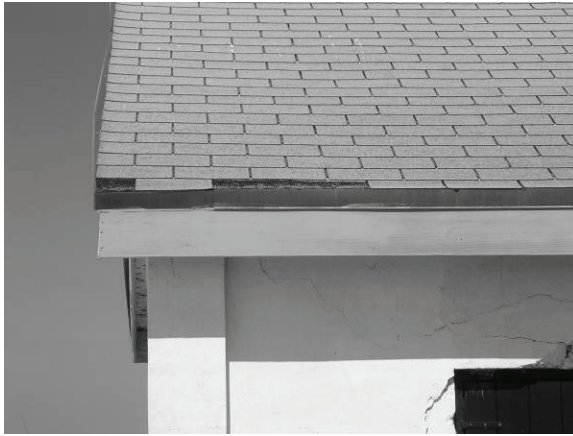
Figure 131. Missing roofing shingles at north elevation.

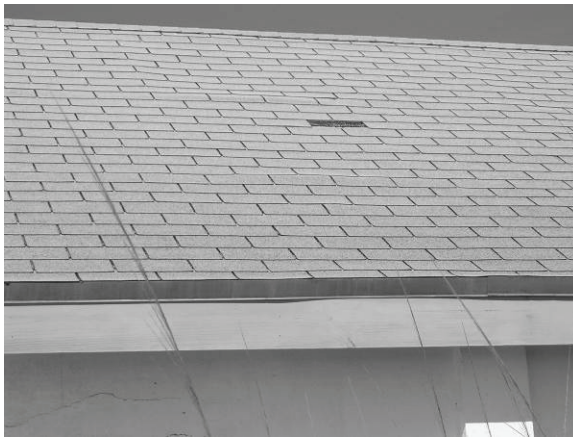
Figure 132. Metal flashing and eave fascia at north elevation.

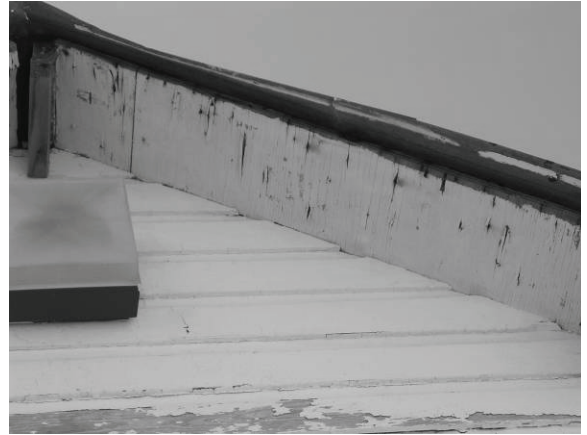
Figure 133. Damage flashing and deteriorating roof decking at east elevation.

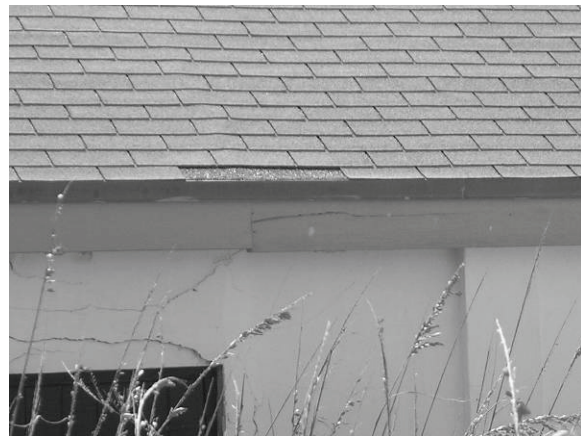
Figure 134. Horizontal crack in eave fascia at east elevation.

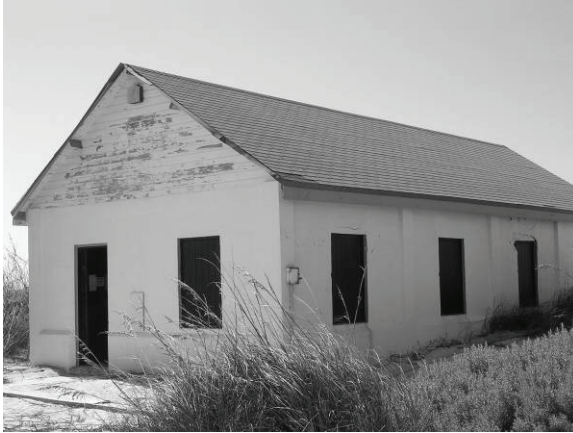
Figure 135. Concrete and framed walls of Boat House.

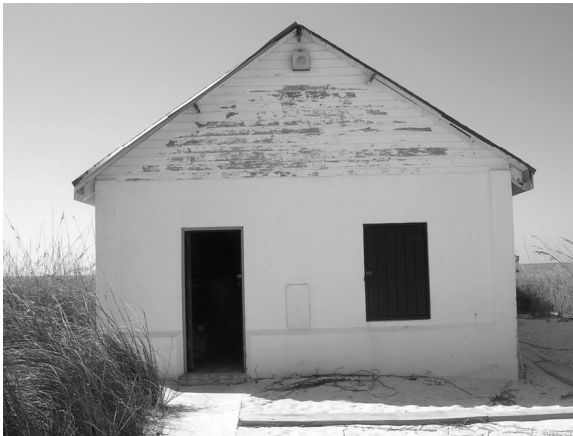
Figure 136. East elevation of Boat House. 134. Horizontal crack in eave fascia at east elevation.

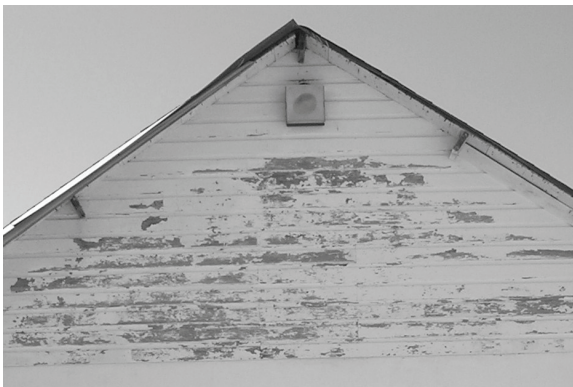
Figure 137. Weathered novelty siding in gable end at east elevation.

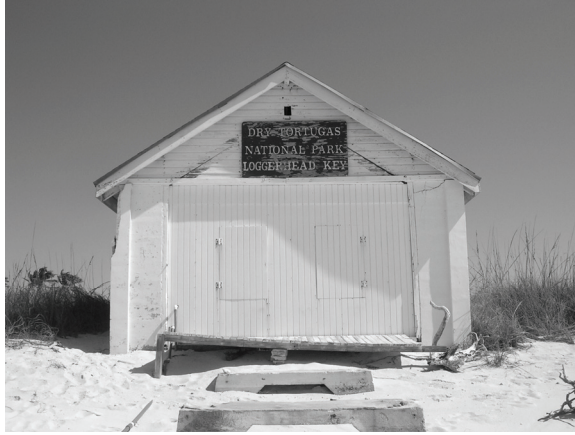
Figure 138. West elevation of Boat House.

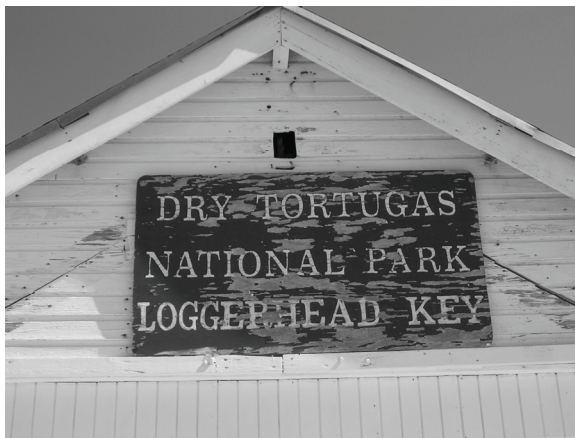
Figure 139. Deteriorated paint finish of novelty siding and signage at west elevation.

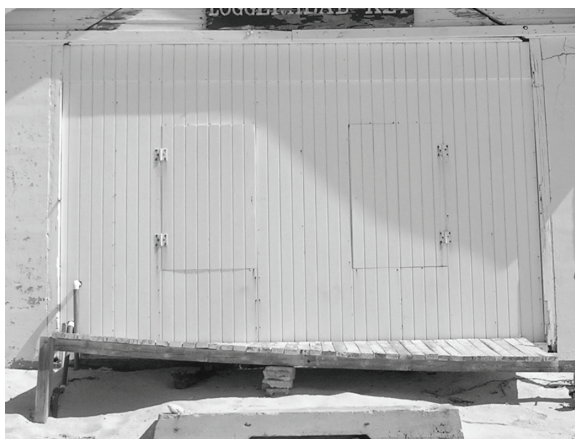
Figure 140. Wood deck at west elevation.

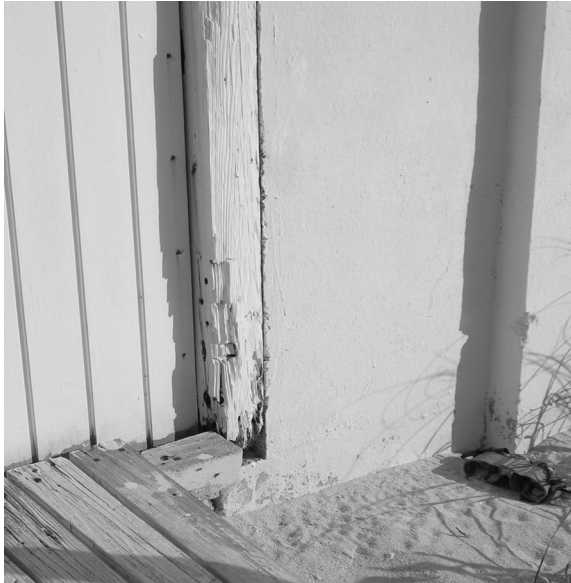
Figure 141. Damaged vertical framing at west elevation.

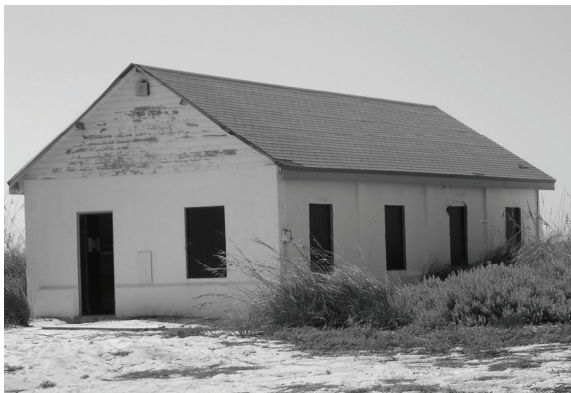
Figure 142. North elevation of Boat House.

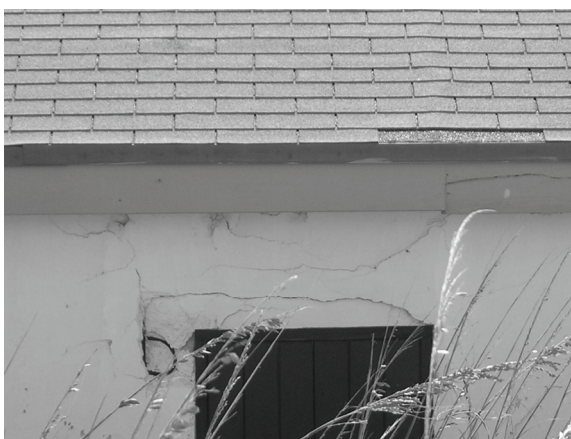
Figure 143. Example of damage to concrete walls at north elevation.

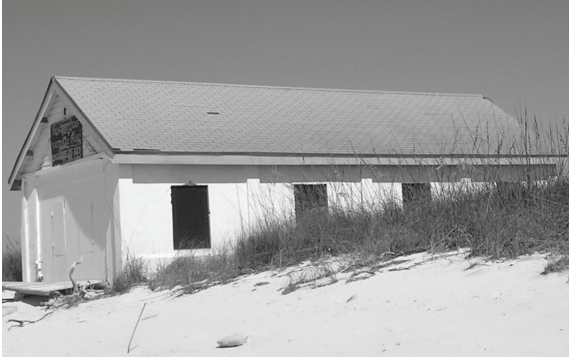
Figure 144. South elevation of Boat House.

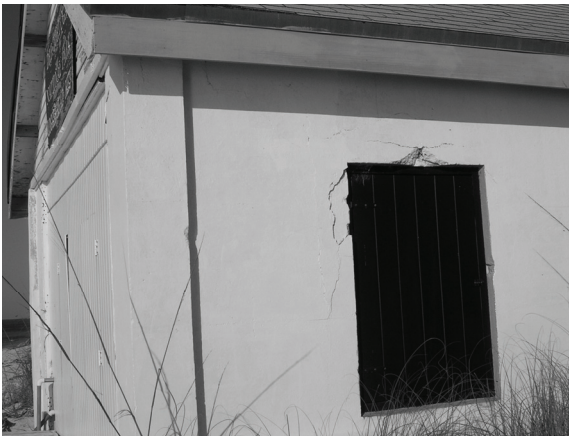
Figure 145. Example of damage to concrete walls at south elevation.

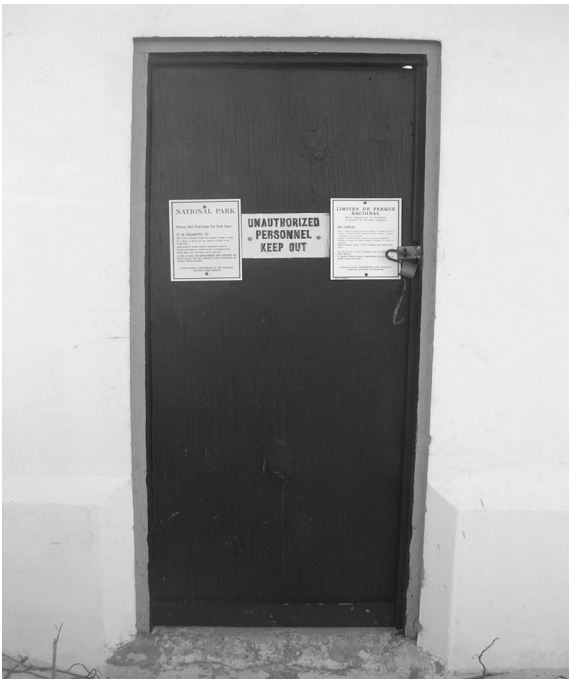
Figure 146. View of wood door at front entry.

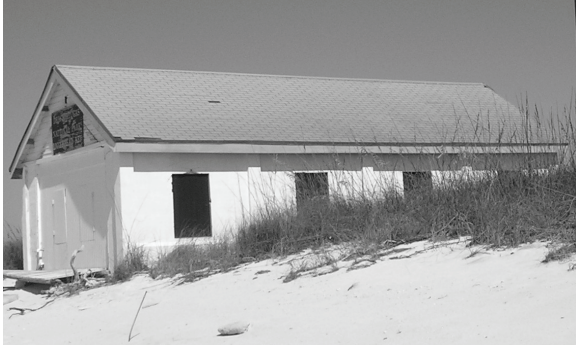
Figure 144. South elevation of Boat House.

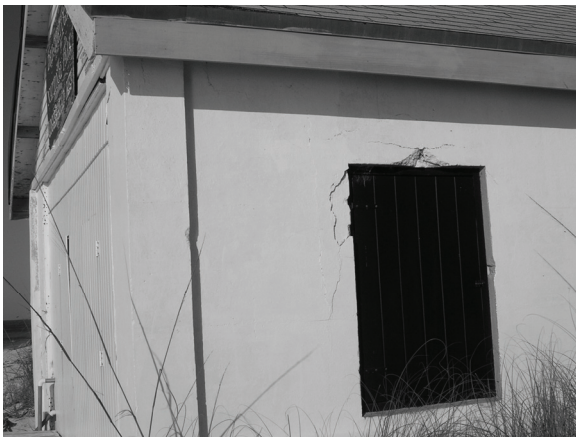
Figure 145. Example of damage to concrete walls at south elevation.

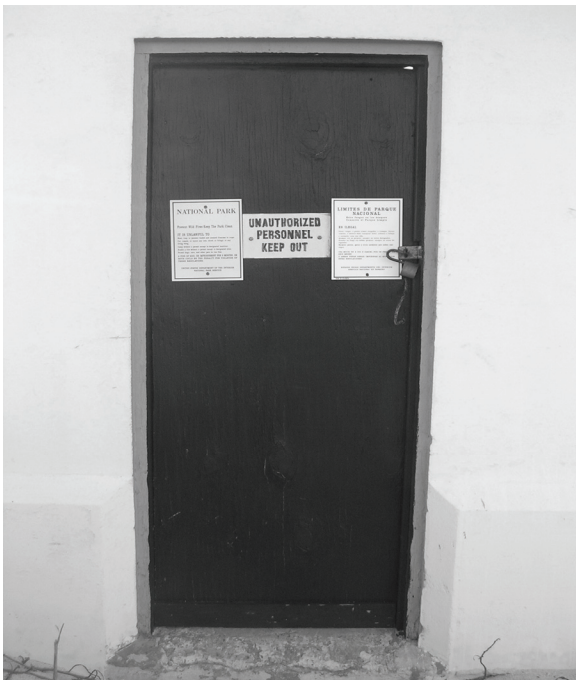
Figure 146. View of wood door at front entry.

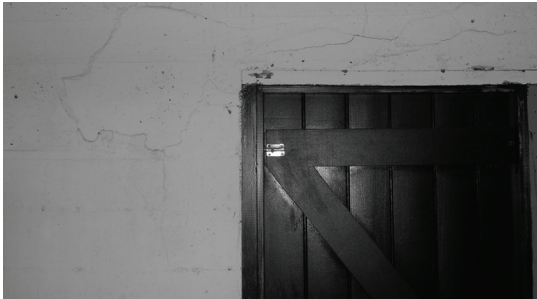
Figure 152. Example of damage to interior face of concrete walls.

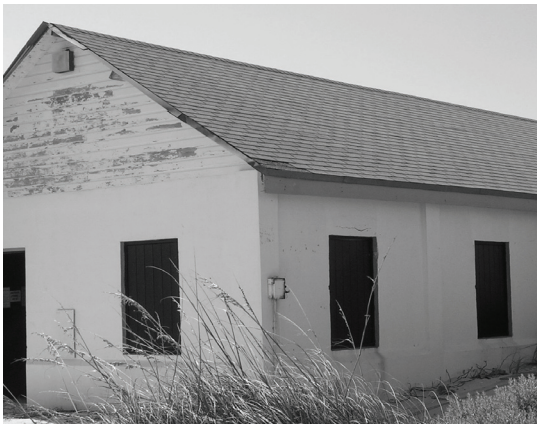
Figure 153. Metal switch box at northeast corner of building.

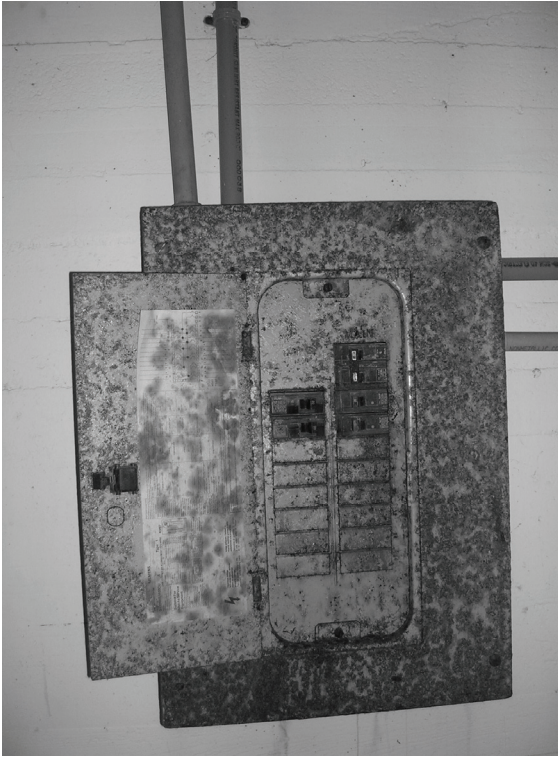
Figure 154. Close-up of six-circuit distribution panel in corroded condition.

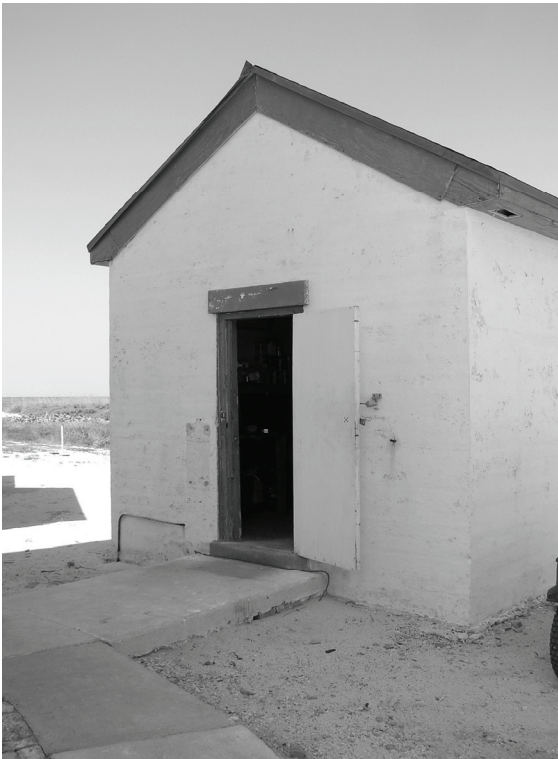
Figure 155. View of New Oil House façade and entry facing west.

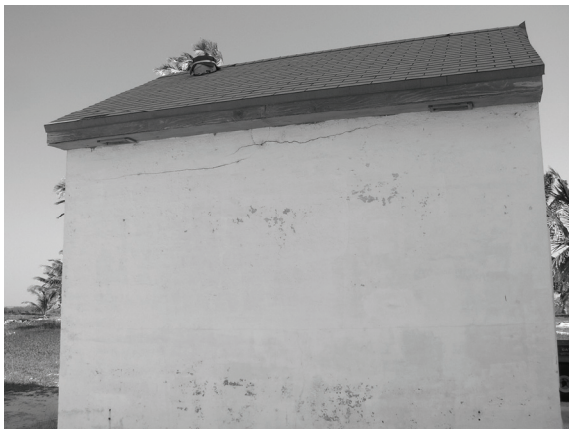
Figure 157. Cracks in mortar joints at the north elevation of New Oil House.

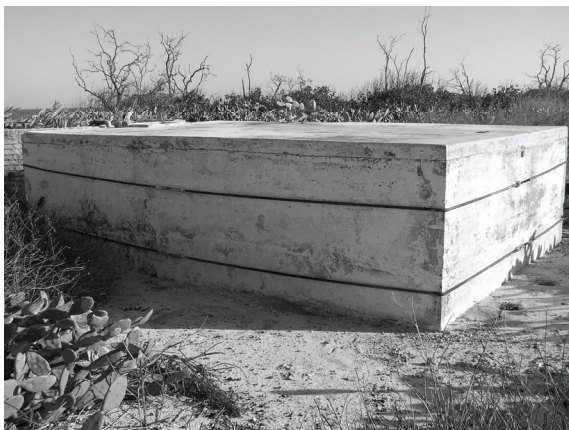
Figure 158. View of south concrete cistern.

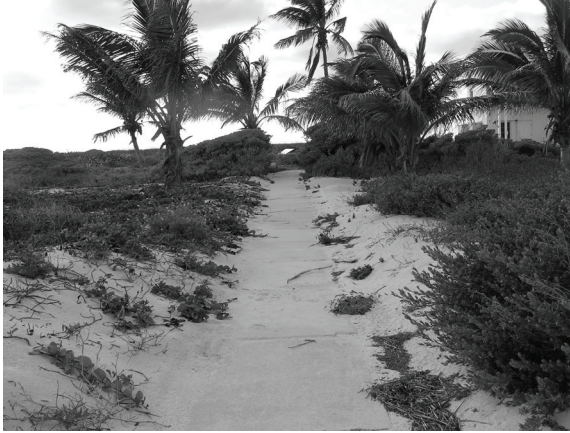
Figure 160. Damaged concrete walkway extending west toward Kitchen Building.

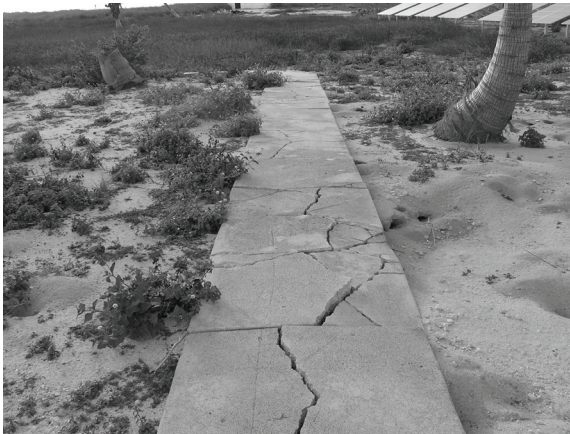
Figure 161. Damaged concrete walkway extending west, with the solar array to the north.
