**PRELIMINARY REPORT OF
RAINFALL EVENT, MAY 22-31, 1984
LOWER EAST COAST**

South Florida Water Management District

June 1984

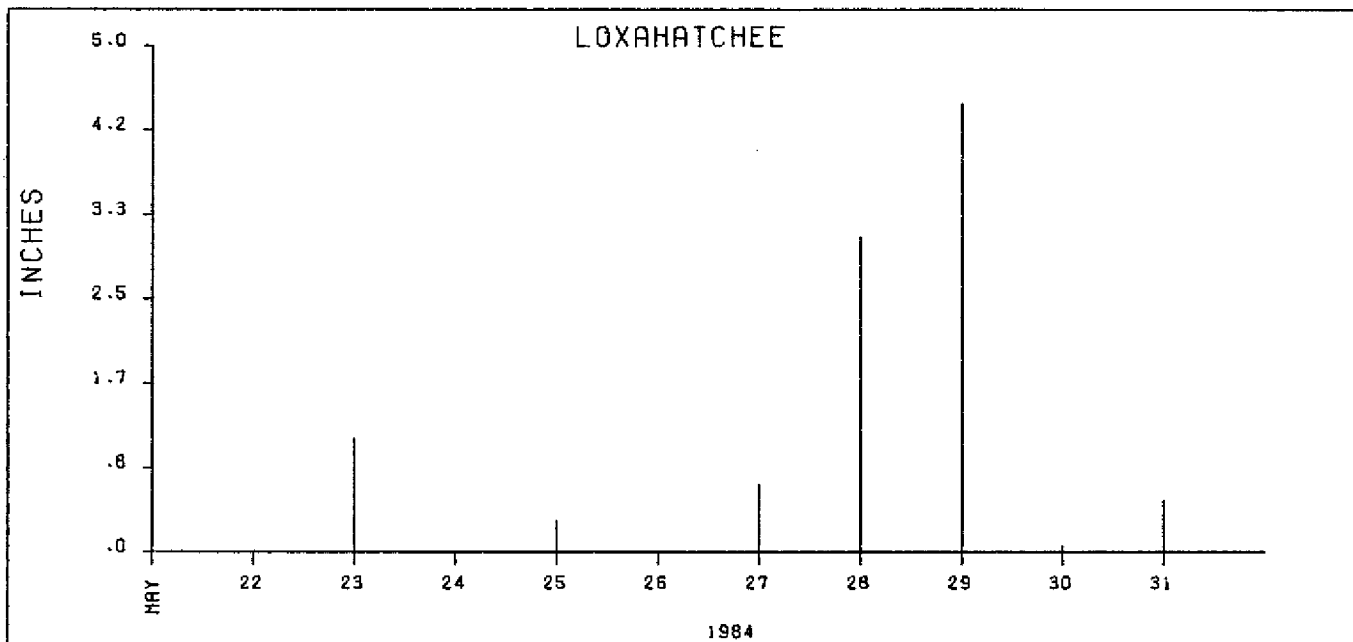
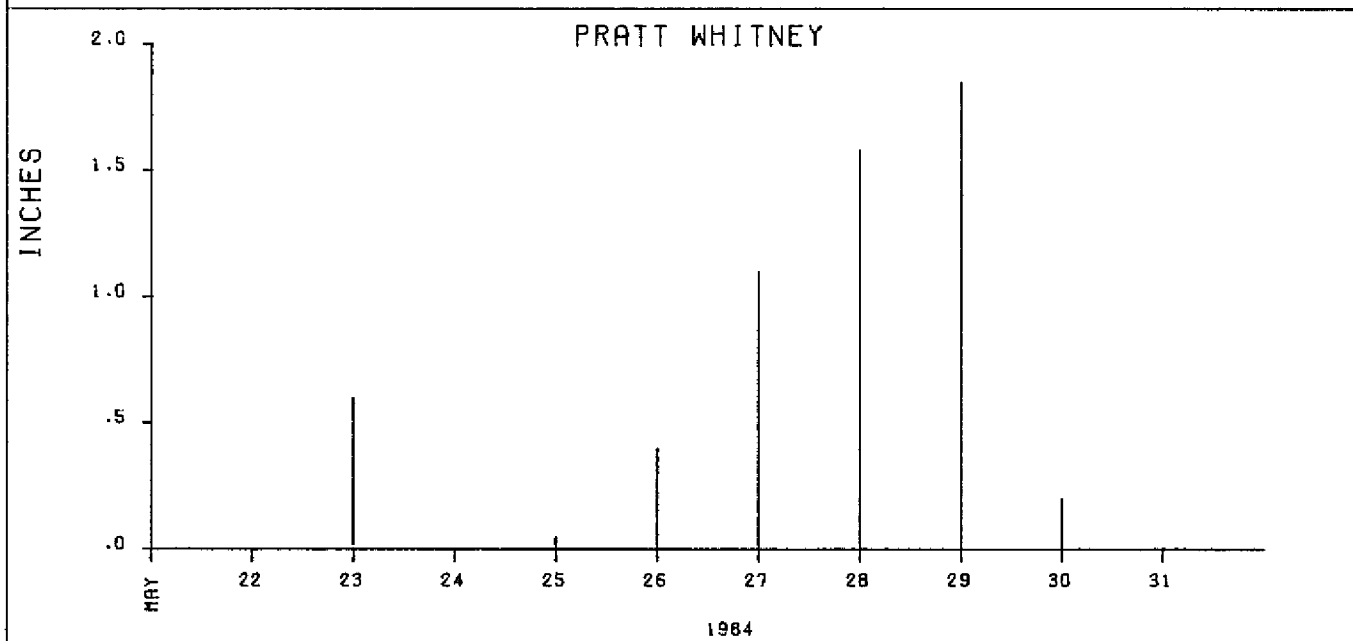
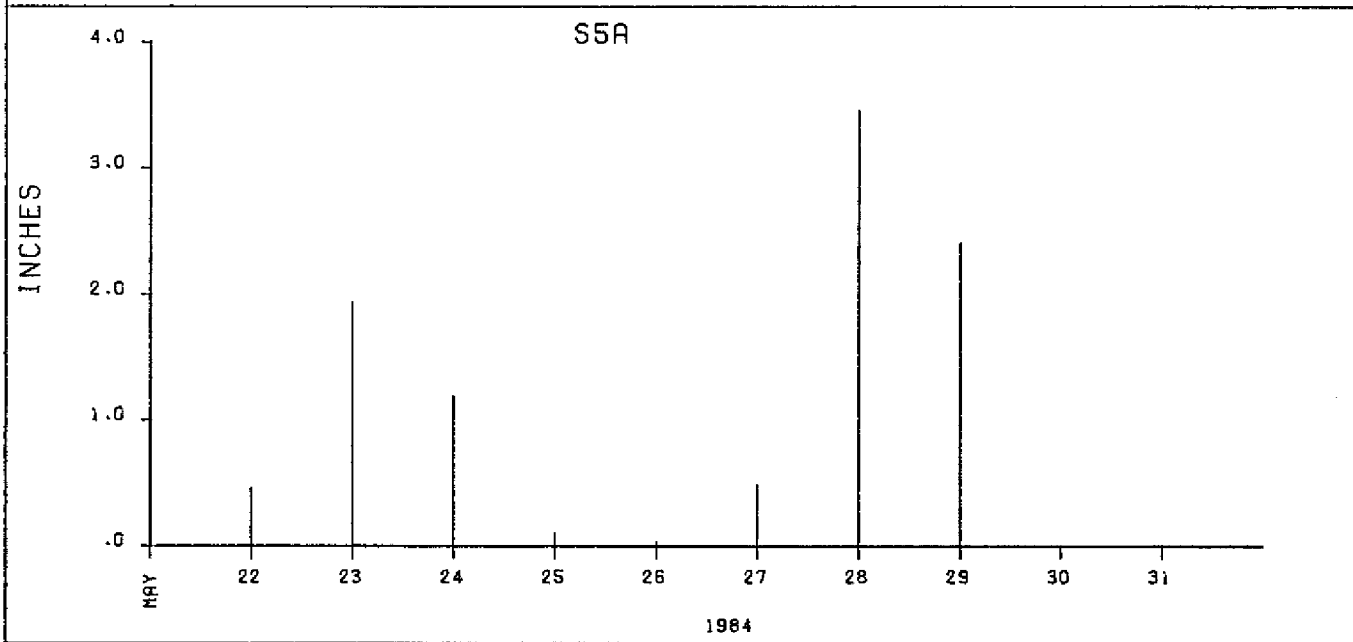
FIG. 1. STORM EVENT RAINFALL FROM MAY22-MAY31, 1984

As described previously, this rainstorm began May 22 and lasted through May 31. Heavy and intensive showers and thunderstorms were widely scattered over the entire central and southern portion of Florida. It is rather hard to pinpoint the rainfall distribution pattern in a time sequence unless a wide range of continuous rainfall records were analyzed. Unfortunately, it was not possible to do so at this time. Figures 1 and 2 present the daily rainfall values recorded at the following six rainfall stations in the lower east coast of Florida: S-5A, Loxahatchee, Pratt & Whitney, Palm Beach International Airport, Miami International Airport, and S-13 in Fort Lauderdale. Even though the hourly distribution of this rainstorm was not shown, the spatial and time variance of is visible. For example, the rainfall started on May 22

at S-5A (Water Conservation Area 1) and also at Miami International Airport. The rain did not begin until May 23 at Loxahatchee, Pratt & Whitney, and Palm Beach International Airport.

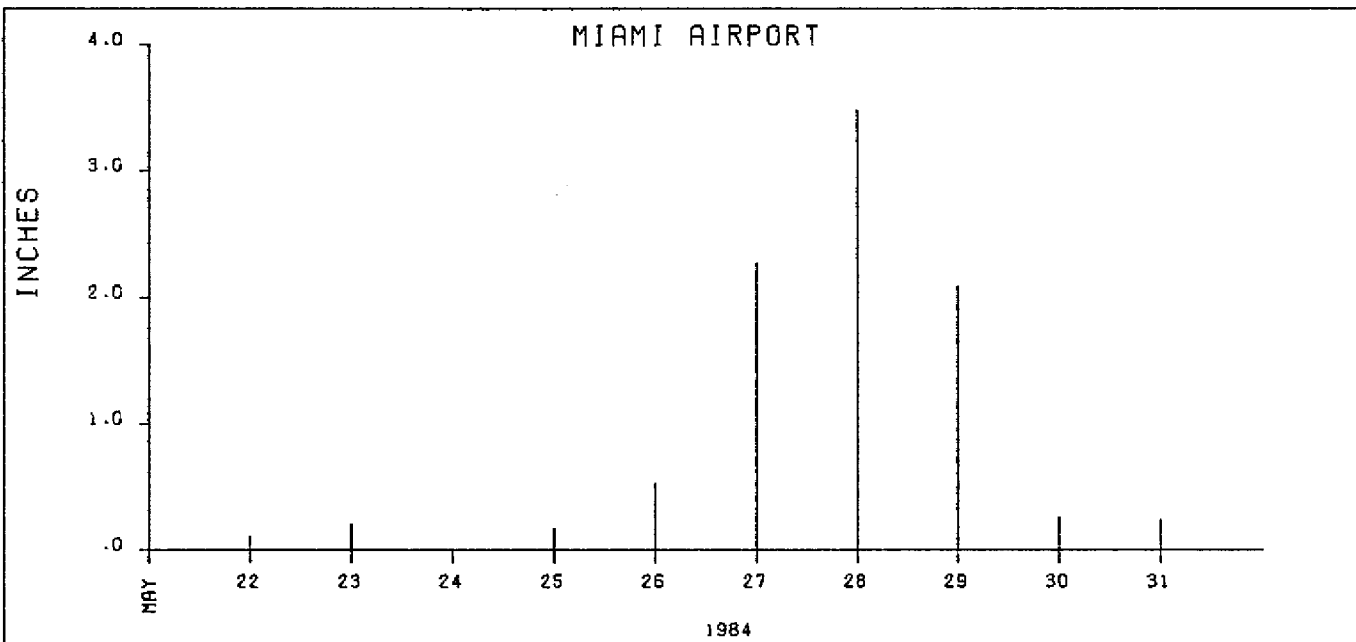
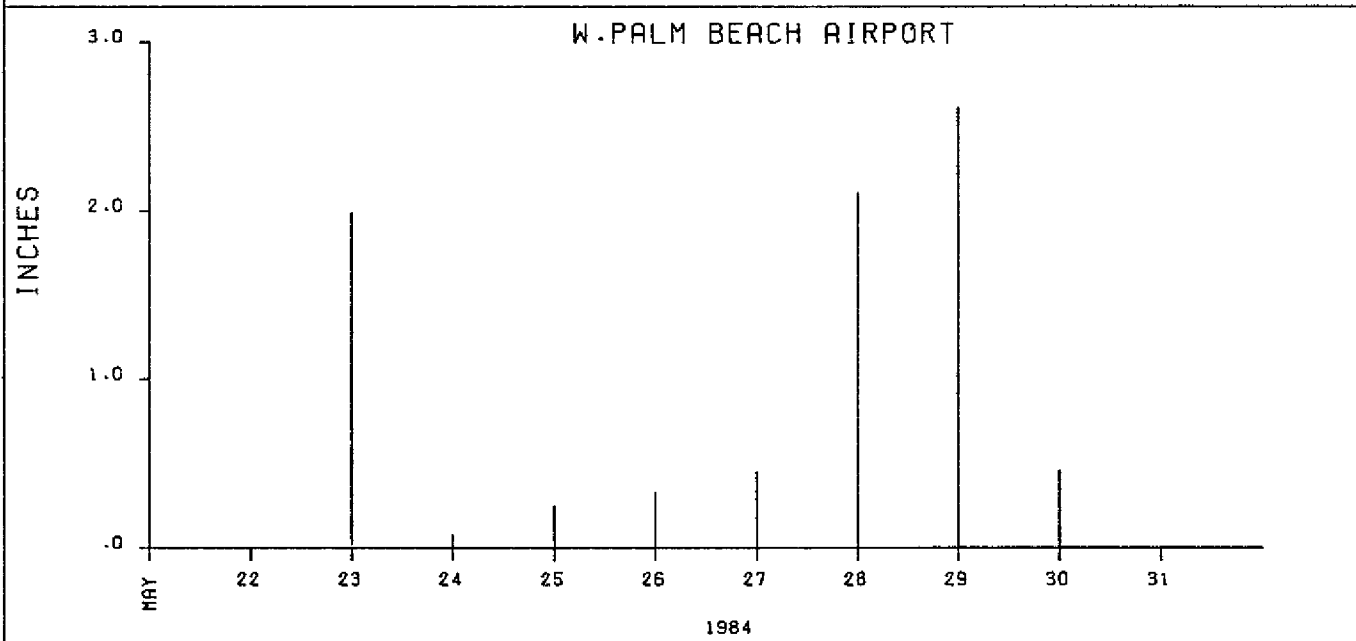
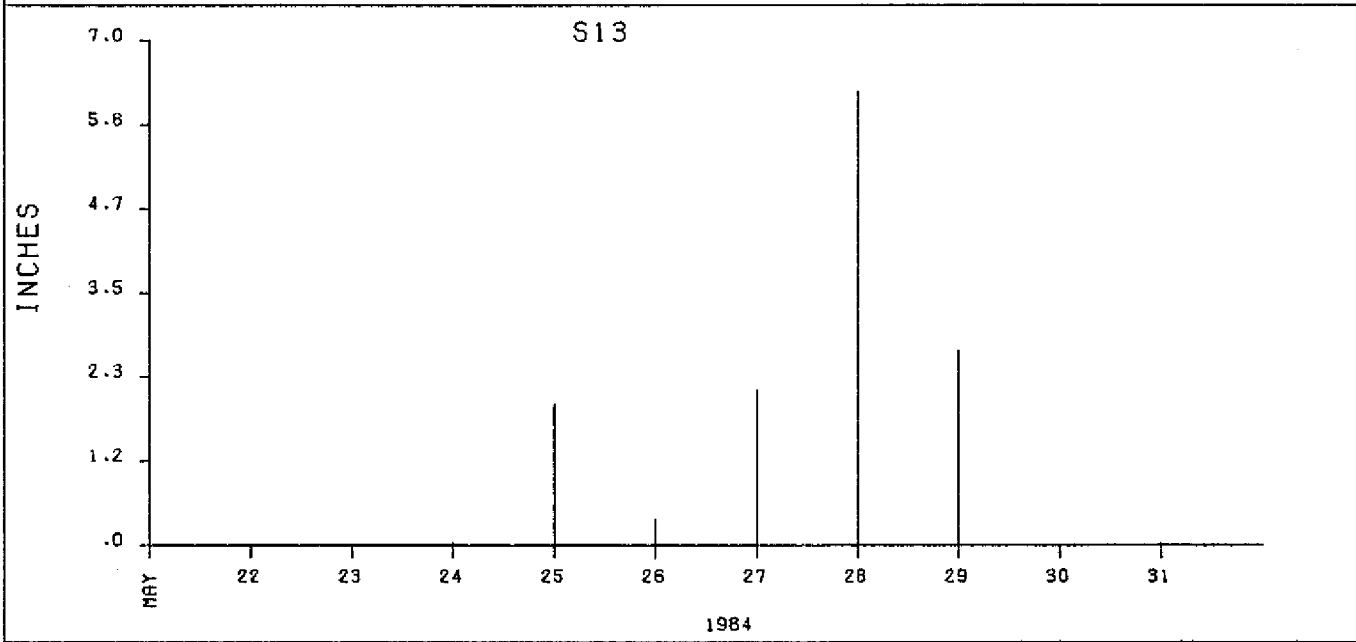
FIG. 2. STORM EVENT RAINFALL FROM MAY22-MAY31, 1984

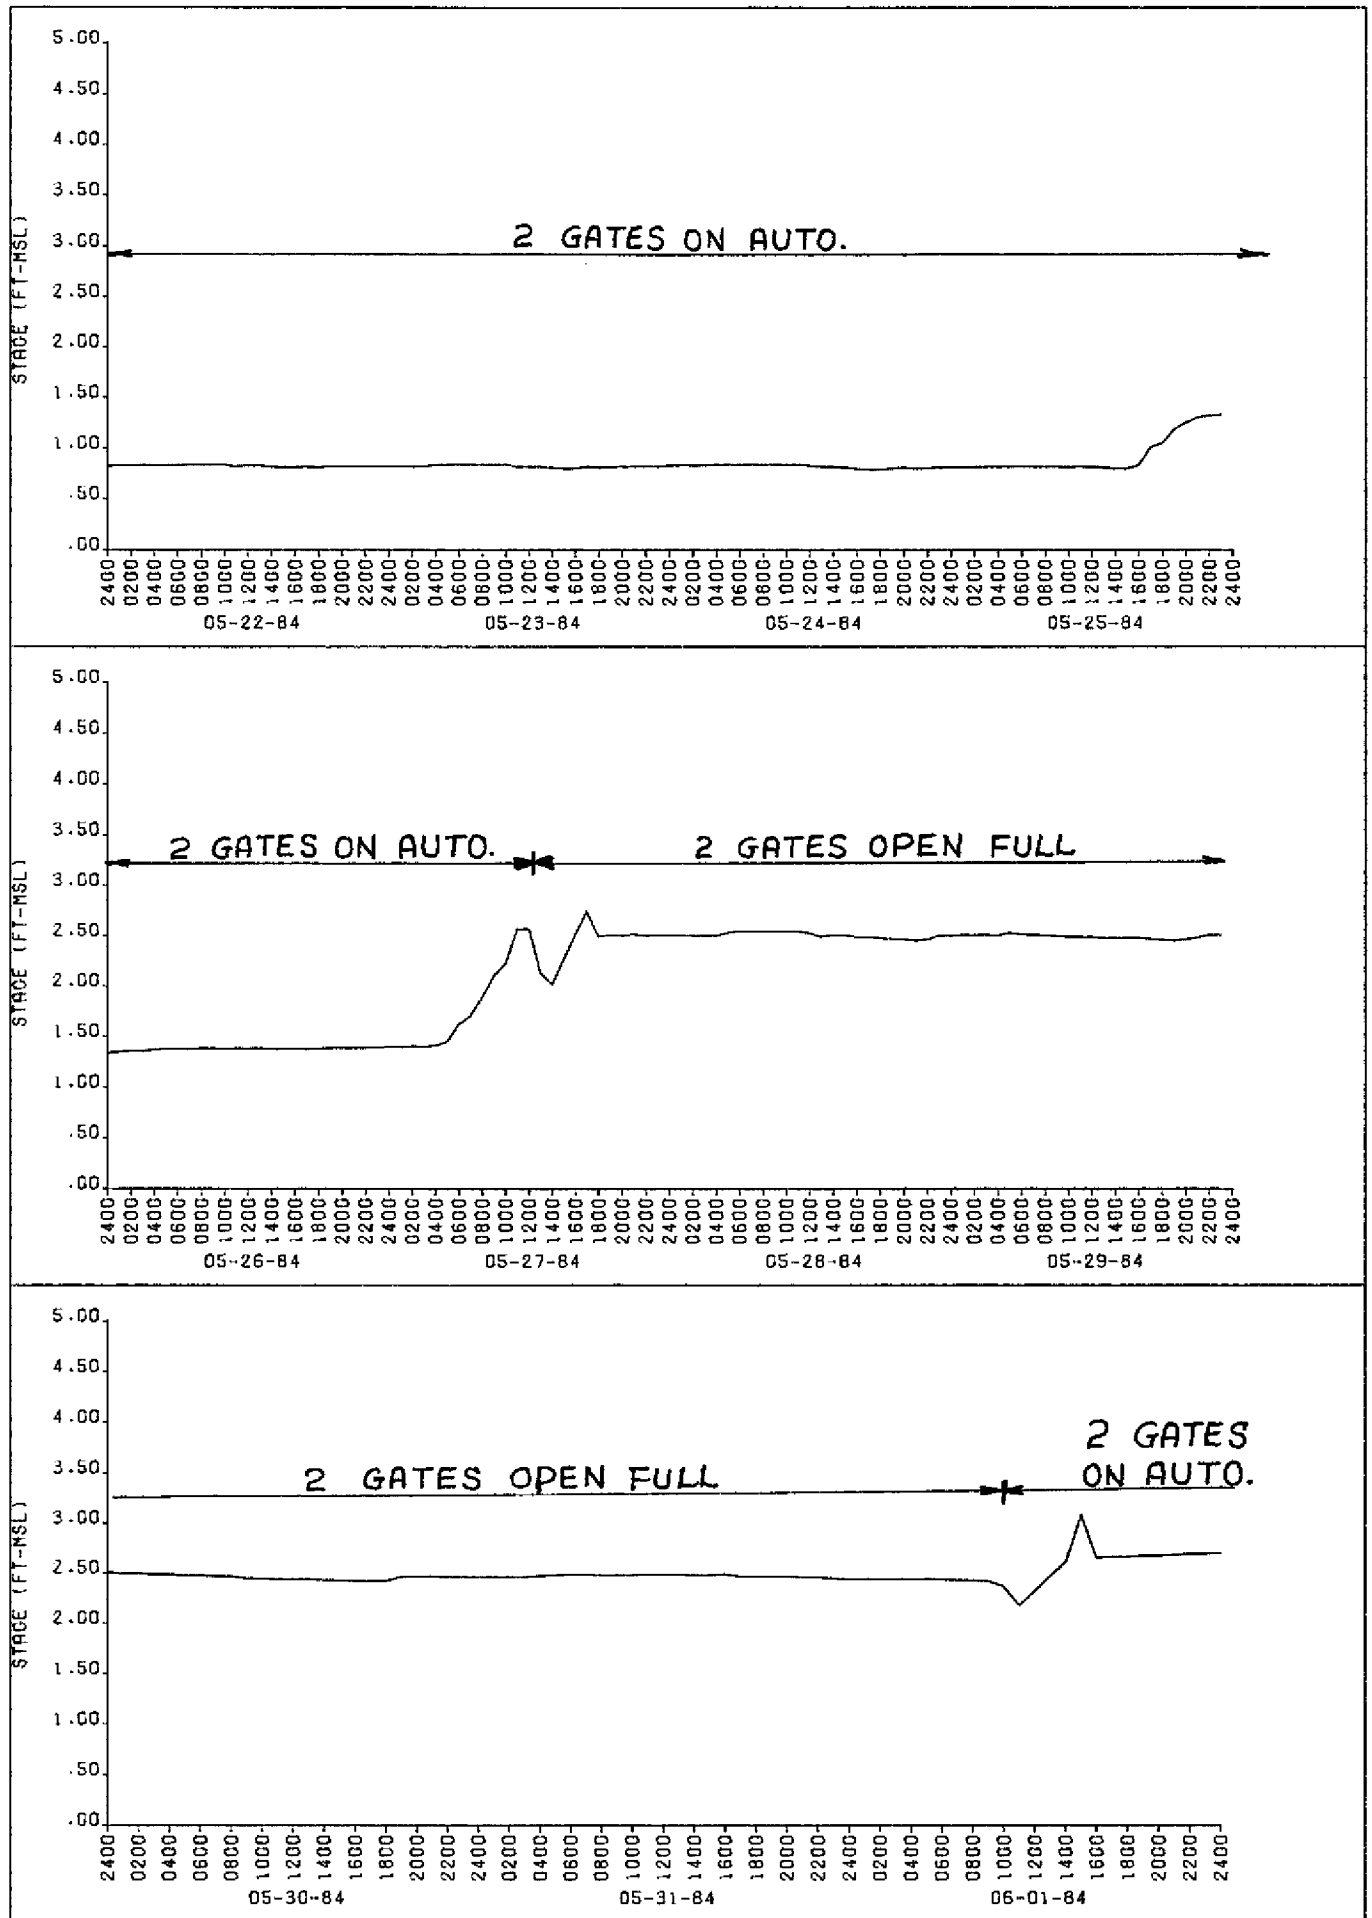
FIG. 9 HOURLY STAGE READINGS AT S-18C HW

The system was operated properly. All canal stages were within their operational range. Figure 9 presents the hourly stage hydrograph at S-18C headwater during this rainstorm. The stage was slightly above the normal optimum of 2.30 ft NGVD; however, the critical stage of 2.80 ft was not reached during this rainstorm. This critical stage is defined as a stage which will not cause any adverse backwater effect to the upstream area. Detailed information on the operation of the south Dade conveyance system during this event is presented in Table 4.

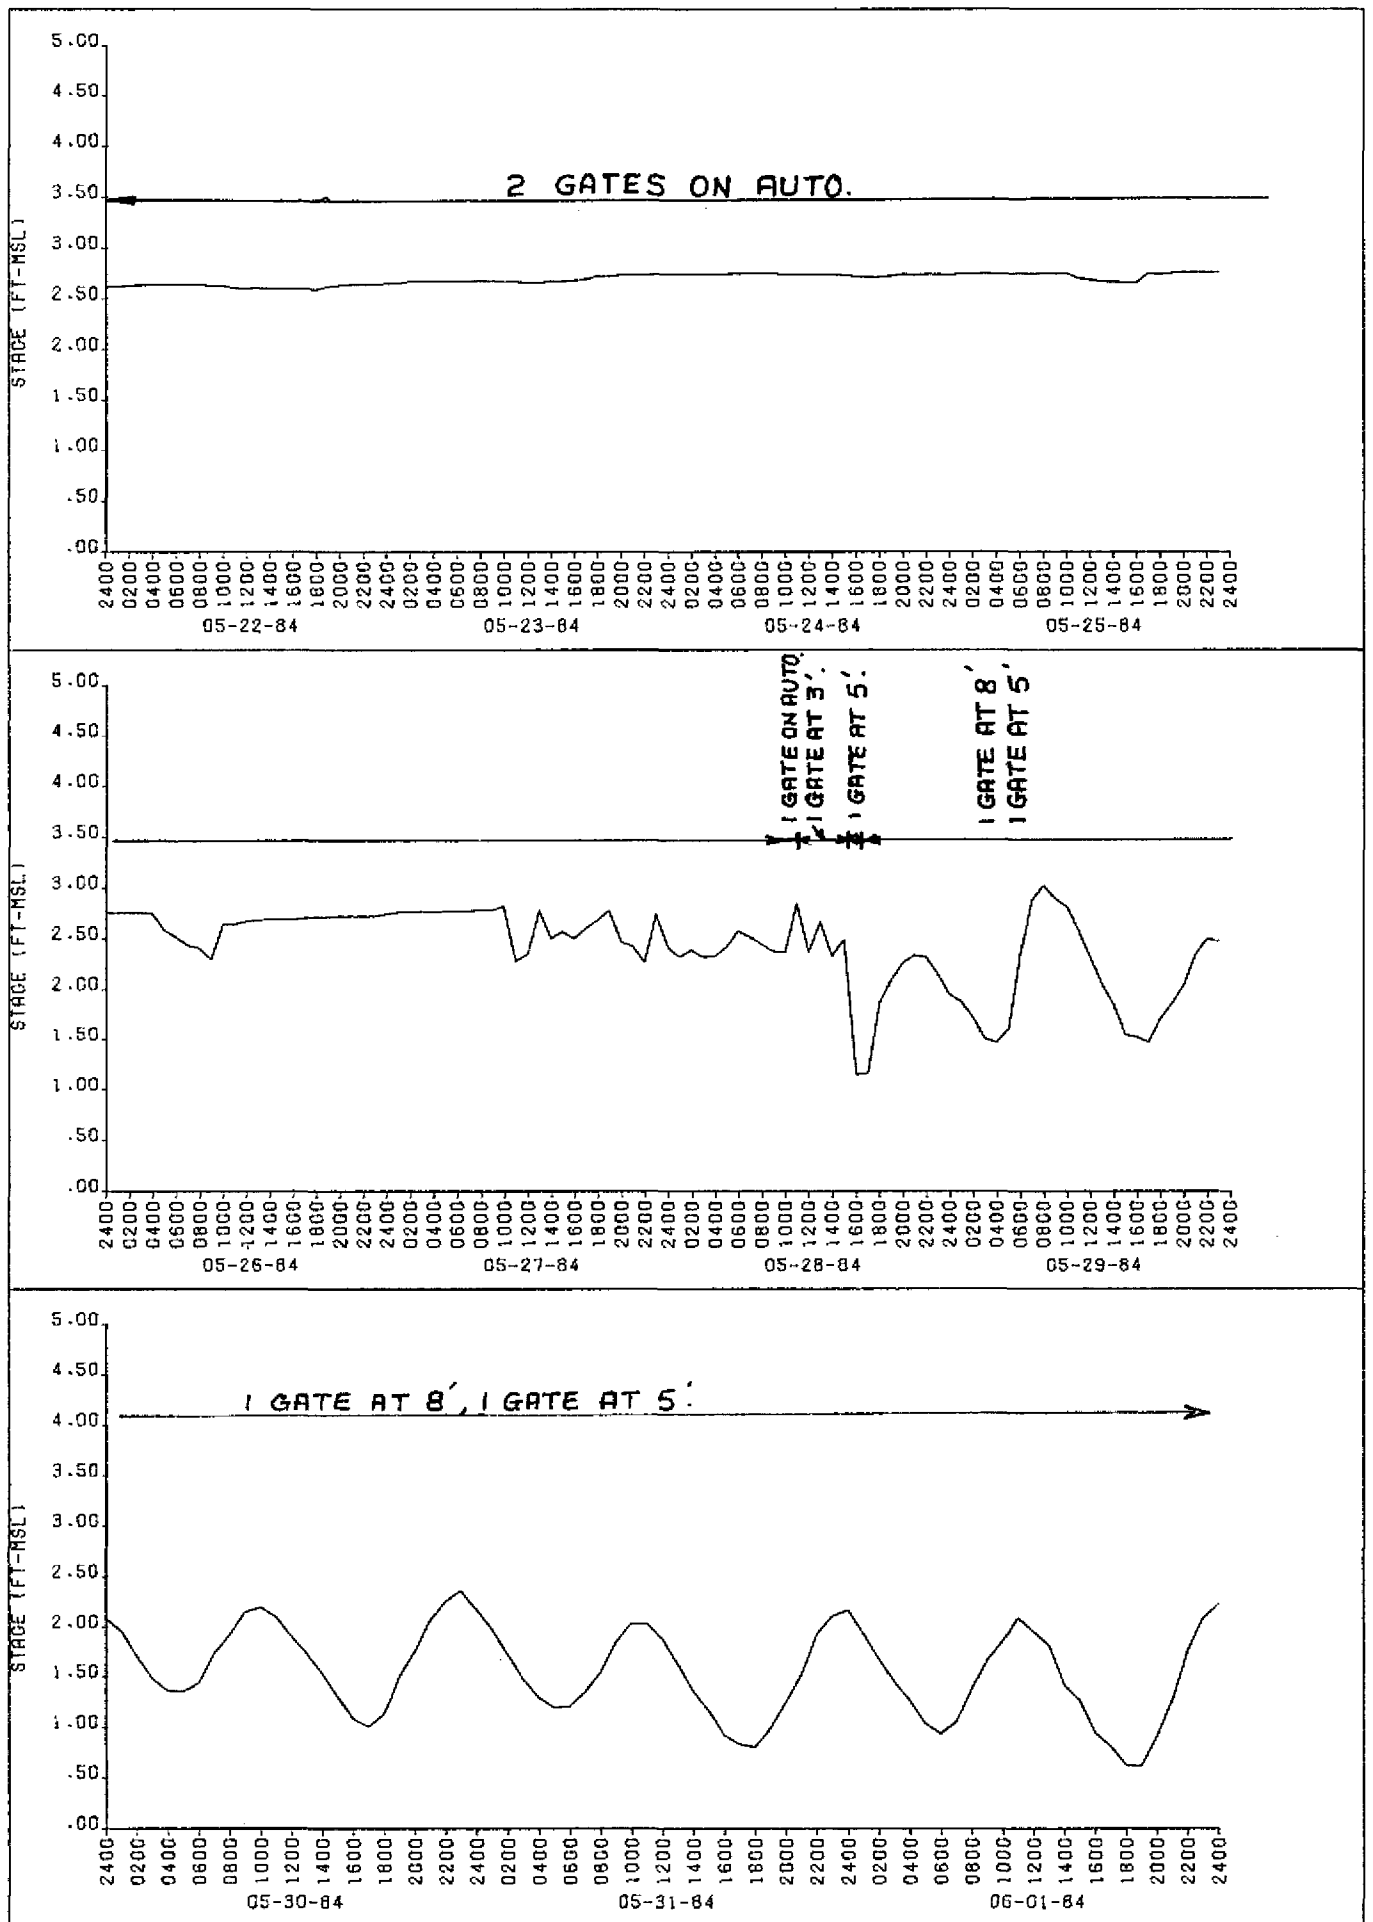
FIG. 10 HOURLY STAGE READINGS AT S-26 HW

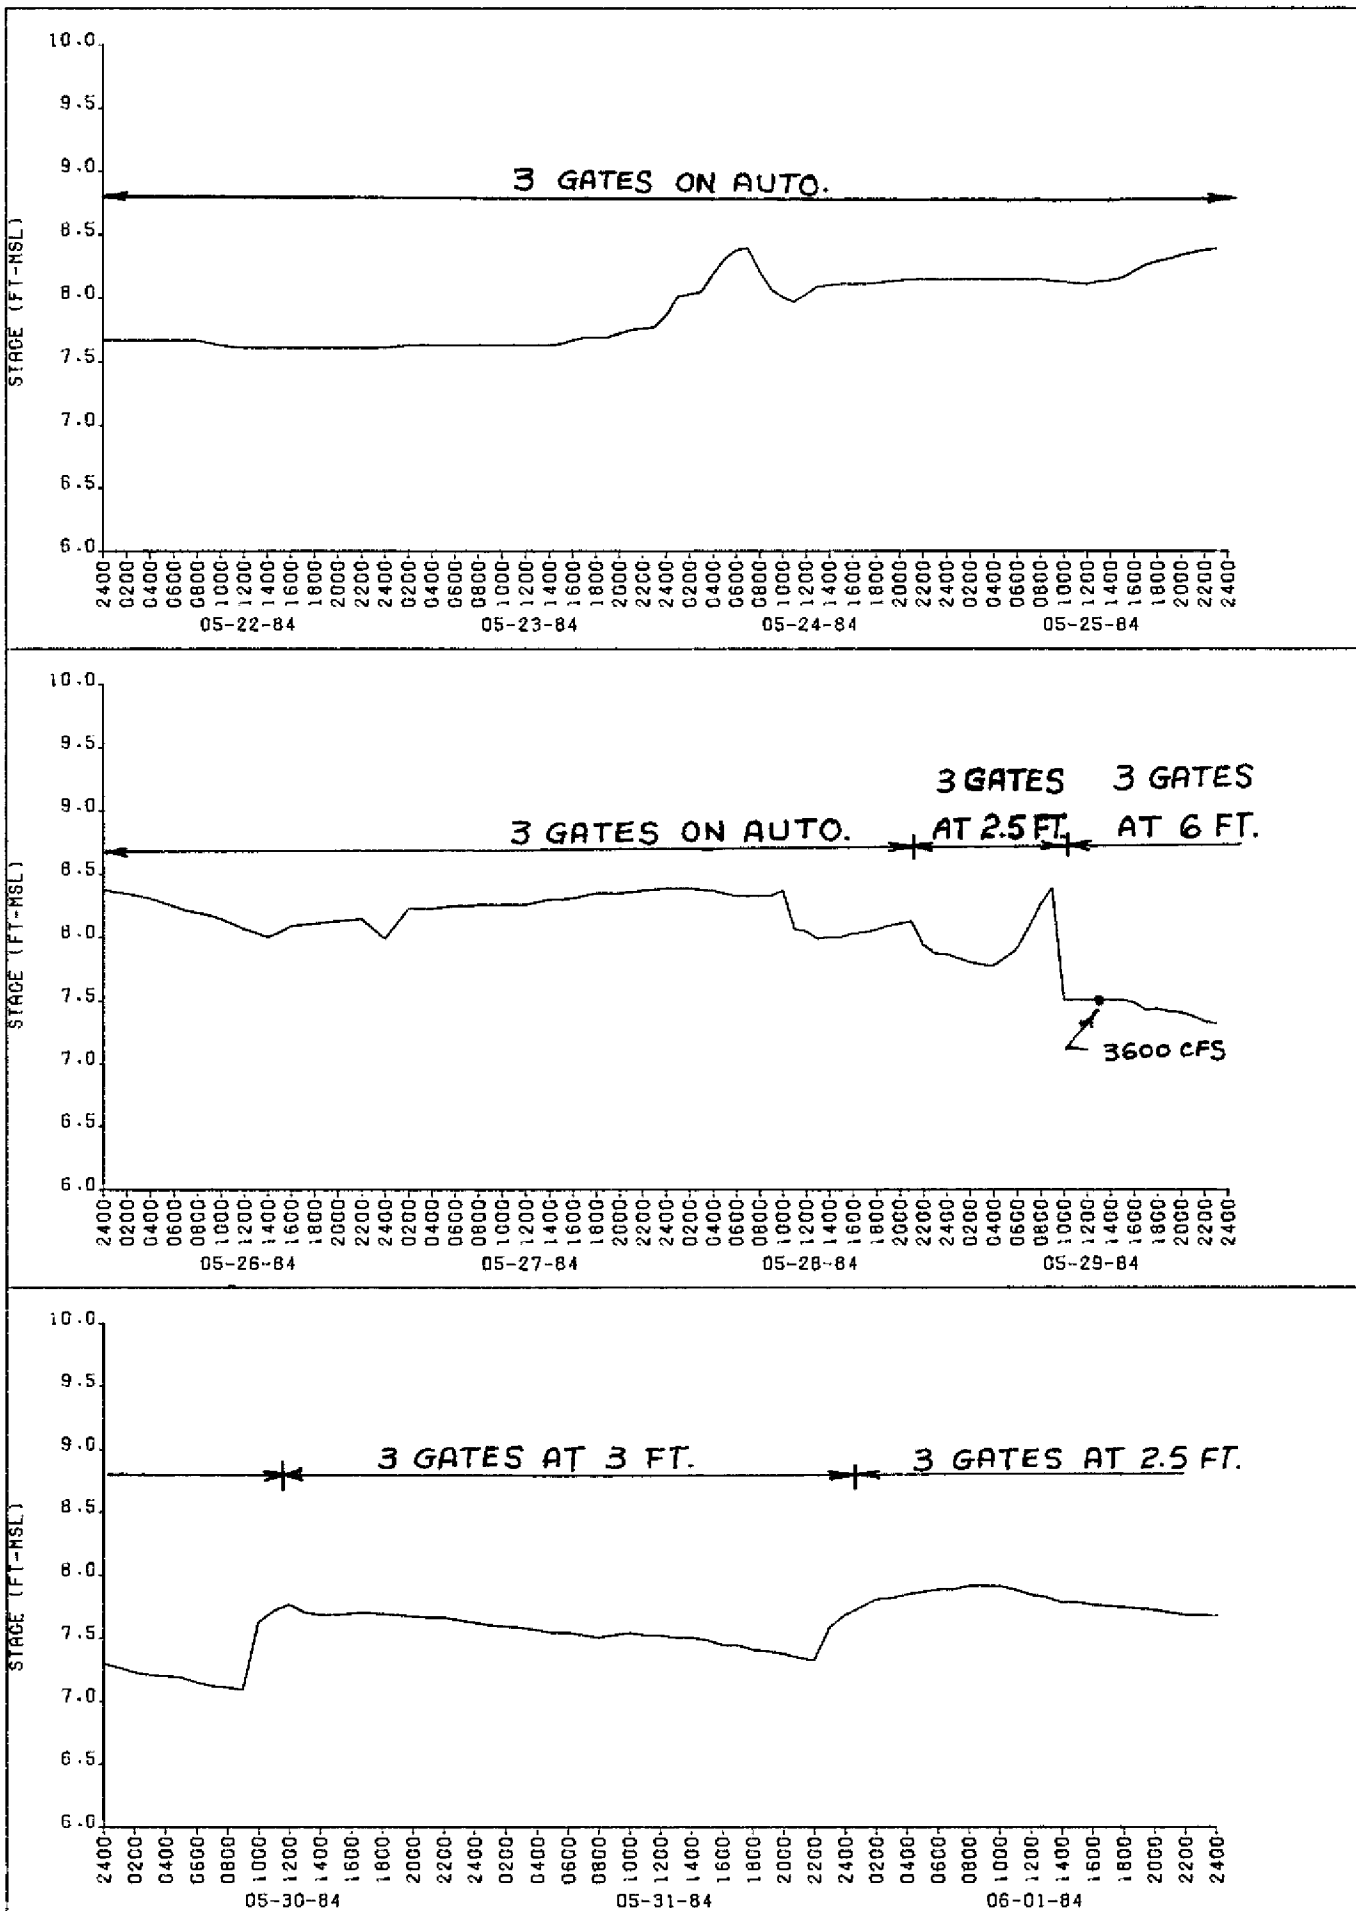
FIG. 11 HOURLY STAGE READINGS AT S-155

Because of the large amount of discharge through the new S-155 structure on the morning of May 30, erosion was found around the north bank of the site when a contractor removed the old Palm Beach Lock. The gates at S-155 were reduced to a 3 ft opening in order to prevent damage to private property.

The operation of the water control structures along the West Palm Beach Canal, and their hourly stage hydrographs, are presented in Figures 11, 12, 13, and 14, and Table 6.

1. 1330 - May 29 at the downstream site of S-155 by the U.S.G.S., total discharge was estimated to be 3600 cfs at a stage of 7.50 ft, three gates were open full.
2. 1430 - May 29 at Blue Trace Bridge by the District, total discharge was estimated to be 726 cfs.
3. 1500 - May 29 at Wellington Bridge, total discharge was estimated to be 1473 cfs at the stage of 15.05 ft NGVD.

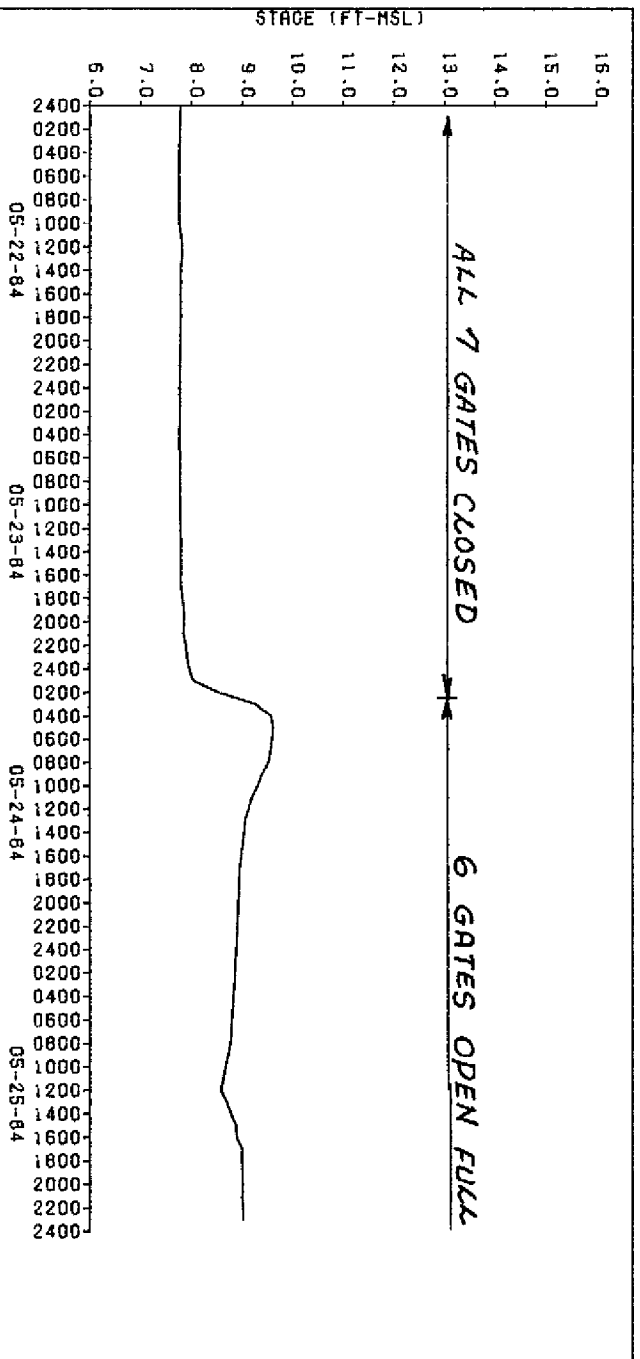
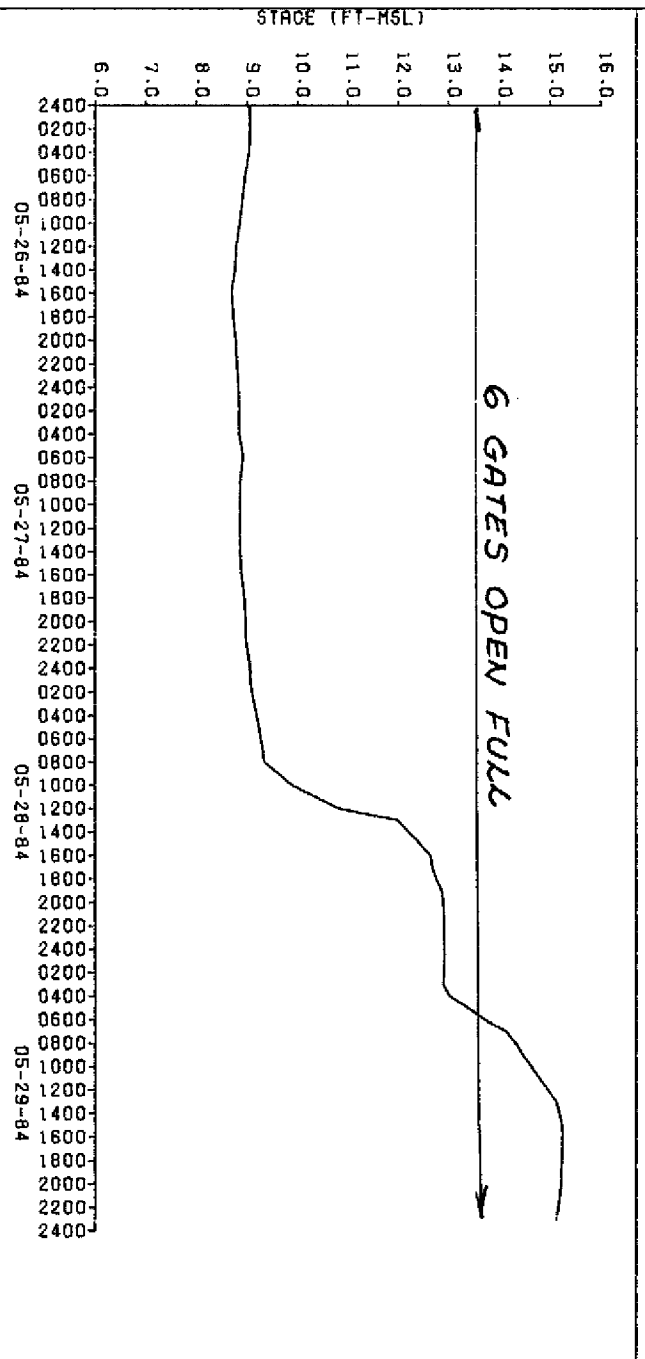
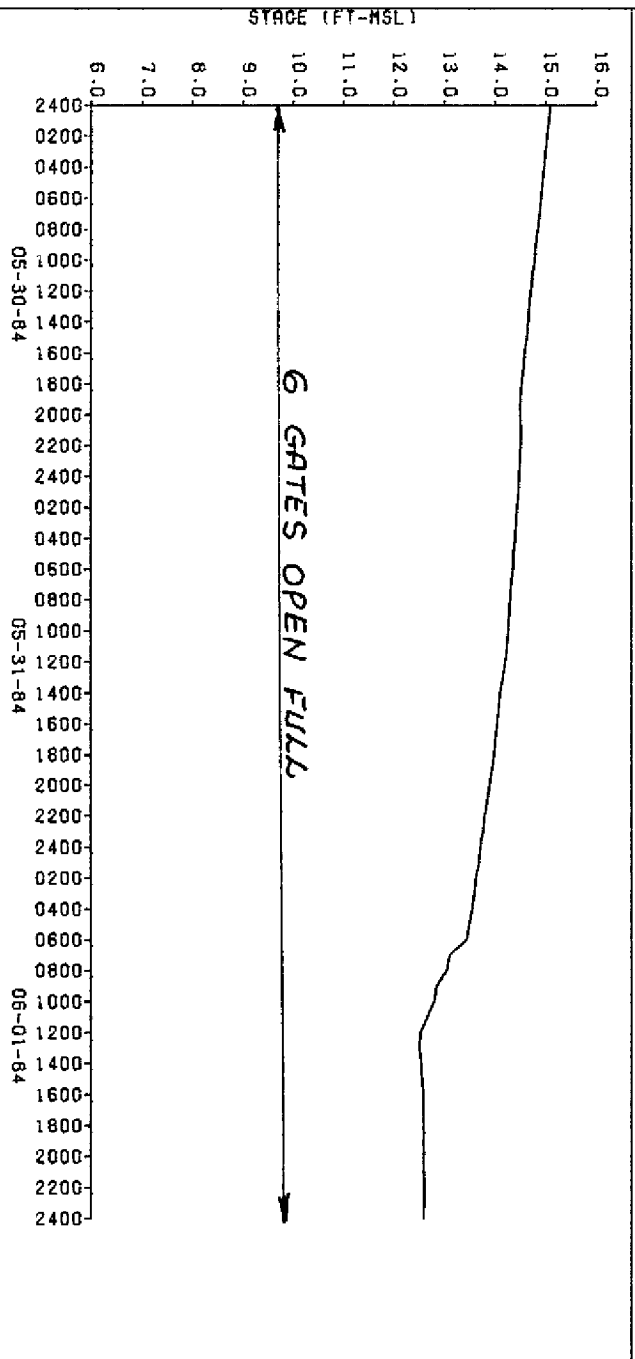
FIG. 12 HOURLY STAGE READINGS AT G-124

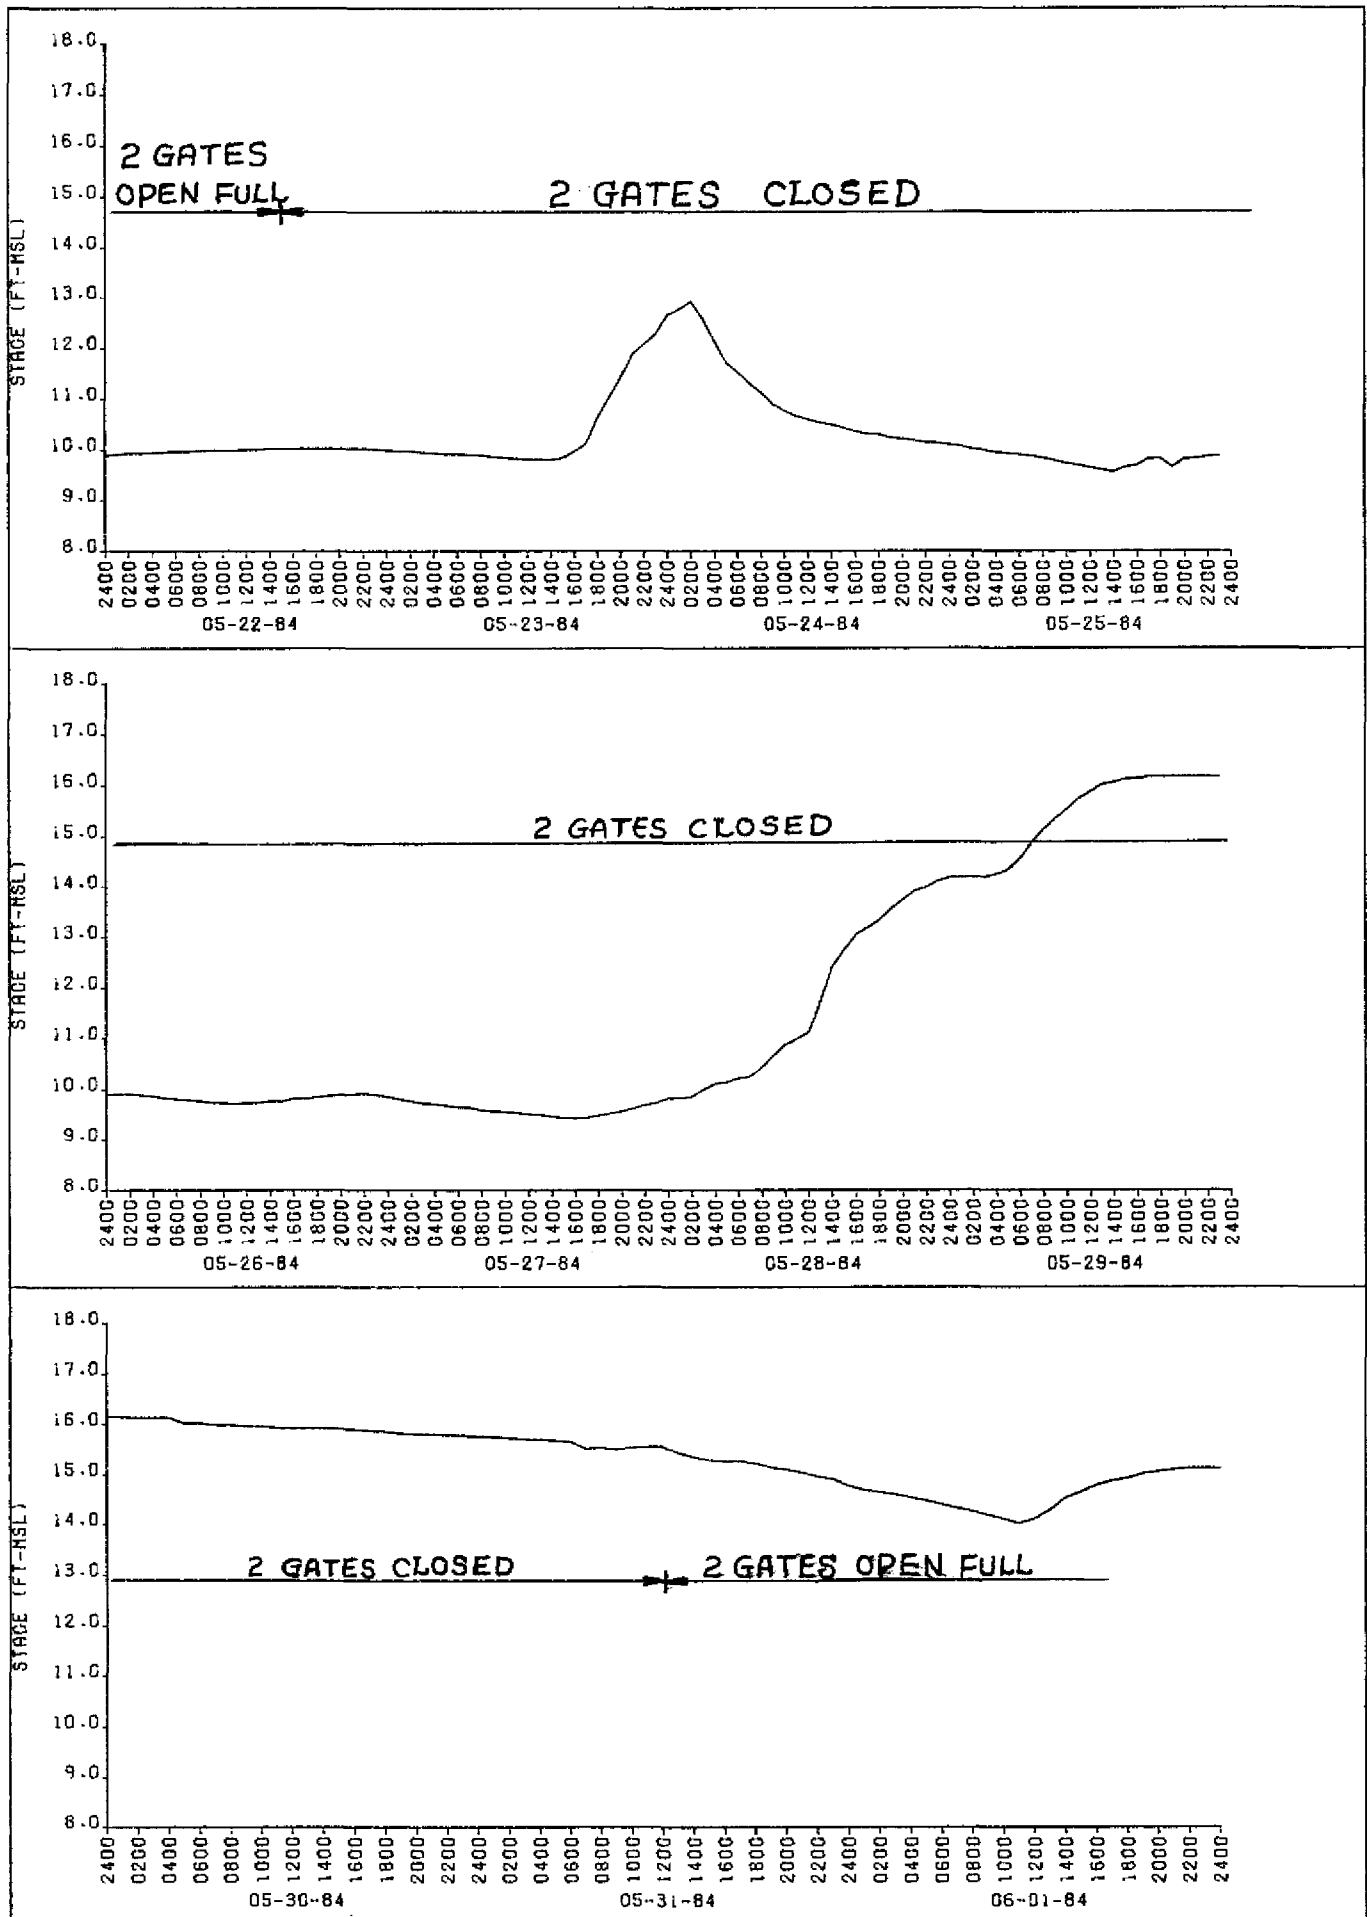
FIG. 13 HOURLY STAGE READINGS AT S-5AE

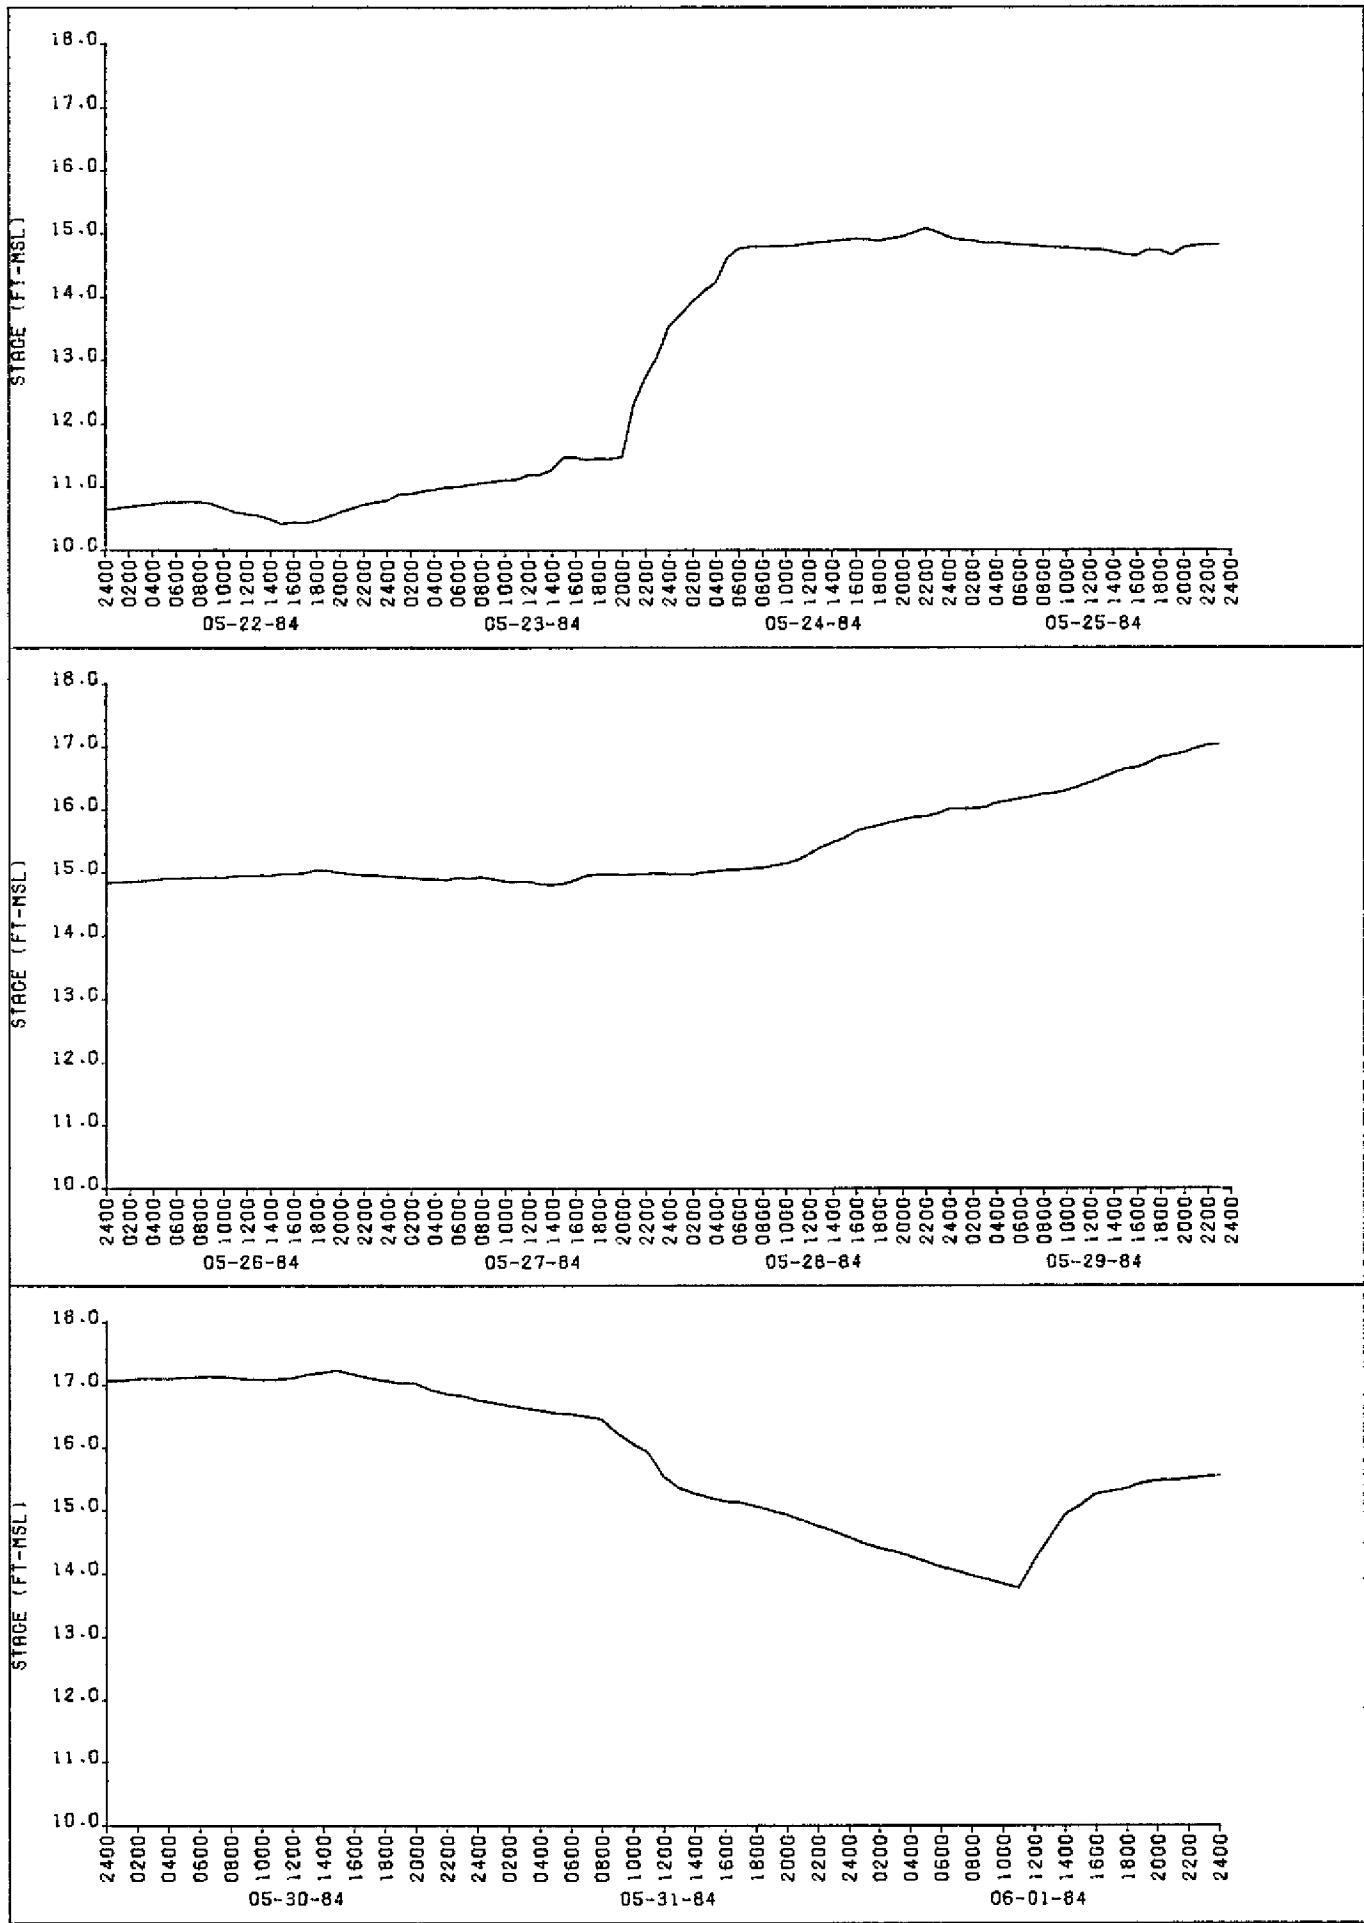
FIG. 14 HOURLY STAGE READINGS AT L-8
