**PRELIMINARY REPORT OF
RAINFALL EVENT, MAY 22-31, 1984
LOWER EAST COAST**

South Florida Water Management District

June 1984

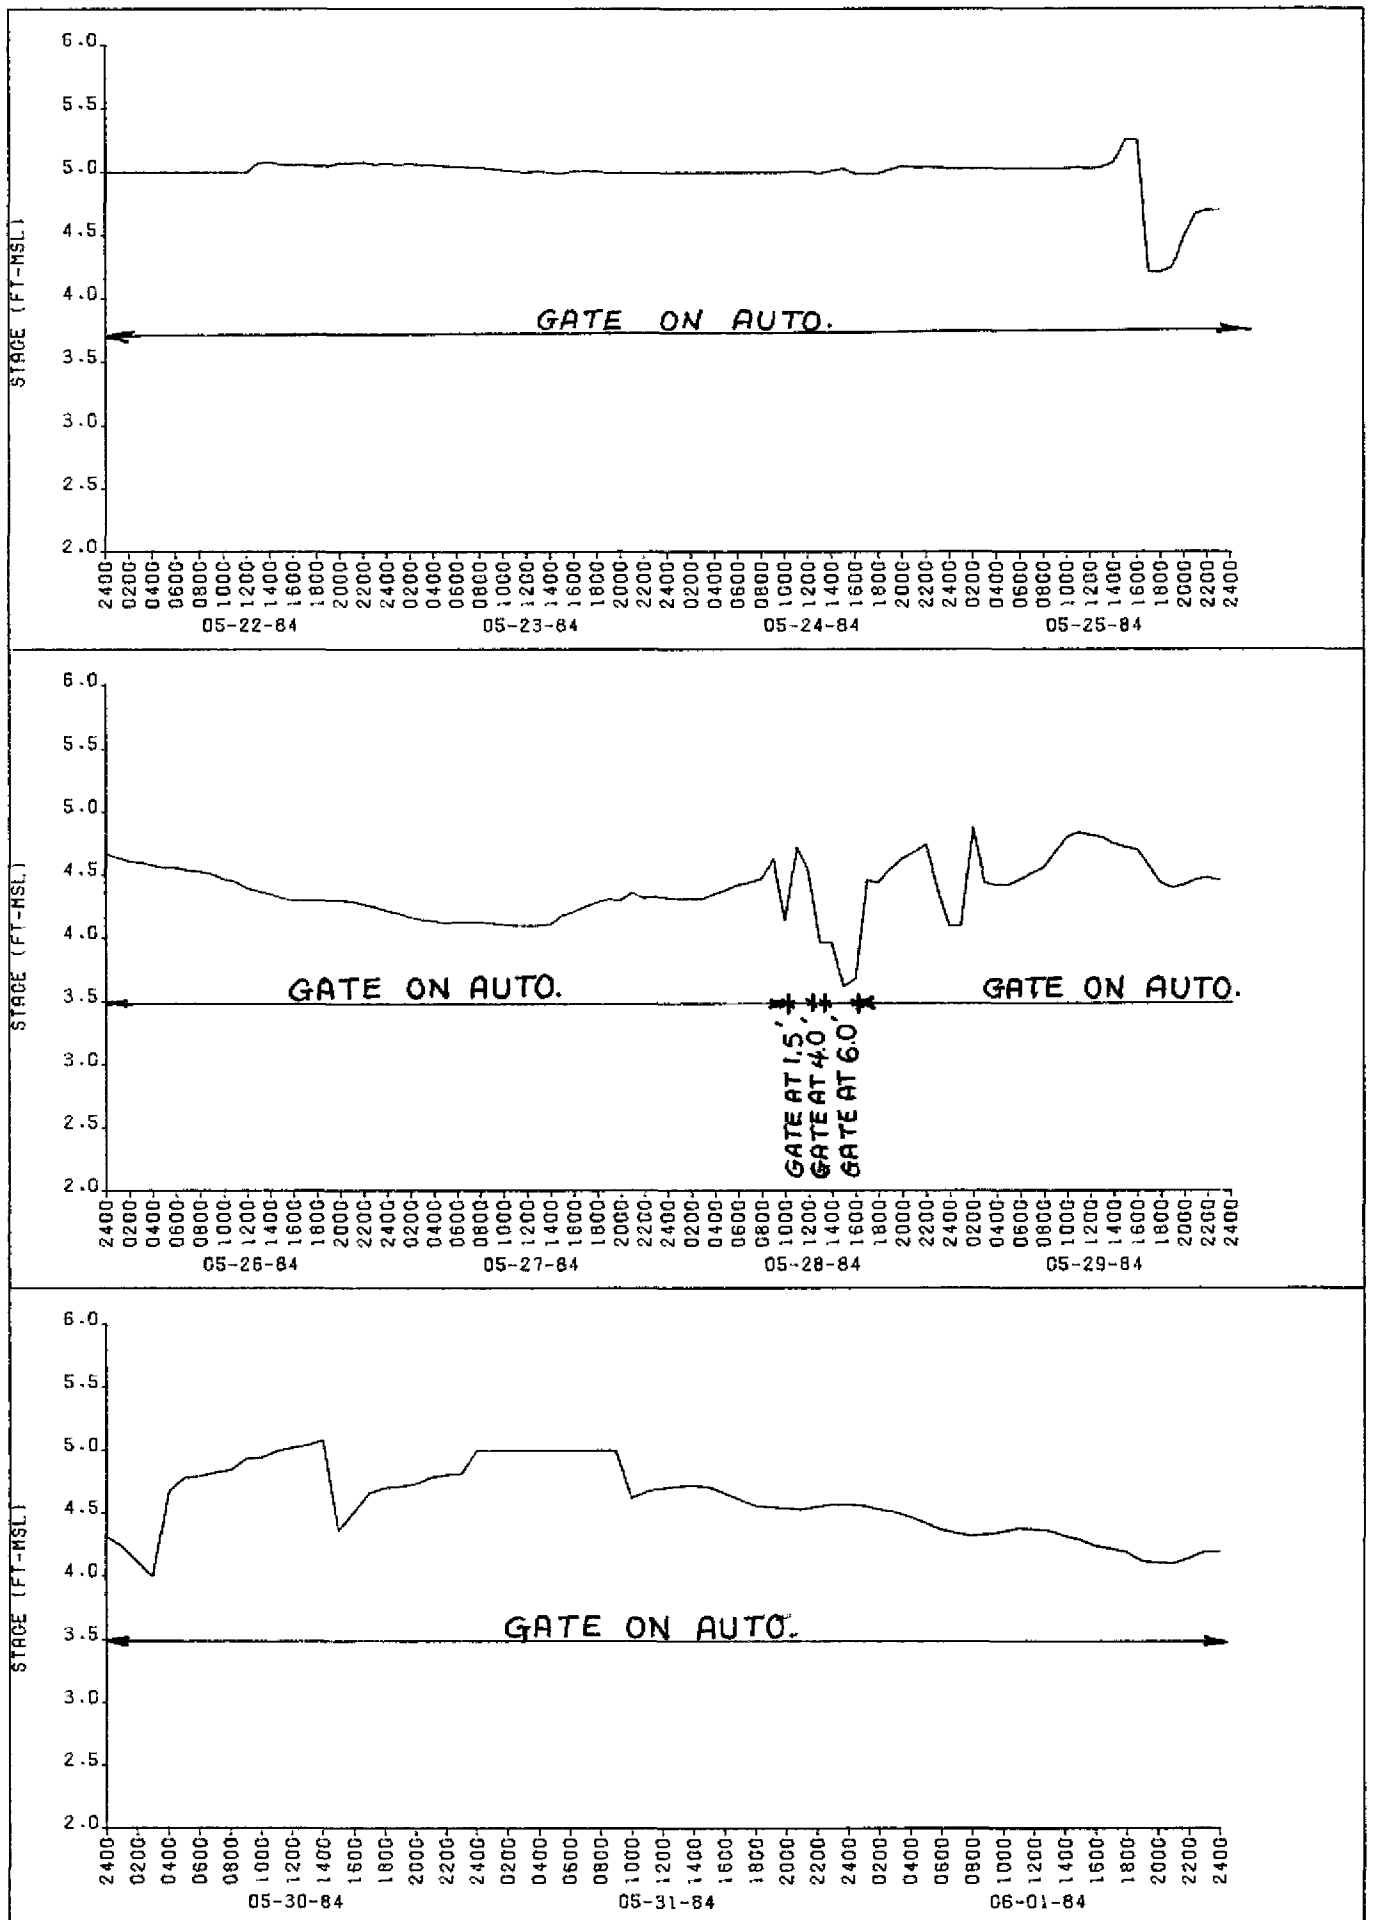
FIG. 15 HOURLY STAGE READINGS AT S-36 HW

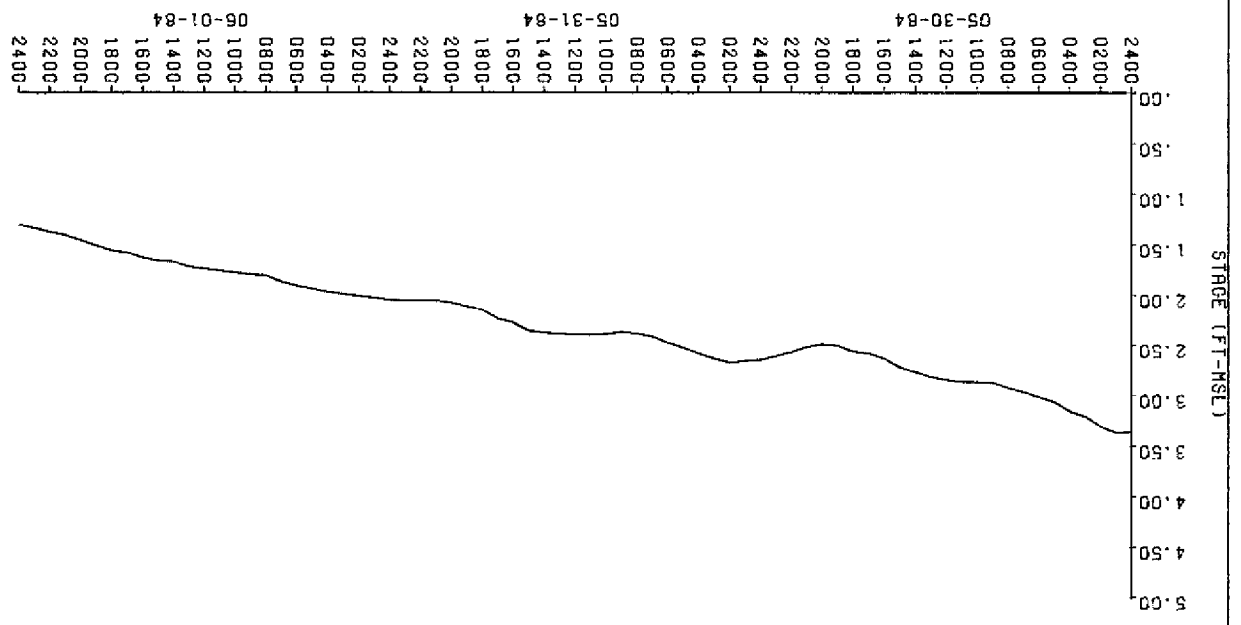
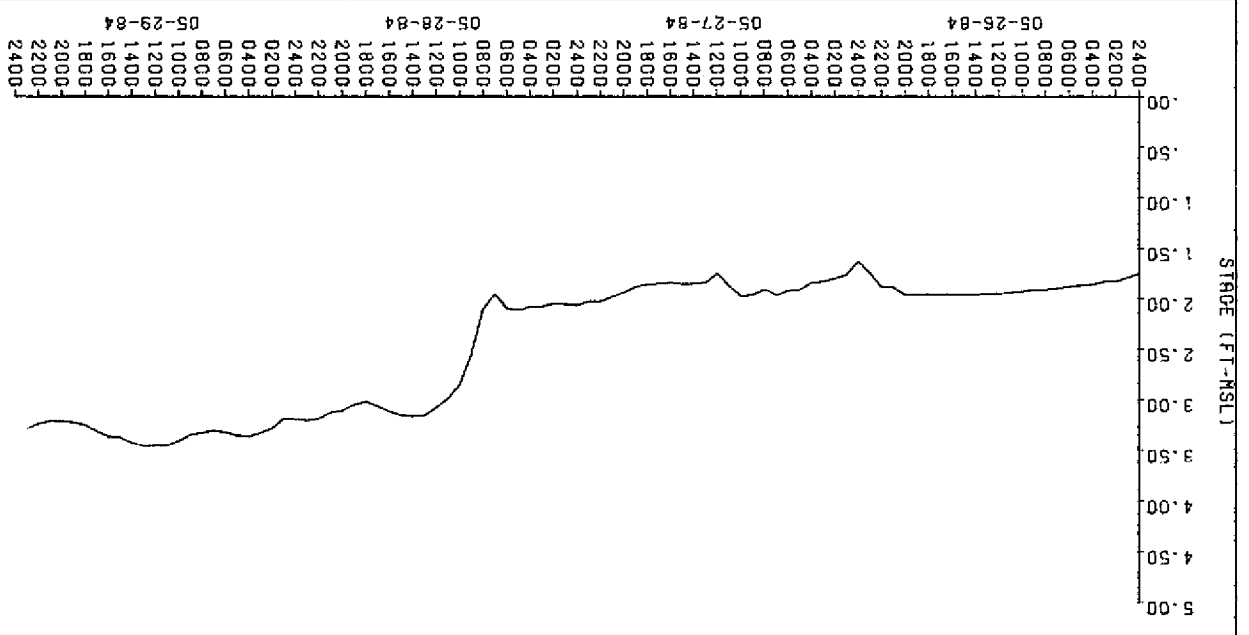
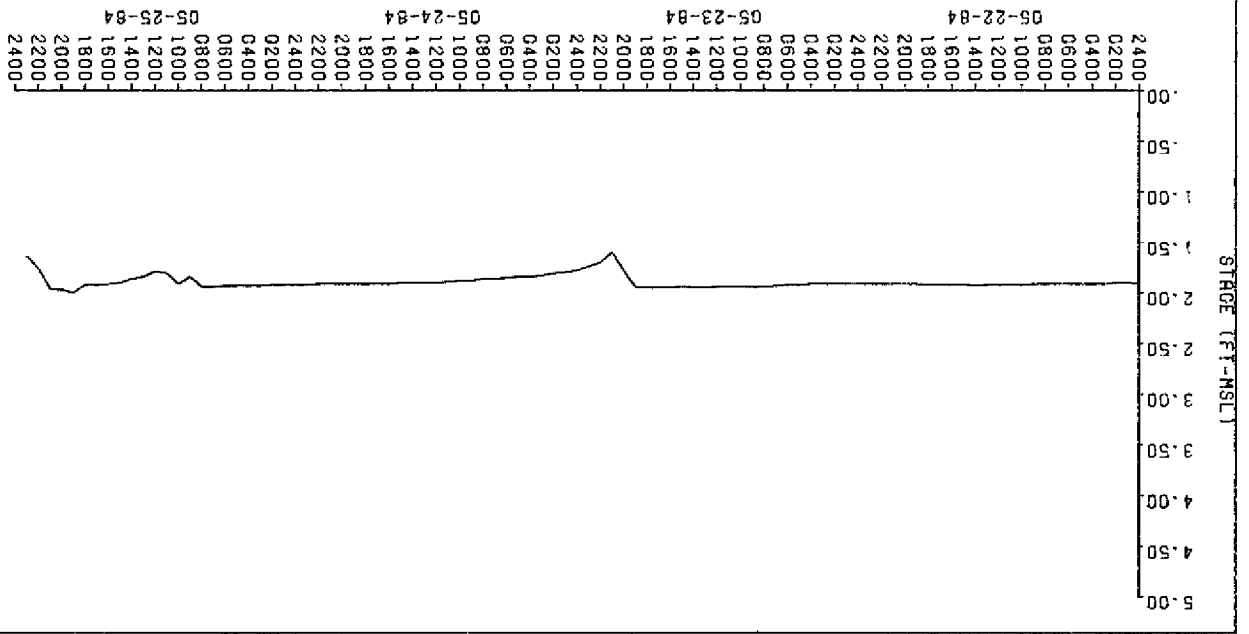
FIG. 16 HOURLY STAGE READINGS AT S-13A TM

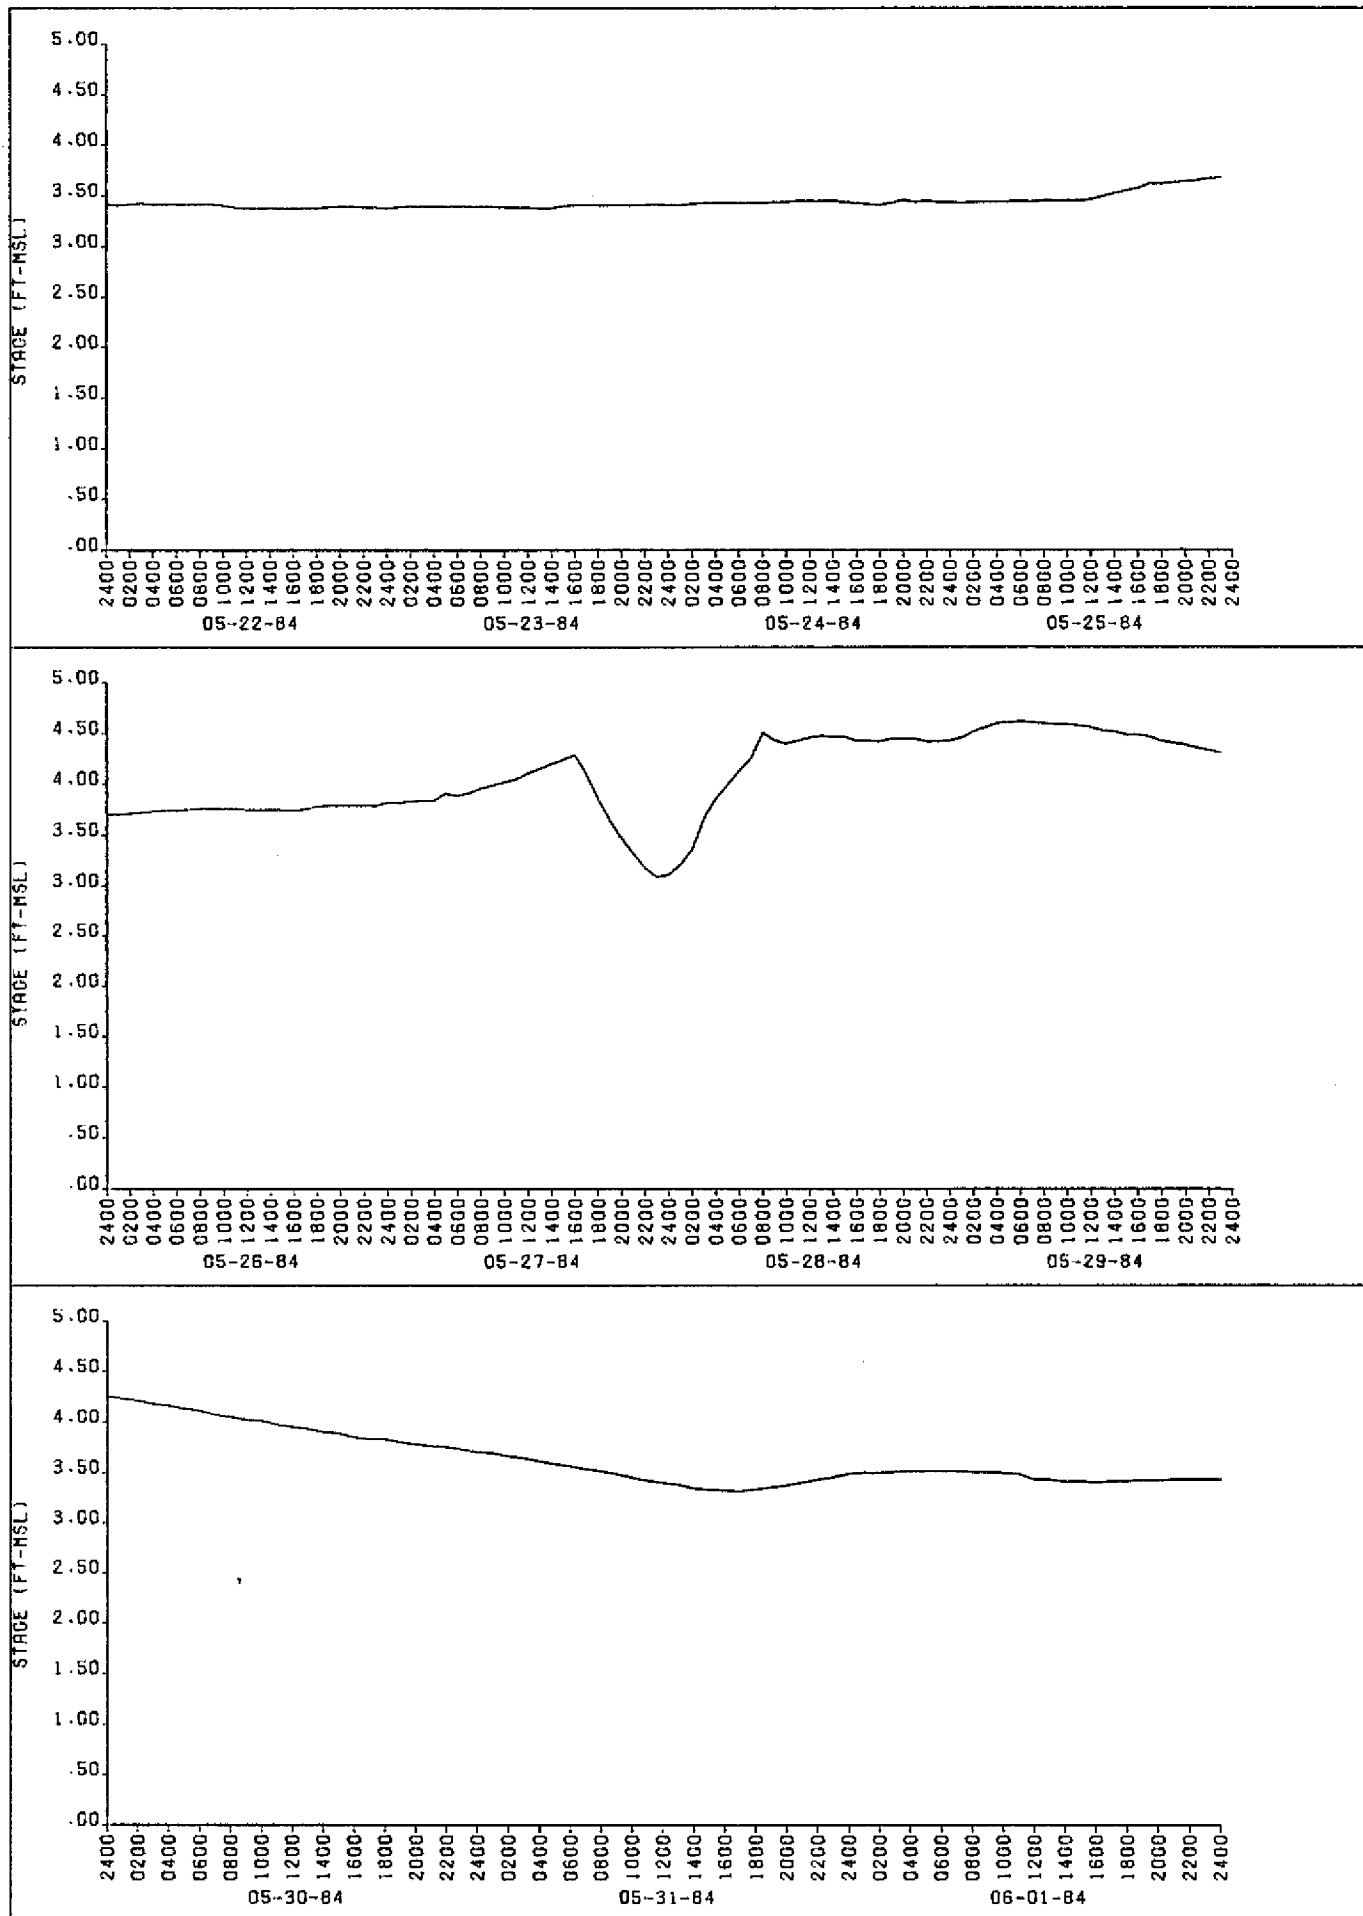
FIG. 17 HOURLY STAGE READINGS AT S-13A HW

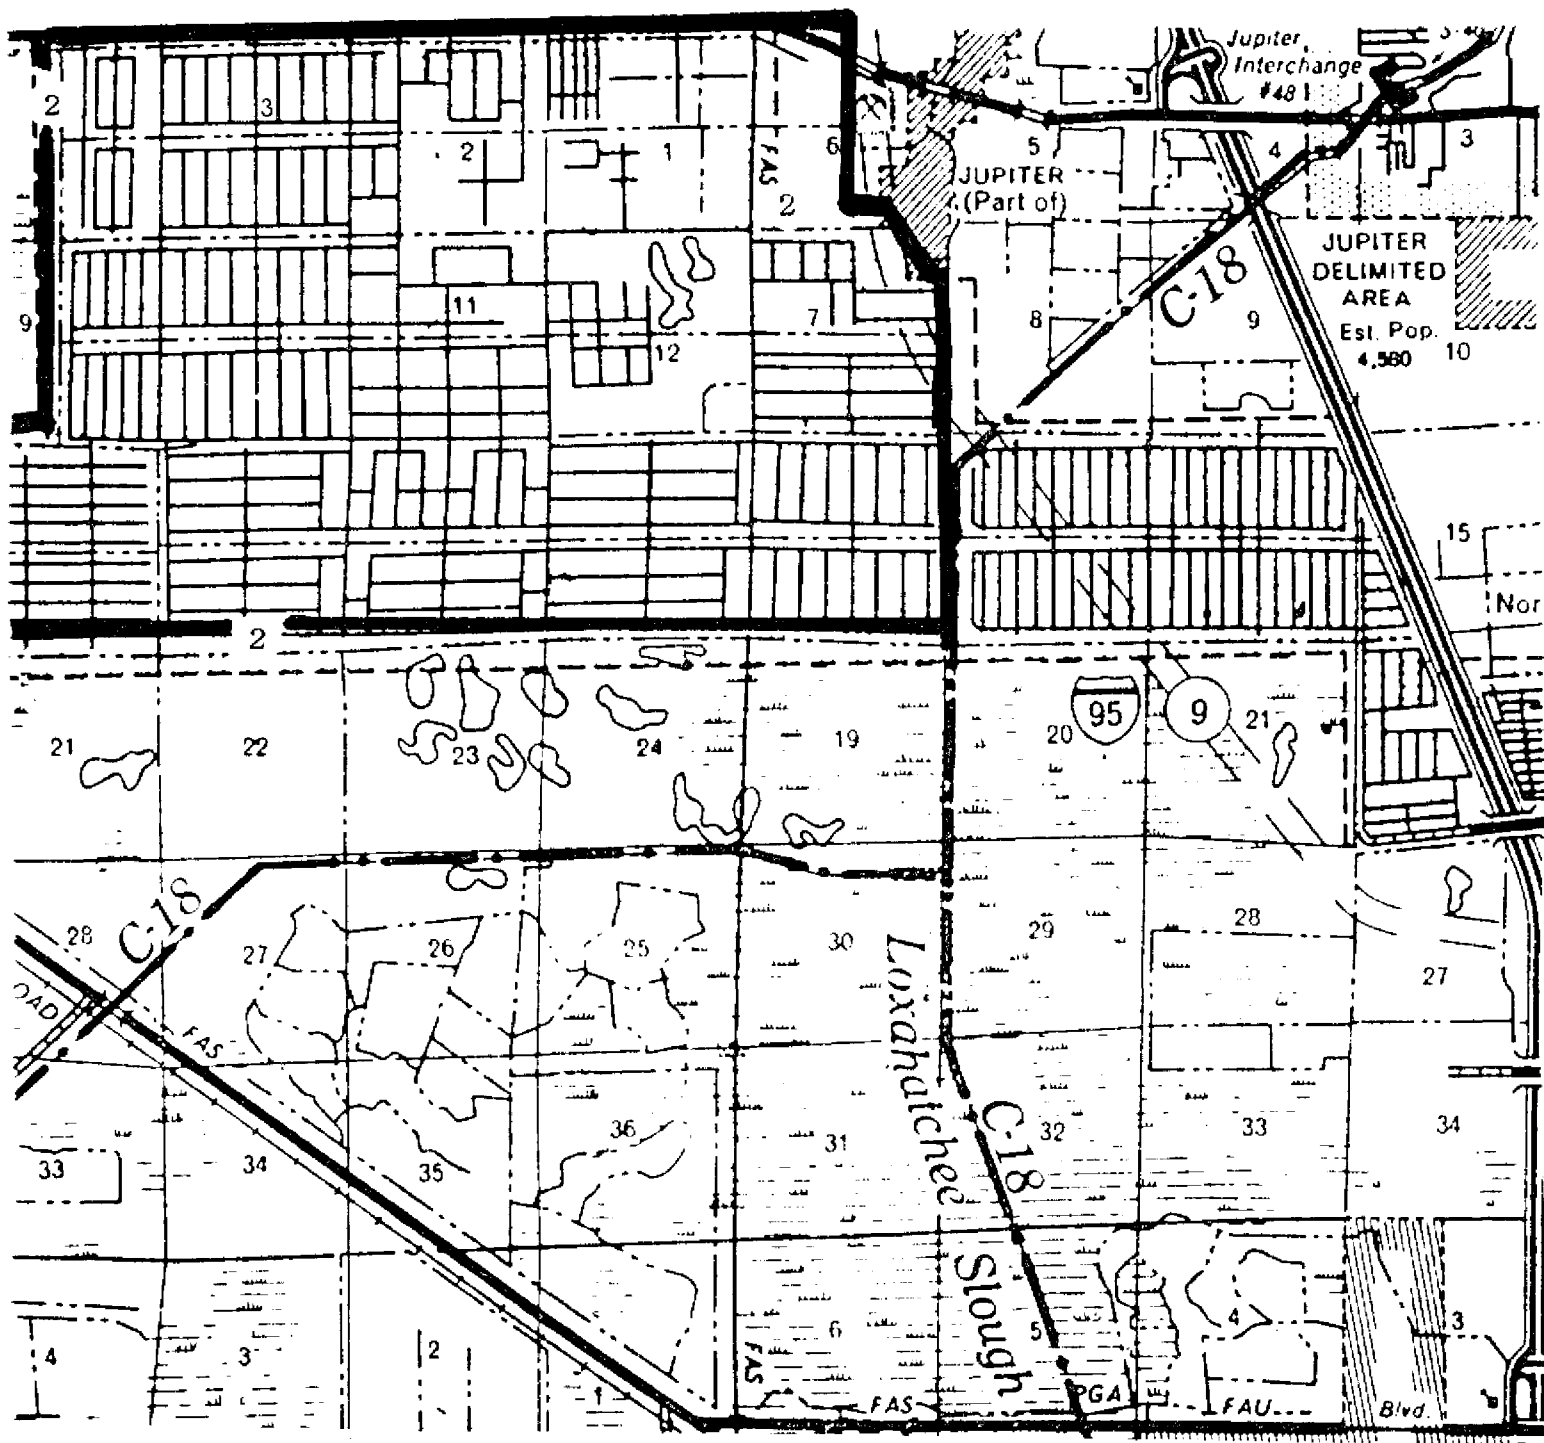
FIGURE 19
Jupiter-West Basin

2) Outline of the area known as Jupiter Farms.

This area had road and minor lot flooding of a short duration.

Jupiter Farms, a rural housing development within this basin, was inspected May 29. This area has drainage provided by the South Indian River Water Control District. Residents within Jupiter Farms experienced road flooding and lot inundation of short duration. Road and lot flooding was limited to an inconvenience level. House flooding was not reported or observed.
