Kissimmee River Restoration Studies

Establishing a Baseline: Pre-restoration Studies
of the Channelized Kissimmee River

Defining Success: Expectations for Restoration
of the Kissimmee River

South Florida Water Management District

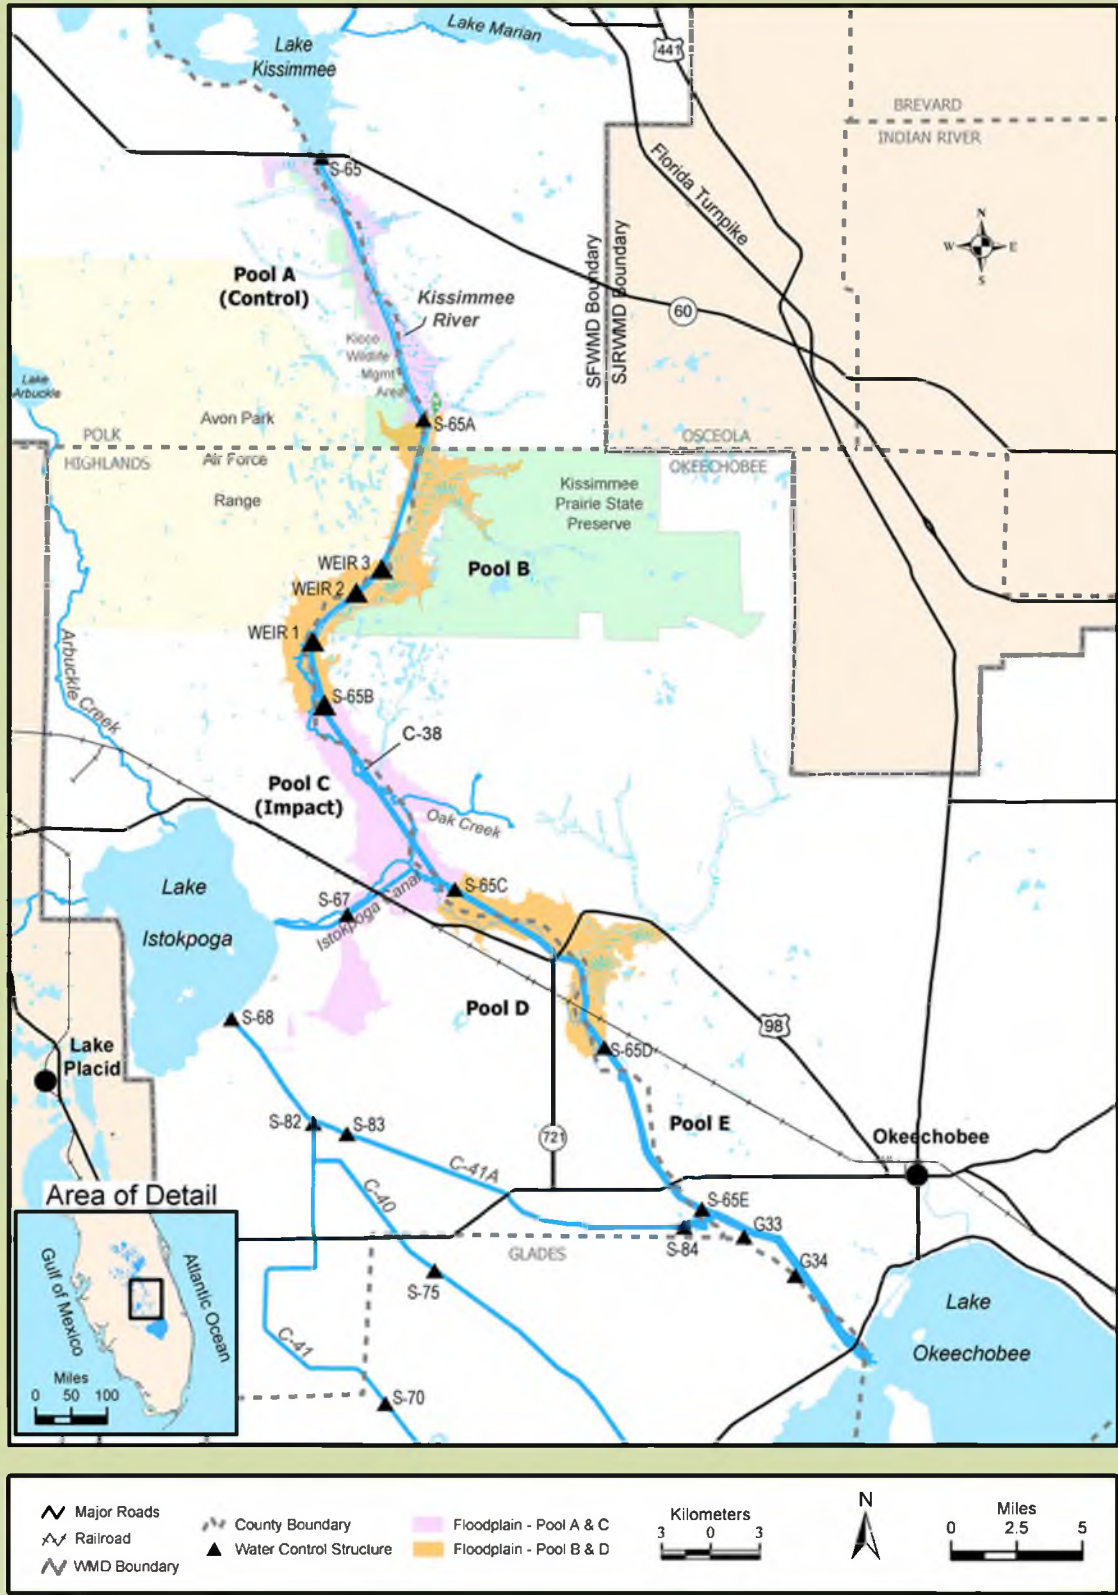
Figure 1. Location of the Kissimmee River in Florida. The C-38 canal cuts through the floodplain and intercepts the meandering river channel. The channelized system includes the floodplain, remnant river channels and the C-38 canal. The canal is divided into a series of five impounded pools (Pools A-E) by six water control structures (S-65 to S-65E). The Upper Chain of Lakes through Lake Kissimmee provides water to the Kissimmee River, which discharges into Lake Okeechobee.

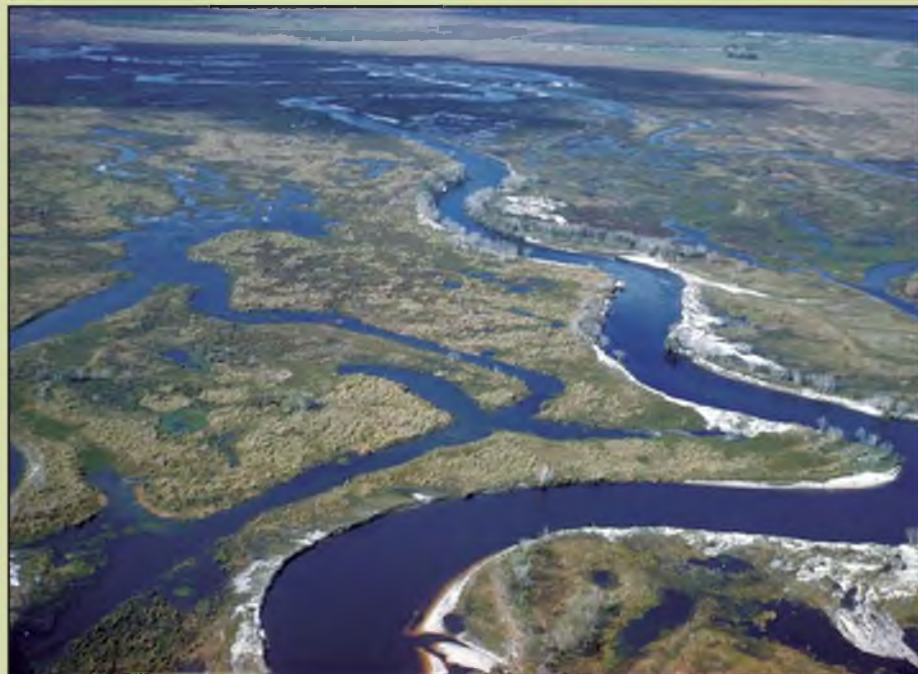
PRIOR TO CHANNELIZATION

Figure 2. Photographs of the Kissimmee River prior to channelization and after channelization.

- Prior to channelization, the Kissimmee River seasonally overflowed its banks, flooding its broad floodplain.
- This “flood pulse” supported a diverse wetland ecosystem that provided habitat for abundant populations of invertebrates, fish, birds, and other animals.
- Water was conveyed downstream by both the river channel, and, when inundated, the floodplain.

These changes converted the meandering river into the 56-mile (90 kilometer) long, 30-foot (9 meter) deep, and 90-300 foot (27-91 meters) wide canal called C-38 (Figure 2). The canal cut through the natural meanders of the original river channel, intercepting virtually all flow from the river and floodplain, leaving the disconnected remnant channels on both sides of the canal without flow, and the floodplain without natural seasonal inundation. The water control structures were designed to regulate flow of water through the canal and to keep water levels constant within each pool. Collectively, these modifications to the river are referred to in this document as channelization. The resulting floodplain, remnant river channels, and the C-38 canal are collectively referred to as the channelized system.

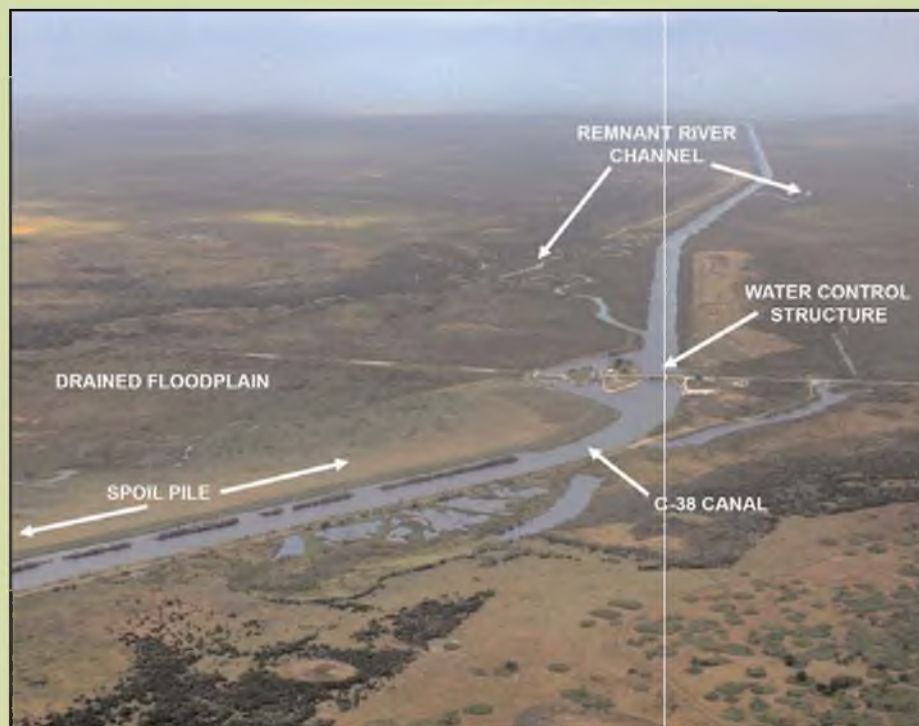
AFTER CHANNELIZATION

- Channelization of the Kissimmee River involved the excavation of canal C-38 and installation of water control structures that divided the canal into five pools.
- The canal cut through the natural meanders of the original river channel, intercepting all flow from the river and floodplain, and leaving the remnant channels on both sides of the canal without flow and the floodplain without seasonal flooding.
- Although these remnant channels contained water, they were stagnant.
- Drier conditions over much of the floodplain resulted in former wetland plant communities converting to upland communities within a few years.

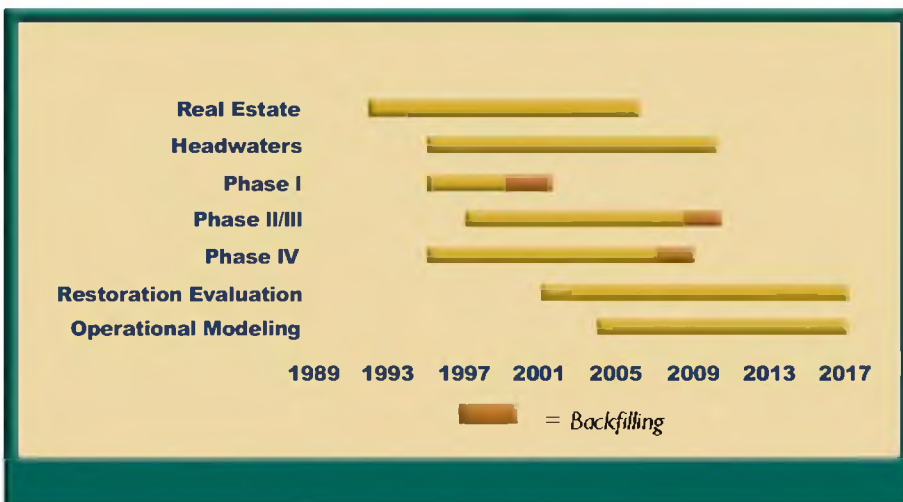
Figure 3. Projected timeline for major components of the Kissimmee River Restoration Project, including real estate acquisition, headwaters revitalization, Phases I through IV of backfilling and construction, restoration evaluation, and operational modeling.

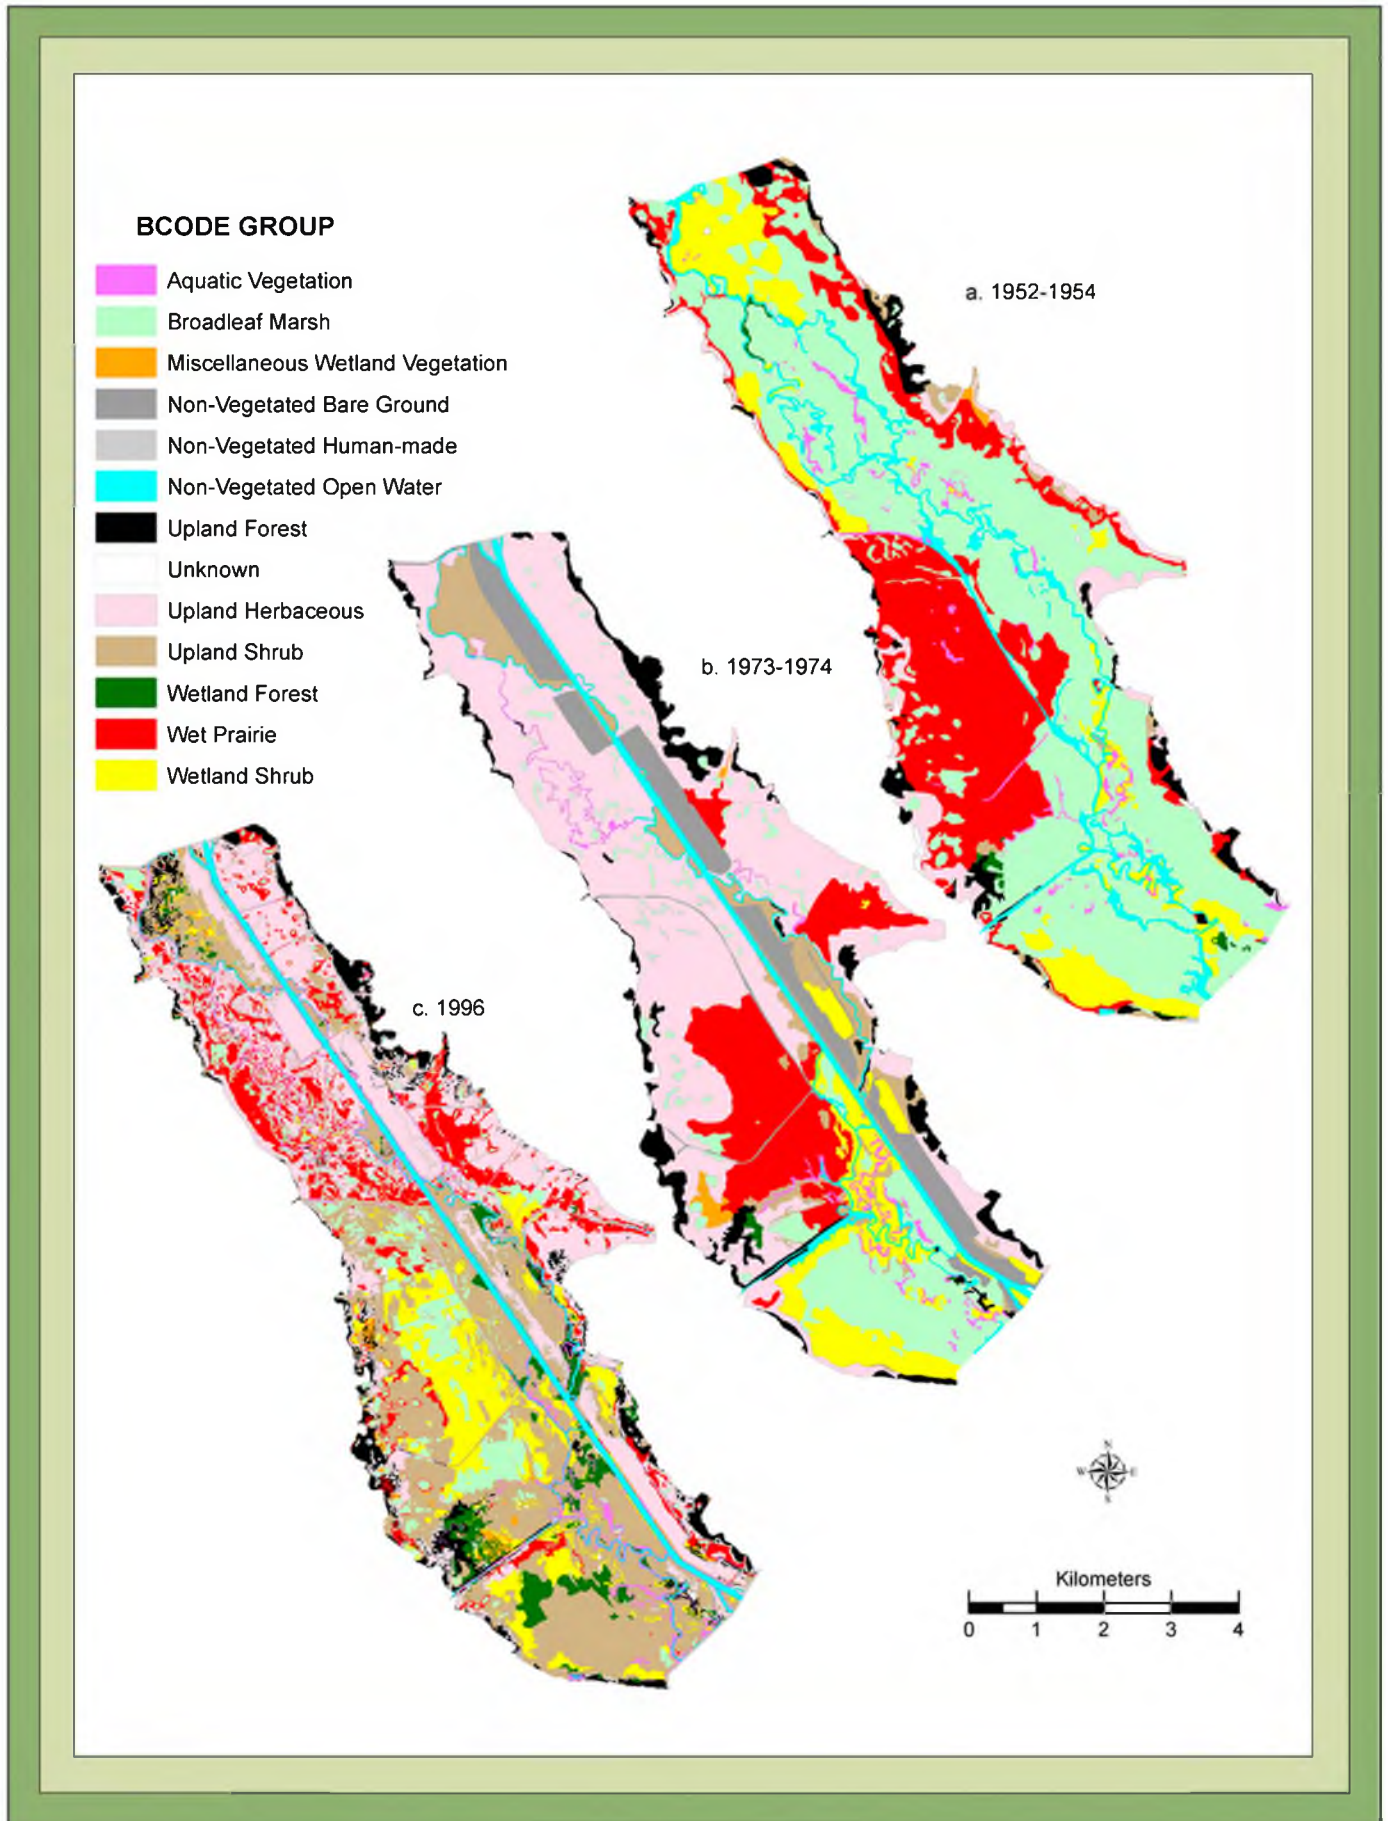
Figure 4. Vegetation maps of Pool C: (a) 1952-1954 (pre-channelization, reference period) (data from Pierce et al. 1982); (b) 1973-1974 (early post-channelization) (data from Milleson et al. 1980); and (c) 1996 (post-channelization, baseline period).

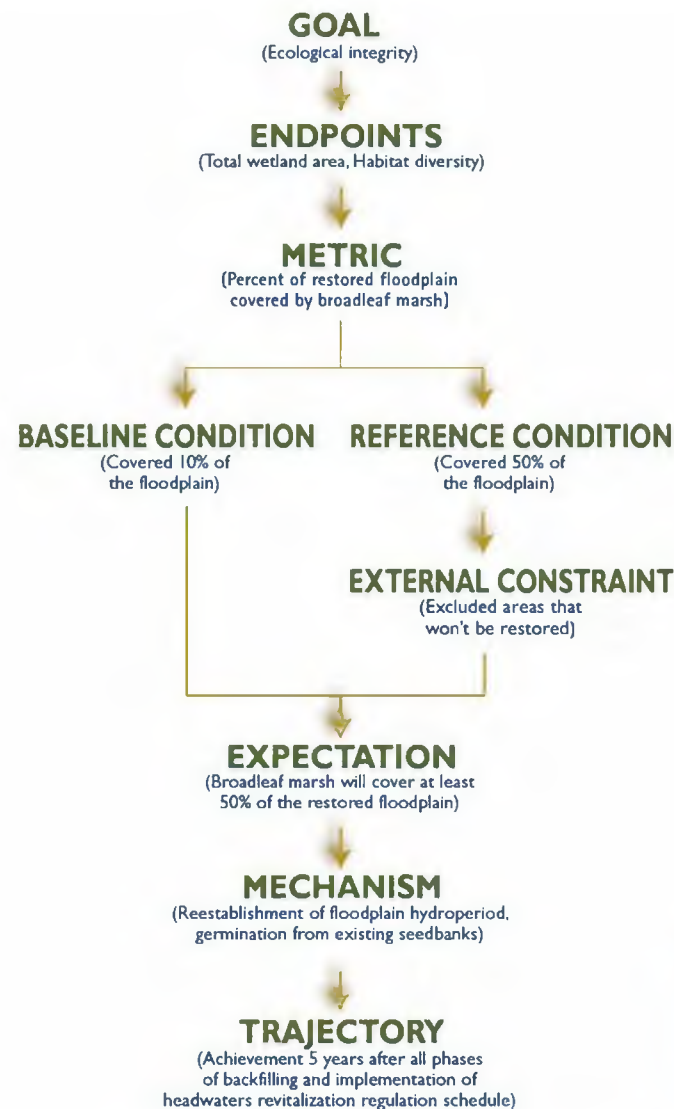
Figure 5. Process or sequence of steps for developing a restoration expectation for Kissimmee River Restoration Project. Parentheses contain examples based on Expectation 13 for Areal Coverage of Broadleaf Marsh.

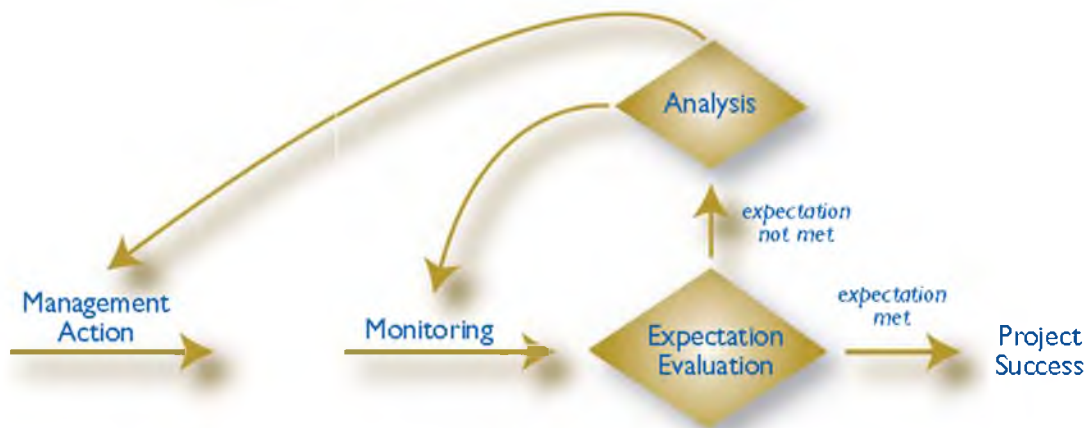
Figure 6. Adaptive management is an iterative process that involves monitoring, evaluating expectations, and analysis to determine if monitoring should be continued, modified, or terminated; and whether management actions need to also be modified to achieve project success.

Evaluation of the restoration expectations will provide feedback for adaptive management by indicating whether particular attributes are recovering to the predicted state within the specified appropriate time frame (Figure 6). Slower recovery of an attribute can serve as a trigger for analysis to determine why the response is occurring more slowly than anticipated and whether monitoring should be continued or modified. Such analyses would also consider if modifications to management actions, such as fine tuning of flow regimes, are necessary to facilitate recovery. Alternatively, these analyses may also lead to reevaluation of expectations.

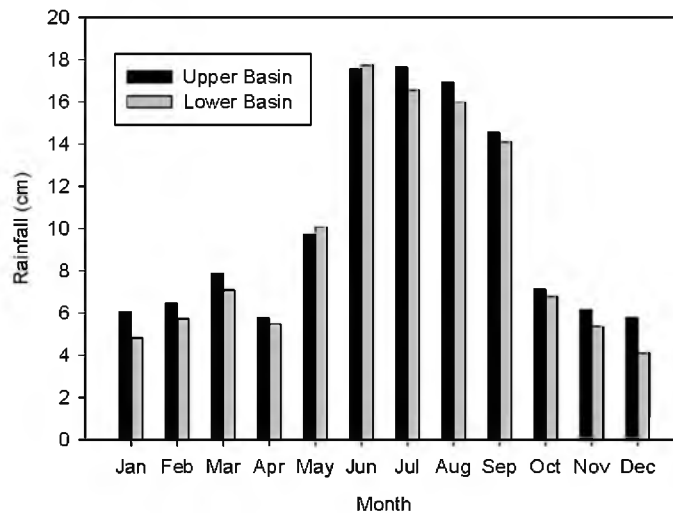
Figure 1-2. Average monthly rainfall in the upper and lower Kissimmee Basins (1971-2000).

The regional climate is humid sub-tropical, with nearly equal-length wet and dry seasons and an average yearly rainfall of 121 and 114 cm in the upper and lower basins, respectively (Figure 1-2). Air temperature ranges from 5° C to 30° C (Figure 1-3). Soils of the lower Kissimmee basin consist mostly of the Manatee-Delray-Okeelanta soil association (McCollum and Pendleton 1971). These soils typically have a surface layer high in organic matter content overlying mineral subsoil (Toth et al. 1995).

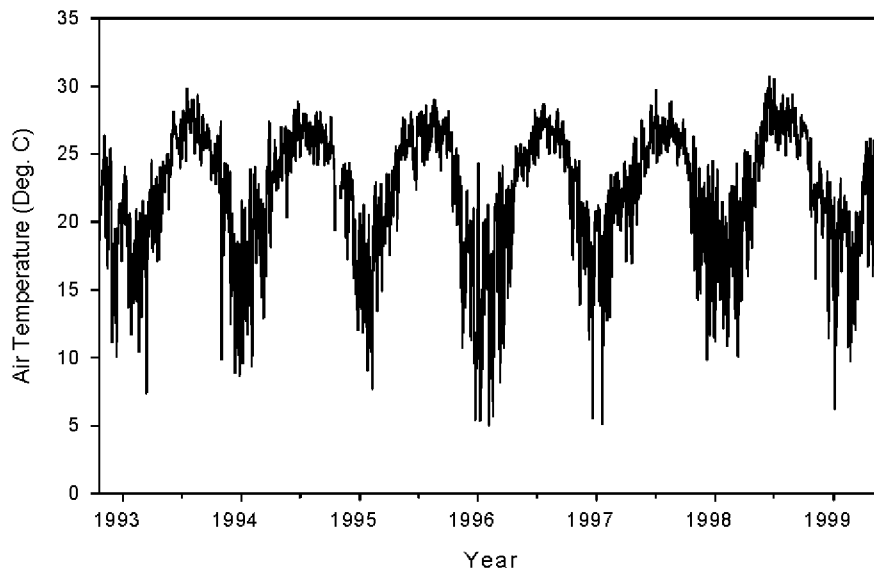
Figure 1-3. Mean daily temperature at water control structure S-65C from October 1992 - June 1999 (SFWMD DBHYDRO Database).

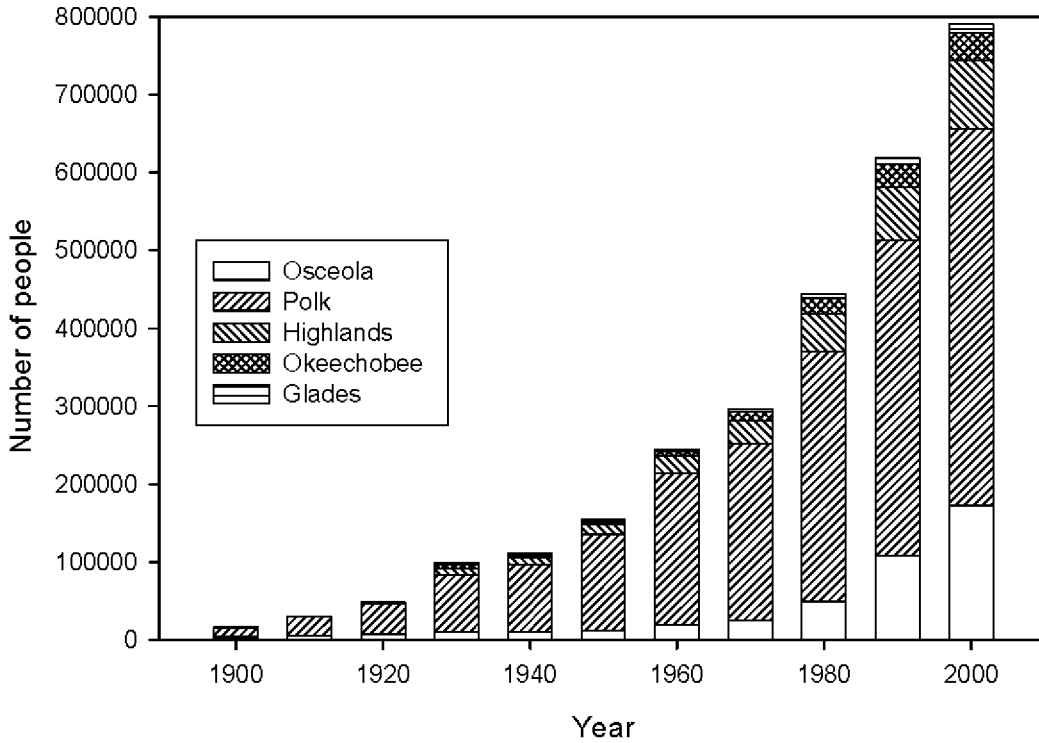
Figure 1-4. Population size for five counties that overlap the Kissimmee Basin. Population estimates were obtained from the State of Florida web page.

rates (Harris et al. 1995). Other impacts on the Kissimmee River Basin that may or may not be related to channelization include an increase in human population growth (Figure 1-4); changes in land use (South Florida Water Management District 2000); and invasion by exotic species of plants, fish, birds, and invertebrates (Ferriter et al. in press).

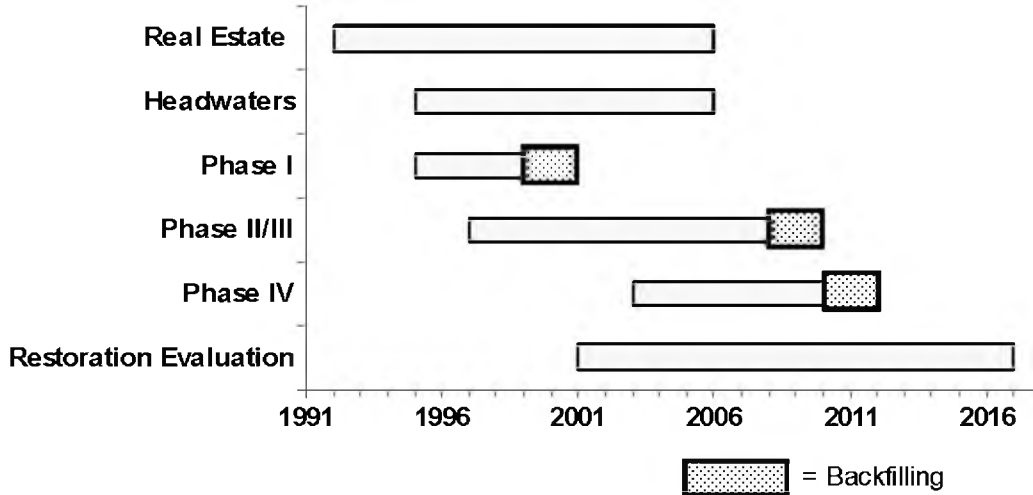
Figure 1-5. Timeline for completing major components of the KRRP including real estate acquisition, headwaters revitalization, Phases I through IV of backfilling and construction, and restoration evaluation.

most of Pool C. Phase II/III will remove S-65C, and will backfill the remainder of Pool C and most of Pool D. Phase IV, which will backfill a section of Pool B north of the Phase I area, is scheduled for completion in 2012. The new headwaters regulation schedule will be implemented following completion of KRRP/Headwaters, which is scheduled for 2010 (Figure 1-5).

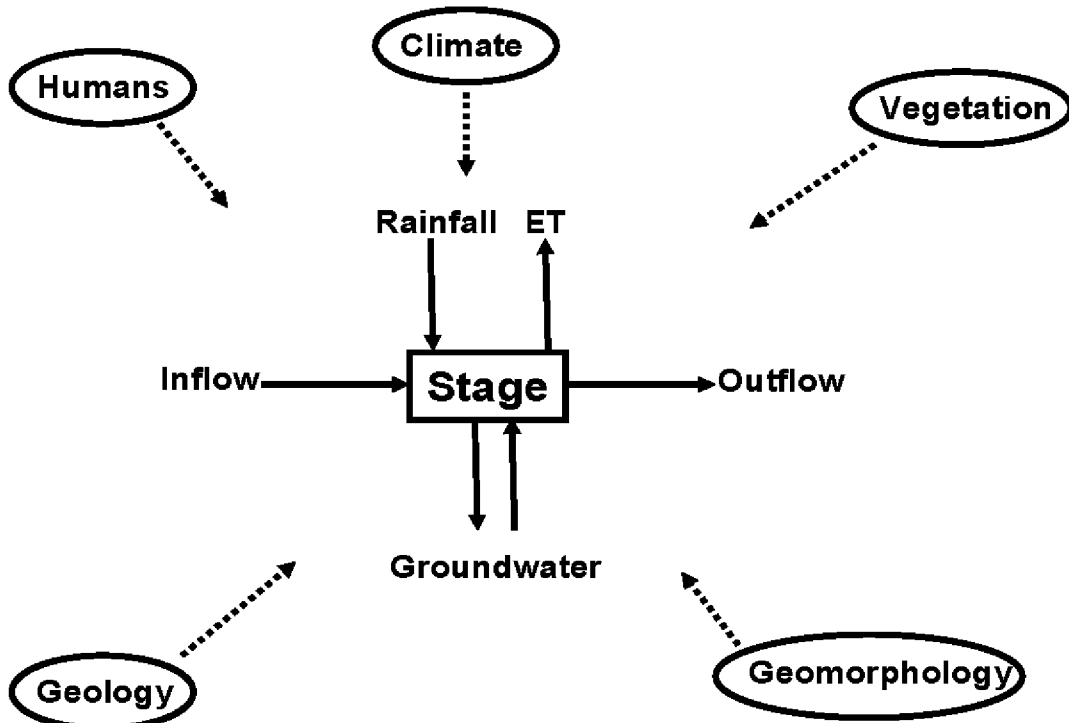
Figure 2-1. Conceptual model for hydrology in the Kissimmee River. The box represents a single compartment for water storage indicated by stage. Solid arrows represent fluxes into and out of the compartment. Ovals and dashed arrows represent system drivers.

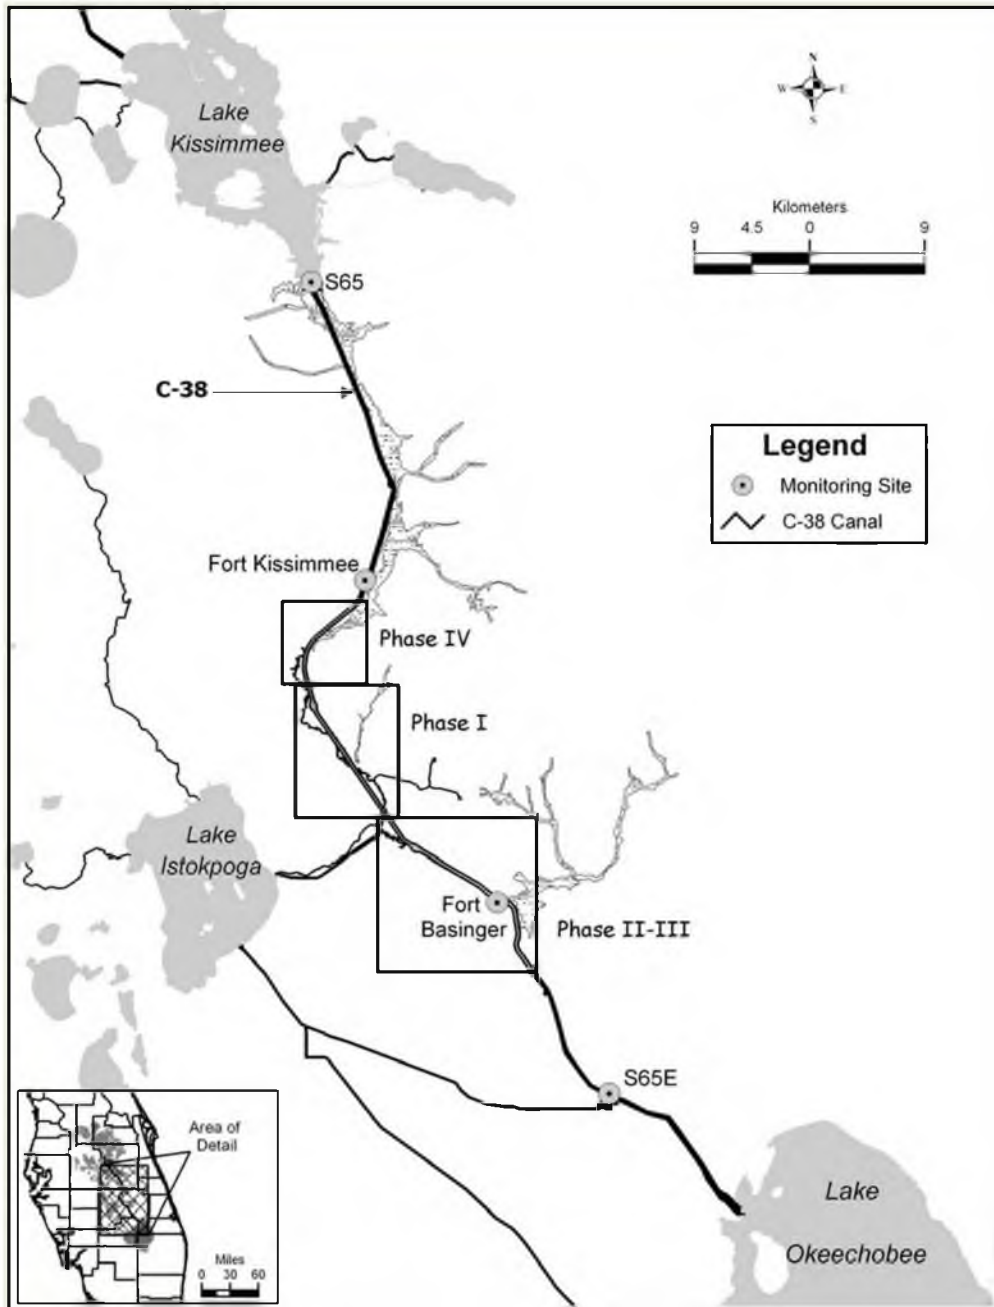
Figure 2-2. Map of the Kissimmee River showing the locations of pre-channelization hydrologic monitoring sites. Rectangles identify the reaches of the river affected by each phase of the restoration project.

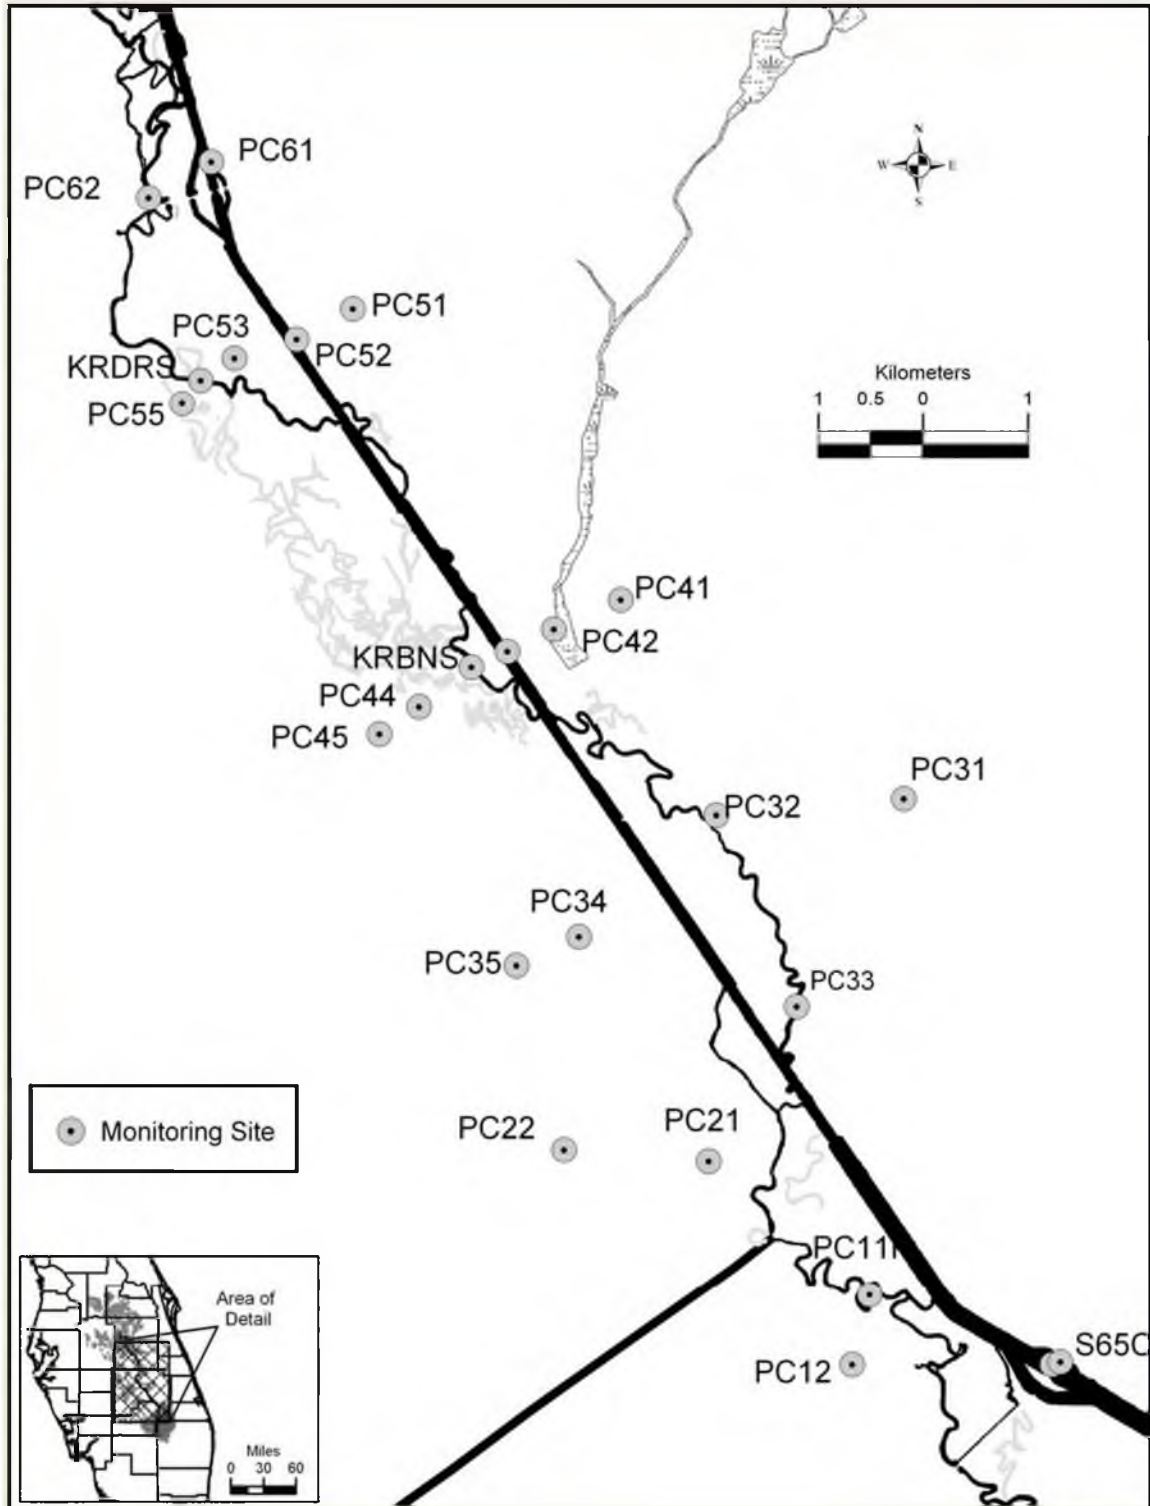
Figure 2-3. Locations of the baseline hydrologic monitoring sites in the area of Phase I of the Kissimmee River Restoration Project.

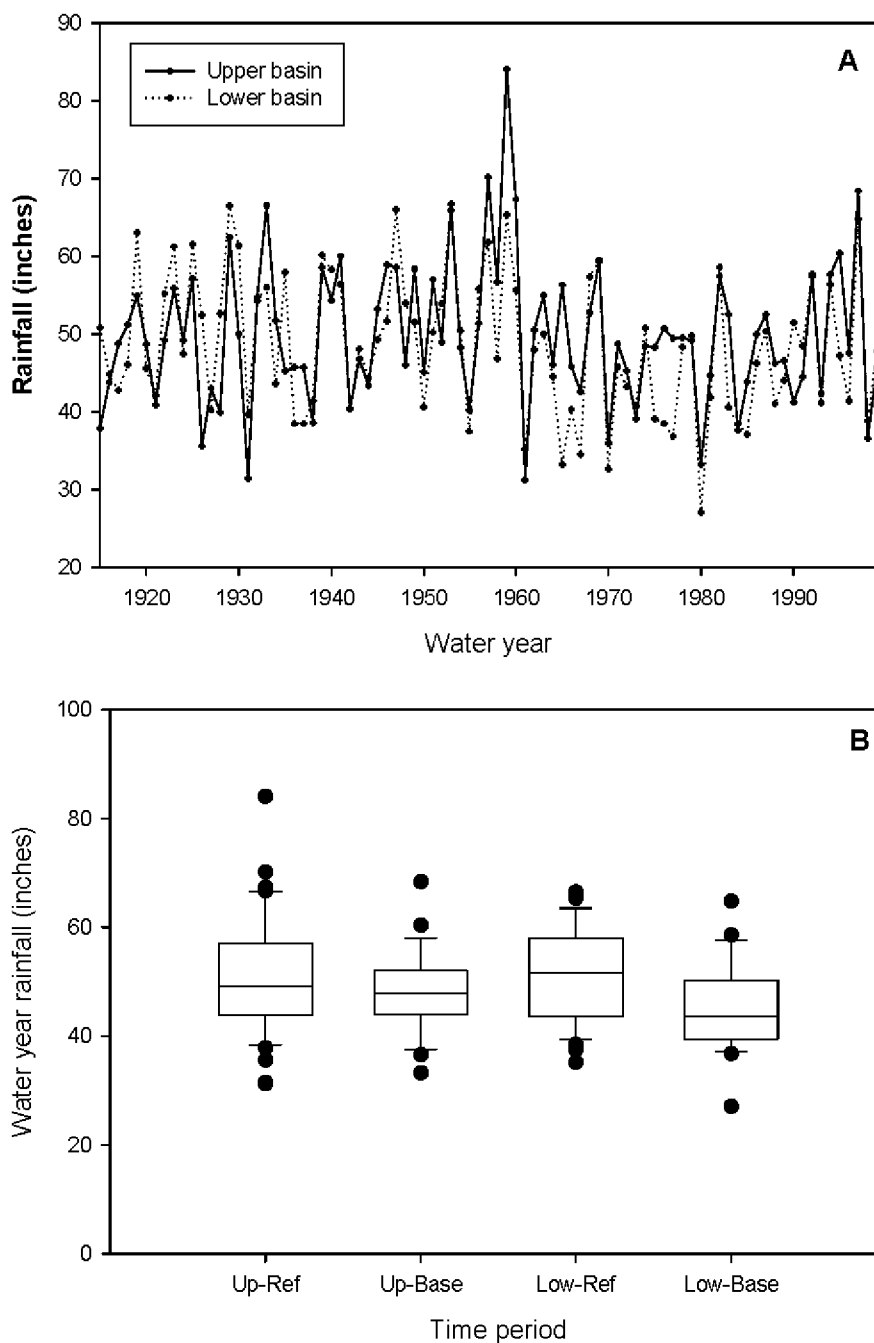
Figure 2-4. A. Annual rainfall by water year (May 1–April 30) for the upper and lower Kissimmee Basins. B. Box plots of annual rainfall for the upper basin reference and baseline periods, and for the lower baseline reference and baseline periods. The reference period was WY 1915–1961, and the baseline period was WY 1972–1999. In the box plots, the horizontal line is the median, the ends of the box represent the 25th and 75th percentiles and the error bars represent the 10th and 90th percentiles. Filled circles are values <10th or >90th percentile.

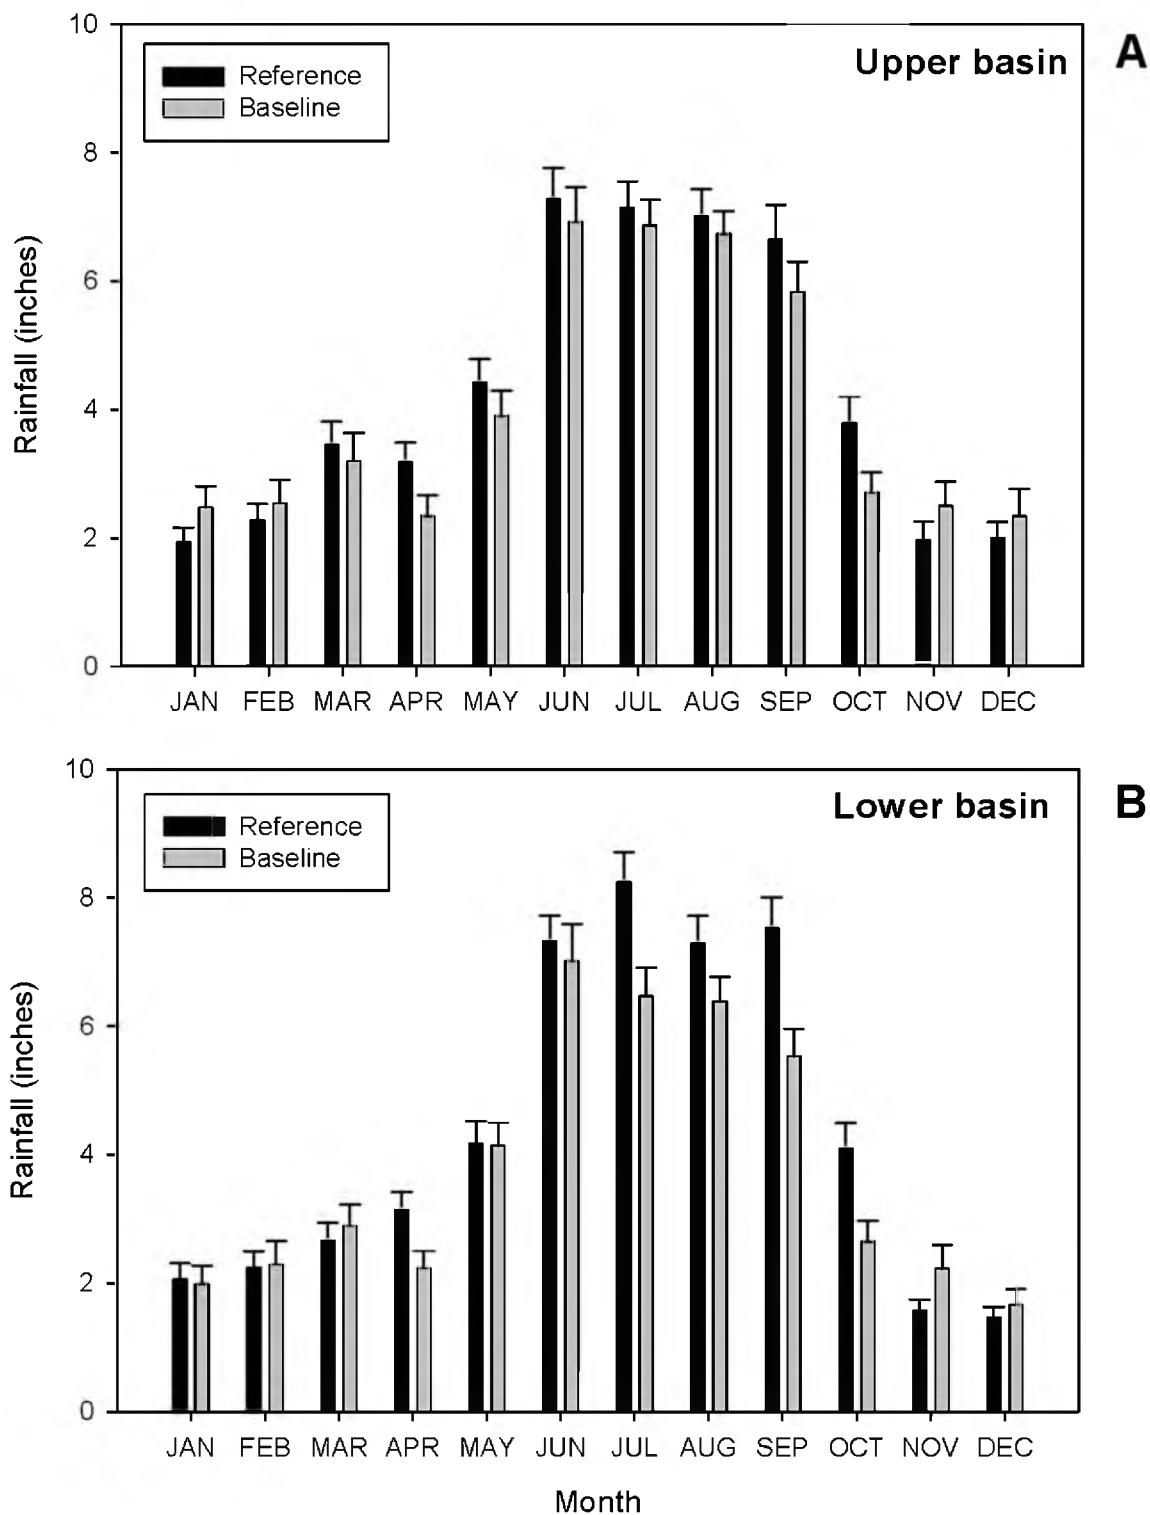
Figure 2-5. Mean monthly rainfall for the reference (1915–1961) and baseline (1972–1999) periods in the upper basin (A) and lower basin (B). Error bars are 1 SE.

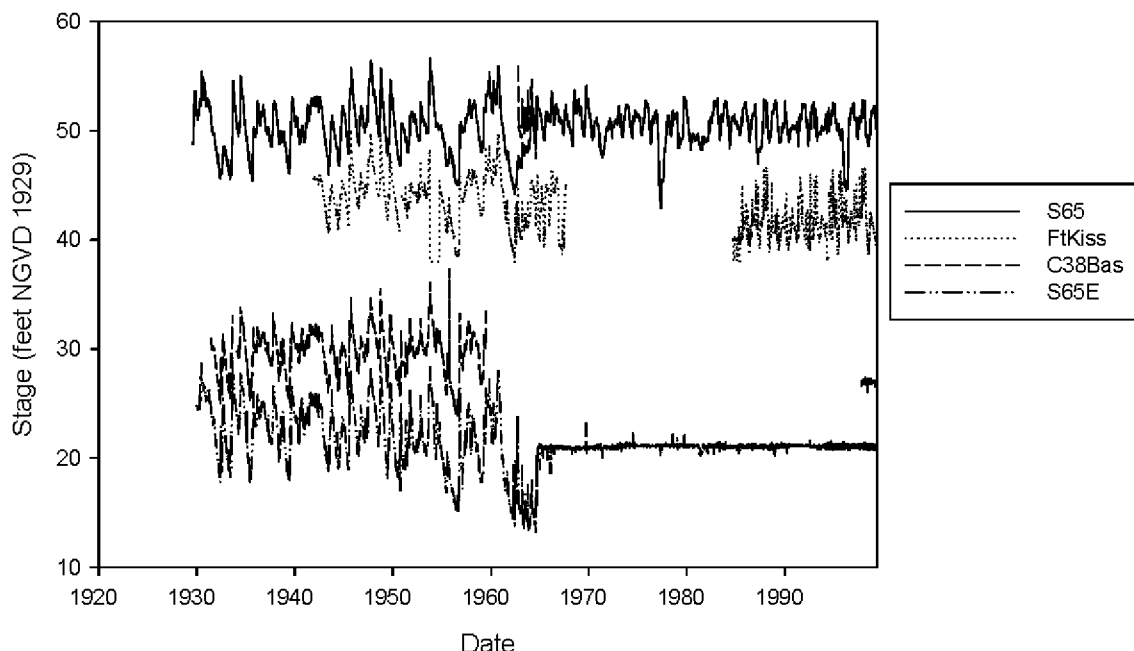
Figure 2-6. Mean daily stage at S-65, Fort Kissimmee, C38Bas, and S-65E. Period of record shown was truncated on June 1, 1999, for the end of the baseline period. Note that the Fort Kissimmee stage period of record resumes after a fluctuating regulation schedule was implemented for Pool B as part of the Kissimmee River Demonstration Project.

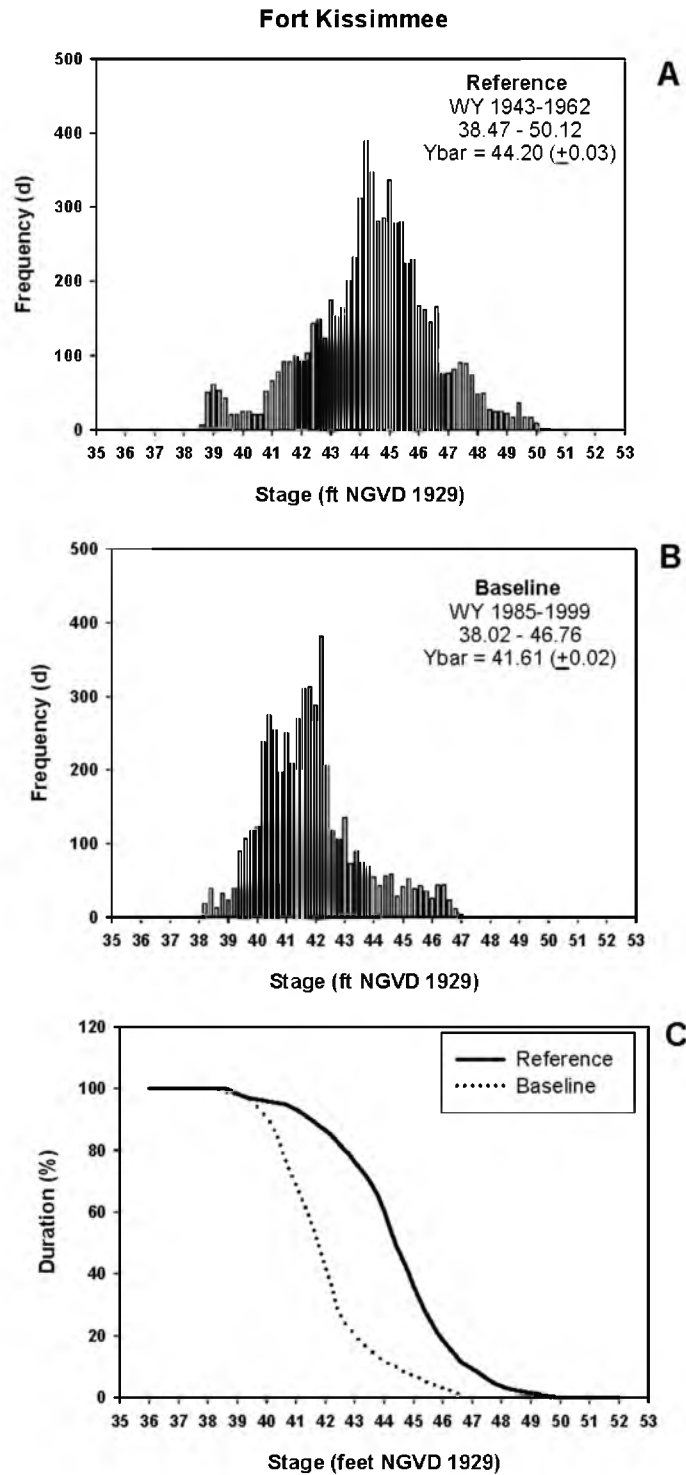
Figure 2-7. A. Frequency of mean daily stage at Fort Kissimmee for the reference period. B. Frequency of mean daily stage during the baseline period. C. Stage duration for the reference and baseline periods. Mean floodplain elevation at this station is 43 feet (Obeysekera and Loftin 1990).

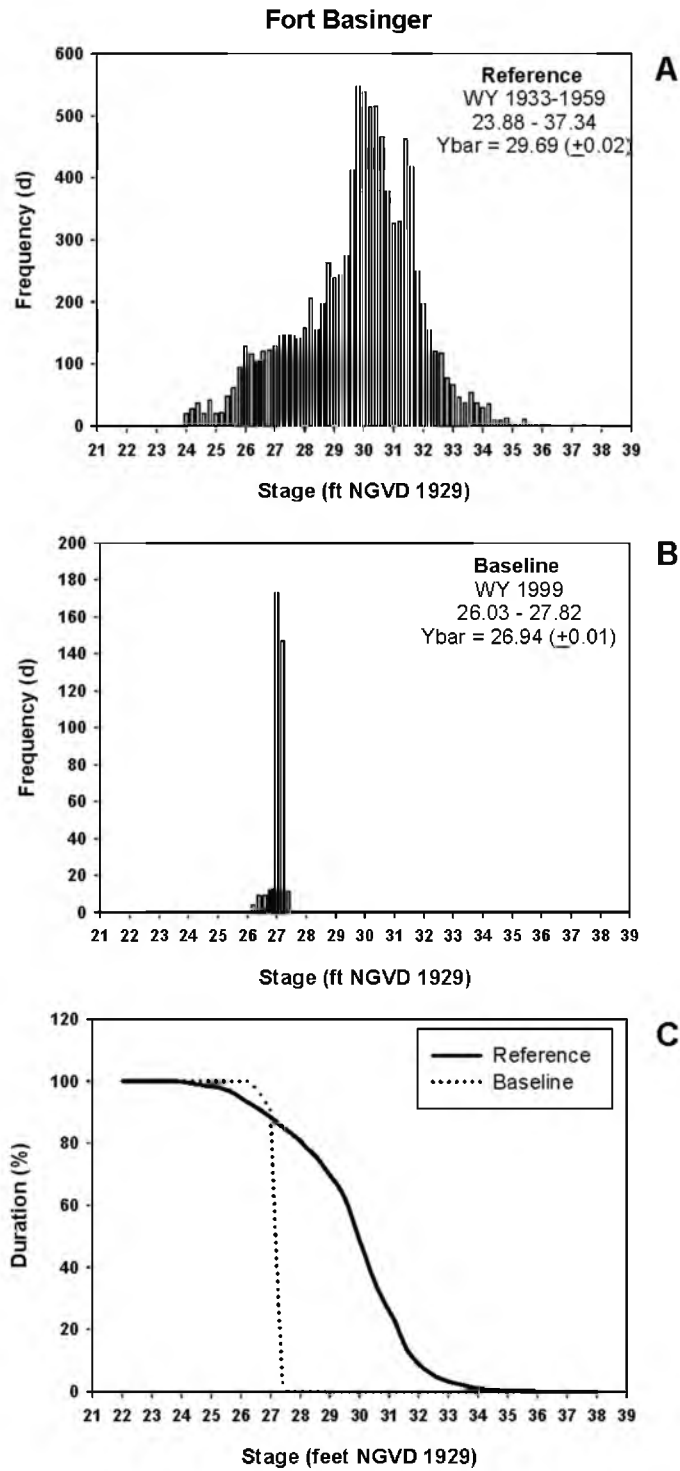
Figure 2-8. A. Frequency of mean daily stage at Fort Basinger for the reference period. B. Frequency of mean daily stage during the baseline period. C. Stage duration for the reference and baseline periods. Mean floodplain elevation at this station is 28.5 feet (Obeysekera and Loftin 1990).

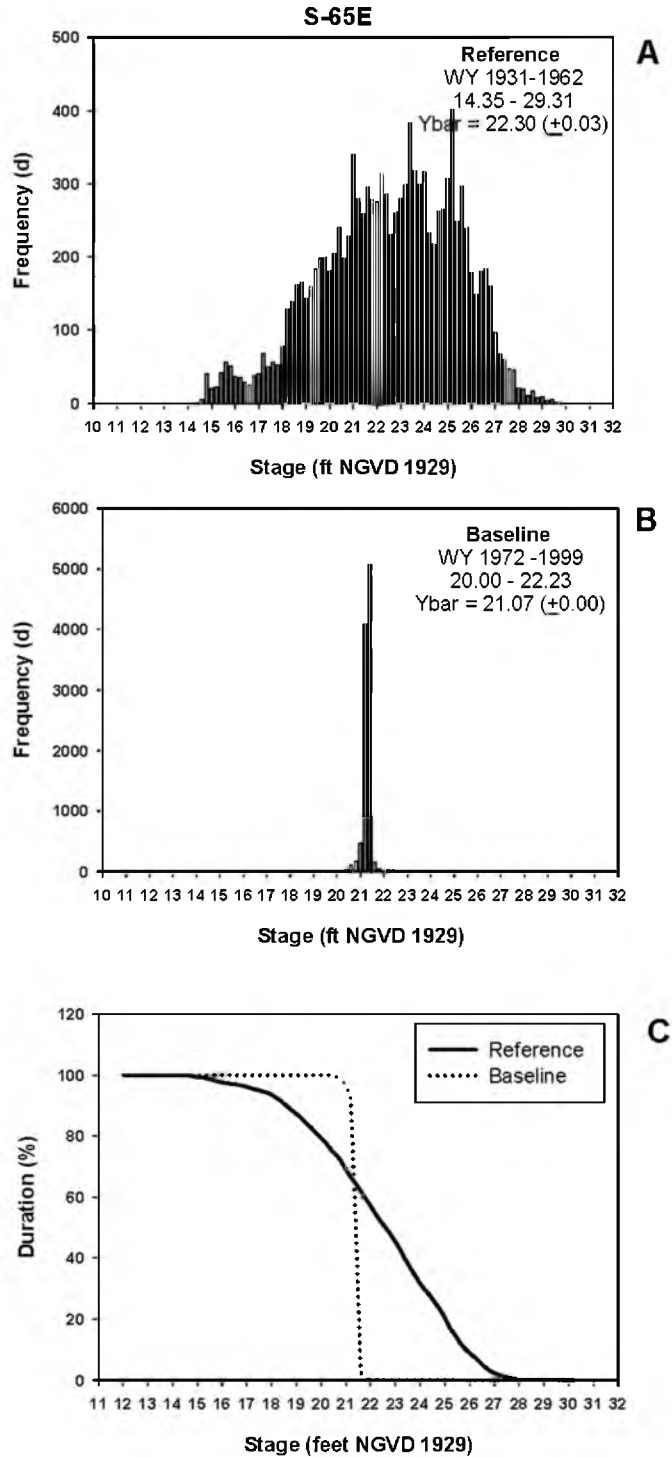
Figure 2-9. A. Frequency of mean daily stage at S-65E for the reference period. B. Frequency of mean daily stage during the baseline period. C. Stage duration for the reference and baseline periods. Mean floodplain elevation at this station is 21 feet (Obeysekera and Loftin 1990).
