Kissimmee River Restoration Studies

Establishing a Baseline: Pre-restoration Studies
of the Channelized Kissimmee River

Defining Success: Expectations for Restoration
of the Kissimmee River

South Florida Water Management District

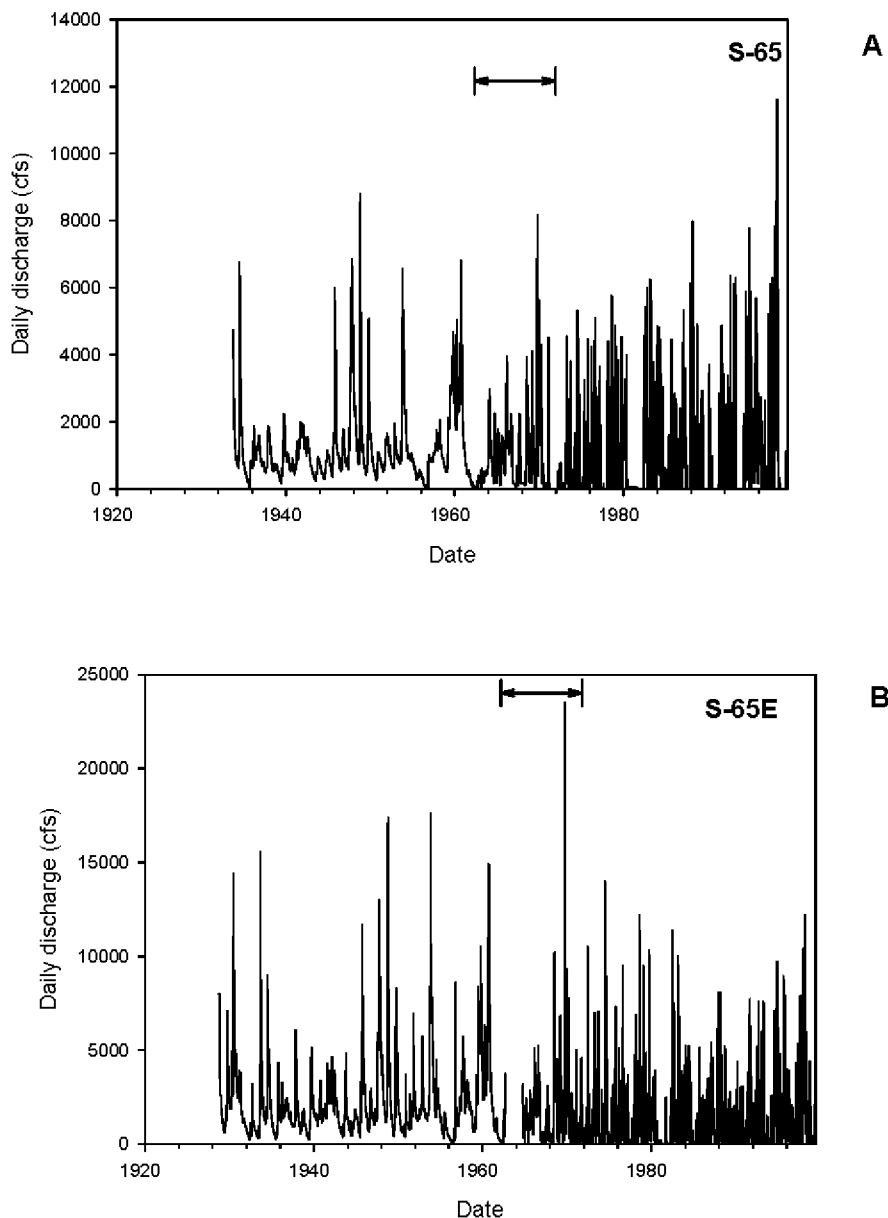
Figure 2-10. Mean daily discharge at S-65 and S-65E. Double-headed arrows indicate the time interval when channelization occurred.

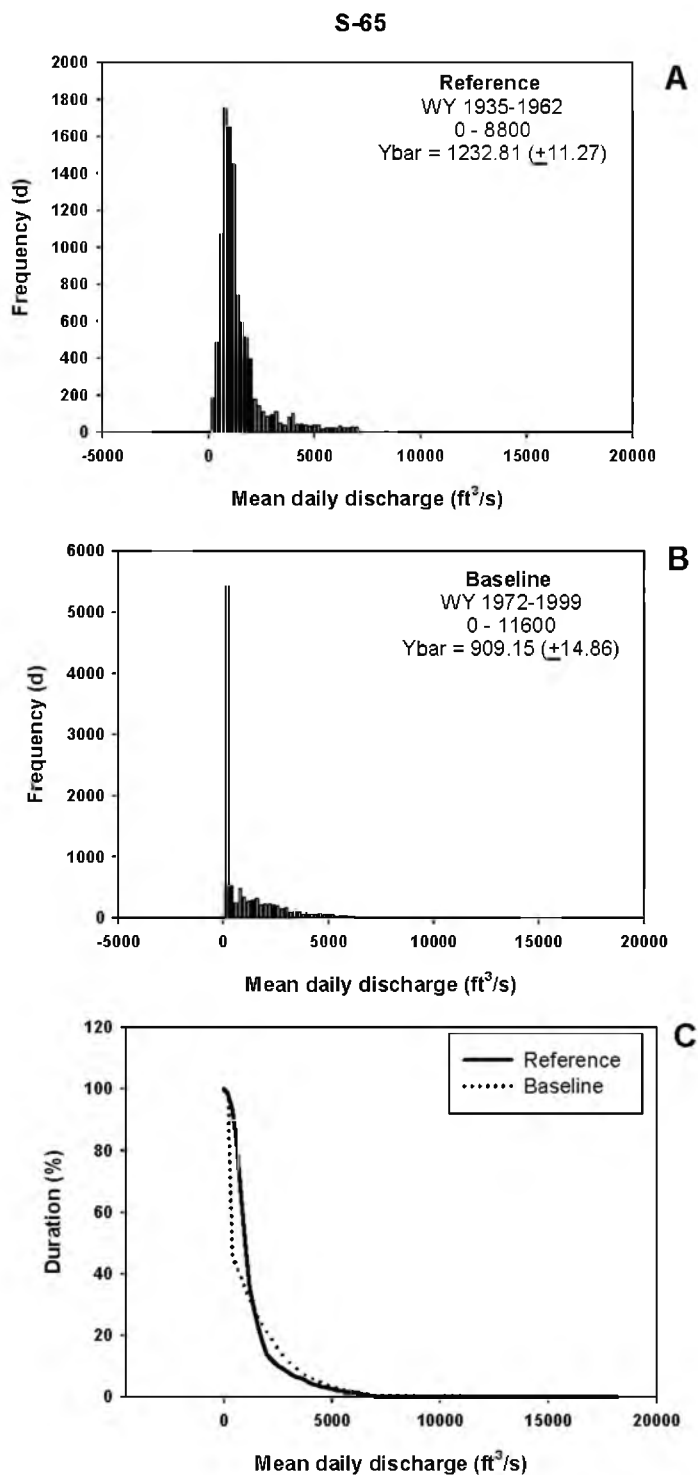
Figure 2-11. A. Frequency distribution of mean daily discharge for the reference period at S-65. B. Frequency distribution of mean daily discharge for the baseline period. C. Duration of discharges during the time interval for the reference period and the baseline period.

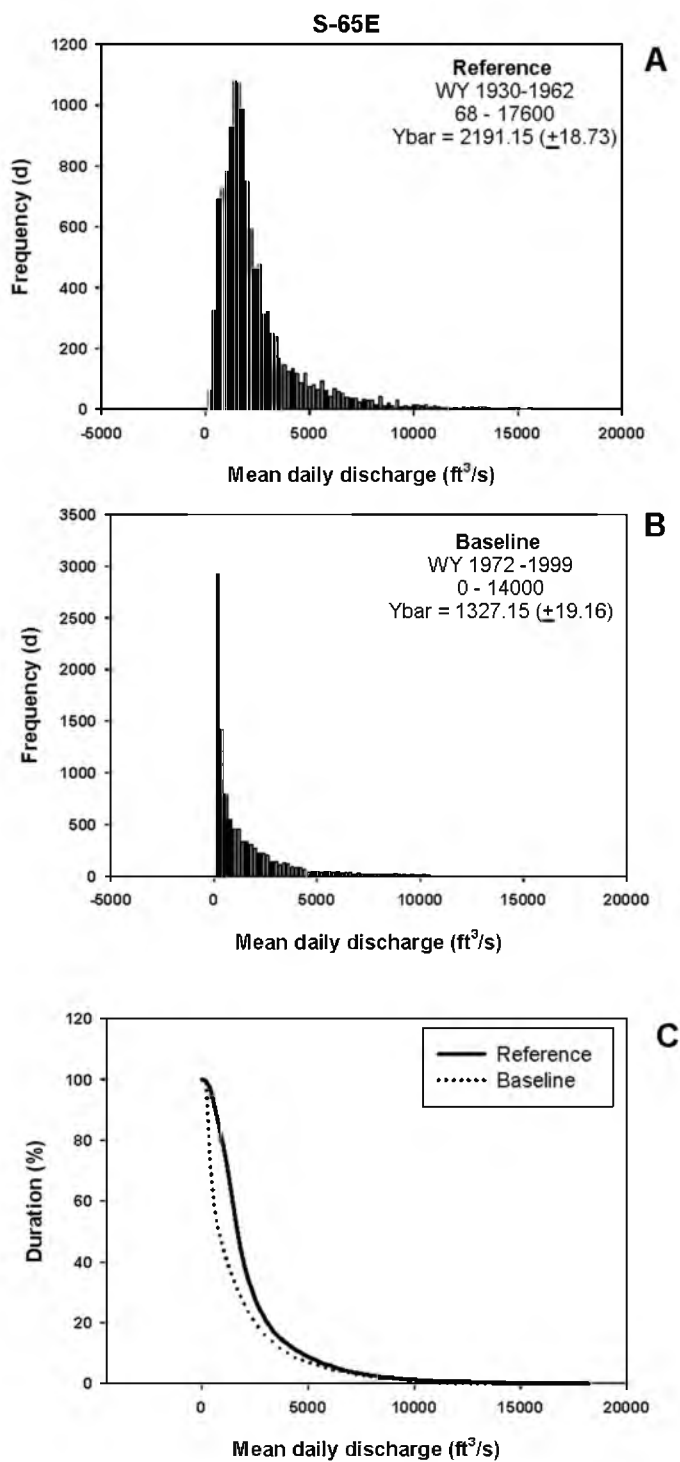
Figure 2-12. A. Frequency distribution of mean daily discharge for the reference period at S-65E. B. Frequency distribution of mean daily discharge for the baseline period. C. Duration of discharges during the time interval for the reference period and the baseline period.

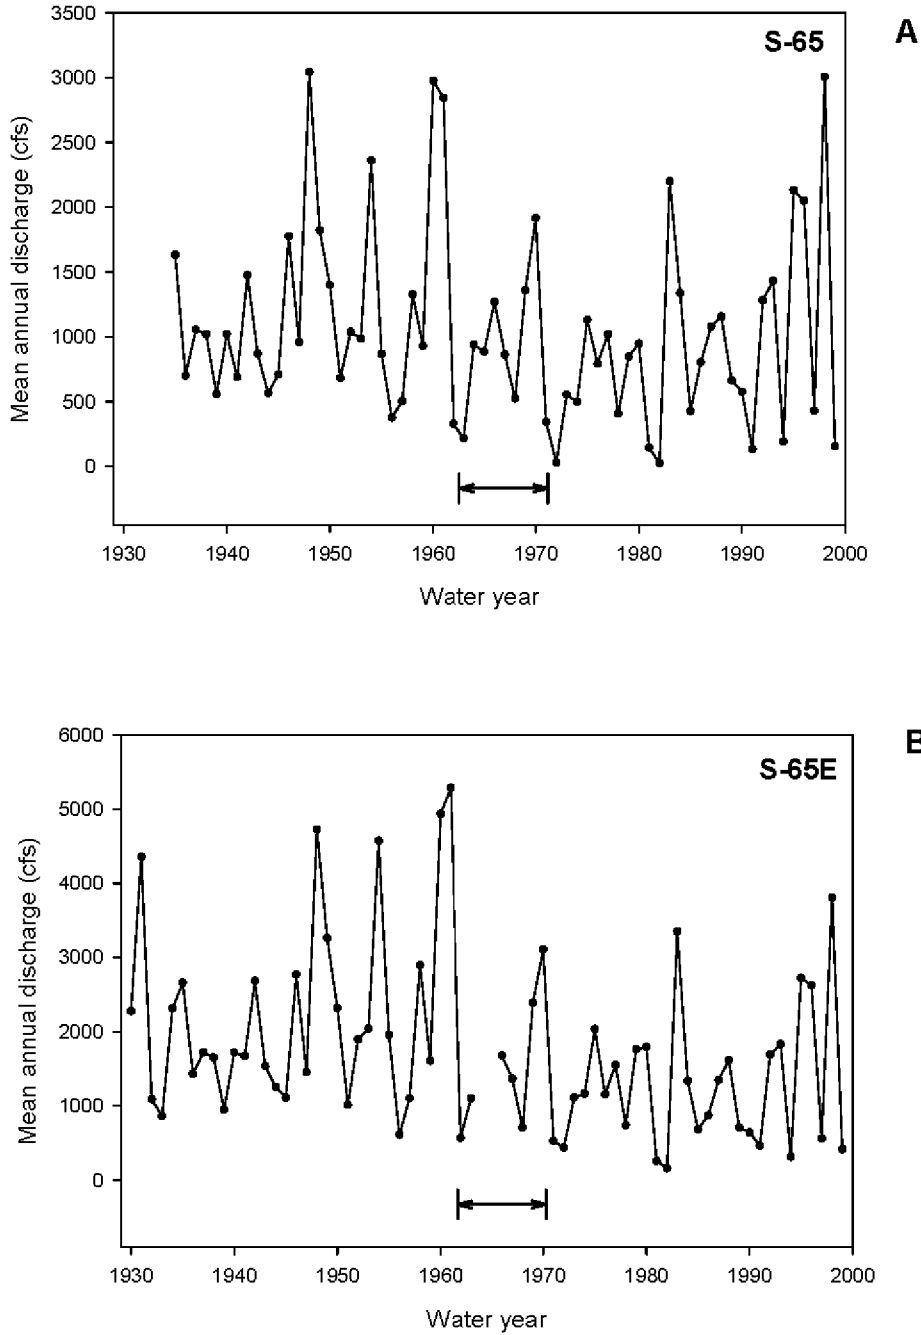
Figure 2-13. Mean annual daily discharge at S-65 (A) and S-65E (B). Double-headed arrows indicate the time interval when channelization occurred.

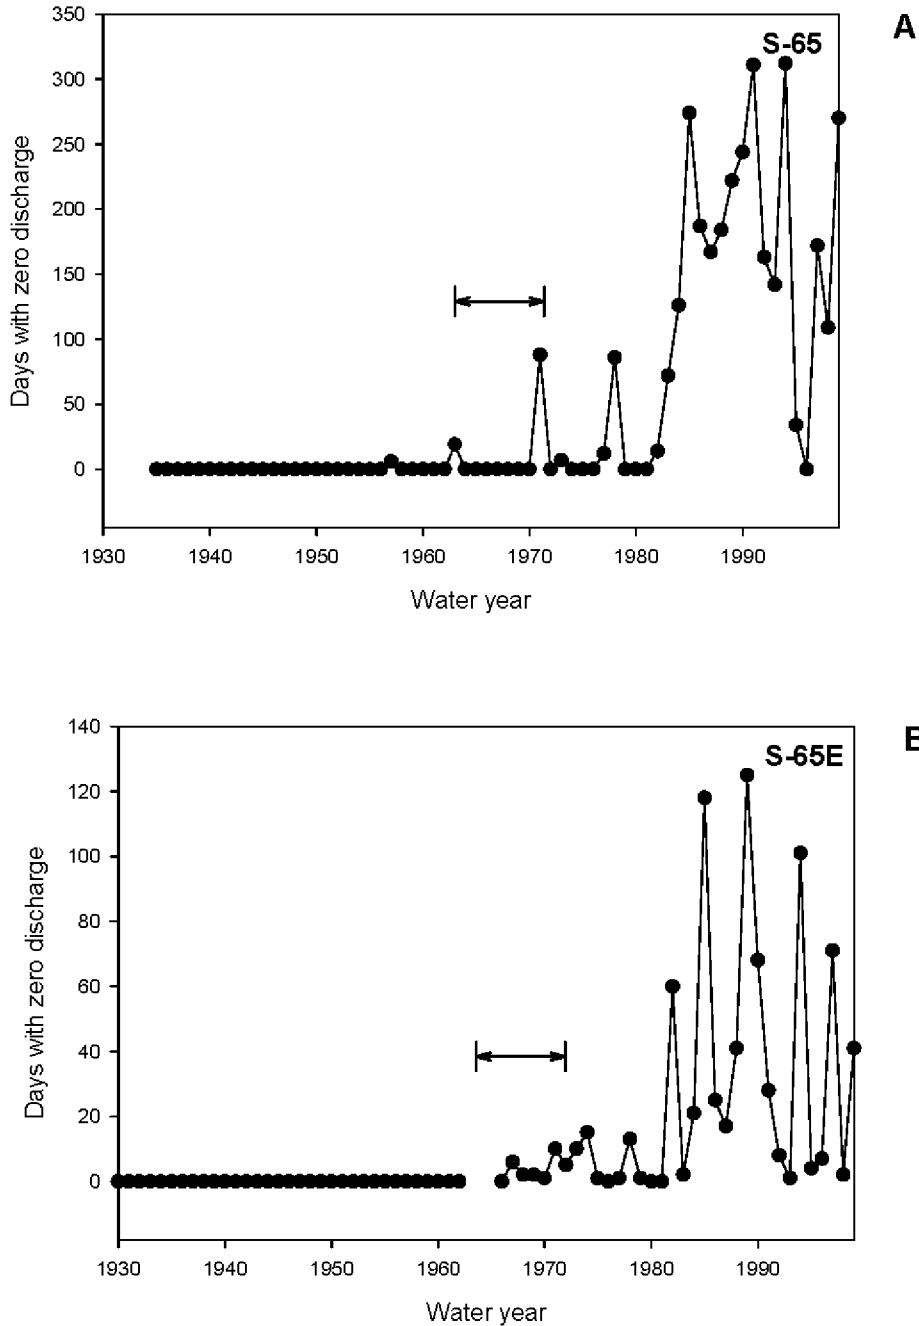
Figure 2-14. Number of days each water year that mean daily discharge was 0 cfs at S-65 (A) and S-65E (B). Double-headed arrows indicate the time interval when channelization occurred.

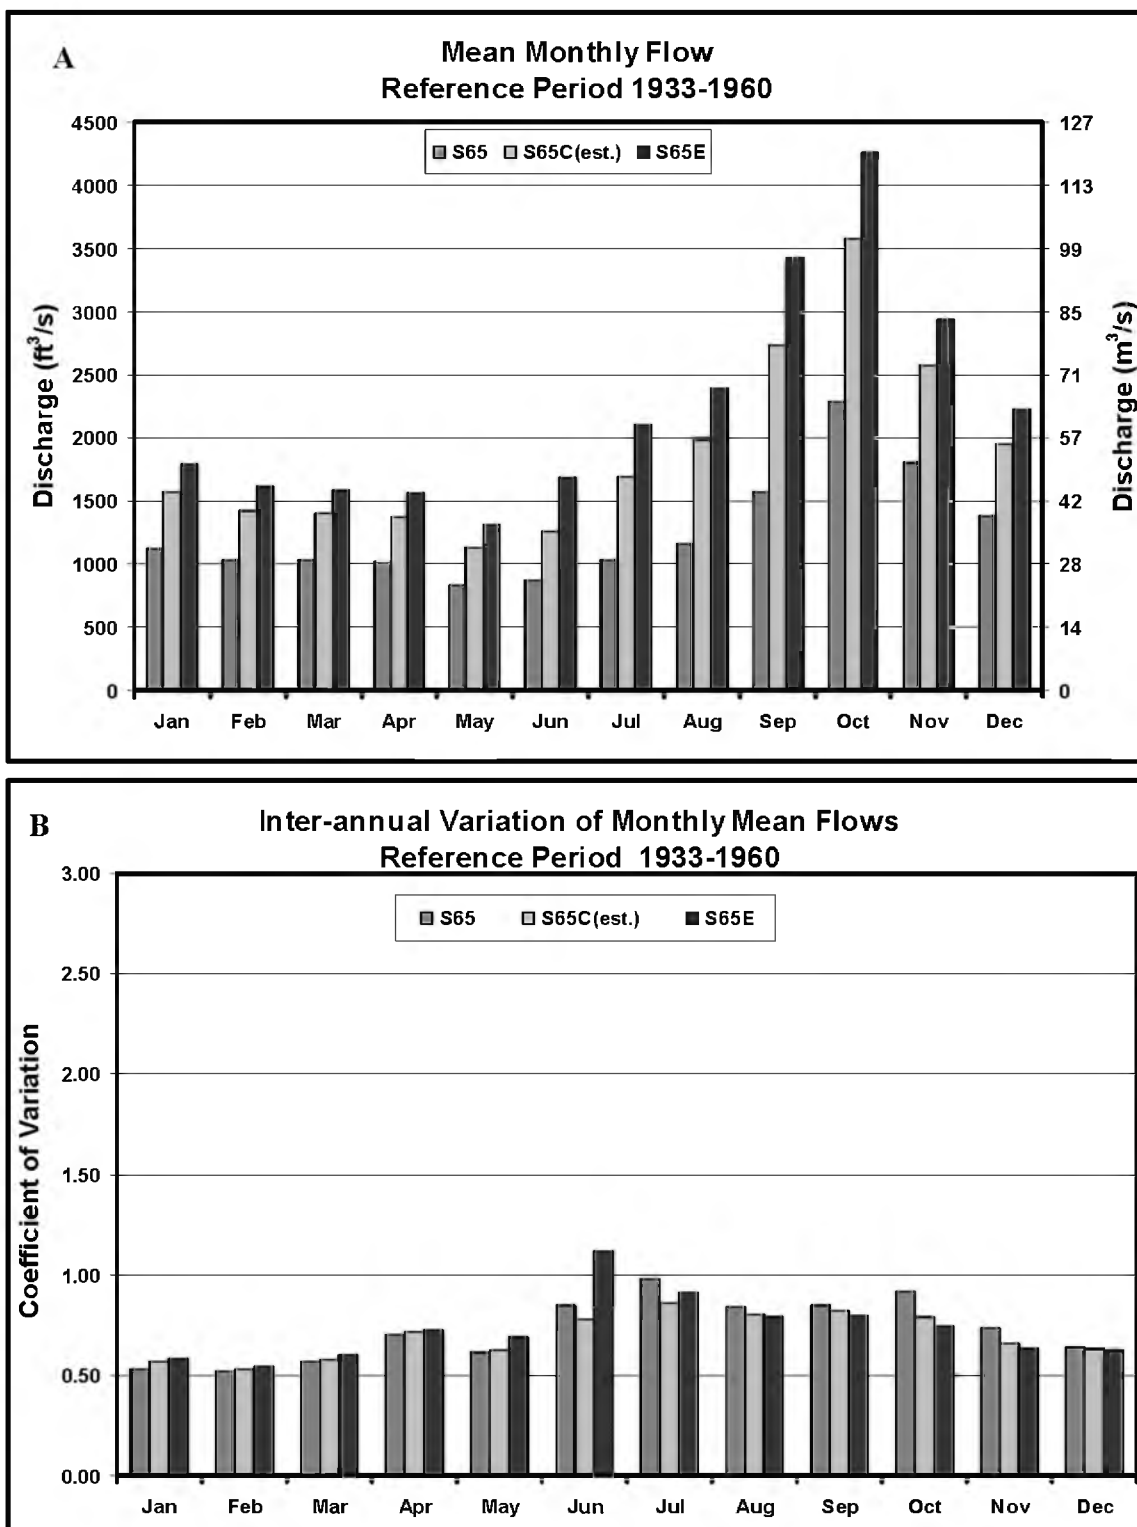
Figure 2-15. A. Mean monthly flow and B. coefficient of variation of mean monthly flow for S-65, estimated S-65C, and S-65E for the reference period (1933–1960).

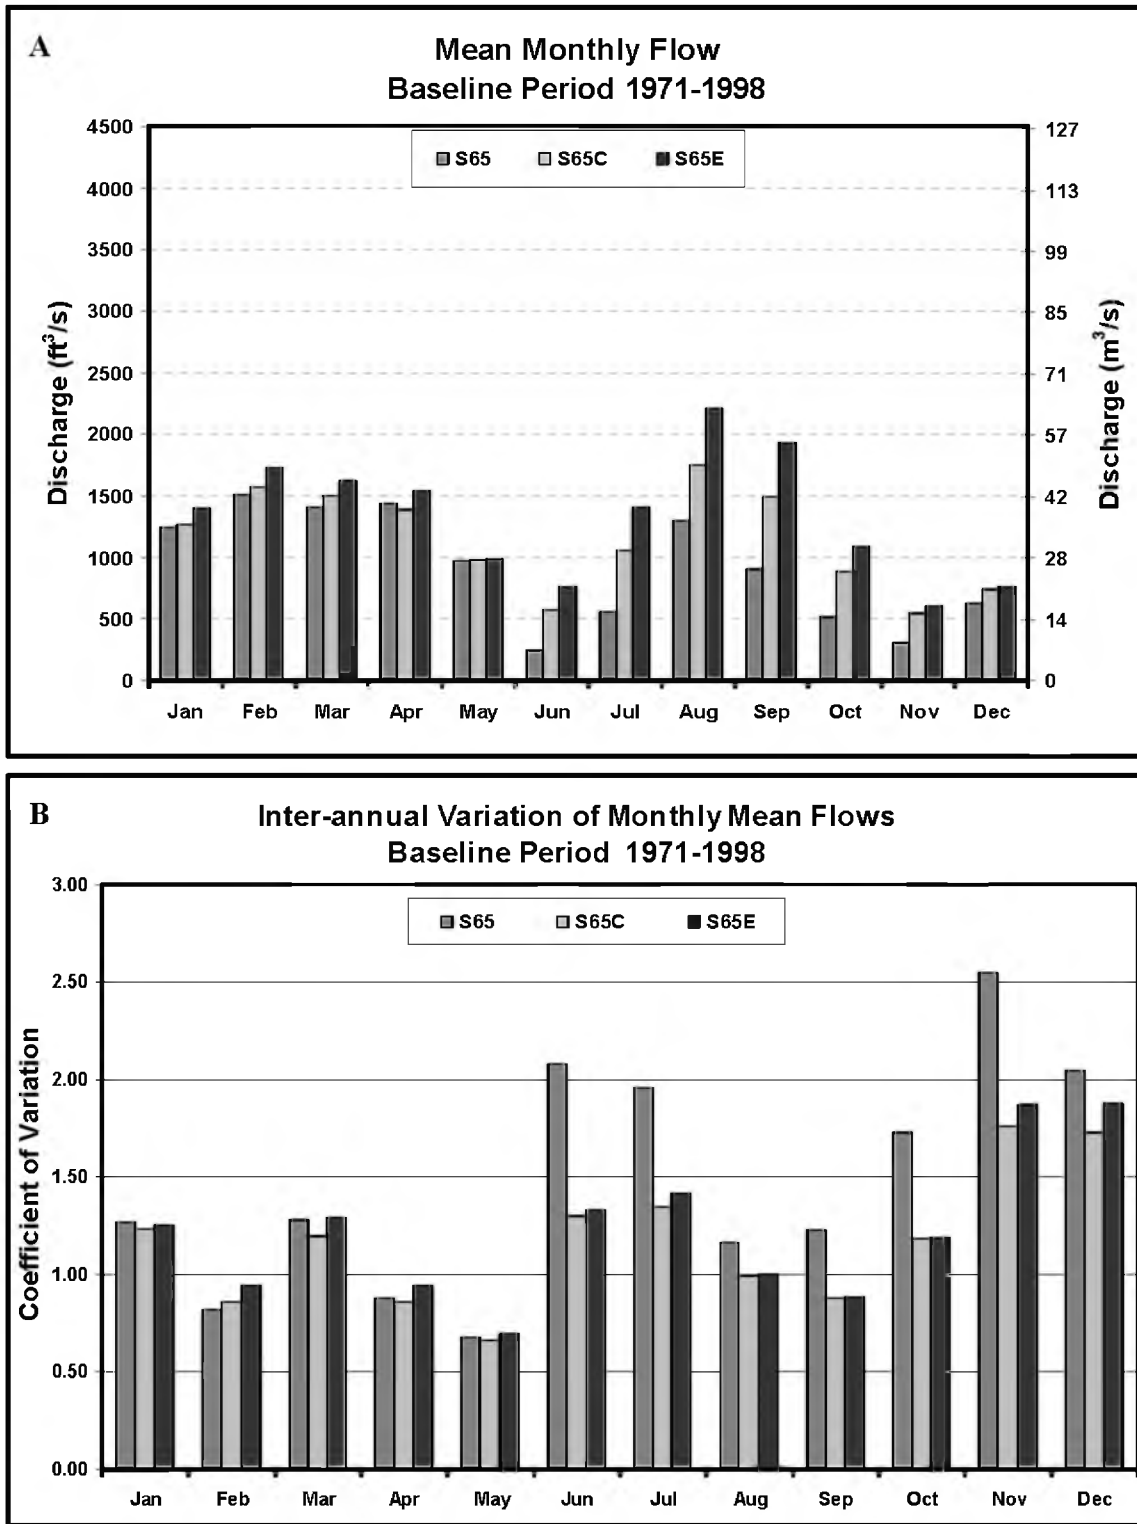
Figure 2-16. A. Mean monthly flow and B. coefficient of variation of mean monthly flow for S-65, S-65C, and S-65E for the baseline period (1971–1998).

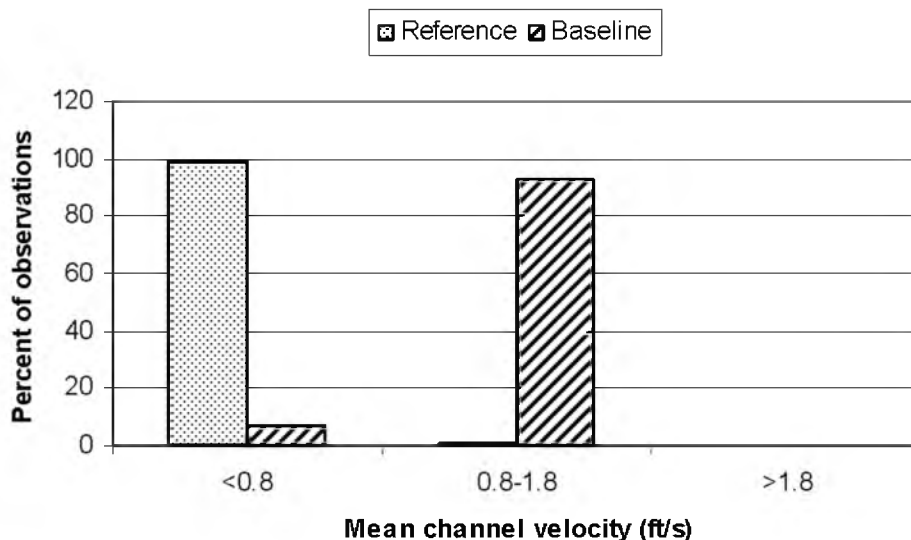
Figure 2-17. Percent of observations of mean channel velocity that were <0.8 ft/s, 0.8–1.8 ft/s, and >1.8 ft/s during the reference and baseline periods.

Baseline Conditions. Baseline conditions were derived from daily discharge at site PC33 on Micco Bluff Run, a remnant river channel in Pool C. Data from this site are representative of baseline conditions (November 1997–May 1999) within remnant river channels that will be affected by the first phase of restoration. Daily discharge at PC33 ranged from 0 to 1170 ft³/s (33 m³/s) but flows greater than 100 ft³/s (2.8 m³/s) occurred only 5% of the time. Mean channel velocities were calculated by dividing discharge by the cross sectional area of the river channel and ranged from 0.0 to 1.61 ft/s (0.49 m/s). However, because remnant river channels rarely conveyed discharge, mean channel velocities were less than 0.8 ft/s (0.2 m/s) 99% of the baseline period (Figure 2-17).

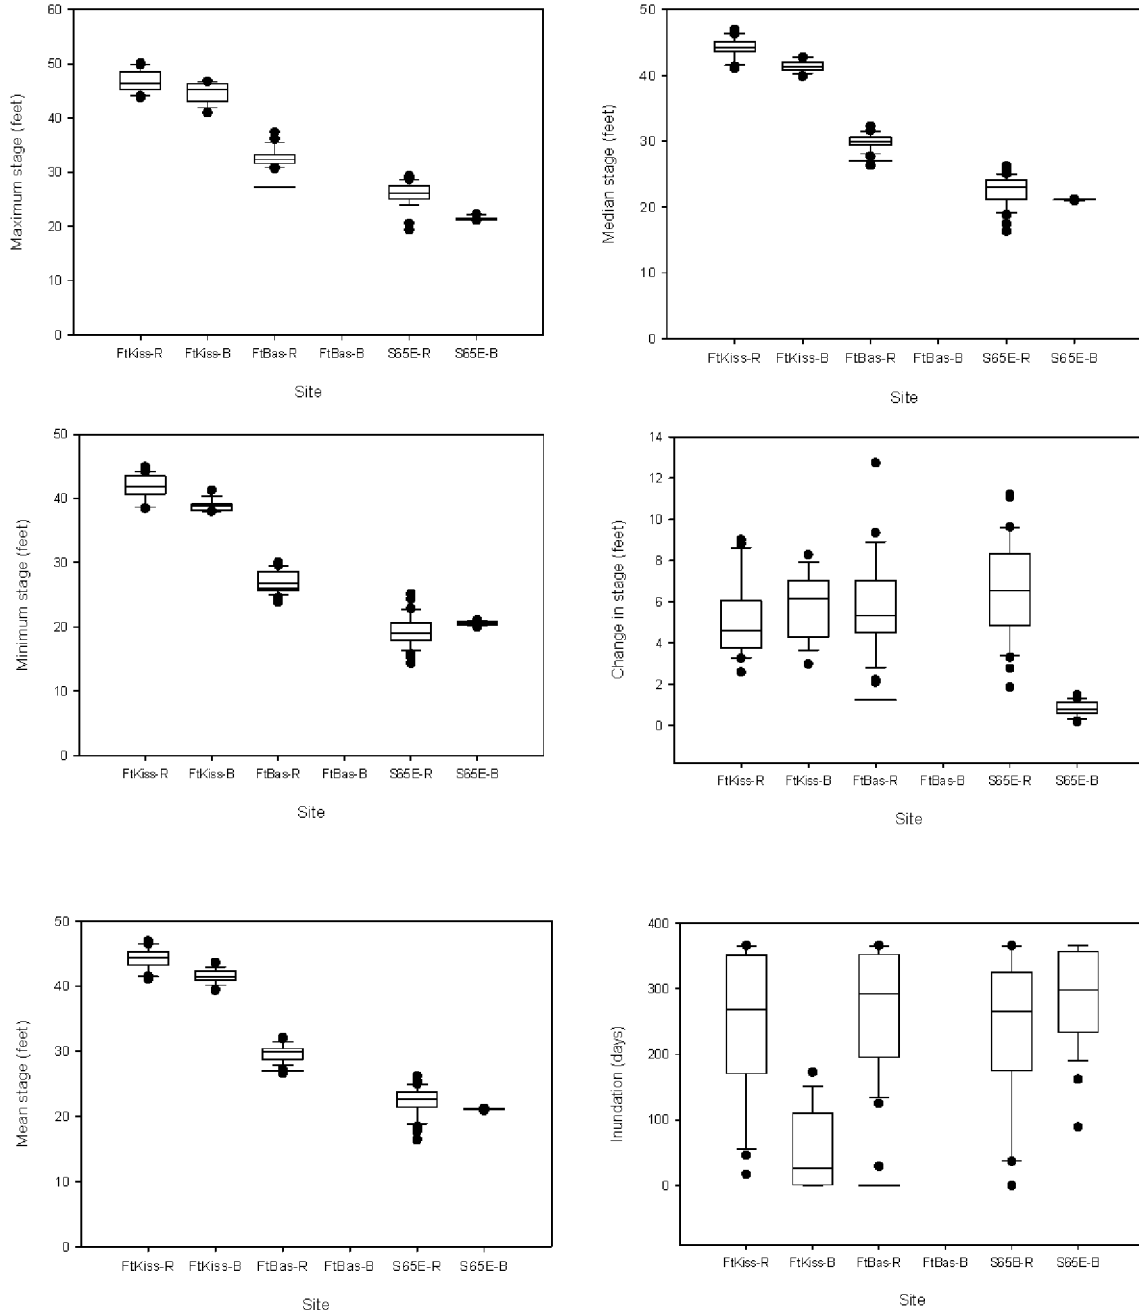
Figure 2-18. Box plots for six metrics describing stage by years for different sites. Sites were Fort Kissimmee during the reference period (FtKiss-R) and baseline (FtKiss-B) periods, Fort Basinger during reference (FtBas-R) and baseline (FtBas-B) periods, and S-65E during reference (S65E-R) and baseline (S65E-B) periods. A box plot was not constructed for Fort Basinger during the baseline period because the single water year of data during the baseline period was not sufficient. In the box plots, the horizontal line is the median, the ends of the box represent the 25th and 75th percentiles and the error bars represent the 10th and 90th percentiles. Filled circles are values <10th or >90th percentile.

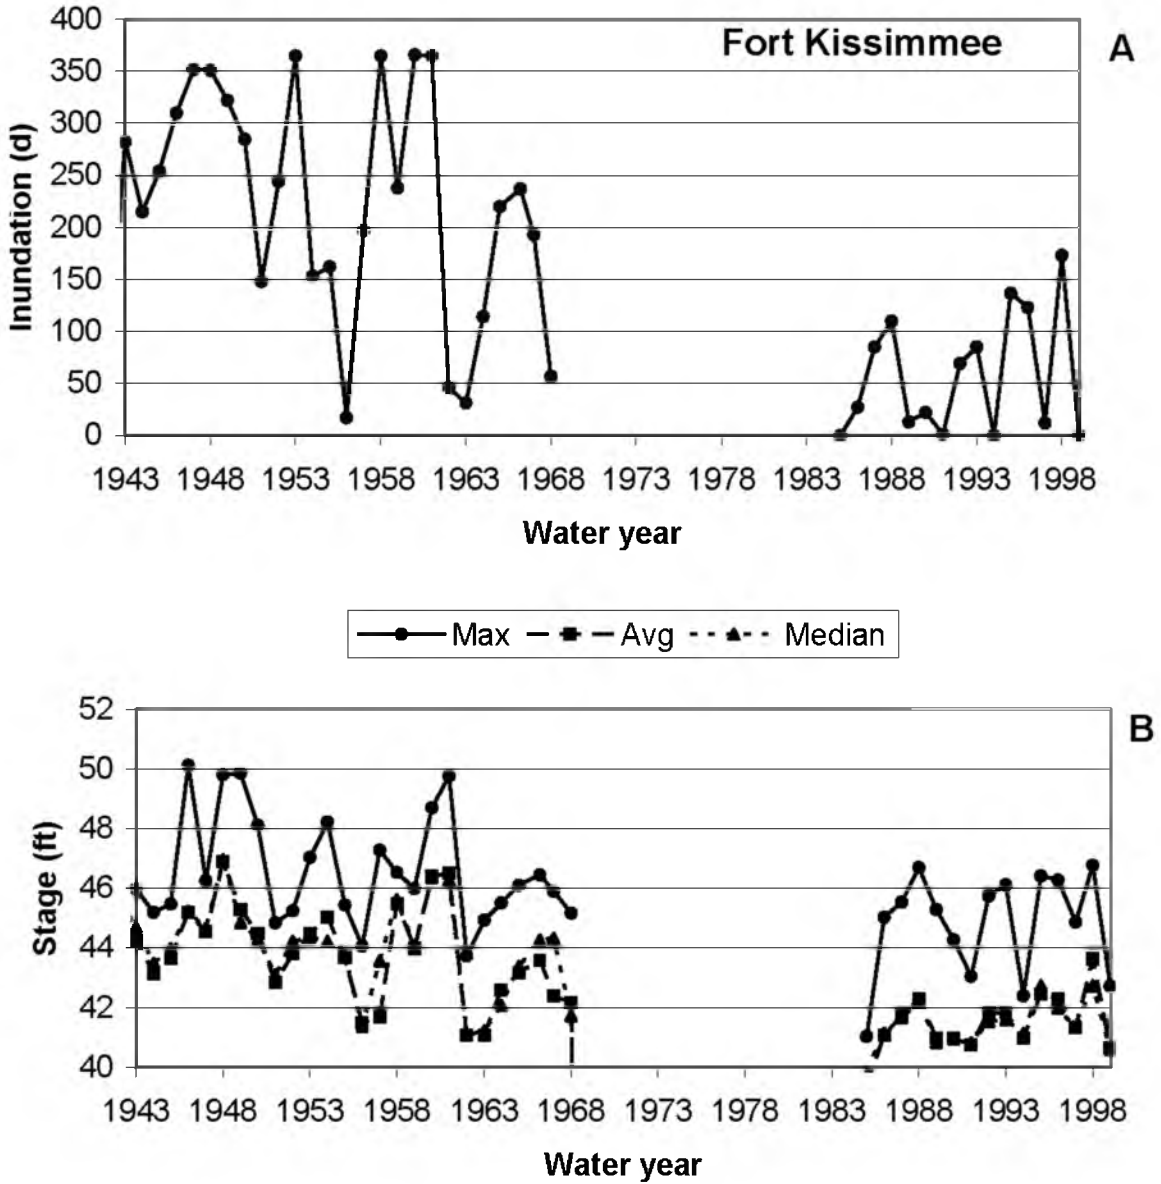
Figure 2-19. A. Number of days that the floodplain was inundated by stages exceeding the mean floodplain elevation of 43 feet (Obeysekera and Loftin 1990) and B. the maximum, average, and median stage for a water year at Fort Kissimmee.

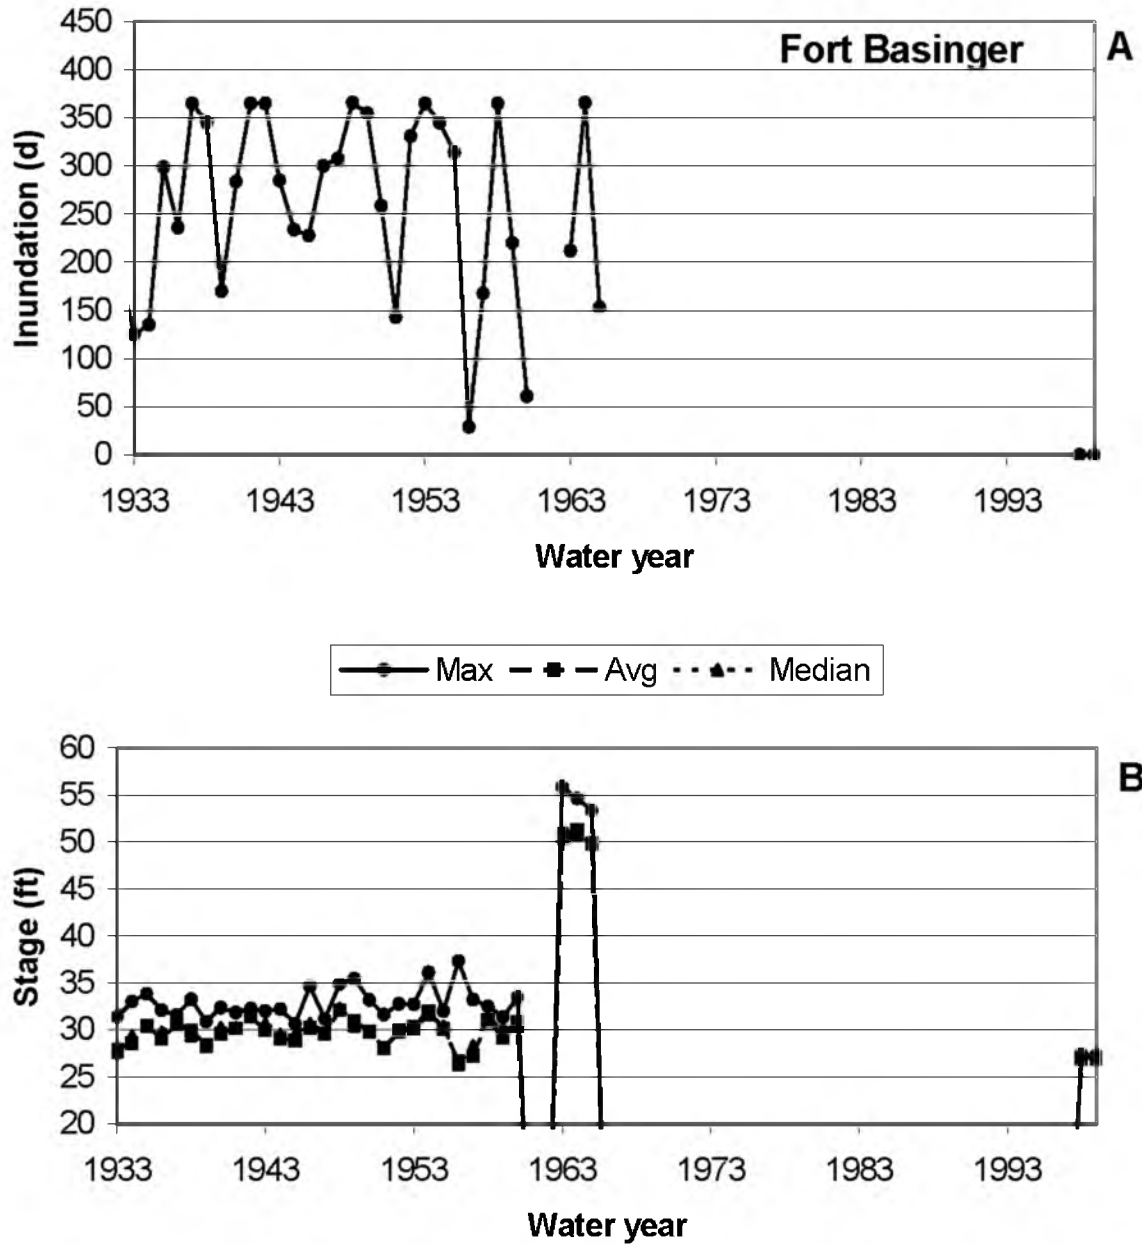
Figure 2-20. A. Number of days that the floodplain was inundated by stages exceeding the mean floodplain elevation of 28.5 feet (Obeysekera and Loftin 1990) and B. the maximum, average, and median stage for a water year at Fort Basinger.

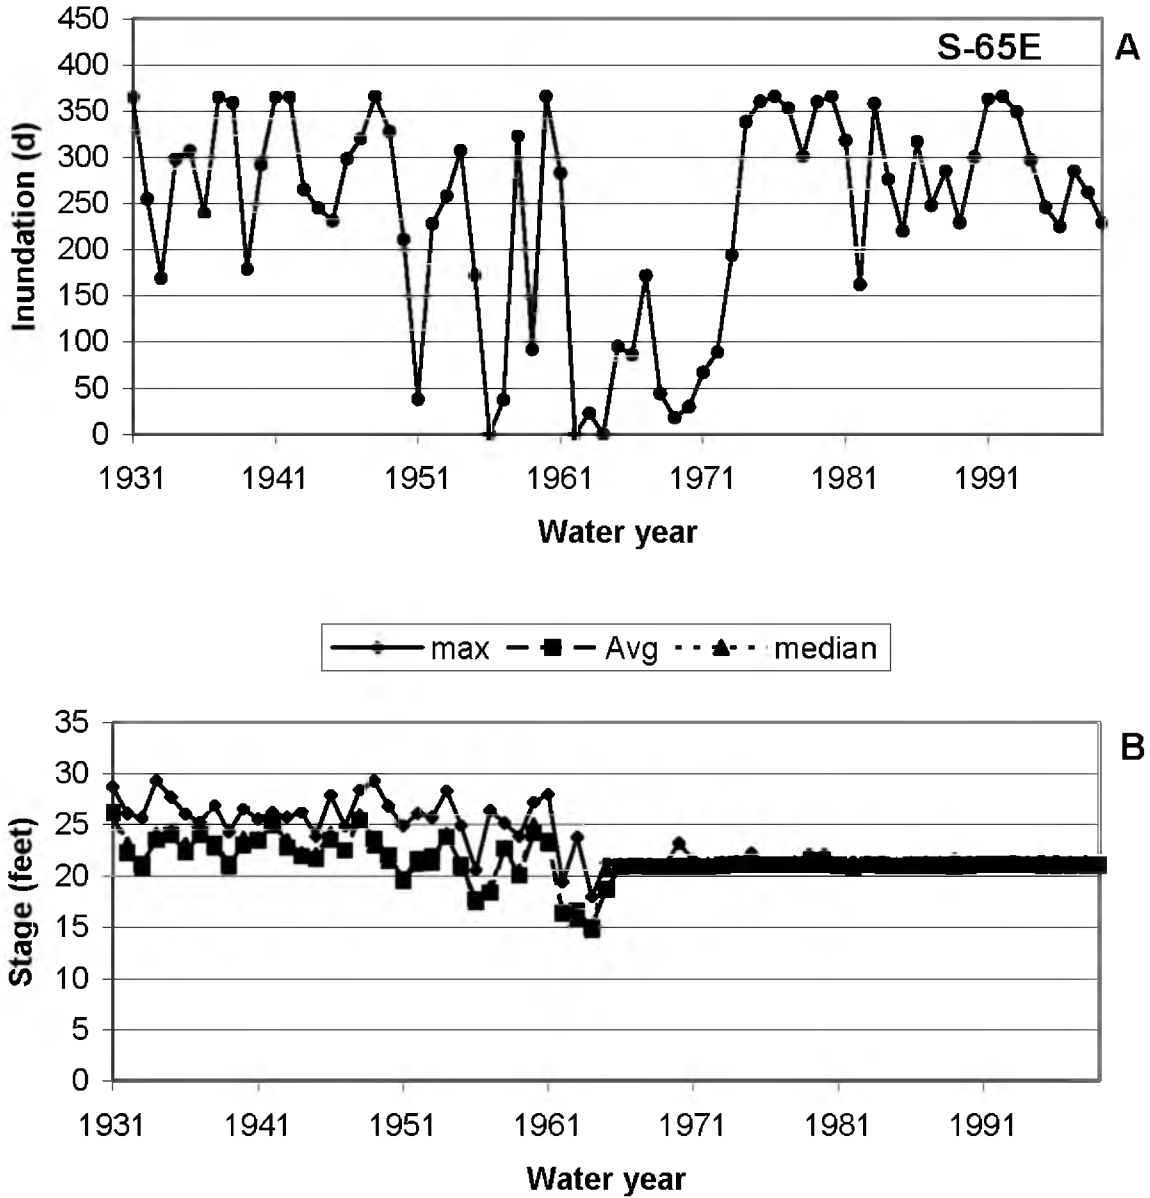
Figure 2-21. A. Number of days that the floodplain was inundated by stages exceeding the mean floodplain elevation of 21 feet (Obeysekera and Loftin 1990) and B. the maximum, average, and median stage for a water year at S-65E.

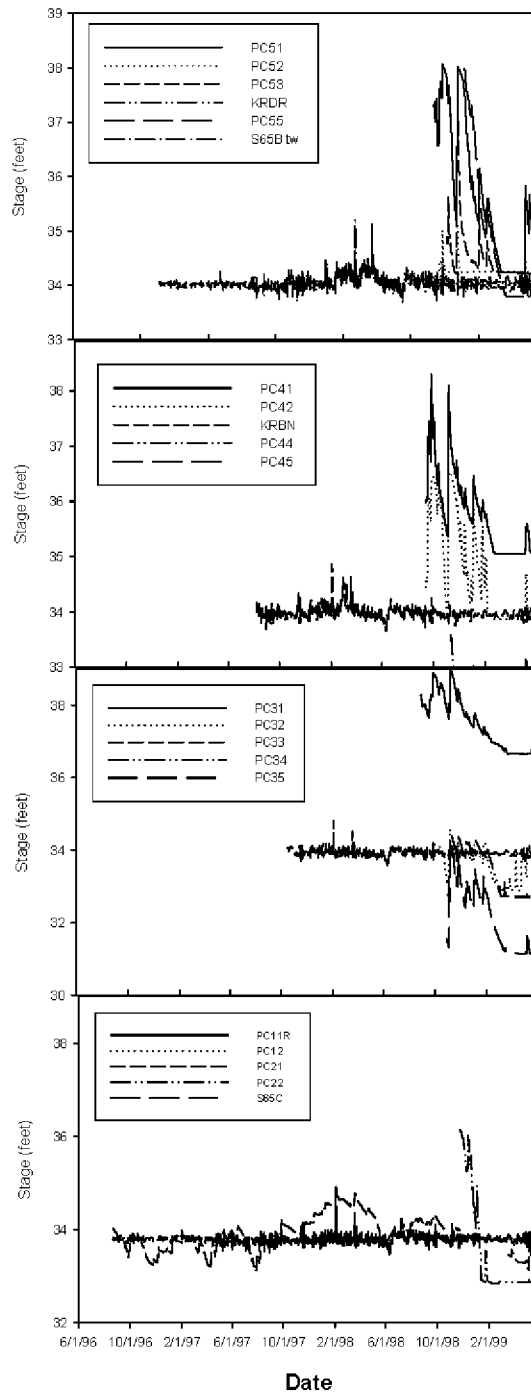
Figure 2-22. Mean daily stage data from the Phase I baseline monitoring network. Data presentation was truncated at the end of the baseline period on May 31, 1999. All stations were located on the floodplain except PC11R, PC33, KRBN, and KRDR, which were located in remnant river channels, and the tailwater of S-65B and the headwater of S-65C, which were located in the C-38 canal.

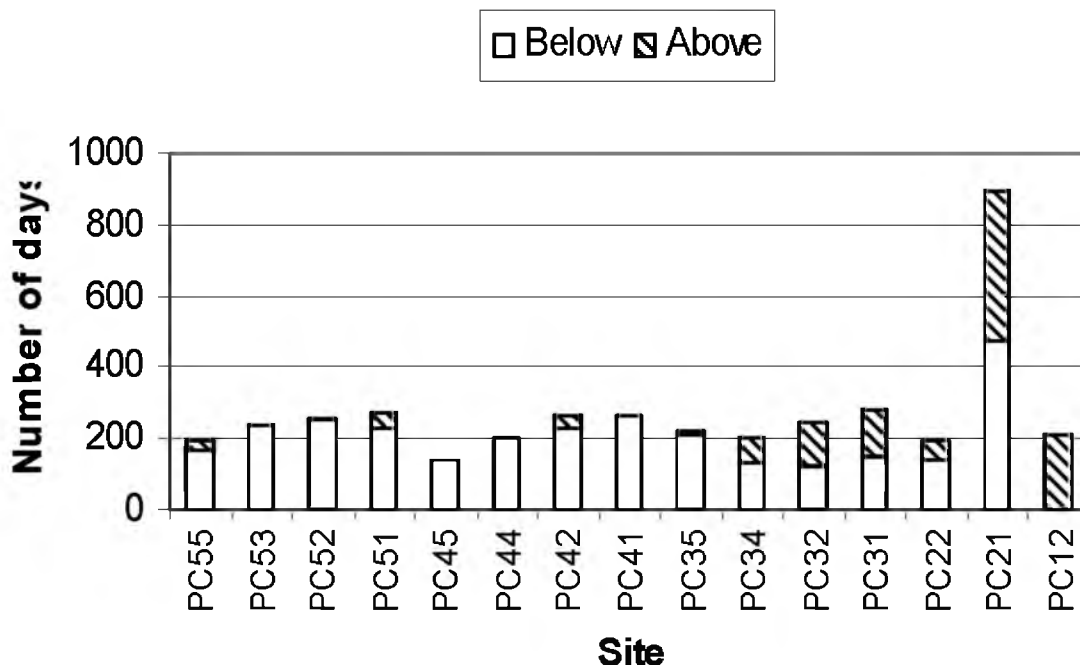
Figure 2-23. Number of days that stage was above or below ground level for each floodplain site during the baseline period (August 22, 1996–May 31, 1999).

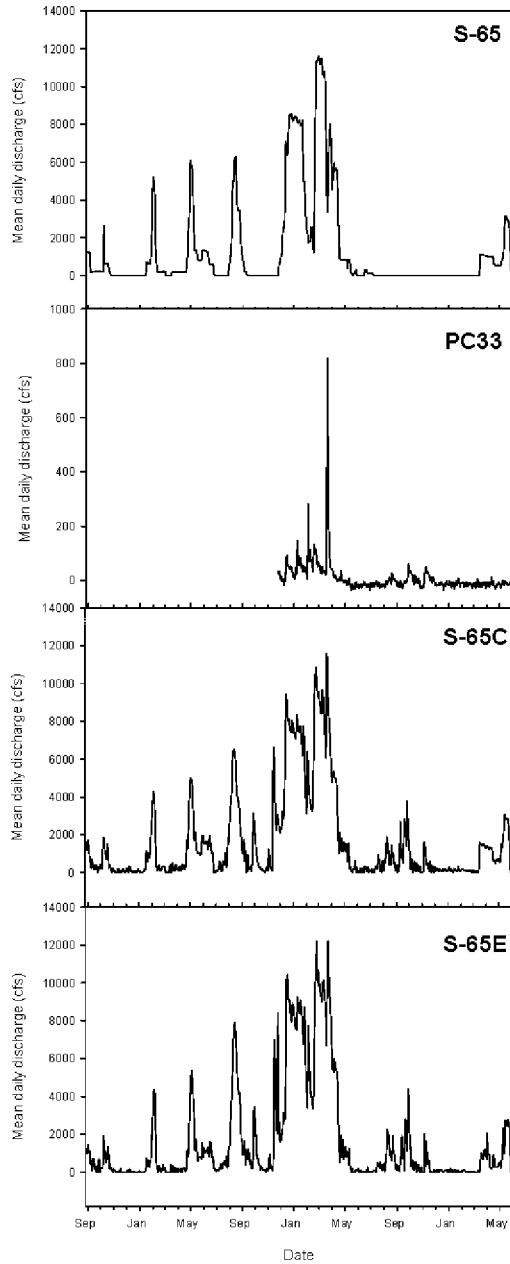
Figure 2-24. Mean daily discharge during the baseline period (August 26, 1996–May 31, 1999) at S-65, PC33, S-65C, and S-65E. Discharge measurements at S-65, S-65C, and S-65E were made at the structure on the C-38 canal and represent the water moving through the system. PC33 was located in a remnant river channel, and discharge measurements at this site are only for the remnant river channel and did not include the floodplain or the C-38 canal. The x-axis begins with September 1996 and continues through May 1999.

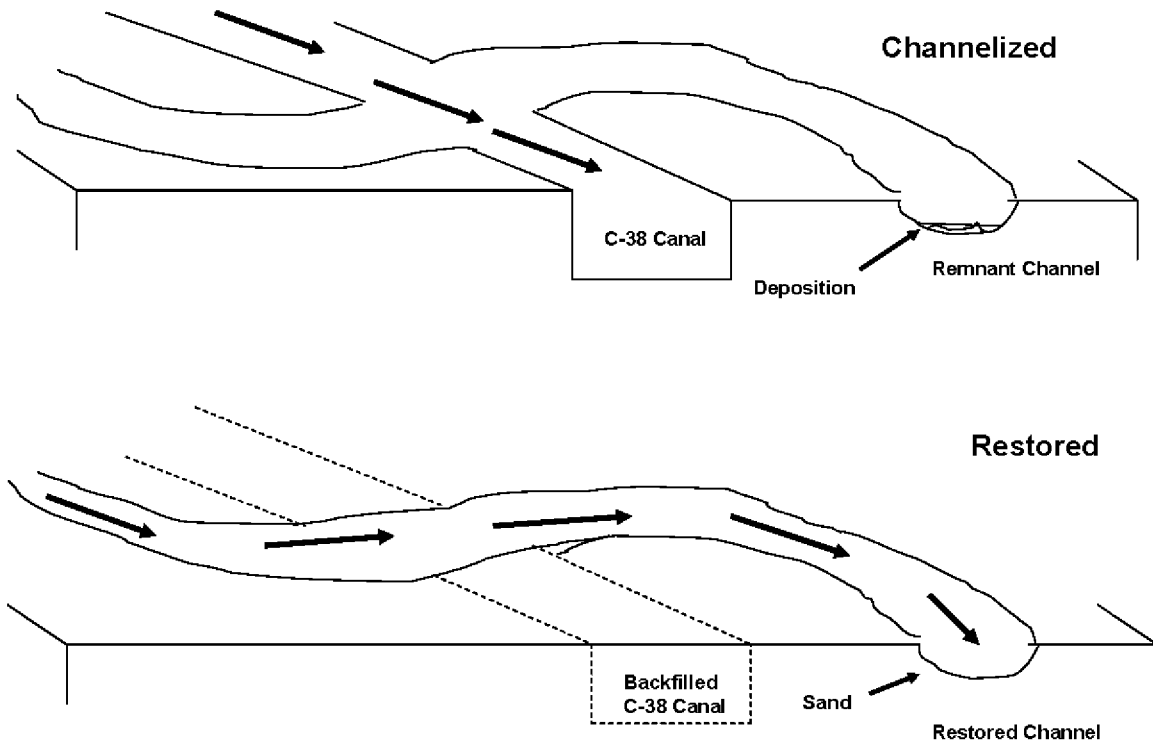
Figure 3-1. Schematic representation of a cross section through the Kissimmee River and its floodplain illustrating changes in geomorphology between the channelized system (top) and the restored system (bottom). Arrows indicate the direction of water flow through the C-38 canal in the channelized system and through the reconnected river channel in the restored system.

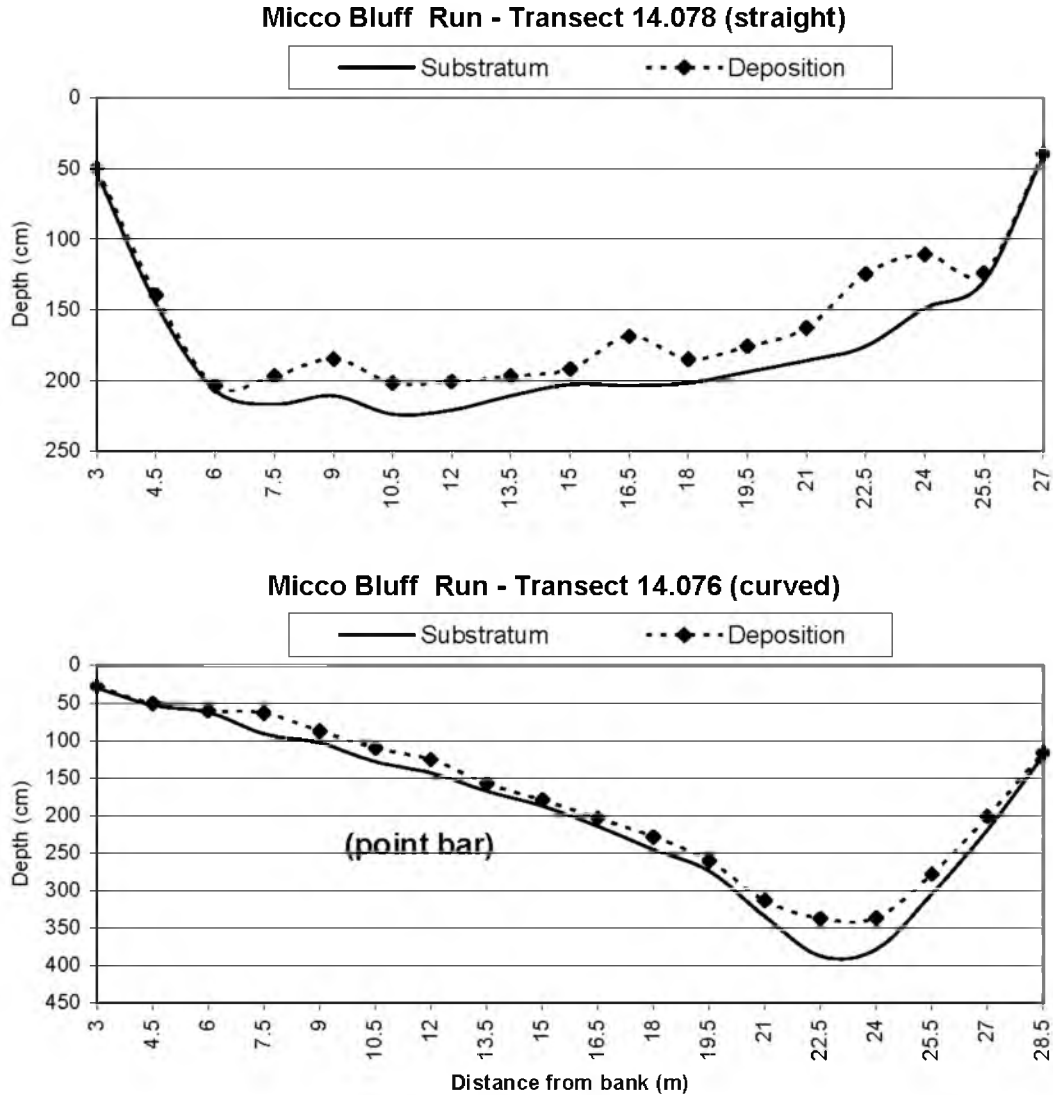
Figure 3-2. Representative channel profiles for transects located in straight (A) and curved (B) sections of channel. These profiles show the surface of the substrate-overlying depositional layer (dashed line) and the surface of the historic channel substrate (solid line). Note that the shallow slope of the bank on the left side of bottom Figure represents a point bar.

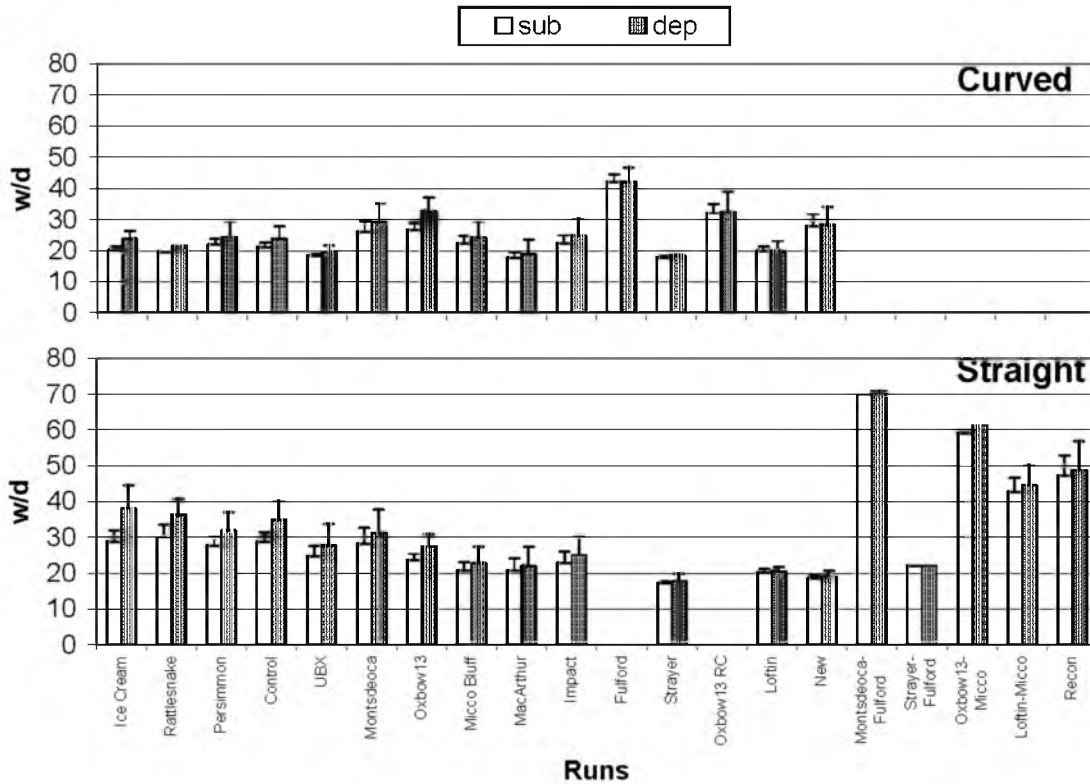
Figure 3-3. Mean width–depth ratio (+1SE) by river runs for transects in curved and straight sections of channel. Width–depth ratios were calculated using the depth to the natural sand substratum (sub) and to the deposits overlying the substratum (dep). River runs are arranged from upstream to downstream within the groupings of Control, Impact, and Recurved.

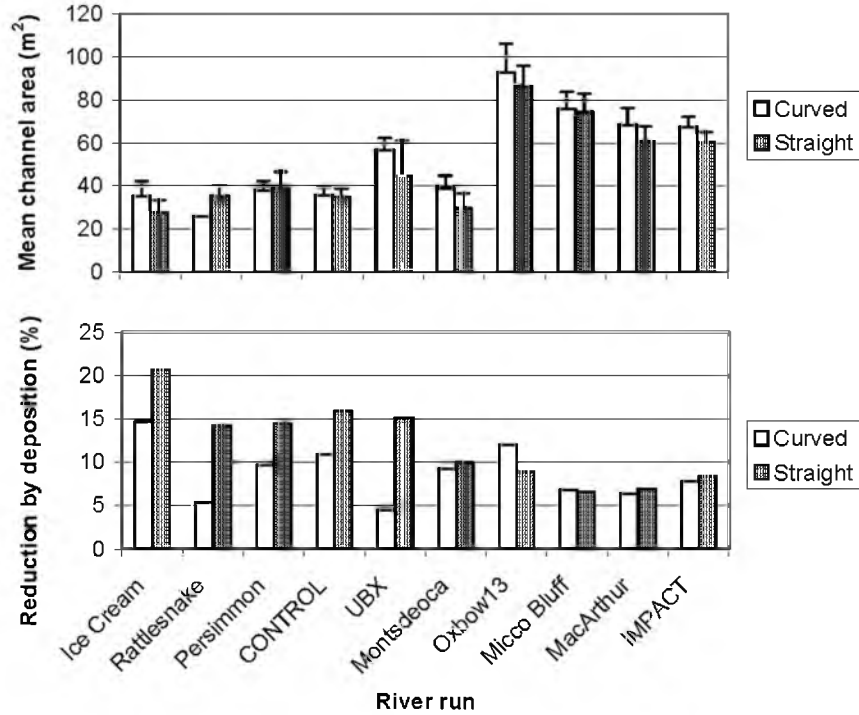
Figure 3-4. Mean (SE) cross-sectional area based on the depth to substratum and percent reduction by deposition on top of the substrate for curved and straight sections of remnant channels in the Control and Impact areas.
