Kissimmee River Restoration Studies

Establishing a Baseline: Pre-restoration Studies
of the Channelized Kissimmee River

Defining Success: Expectations for Restoration
of the Kissimmee River

South Florida Water Management District

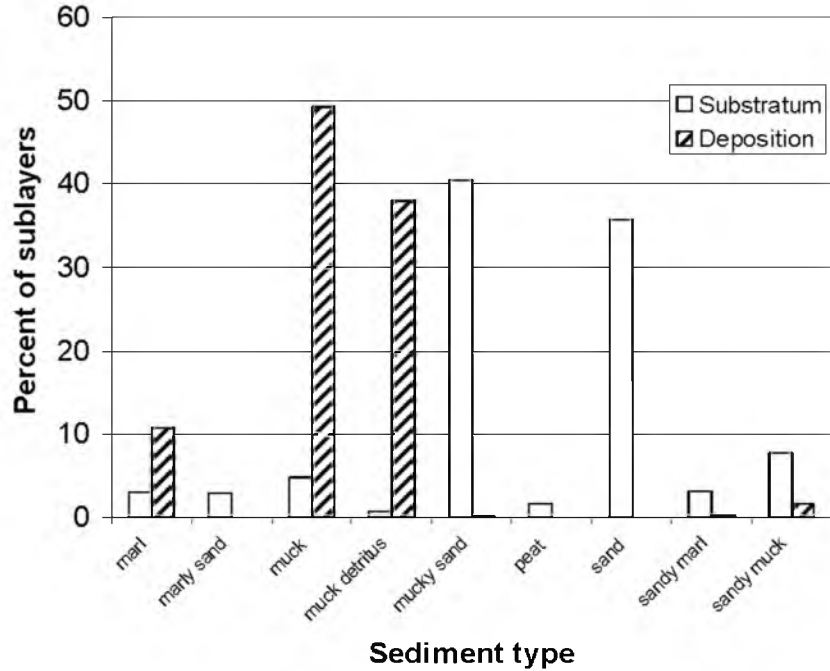
Figure 3-5. Percent of identified sublayers belonging to different sediment types. Sediment types are defined in Table 3-2. Sediment types were identified for 4487 sublayers in the above-substrate depositional layer and for 3351 sublayers in substratum layer.

Channel sediments were characterized by collecting 7-56 samples per transect for a total of >3,000 samples. We defined 12 sediment types, but three (detritus, sandy peat, and mucky peat) were not observed in core samples (Table 3-2). The remaining nine sediment types occurred in the natural channel bed substratum, and all but two types (marly sand and peat) occurred in the substrate-overlying deposits (Figure 3-5). Almost 90% of the substrate-overlying sublayers were characterized as muck (herein defined as fine particles from highly decomposed plant fragments, irrespective of mineral matter content) or muck detritus (fine muck and plant fragments). Muck as used in this study included both material commonly recognized as muck and more flocculent material. Another 11% were marl (calcite mud). The substrate was more diverse with mucky sand and sand accounting for 76% of the sublayers.

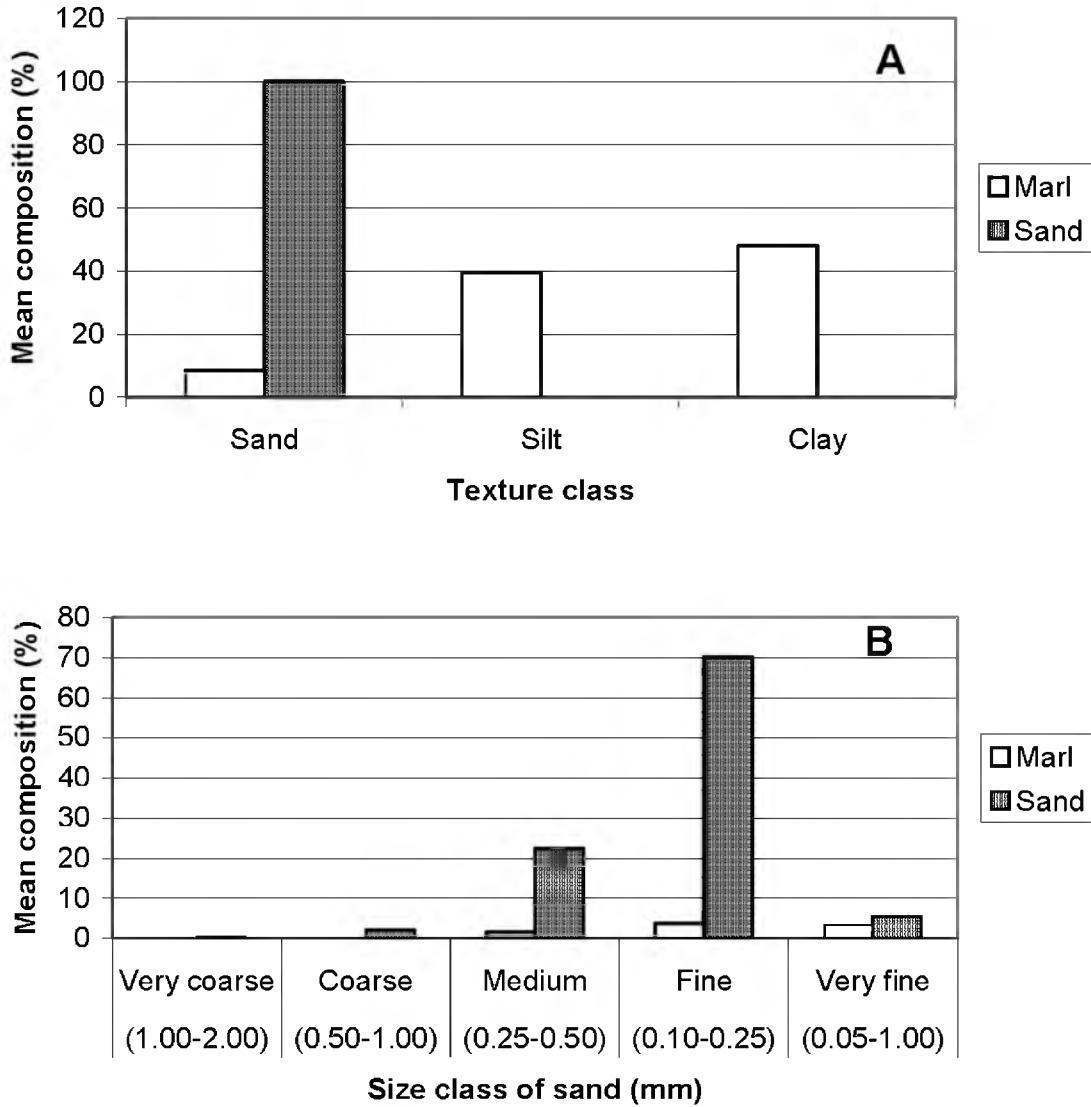
Figure 3-6. Mean composition of different texture classes (A) and different size classes of sand for ten samples of marl sublayers and 21 samples of sand sublayers.

Sand and marl samples contained particles with different size distributions. Sand samples were composed of sand-sized particles (0.05–2.0 mm), while marl samples contained nearly equal quantities of clay and silt-sized particles (<0.05 mm) and averaged <10% sand (Figure 3-6A). Sand samples contained mostly fine-sized sand particles with some medium-sized particles (Figure 3-6B), while the sand fraction of marl was more evenly divided between very fine, fine, and medium-sized sand particles. The total carbon content (as a percentage) of marl was less than half that of muck detritus but only slightly less than that of

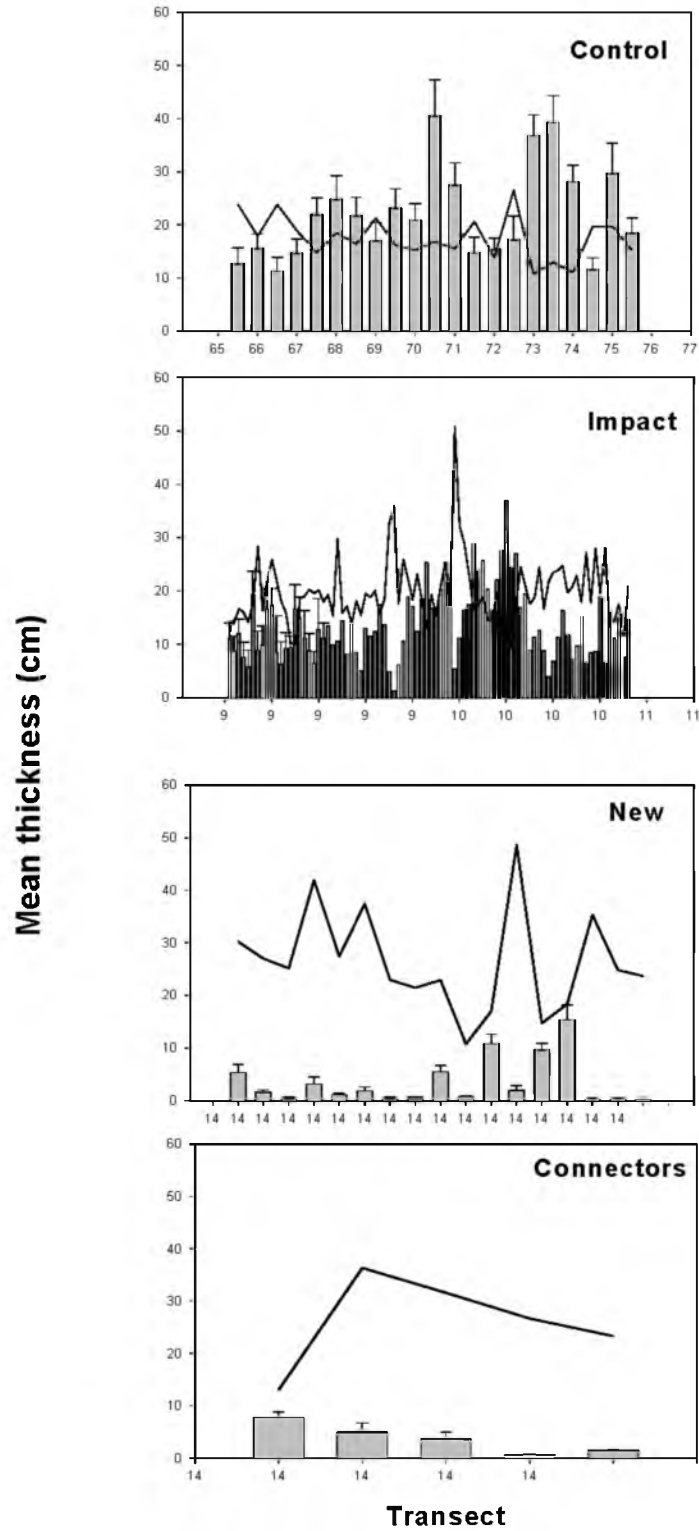
Figure 3-7. Mean thickness (SE) of substrate-overlying deposits (bars) and sampling precision (line) for each transect in the control, impact, new and connector channel types. Sampling precision was the standard error divided by the mean.

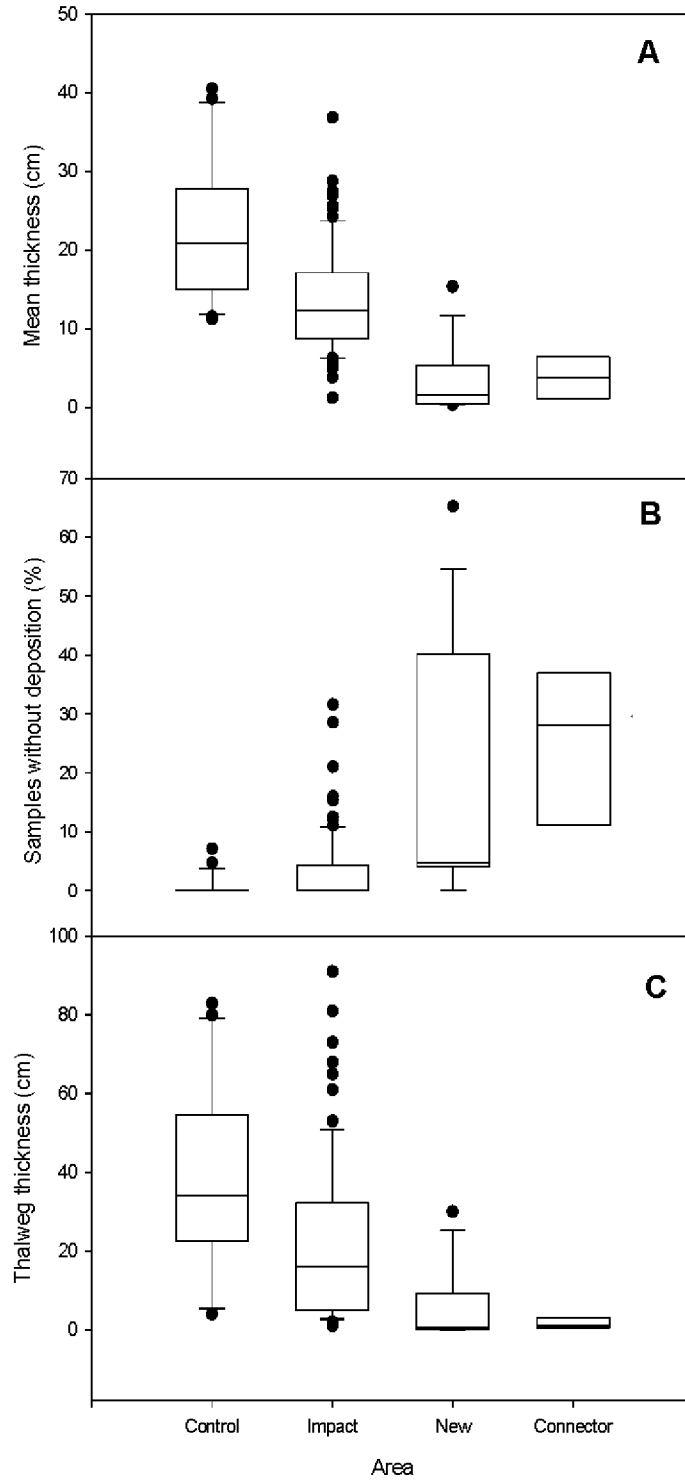
Figure 3-8. Box plots of mean thickness (A), percent of samples without deposition (B) and thalweg thickness (C) for each channel type. Horizontal lines represent the median values, the ends of the boxes represent the 25th and 75th percentiles, and the error bars indicate the 10th and 90th percentiles. Circles indicate values outside the 10th and 90th percentiles.

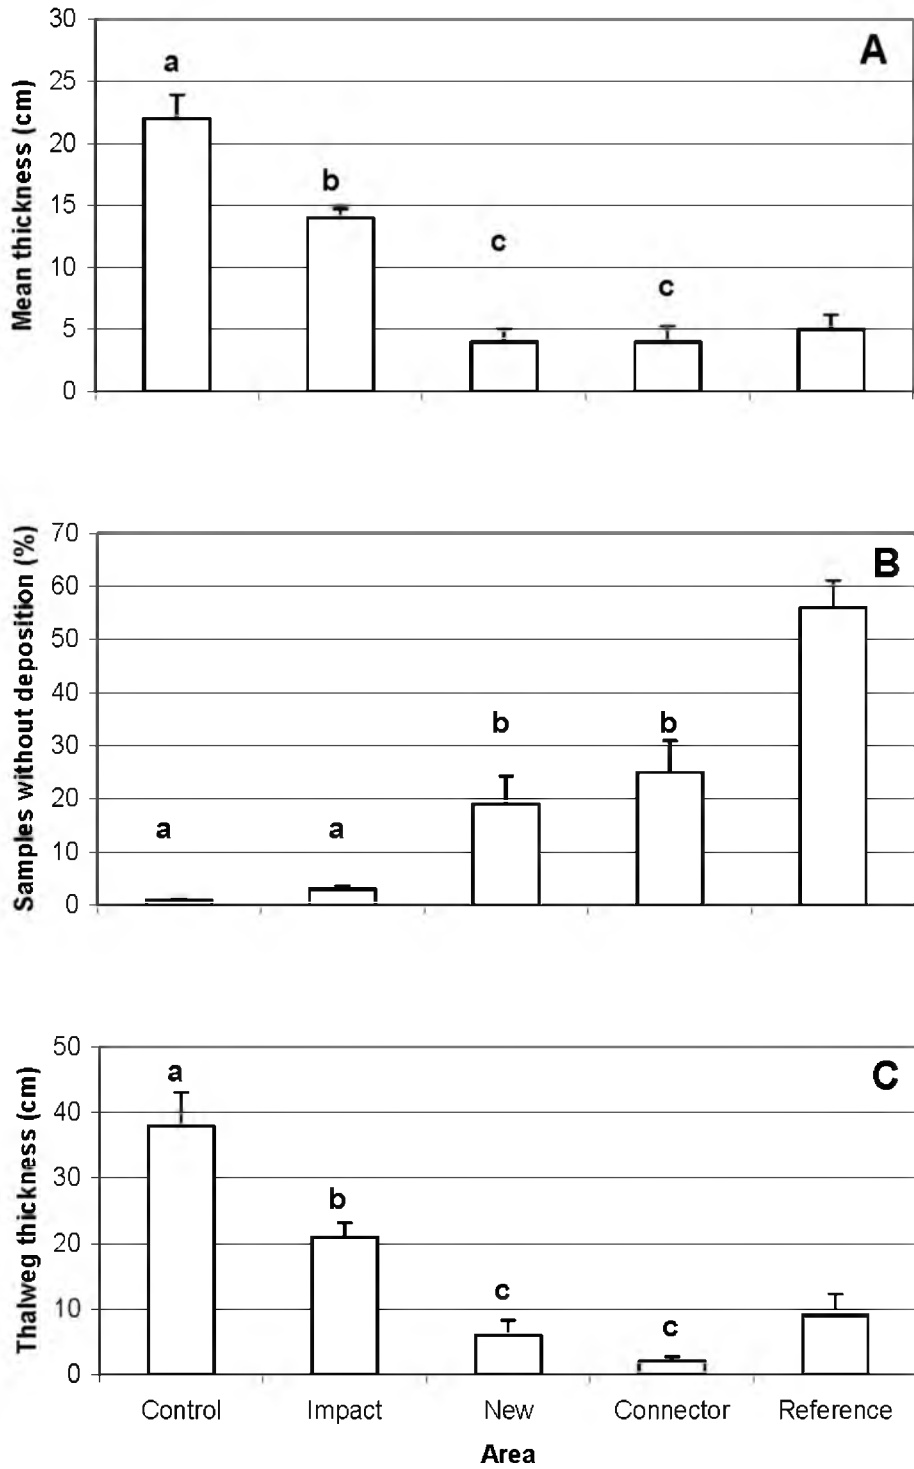
Figure 3-9. Mean (+SE) values for mean thickness of substrate-overlying layer on a transect (A), percentage of samples without a substrate-overlying layer on a transect (B), and thickness of the substrate-overlying layer at the thalweg of each transect (C) for control, impact, new and connector channel types. Reference is for the Demonstration Project data. Different letters identify which baseline channel types were significantly different (Tukey's HSD, $p < 0.01$).

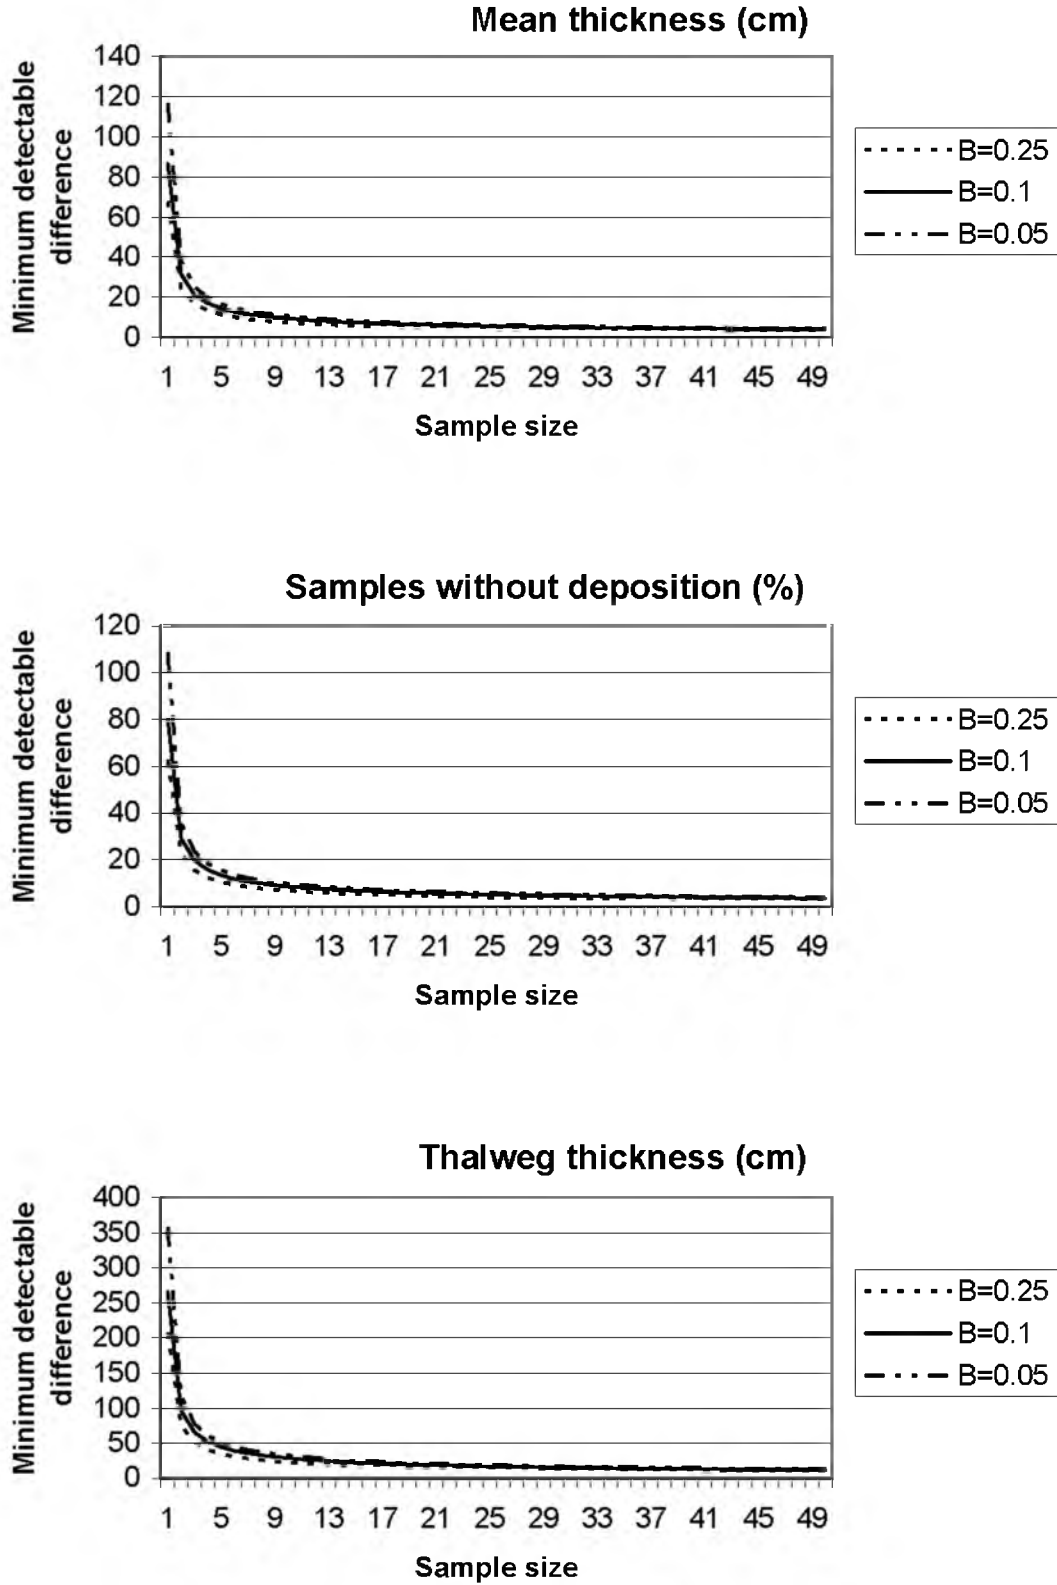
Figure 3-10. Minimum detectable difference versus sample size from a power analysis on mean thickness of the substrate-overlying layer (A), percent of samples without substrate overlying deposits (B), and thalweg substrate-overlying layer thickness (C), when $\alpha = 0.05$ and for three levels of β .

Estimates of the minimum detectable difference showed similar relationships to sample size and β for mean thickness of substrate-overlying deposits, percent of samples without substrate-overlying deposits, and thickness of substrate-overlying deposits at the thalweg (Figure 3-10). For all three metrics, the minimum detectable difference decreased with increasing sample size, especially for sample sizes <10 . Minimum detectable difference increased with increasing values of β until $n = 10$, and then β had little effect on the minimum detectable difference.

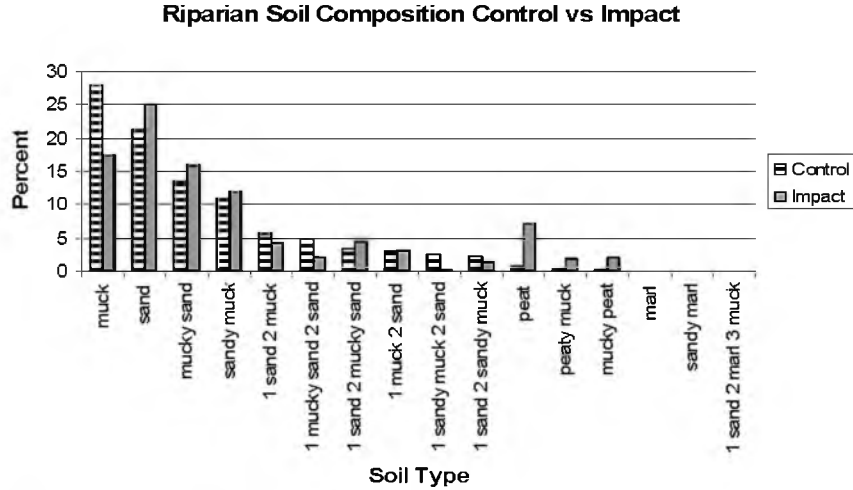
Figure 3-11. Riparian soil composition, Control vs. Impact. Percentages are based on total number of core samples taken from the Control and Impact area.

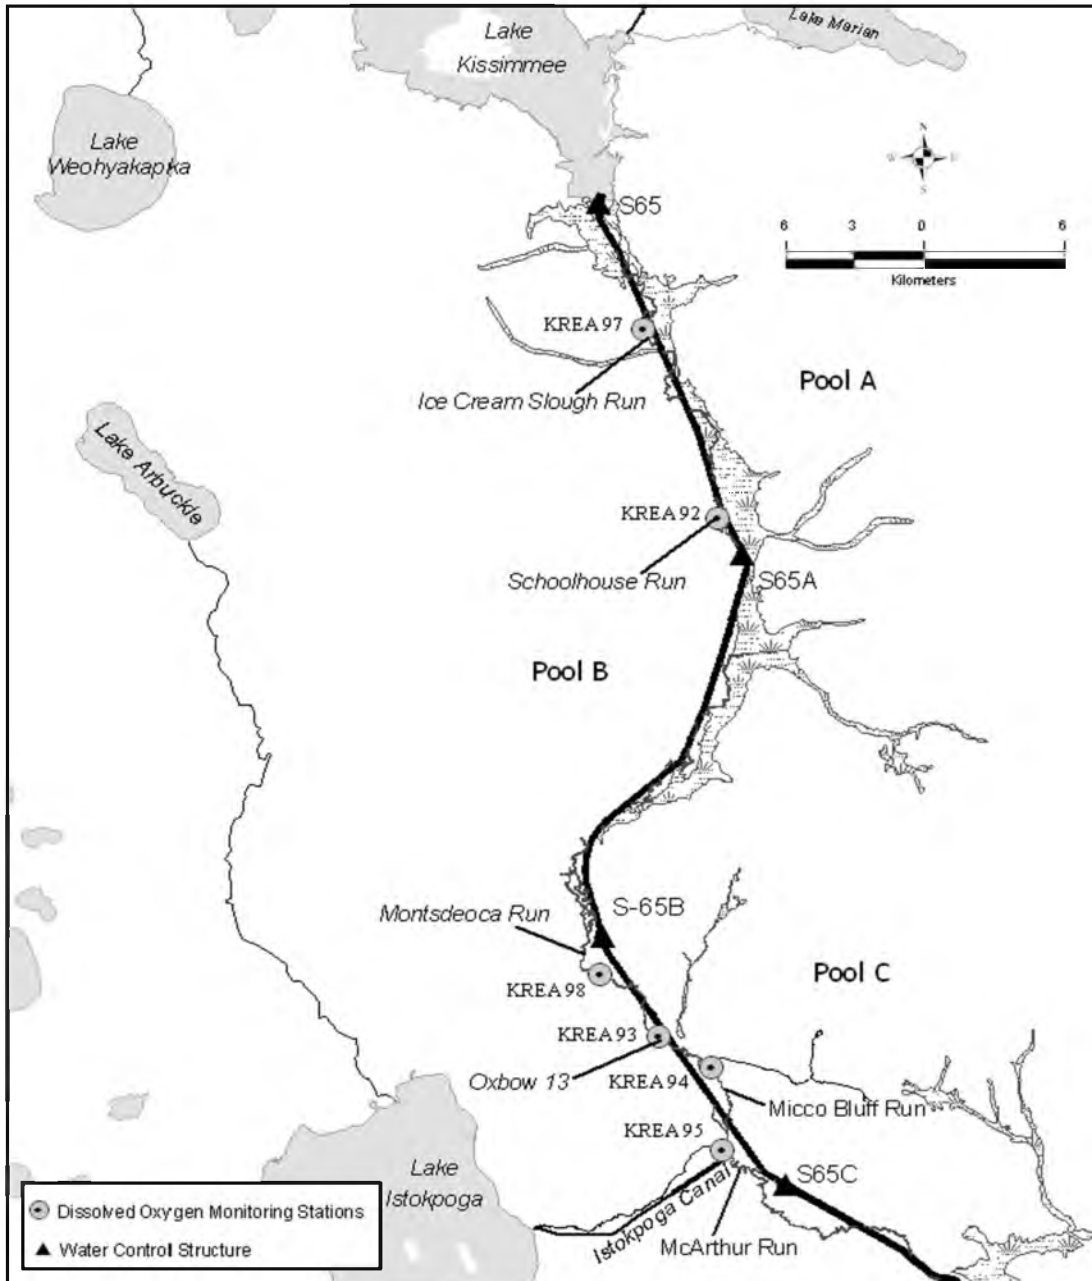
Figure 4-1. Dissolved oxygen monitoring stations along the channelized Kissimmee River.

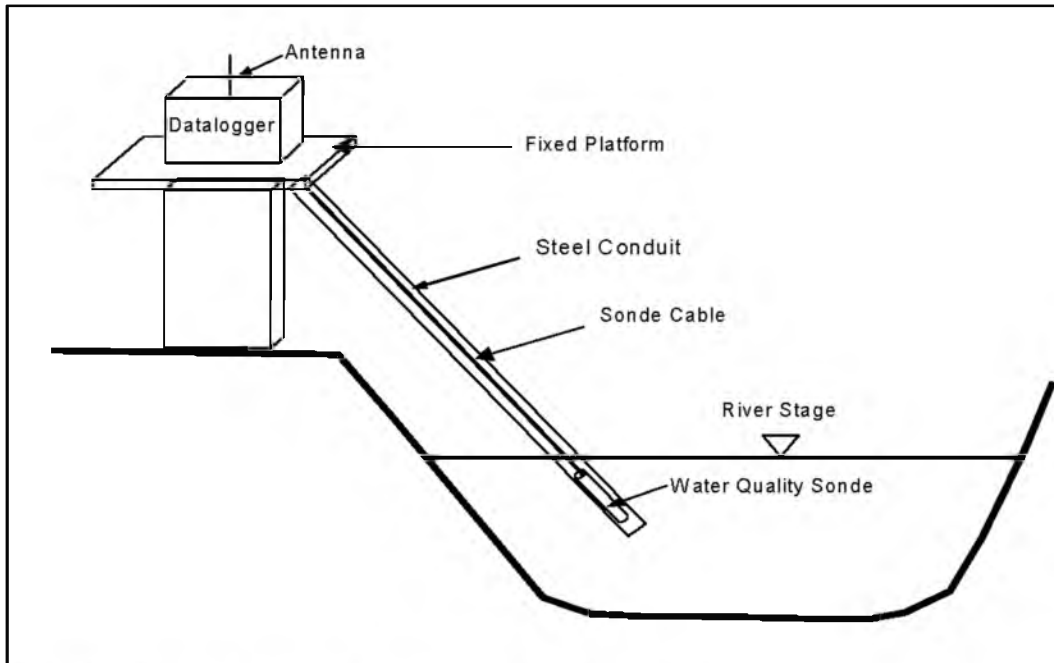
Figure 4-2. Continuous water quality monitoring station design.

Dissolved oxygen and water temperature were monitored continuously with a YSI 600R multiparameter water quality sonde (YSI Inc., Yellow Springs, Ohio) at three remnant river run stations in the impact and control areas (KRBN, KRDR and KREN; Figure 4-1). Sondes were fixed at a depth of approximately one meter at each station. Each sonde was wired to a Campbell CR10 datalogger (Campbell Scientific, Logan, Utah) and programmed to record data at 15 minute intervals (Figure 4-2). Data were uploaded automatically to the South Florida Water Management District (SFWMD) base station via radio signal every evening. Sonde calibration and maintenance were performed weekly according to YSI calibration procedures. Monitoring began at each station between July and October 1997.

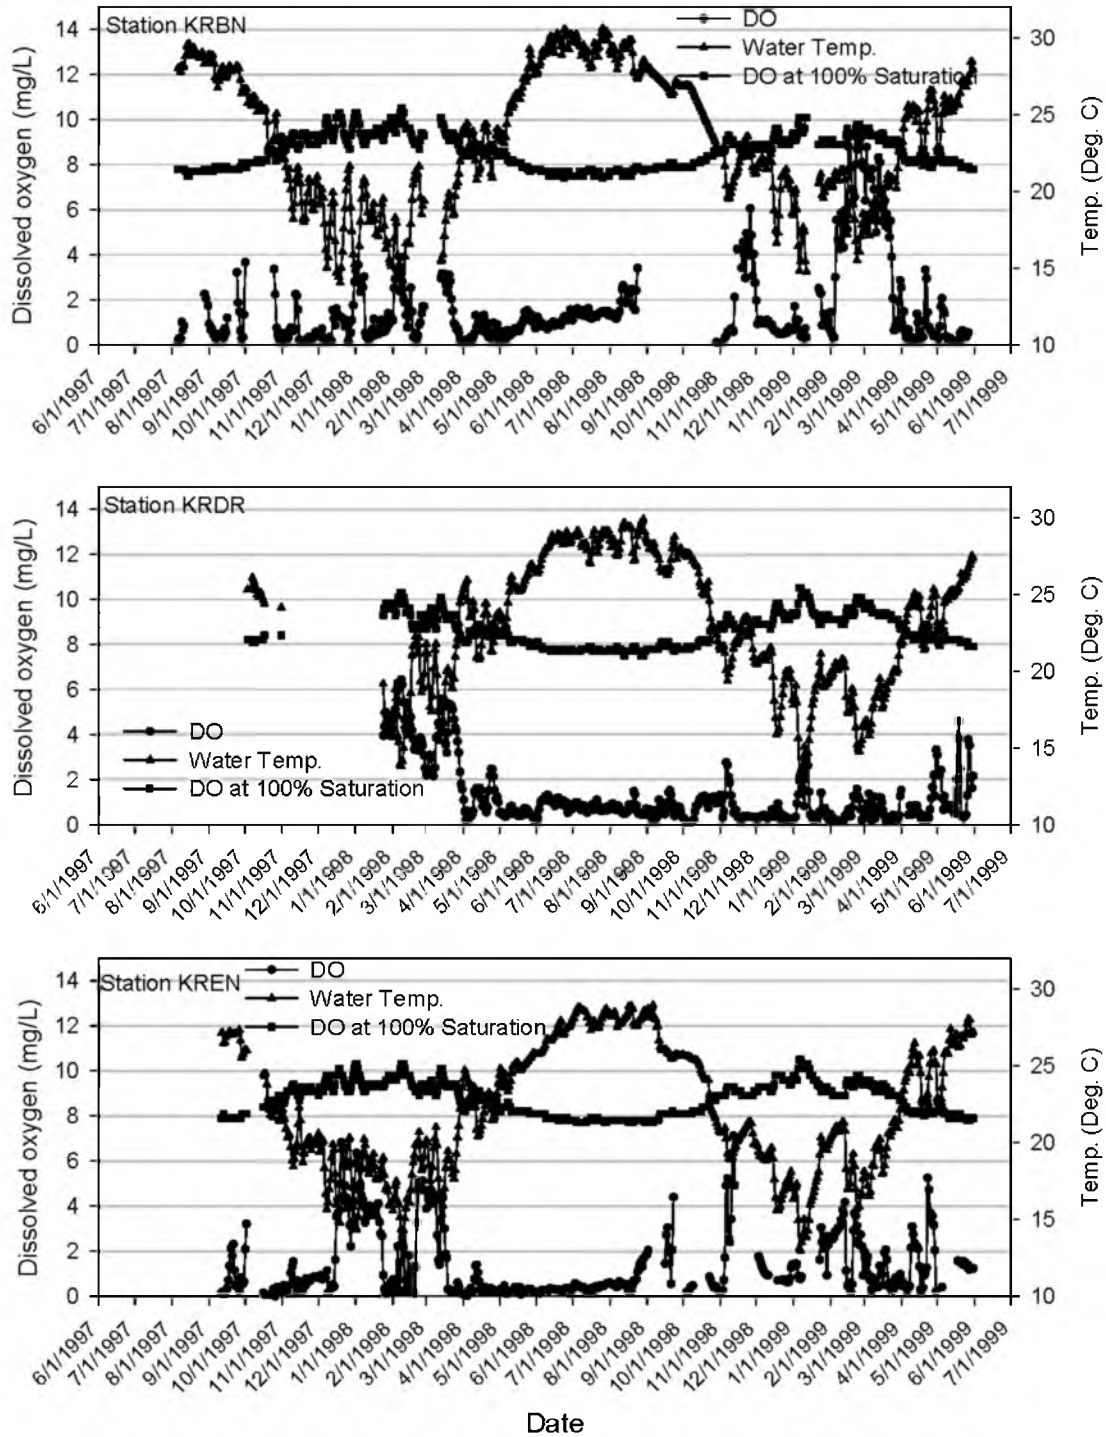
Figure 4-6. Mean daily dissolved oxygen (DO) concentration, water temperature and DO concentration at 100% saturation at remnant river channel stations. Breaks in the data are due to data discarded by the QA/QC process.

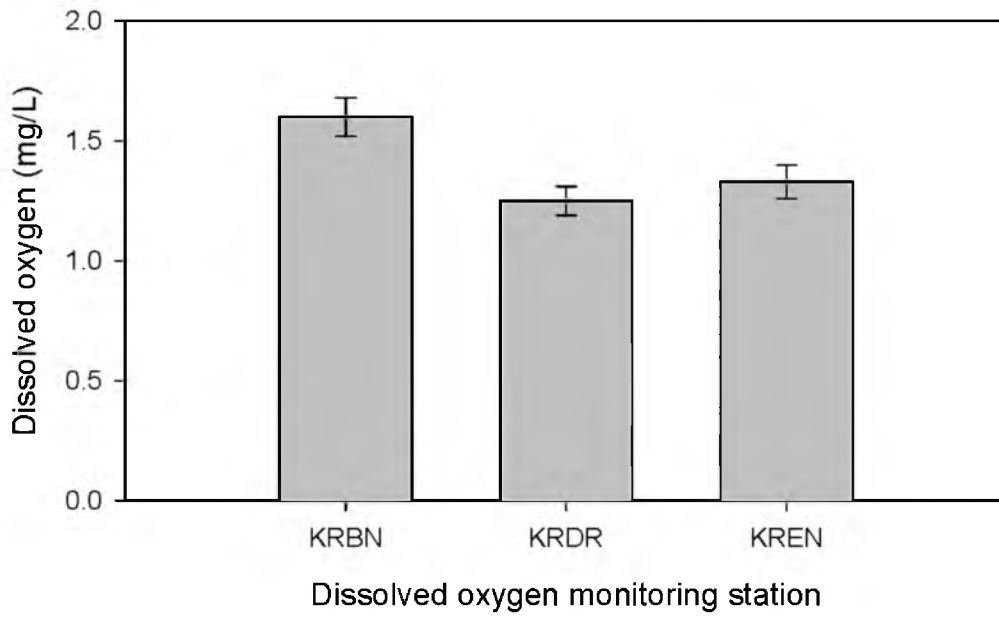
Figure 4-7. Mean daily dissolved oxygen (DO) concentration (± 1 standard error) at remnant river channel stations during the baseline study period. Means were calculated using average daily DO concentrations (average of 96 values per day) at each station.

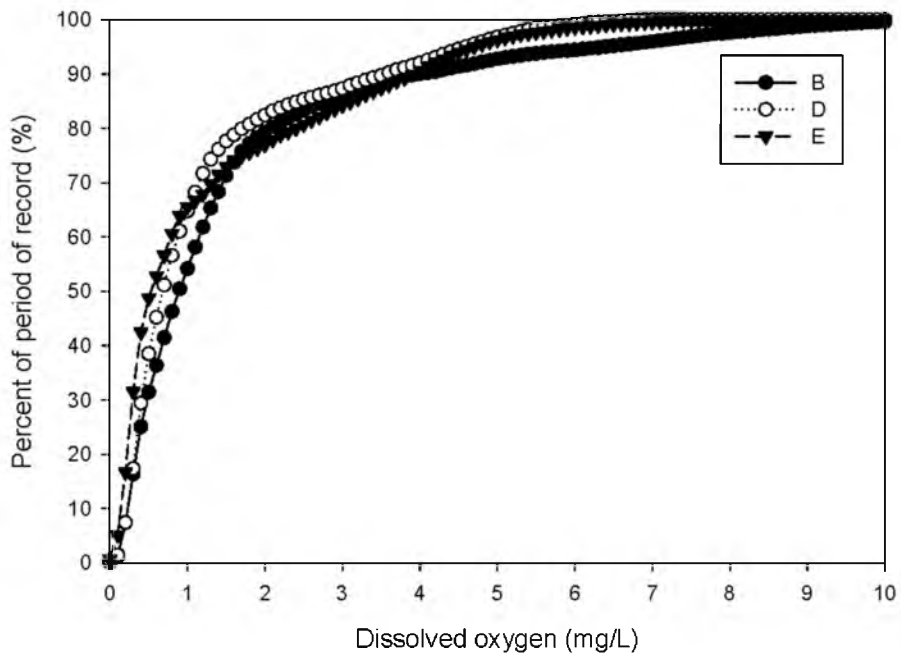
Figure 4-8. Cumulative frequency diagram of dissolved oxygen concentrations at stations KRBN, KRDR and KREN (July 1997–June 1999).

Mean daily DO concentrations at stations KRBN, KRDR, and KREN were <2 mg/L for 77–82% of the baseline period and <5 mg/L for 93–97% of the baseline period (Figure 4-8).

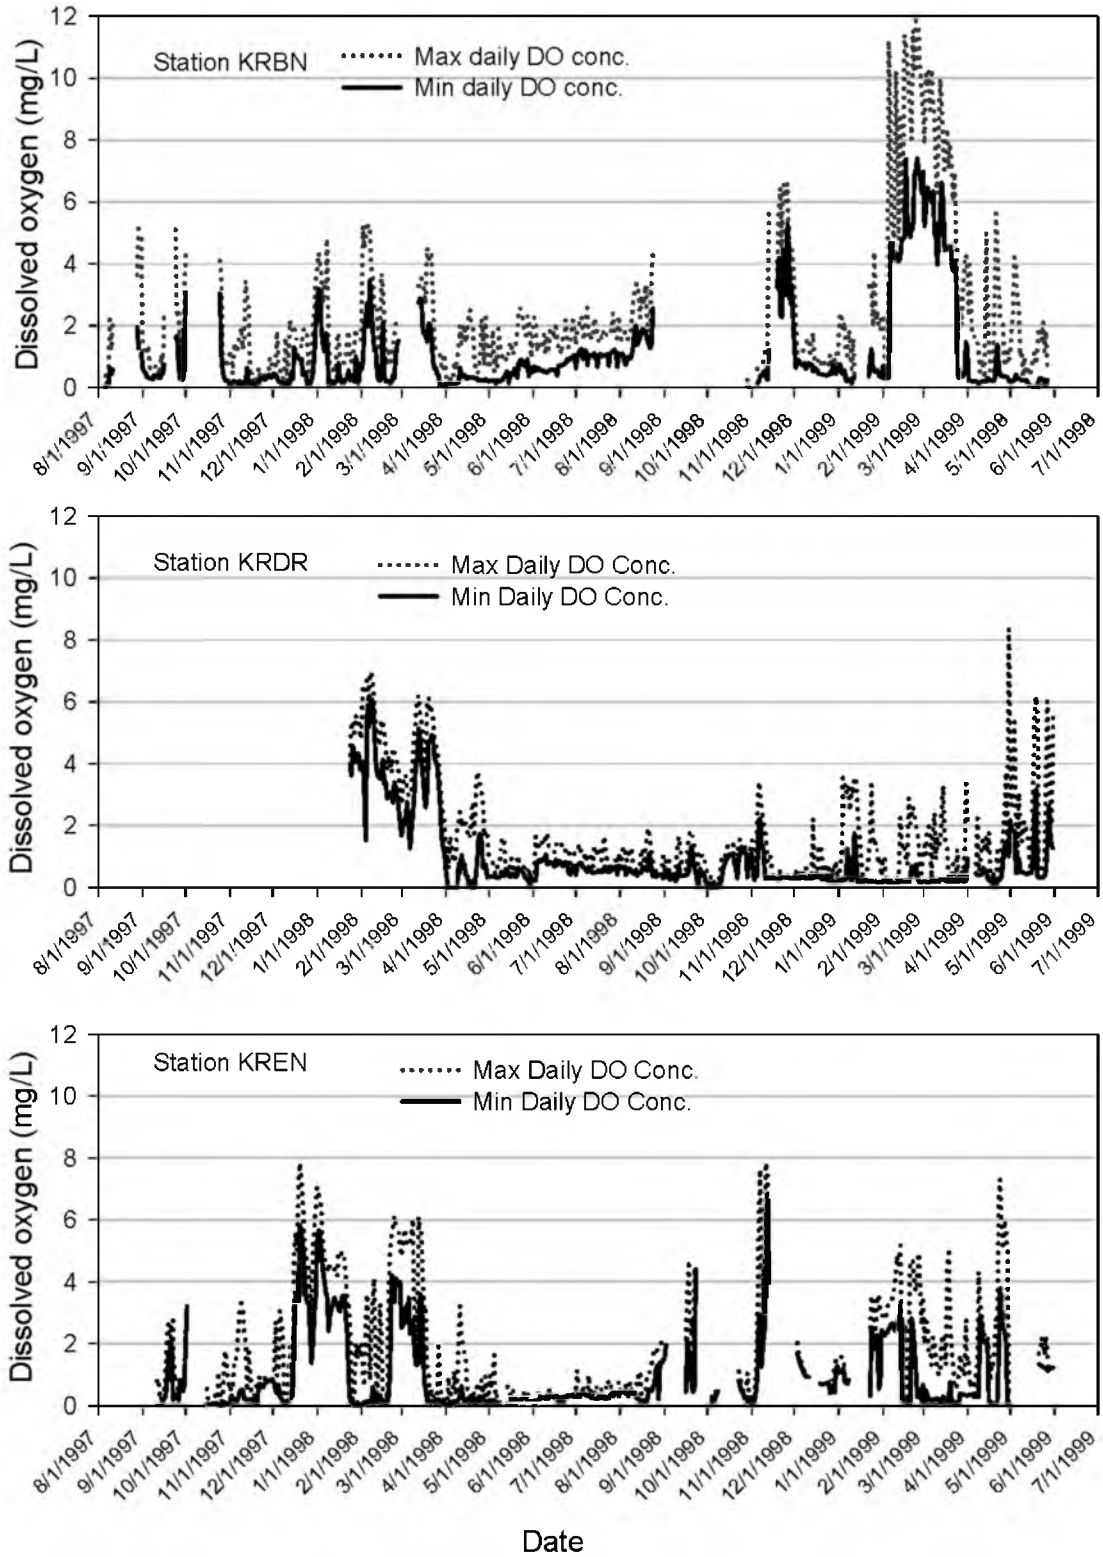
Figure 4-10. Maximum and minimum daily dissolved oxygen concentrations at remnant river channel stations during the baseline study period.

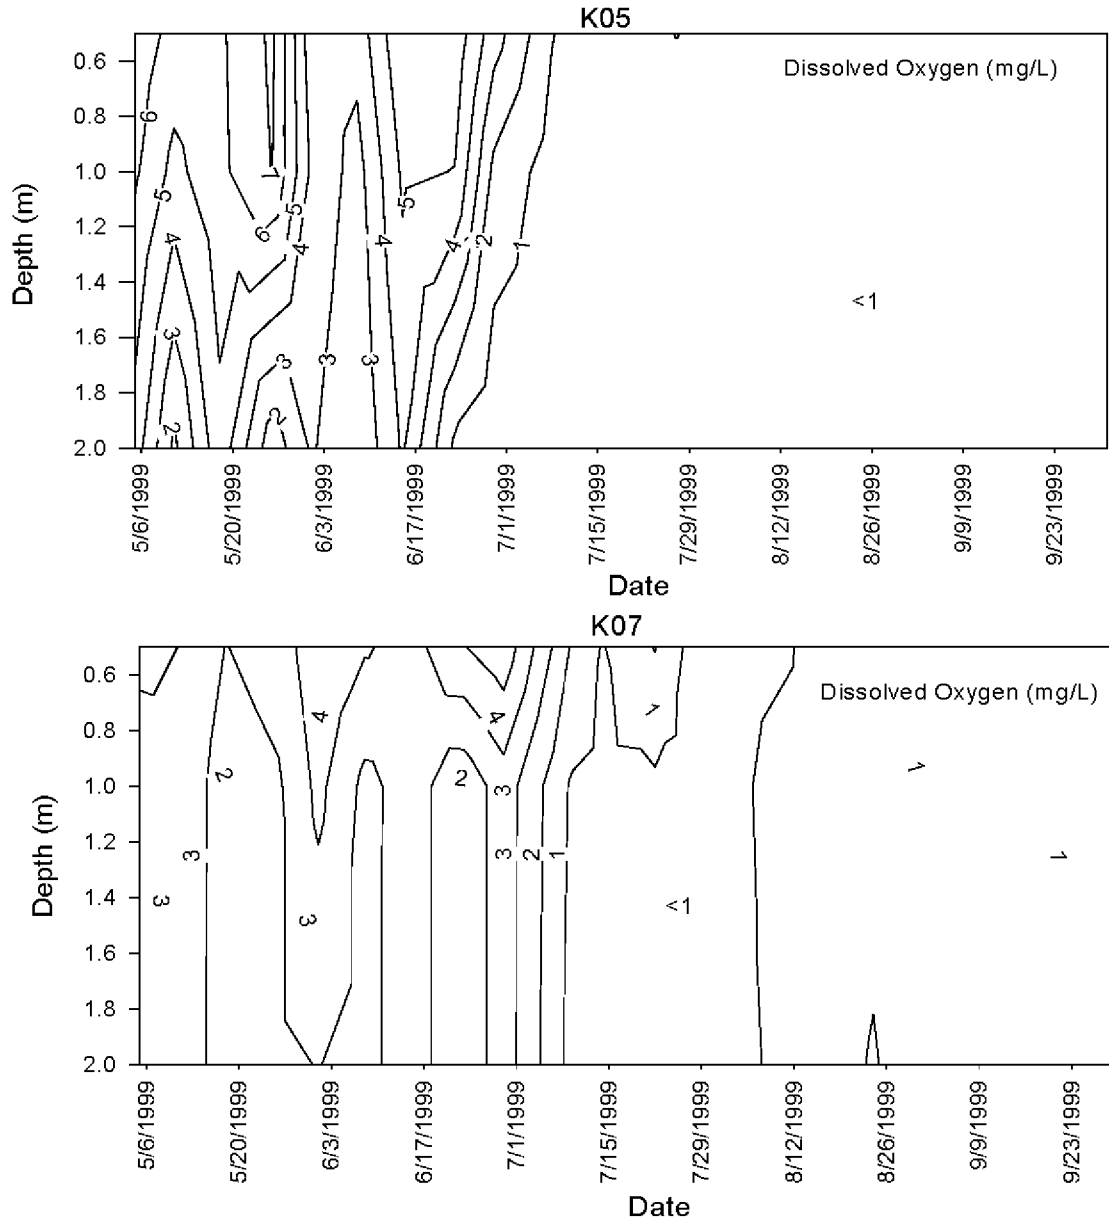
Figure 4-11. Vertical gradient of dissolved oxygen concentrations (mg/L) within Micco Bluff Run during May–October 1999.

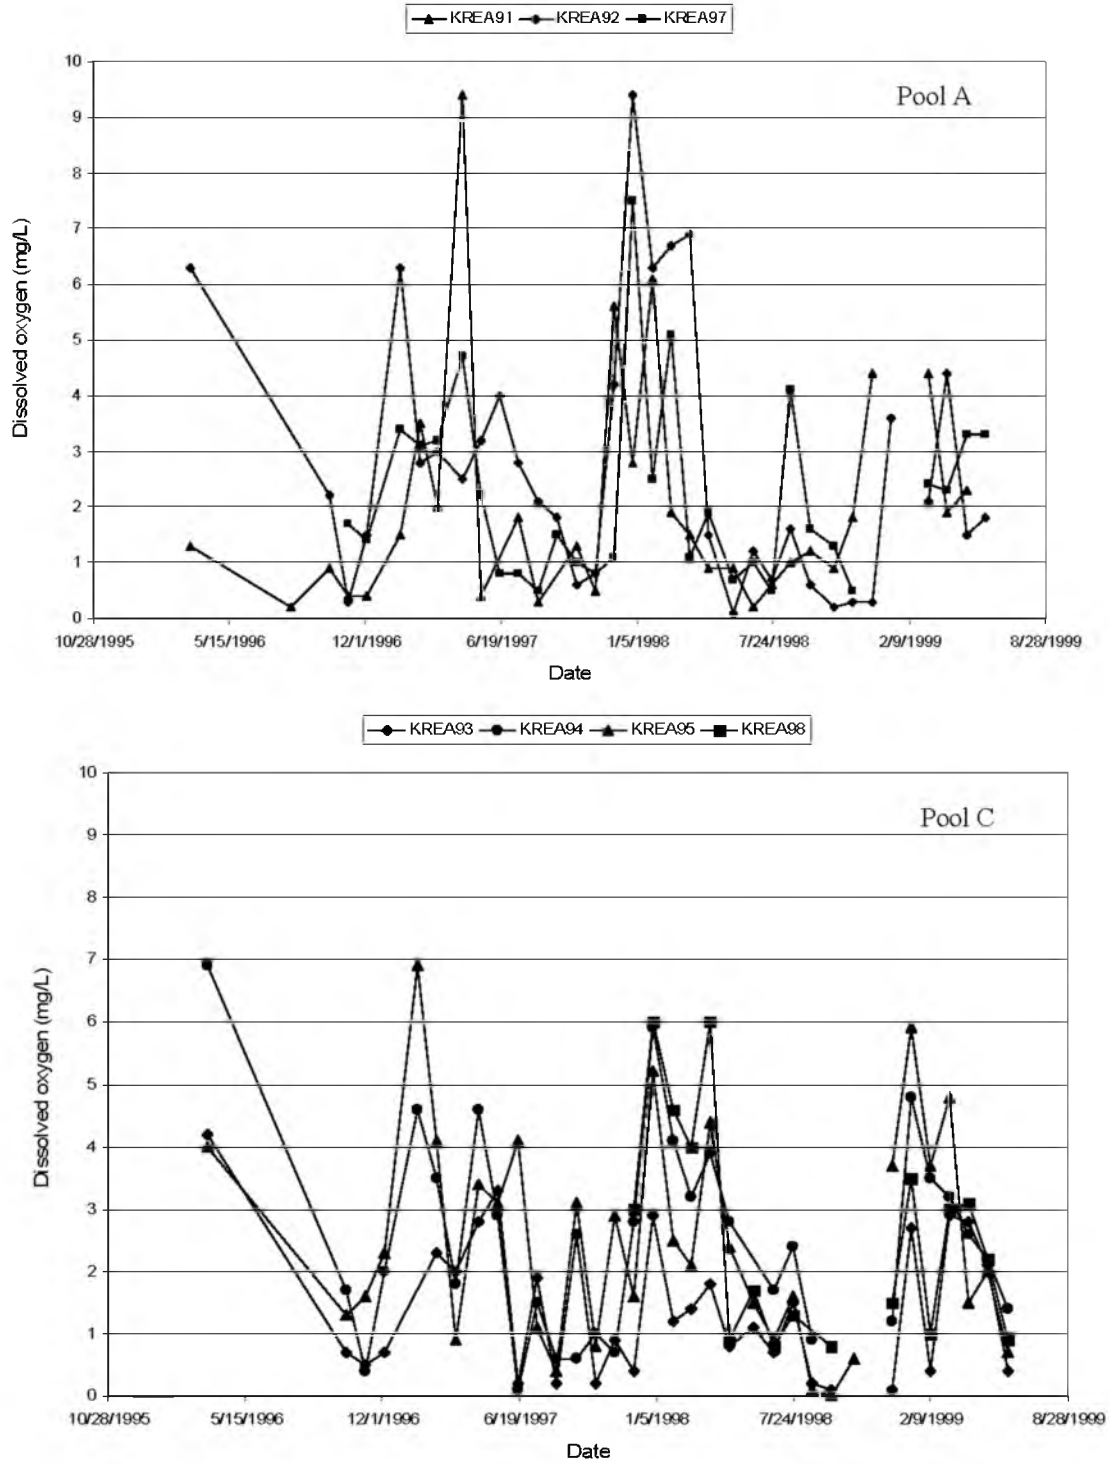
Figure 4-12. Monthly dissolved oxygen concentrations at 0.5 m in remnant river runs of Pools A and C.

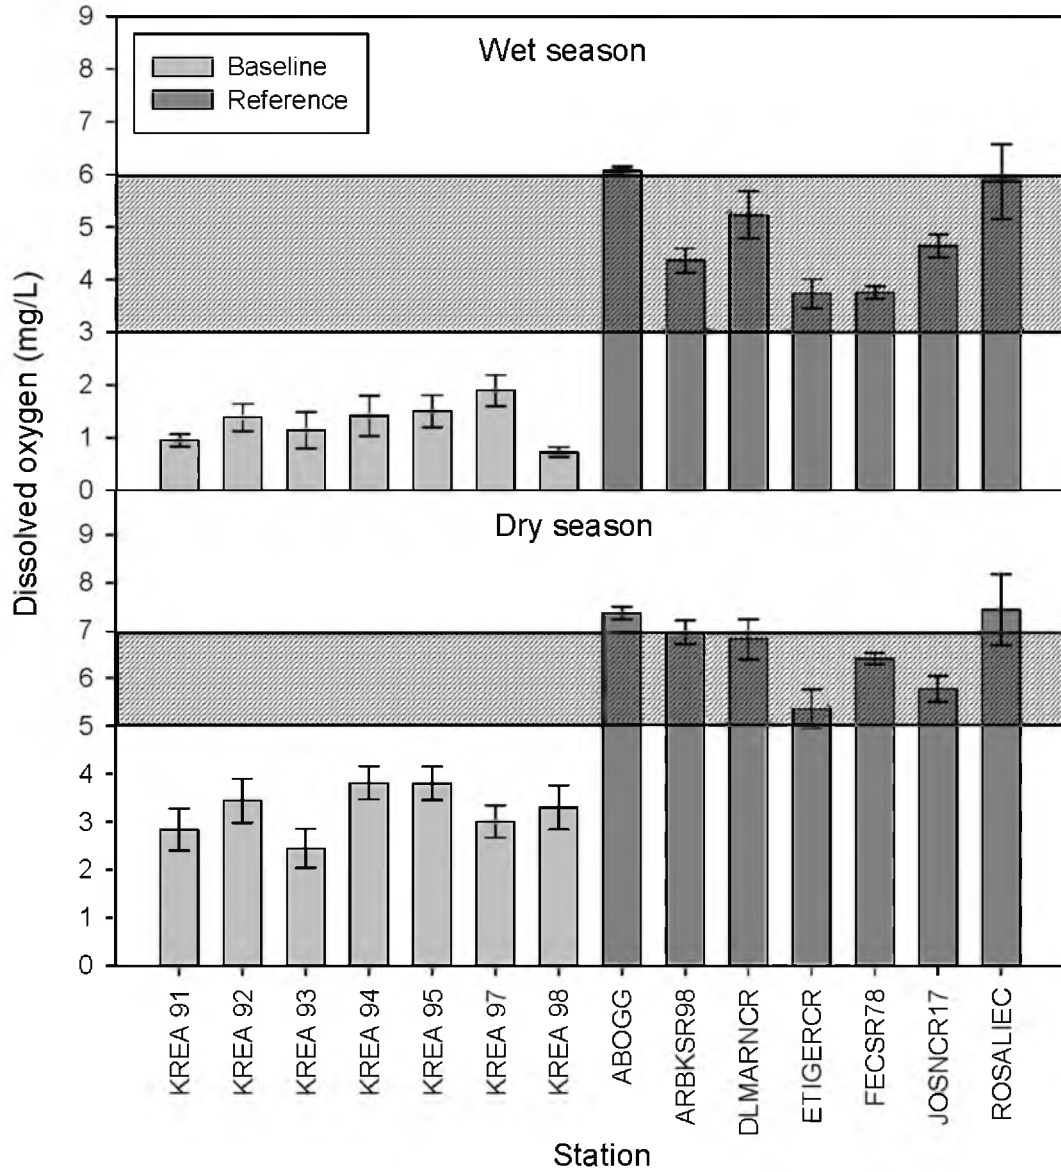
Figure 4-13. Mean (\pm standard error of the mean) dissolved oxygen (DO) concentrations in free-flowing, blackwater, south Florida streams and remnant runs of the channelized Kissimmee River during the wet and dry season. Cross-hatched area represents expected range of DO concentrations in the Kissimmee River after restoration.

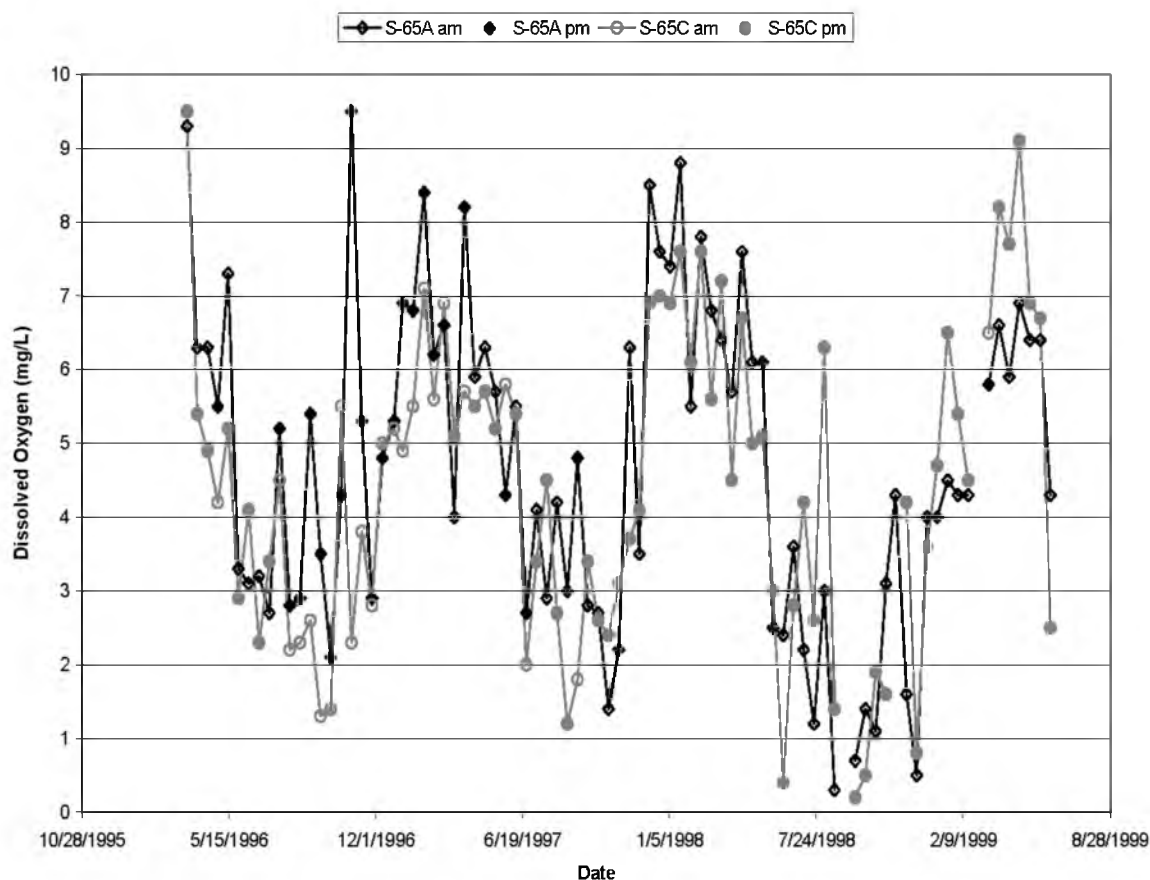
Figure 4-14. Dissolved oxygen concentrations at S-65A and S-65C at 0.5 m.

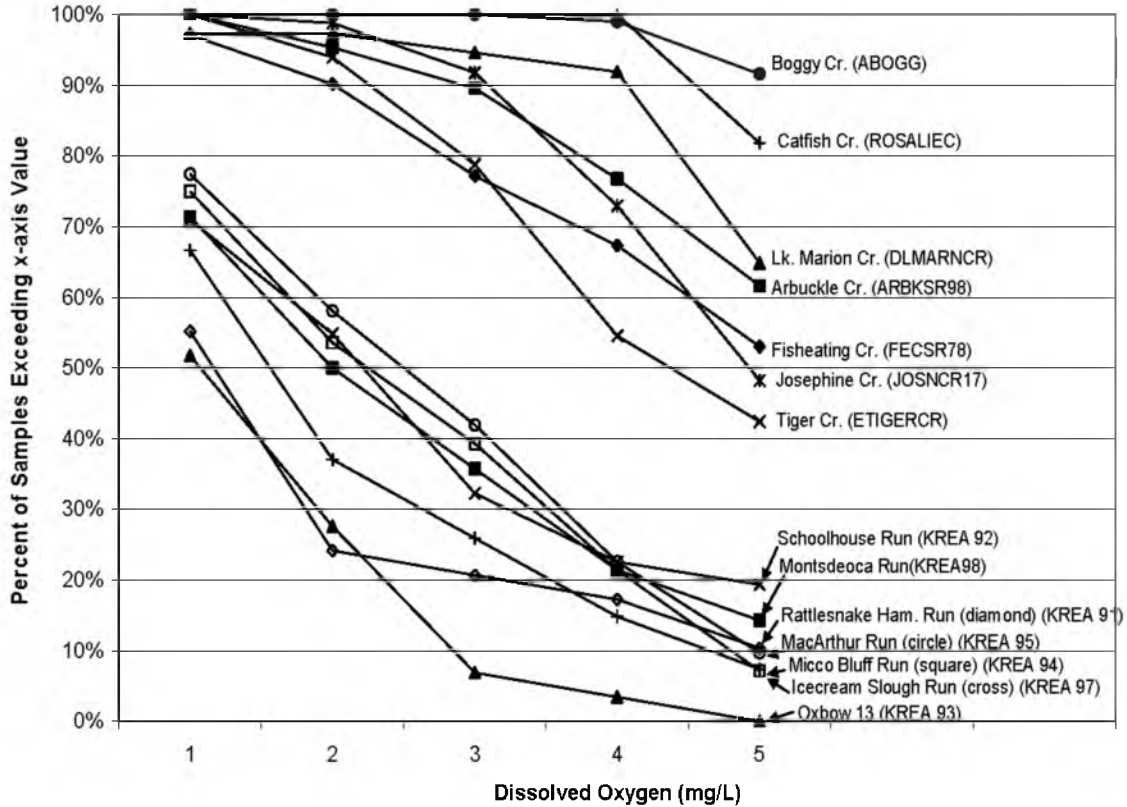
Figure 4-15. Dissolved oxygen concentrations at 0.5 m depth in south Florida reference streams and remnant river runs of the channelized Kissimmee River.
