Kissimmee River Restoration Studies

Establishing a Baseline: Pre-restoration Studies
of the Channelized Kissimmee River

Defining Success: Expectations for Restoration
of the Kissimmee River

South Florida Water Management District

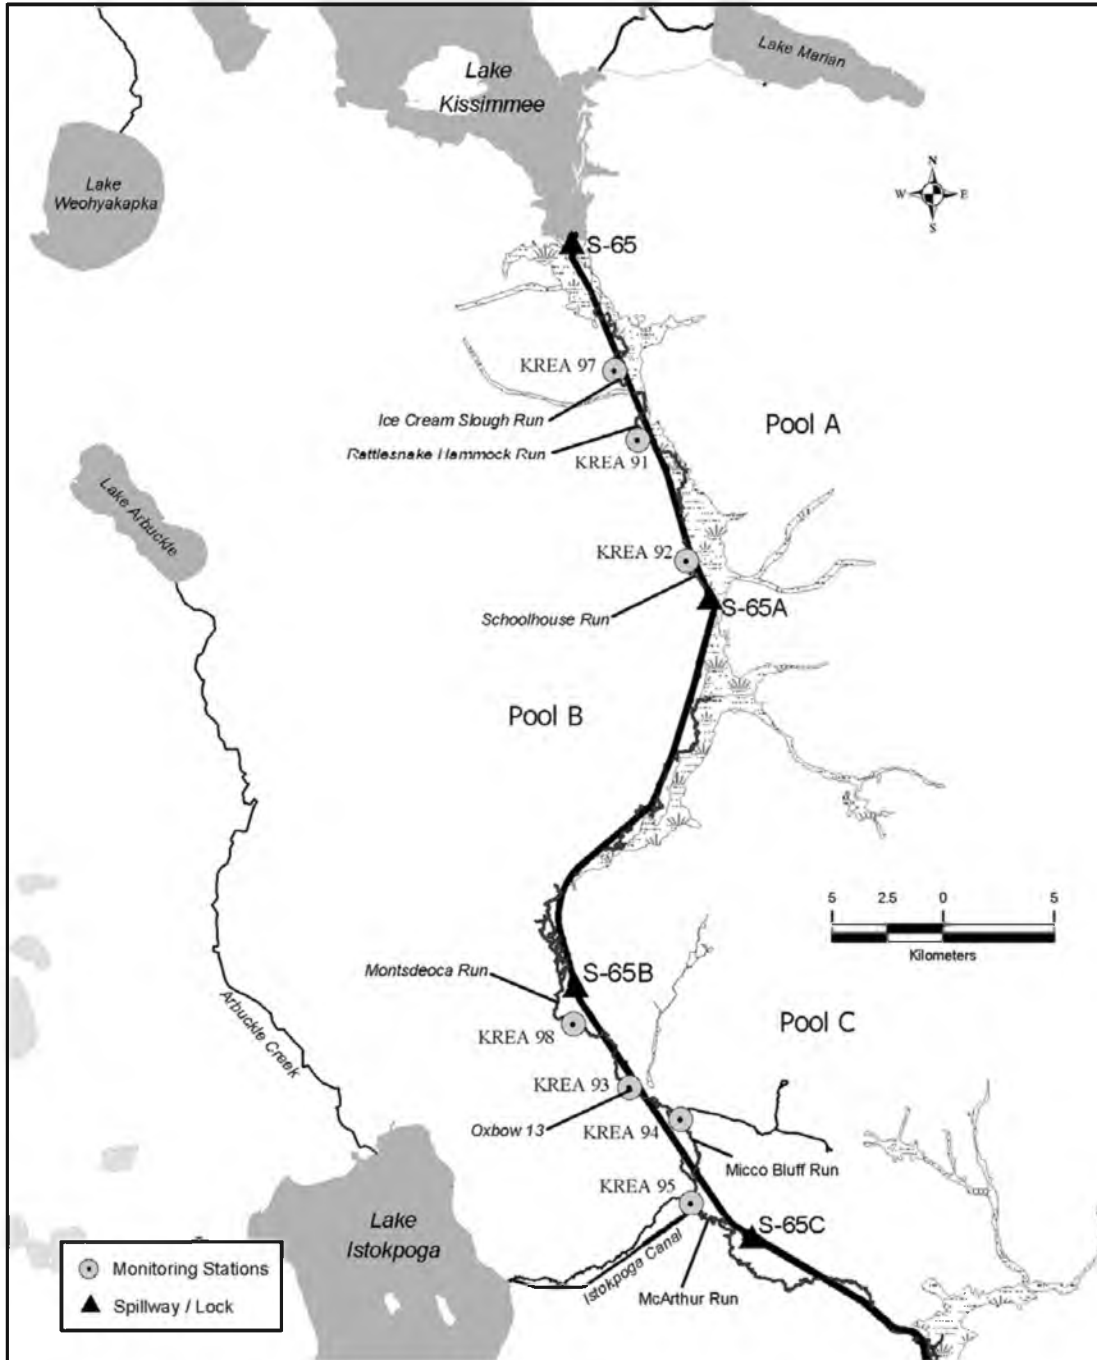
Figure 5-1. Locations of grab sample water quality monitoring stations (KREA91–KREA98) in Pools A and C.

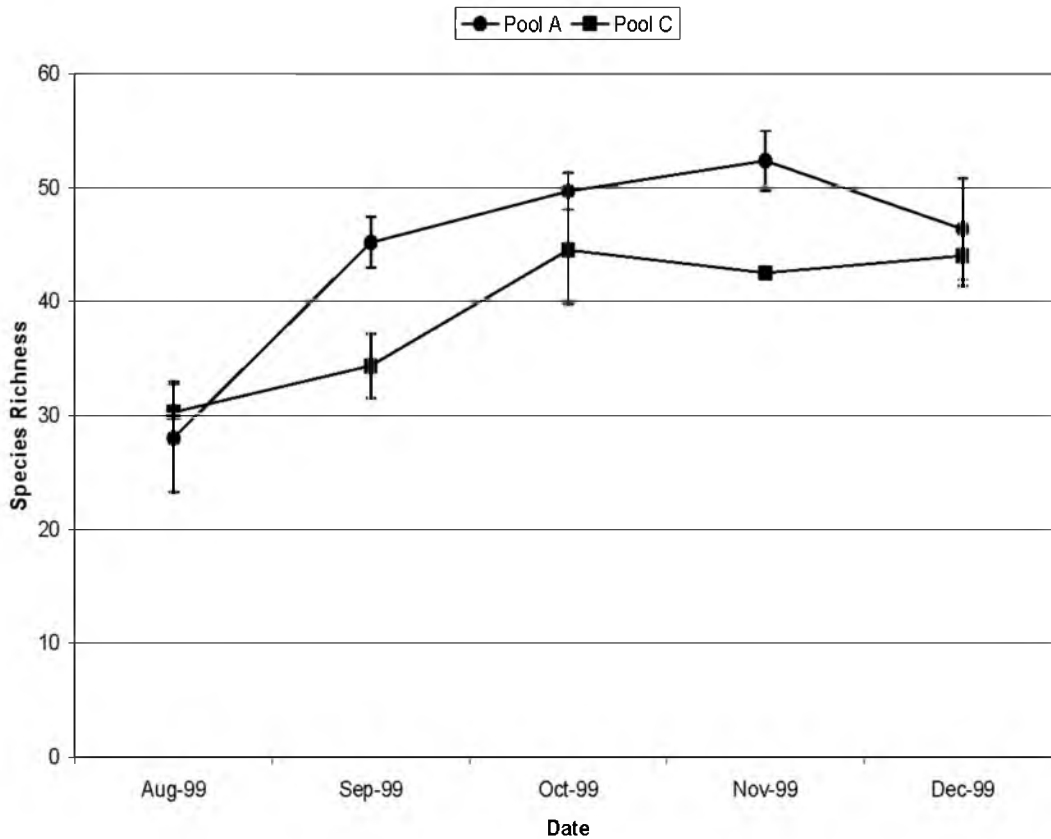
Figure 6-2. Mean monthly periphyton species richness in Pools A and C from August 1999 through December 1999. Error bars represent the standard error of the mean.

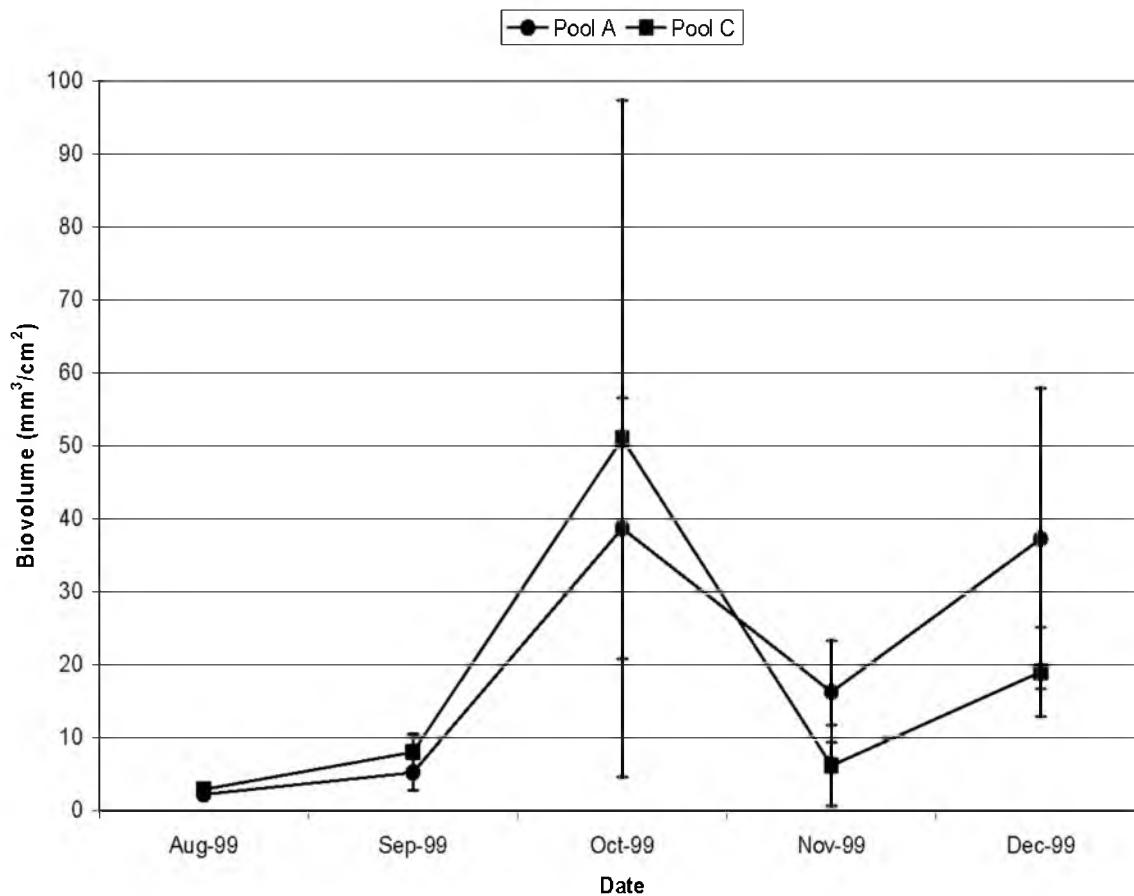
Figure 6-3. Mean monthly periphyton biovolume (mm^3/cm^2) in Pools A and C from August 1999 through December 1999. Error bars represent the standard error of the mean.

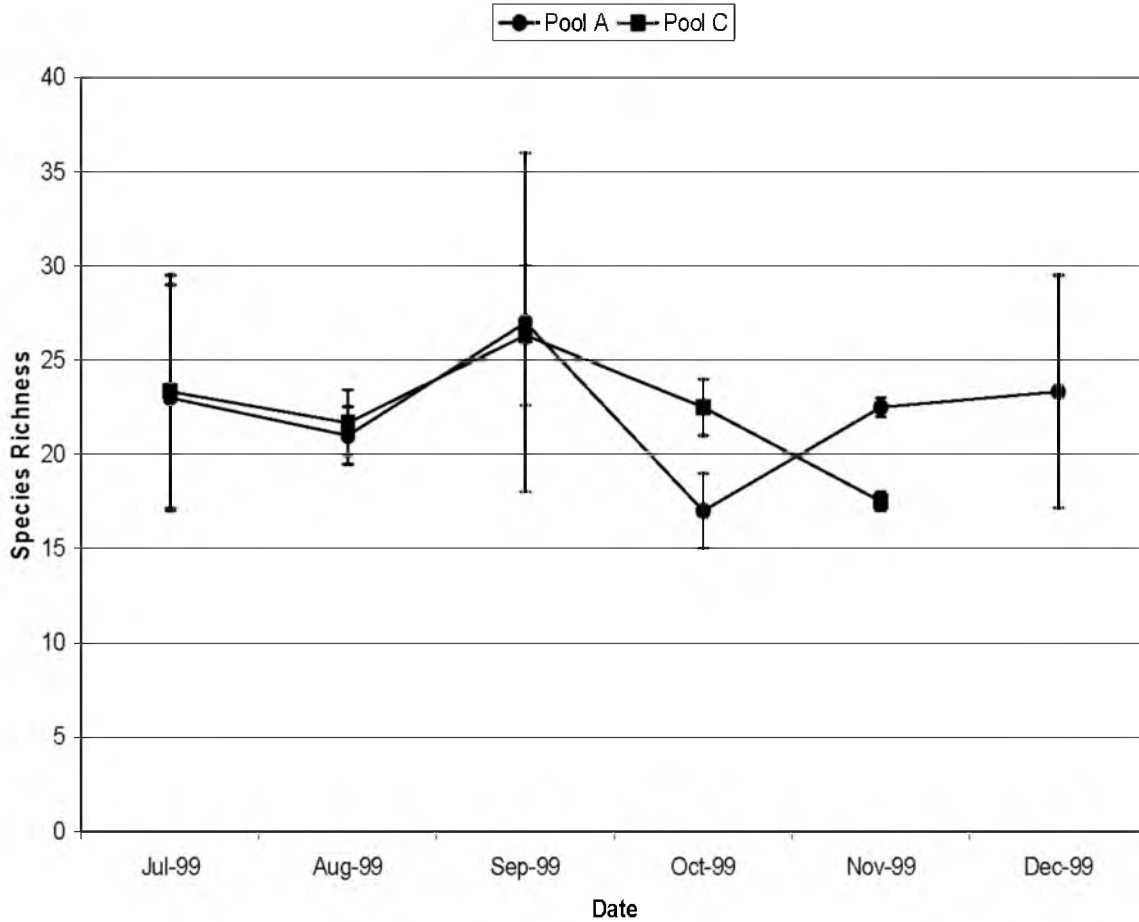
Figure 6-4. Truly planktonic phytoplankton species richness in Pools A and C from July 1999–December 1999. Error bars represent the standard error of the mean.

Mean species richness of truly planktonic species (water column obligates) per sample in remnant river channels was 22.3 ± 1.8 in Pool A and 22.6 ± 1.7 in Pool C (Table 6-4). Phytoplankton species richness varied considerably for some months and very little for other months (Figure 6-4). Highest species richness values occurred during September and lowest values occurred during October–November.

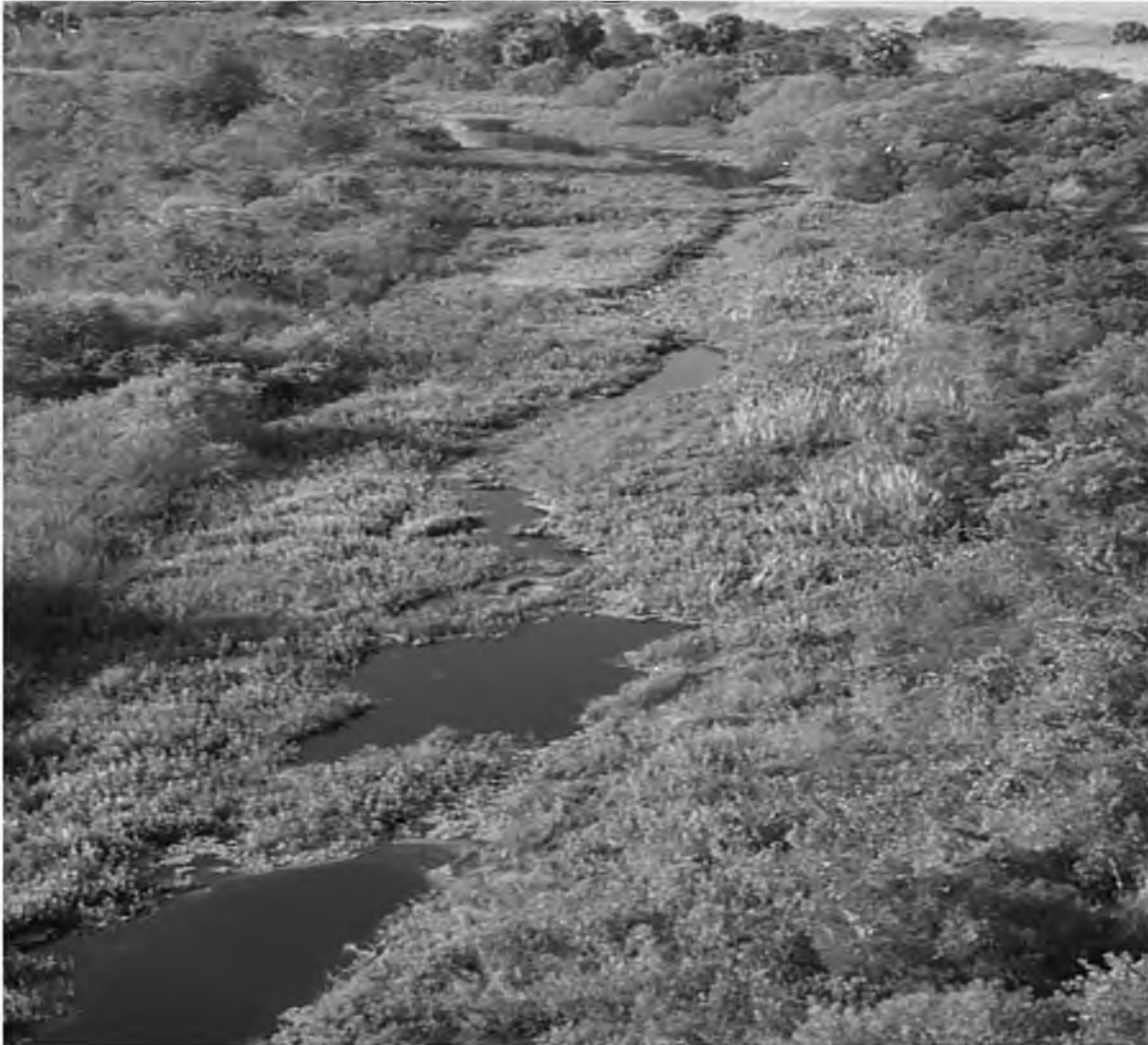
Figure 7-1. A remnant channel in the channelized Kissimmee River, ca. 1999, showing “floating mat” expansion toward center of river channel.

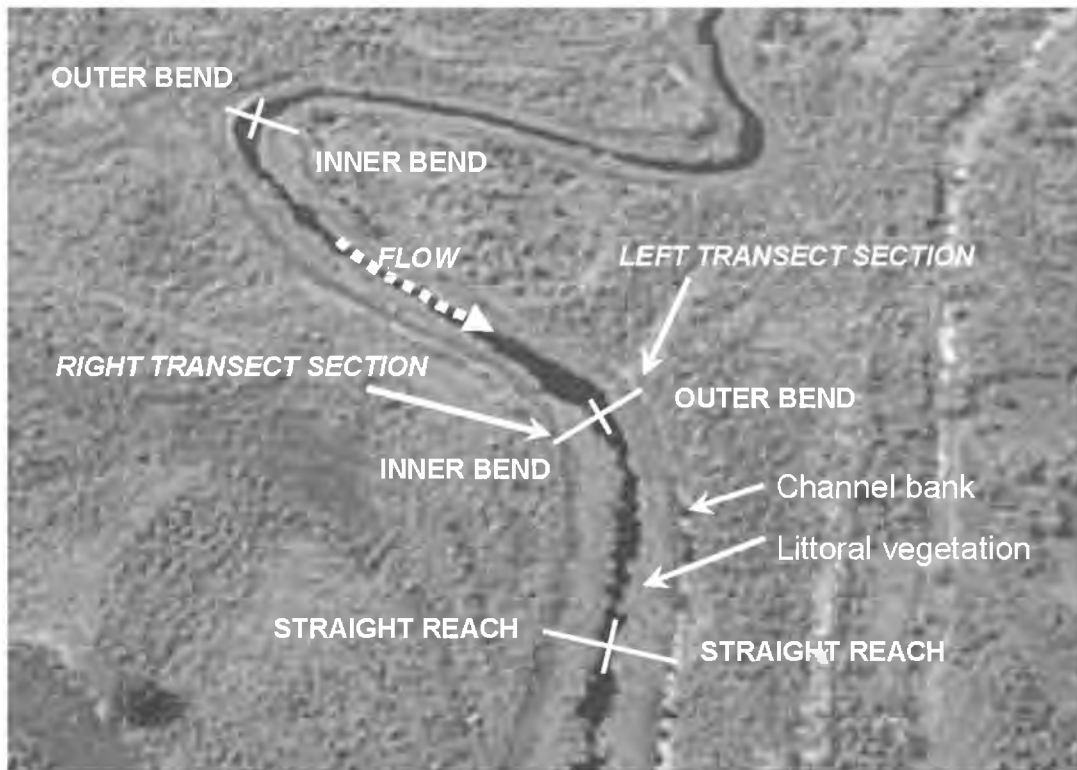
Figure 7-2. Diagram of transect orientation illustrating classification of transect sections at inner bends, outer bends, and straight reaches.

Transect sections in both the baseline and reference data sets were categorized as being located at inner margins of curved channel bends (inner), outer margins of curved channel bends (outer), or at the margins of straight reaches (straight) (Figure 7-2) for evaluations of variation in width associated with channel pattern or curvature/position. Grand means of widths presented for the baseline period are the averages of the four baseline sample period means for each pattern category ($n=4$). Widths and vegetated percentage of channel were averaged over all sampled transect sections in each pattern category for each of the four sample periods. An average of 130 transect sections were measured per sample period in the Impact area; 42 transect sections were measured per sample period in the Control area.

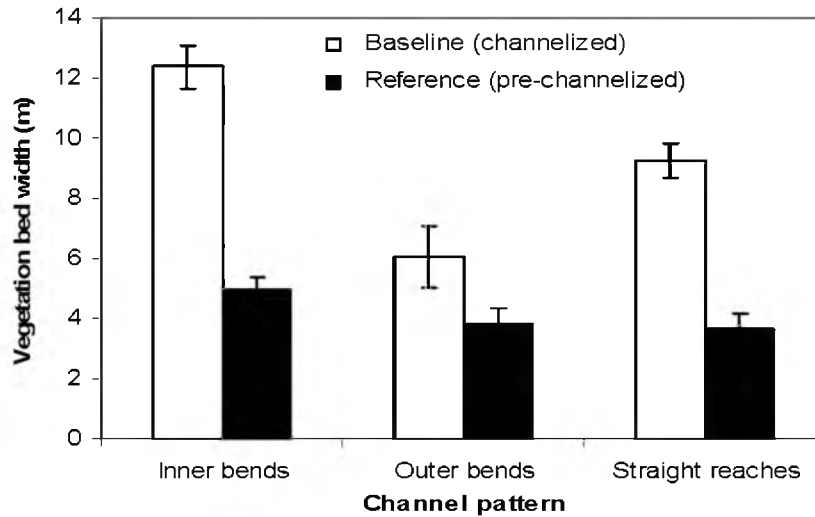
Figure 7-3. Vegetation bed widths on inner and outer bends and straight reaches in the baseline and reference area data. Error bars represent the 95% confidence interval of the mean.

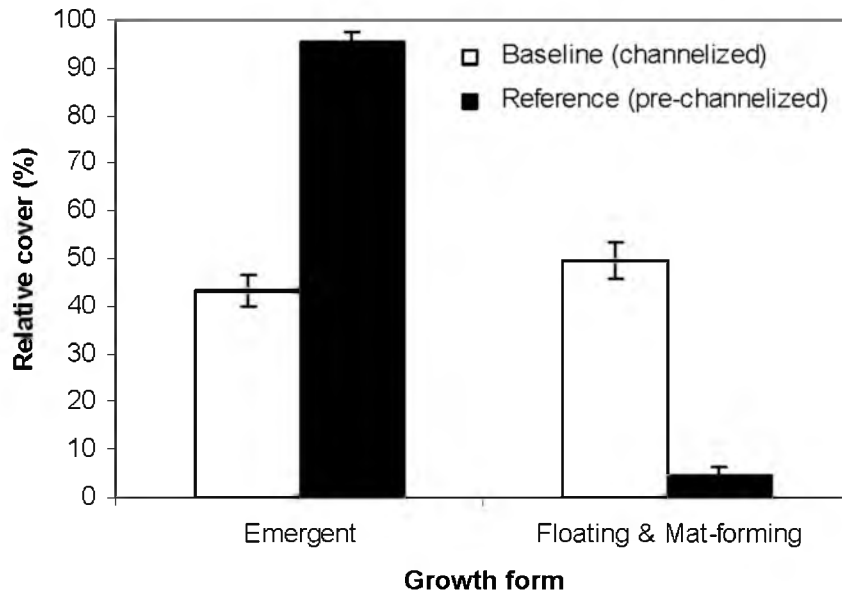
Figure 7-4. Mean relative cover of plant growth forms in baseline (channelized) and reference (flowing) channels. Error bars represent the 95% confidence interval of the mean.

identified only to family or genus) (Figure 7-4). In contrast, emergent species clearly dominated littoral zones in the reference semi-restored flowing channel. Based on the field survey data, mean combined relative cover of emergents was $95.5\% \pm 2.0\%$, and the estimate based on photointerpretation was 97%. Mean combined relative cover of floating and mat-forming species in the field survey was $4.5\% \pm 1.9\%$, and 3% in the photointerpretation estimate. Mean relative cover of emergent species and floating and mat-forming species were significantly different between the baseline and reference survey data ($P < 0.01$, Kruskal-Wallis one-way analysis of variance on ranks) (Table 7-2).

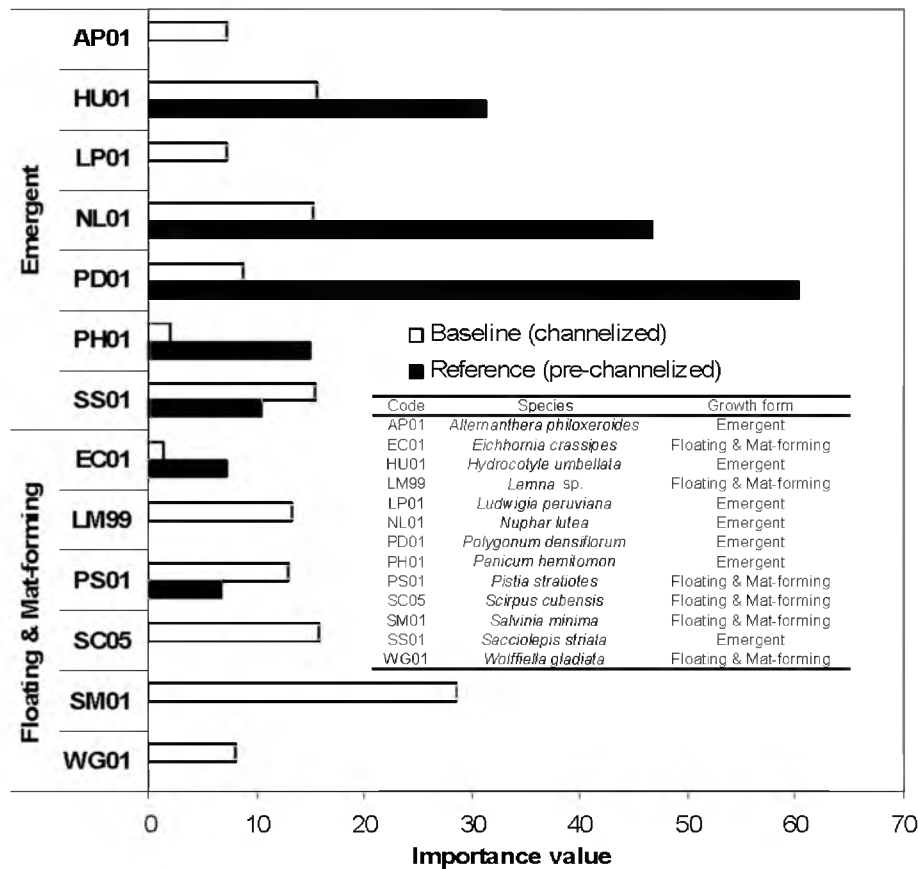
Figure 7-5. Common (IV ≥ 5) species in baseline (channelized) and reference (flowing) area remnant channels. Error bars represent \pm one standard error of the mean.

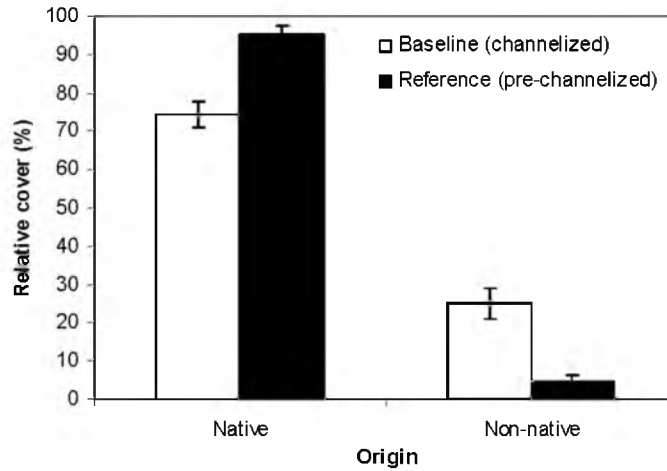
Figure 7-6. Mean relative cover of native and non-native species in the baseline and reference littoral vegetation surveys. Error bars indicate \pm one standard error of the mean.

Native species had lower mean relative cover ($74.4\% \pm 4.6\%$) in the baseline data than in the reference area ($95.5\% \pm 2.0\%$) (Figure 7-6) (Kruskal-Wallis one-way analysis of variance on ranks, $P < 0.001$) (Table 7-2). Free-floating invasive non-natives (primarily *E. crassipes* and *P. stratiotes*) were present in both data sets but occurred in only about 10% of transect sections in the reference data, and 6% of transect sections in the baseline data. However, combined mean relative cover of invasive non-natives was not high (5–10% in both datasets).

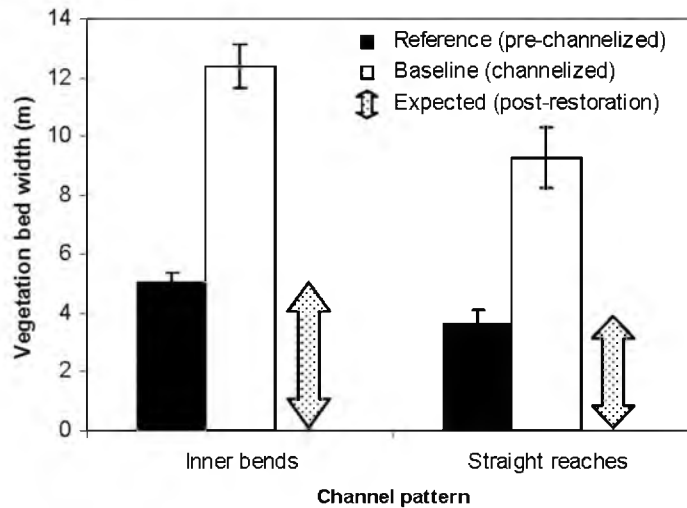
Figure 7-7. Mean littoral bed widths on inner bends and straight reaches of river channel in the baseline and reference littoral vegetation surveys, showing values expected following restoration of flow based on reference data. Error bars indicate \pm one standard error of the mean.

The expectation for vegetation bed widths (Bousquin and Hovey 2005a) was based on reference vegetation bed width data for inner bends and straight reaches of channels; an expectation was not developed for outer bends because widths were not significantly different between the reference and baseline data (Table 7-2). The expectation predicts that, following restored flow, littoral vegetation beds will persist in restored river channels, but that their mean widths will decrease to five meters or less from the bank on inner channel bends, and four meters or less from the bank on straight channel reaches (Figure 7-7).

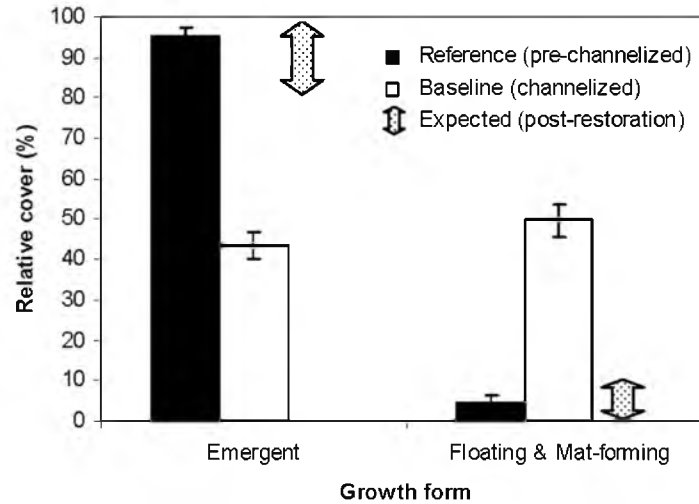
Figure 7-8. Mean relative cover of emergent and floating and mat-forming species in the baseline and reference littoral vegetation surveys, graphed with values expected following restoration of flow. Error bars indicate \pm one standard error of the mean.

The expectation for littoral plant community structure (Bousquin and Hovey 2005b) was also based on the reference data presented in this report. Mean relative cover of both emergent species and floating/mat-forming species differed significantly between the reference and baseline areas (Table 7-2). The expectation predicts that, following restored flow, littoral plant community structure will undergo the following changes: (a) combined mean relative cover of emergent species will increase to >80%, and (b) combined mean relative cover of floating and mat-forming species will decrease to <10% (Figure 7-8).

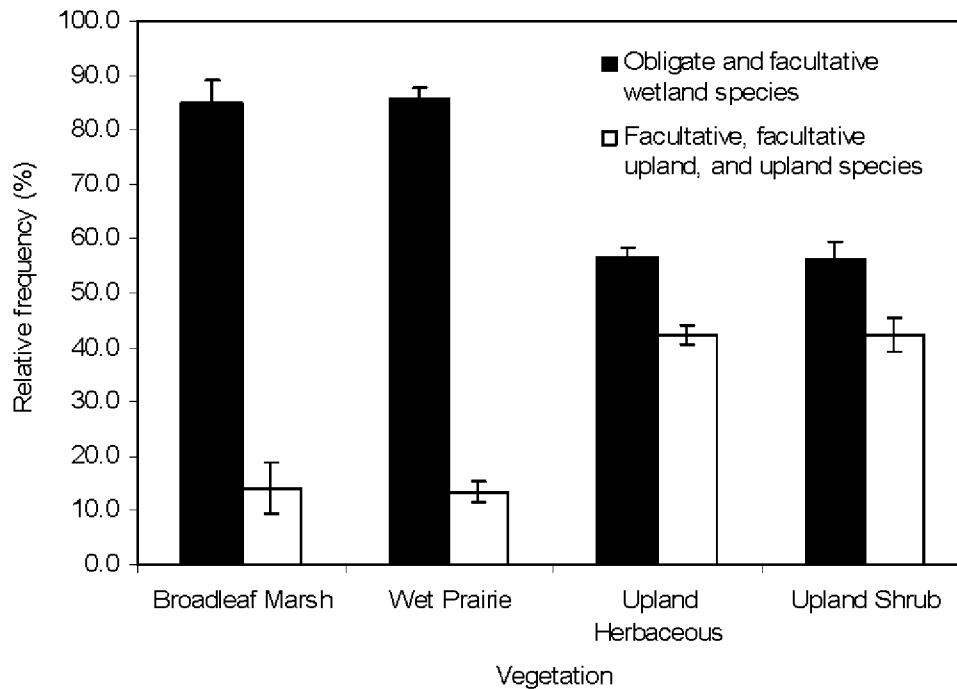
Figure 8-1. Relative frequency of species wetland status categories in the baseline vegetation plots, summer 1998 data.

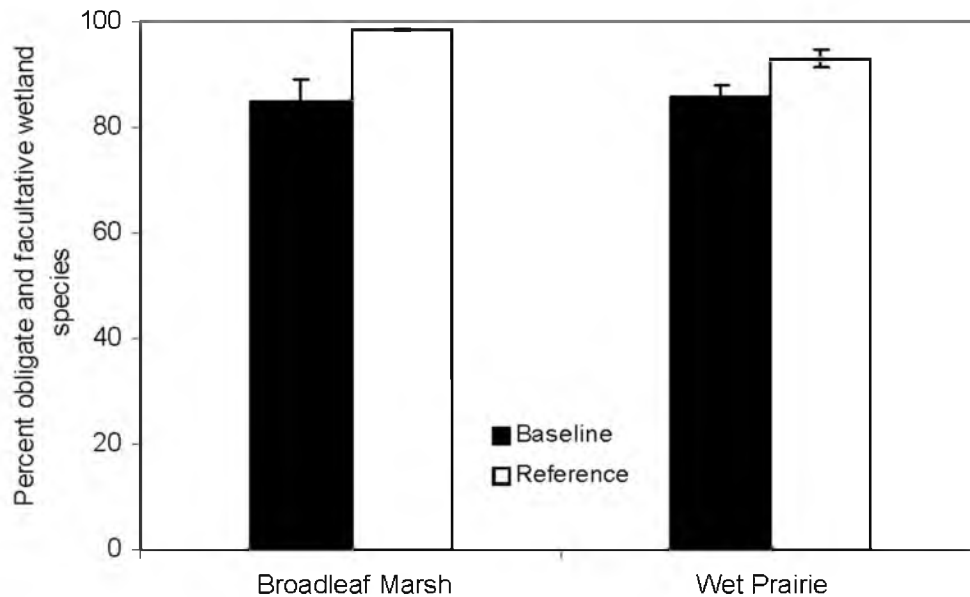
Figure 8-2. Relative frequency of obligate wetland and facultative wetland species in the baseline and reference data.

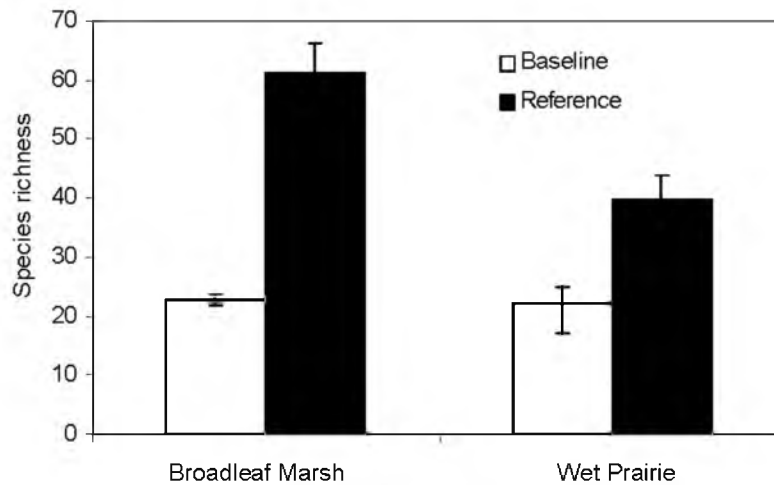
Figure 8-3. Species richness in the baseline and reference data.

Mean percentage of obligate and facultative wetland species was significantly higher in the reference data than in the baseline data both for Broadleaf Marshes (t-test, $P = 0.010$) and Wet Prairies (t-test, $P = 0.020$) (Figure 8-2). Species richness in both Broadleaf Marsh and Wet Prairie were significantly higher in the reference data than in the baseline data (t-tests, $P = 0.002$ and $P < 0.001$, respectively) (Figure 8-3). However, direct comparisons between the baseline and reference data may be misleading because of differences in baseline and reference data collection methods.

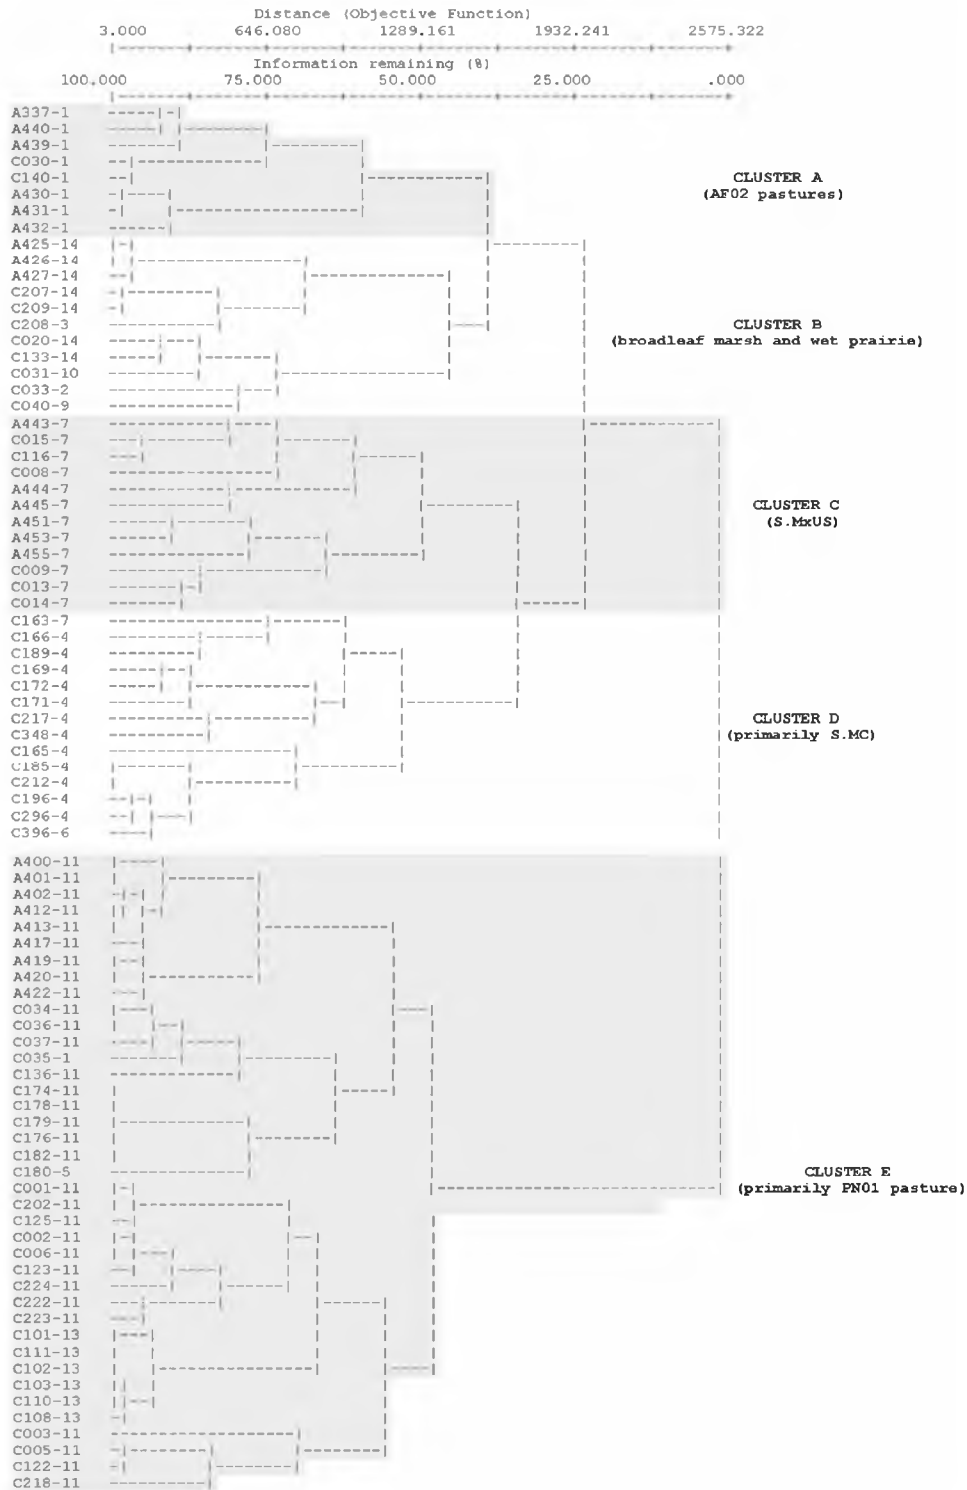
Figure 9-1. Dendrogram for the cluster analysis of 84 floodplain vegetation plots, classified from the *Key to Bcode Groups and Community types* (Appendix 9-1A). The first column gives plot numbers followed by a hyphen and the numeric code (Table 9-4) of the assigned community type. Shaded areas separate natural clusters; however the horizontal extent of shading is a graphical device and has no quantitative meaning.

The cluster analysis dendrogram is shown in Figure 9-1. Sample units were coded as pppp-xx where p is the plot code (minus the “VP” used in the data collector’s original designation) and x is a numeric code for the assigned community type as given in Table 9-4. Important clusters are labeled A–E. The clustering algorithm used species data exclusively (not the vegetation categories assigned to the site names) for analysis.

The algorithm placed all H.AF sites (*Axonopus fissifolius* Herbaceous Vegetation, code 1) in a single cluster (Figure 9-1, cluster A), indicating that the procedure had little difficulty distinguishing H.AF from other community types. This also was the case for H.PN (*Paspalum notatum* Herbaceous Vegetation, code 11), although C035, an H.AF community, also was placed in this cluster. This site had high cover of *Paspalum notatum* (cover class 3) although the site was dominated by *Axonopus fissifolius* (cover class 4). Plot C180, which was classified as H.CD (*Cynodon dactylon* Herbaceous Vegetation, code 5) also clustered with the *P. notatum* communities. Disregarding dominance, species composition of C180 is similar to the *Paspalum notatum*-dominated pastures. All of these dominant species (*A. fissifolius*, *P. notatum*, and *C. dactylon*) are introduced pasture grasses.

One plot (C396) classified as H.MxFN (Miscellaneous Fern-Dominated communities, code 6) was placed by the clustering algorithm with H.MC (*Myrica cerifera* shrubland, code 4) sites because of similar species composition (Figure 9-1, cluster D). The fern *Osmunda regalis* is a common understory component of *Myrica cerifera* stands, often with high cover. Although species composition of this plot was similar to the *Myrica* stands, shrub cover was insufficient to classify them as S.MC (less than 30% shrub cover, see Appendix 9-2A). The cluster analysis placed all S.MC plots together in a single cluster (cluster D), and all but one S.MxUS (Miscellaneous Upland Shrubland) plot in a separate cluster (cluster C). The S.MxUS plot (C163) was placed in a cluster adjacent to the other S.MxUS plots (cluster D) otherwise composed of S.MC plots and the fern-dominated plot. Near the boundary between these two dendrogram clusters (clusters C and D), *Myrica cerifera* is present in plots in both clusters; keying of C163 as S.MxUS is due to higher cover of *Baccharis halimifolia* than *Myrica cerifera* (Appendix 9-2A). *Myrica cerifera* occurs in a variety of habitats: uplands, floating mats, and wetland-upland transition areas.

The remaining cluster, labeled B in Figure 9-1, is composed of seven H.PS-PH plots (*Pontederia cordata-Sagittaria lancifolia-Panicum hemitomon* Herbaceous Vegetation, code 14); one H.PH plot (*Panicum hemitomon* Herbaceous Vegetation, code 10); one MxWP (Miscellaneous Transitional Wetland Herbaceous Vegetation, code 9); one H.LH (*Leersia hexandra* Herbaceous Vegetation, code 3 - *L. hexandra* is a native obligate wetland grass); and one H.LF (*Luziola fluitans* Herbaceous Vegetation, code 2, another native obligate wetland grass). In this data set there is overlap in species composition among these five community types. However, these community types are all classified as Wet Prairie types (group WP) with the exception of H.PS-PH, which is a gradient community type transitional between Wet Prairie and Broadleaf Marsh (Appendices 9-1A and 9-5A).

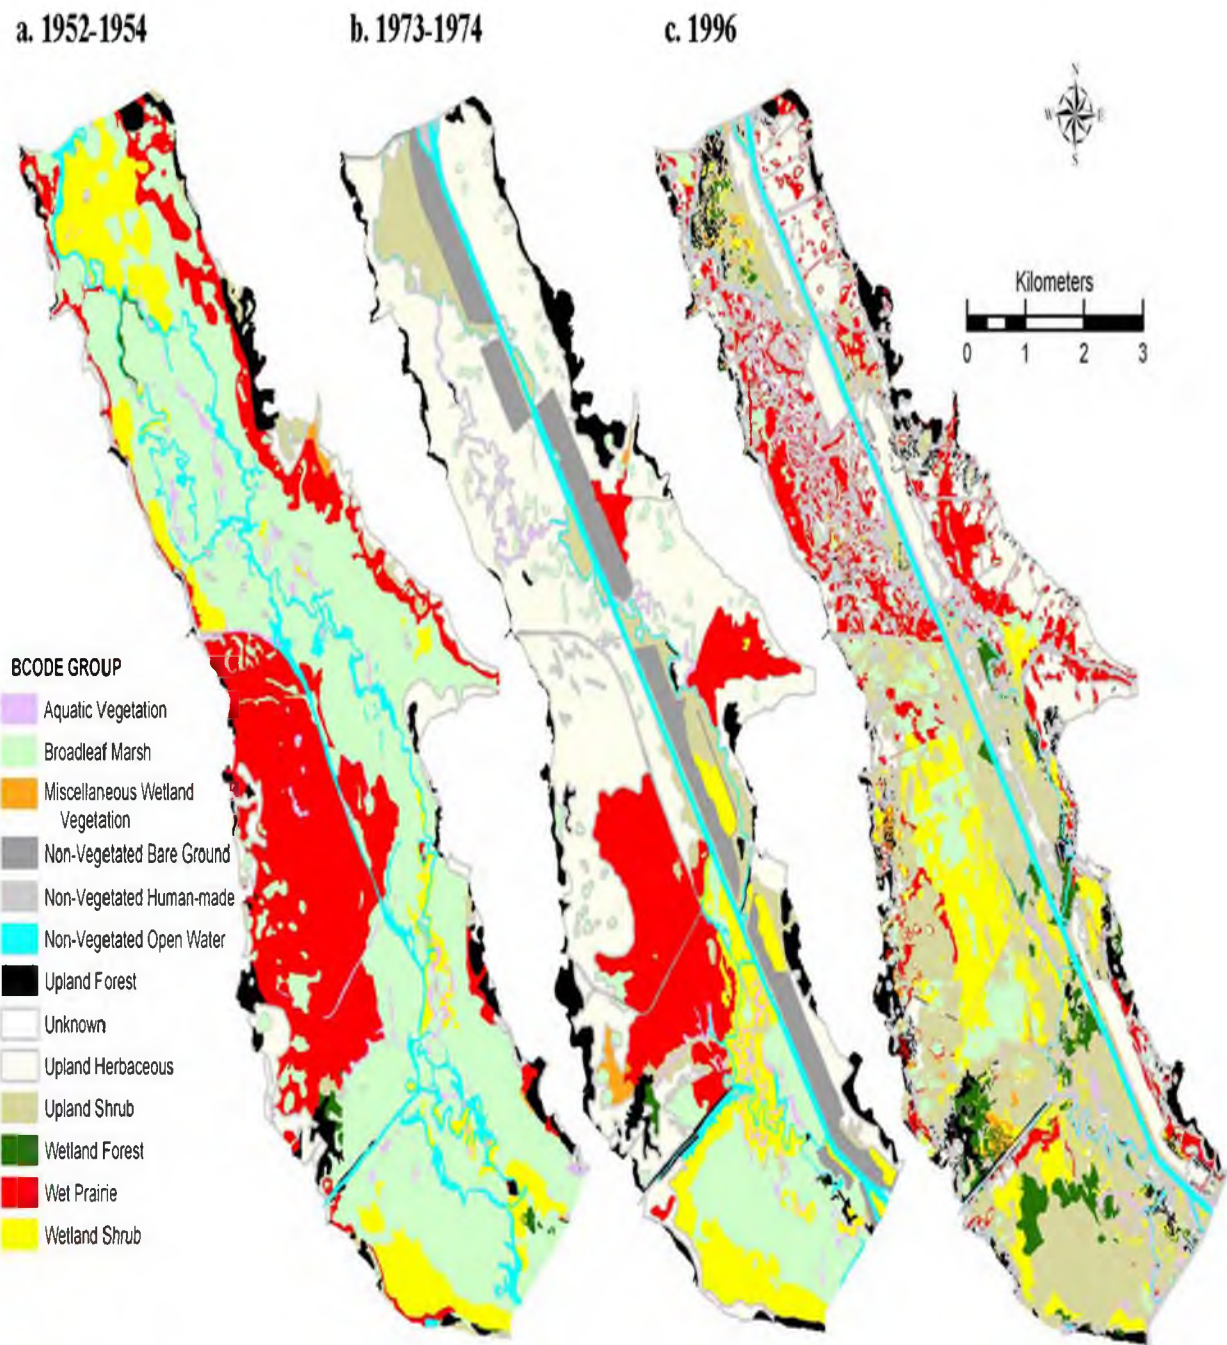
Figure 10-1. Vegetation maps of Pool C: (a) 1952–1954 (pre-channelization, reference period) (data from Pierce et al. 1982); (b) 1973–1974 (early post-channelization) (data from Milleson et al. 1980); and (c) 1996 (post-channelization, baseline period).
