## **Hydrologic Restoration of the Biscayne Bay Coastal Wetlands: *mosquito and drainage ditch inventory and recommendations***

Pablo L. Ruiz and Michael S. Ross

26 August 2004

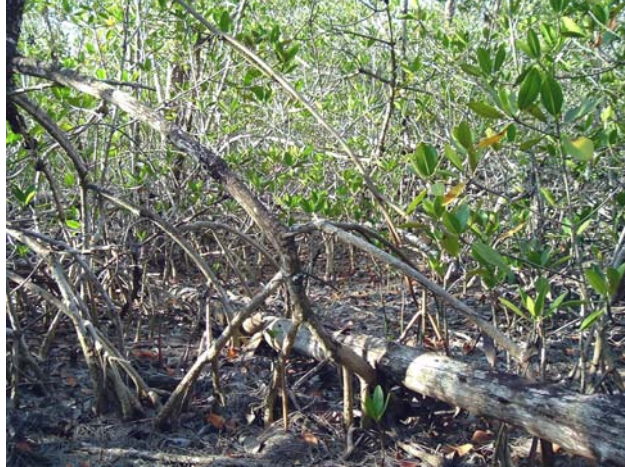
A total of 554 mosquito ditches and 102 drainage ditches were found within the study area (**Table 1** & **Figure 2**). Drainage ditches were generally deeper and longer than the mosquito ditches but not necessarily wider (**Table 1**). Drainage ditches on the west side of the L-31E levee (Reach 2) tended to be uniform in depth, partially silted-in, and stagnant. On the other hand, the drainage ditches on the other three Reaches (1, 3, & 4) tend to widen and deepen towards the coast, with few silted-in. For the most part, these drainage ditches emptied directly into Biscayne Bay. However, some ditches were found draining into existing creeks which then emptied into Biscayne Bay. Mosquito ditches, in turn, were found partially or fully connected to the east-west running drainage ditches. In general, mosquito ditches were found in one of the following three conditions: 1) silted-in and hydrologically inert (**Figure 4a**), 2) not fully silted-in but hydrologically inert (**Figure 4b**), or 3) partially silted-in but hydrologically active (**Figure 4c**).

Figure 4a: Mosquito ditch silted-in and hydrologically inert.
