# Hydrologic Restoration of the Biscayne Bay Coastal Wetlands: mosquito and drainage ditch inventory and recommendations

Pablo L. Ruiz and Michael S. Ross

26 August 2004

Cooperative Agreement H525003D084

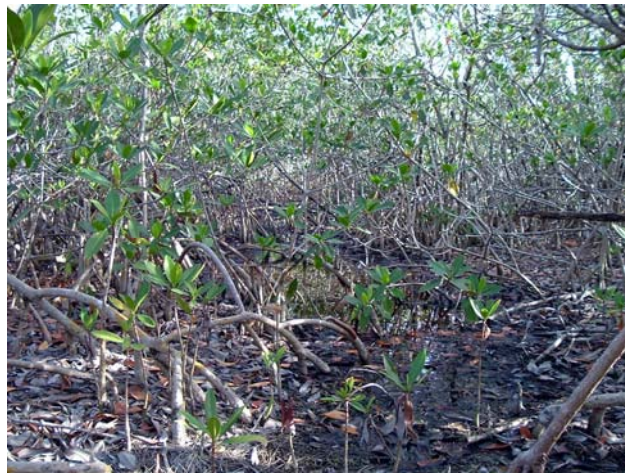
Figure 4b: Mosquito ditch not fully silted-in but hydrologically inert.
