# ON THE WATER | PALISADE BAY

# EDGE ATLAS

*Be it at the hand of man or Mother Nature, the coastline of the New York-New Jersey Upper Bay is constantly being redrawn. Its current shape has been in the making for tens of thousands of years. The most legible changes occurred with the settlement and development of New York City and the surrounding metropolitan region. This section details our efforts to understand the transformation of the edge and to document its current state for comprehensive and scientific purposes.*

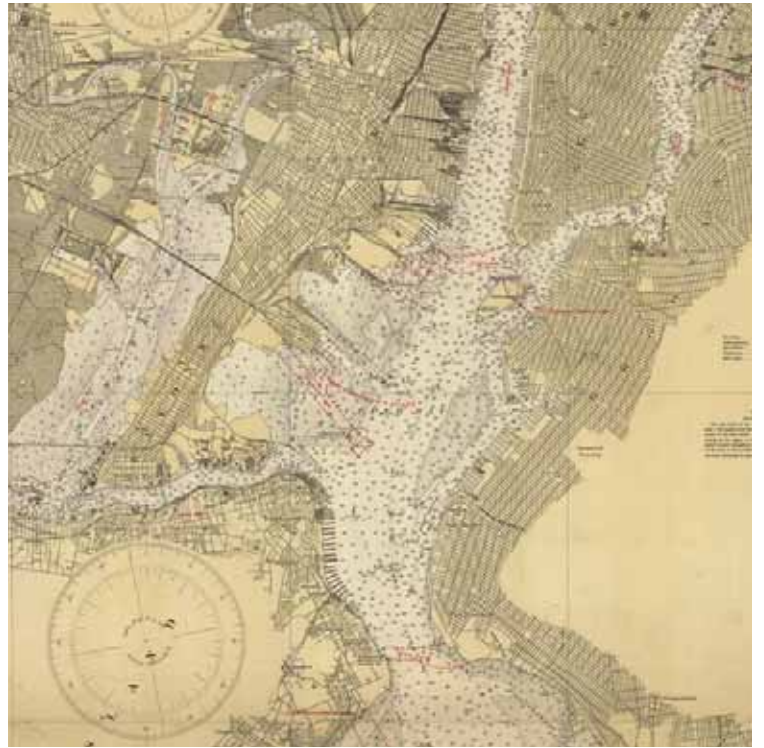
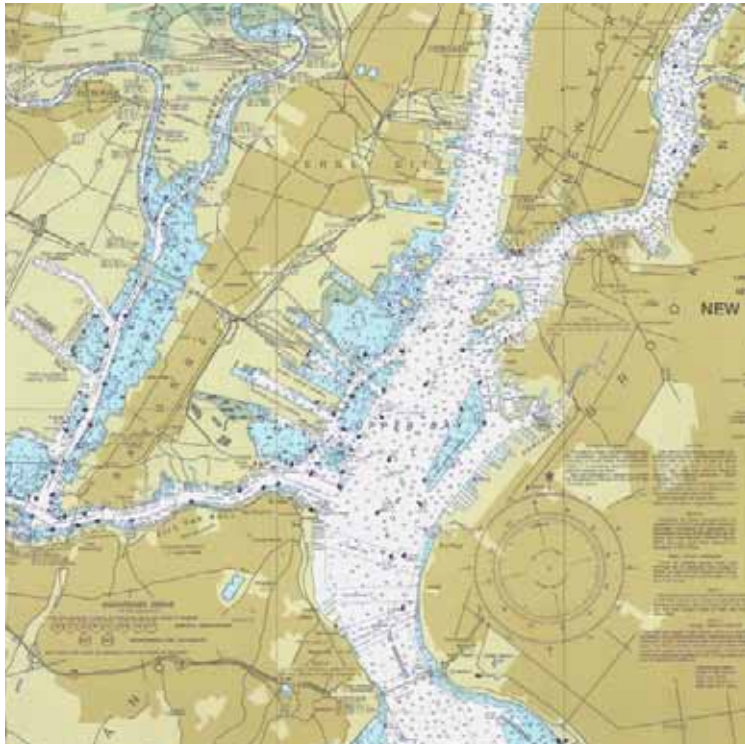
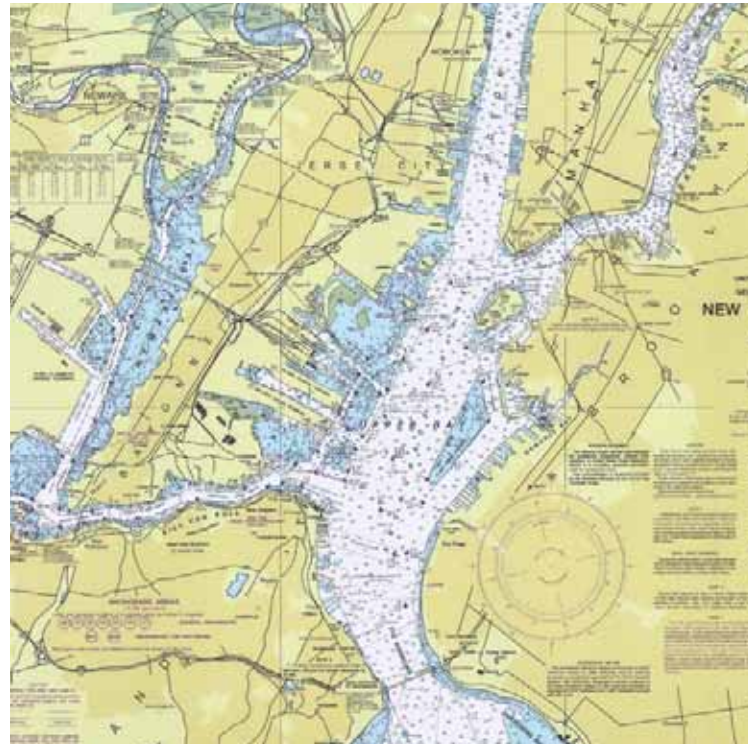
opposite  
Upper Bay coastline through the twentieth century, traced from NOAA nautical charts  
overleaf  
Historical nautical charts, Office of Coast Survey, National Ocean Service, NOAA

With these historical changes to the urban environment, the coastline of the NY-NJ Upper Bay was likewise reshaped. The line drawing at right illustrates the state of the coastline and the shallow underwater flats decade by decade through the twentieth century. The years between 1918 and 1928 saw extensive construction of piers along the eastern waterfront of Staten Island and elsewhere around the harbor. By 1944 significant filling of land on the New Jersey side had begun, including the development of the Military Ocean Terminal, and throughout the harbor shoals and flats were made smaller or eliminated altogether by dredging. Between 1967 and 1977, the maritime industry recentered itself in New Jersey, resulting in the construction of a second large landfill pier in Bayonne and the removal of the piers lining Manhattan. The end of the century saw continued disintegration of piers in Brooklyn and Staten Island.

In the past century or so, once gradual adjustments to the coastline due to geological and climatological processes gave way to more frequent and more dramatic adjustments due to artificial processes. It was during that time that the metropolitan New York region underwent a number of important changes including major growth in its population, the peak and subsequent decline of local industry, shifts in maritime use, and the establishment of the highway system.
