FLORIDA MASTER SITE FILE
Site Inventory Form

Site Name _____ Site No. 830 = = Survey Date 8505 820 = =
 Address of Site: 121 NE 92 St., Miami Shores, Fla. 33138 905 = =
 Instruction for locating N side of NE 92 St. between NE 1st Ave &
NE 2nd Ave. 813 = =
 Location: Miami Shores Sec. 1 Amd. 23 E 1/2 16 & all 868 = =
subdivision name block no. lot no.
 County: Dade 808 = =
 Owner of Site: Name: Cogswell, Edwina ;
 Address: 121 NE 92 St., Miami Shores, Fla. 33138 902 = =
 Type of Ownership private 848 = = Recording Date _____ 832 = =
 Recorder:
 Name & Title: Stofik, Marty ;
 Address: MSHPB 818 = =

121 NE 92 ST.

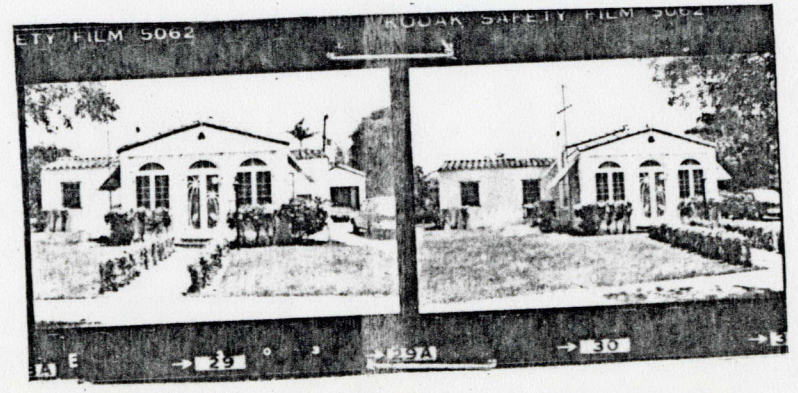
Contact Print

Structure is a one-story Mediterranean Revival cottage. Three-bay entry on S has French doors flanked by windows of similar proportion, all three with double-light ^{arched} transoms. Entry screened door is excellent example of wrought iron tropical scene with palm trees and birds. Entry steps are faced with decorative glazed tile. Stucco is extremely rough. Some windows have solid wood hurricane awnings; all have wrought iron security grills. Semi-detached single-story garage in rear is of similar style.
