FLORIDA MASTER SITE FILE
 Site Inventory Form

Site Name _____ Site No. _____
 Address of Site: 126 NE 93 St., Miami Shores, Fl 33138 Survey Date 8506 820 = =
 Instruction for locating on S side of NE 93 St. between NE 1st Ave & 905 = =
NE 2nd Ave. 813 = =
 Location: Miami Shores Sec 1, Amd. 23 11 & 12 868 = =
subdivision name block no. lot no.
 County: Dade 808 = =
 Owner of Site: Name: Walker, William H. ;
 Address: 444 NE 96 St., Miami Shores, Fl 33138

NR Classification Category: Building 916 = =

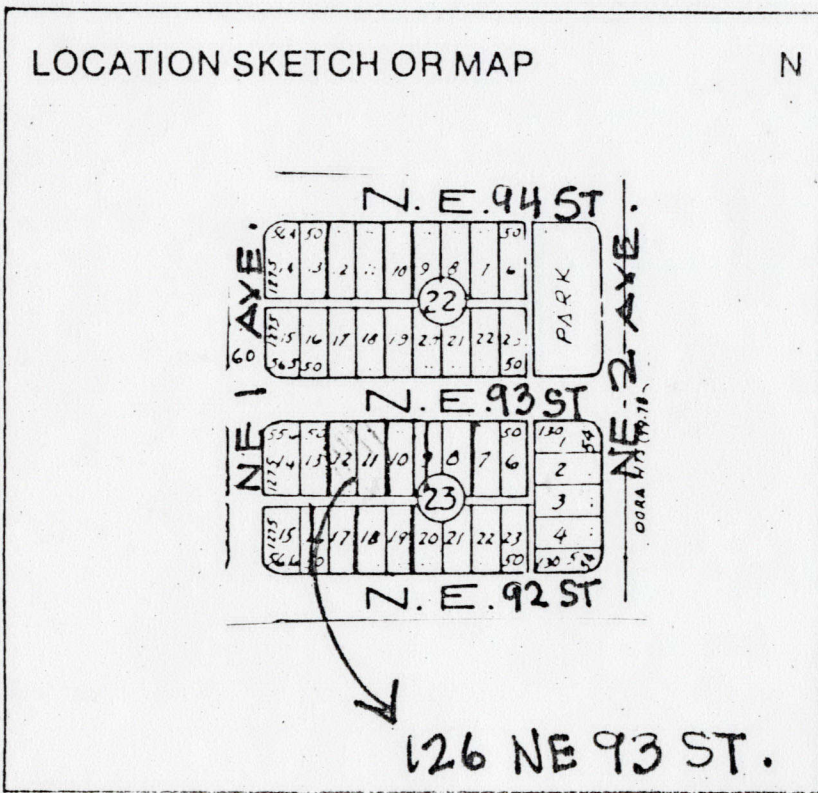
Photographic Records Numbers 85N104HG8/85N104HG9 860 ==

Structure is a two-story residence of Mediterranean Revival design but without the intricate detailing of its 1920s predecessors. Its most noteworthy feature, a wide arched entrance, has been enclosed and set with a rectangular door offset to the E. Windows on the front (N) facade have functional simple shutters. A porte cochere is attached on W.

Front windows altered 1948
Enclosed screened porch 1940
Remodeled main's quarters 1949
Replaced garage door and some windows 1965
Reroofed 1957
Three new windows 1949
