Geotechnical Services Report

Roadway Soils Survey

SR-847/NW 47th Avenue PD&E Study

From SR-860/NW 183rd Street to Premier Parkway

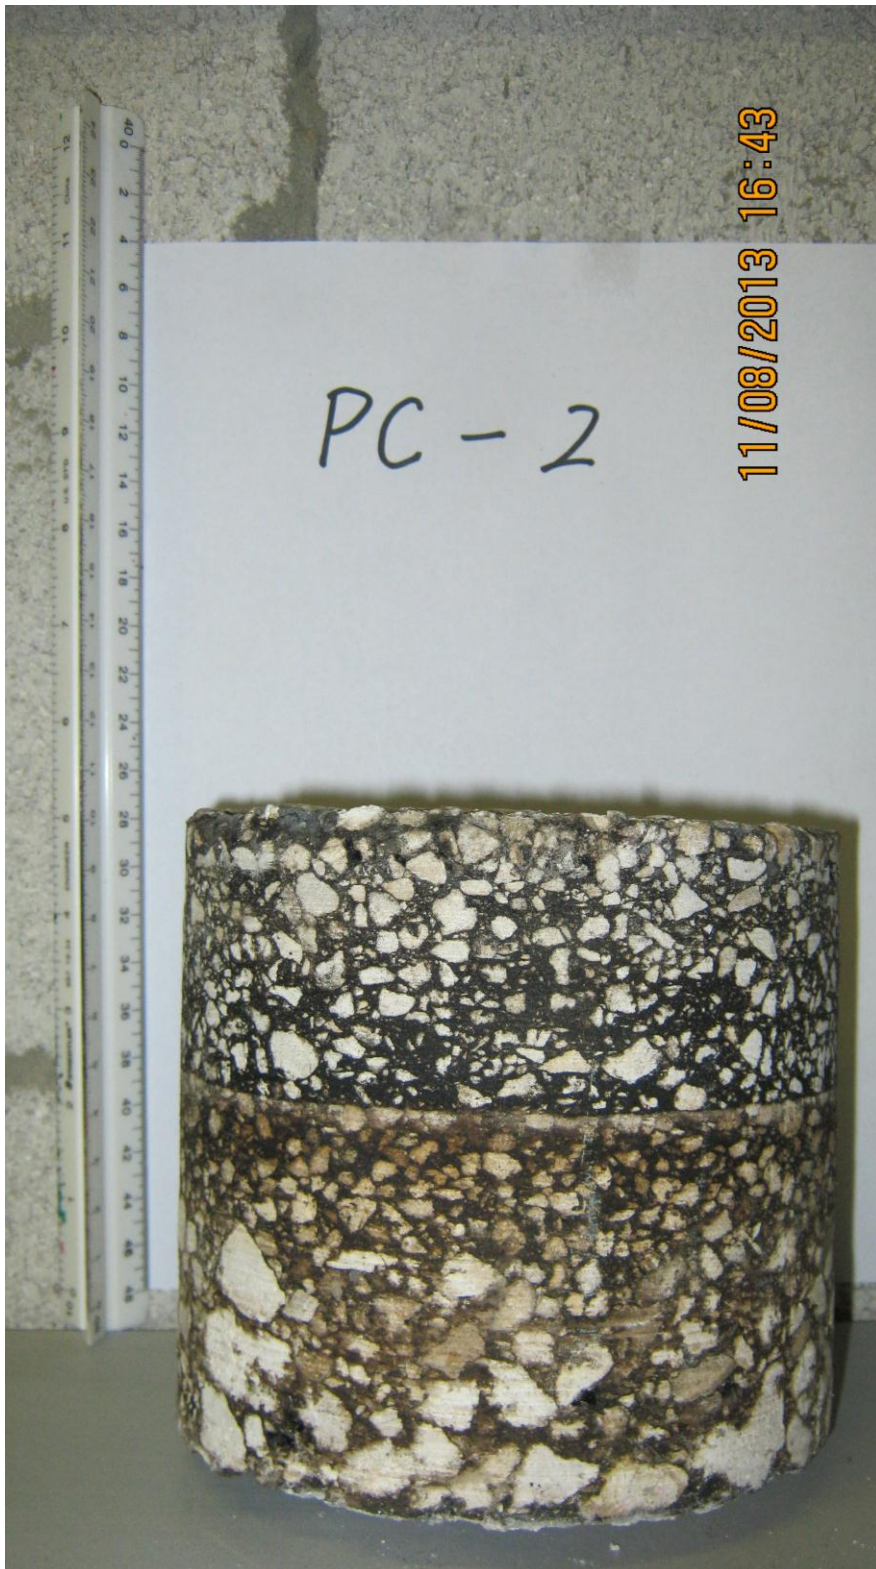
Photo – 2: Core PC-2; NW 47th Ave., Northbound

In order to accurately evaluate the existing pavements in these areas, we have cut cores of the asphalt and base course materials and deepened the holes utilizing power augers to a depth of at least 6 inches below the base course materials in order to check the depth and consistency of the base course and subgrade soils. The depth drilled at each location varied approximately between 1.1 and 1.2 feet, measured from the top of asphalt. Rut depths and cross slopes were measured at the corresponding lanes where the cores were cut. A general pavement condition survey including evaluation of class, type and extent of cracking (if any) was also completed during our field study. The results of our field study are shown on the Pavement Evaluation and Condition Data (Table – 3). The pictures of the core samples are presented in Appendix – D.

The five (5) cores had asphalt thicknesses ranging between 3.7 to 7.8 inches. The results of the pavement cores are presented in Table – 3. Base course material found below the asphalt layers mainly consists of crushed limerock with some sand and silt, and was between 5 and 9 inches thick. In addition, we have measured a maximum depression about 0.722 inches at the left wheel path of the north bound lane, the location of PC-4, approximate station 194+00. The subgrade soils found below the base course generally consisted of sands. Subgrade soils generally extend to termination depths of exploration at each core location. The details of materials found at each location are shown in Table – 4.
