August 25, 2008
Miami-Dade Pedestrian Safety Project: Phase II
FINAL IMPLEMENTATION REPORT AND EXECUTIVE SUMMARY

Pedestrian Safety Engineering and Intelligent Transportation
System-Based Countermeasures Program for Reduced Pedestrian Fatalities,
Injuries, Conflicts and Other Surrogate Measures: Miami-Dade Site

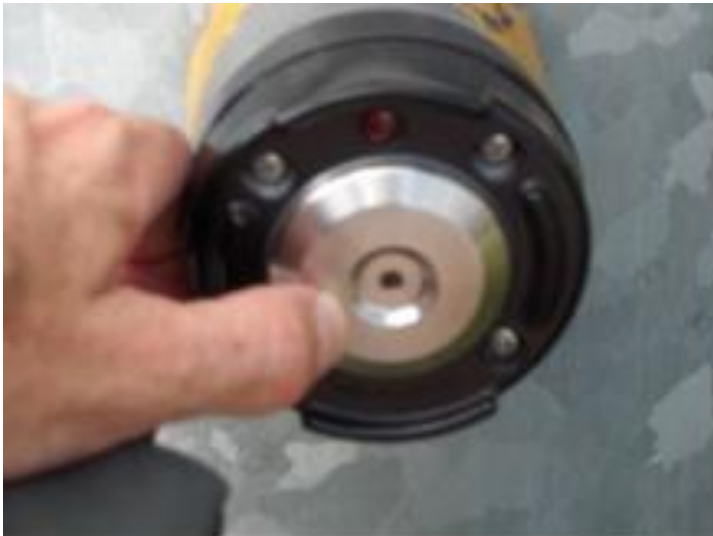
This treatment consists of a pedestrian stainless steel push button with a piezo driven solid state switch that provides two types of feedback when the push button is pressed. First, the button is illuminated with a 1200 mcd red light emitting diodes (LED) for 0.1 s (Momentary LED Model) and second, a 2.6 kHz tone is sounded simultaneously with the LED flash when the button was pressed and a 2.3kHz tone was sounded when the button was released. The device could also be modified so the light remained on until the onset of the “WALK” indication. These buttons were installed at 17 intersections, typically with 2 buttons per intersection.

Figure 3.1 Picture of Pedestrian Push Button That Confirms Press

Notes: It was difficult to see the LED light in bright Florida sunlight. It appeared that the auditory feedback was more critical to the efficacy of the device. In areas with less bright sunlight the pilot light might be more salient. These buttons might also be of useful to visually impaired pedestrians because they confirm the button press. However, accessible call buttons with a locator tone would be preferred when taking into account the needs of visually impaired pedestrians.

These devices seem reliable and durable and are associated with minimal maintenance needs. Because these push buttons provide feedback when they are pressed we observed fewer multiple presses, which could extend the life of the buttons, reducing maintenance costs over conventional buttons.

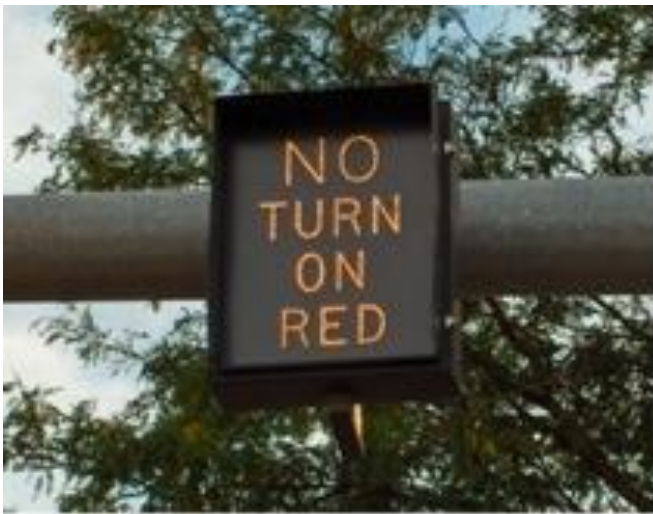
This sign was illuminated when right turn on red was not permitted. The sign was installed on the mast arm in the same location that the static “No turn on red when pedestrians in crosswalk” sign and the “No turn on red” sign were installed. This allowed a direct comparison of all three signs.

Figure 3.6 Picture of Electronic No Turn on Red Sign

Notes: The electronic NRTOR sign reduced the percentage of motorists turning right-on-red when a pedestrian was present over that produced by the two static signs and reduced the percentage of conflicts between vehicles turning right on red and pedestrians crossing within the crosswalk over the other two signs. However there were many violators during all conditions. The electronic sign had an even larger effect on increasing the percentage of violators coming to a complete stop

There were no maintenance requirements associated with this countermeasure. However this sign will eventually need to be replaced or serviced after the service life of the lights has expired.

Many drivers make right turns on red without stopping and some do so without even slowing more than they would if facing a green signal indication. This study compared the efficacy of a conditional "No Turn on Red When Pedestrians in Crosswalk" sign, the standard metal sign "No Turn on Red" (NTOR) sign and an electronic NTOR that is illuminated when a right turn on red is prohibited. The results of the experiment indicated 34 percent of drivers violated the NTOR prohibition with the conditional sign, and 41 percent violated it with the standard sign. The electronic sign reduced violations to 32 percent and they recovered to previous levels during a short return to the standard sign. Data also indicated that the percentage of violators making a full stop before violating NTOR increased from 29 percent and 31 percent for the conditional and standard NTOR sign during the baseline condition, to 78 percent with the electronic sign and to 65 percent during the short return to the standard NTOR sign condition. The results for violators making rolling stops or no stop at all show that the improvement in compliance was the result of equivalent large reductions in both types of violations. Data also indicated that the standard NTOR sign was associated with a decline in the percentage of violations when pedestrians were in the crosswalk, and that the electronic sign produced further declines in violations of pedestrian right-of-way. The results further documented a reduction of motor vehicle-pedestrian conflicts with the electronic sign but not with the standard NTOR sign. Increasing compliance with the NTOR prohibition associated with the electronic NTOR sign was also associated with an increase in the percentage of drivers blocking the crosswalk and a smaller increase in the percentage of pedestrians that needed to walk around vehicles when the crosswalk was blocked. The results of the Electronic No Right Turn on Red Sign intervention are presented in Table 4.6.

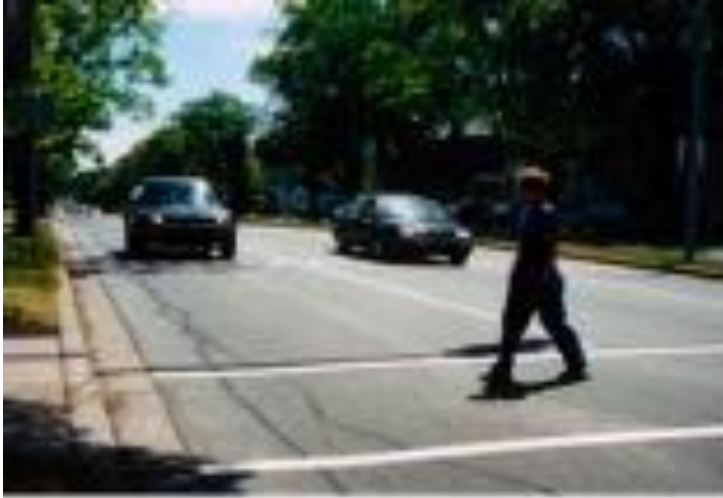
Advance yielding markings may be installed in advance of crosswalks at uncontrolled locations. Previous work has shown that advance yield markings placed 30 feet in advance of the crosswalk increases the distance that drivers yield in advance of the crosswalk. Advance yield markings were only installed at one site because the sign size specified in the 2003 manual was much smaller than the sign used in the research that supported the introduction of this marking into the manual.

Figure 3.13 Picture of Advance Yield Markings

Notes: This treatment is designed to reduce multiple threat conflicts and therefore has been installed at the two multilane locations with the rectangular LED rapid flash beacon.

This marking does not have a significant impact on maintenance costs.

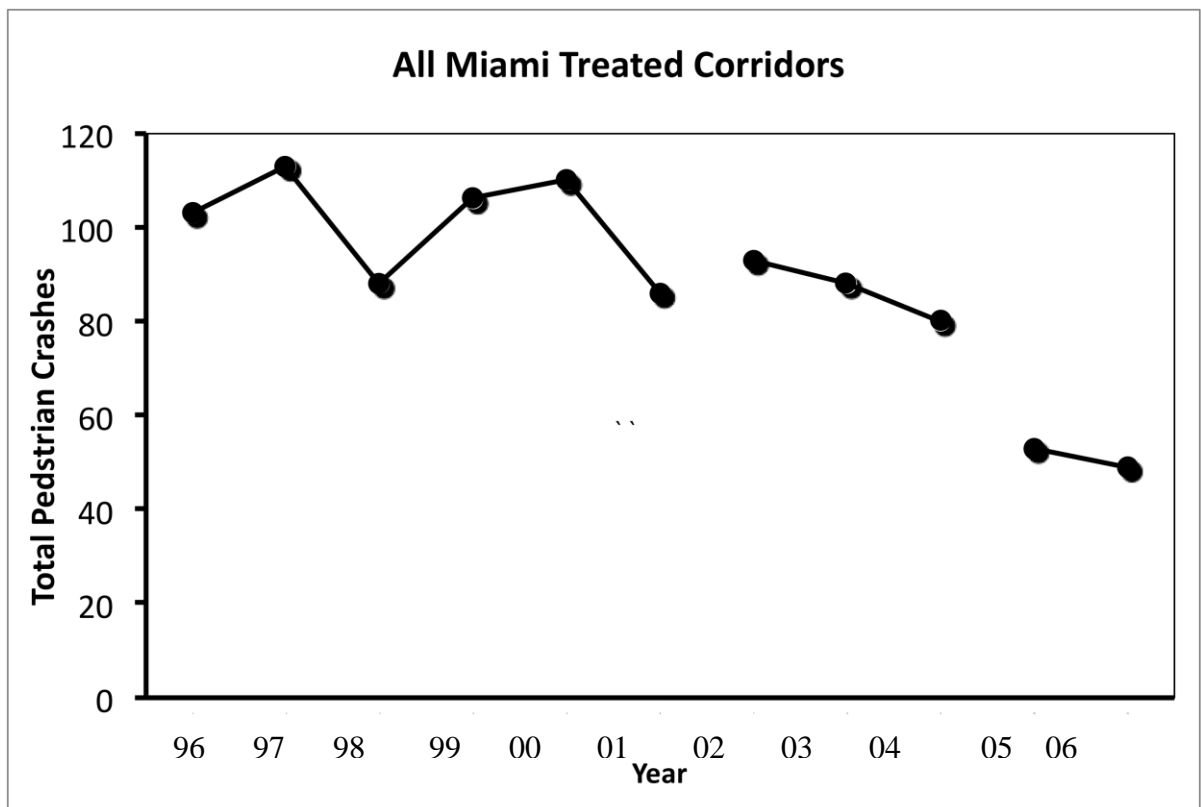
Data were collected for each corridor for 6 years prior to the introduction of the NHTSA project, for the 3 years that the NHTSA project was implemented, and for an additional 2 years that the FHWA project was implemented. This provides a total of 11 years of crash data along these high crash corridors. Figure 4.2.1 shows the crash rate for all eight treated corridors remained reasonably stable with a slight downward trend during the 6 years prior to the introduction of the NHTSA project. The introduction of the NHTSA project appeared to lead to a small decrease in pedestrian crashes from a mean of 101 during the baseline period to a mean of 87 (a decrease of 11.5%) during the three years that the NHTSA project was in effect. The installation of the engineering countermeasures on top of the NHTSA education and enforcement efforts lead to a further reduction to an average of 51 crashes per year. This represents a 50% reduction over the baseline level and a 41% reduction from the NHTSA project levels. It is interesting to note that during the 9 years prior to the FHWA project there were 15,472 pedestrian crashes in Miami-Dade County. Of these 46% occurred on State and County Roads for a total of 7,117 crashes or 791 crashes per year. Around 100 per year or nearly 13% of these crashes occurred along the treated corridors.

Figure 4.2 Crashes per Year for All Eight Crash Corridors from 1996-2006

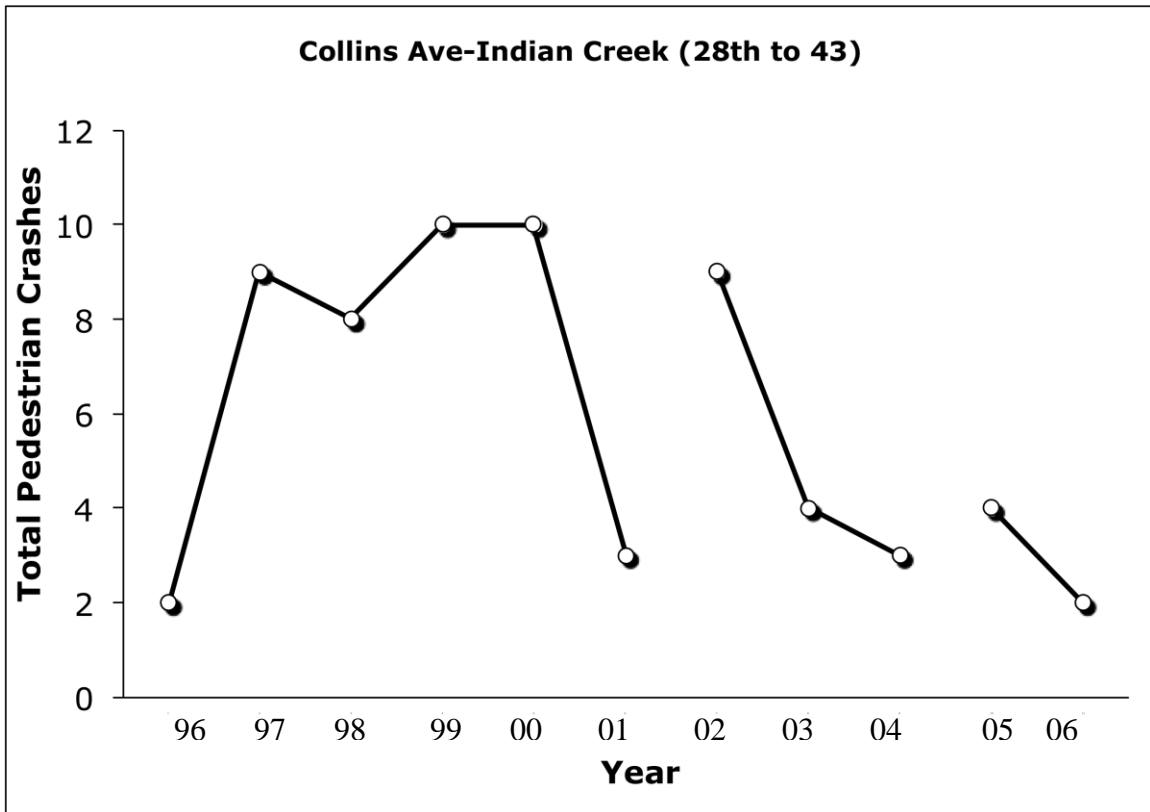
This corridor is immediately adjacent to the Collins Ave (5th to 24th St.) corridor. Treatments installed along this corridor included “TURNING VEHICLES YIELD TO PEDESTRIANS” symbol signs, and the use of the speed trailer. Crashes averaged 7 per year during the baseline period along this corridor, 5.3 per year during the NHTSA project and 3 per year during the FHWA project. The graph of the yearly crash data is shown in Figure 4.6. Although the average number of crashes is lower during the FHWA study there are too few crashes and too much overlap to conclude much about the efficacy of the treatment at this location.

Figure 4.7 Crashes per Year Collins Ave. (Indian Creek 28th St. to 43rd St.) from 1996 to 2006

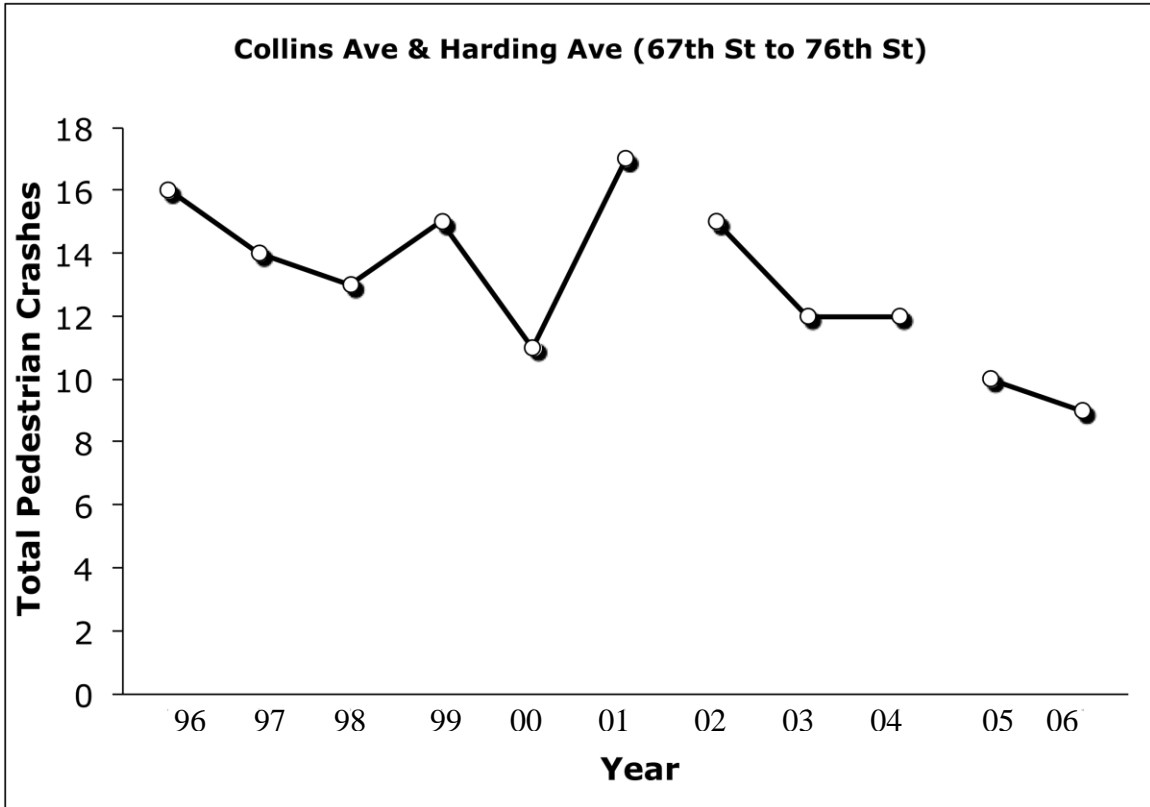
This crash corridor had the highest percentage of crashes involving turning vehicles during baseline of all of the selected corridors averaging 80% and the highest percentage of pedestrians struck over the age of 65 years (49%). Treatments installed along this corridor included “Turning vehicles yield to pedestrians” symbol signs, pedestrian zone signs, and the speed trailer. During the baseline condition the number of crashes per year averaged 14.3, during the NHTSA project crashes averaged 13 per year and during the FHWA project they averaged 9.5 per year. Overall it appeared the treatments were only moderately effective at this site. A graph of the yearly crash data is shown in Figure 4.8.

Figure 4.8 Crashes per Year Collins Ave. and Harding Ave. (67th St. to 76th St.) from 1996 to 2006

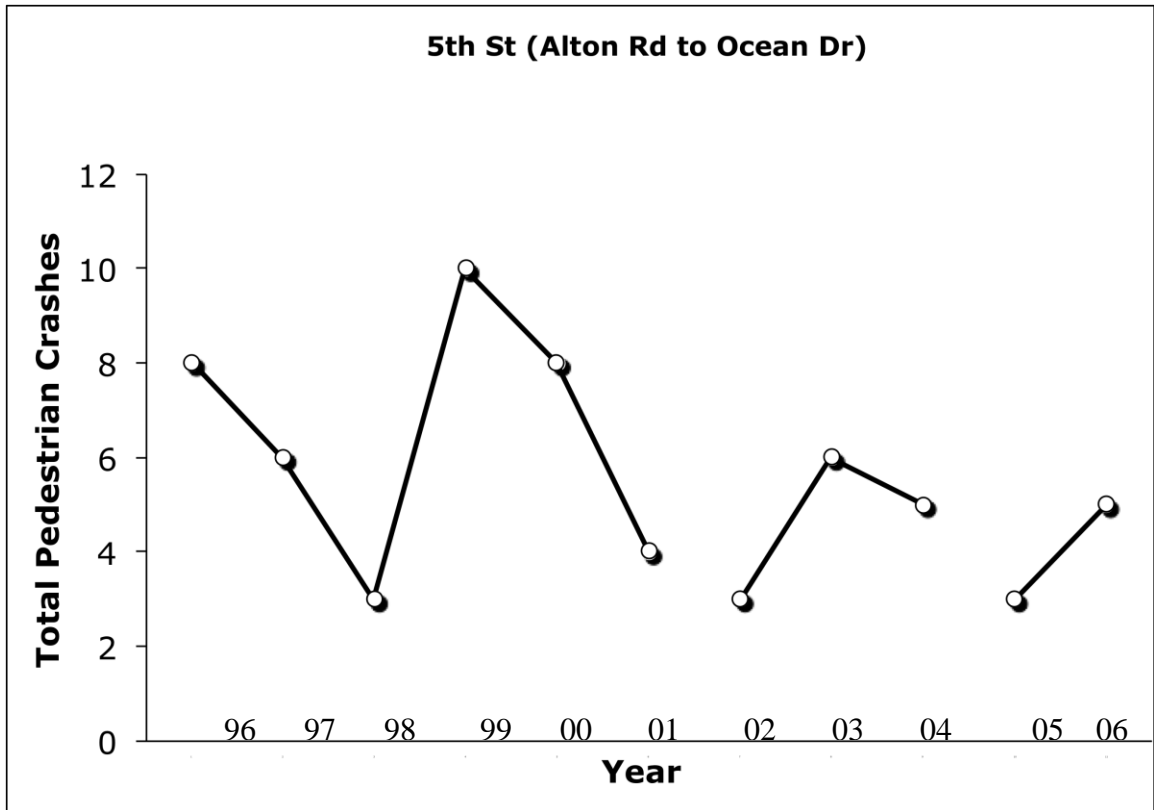
The final graph shows the number of crashes occurring on 5th St. between Alton Rd. and Ocean Drive. More than half the crashes along this corridor occurred at night and only 23% involved turning vehicles. Treatments installed along this corridor included push buttons that confirmed the button press, and “Turning vehicles yield to pedestrians” symbol signs. During the baseline condition pedestrian crashes averaged 6.5 per year. After the NHTSA program was introduced these crashes declined to 4.7 per year and following the introduction of the FHWA project crashes declined to 4 per year. Figure 4.10 shows crashes at this site. Overall there were not a large number of crashes along this corridor and it is difficult to determine whether the treatments had an effect.

Figure 4.10 Crashes per Year on 5th St. Between Alton Rd. and Ocean Dr.) from 1996 to 2006
