EVALUATION OF WATER QUALITY AND AQUATIC ECOSYSTEM HEALTH IN
THE MARA RIVER BASIN EAST AFRICA

MASTER OF SCIENCE

ENVIRONMENTAL STUDIES

Beth A. McCartney

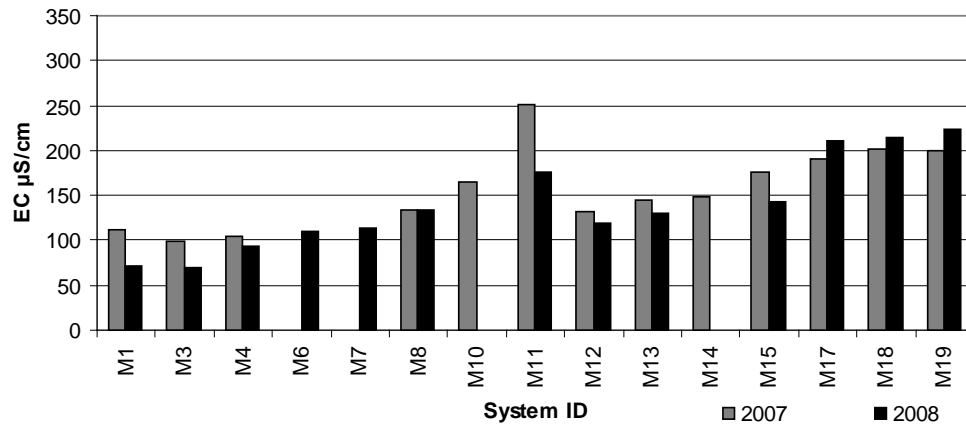
Figure 12: Conductivity – Main Stem Mara and Wetlands

Conductivity results for 2007 ranged from 22 $\mu\text{S}/\text{cm}$ at the Enupuiyapi Swamp (A1) to 2038 $\mu\text{S}/\text{cm}$ at Olare Oreko (OO2). The next highest value was 1171 $\mu\text{S}/\text{cm}$ at Entiakiak (OO3). Results from 2008 ranged from 31 $\mu\text{S}/\text{cm}$ at the Mugango River site

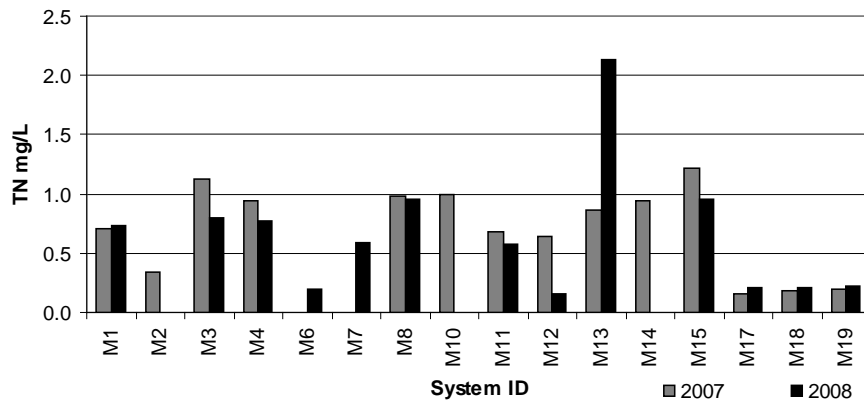
Figure 25: Total Nitrogen – Main Stem Mara and Wetlands

Total nitrogen (TN) values from 2007 ranged from 0.16 mg L⁻¹ at Lyamisanga (M17) to 6.34 mg L⁻¹ at Sub Baringo (M5). The next highest value was 3.58 mg L⁻¹ at Thighte (TH1). In 2008, the 43 ranged from 0.14 mg L⁻¹ at Tabora (TB1) to 10.81 mg L⁻¹ at the Tenwek Bridge (N4). The next highest value was Thighte (TH1) at 10.16 mg L⁻¹.

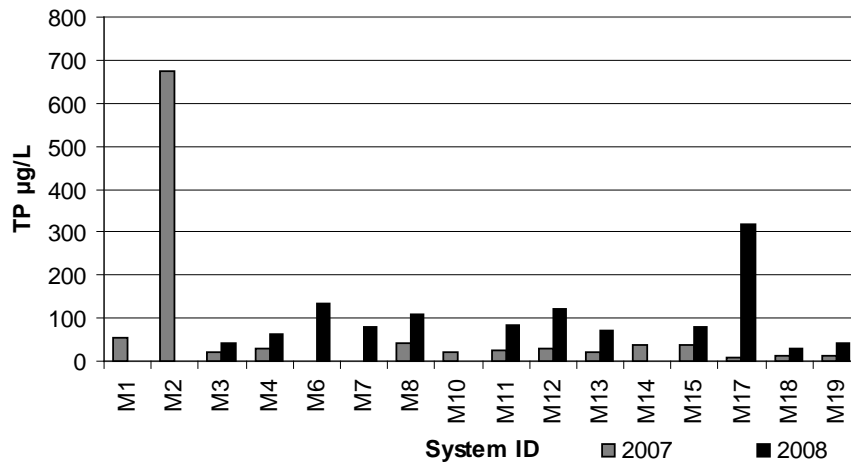
Figure 31: Total Phosphorus – Main Stem Mara and Wetlands

In 2007, total phosphorus (TP) ranged from 4.96 $\mu\text{g L}^{-1}$ at Leshuta (S2) to 672.70 $\mu\text{g L}^{-1}$ at the sewage discharge site (M2). The next highest value was 189.10 $\mu\text{g L}^{-1}$ at the Borogonga Bridge (B2). Total phosphorus results from 2008 ranged from below detection at 2 sites to 317.75 $\mu\text{g L}^{-1}$ at Lyamisanga (M17).

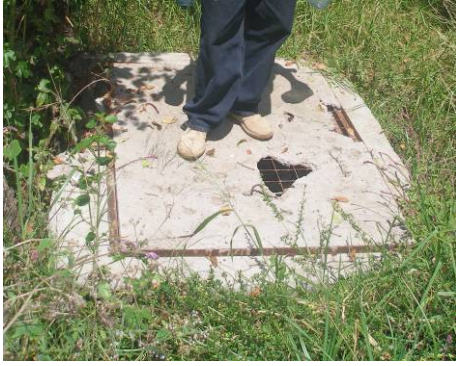
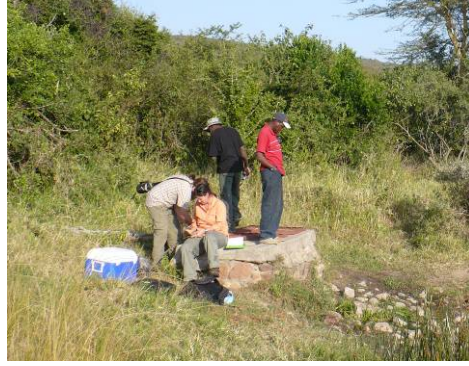
As expected, flow in the headwater regions was low such that the Leshuta site (S2) in 2007 did not have enough water for the YSI probe. Therefore no in-situ chemistry readings are available. A low pH reading occurred at the Olochro Ole Tuya site. Low pH was expected at this site given that it was densely forested and had significant vegetation litter.

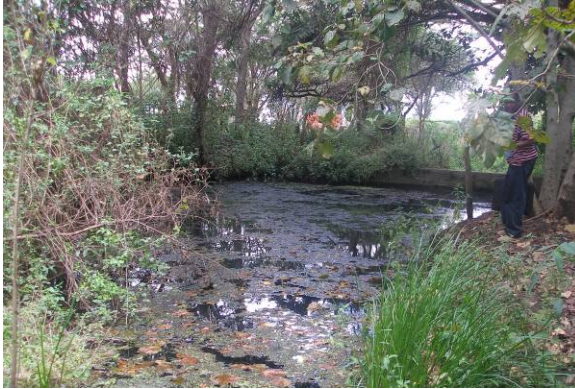
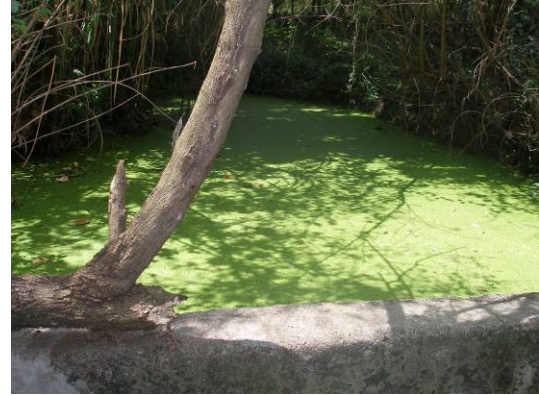
Dissolved oxygen trended low at Olochro Ole Tuya (S3) due to high organic content, Ochor Orike (S1) possibly due to organic waste inputs and Oke Ngalane due to its spring like nature. Temperature did not appear to be a factor. Otherwise values were in range. Conductivity trended low as expected.

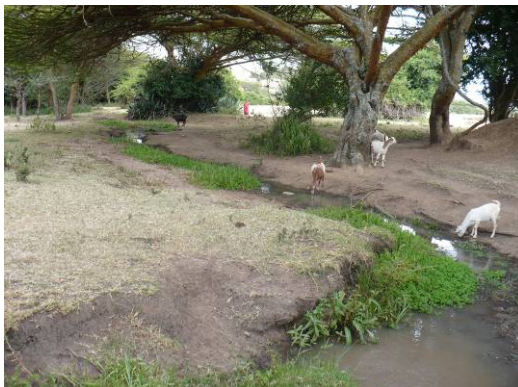
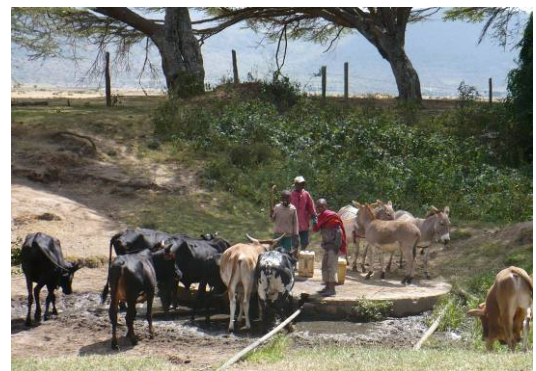
Sites in the headwaters of the Sand River exceeded suspended solids and turbidity limits. The Olare Orike site (S1) was the only site to have received a highly disturbed ranking. This site was densely populated with livestock and had an abstraction pump. The high turbidity and TSS values were most likely a result of livestock trampling and an impaired riparian zone.

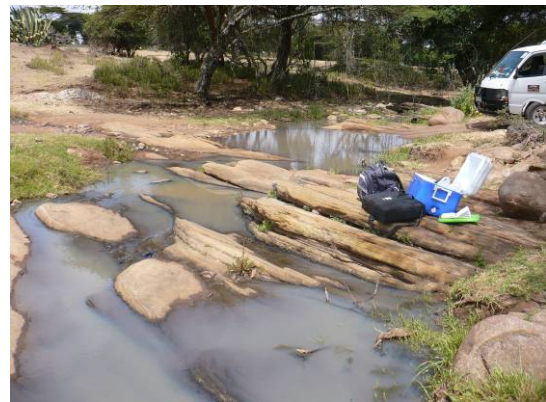
Elevated turbidity and TSS at Olochro Ole Tuya (S3) may have resulted because of the unsettling of sediment by the artificial dam while the results for Olchor Orok Leshuta (S4) may be attributed to lack of significant flow. The Borogonga site (B1) was located in the protection of the Serengeti National Park. Talek site Oke Ngalane (T1) was more spring like with a surrounding marsh area and higher flow was observed at the Pakaitibiao site (T2). These factors may have prevented elevated turbidity and TSS values.

Olchor Orok Leshuta was also high in total dissolved nitrogen. The riparian area at this site was patch grass with a few trees. TDN may have accumulated to levels beyond vegetation needs given that the system has such low flow and therefore is not allowing nutrients to flush out. Ochor Orike (S1) demonstrated elevated levels of total phosphorus in 2008 only. This sample may have been collected after a rain event which washed particulate in to the channel or dilution in 2007 may have exceeded that of 2008. Macro invertebrate scores for these areas trended mid range, with sites along the Talek River ranking highest. The Talek sites appeared to have more suitable vegetation and

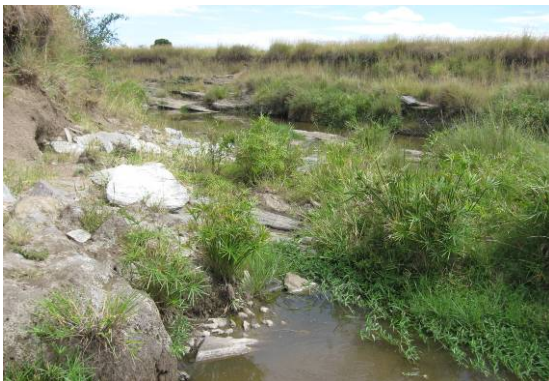
The sites that displayed high dissolved carbon values, Entiakiak (OO3) and Talek (T4), are characterized as bushland with no agriculture in proximity. Studies indicate that DOC content in rivers is indicative of the catchment and that DOC can be divided into 2 groups, humic substances and more complex compounds. Humic substances may account for 60 – 90% of surface water DOC (Sachse 2005). The high DOC values observed at OO3 and T4 are most likely the result of decaying organic material and low water levels. Excess DOC at OO3 may also be attributed to a hippopotamus (*Hippopotamus amphibious*) pool observed upstream.

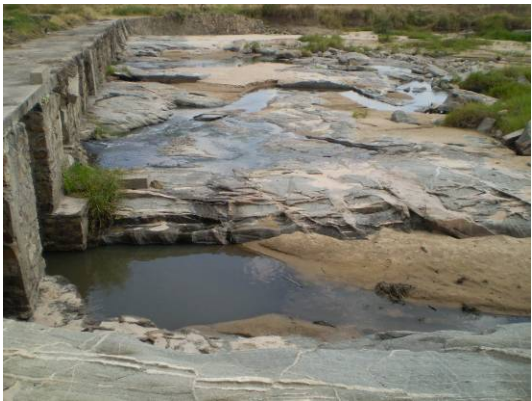
Borogonga (2007)

A number of sites ranked high in total phosphorus, including the Borogonga Bridge both years. It is believed that particulate phosphorus is derivative of mineral material. Research indicates that total phosphorus follows total particulate trends, i.e. suspended

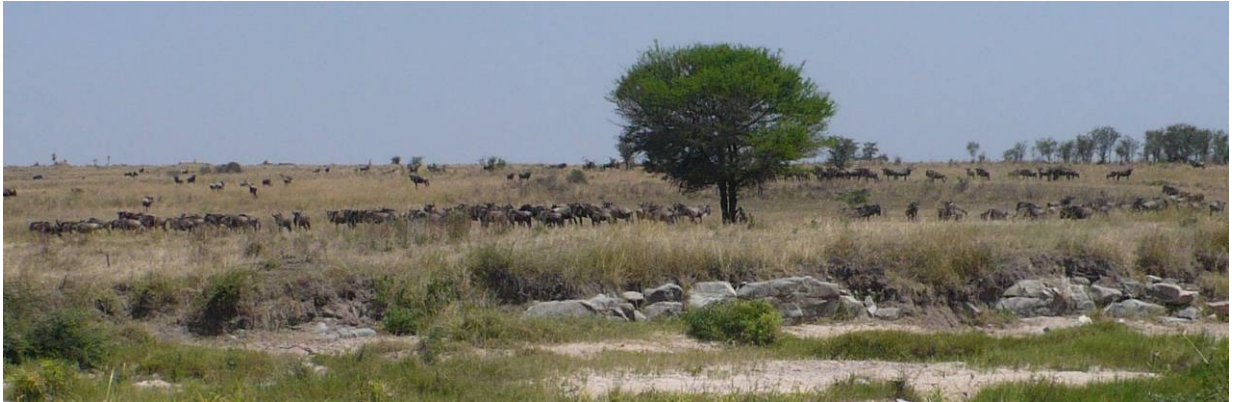
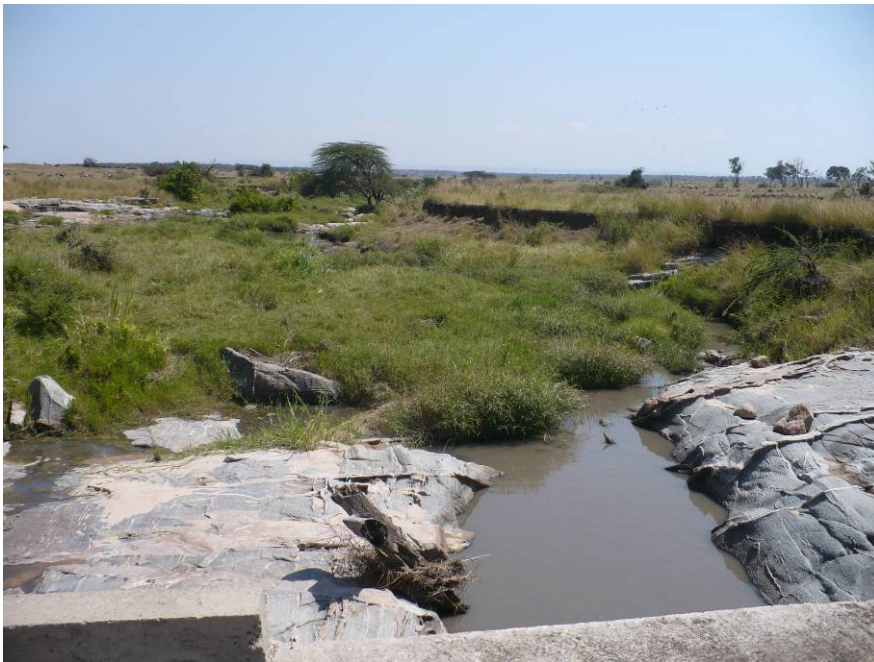
Borogonga Bridge 2008

Sewage discharge site M2, the Old Mara Bridge site (M4), and the Mara/Borogonga confluence (M11) exceeded soluble reactive phosphorus limits. Sites M2 and M4 also ranked high in total dissolved phosphorus. These results were expected for the sewage discharge site. M11 only exceeded limits in 2008 while M4 exceeded limits both years, TDP as well. Large numbers of migratory wildlife were observed in the upstream regions of the Borogonga River in 2008, more so than in 2007. This river also demonstrated low water levels. The concentration of animal waste inputs and low

dilution ability of the waters most likely resulted in the high levels of SRP observed downstream.

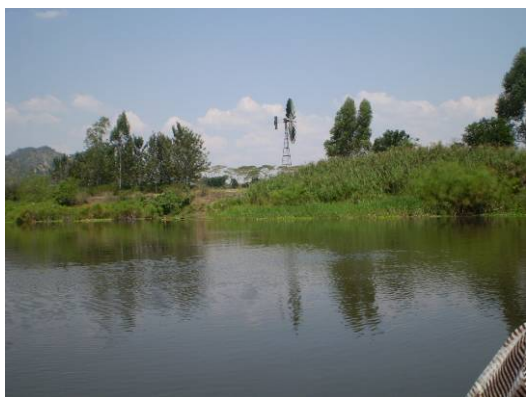
2007 Sampling Point

As expected, all 3 sites demonstrated low dissolved oxygen. The Lyamisanga site, M17, displayed low pH which may have been a result of high organic decomposition and elevated tannic acids. This site also exceeded turbidity and total suspended solid limits in 2008. The 2008 sample was taken closer to the bank whereas the 2007 sample was taken more mid channel. The high turbidity and TSS levels were most likely a result of reduced water column mixing and erosion at the access point.
