Virginia Key Beach Park
Tidal Current Study
Miami-Dade County, Florida

Coastal Systems International, Inc.
464 South Dixie Highway
Coral Gables, FL 33146

September 2009

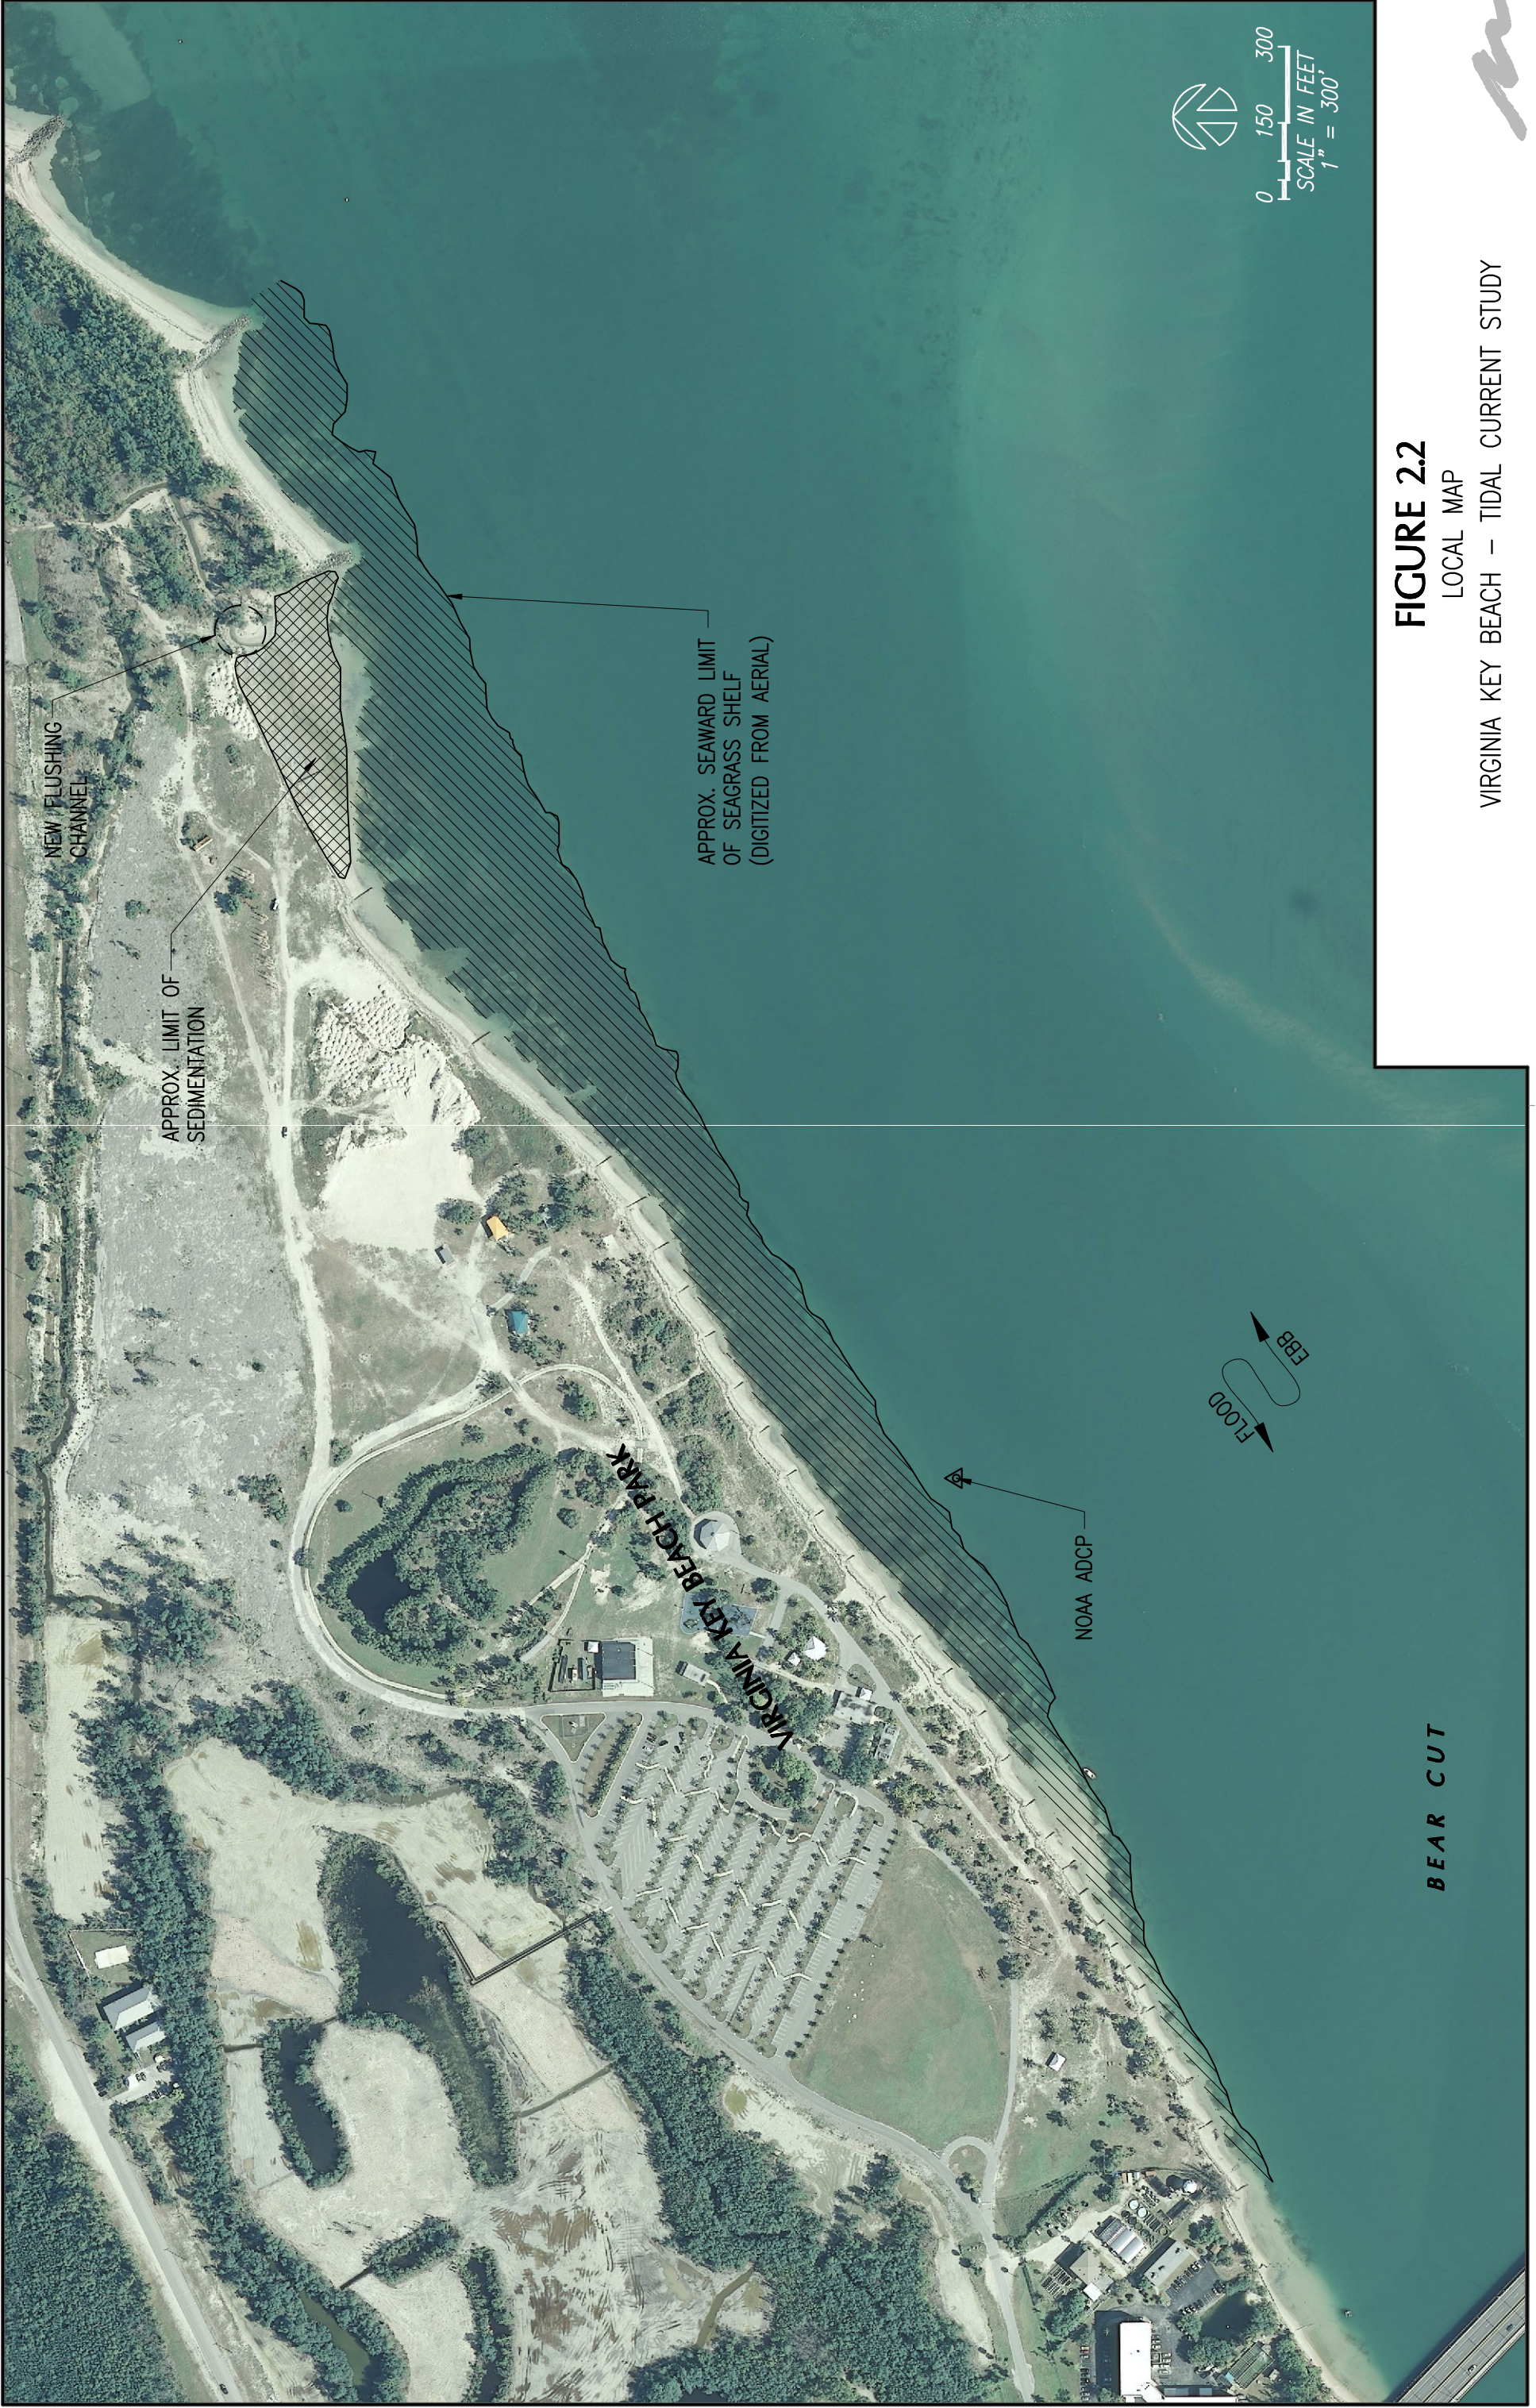
FIGURE 2.2
LOCAL MAP

The bathymetry along the shoreline is unique. Parallel to the shoreline a shelf covered with, and possibly anchored by, seagrass exists. Beyond the "seagrass shelf", the depth increases rapidly into the channel of Bear Cut. While onsite, the current speeds on the shallow seagrass shelf appeared to be generally manageable for beachgoers; however the current speeds in Bear Cut channel, immediately beyond the shelf, were likely hazardous to swimmers. The seagrass shelf is widest along the eastern section of the park shoreline, and becomes increasingly narrow along the western half of the Park shoreline (Refer to Figure 2.2).

Along the section of beach immediately west of the rock groins a channel was purposely cut to connect an interior lagoon system with the ocean water (Refer to Photos 3 - 5 in Appendix A and Figure 2.2). As a result, significant sedimentation was observed in the nearshore area resulting from the deposit of material transported out of the lagoons during tidal exchange (refer to Figure 2.2).

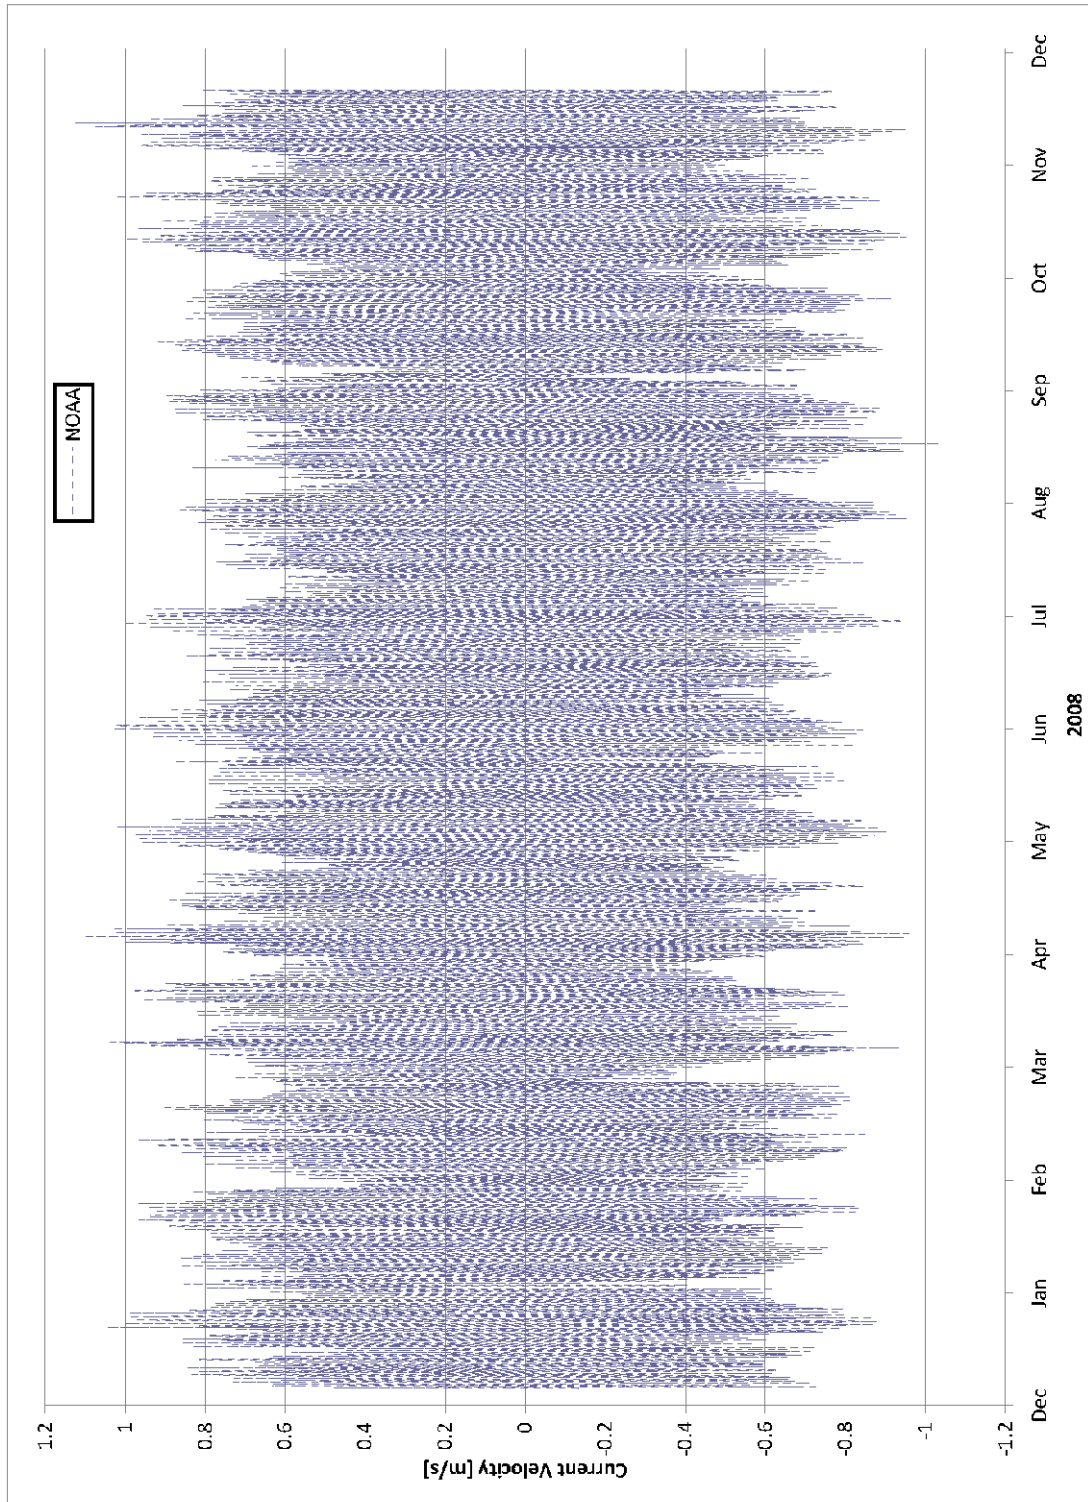
FIGURE 2.4
NOAA CURRENT MEASUREMENTS
VIRGINIA KEY BEACH – TIDAL CURRENT STUDY

Due to the tidal characteristics of Biscayne Bay and the bathymetric features of the Bear Cut channel, the tidal current speeds in the Project vicinity can exceed 3.3 ft/sec (1.0 m/s). Recently, NOAA conducted a current study in the Bear Cut channel with the deployment of an Acoustic Doppler Current Profiler (ADCP) on the seabed at a depth of approximately 13.1 ft (4.0 m), located at Latitude: 25° 44.073' N, Longitude: 80° 09.305' W (see Figure 2.1) (NOAA, 2009). The ADCP recorded current velocities as well as the water surface elevation from December 6, 2007 until November 25, 2008. During this study the maximum recorded current velocity was approximately 3.6 ft/sec (1.1 m/s). According to the NOAA study, the measured current speeds were greater than 1.6 ft/sec (0.5 m/s) approximately 40% of the time. A plot of the measured current velocities for the duration of the ADCP deployment is exhibited in Figure 2.4.

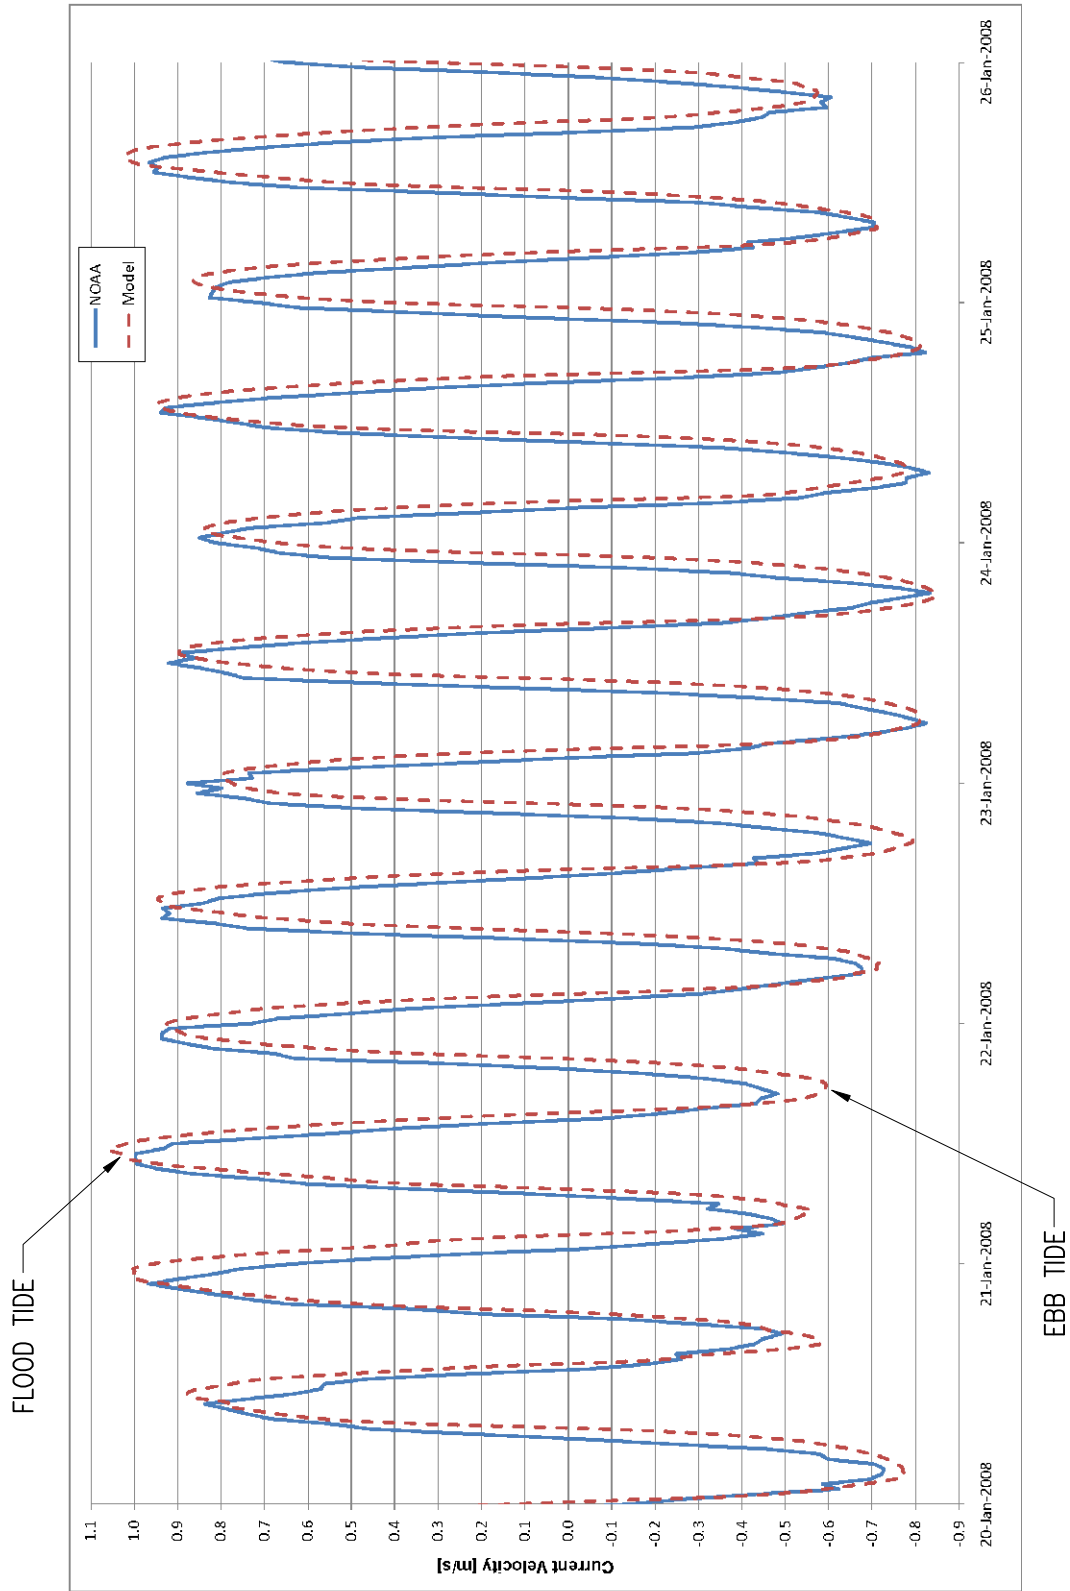
FIGURE 3.3
CURRENT COMPARISON
VIRGINIA KEY BEACH – TIDAL CURRENT STUDY

The modeled current speeds were compared with the field measurements at the NOAA ADCP location (refer to Figure 2.1), and the results are displayed in Figure 3.3. As illustrated in Figure 3.3, the modeled and measured current speeds are in general agreement. Specifically, the peak measured current speeds are simulated by the numerical model. Therefore, the numerical model was successfully calibrated.

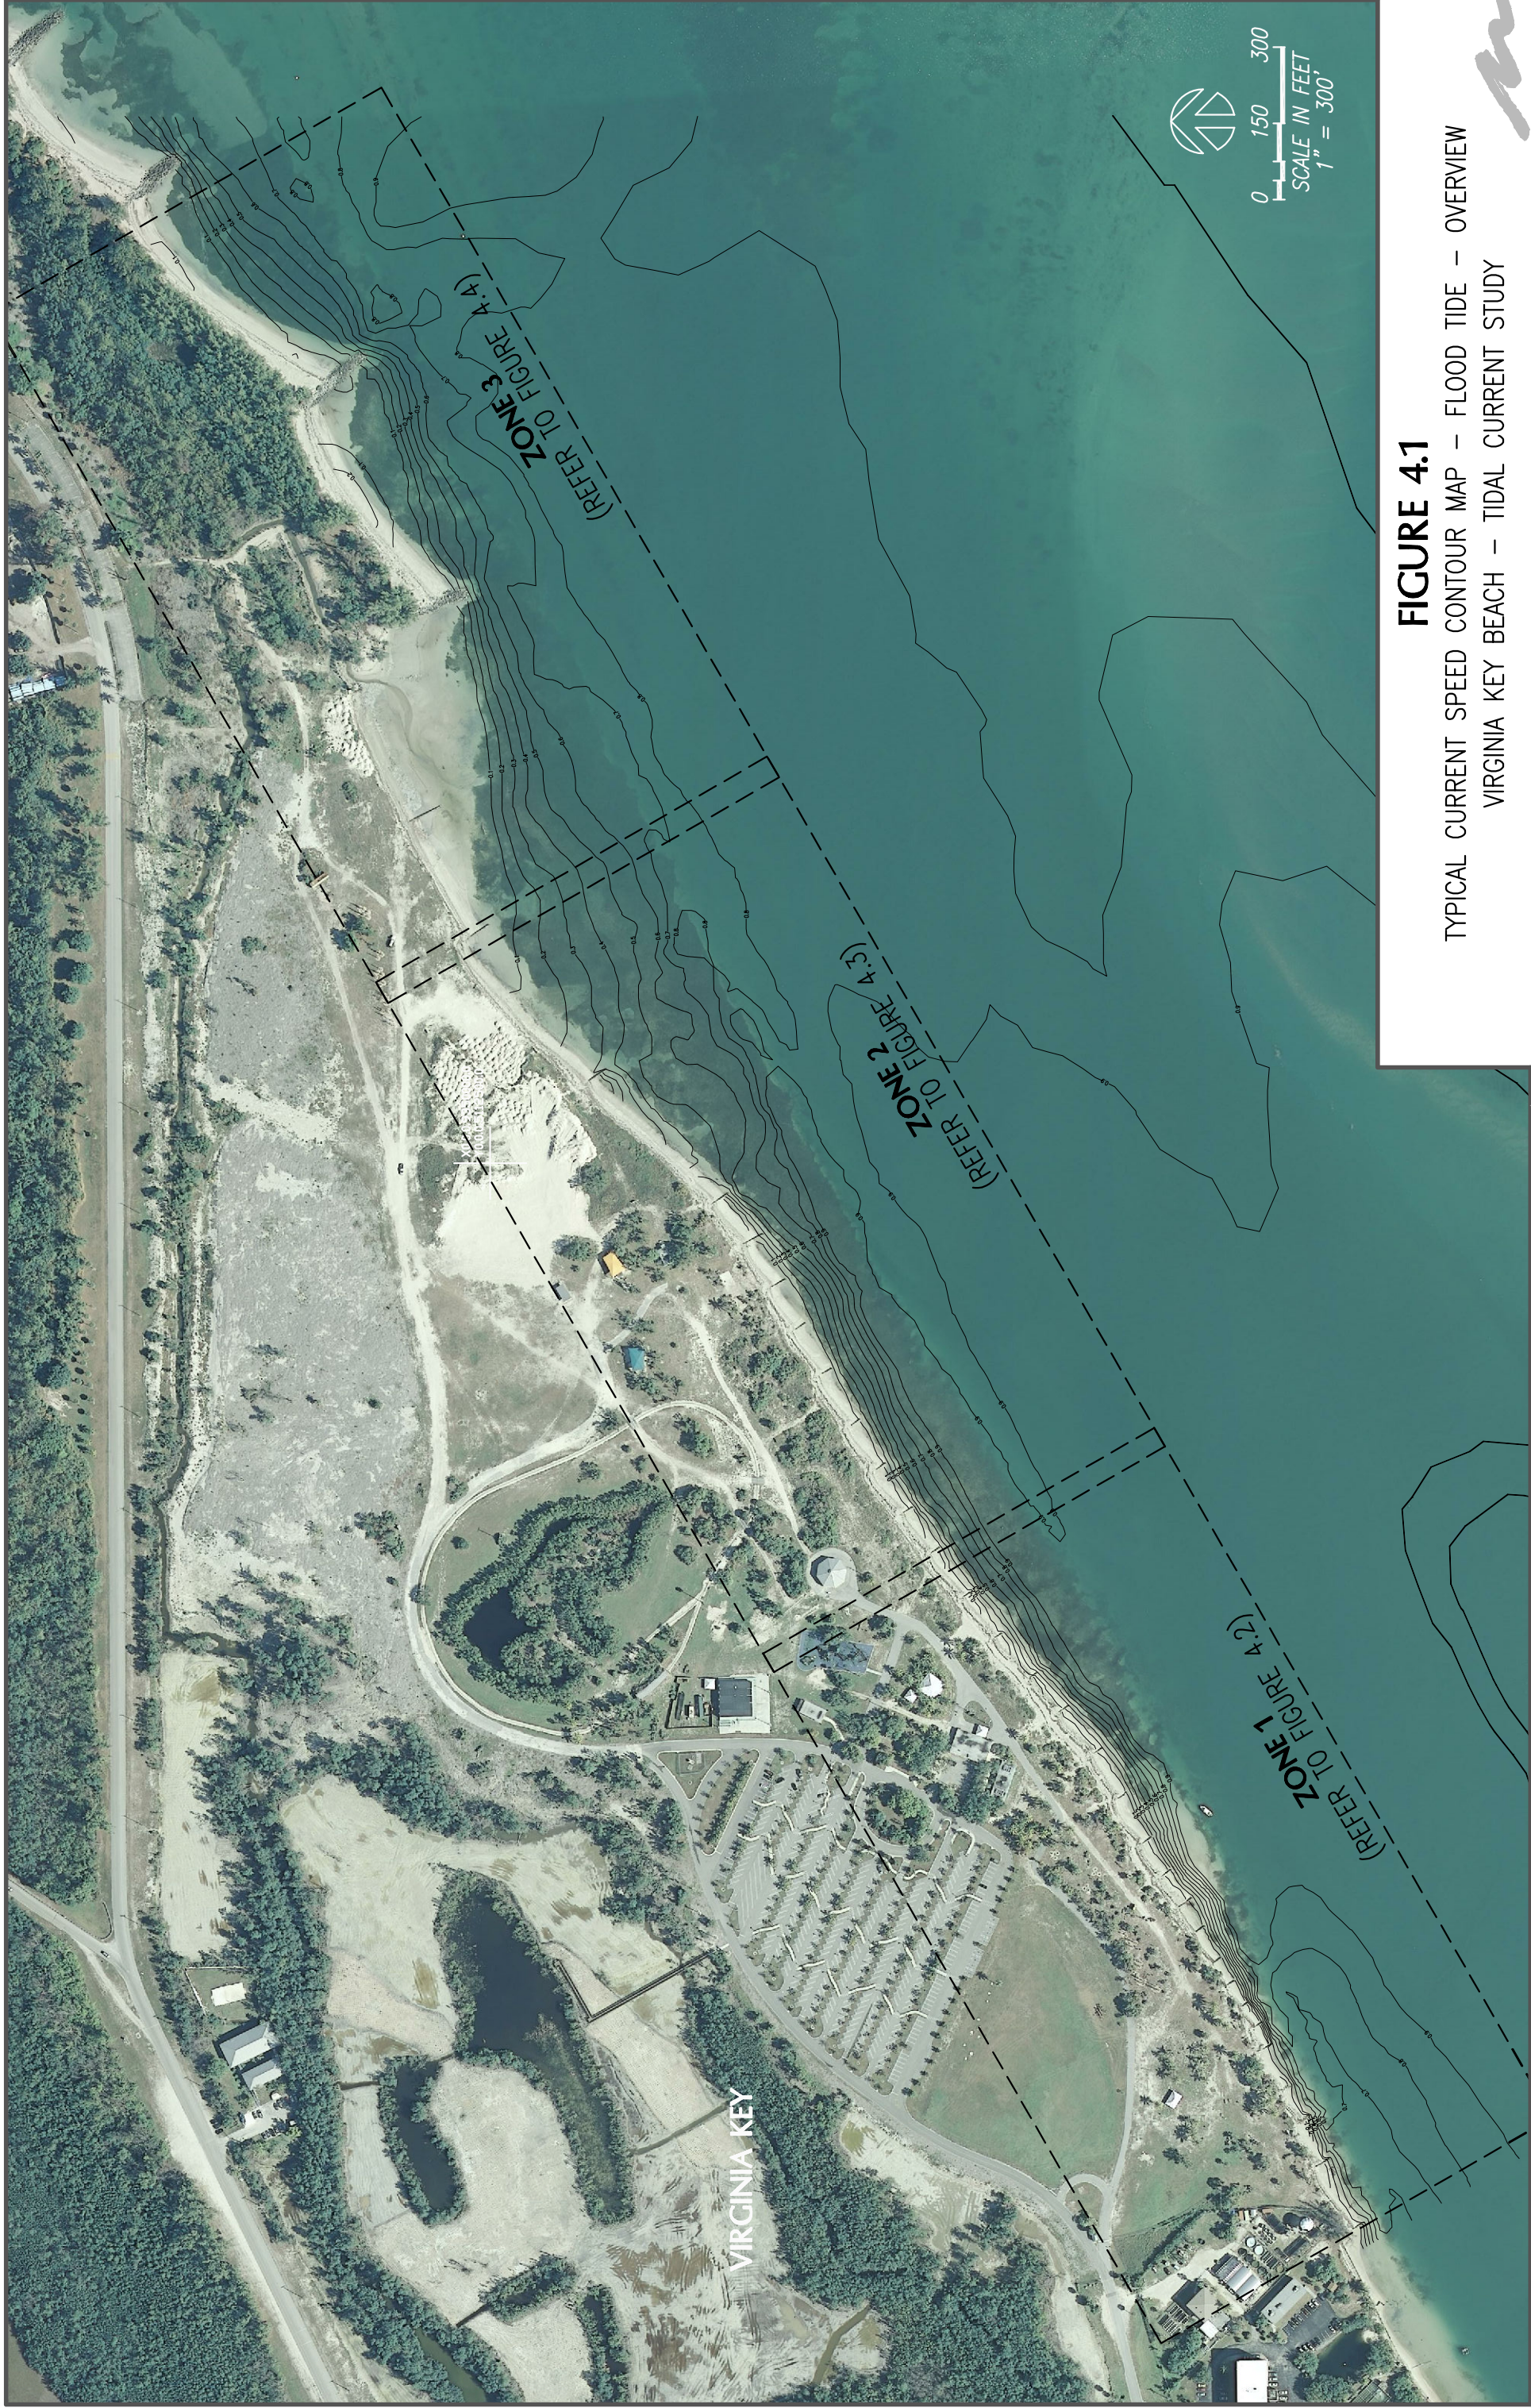
TYPICAL CURRENT SPEED CONTOUR MAP – FLOOD TIDE – OVERVIEW
 VIRGINIA KEY BEACH – TIDAL CURRENT STUDY

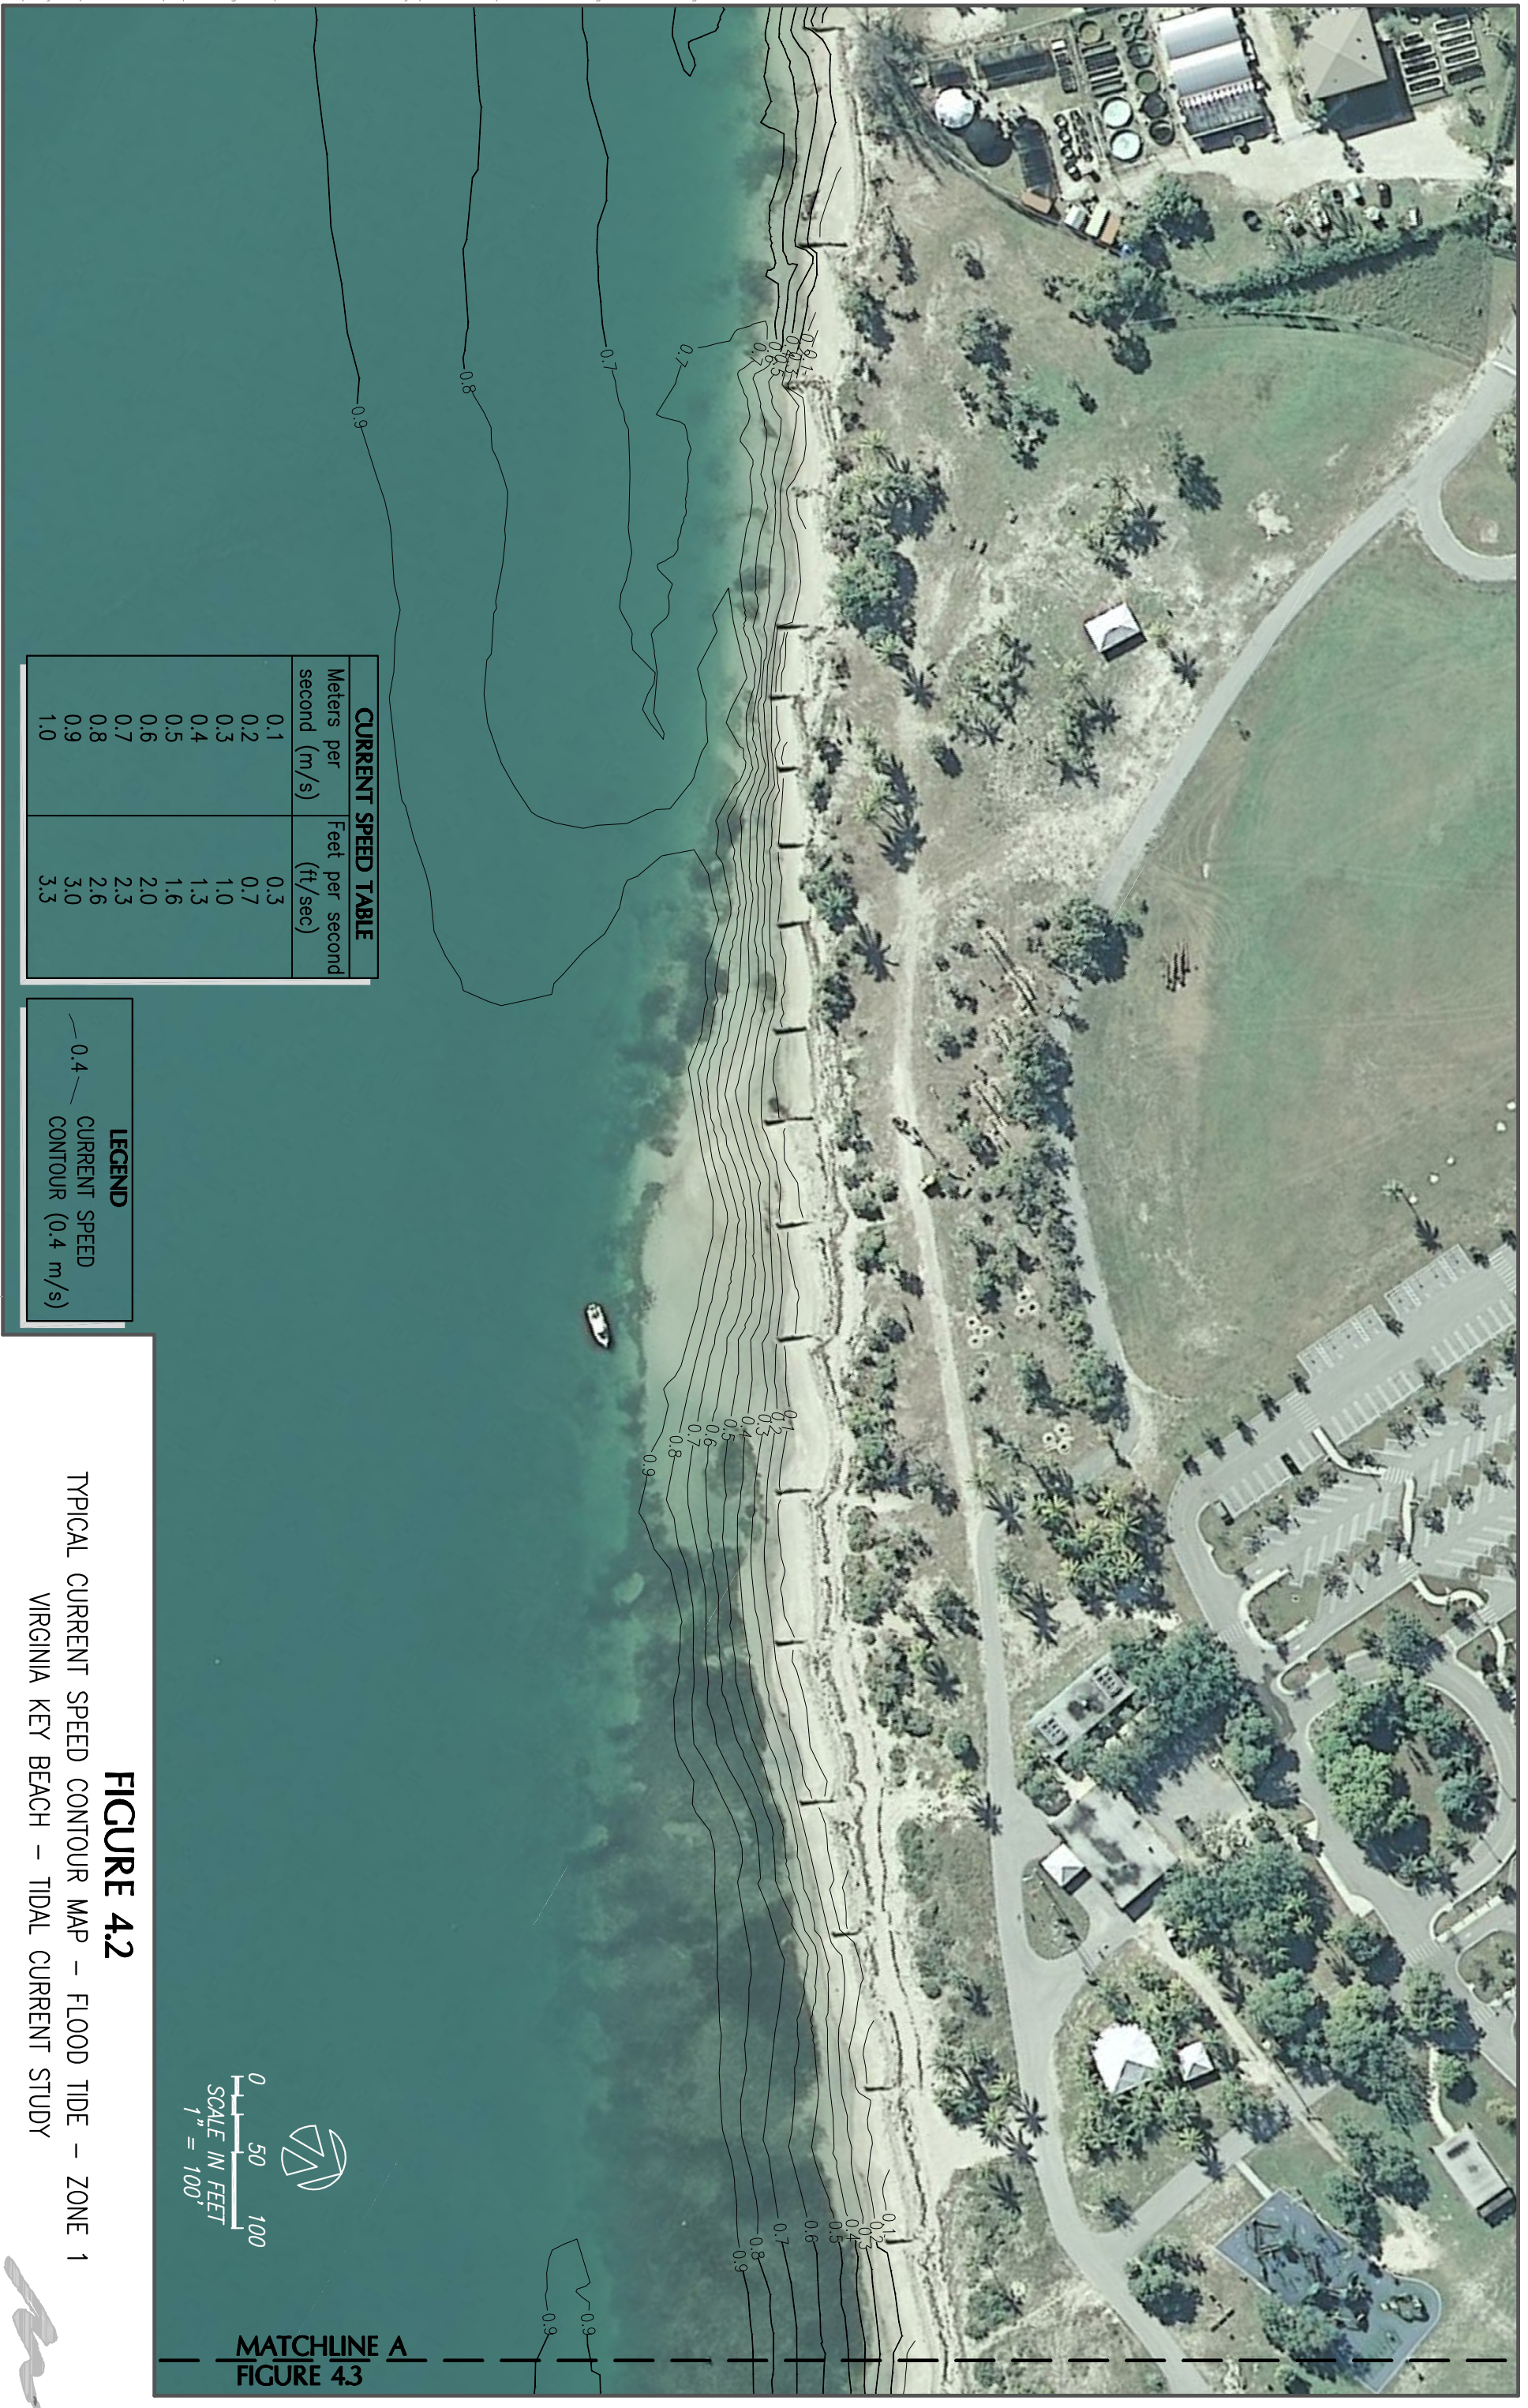
FIGURE 4.2
 TYPICAL CURRENT SPEED CONTOUR MAP – FLOOD TIDE – ZONE 1
 VIRGINIA KEY BEACH – TIDAL CURRENT STUDY

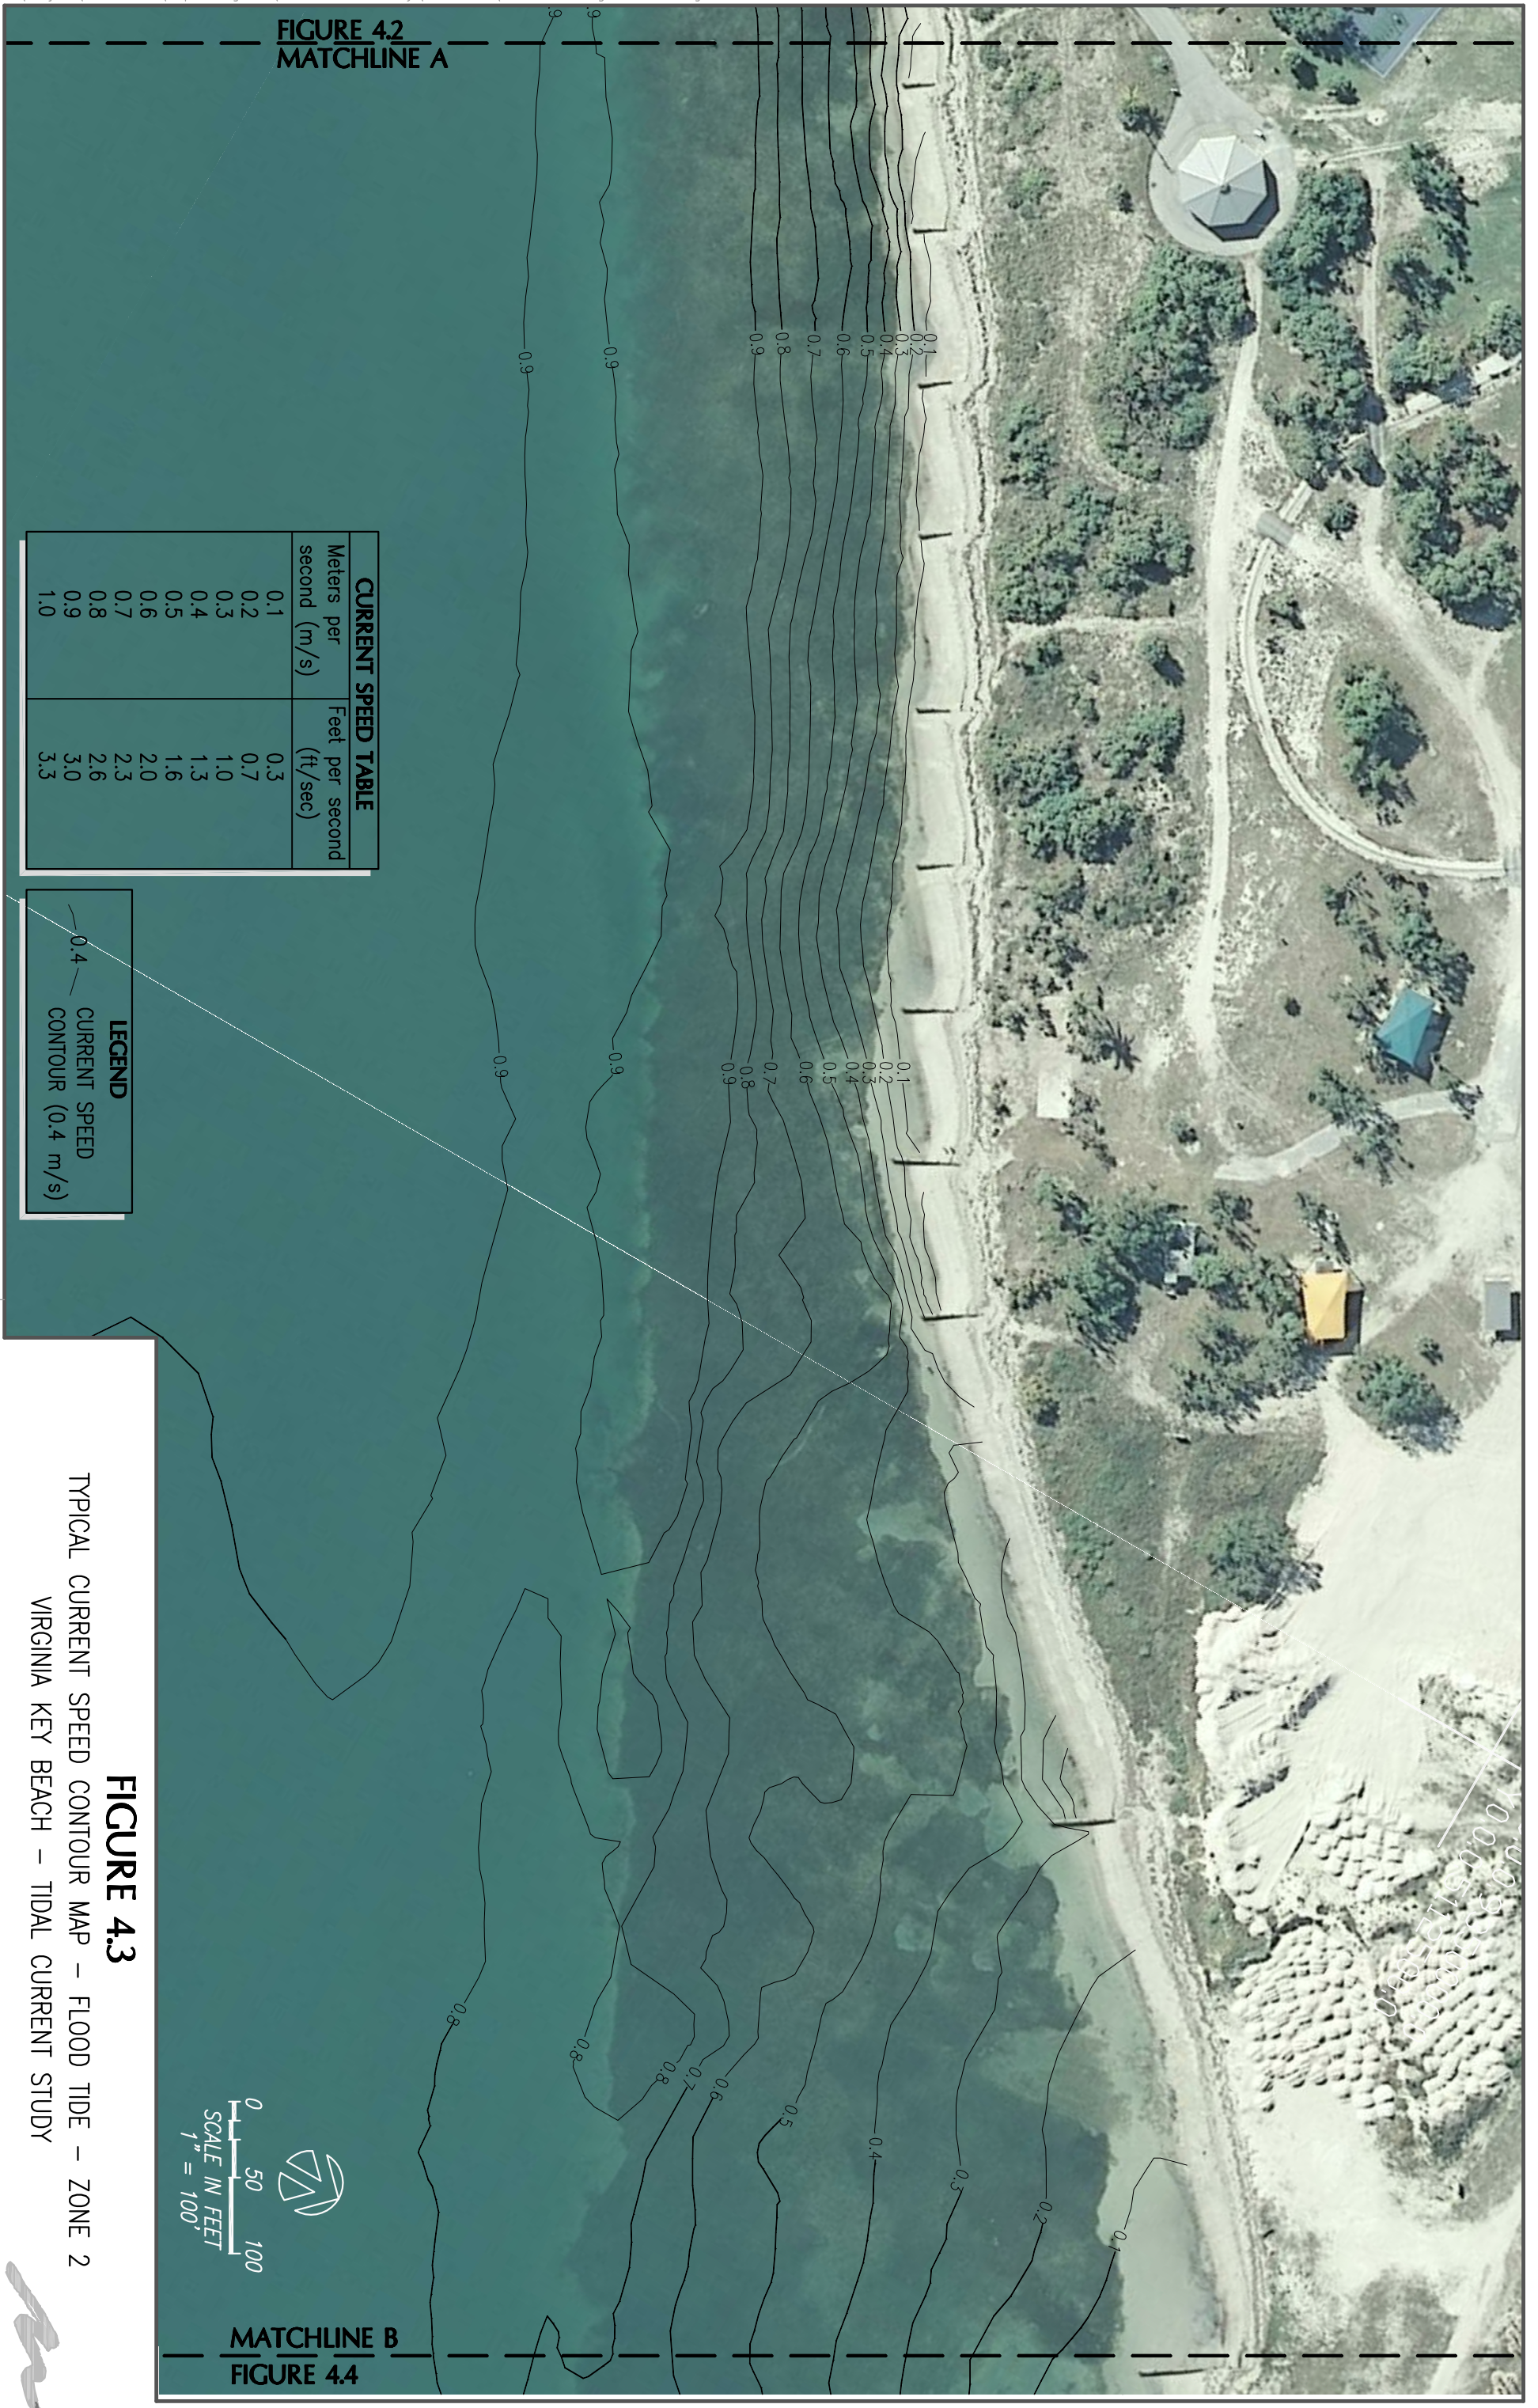
TYPICAL CURRENT SPEED CONTOUR MAP – FLOOD TIDE – ZONE 2
VIRGINIA KEY BEACH – TIDAL CURRENT STUDY

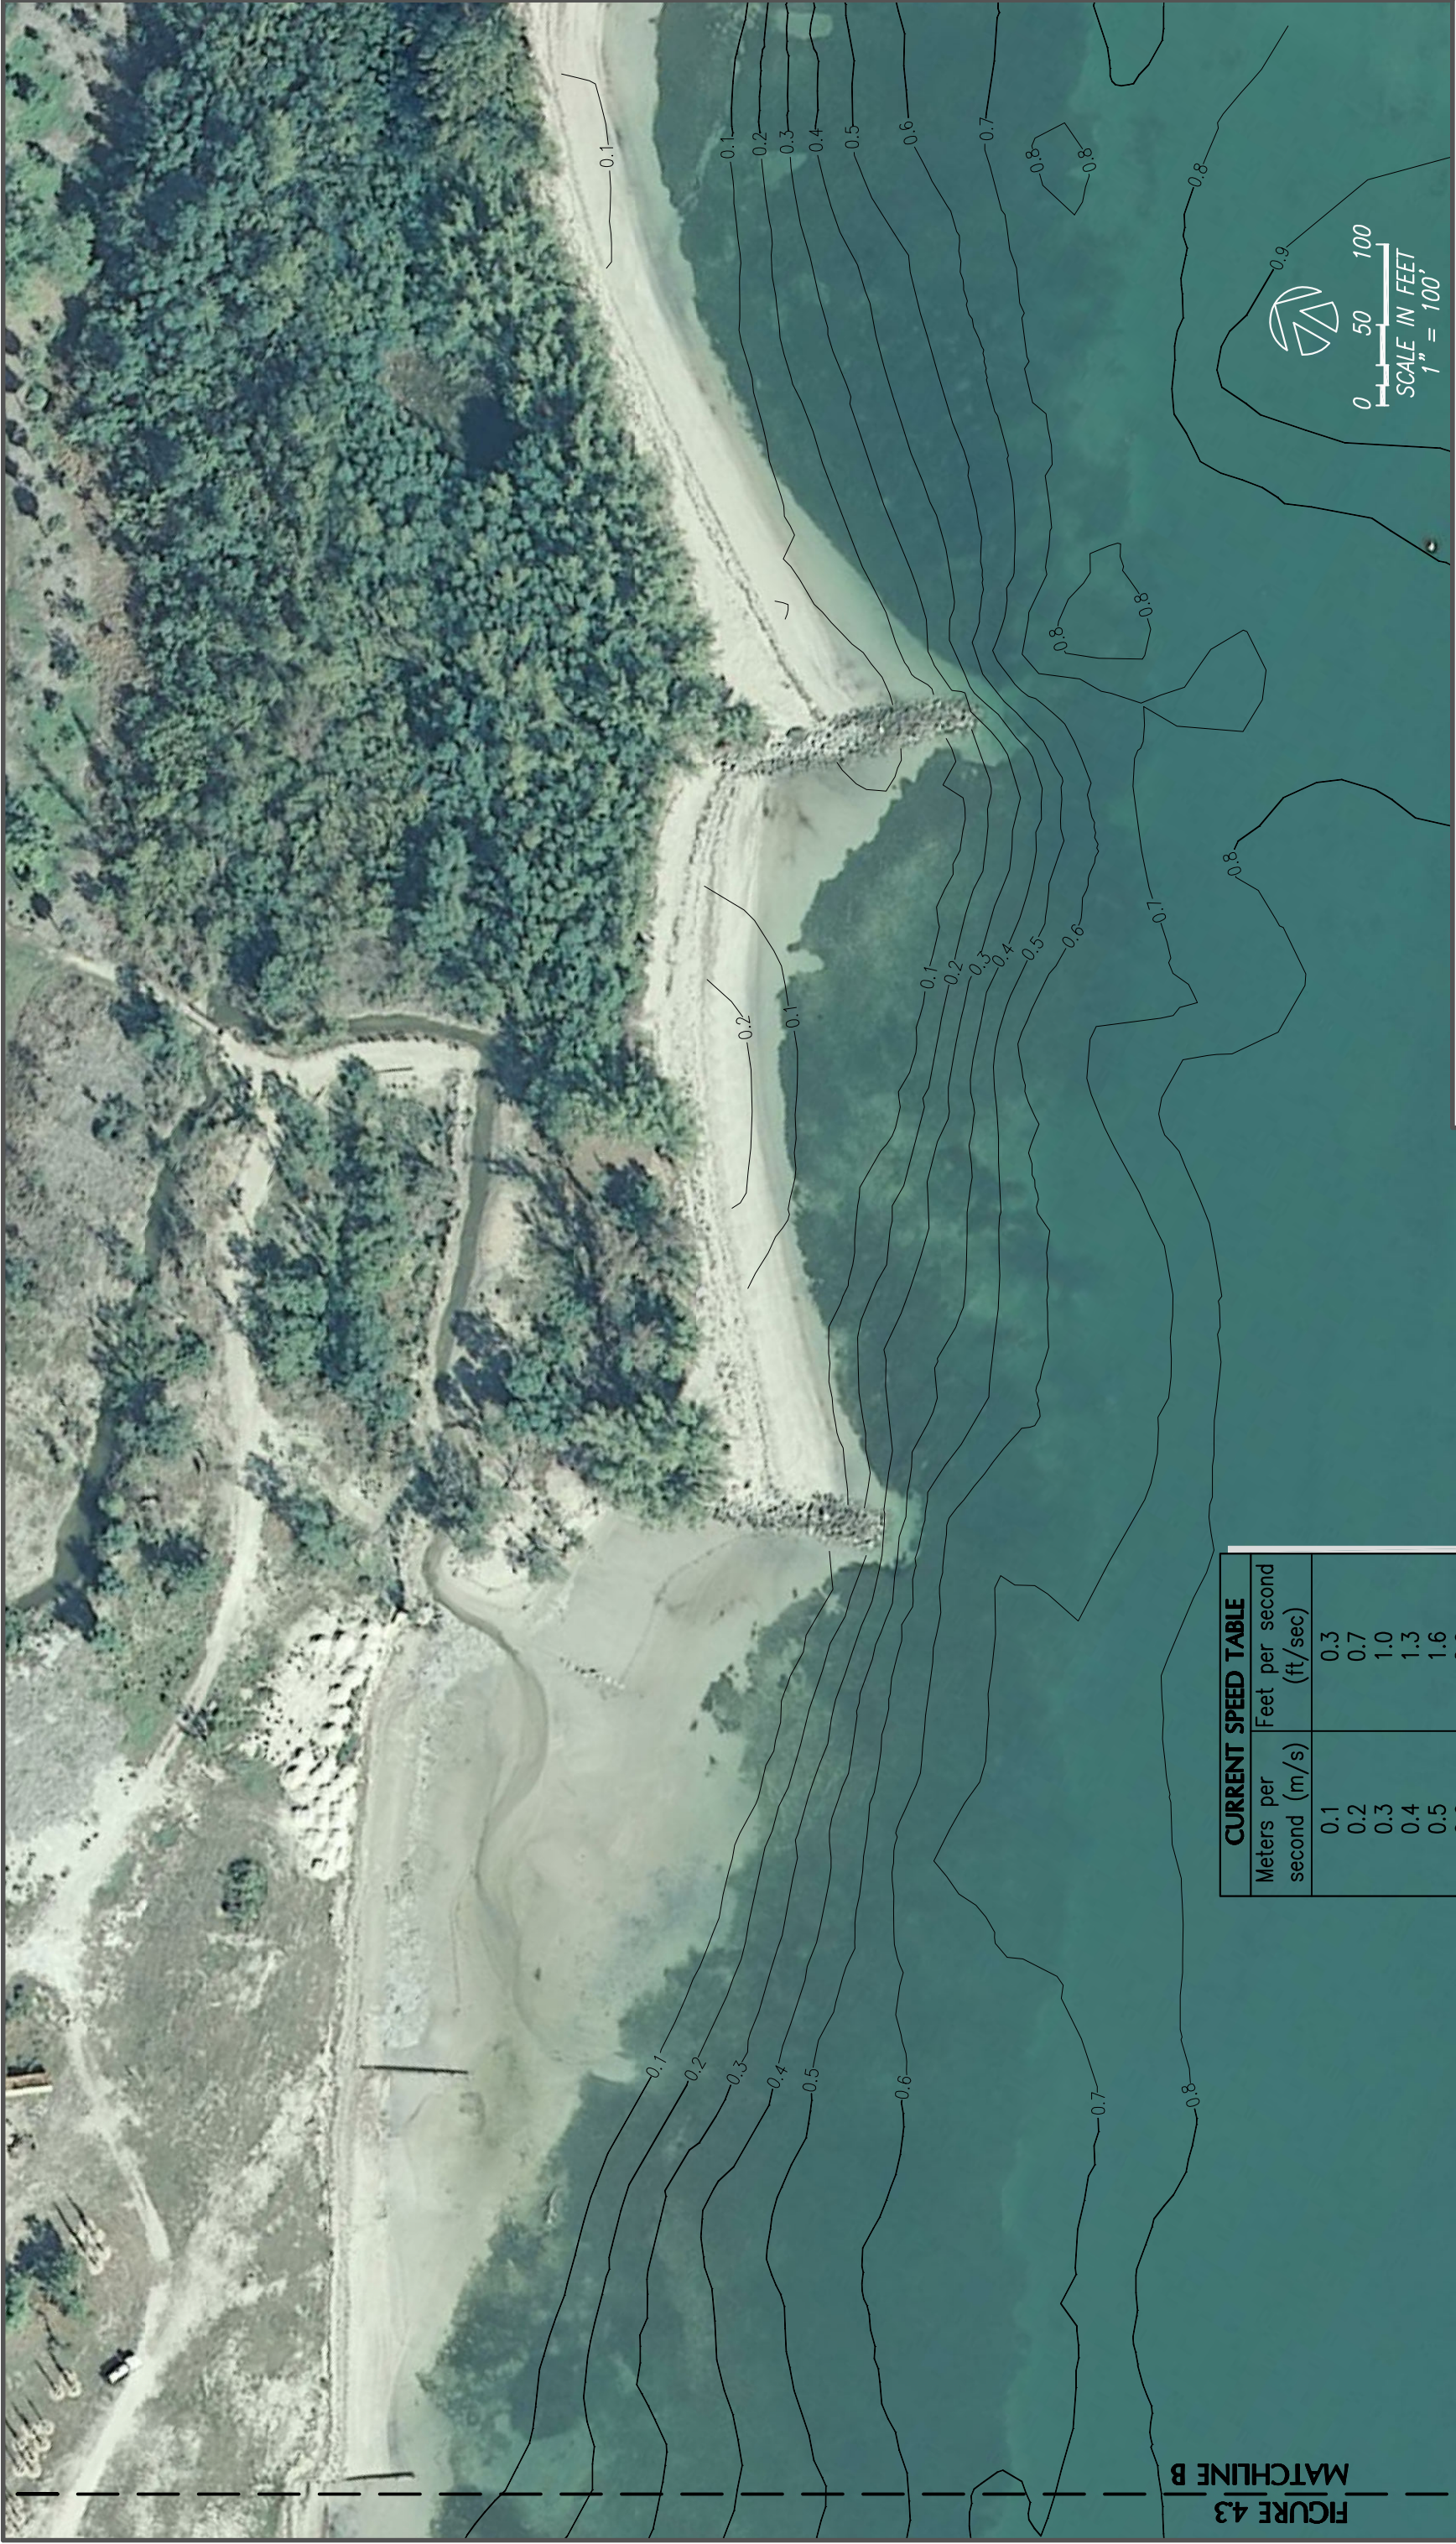
TYPICAL CURRENT SPEED CONTOUR MAP – FLOOD TIDE – ZONE 3
VIRGINIA KEY BEACH – TIDAL CURRENT STUDY
