Virginia Key Beach Park
Tidal Current Study
Miami-Dade County, Florida

Coastal Systems International, Inc.
464 South Dixie Highway
Coral Gables, FL 33146

September 2009

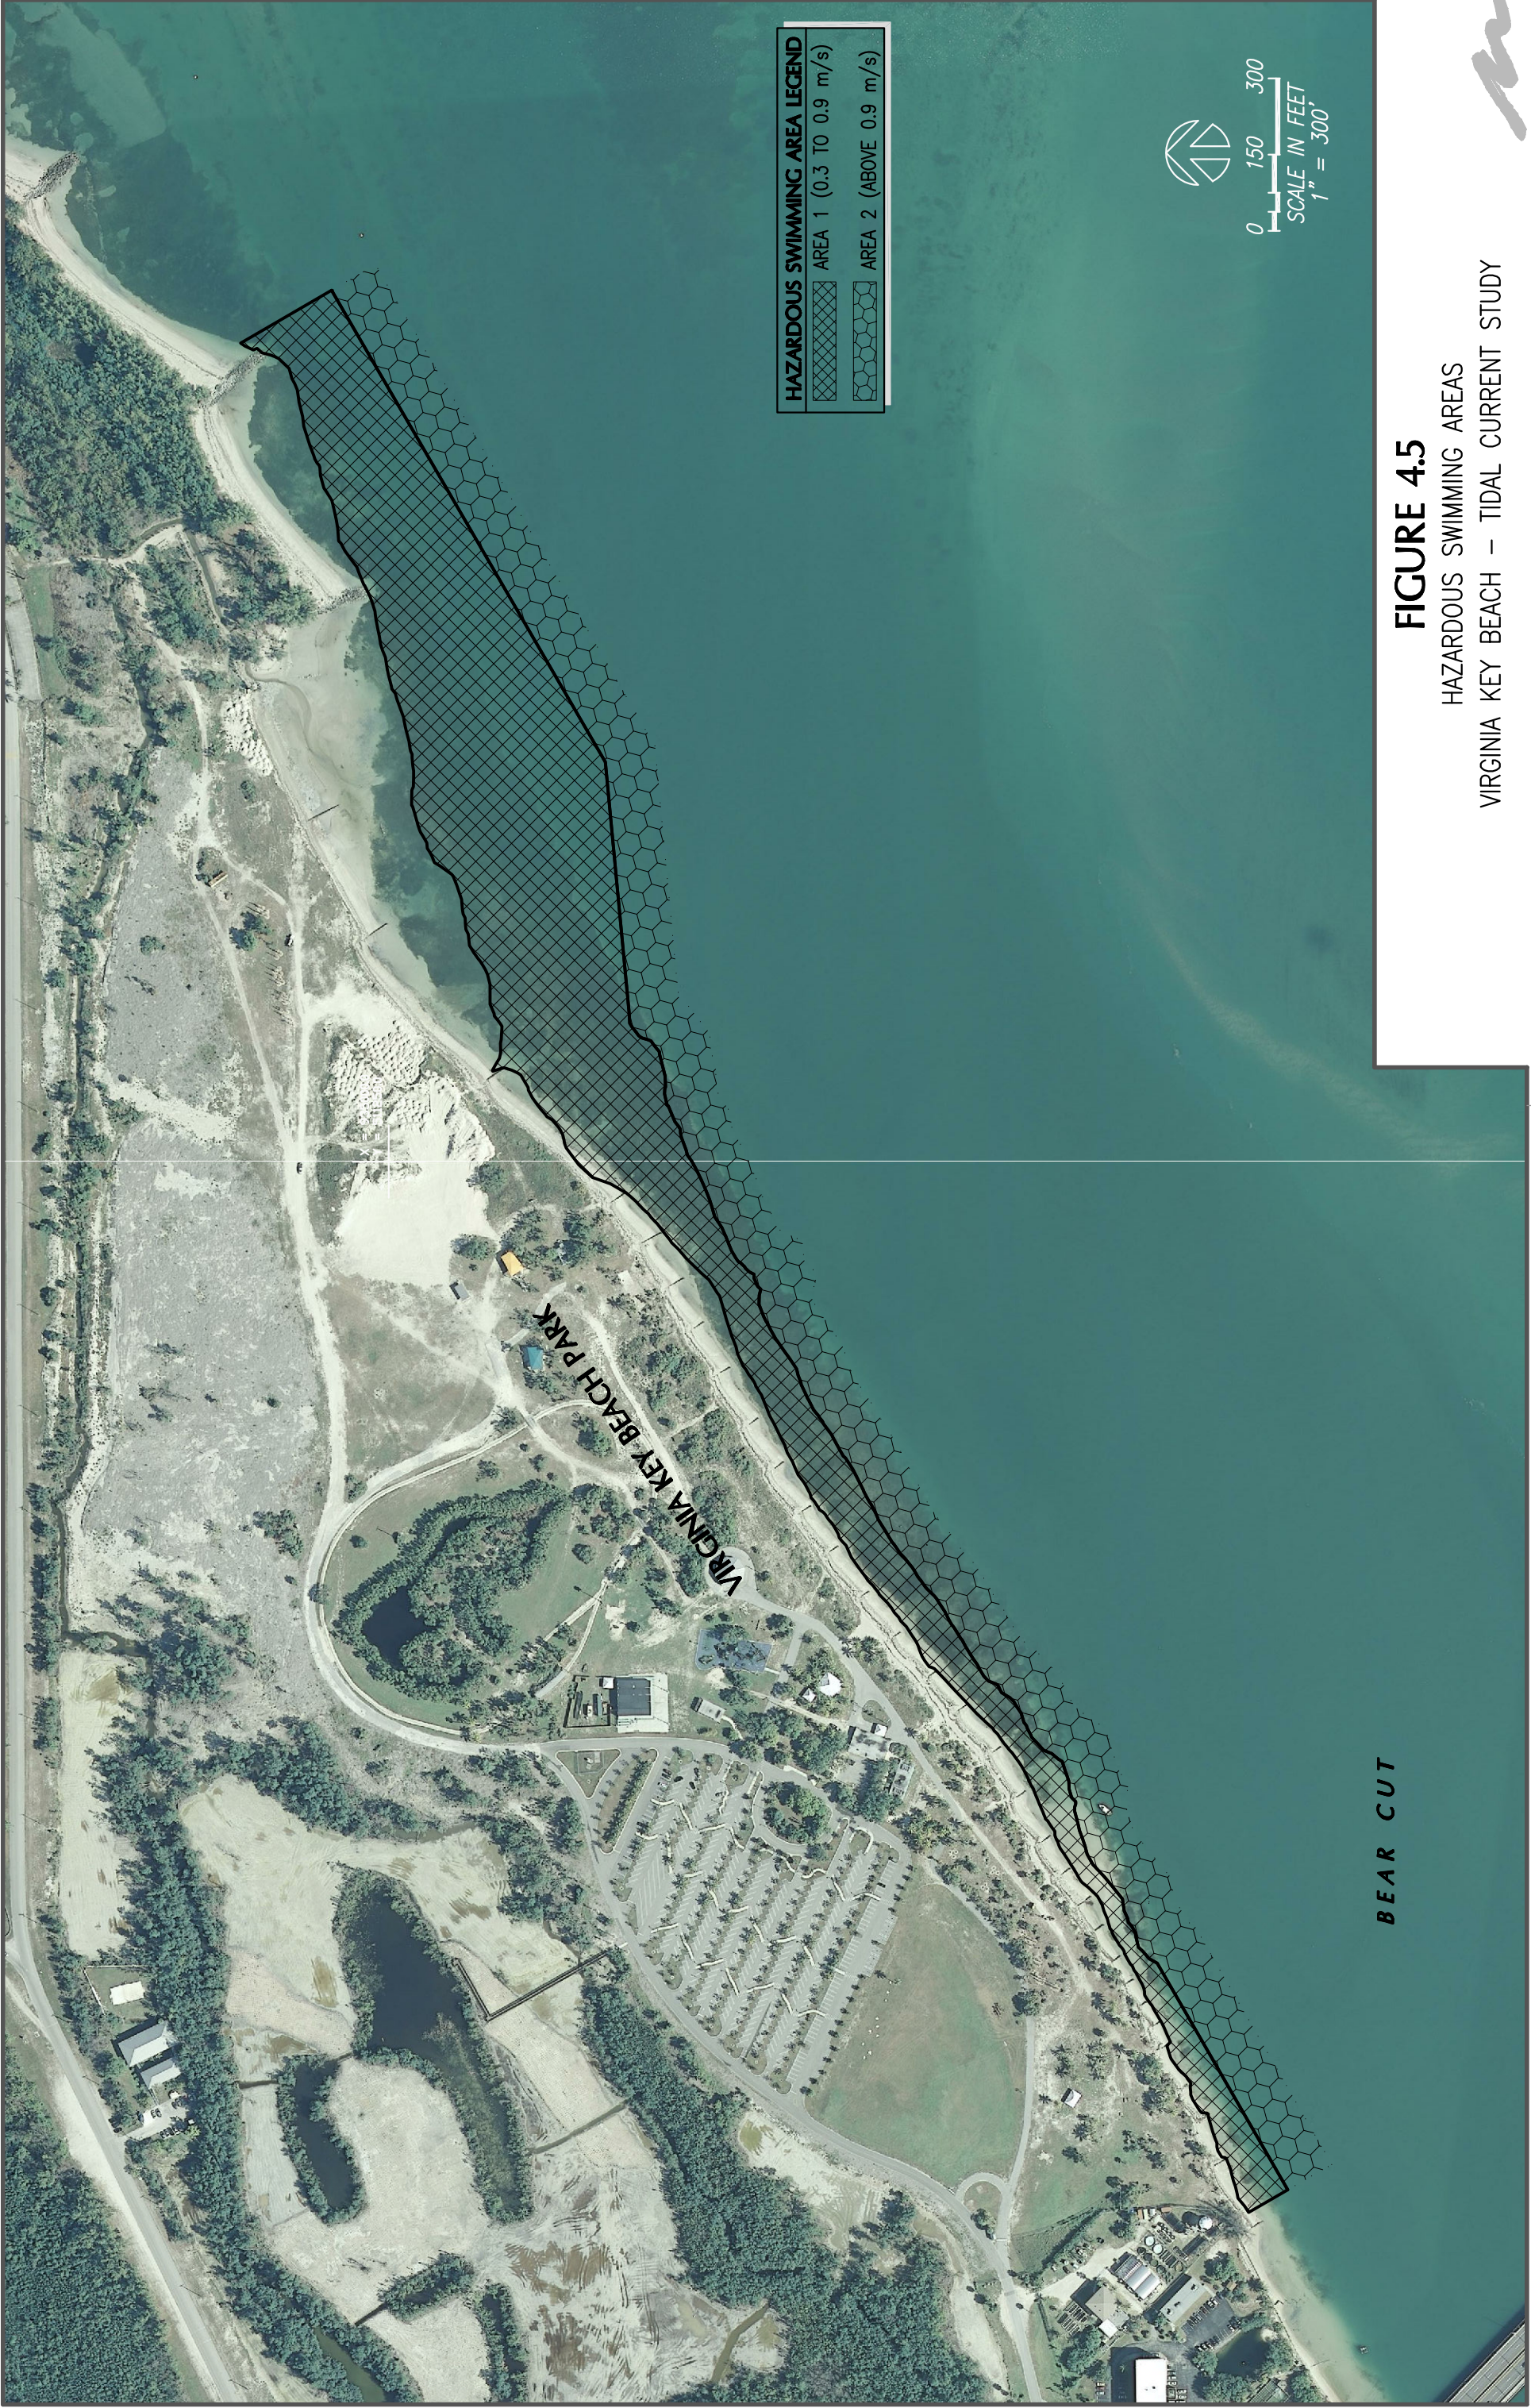
FIGURE 4.5
HAZARDOUS SWIMMING AREAS
VIRGINIA KEY BEACH – TIDAL CURRENT STUDY

The above parameters and results from the numerical modeling provided the foundation for the following mapping. Figure 4.5 exhibits the hazardous swimming areas along the Park shoreline corresponding to the high current speeds simulated during a typical peak flood tide.

The nearshore water in Area 1, characterized with current speeds ranging from 1.0 ft/sec (0.3 m/s) to 3.0 ft/sec (0.9 m/s), is deemed hazardous for individuals in water depths

approximately above the knee to waist level, depending on the physical condition of the individual. The nearshore water in Area 2, characterized with current speeds greater than 3.0 ft/sec (0.9 m/s), is deemed hazardous for all individuals and no swimming is recommended.

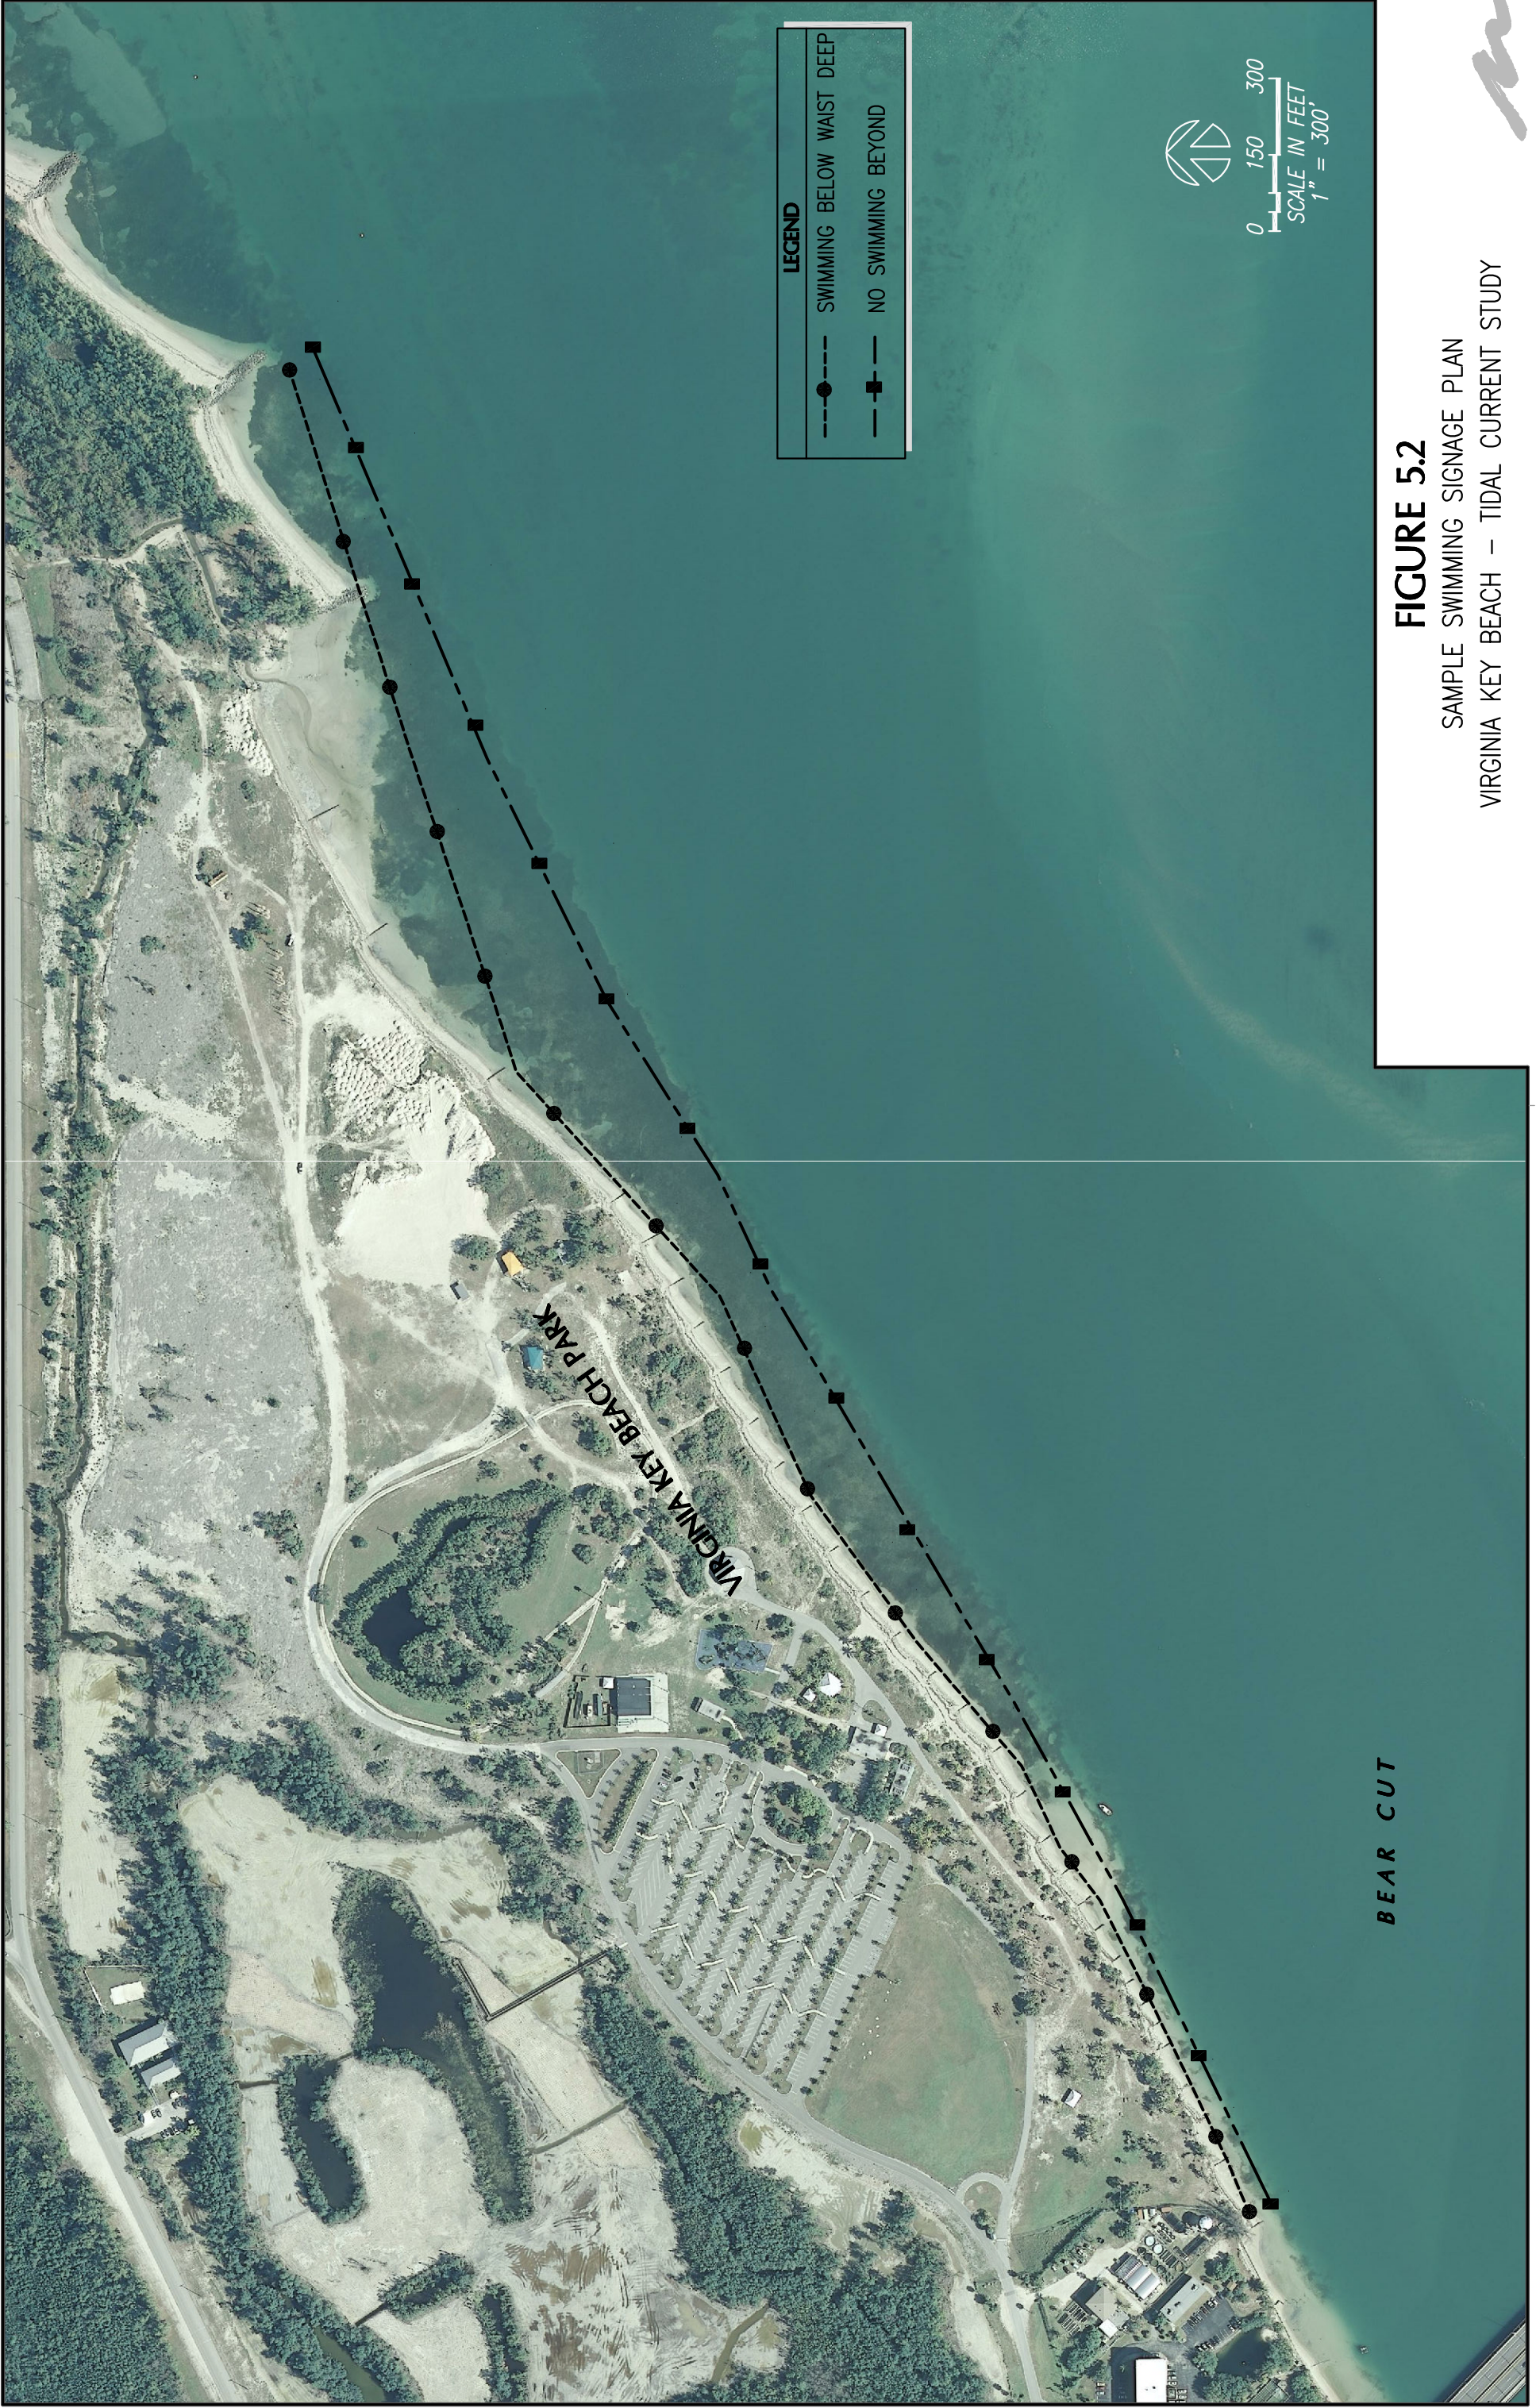
FIGURE 5.2
 SAMPLE SWIMMING SIGNAGE PLAN
 VIRGINIA KEY BEACH – TIDAL CURRENT STUDY

A sample signage plan, based on the results of the hazardous area mapping (refer to Section 4.0) and the local bathymetry, is illustrated in Figure 5.2. The first sign would warn against hazards of swimming in depths greater than waist deep. The second row of signs would impose a recommended swimming limit, which beyond this limit swimming should not occur under any conditions. The distances from the approximate high water line to the first and second row of signs ranges from 15 feet and 60 feet, respectively, in the western segment of the Park shoreline. However, in the eastern segment of the Park shoreline the distance from the approximate mean high water line to the first and second row of signs can range rang up to 250 feet and 400 feet, respectively. This sample signage plan was prepared for discussion purposes and should not be applied directly. Prior to establishing a final signage plan, the proper spacing between signs as well as the lateral buffer zones between hazardous conditions and signage should be evaluated.

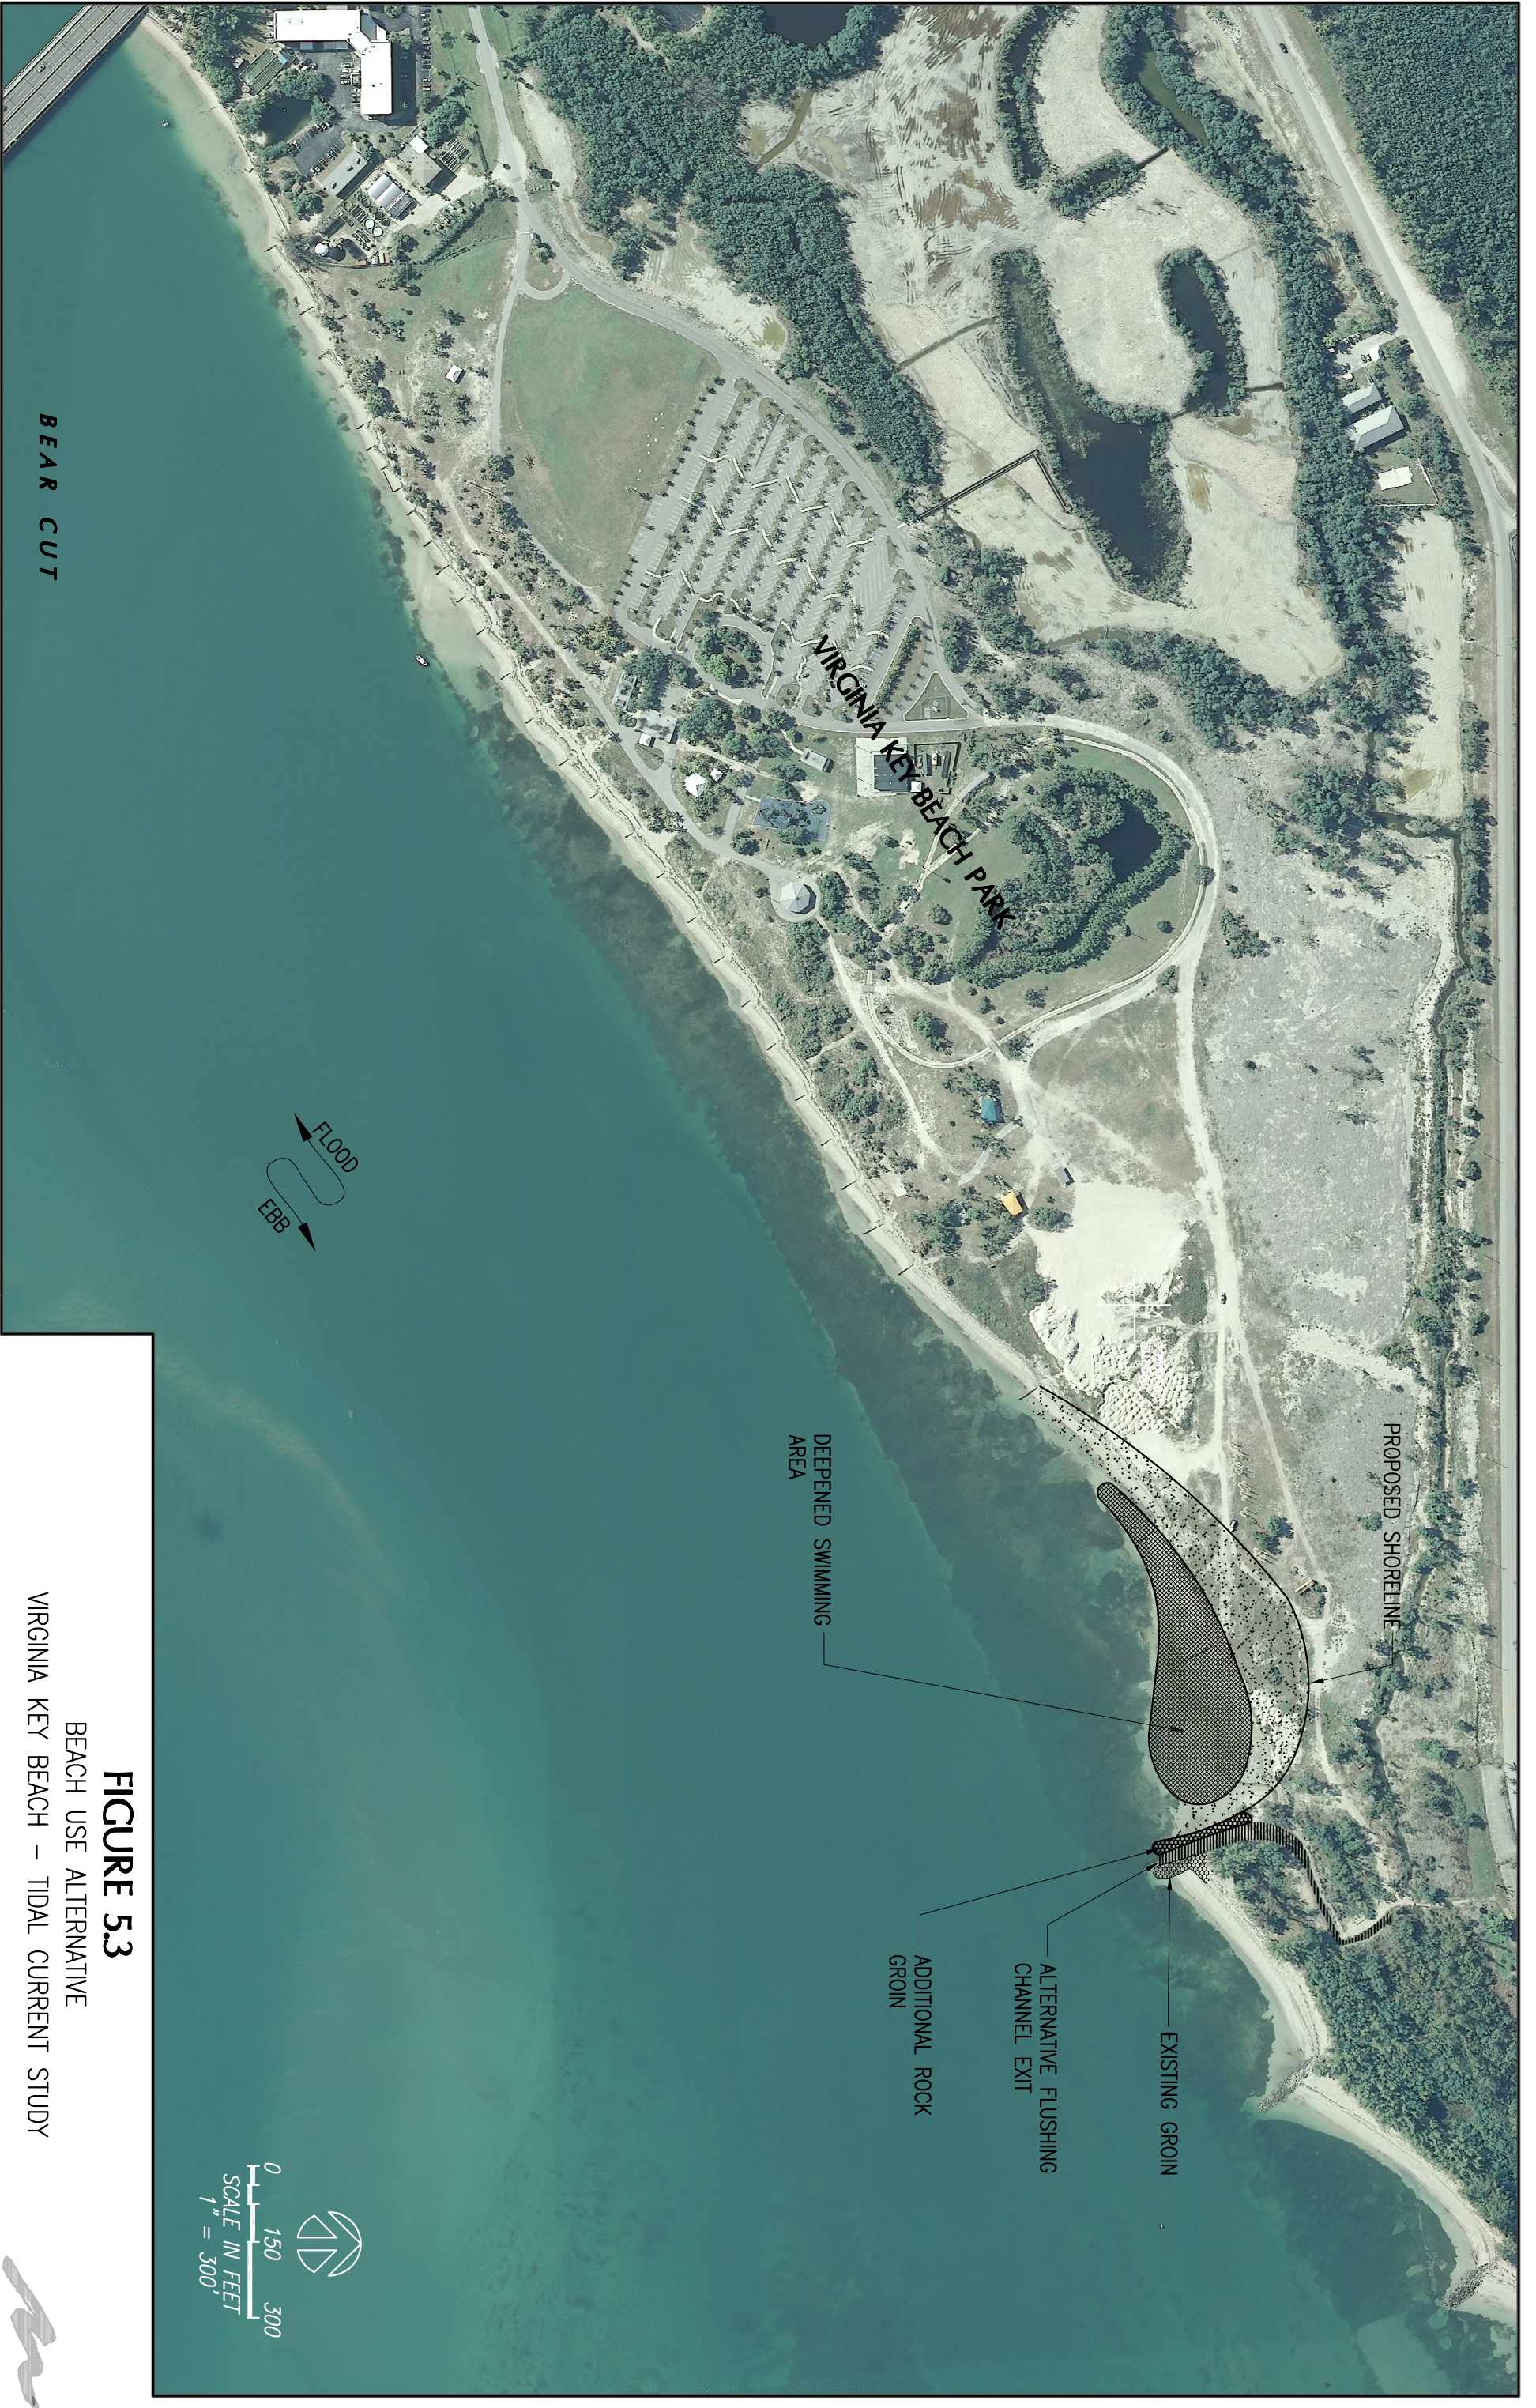
FIGURE 5.3
BEACH USE ALTERNATIVE
VIRGINIA KEY BEACH – TIDAL CURRENT STUDY

Due to the potential for seagrass impacts, any seaward enhancement would likely be limited, and therefore landward expansion should be considered. Figure 5.3 illustrates a concept for landward expansion in the low current area. The flushing channel would be relocated along the existing rock groin, and stabilized with an additional rock groin along the western side of the channel. The shoreline would then be moved landward and the nearshore water deepened to create a pleasant swimming environment.

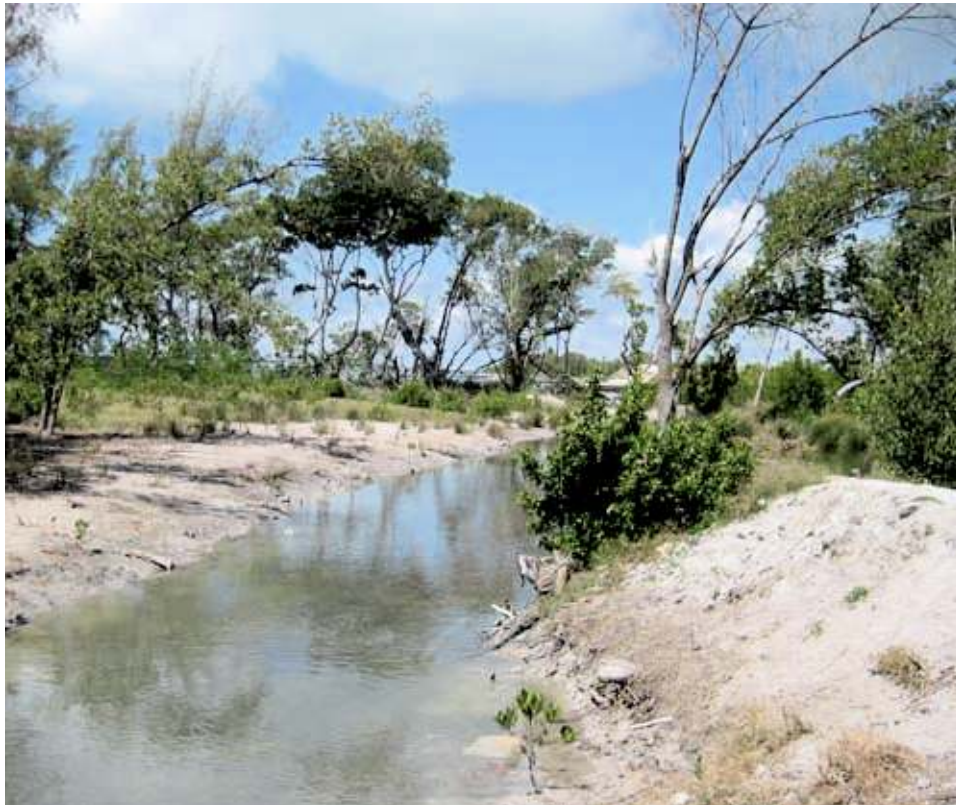
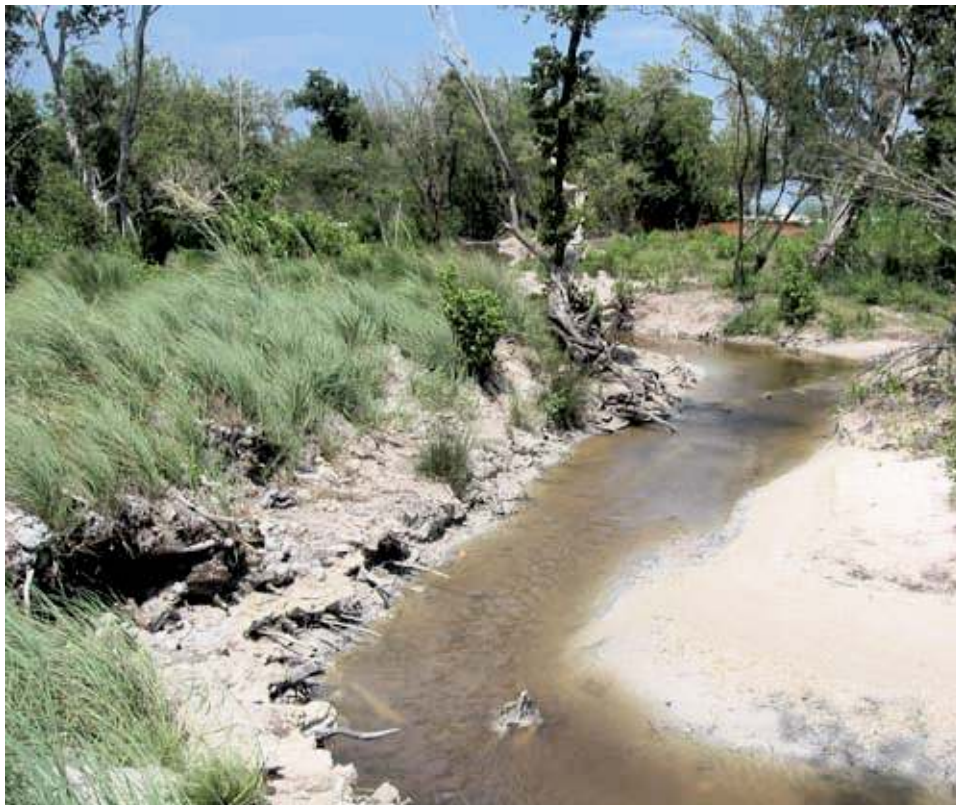
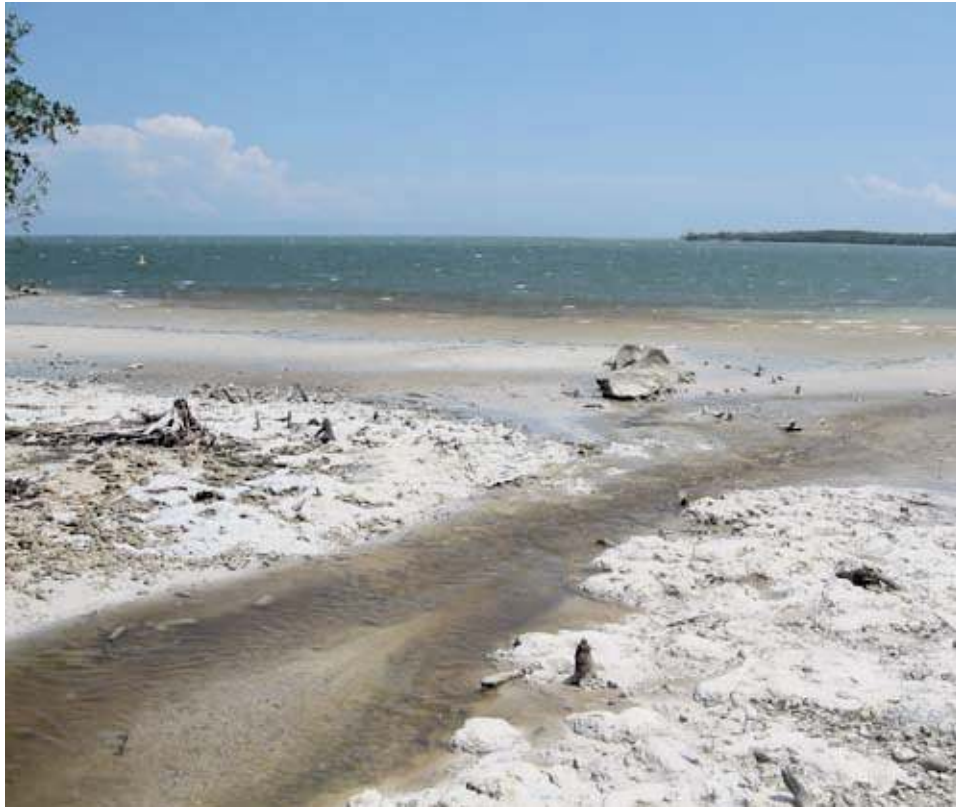
Photo 3: Flushing channel - view 1.

Photo 4: Flushing channel - view 2.

Photo 5: Flushing channel - view 3.

Along the section of beach immediately west of the rock groins a channel was purposely cut to connect an interior lagoon system with the ocean water (Refer to Photos 3 - 5 in Appendix A and Figure 2.2). As a result, significant sedimentation was observed in the nearshore area resulting from the deposit of material transported out of the lagoons during tidal exchange (refer to Figure 2.2).
