1.0 INTRODUCTION

This report describes the Turkey Point Unit 3 containment dome, delamination of the dome concrete during post tensioning of tendons, the subsequent investigation and analysis of this phenomena, and the repair and test program. When about two thirds of the dome tendons had been tensioned, it was noted that concrete cracking and sheathing filler leakage was developing and that in some areas of the dome, the concrete felt springy when walked on. The dome was struck with a sledge hammer and, in some areas, it sounded as if it were hollow. The concrete was locally removed in some of these areas and shallow (approximately 1/2" to 4") delamination planes were found running almost parallel with the surface, but eventually intersecting it. A full investigation was begun to determine both the extent and cause of the delaminations, and to cover the following:

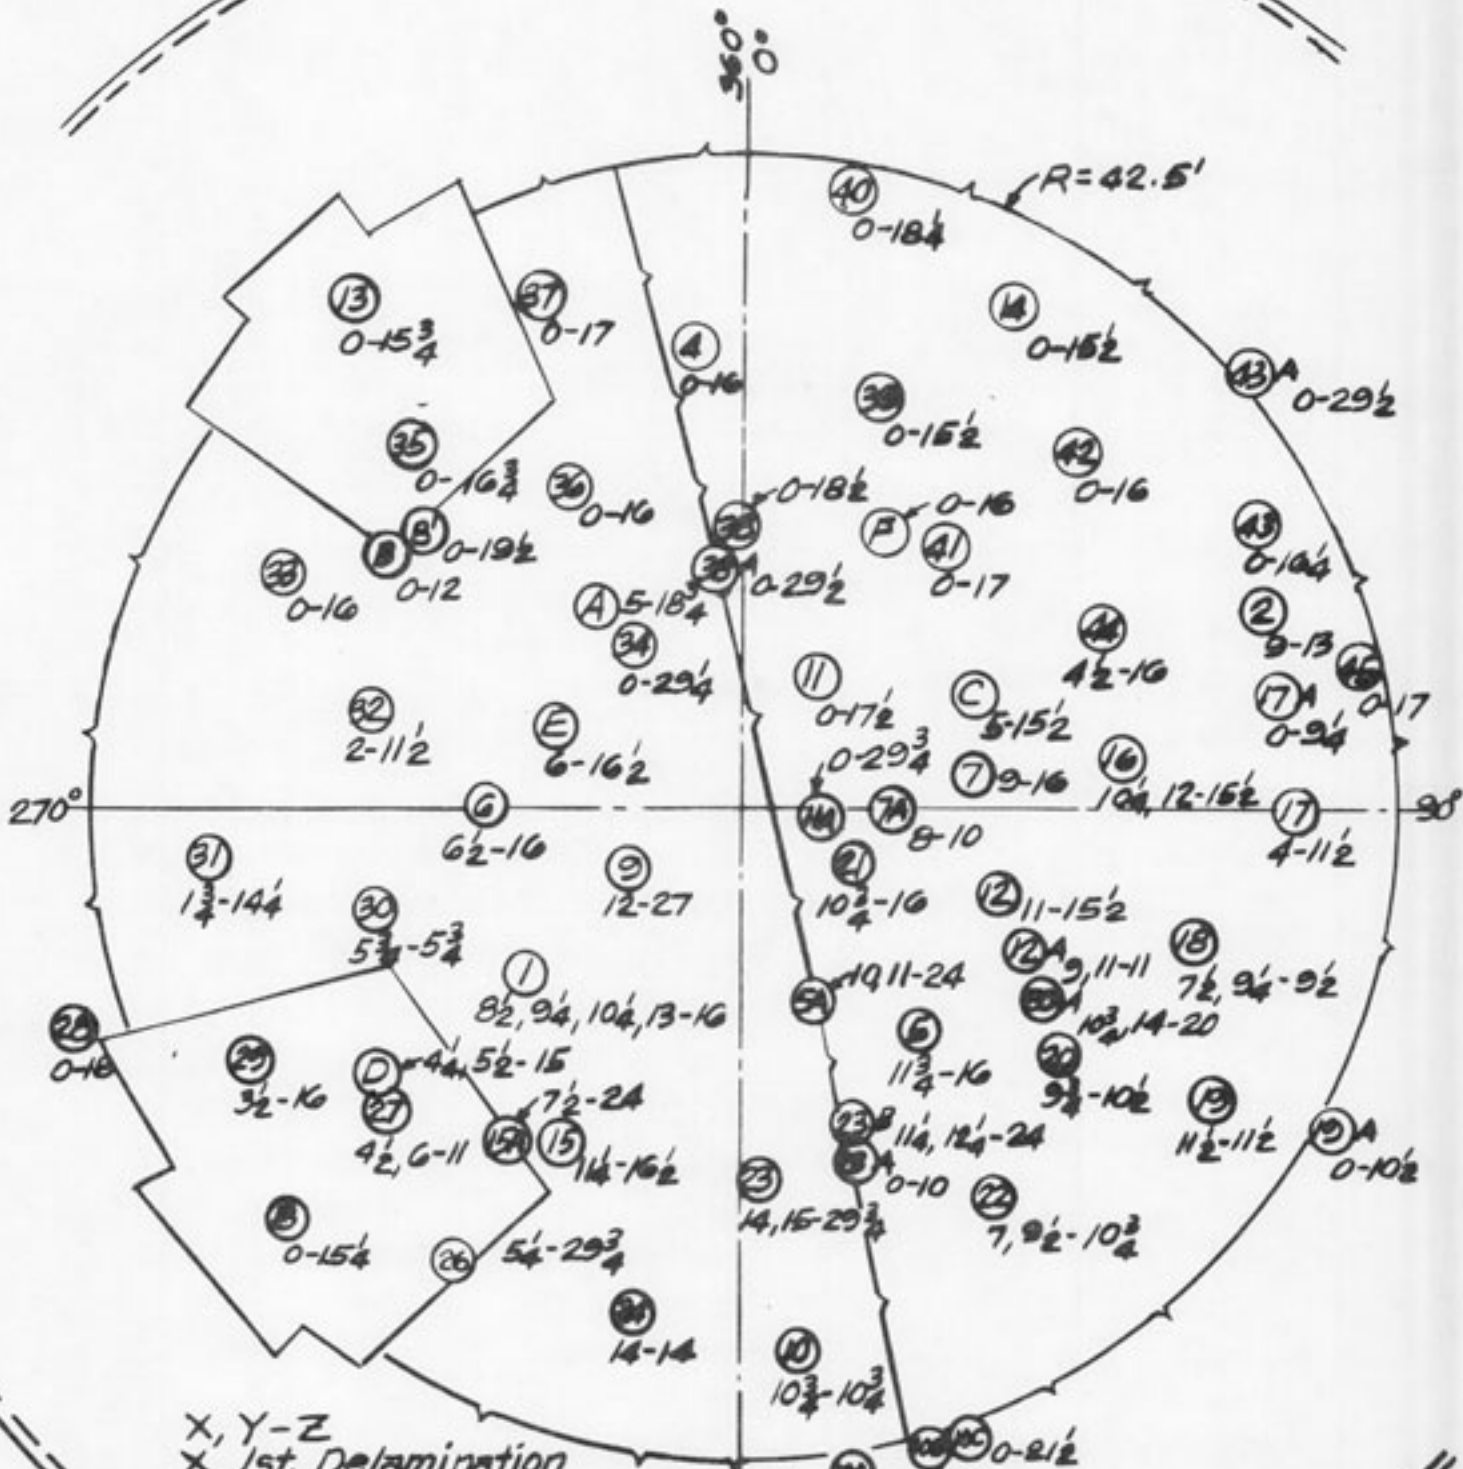
A summary of the information obtained from coring is given in Table 3-1. To help visualize the extent and depth of the delaminations inferred from coring, Figures 3-1 and 3-2 have been included. Figure 3-1 shows the core locations together with the depth to the delaminations and the core hole depth. Figure 3-2 is an estimate, from coring information, of the depth and area extent of the delaminations.

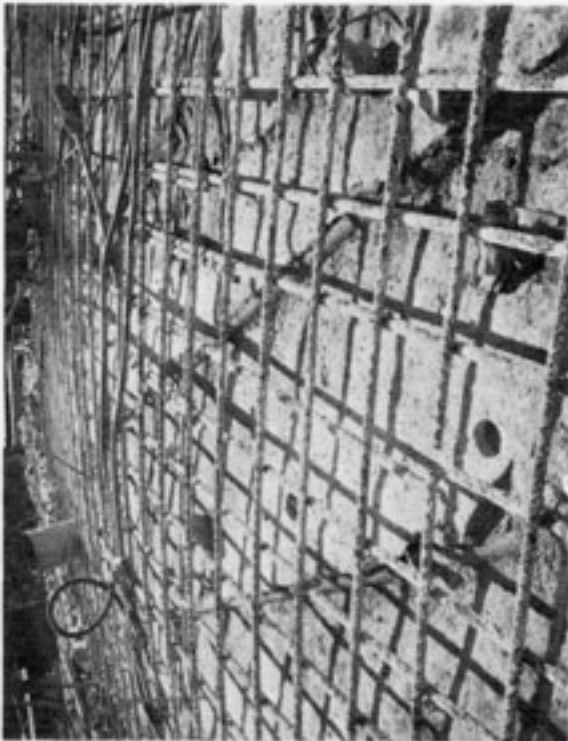
Looking south along West side. Note step effect of first delamination in region of top group 3 tendons.

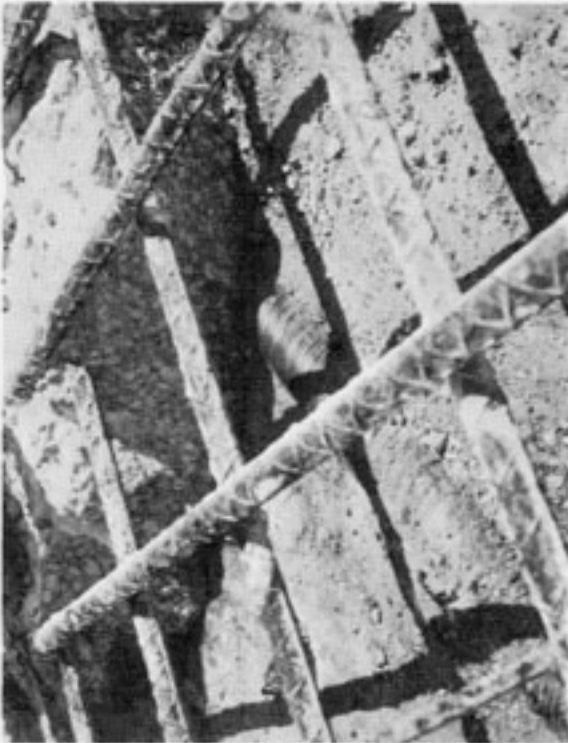
Looking S.E. along delamination through top group 3 tendon on east side. Note same depth on both sides of tendon.

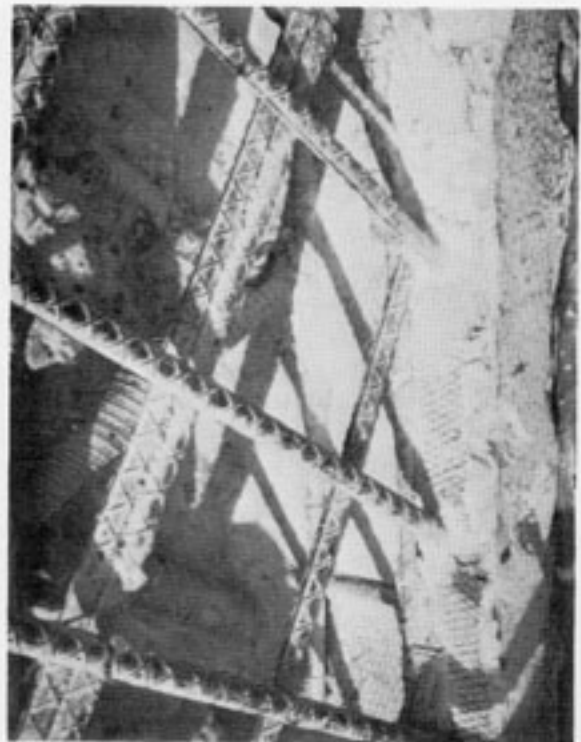
Meridional construction joint 10'-15' south of apex to a depth of 18".

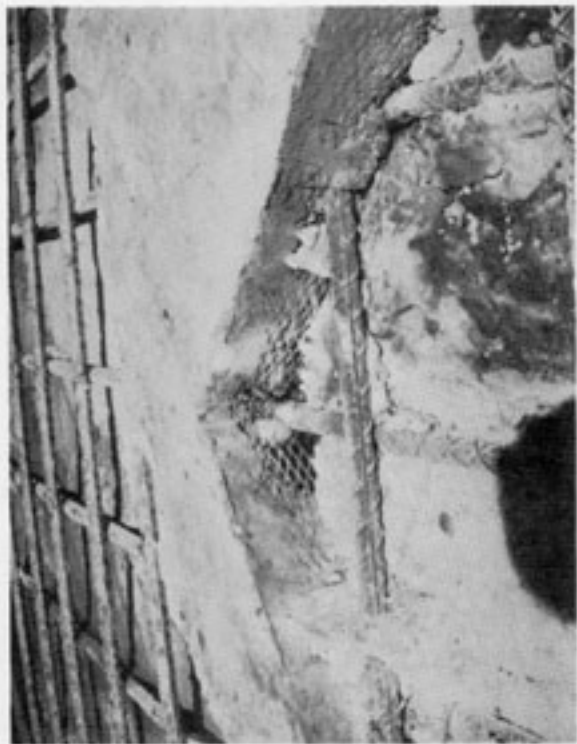
Northeastern corner of the S.W. blockout. Note void at corner and lack of bond along sides.

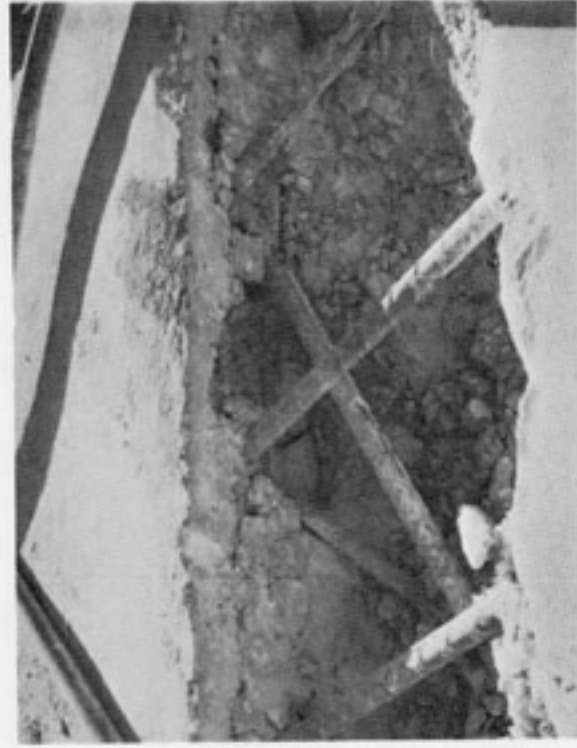
Looking southeast at radial construction joint of the N.W. blockout. Note poor consolidation and separation from expanded metal.

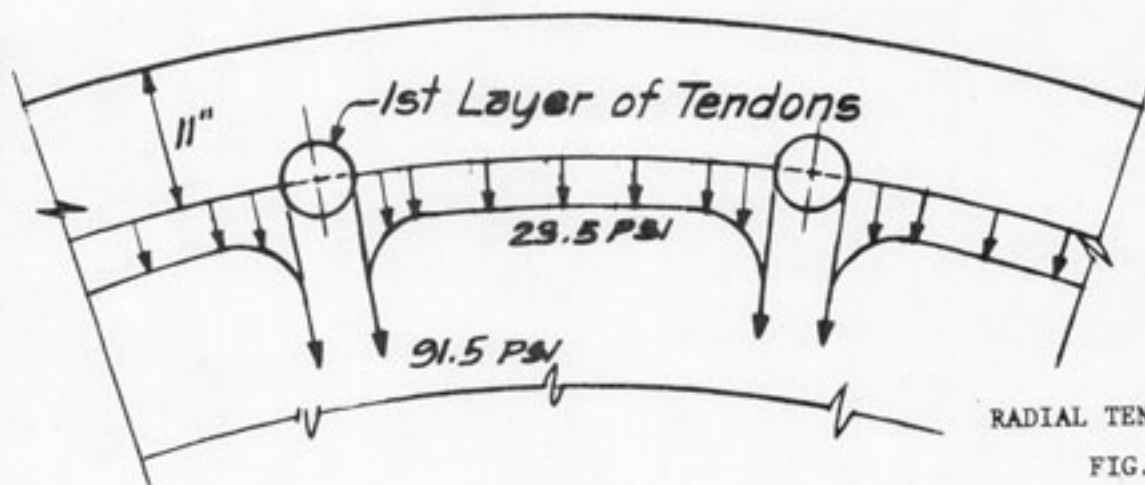
RADIAL TENSION
FIG. 5-3

Where P_1 is the tension in the top 11" of concrete, P_2 is the applied pressure, t_1 is the thickness of the top layer and t_2 is the total thickness. Then the radial tension is $P_1 = \frac{11}{39} (83.3) = 23.5$ psi. A finite element analysis of a small portion of the dome was made to evaluate the local effects of the top layer of tendons. The analysis indicated that the peak radial tension was +68 psi occurring near the edge of the tendon sheathing void. The radial stress reduced greatly a few inches from the hole. Superimposing the two results lead to the radial tension distribution shown in Figure 5-3.

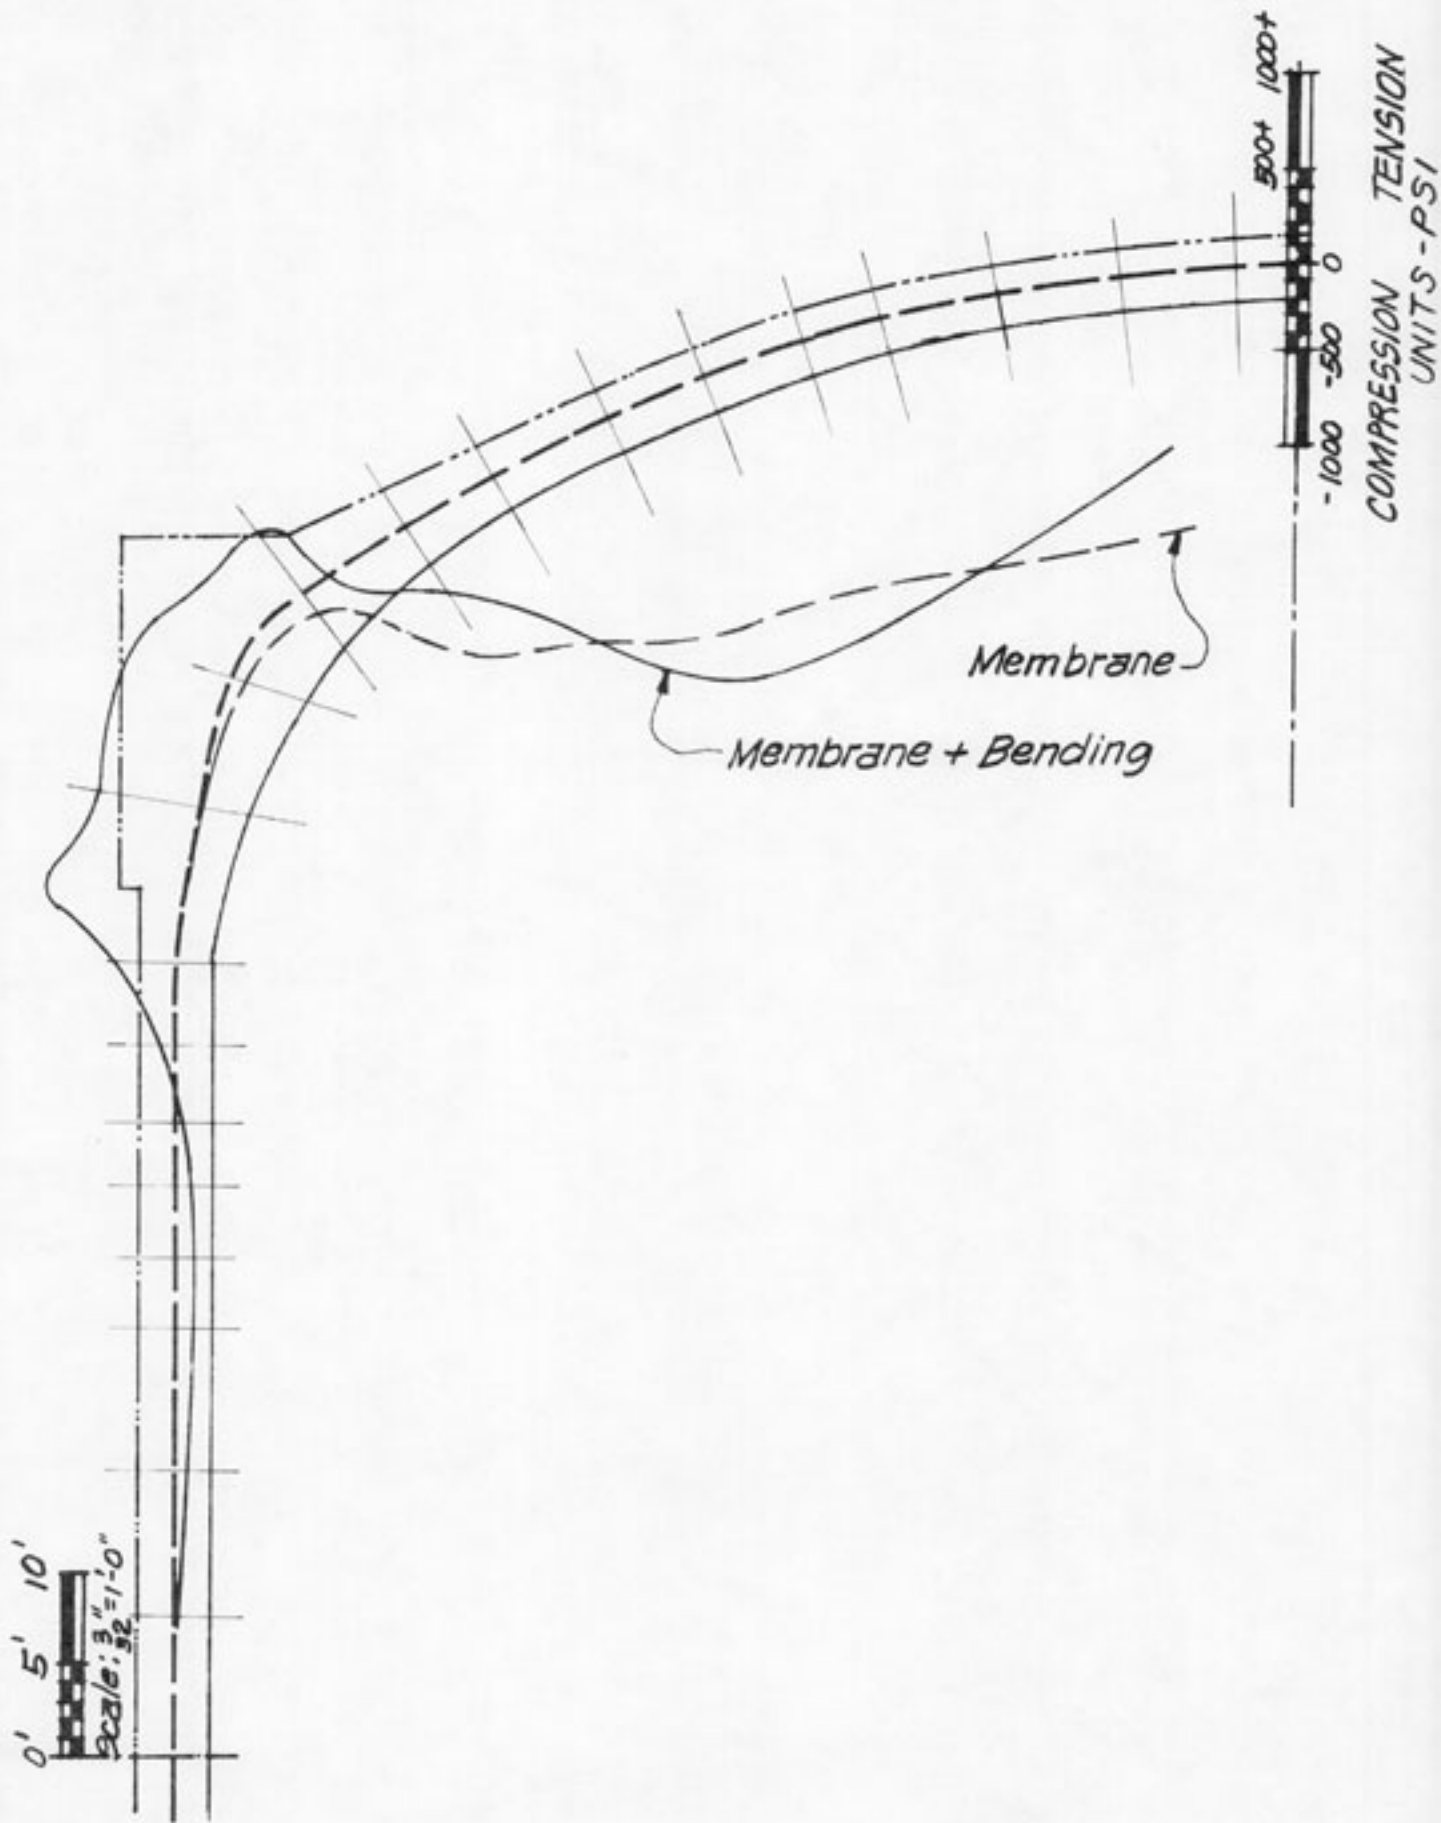
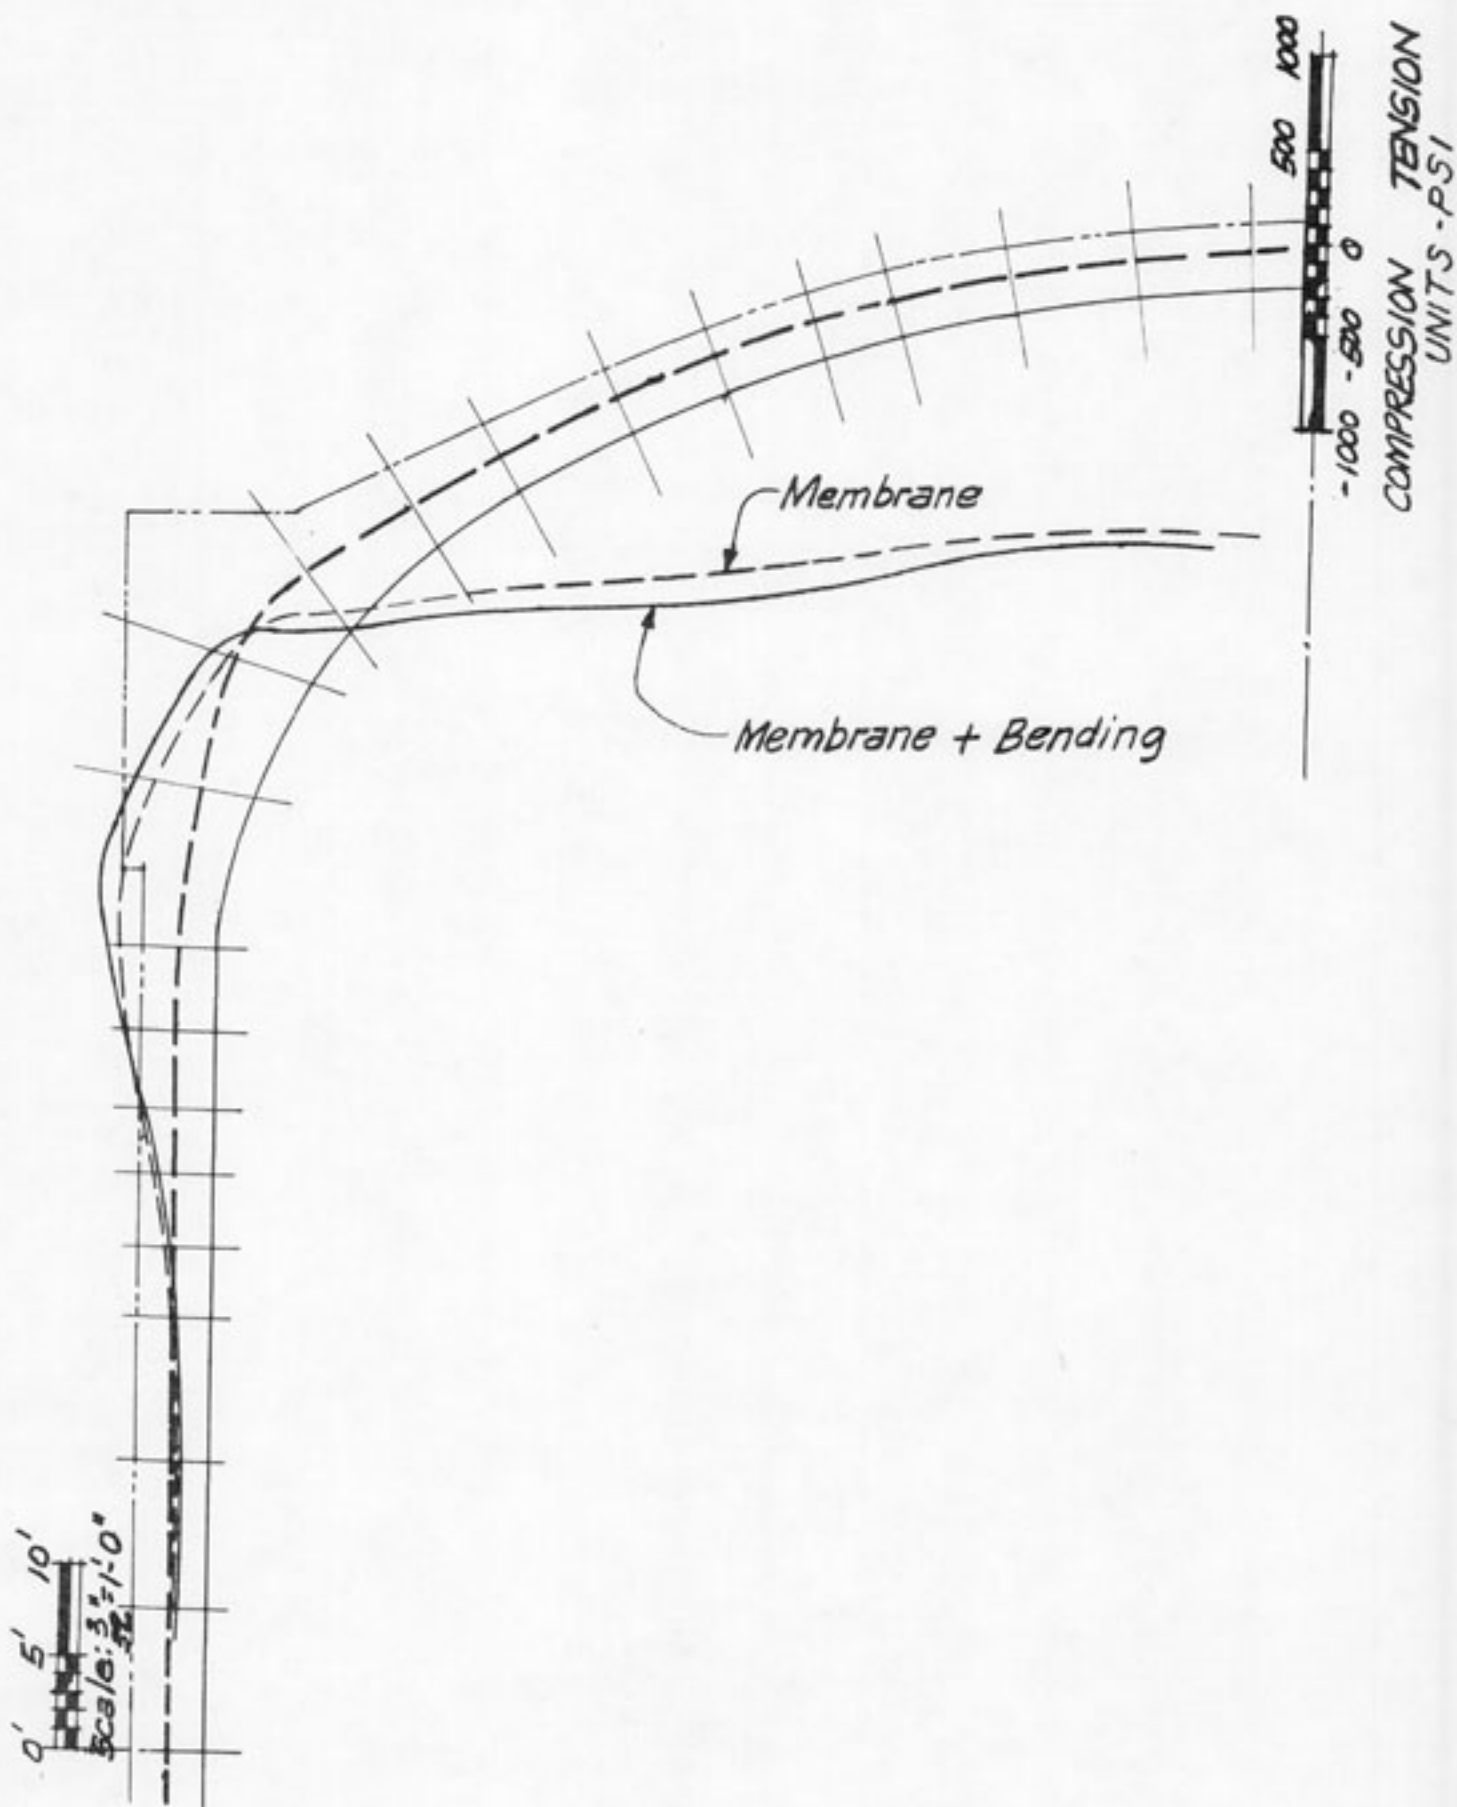
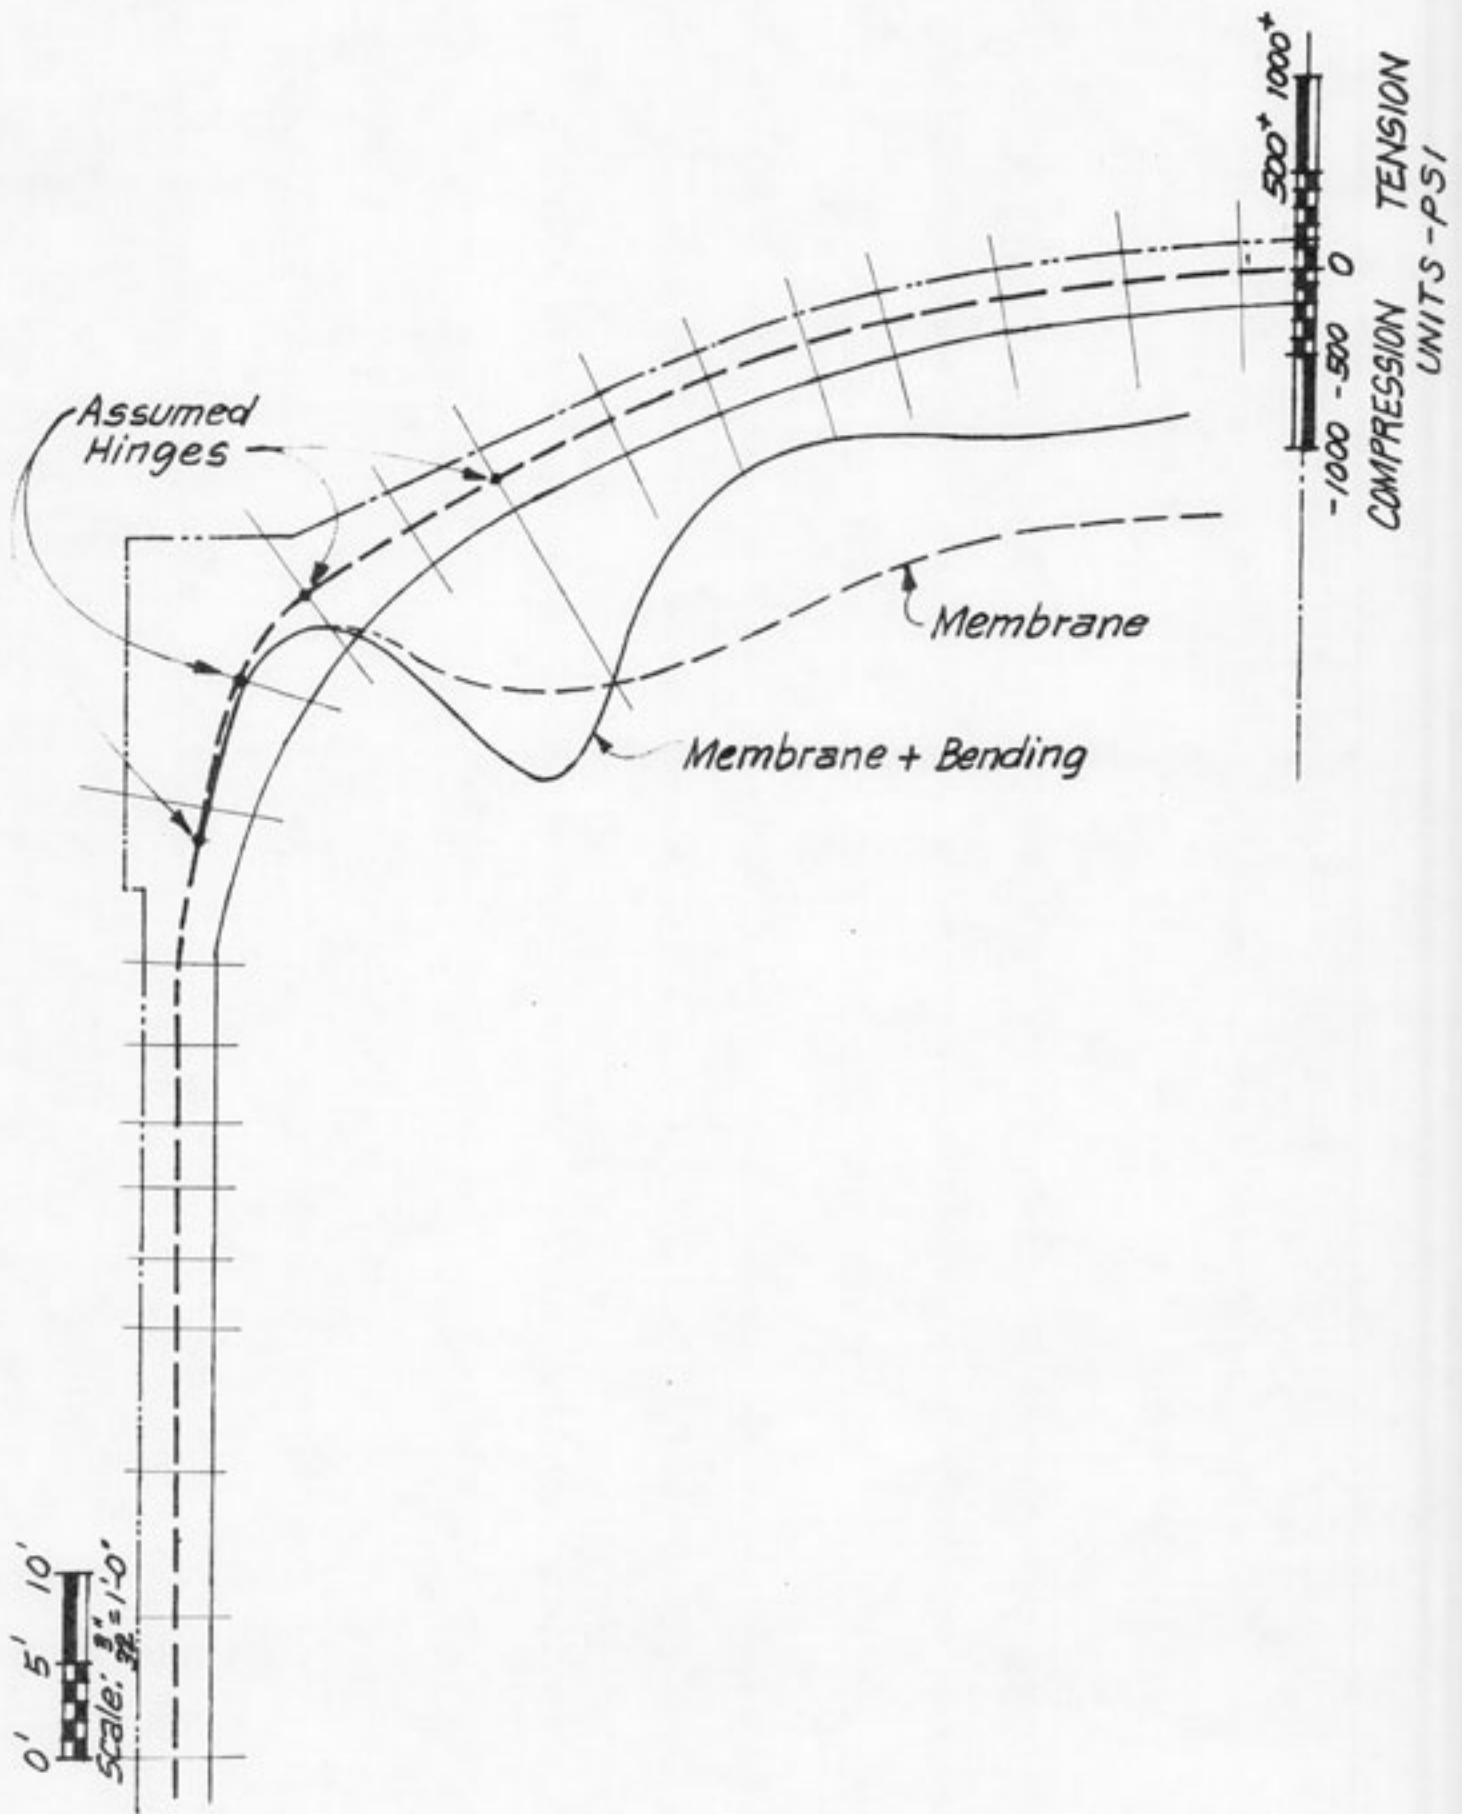
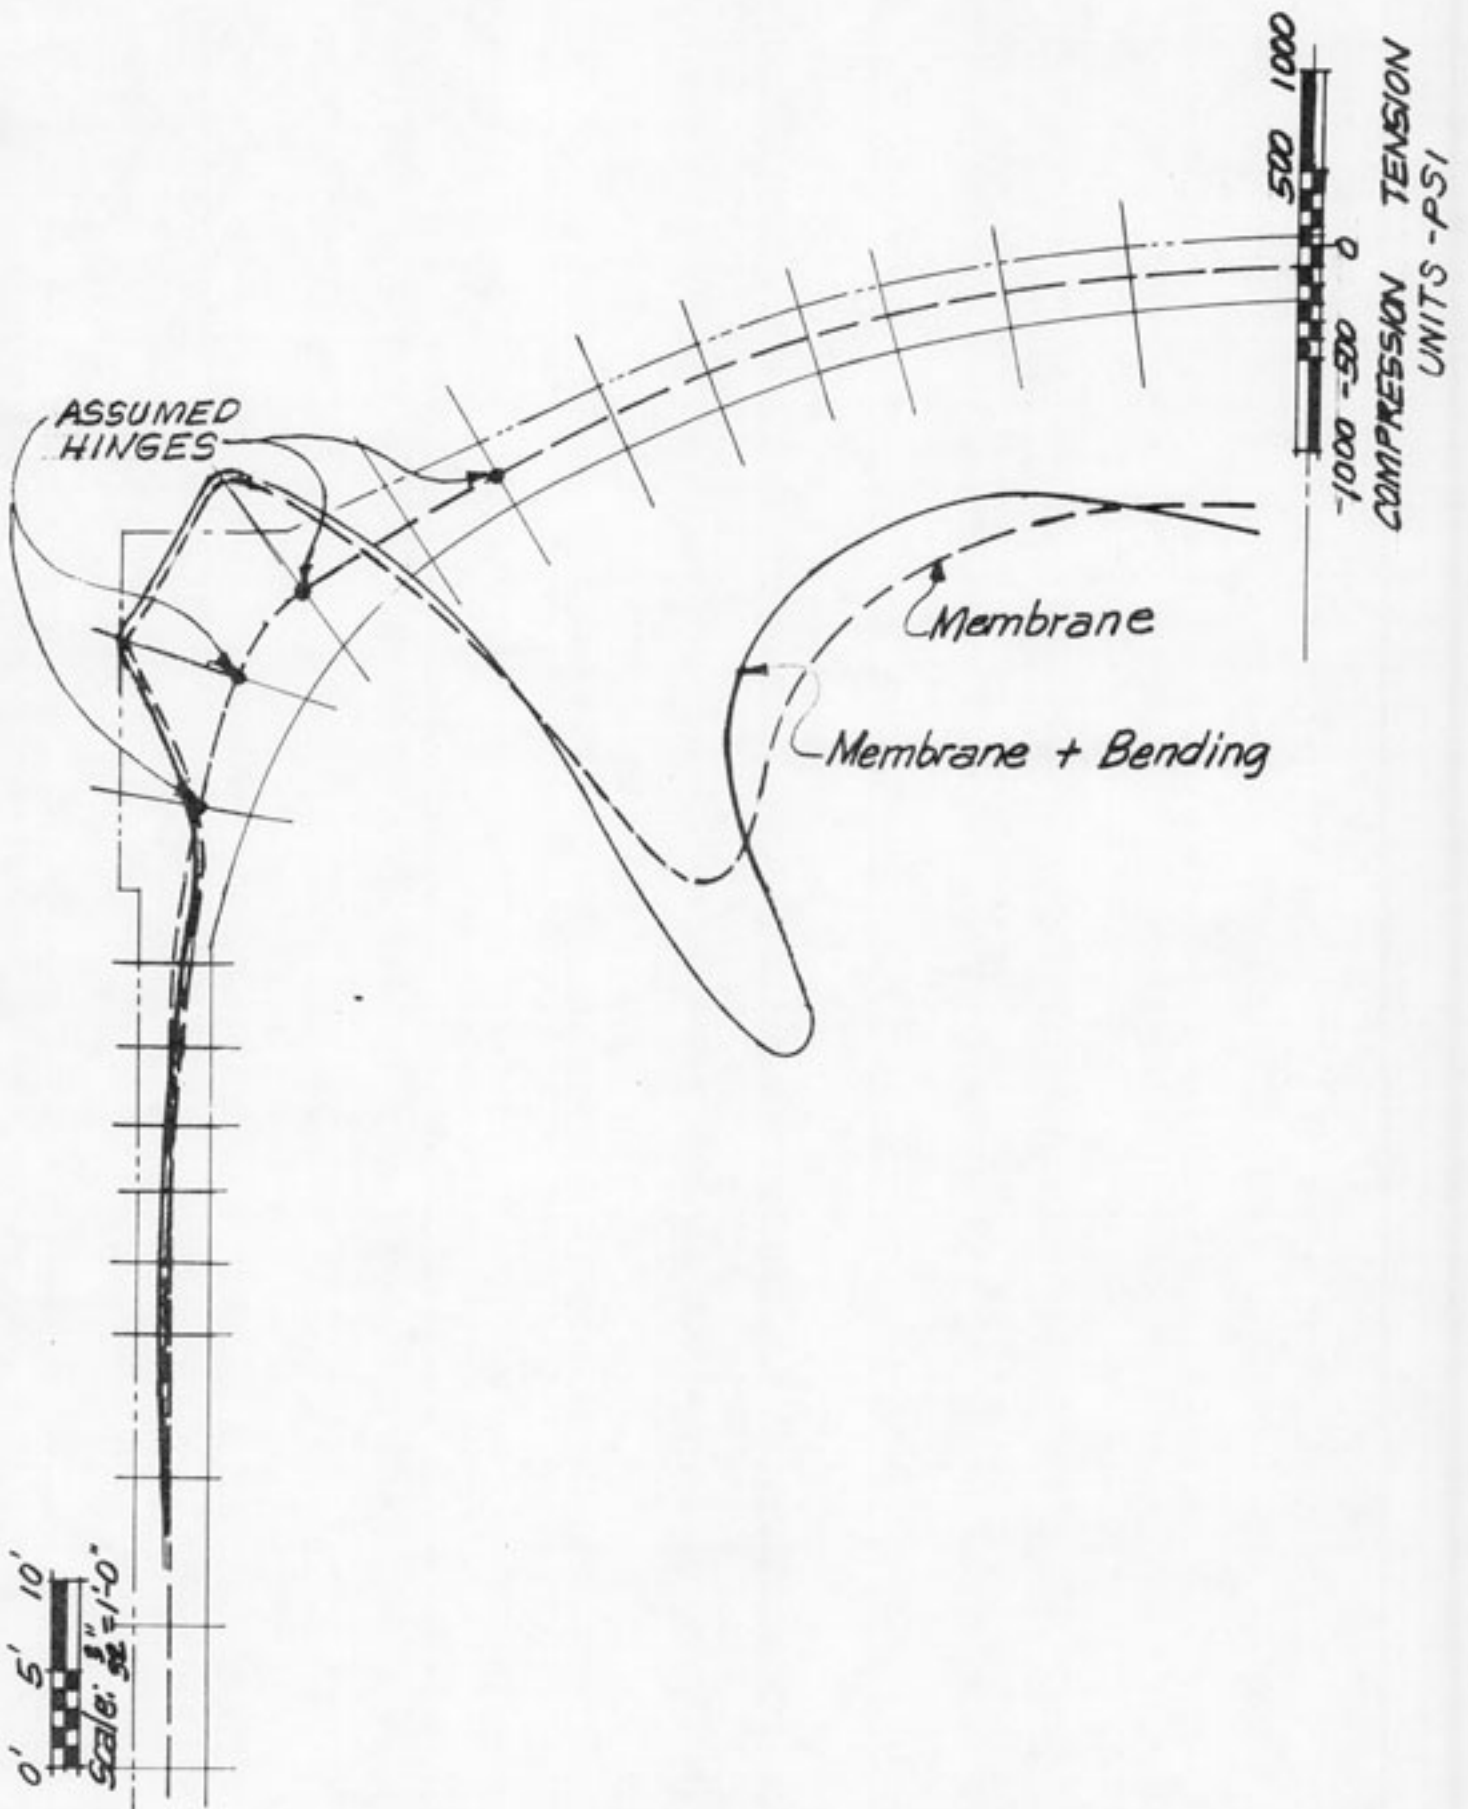
In the first part of the analysis the structure was loaded with the unbalanced load resulting when post-tensioning was 50% complete as shown in Figure 5-4. Due to the assumed boundary conditions all the forces at the construction joints acted through the center of the section with no eccentricity. The stresses resulting at the outer surface from this loading condition are shown on Figures 5-15 and 5-16 for the meridional and circumferential directions. The peak meridional stress is - 1420 psi (compression) and the peak circumferential stress is - 1220 psi.

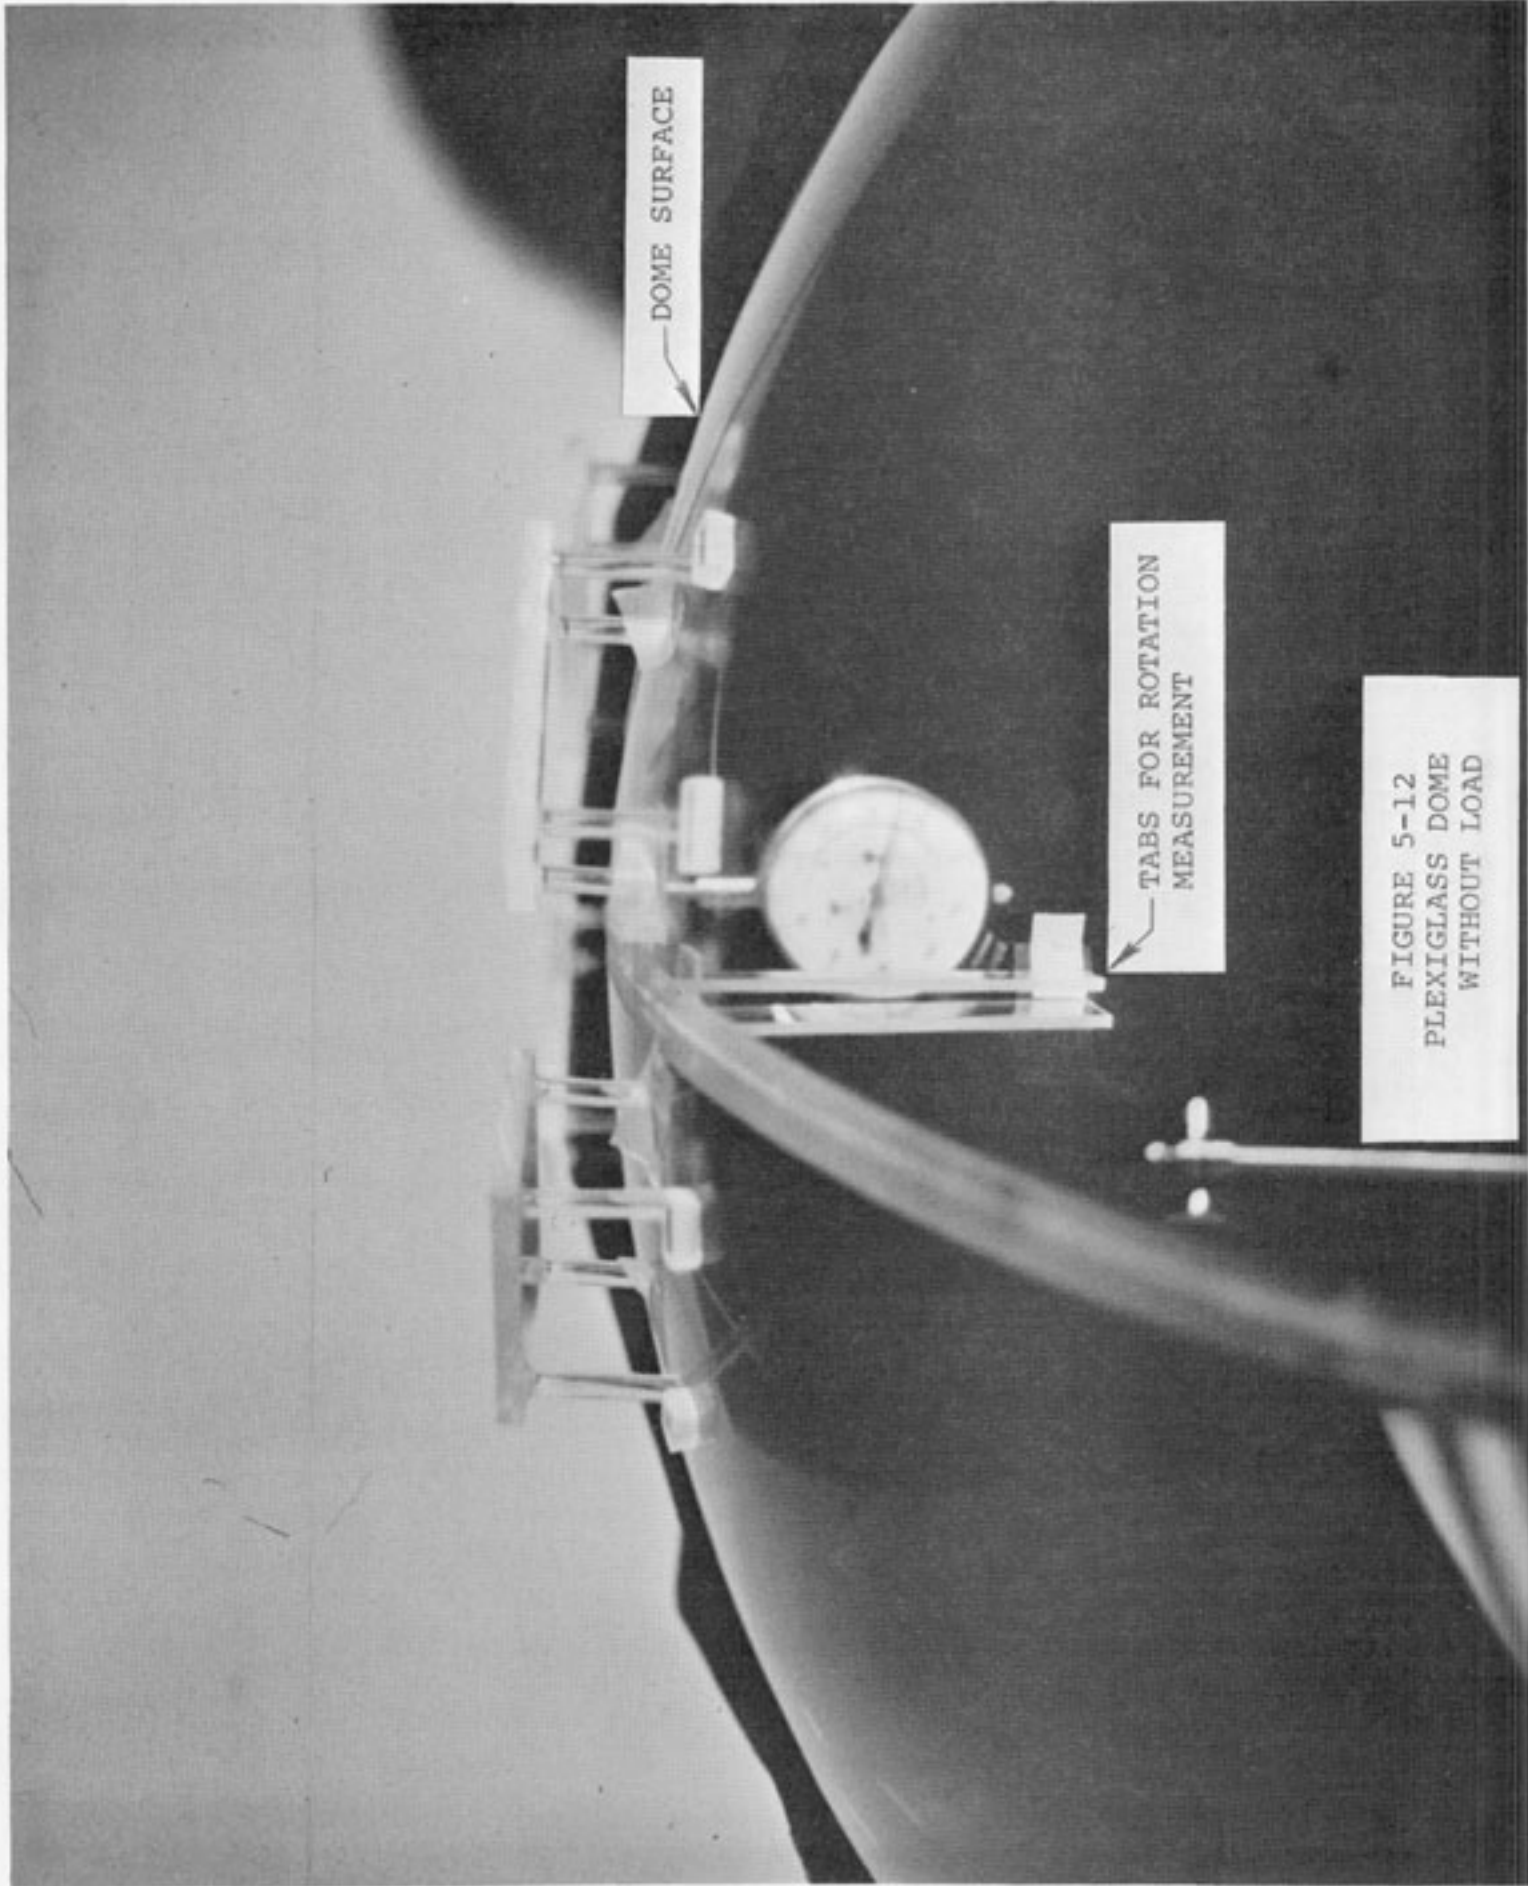
FIGURE 5-12
PLEXIGLASS DOME
WITHOUT LOAD

Two plexiglass domes were obtained to help visualize the phenomenon of the joint rotation. One of the domes was a hemisphere and the other was a hemisphere cut in half and then taped together so that only shear could be transmitted through the joint. Figures 5-12 and 5-13 show the split plexiglass dome before and after applying a load across the joint. Two plexiglass tabs were mounted normal to the surface, pointing inward, on each side of the simulated joint. The photographs indicate that as the load is applied the joint rotates, opening at the bottom.

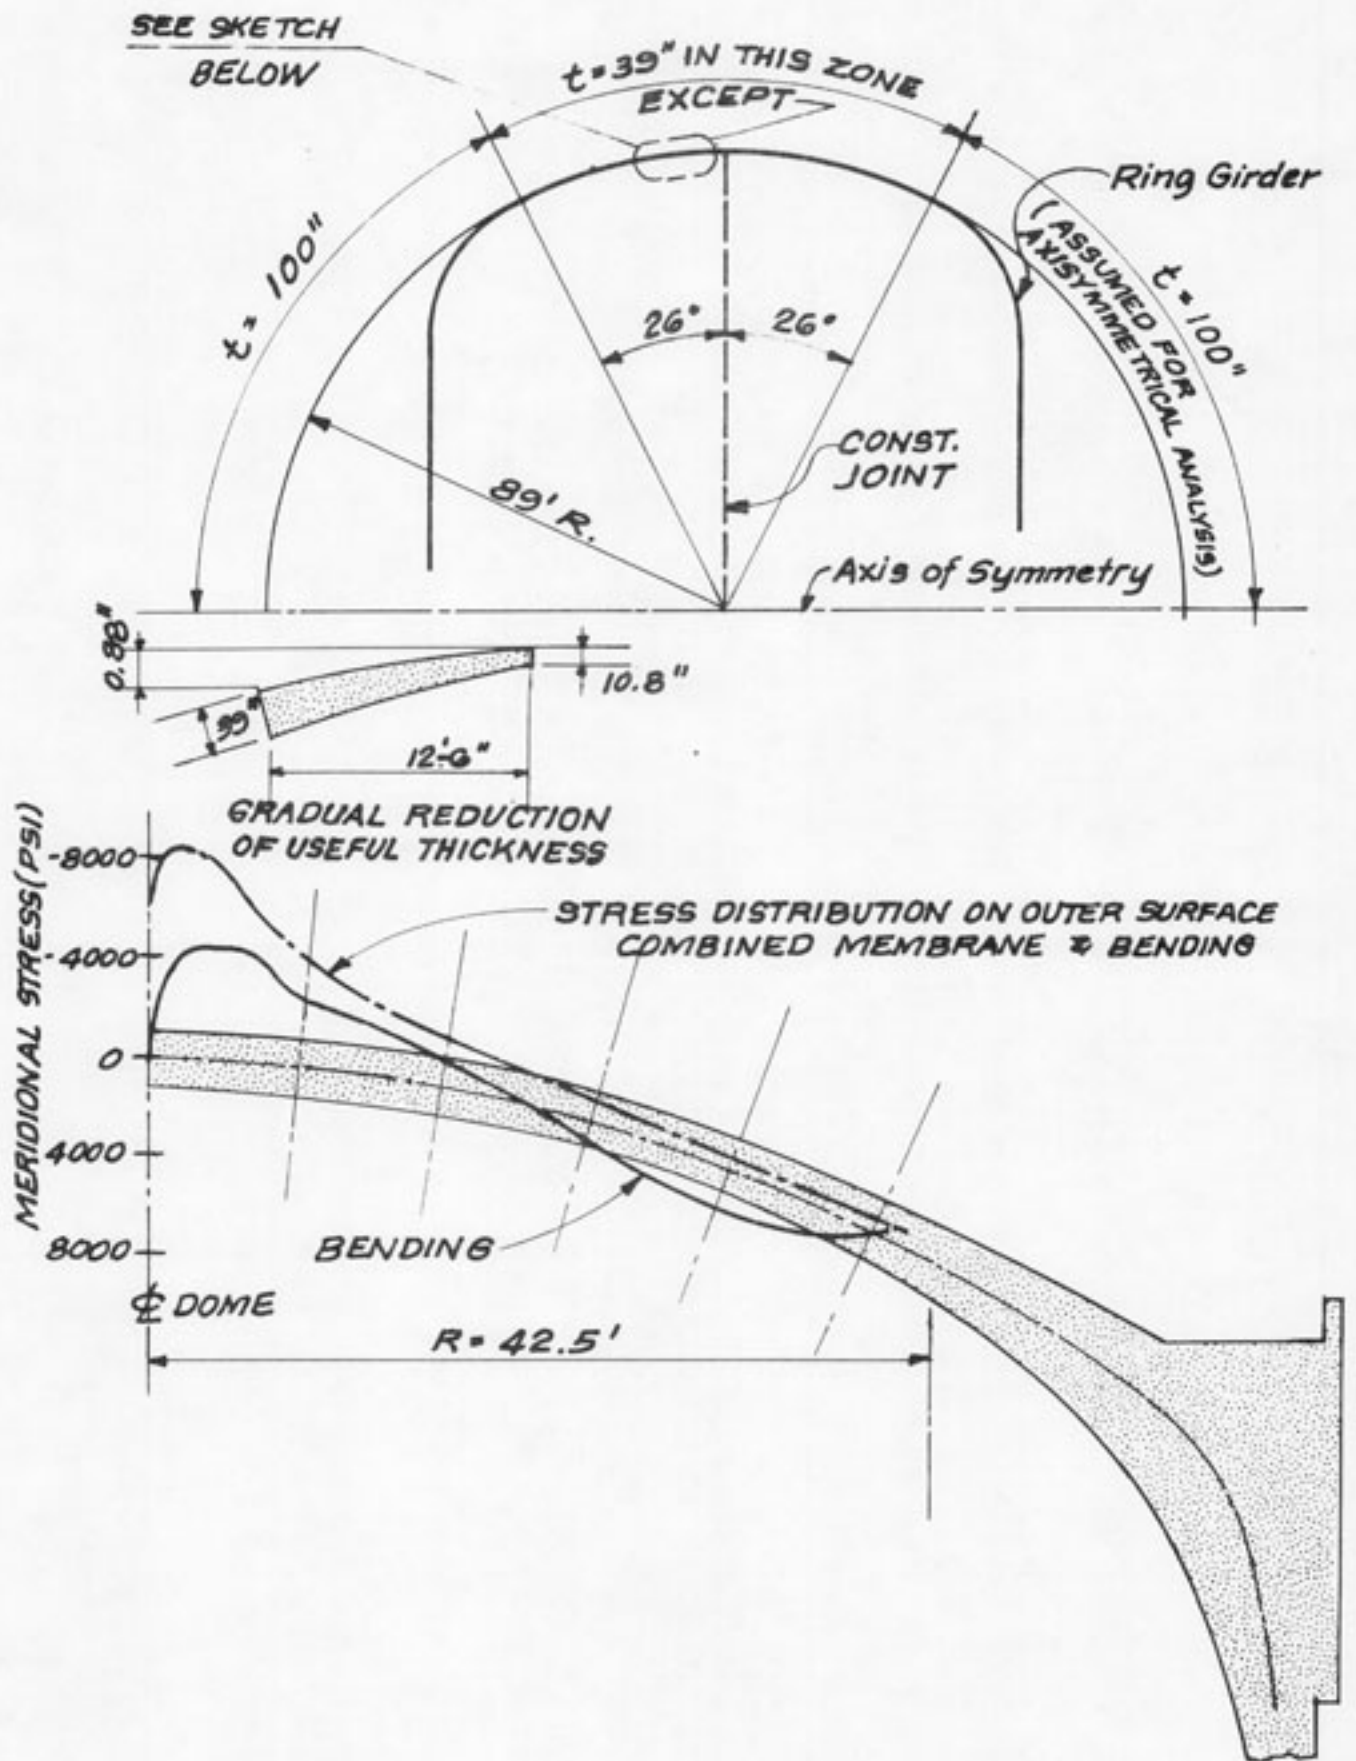
AXISYMMETRICAL SIMULATION OF THE MERIDIONAL CONSTRUCTION JOINT
