1.0 INTRODUCTION

This report describes the Turkey Point Unit 3 containment dome, delamination of the dome concrete during post tensioning of tendons, the subsequent investigation and analysis of this phenomena, and the repair and test program. When about two thirds of the dome tendons had been tensioned, it was noted that concrete cracking and sheathing filler leakage was developing and that in some areas of the dome, the concrete felt springy when walked on. The dome was struck with a sledge hammer and, in some areas, it sounded as if it were hollow. The concrete was locally removed in some of these areas and shallow (approximately 1/2" to 4") delamination planes were found running almost parallel with the surface, but eventually intersecting it. A full investigation was begun to determine both the extent and cause of the delaminations, and to cover the following:

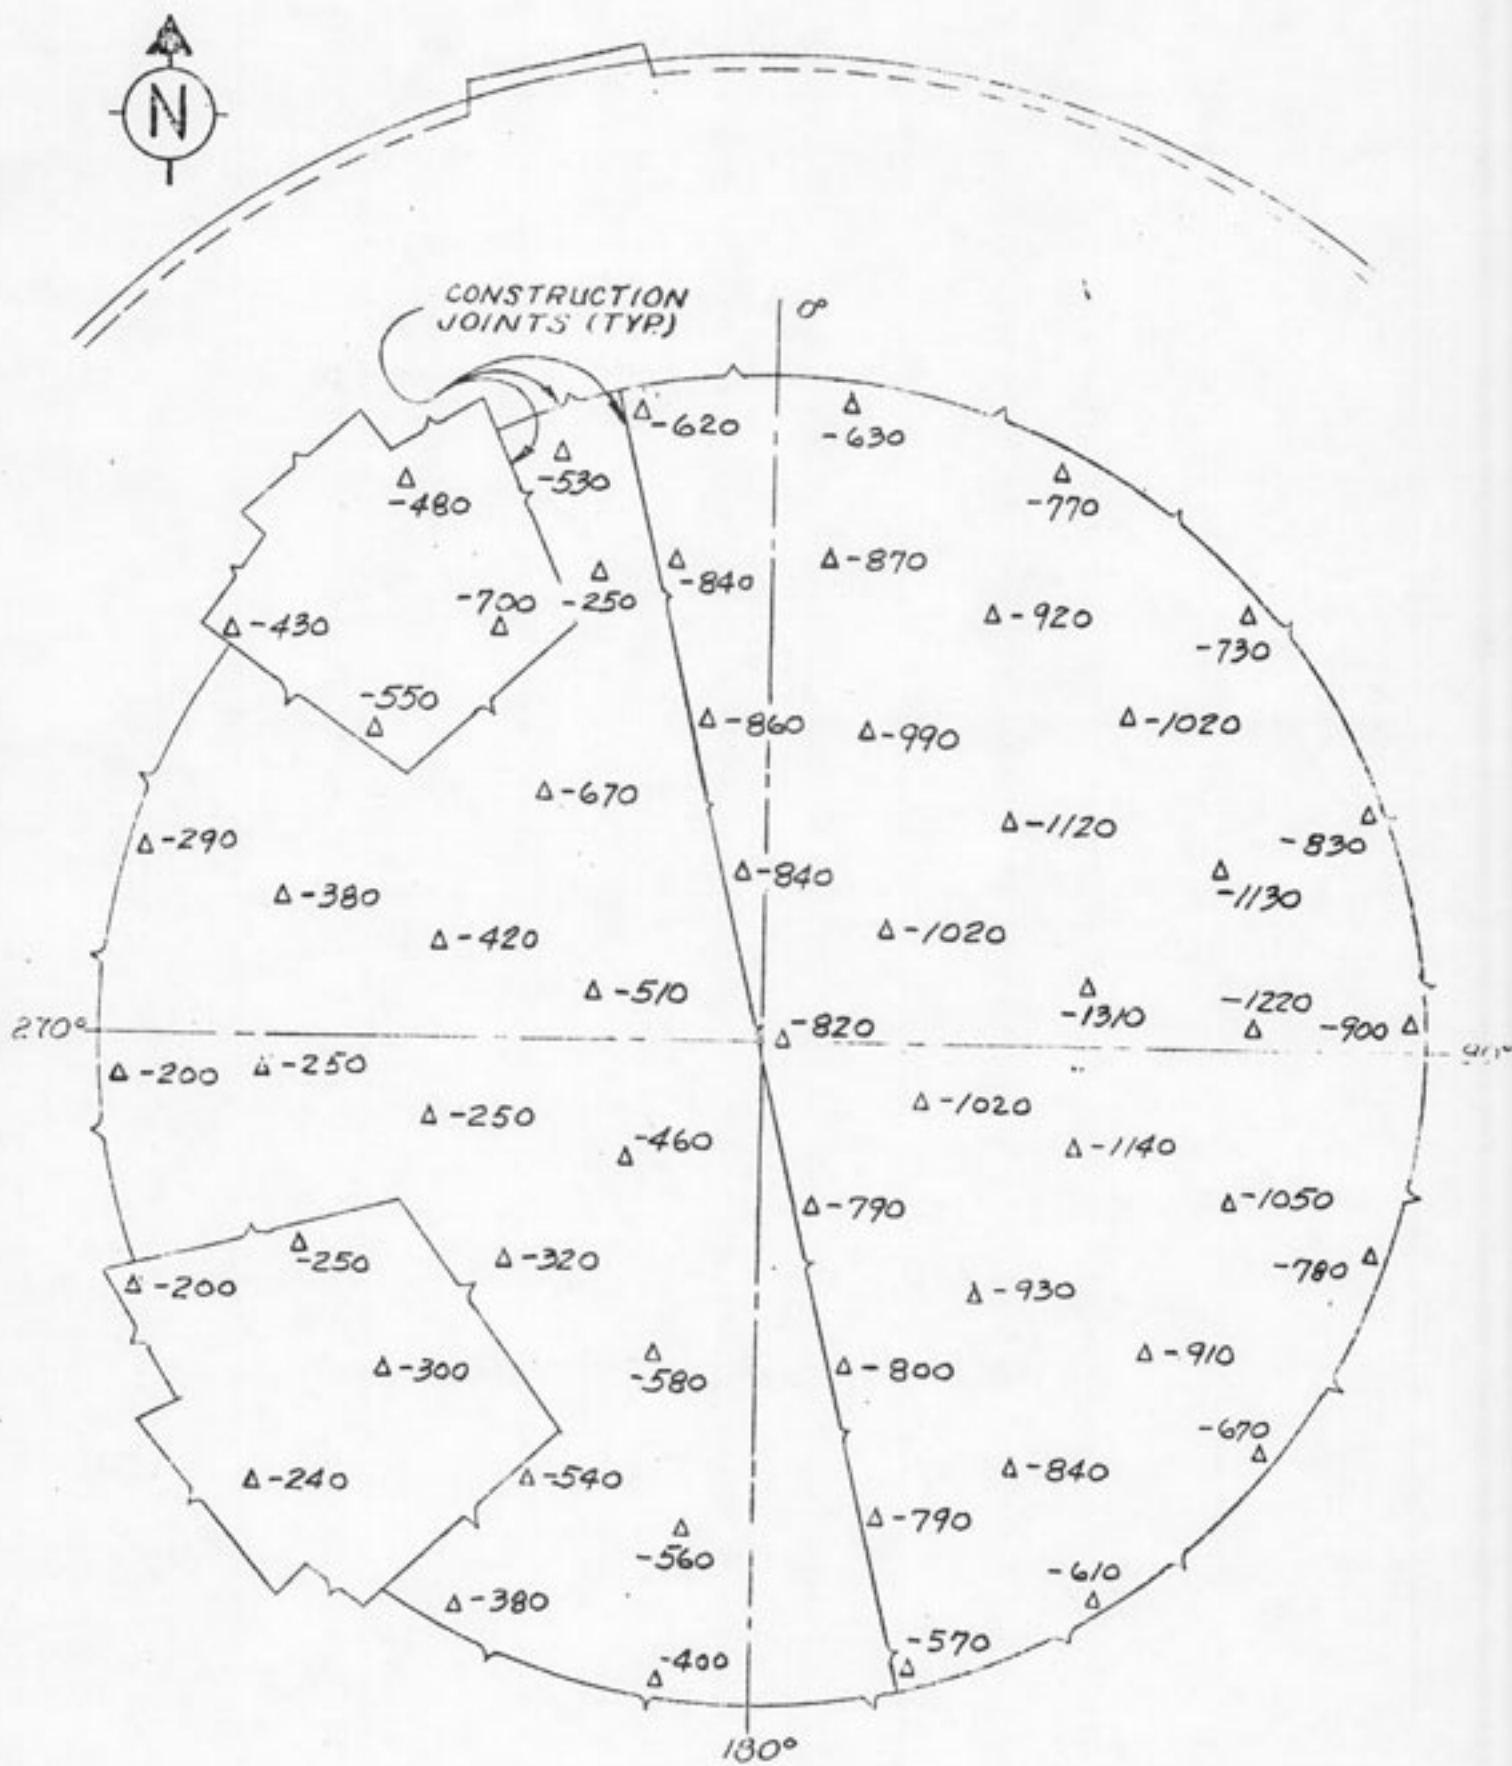
CIRCUMFERENTIAL STRESSES AT THE OUTSIDE SURFACE FROM THE POST-TENSIONING LOAD AT 50% COMPLETION. ALL JOINTS ASSUMED HINGED WITH MEMBRANE FORCES, ACTING AT CENTER OF SECTION. UNITS-PSI

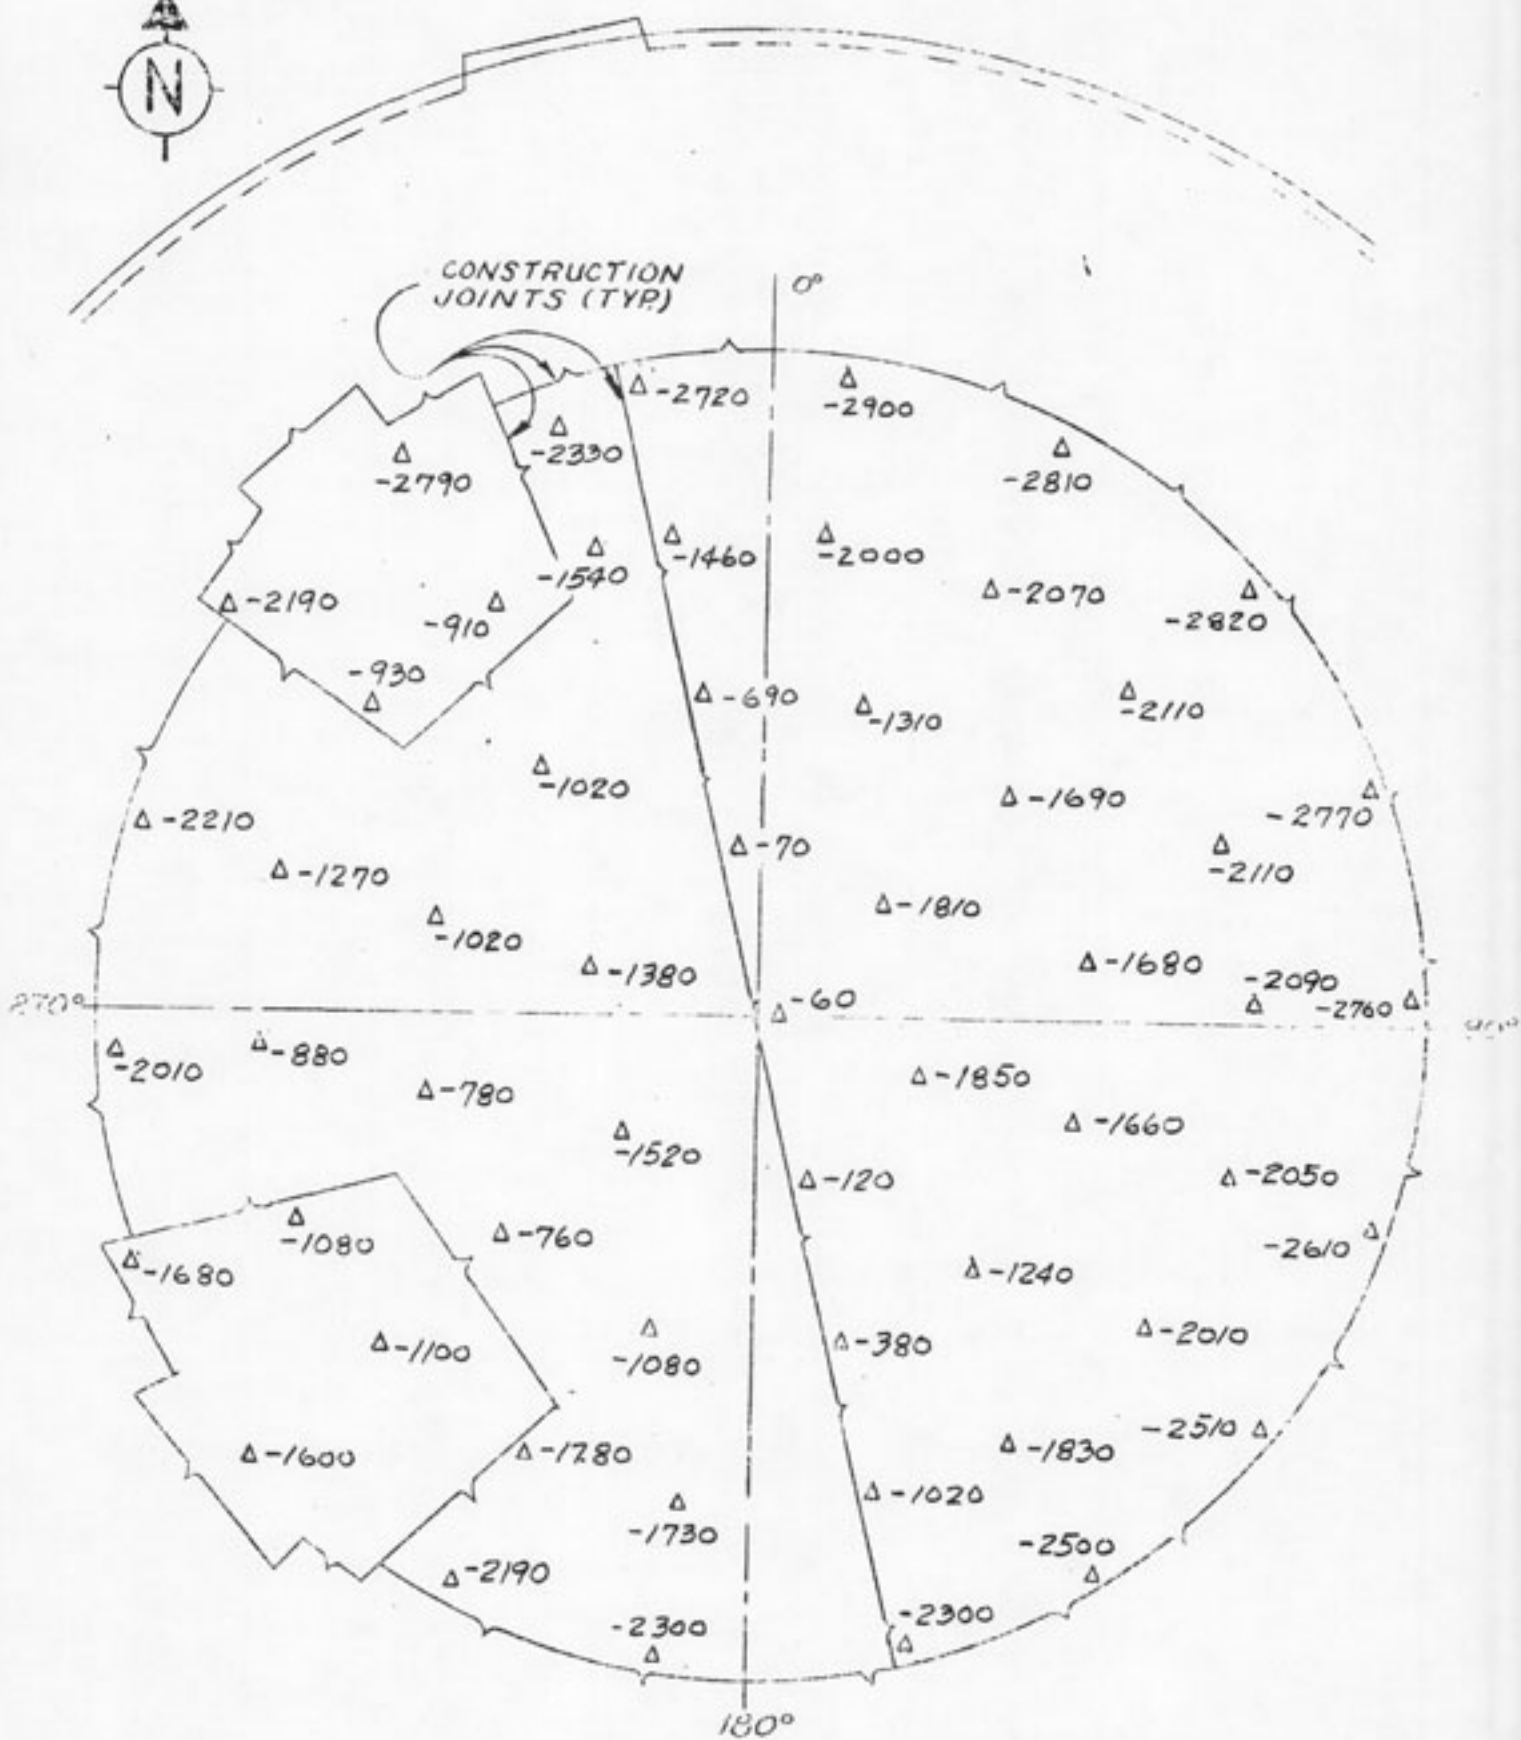
MERIDIONAL STRESSES AT THE OUTSIDE SURFACE FROM THE POST-TENSIONING LOAD AT 50% COMPLETION. ALL JOINTS ASSUMED HINGED WITH THE MEMBRANE FORCES, ACTING AT THE TOP OF THE CIRCUMFERENTIAL AND MERIDIONAL JOINTS.

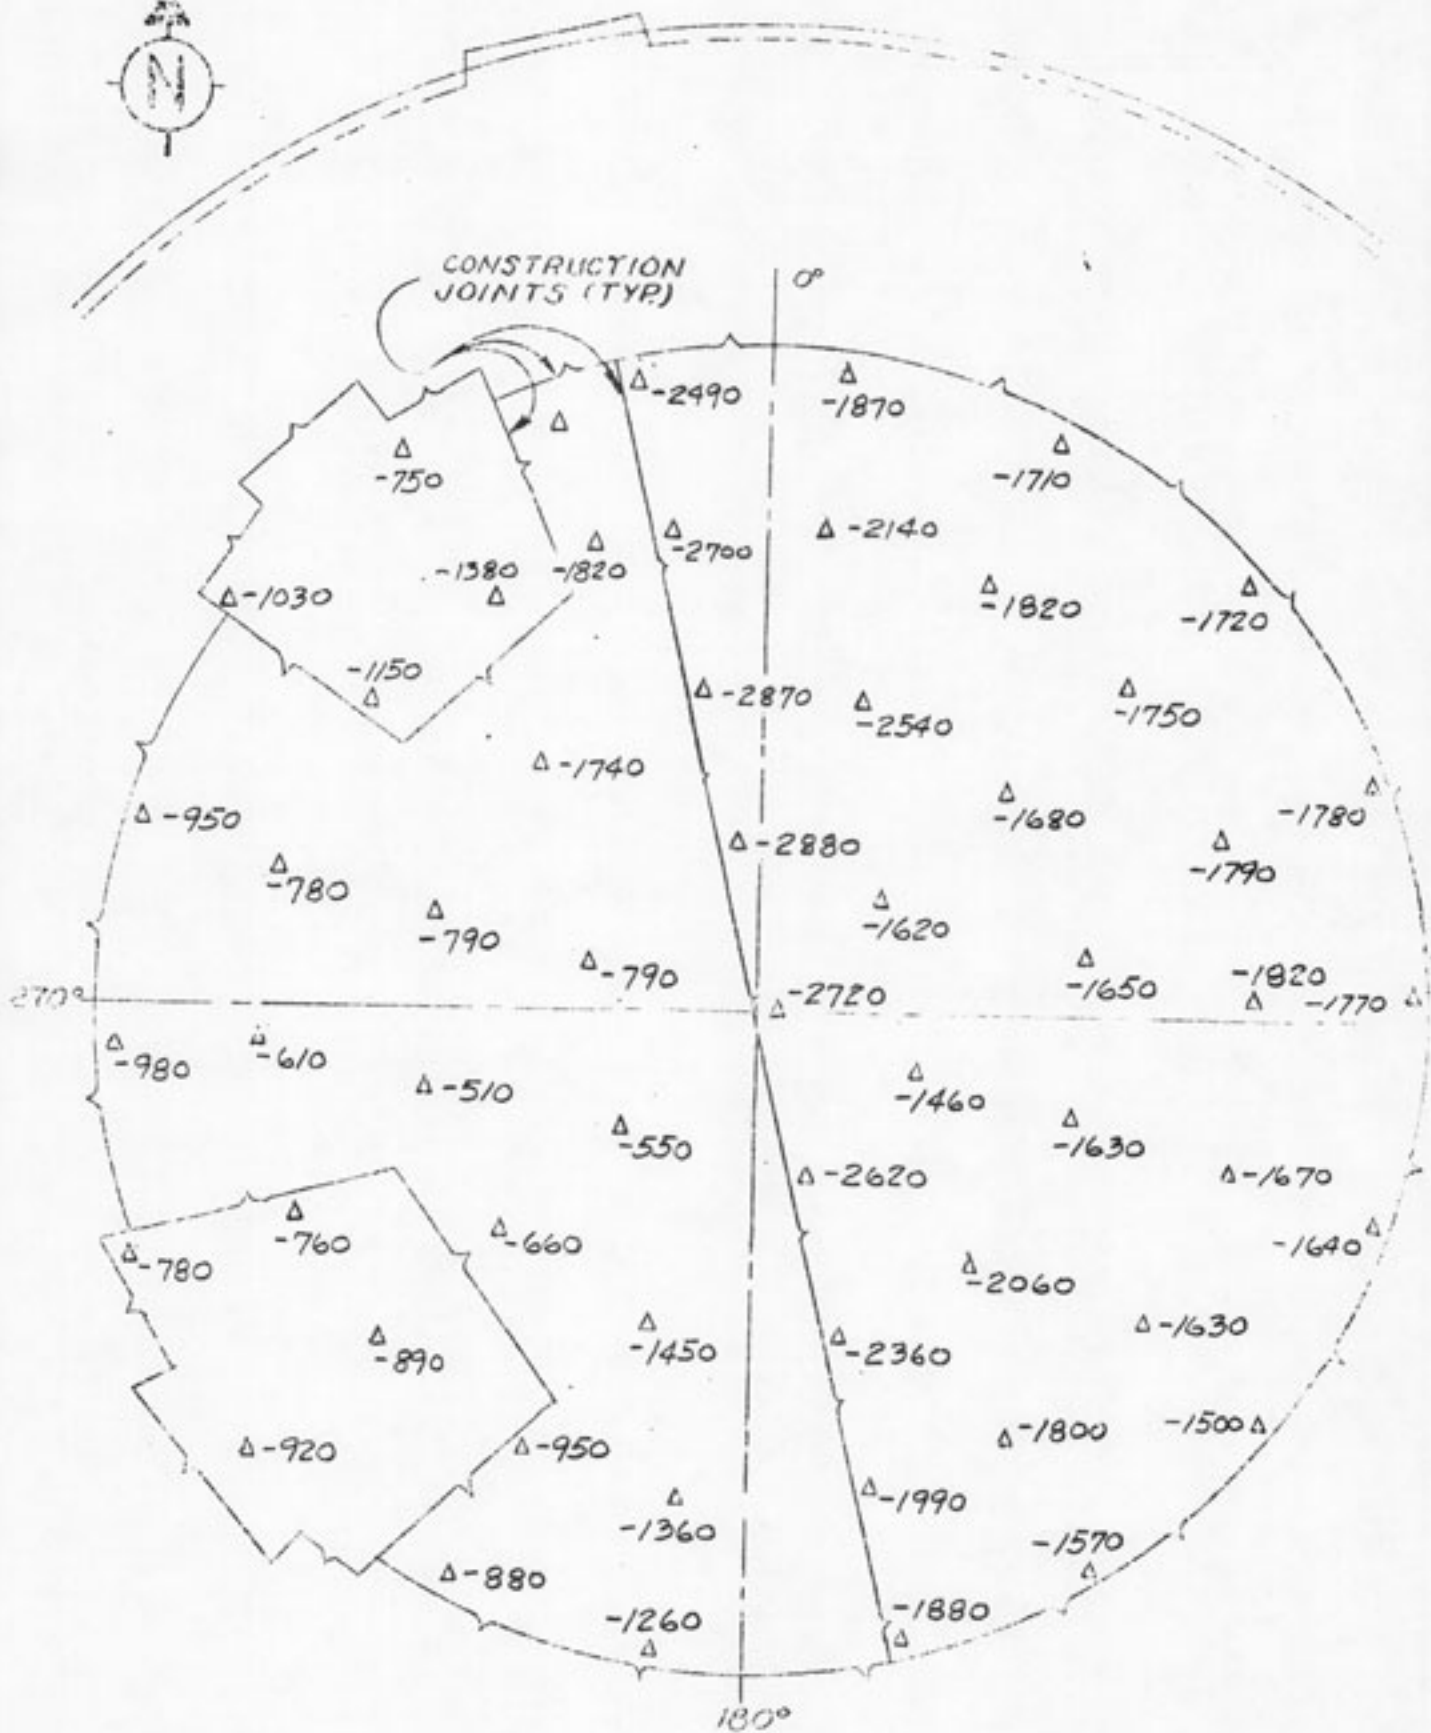
CIRCUMFERENTIAL STRESSES AT THE OUTSIDE SURFACE FROM THE POST-TENSIONING LOAD AT 50% COMPLETION. ALL JOINTS ASSUMED HINGED WITH THE MEMBRANE FORCES ACTING AT THE TOP OF THE CIRCUMFERENTIAL AND MERIDIONAL JOINTS.

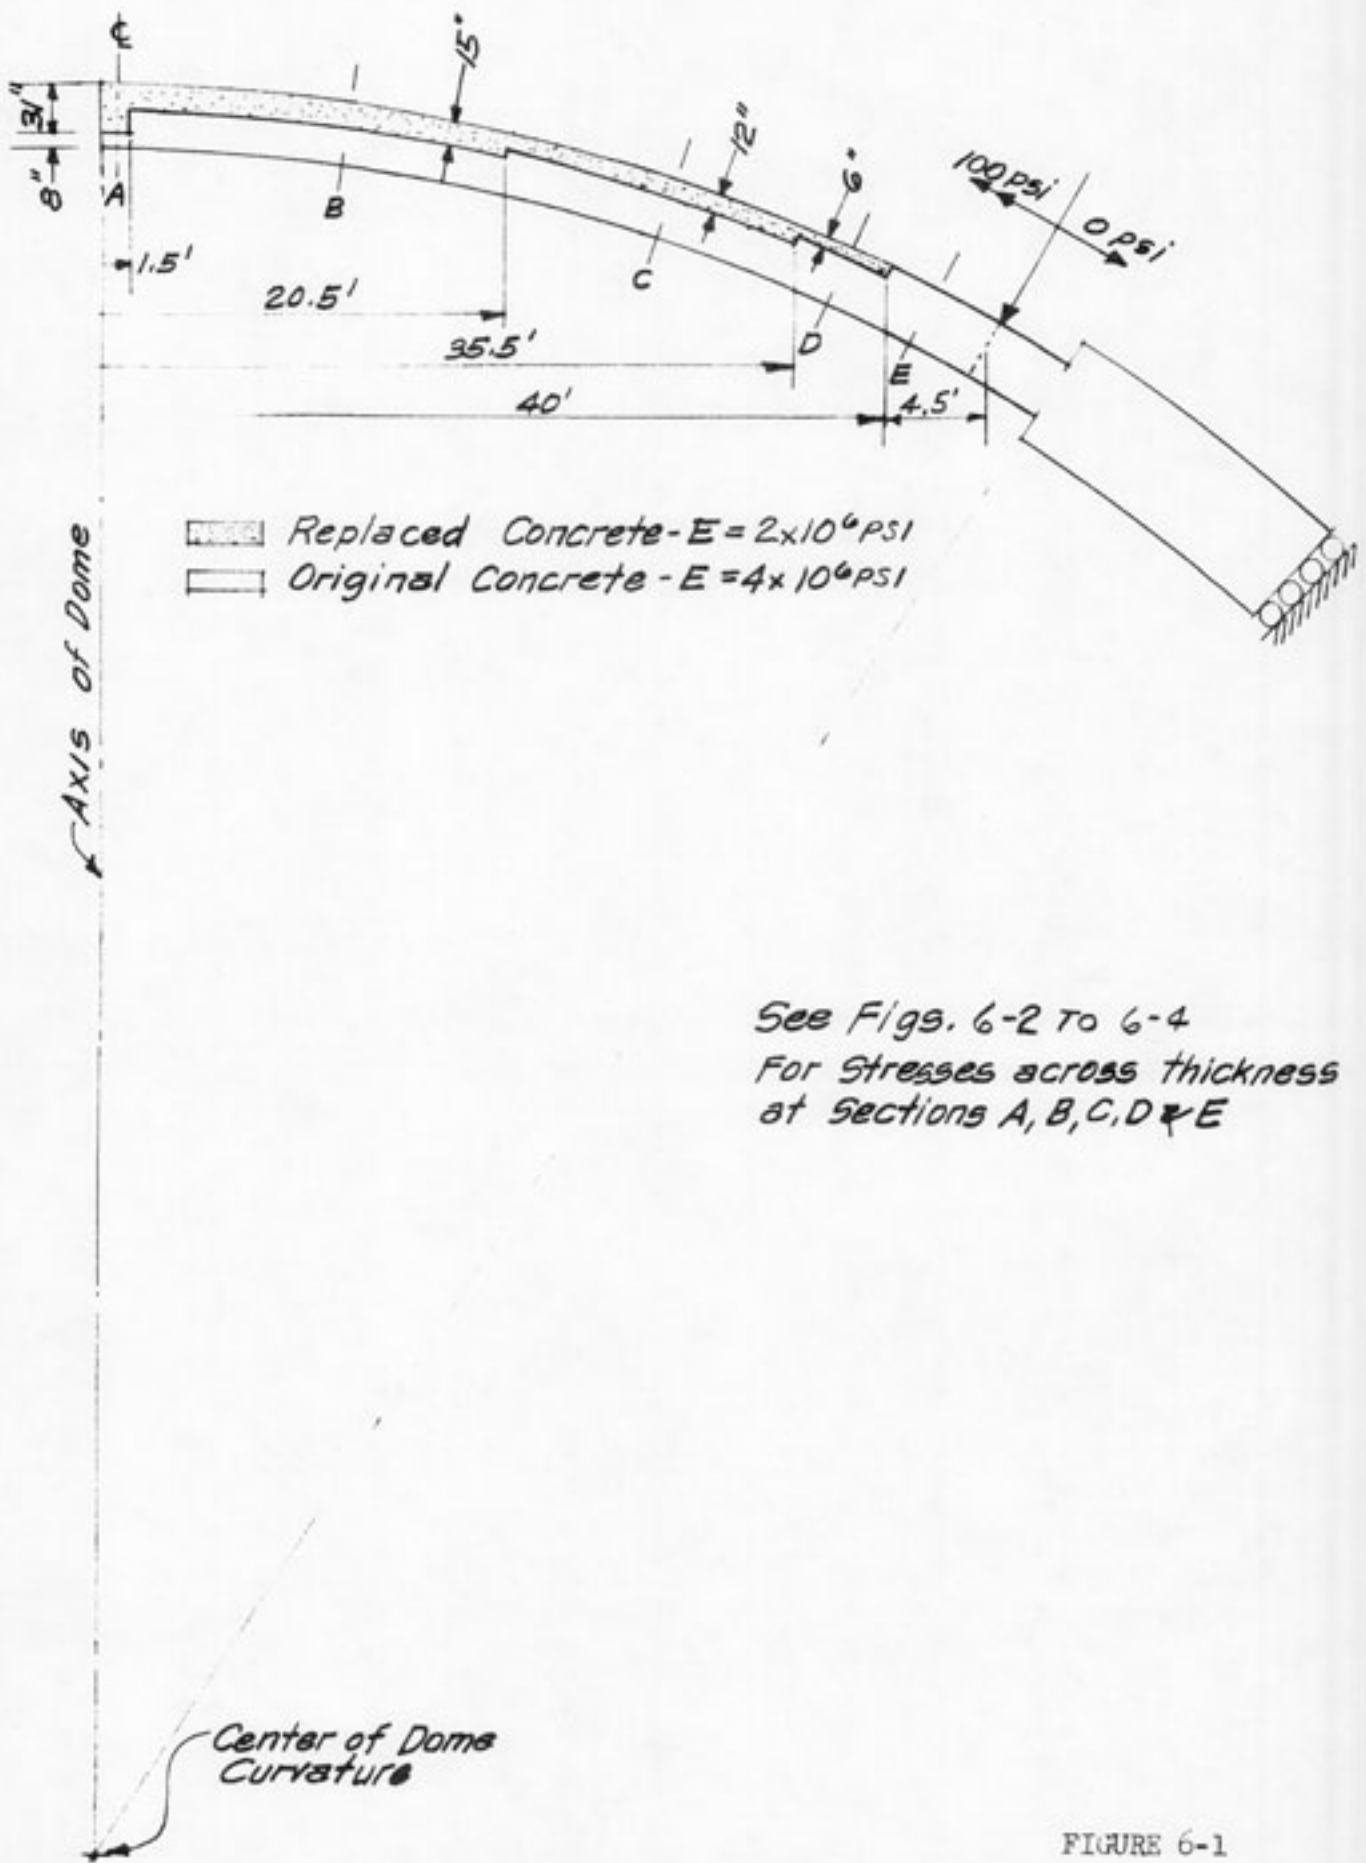
FIGURE 6-1

The analytical model is shown in Figure 6-1. The amount of replaced concrete was assumed to be a worst case based on the concrete coring information obtained before detensioning. Figures 6-2 to 6-4 show the stress distribution at various section, in the meridional direction. Section B shown in Figure 6-2 will be discussed in detail since it involves the greatest volume of replaced concrete. At this cross section the replaced concrete had a thickness of 15 in. and the original concrete had a thickness of 24 in. in the figure. The dotted line shows the stress distribution for an analysis assuming the same modulus of elasticity throughout the thickness. As shown on Figure 6-2 there is a small amount of flexure at Section B. The average stress in the top 15" is - 1700 psi and in the bottom is - 1450 psi. The solid line shows the stress distribution with the modulus of elasticity of the top portion as 1/2 of that of the bottom. The average stress in the top 15" is - 1500 psi and the average in the bottom 24" is - 1800 psi. The analysis indicates an increase of - 350 psi in the bottom portion due to the effect of replaced concrete. Since the modulus of elasticity for both the top and bottom portion were based on creep data for a - 1500 psi load, the analysis is yielding conservative results since creep is considered linearly

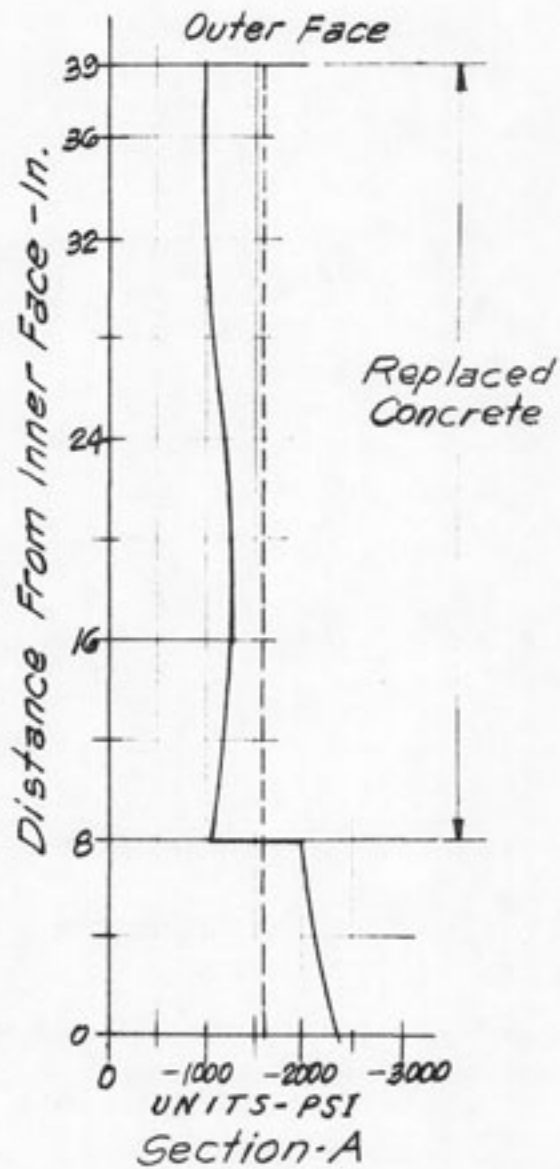
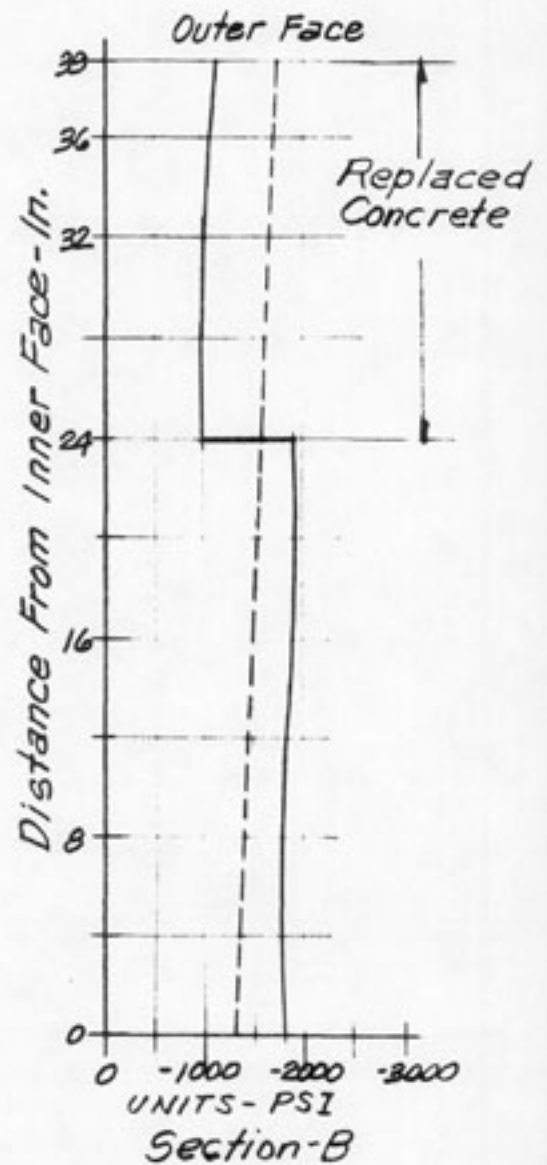
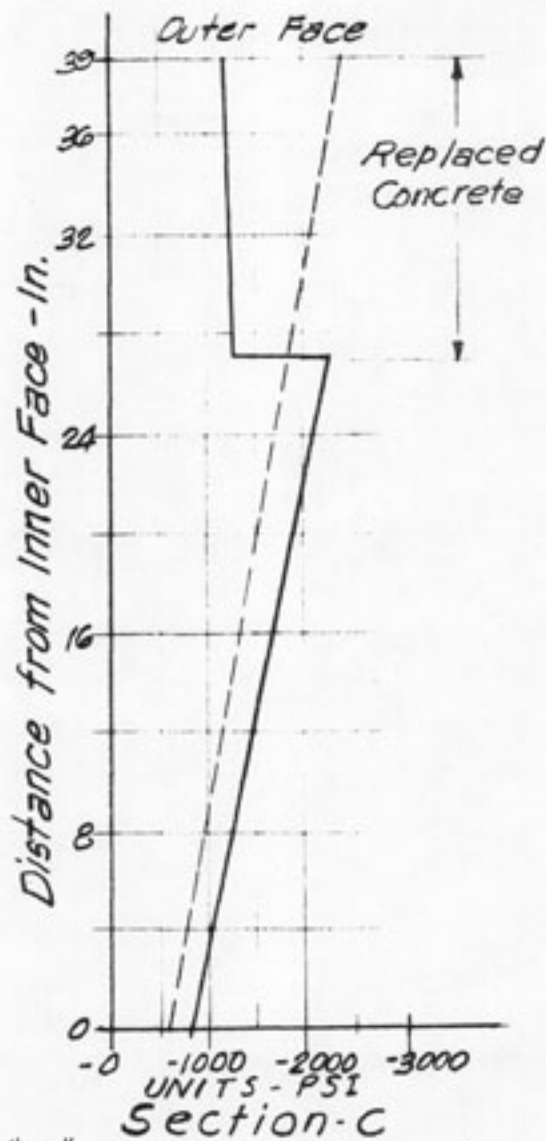
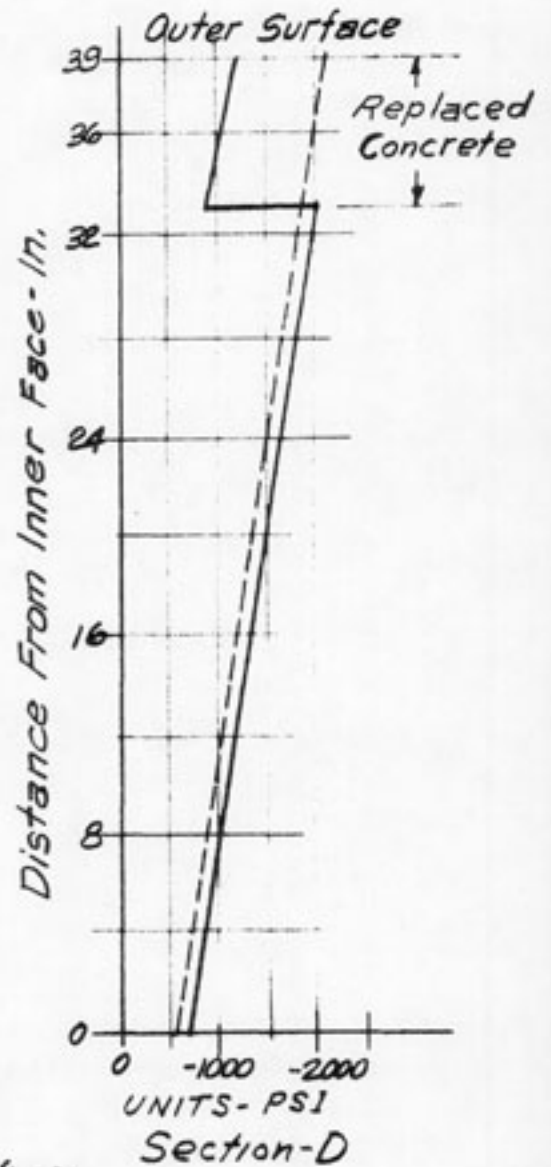
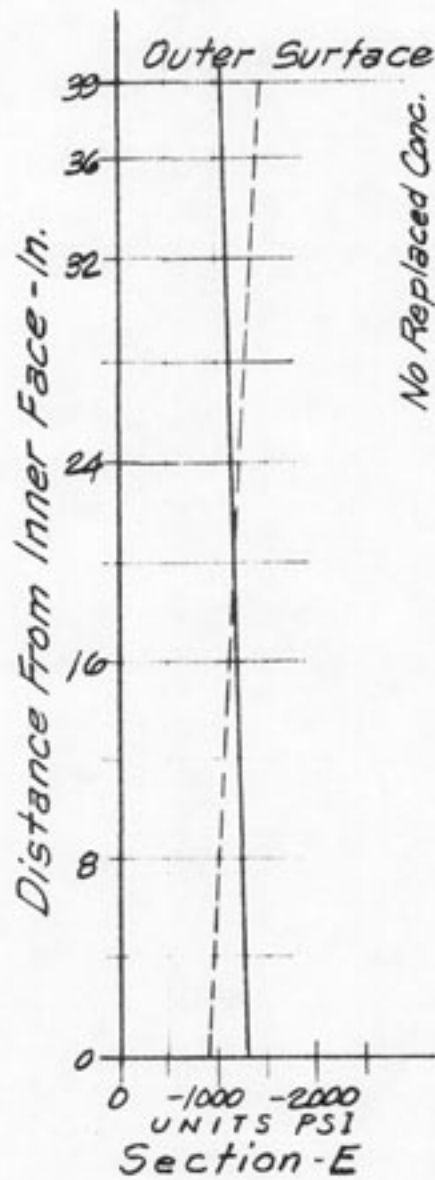
proportional to applied stress. In reality the bottom portion with the higher stress would creep more than indicated by the analysis and this would increase the stress in the top portion and reduce it in the bottom. With the exception of Section A the increase in stress is quite small in the original concrete. In Section A the stress increase is - 700 psi, however only a small volume of concrete is affected. As shown by the analysis the dome should respond to load essentially the same as it would if the top concrete had not been delaminated and replaced.

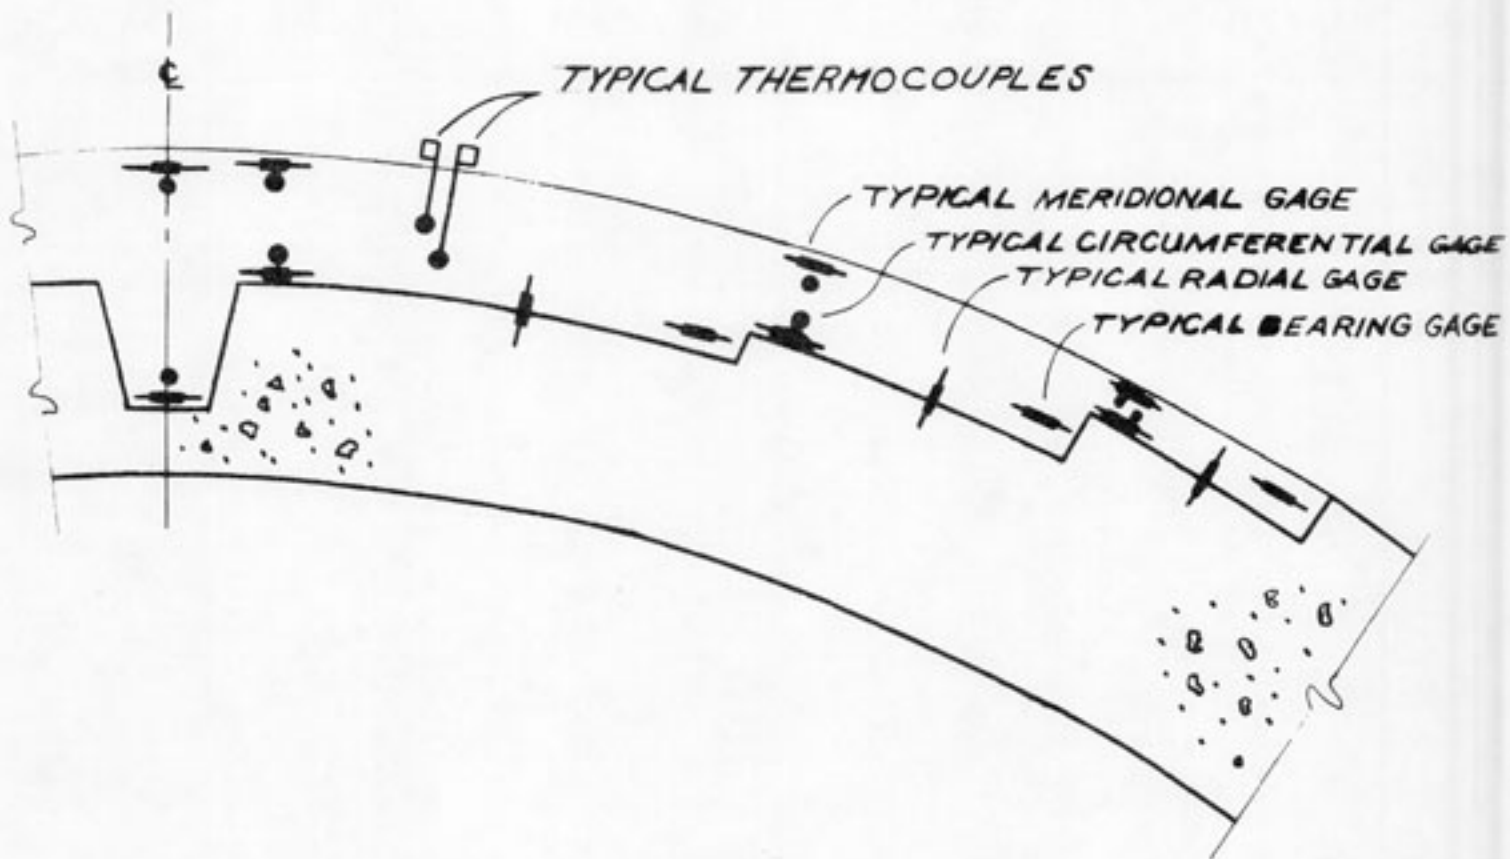
FIGURE 6-7

ILLUSTRATION OF TYPICAL
INSTRUMENTATION

Instrumentation will be provided in the replaced concrete. Instrumentation installed earlier but damaged by concrete removal will be replaced. Strain gages and thermocouples will be installed on both the east and west side of the dome. There will be two lines of gages and thermocouples, a typical line is shown in Figure 6-7. The purpose of the instrumentation is to provide verification that the replaced concrete is carrying a portion of the applied load.
