INTERIM FINAL DRAFT REPORT
ON
EMBANKMENT FAILURE
FLORIDA POWER & LIGHT COMPANY
MARTIN PLANT COOLING RESERVOIR

April 1980

South Florida Water Management District
West Palm Beach, Florida

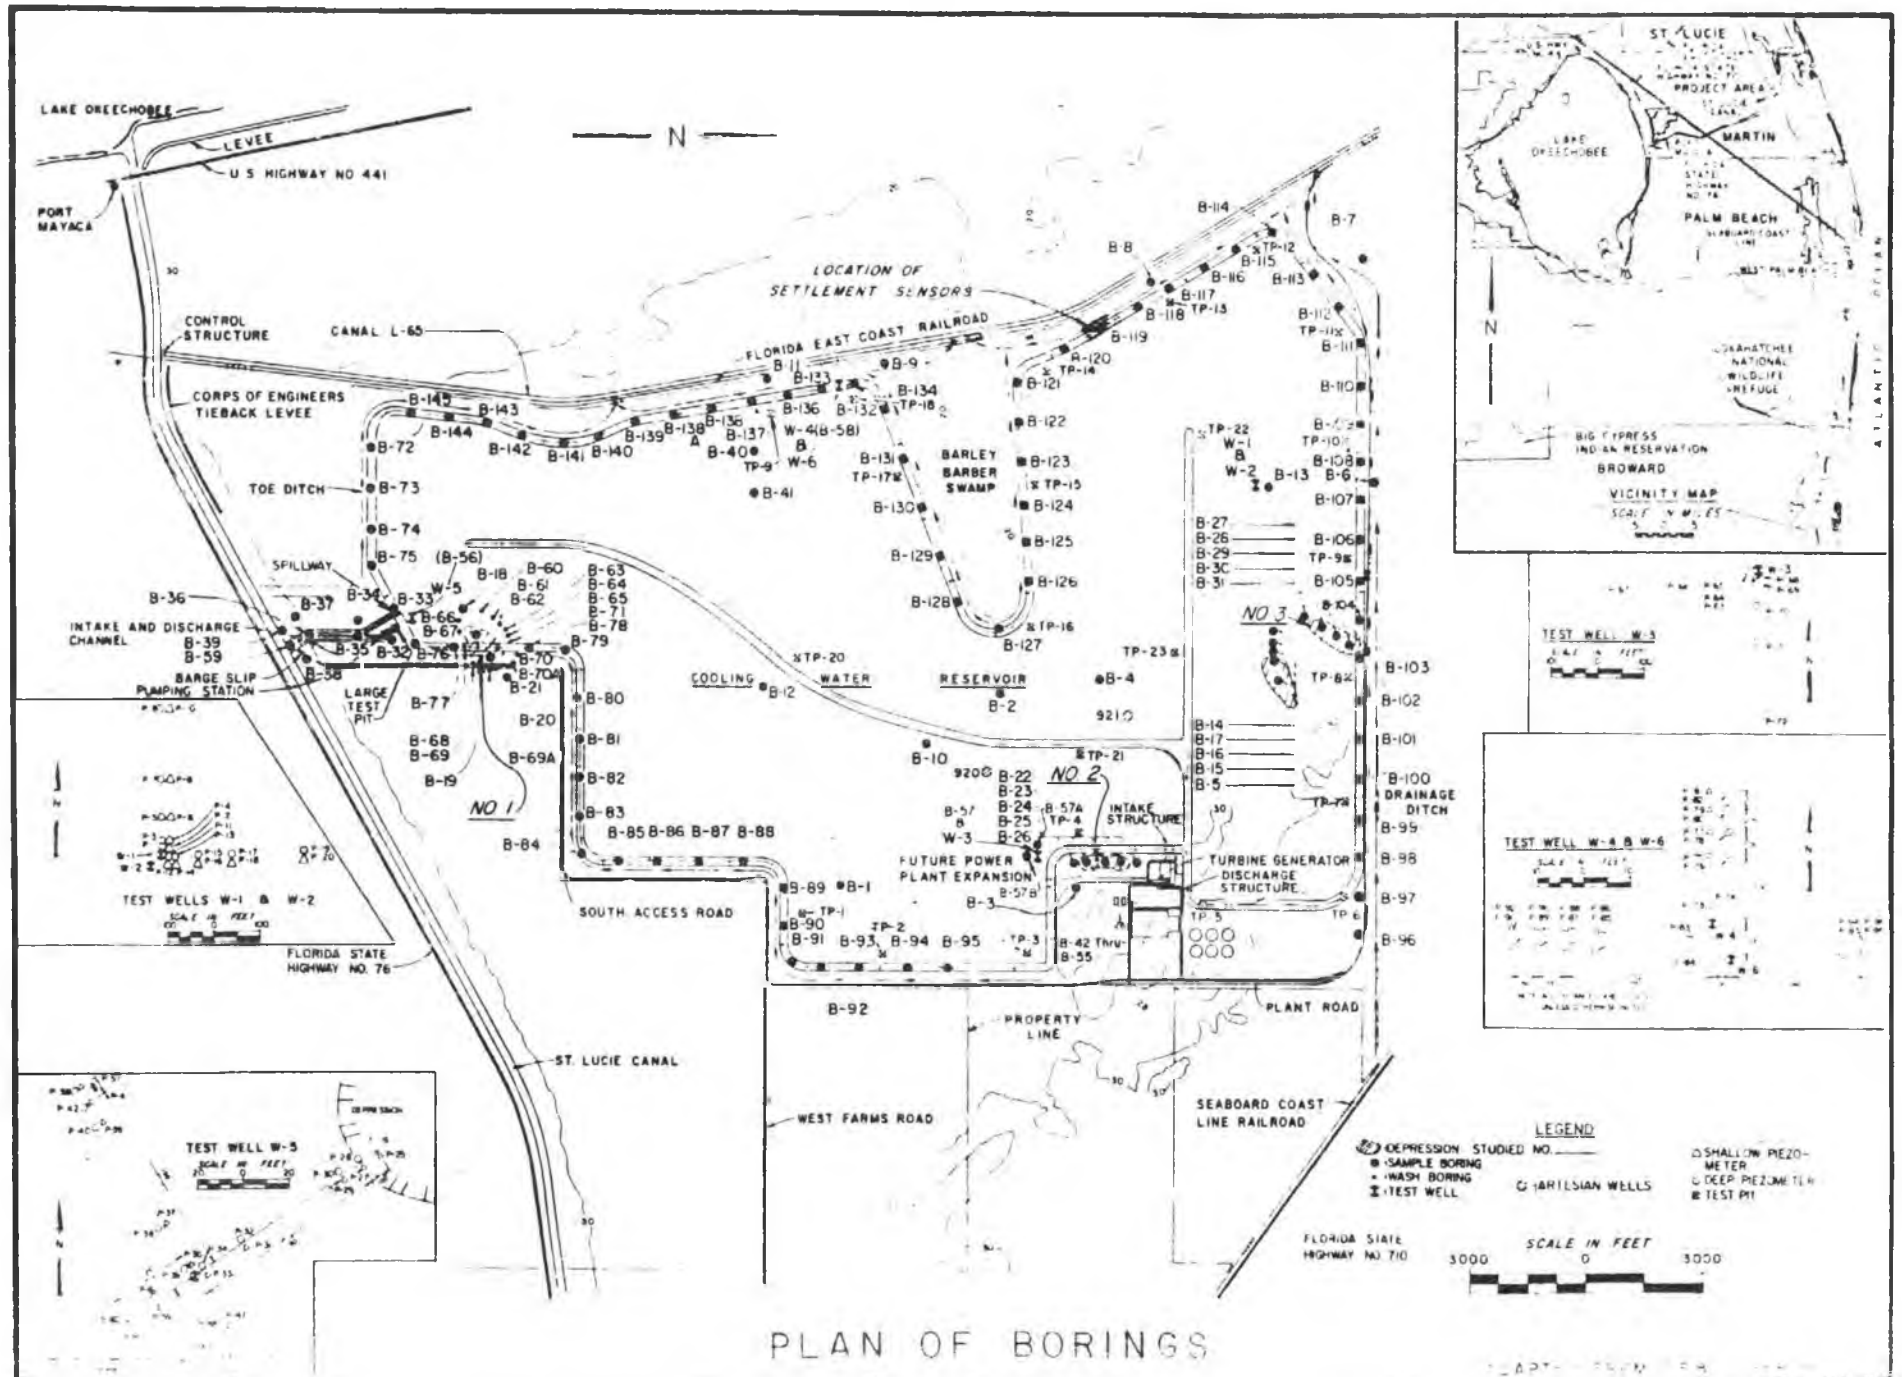
Figure 2-1

2-1, 2-2, 2-3
Figures 2-1, 2-2, 2-3 taken from FP & L reports show the location of various elements of the subsurface exploratory program; a location plan of the shallow depressions that were examined and the detail of a typical depression. investigation.

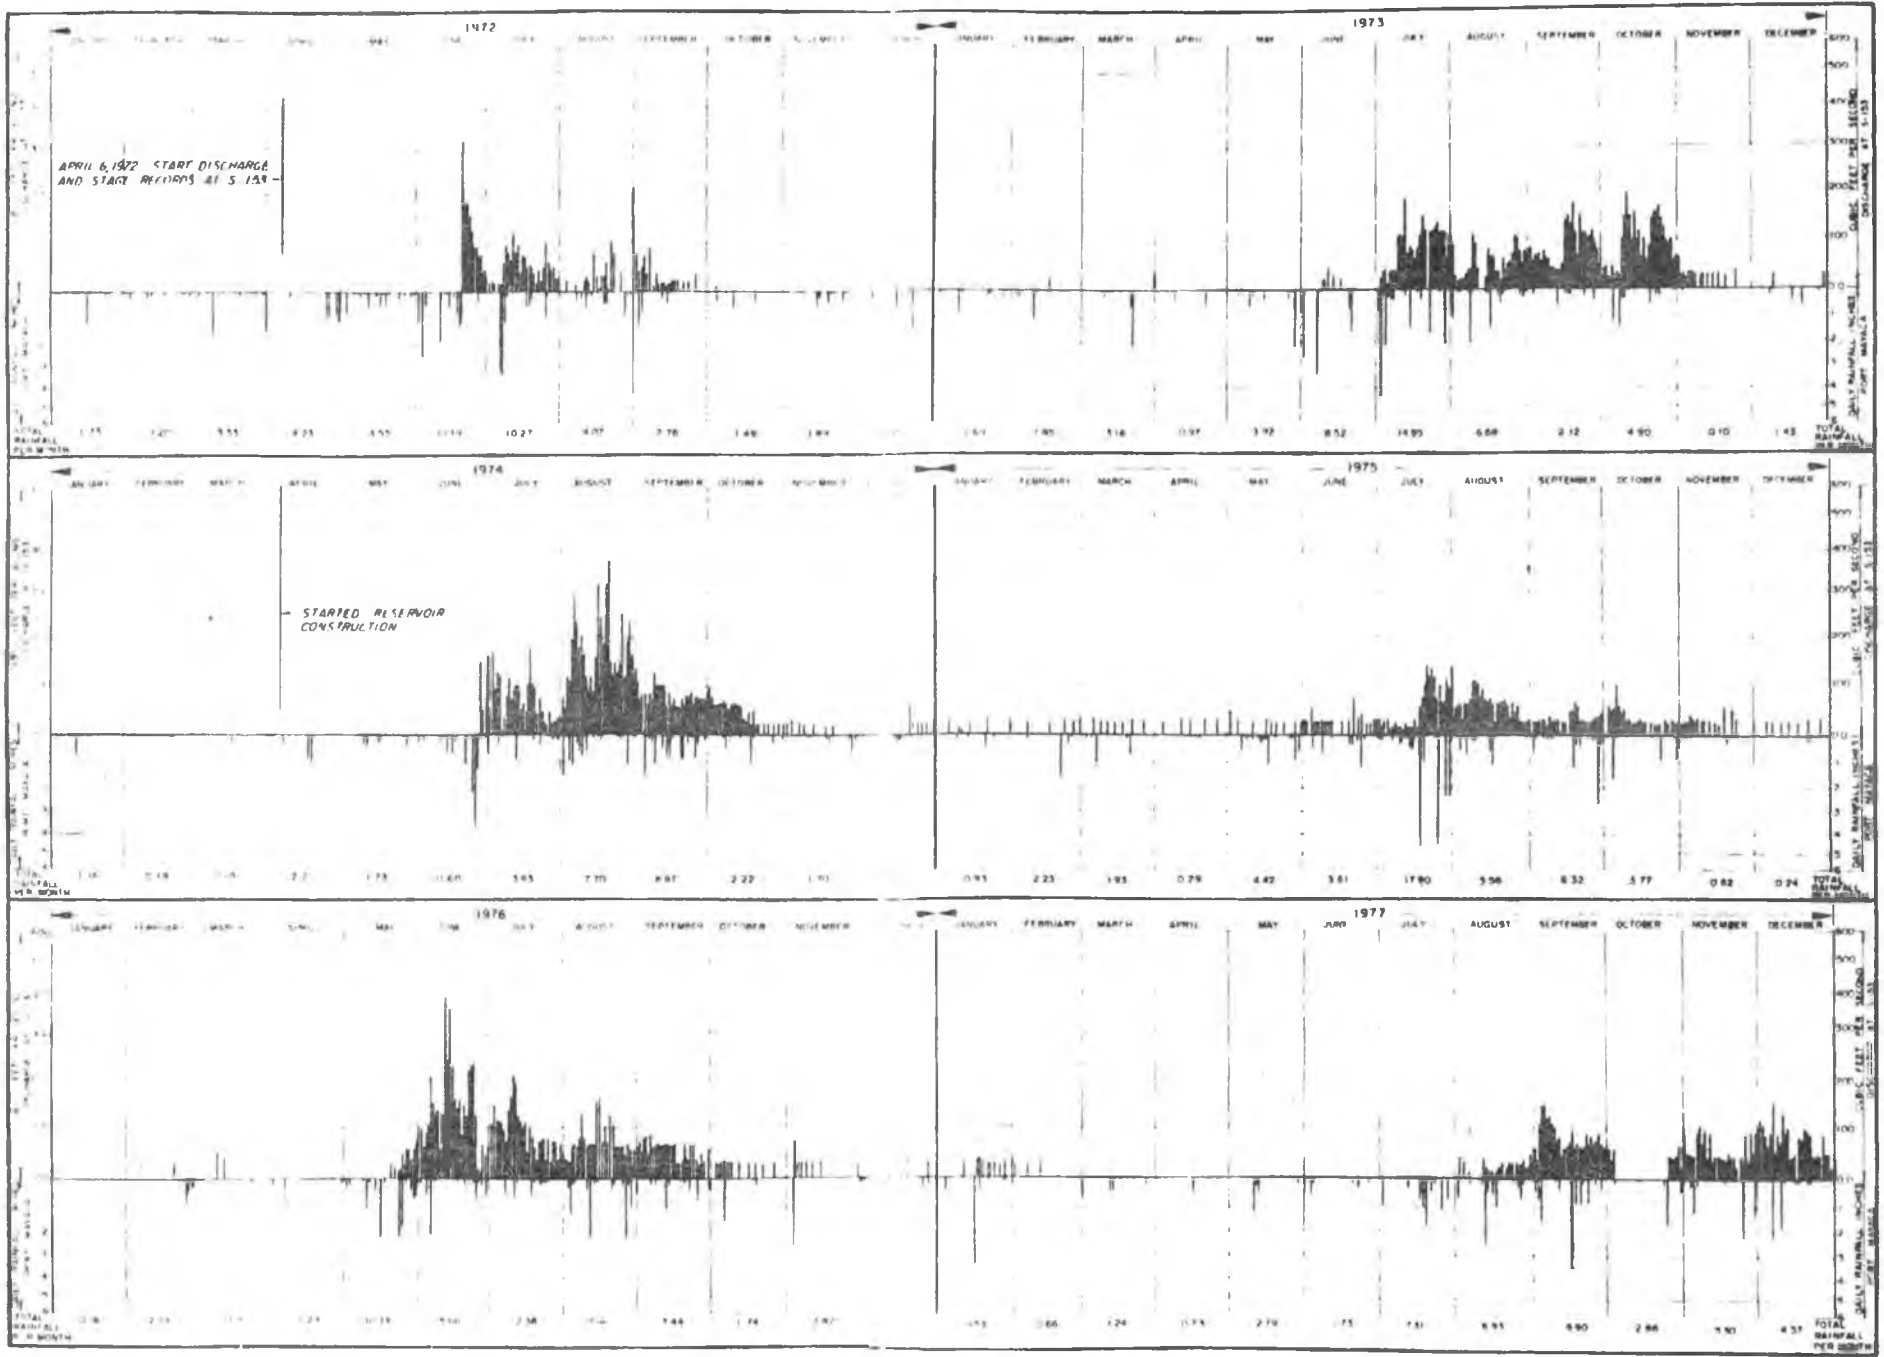
Figure 4-4A

Seepage losses, calculated from formula (2) are shown in Figures 4-4A+B.

Unfortunately, these values are meaningless because the "reasonable" evaporation values obtained from formula (3) are specious. These values range from 0.2 to 0.6 inches per month. Class A pan evaporation, measured by the National Weather Service at Moore Haven Locks, ranges from 4 to over 10 inches per month during the same time period. It must be recognized,

Initially this investigation required that as much pertinent historical data as available be reviewed. These data are displayed chronologically in Composite Data Chart (Figure 4-4A, 4-4B). This chart more easily identifies related events that were not otherwise obvious. The most obvious example was the discharge at District Structure 153 with the simultaneous conditions of rainfall and seepage related to it.

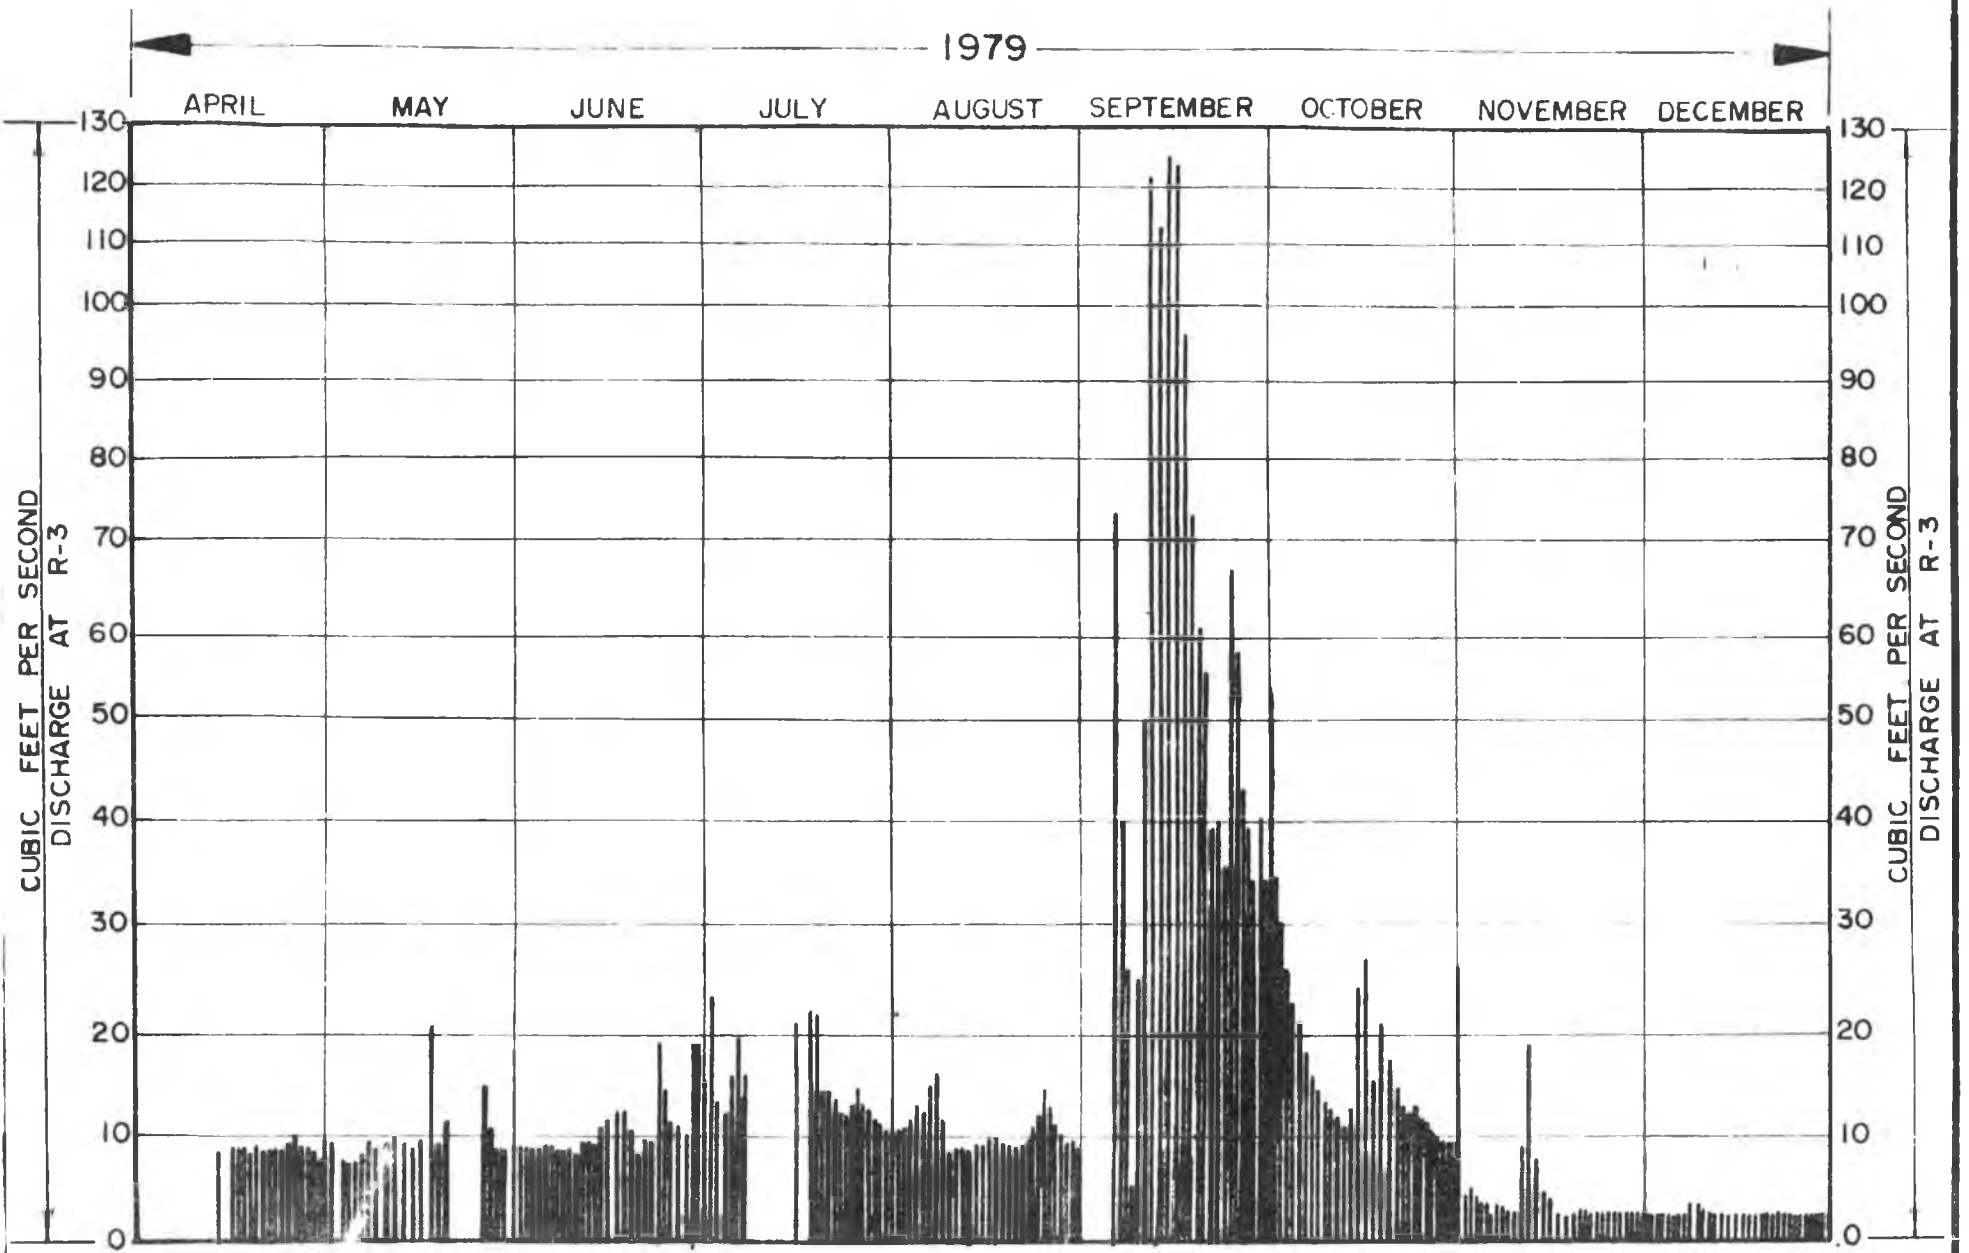
Figure 4-5

the reservoir as well as seepage from the entire north embankment. Because of the diverse source of this runoff, these records are of little value and have not been considered further. The calculated flow at R3 on the other hand is very significant. Unfortunately the drainage area of this gage includes about a two-square mile area between the power plant and SR 710. Consequently, after substantial rainfall, this latter area contributes heavily to the runoff. After sustained drought periods, R3 records the seepage from the reservoir and a small base flow. Figure # 4-5 shows a rather consistent discharge of about 8 cfs between April 13 and May 15, 1979. There was little rainfall recorded between March 8 and May 15. Again, after the embankment failure on October 30, the discharge at R3 rapidly declined to a rather consistent level or a base flow of about 2 cfs from November 15 to December 31, 1979. Rainfall in the antecedent period from October 15 to December 31 was also very light, except for a one day event on November 12. Thus it may be concluded from an analysis of this hydrograph, that the pre-failure flow from the six-mile reach on the east side of the reservoir of 8 cfs was equal to the seepage of 6 cfs plus a base flow of 2 cfs. The seepage therefore was roughly one cfs per mile. Much of the seepage, however, probably didn't reach the toe ditch, but evaporated along the very wet toe of the embankment. Thus the total seepage might ^{reasonably} be 2 cfs per mile.

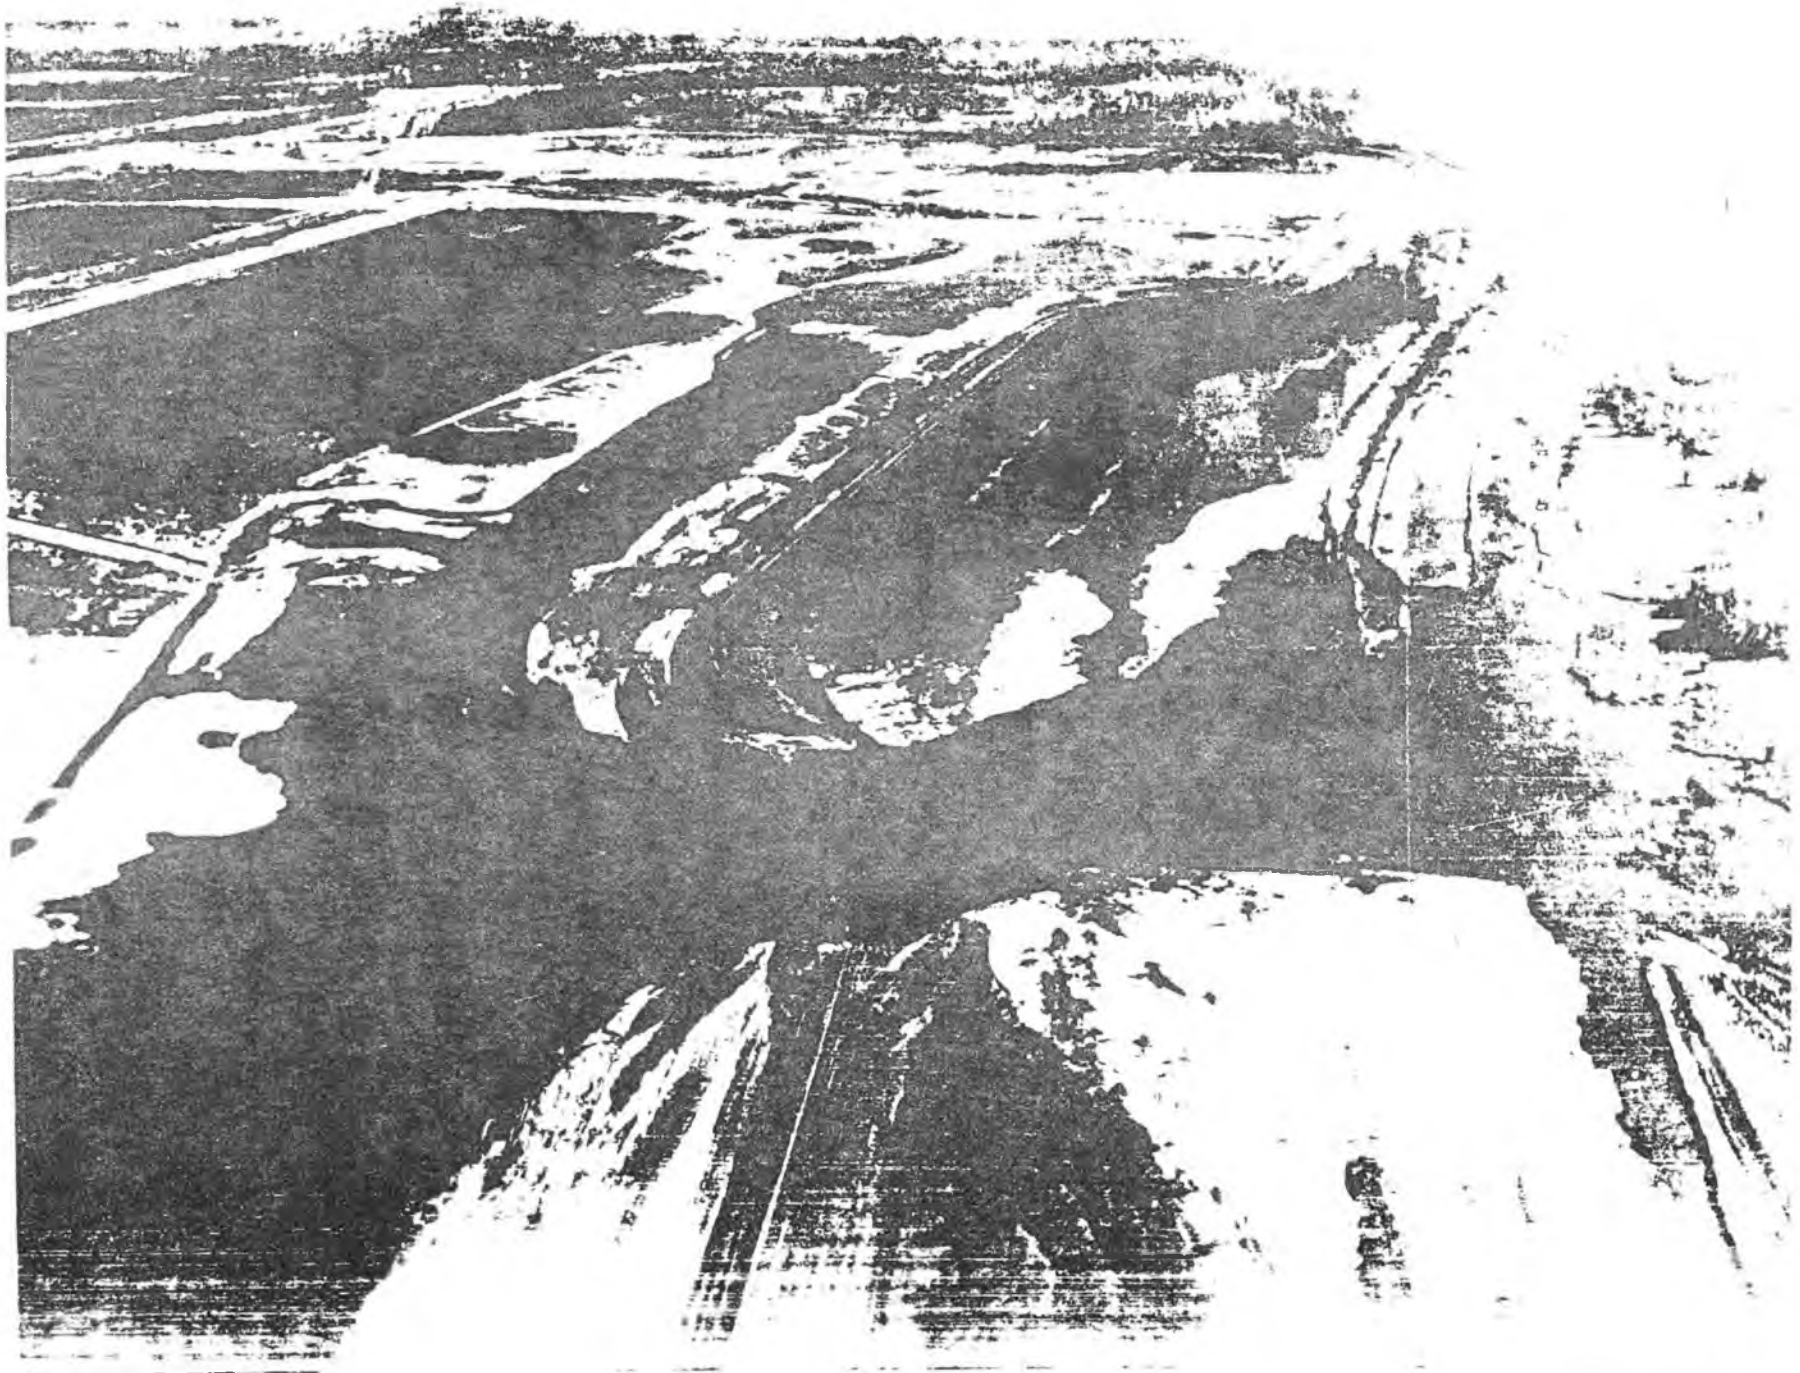
Figure 5-10

5. Photos taken from the District helicopter within twenty-four hours after failure which were used in gaining additional insight into location and direction of flow through and downstream of the breach area. See Figure 5-10.

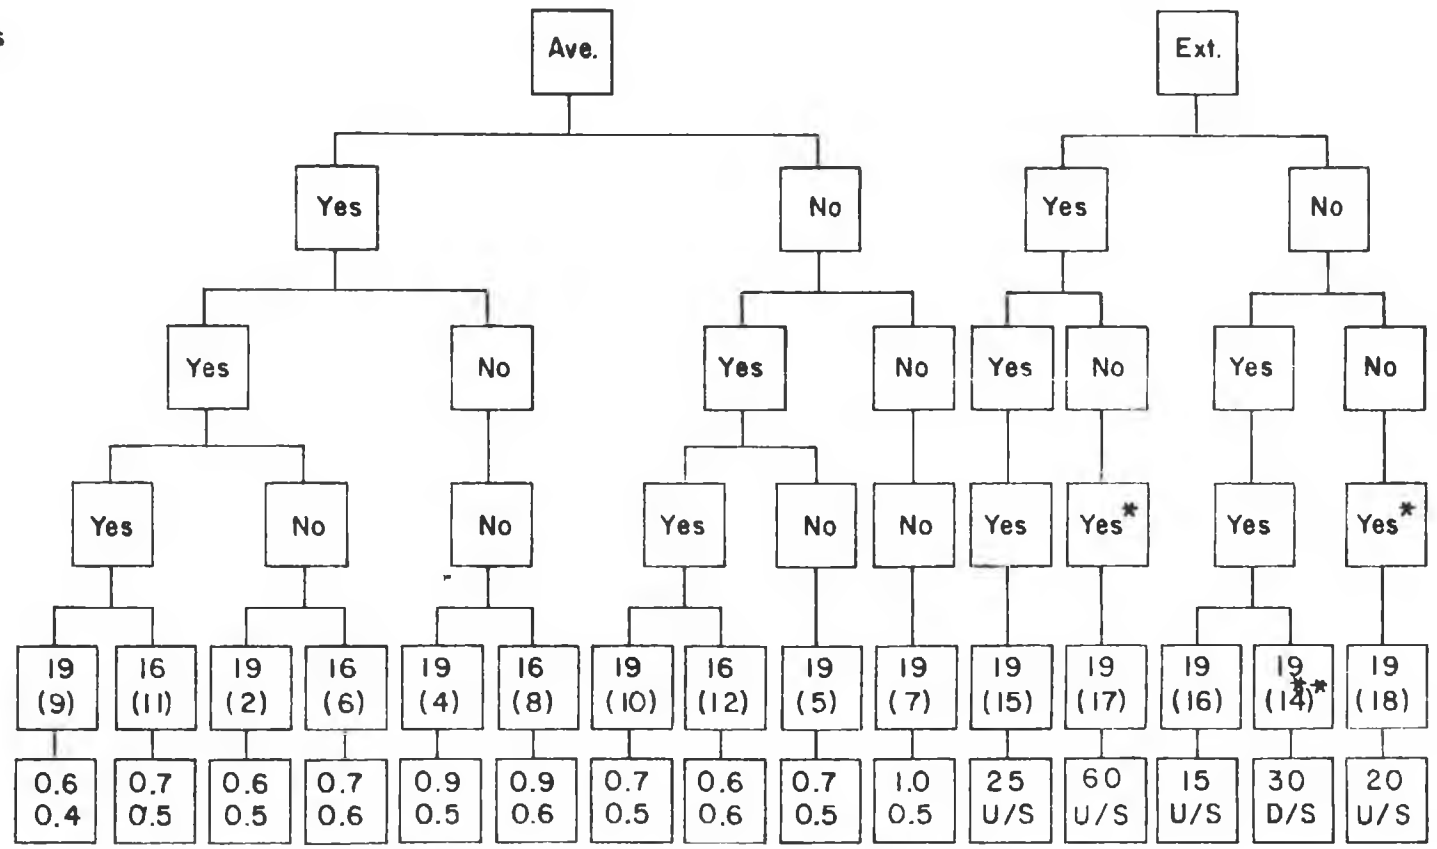
Figure 5-13

Flow nets were constructed to demonstrate the flow and hydrostatic pressure distribution in the embankment proper and its foundation. These flow nets are included in the appendix. Fig. 5-13 summarizes the various cases studied and the conditions prevailing with various remedial works under various assumed conditions. Cases 1, 3 and 13 represent conditions in the breach area as they might have been prior to the failure. Cases 1 and 3 are based on the assumption that the piezometric pressures were the same at the breach as the average around the rest of the reservoir. Case 1 is based on the assumption that the hardpan layer was present; case 3 is based on the assumption that the hardpan was absent. Case 13 is based on the extreme case, previously discussed, with a $2\frac{1}{2}$ foot downward head differential through the cemented shell layer at the downstream toe, with hardpan present.
