**PRELIMINARY REPORT OF  
RAINFALL EVENT, NOVEMBER 21-26, 1984  
SOUTH FLORIDA COASTAL AREA**

**South Florida Water Management District**

**December 1984**

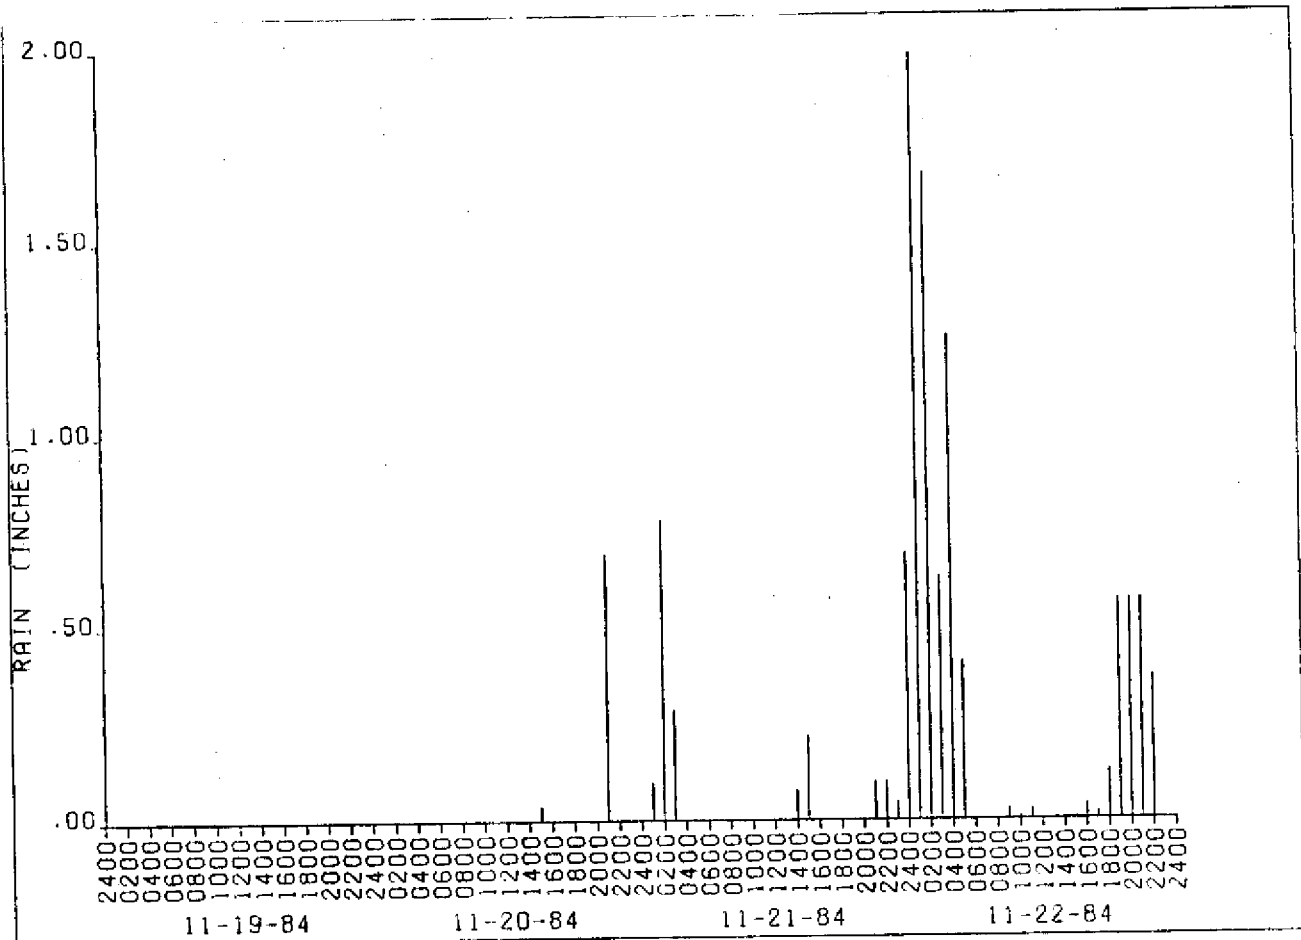
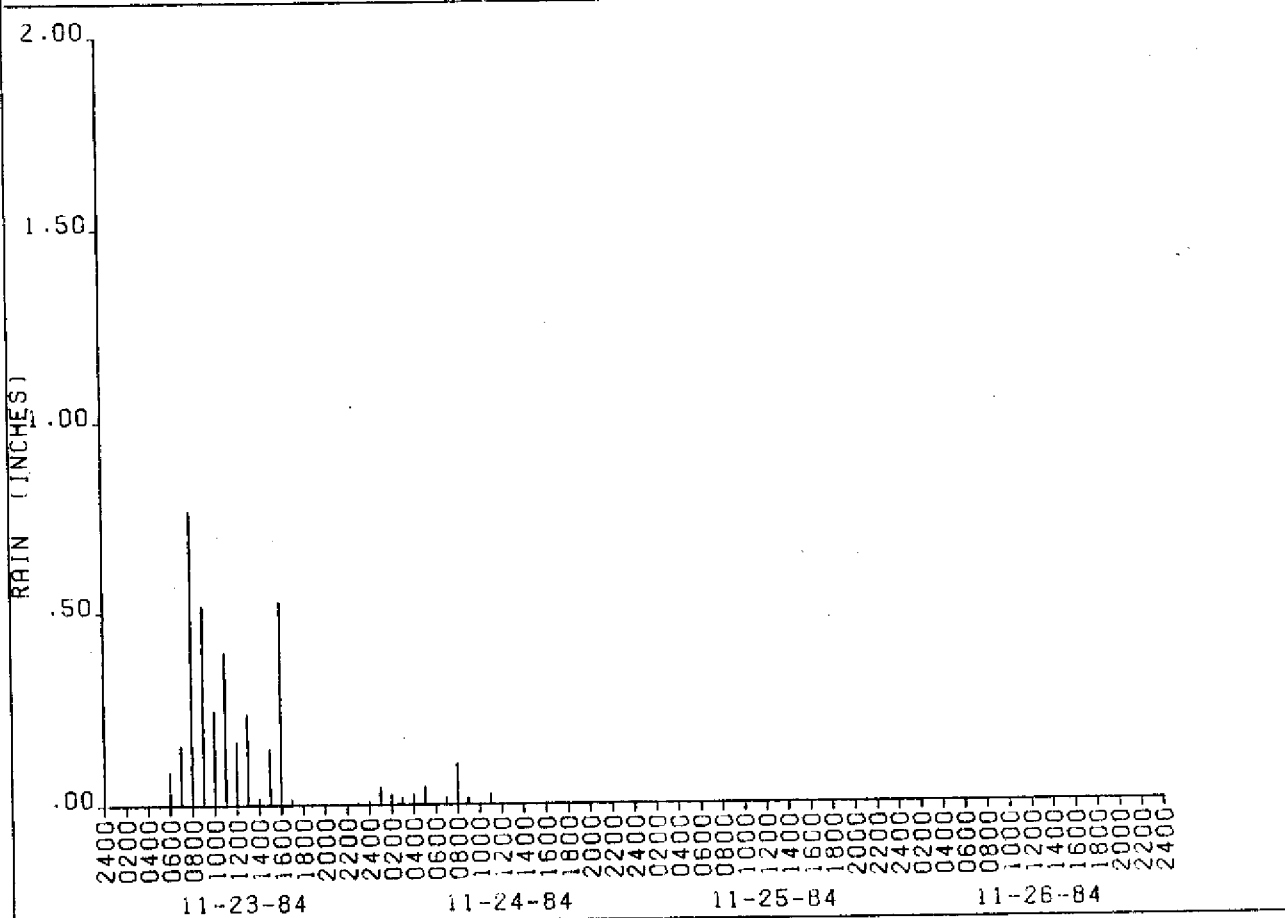
FIG. 3C HOURLY RAINFALL AT W. PALM BCH. F/S

The hourly rainfall distribution at five recording stations is shown in Figure 3. The recorders are located at St. Lucie Lock, Jupiter Fire Station West, West Palm Beach Field Station, Fort Pierce, and S-5A. The most intense rainfall was recorded at the West Palm Beach Field Station between 2300 hours, November 21, and 0500 hours, November 22, with an average rate of more than 1 inch per hour. At the field station, the maximum intensity was 1.99 inches per hour recorded between midnight and 0100 hours November 22. Lighter rains continued throughout the day until 1800 hours, November 22, when moderately heavy rain dumped an additional 2.21 inches of water on the area. The most intense rainfall during November 22 fell between 2000 and 2100 hours when 0.92 inch was recorded. Moderate showers continued throughout the following day. A total of 6.6 inches of rainfall in 6 hours has a one in ten year recurrence frequency

(Weather Bureau Technical Report #40). A total rainfall of 9 inches on November 22, recorded at the West Palm Beach Field Station, is approximately a once in ten year frequency. The three and five day rainfall totals were in the order of once in 25 year events ("Frequency Analysis of Rainfall Maximums for Central and Southern Florida" District Technical Publication 81-3). The region west of Jupiter, which received between 12 and 14 inches of rainfall during the five day, period had an overall return frequency of about once in 25 years. However, the highest rainfall of 19 inches, west of Jupiter, had a return frequency slightly less than once in one hundred years. The Dyer landfill area had about 12 inches of rainfall which has a return frequency of about once in 15 to 20 years. The West Palm Beach Field Station recorded the highest intensity hourly rainfalls.

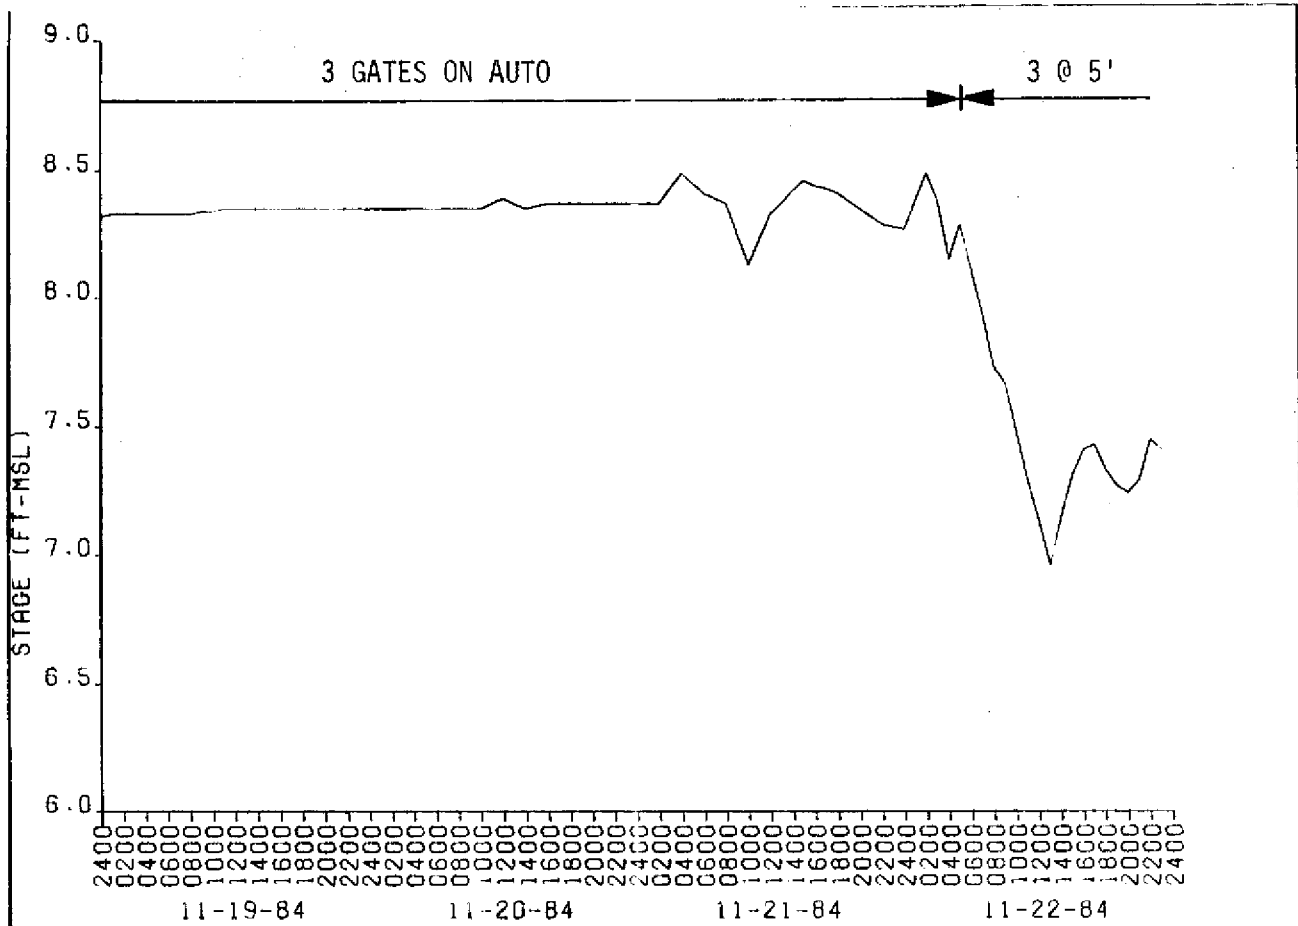
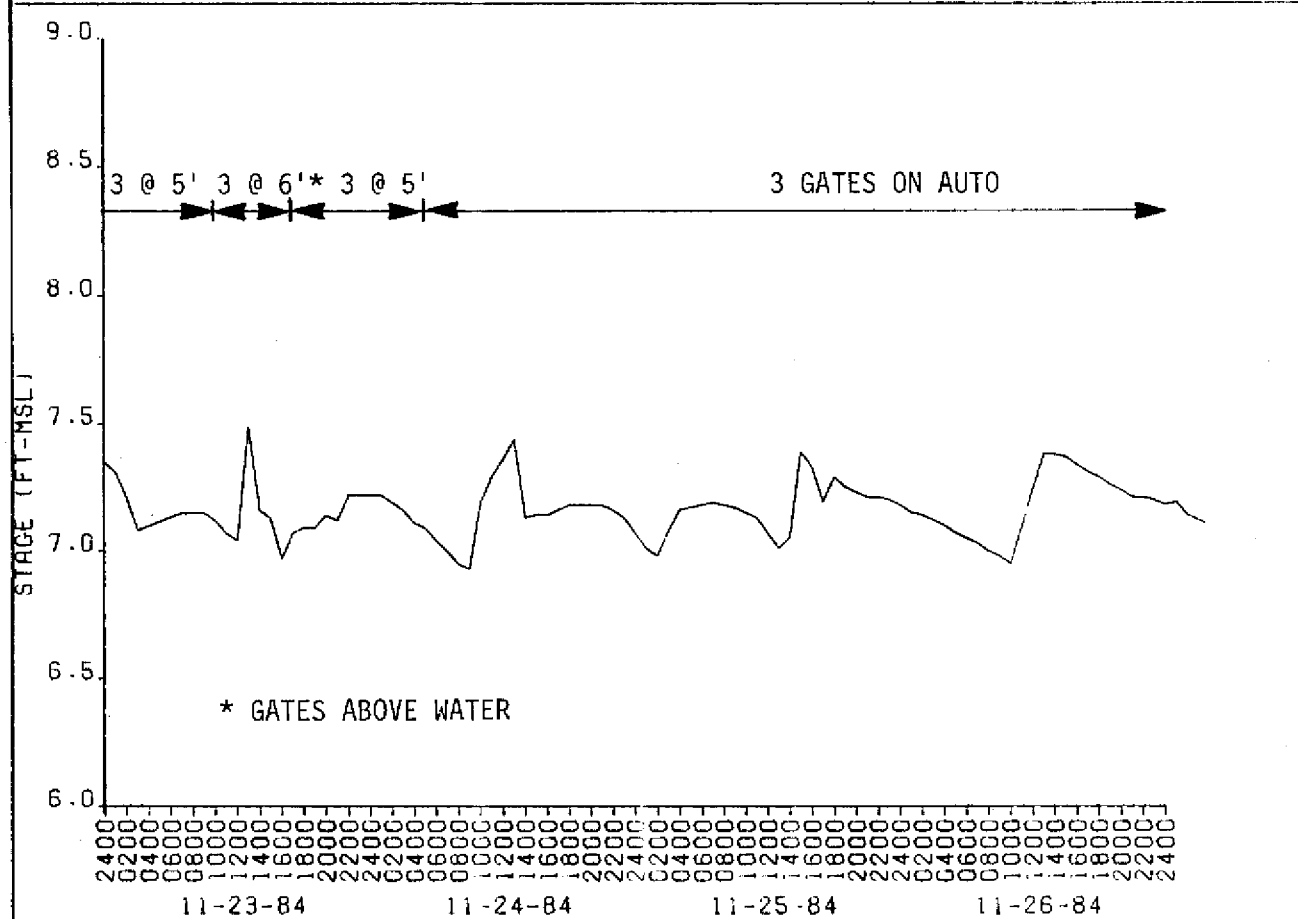
FIG. 8 HOURLY STAGE READINGS AT S-155HW

The headwater stage was between 8.0 to 8.5 ft above mean sea level. After the storm started, the stage was lowered to 7.0 ft msl to facilitate the inflow from the West Palm Beach Canal basin. The details of the operation are presented in Table 4. The stage at the headwater of S-155 reached 8.49 ft at 2 a.m. on November 22, 1984. The hourly stage hydrograph with gate operations is presented in Figure 8.

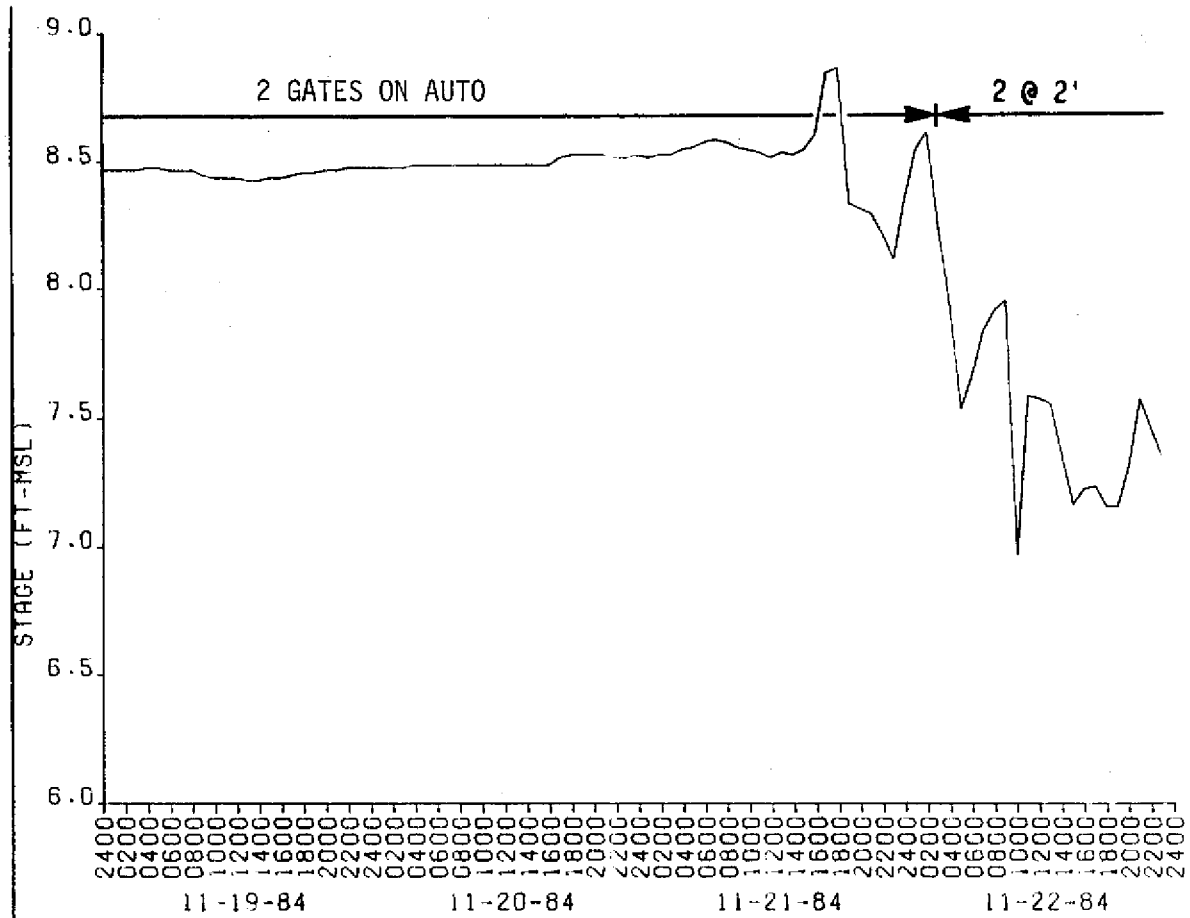
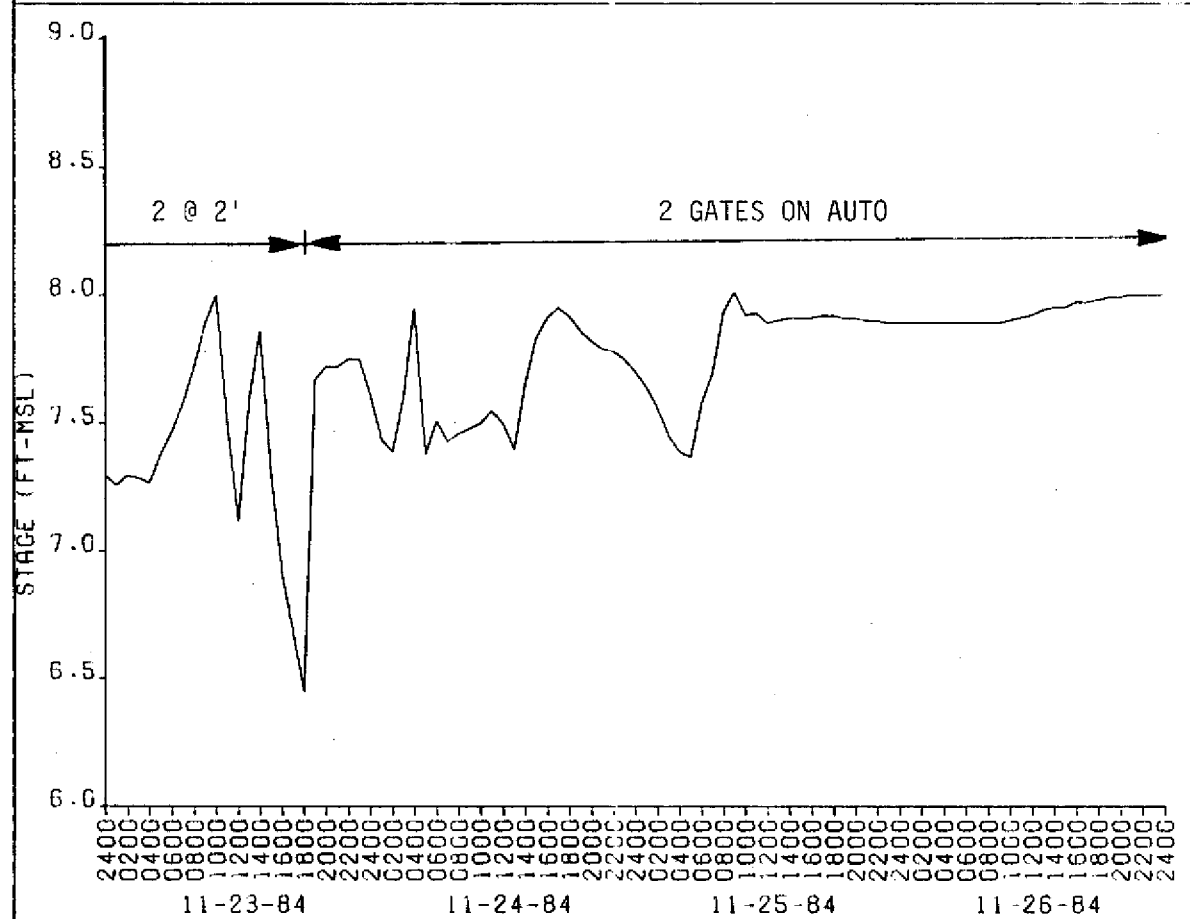
FIG. 9 HOURLY STAGE READINGS AT S-41HW

This structure is a reinforced concrete gated spillway with two automatically controlled gates. This structure maintains and drains the C-16 basin which covers the area of Boynton Beach, Lake Worth, Lantana, Hypoluxo, Atlantis, etc., due to the fact that this basin is interconnected with the C-51 and C-15 basins; therefore, the same gate operating criterions as for S-155 are applied to this structure. The headwater stage was lowered to between 7.5 and 8.0 ft msl during this storm period from a normal range of 7.9 ft to 8.80 ft msl. Figure 9 shows the hourly stage hydrograph at the headwater of S-41 during this storm.

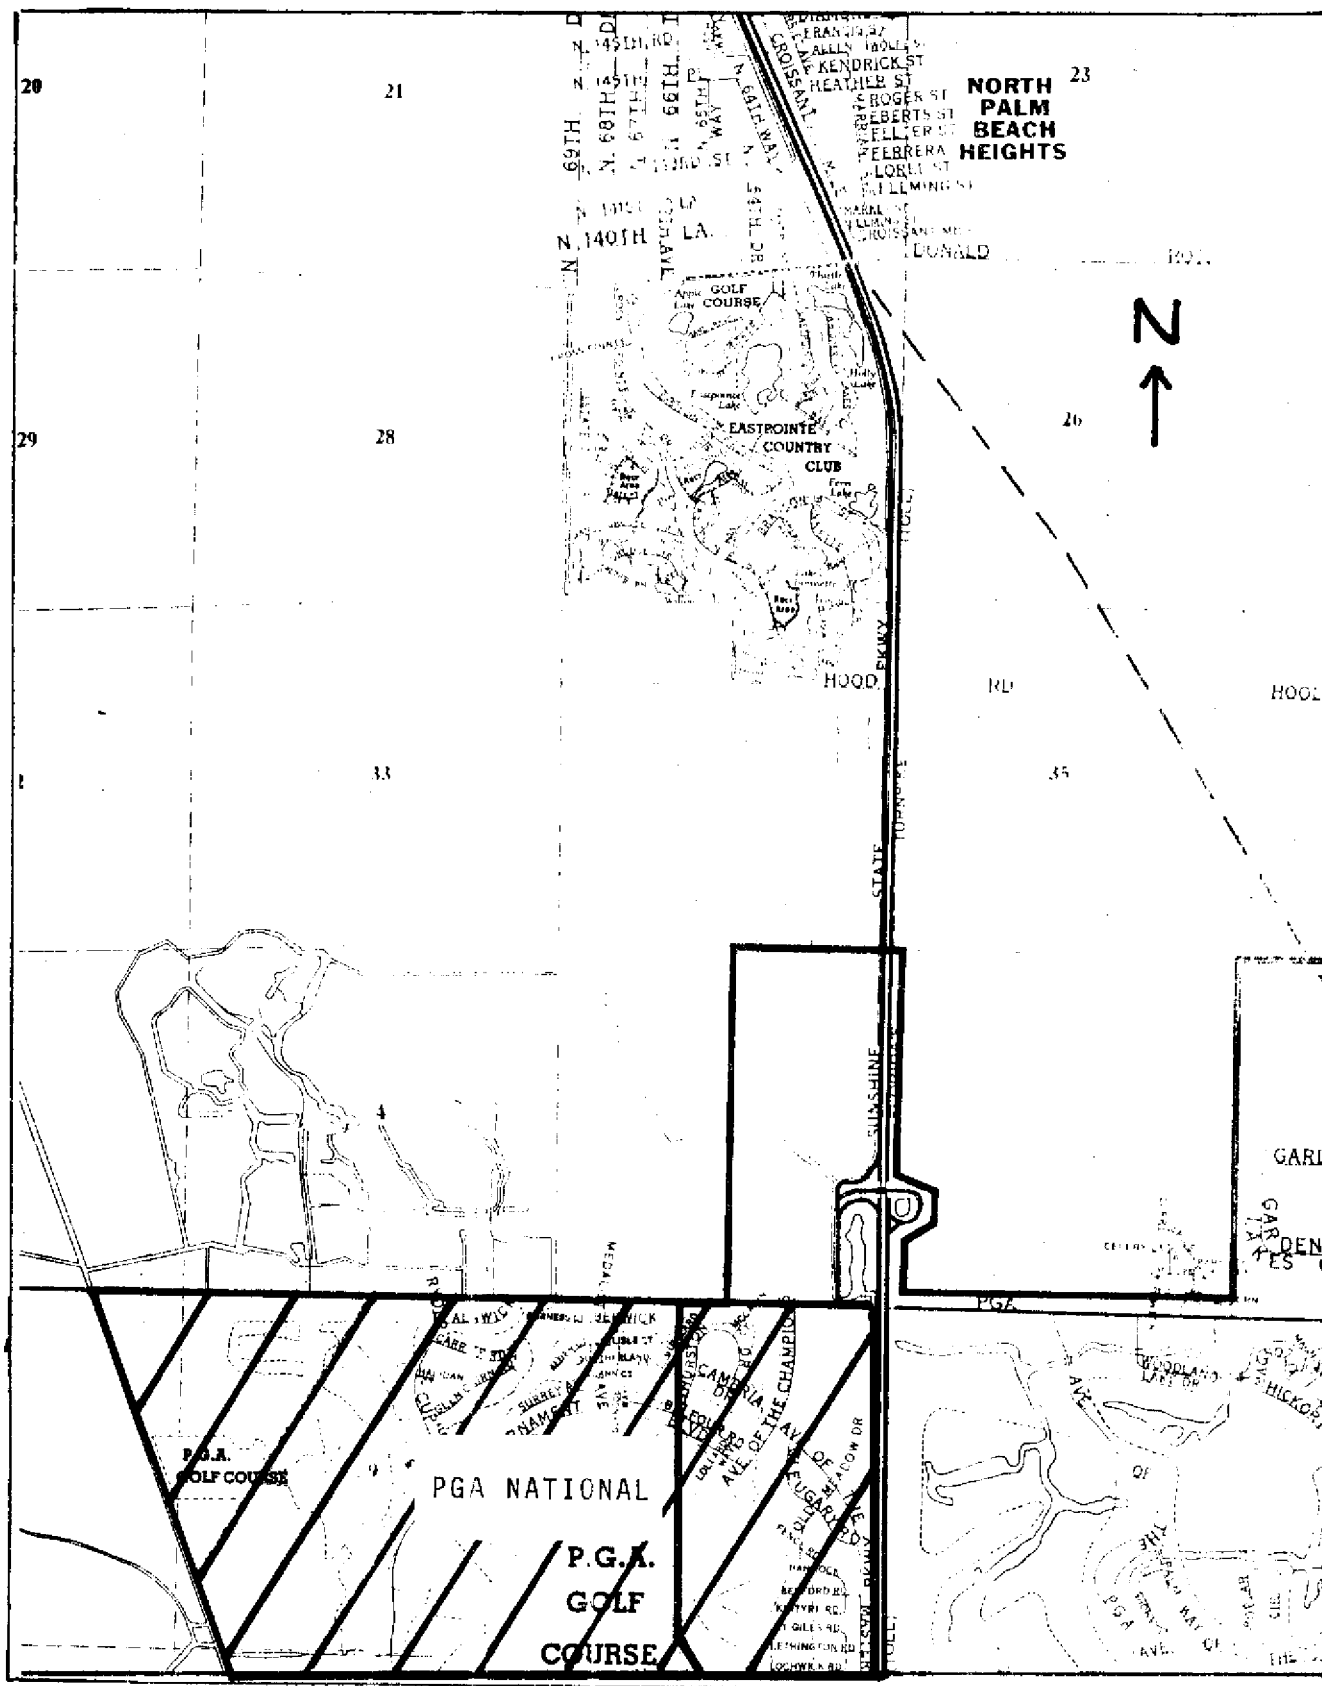
FIGURE 15 LOCATION OF PGA NATIONAL

### PGA National (Figure 15)

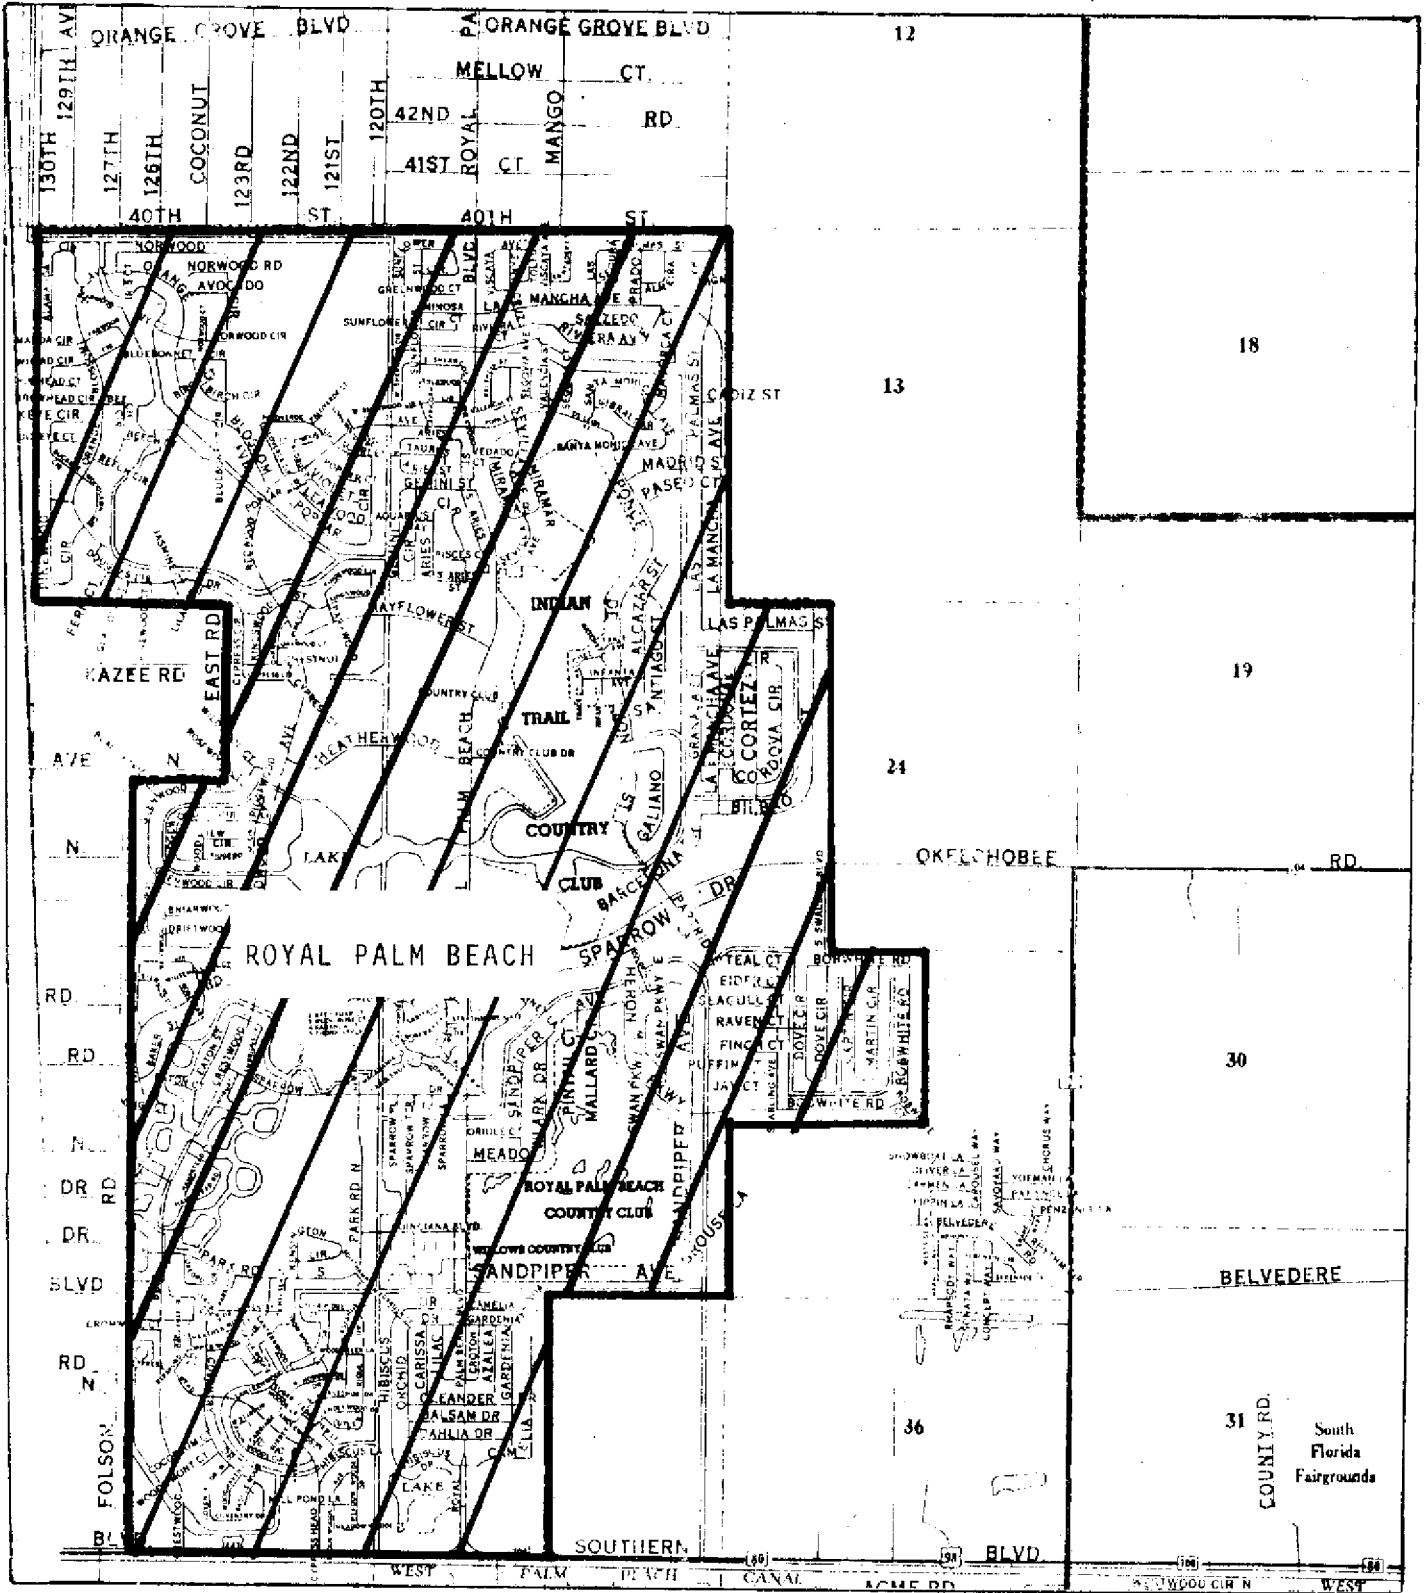
FIGURE 16 LOCATION OF ROYAL PALM BEACH

This area is located west of SR-7 and north of SR-80. This community was inspected during the afternoon of November 23. Some minor yard and street flooding was observed. The stage in the M-1 Canal of the Indian Trail Water Control District was 3 to 4 feet higher than the stage in C-51 at the Amil gate, the main outlet of Royal Palm Beach Village.

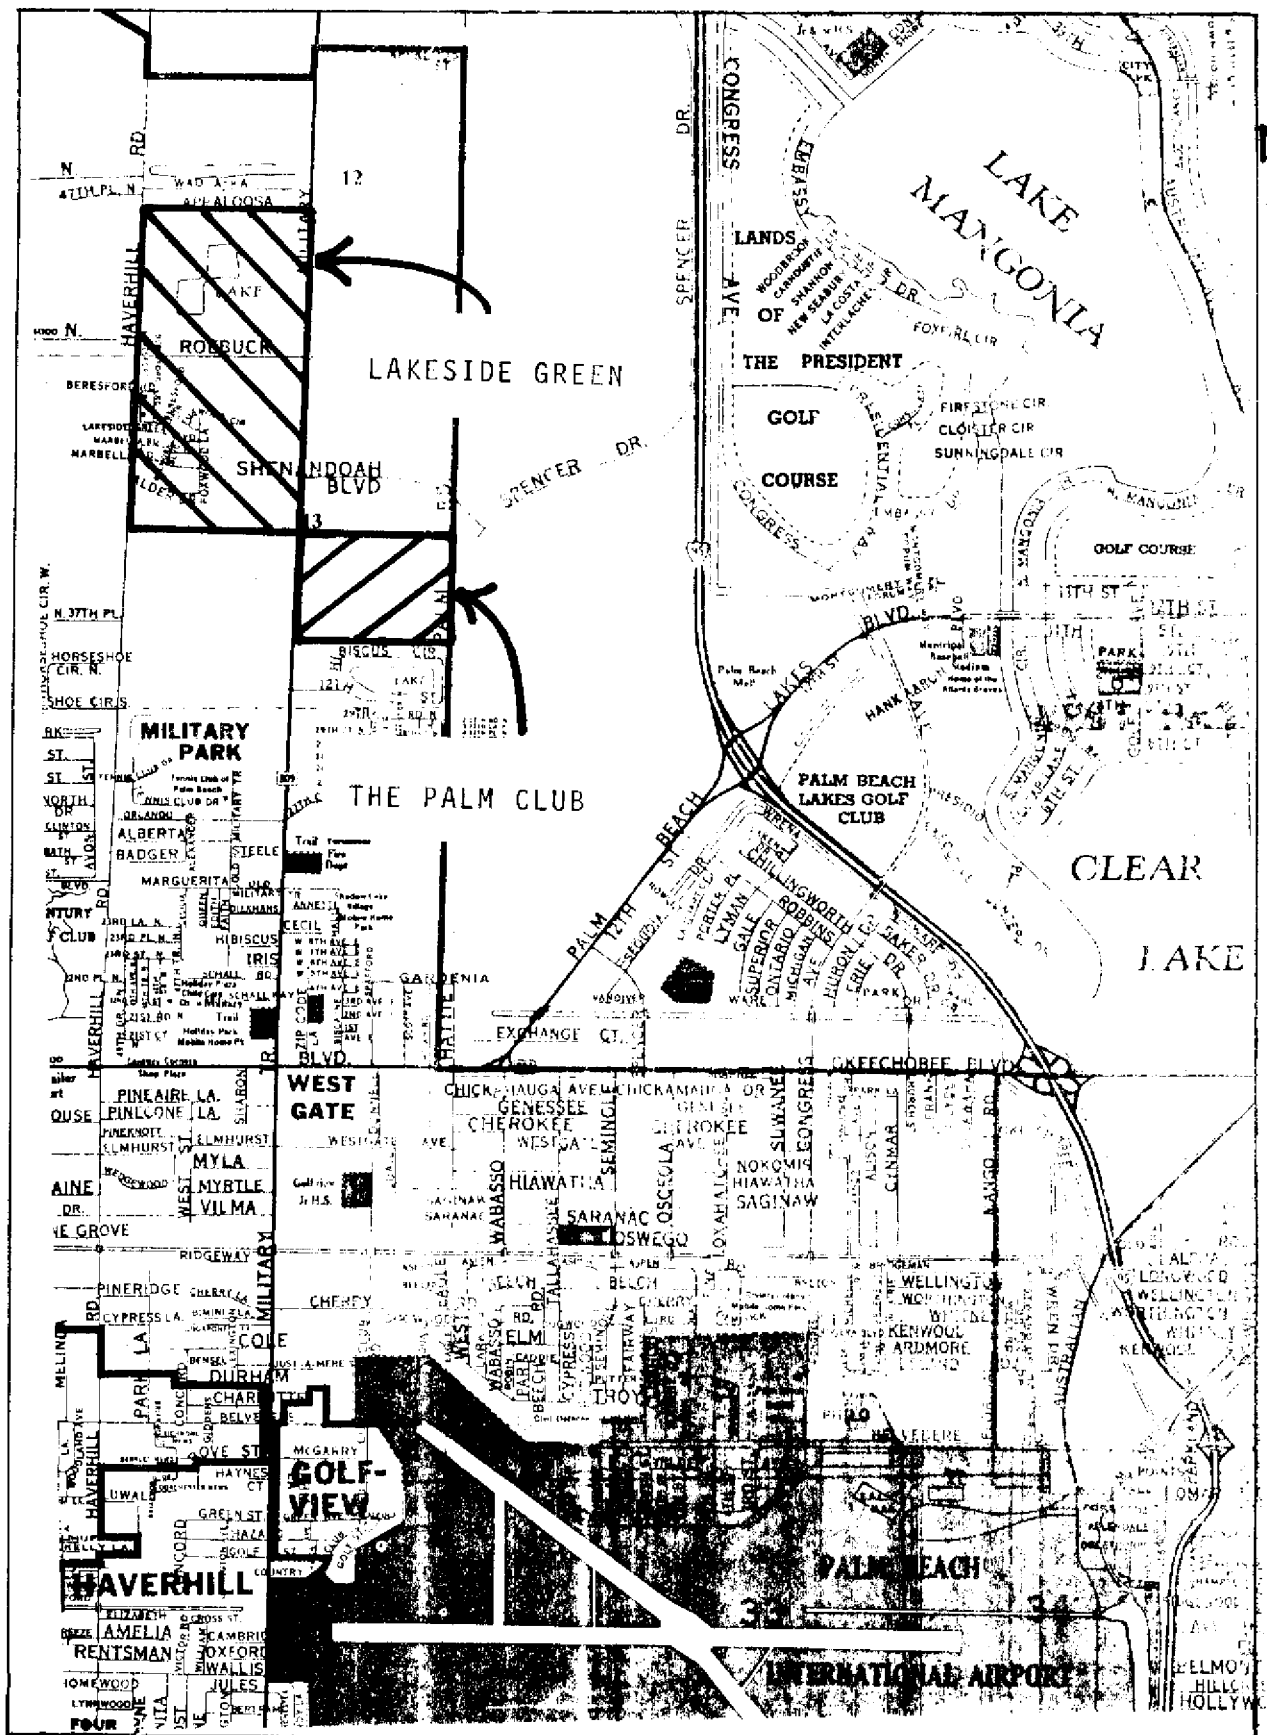
FIGURE 17 LOCATION OF LAKESIDE GREEN AND THE PALM CLUB

This development is located east of Military Trail, north of Okeechobee Boulevard. It was inspected on the afternoon of November 23. Street flooding was evident. Several vehicles had water in them. Ingress and egress from the development was hazardous. The retention areas were over their banks. No homes were flooded. The water control structure for the project appeared to be impacted by the stage in northern Palm Beach County WCD canal "EPB 11-S", which is the receiving body for the project.

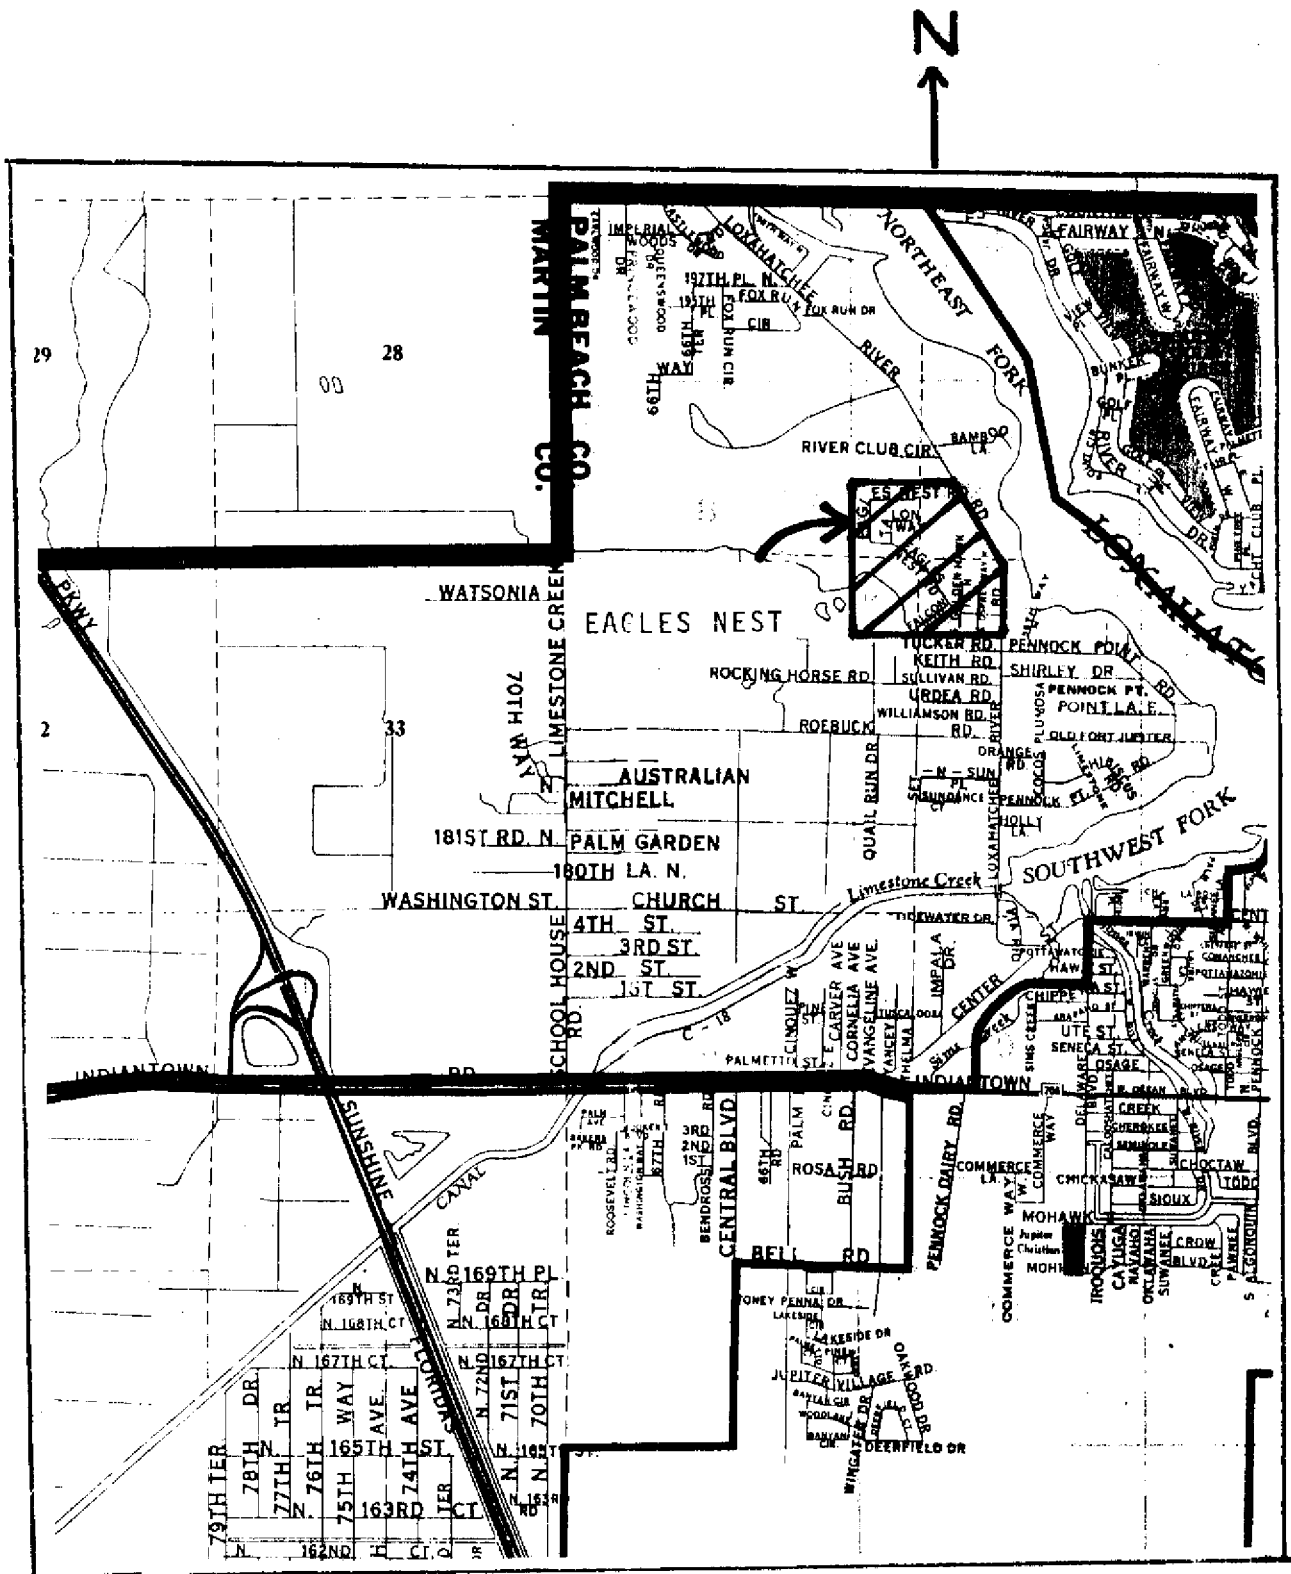
FIGURE 19 LOCATION OF EAGLES NEST

This development is about 2 miles south of the Town of Jupiter, west of Military Trail. At the time of inspection (November 23), the retention area had equalized with its outfall. Street flooding was observed in two locations.
