STORM EVENT OF OCTOBER 8-10, 1991

December 1991

**South Florida Water Management District
West Palm Beach, FL**

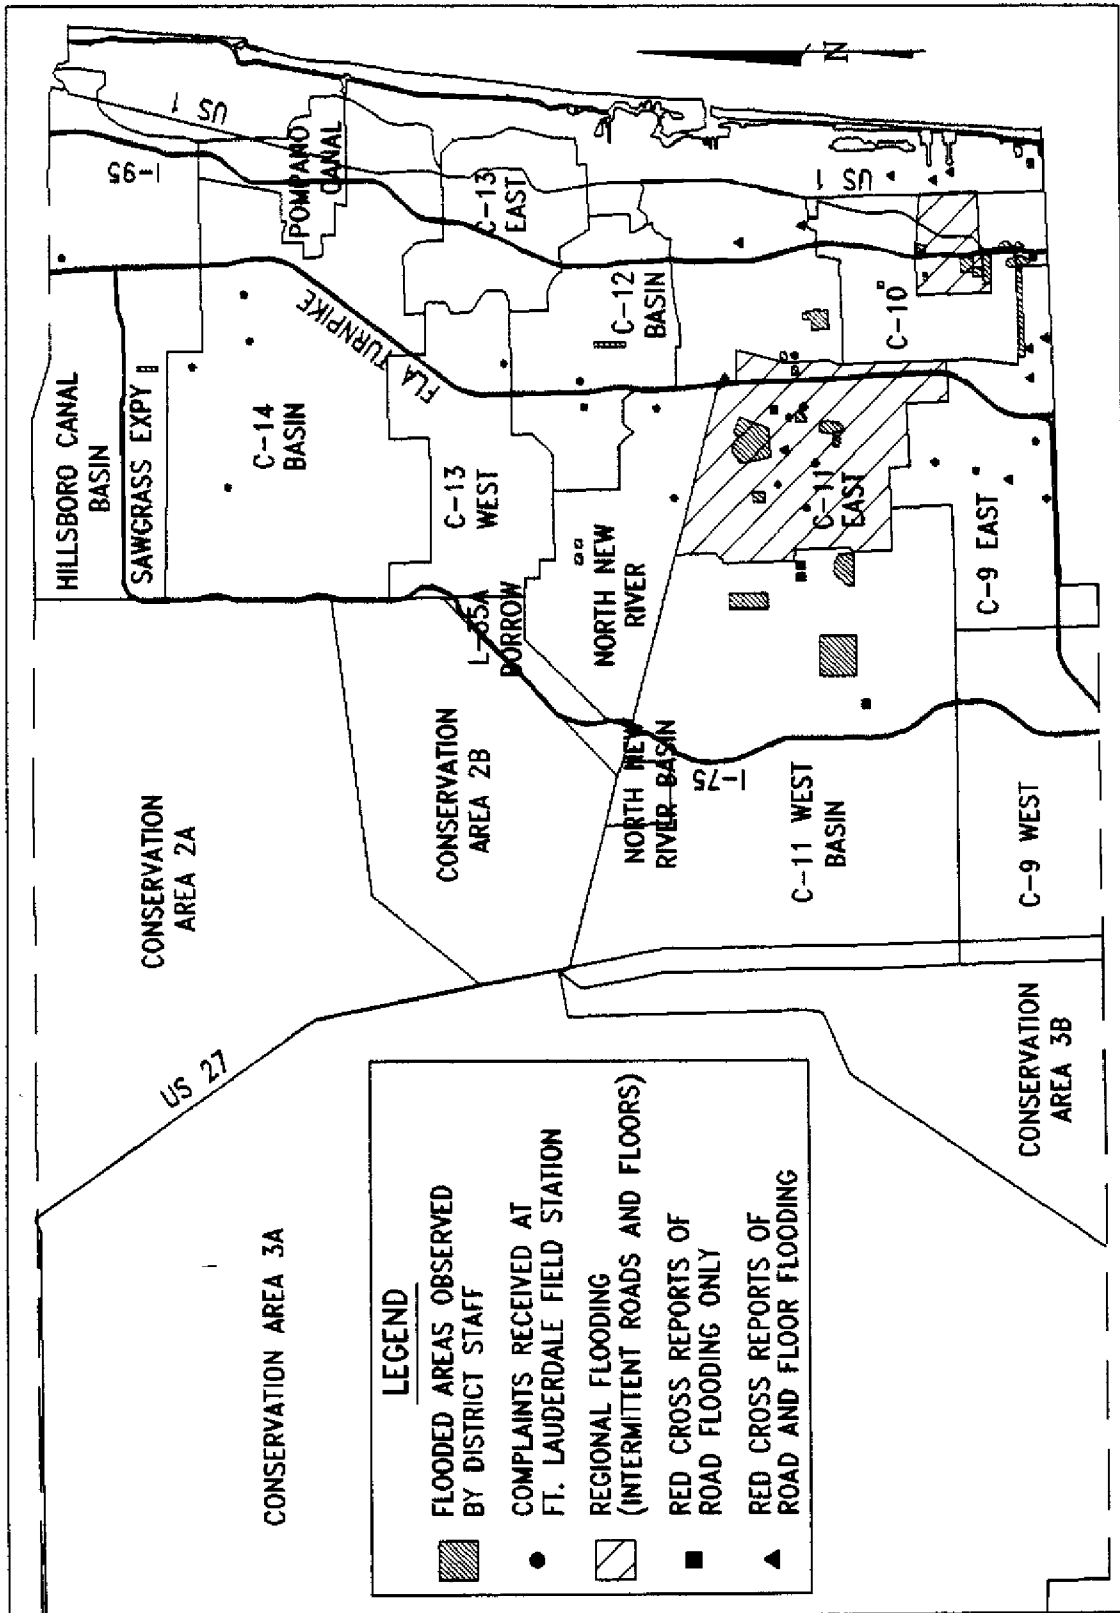
Figure C-1. Areas of Observed and Reported Flooding in Broward County

- a. Nova High School/University: Maintenance buildings and green houses were flooded [1].
- b. Emerald Isles Apartments: Parking and air conditioning units flooded to 16 inches [2].
- c. Majestic Groves subdivision: Streets and yards flooded up to building foundations [3].
- d. Little Ranches: Streets flooded [4].
- e. Davie Road and 52nd Street: Streets and floors in lower areas flooded [5].
- f. Davie Road area south of Griffin Road: Streets flooded [6].
- g. Shopping Center at 441 and Griffin Road: Parking lot flooded to 20 inches [7].
- h. SW 30 St/Rolling Hills Golf Course: Streets, yards and golf course flooded from 10 to 12 inches [8].

- r. Sunshine Acres: High water caused drainfield problems [18].
- s. Sunset Strip from NW 91 Avenue to NW 96 Avenue: Street and yard flooded to 6 inches [19].
- t. Pine Island Rd./Sunset Strip intersection: Flooded to 20 inches, street closed [20].
- u. Godfrey Road at Wiles Road: Streets and paddocks flooded to 10 inches [21].
- v. Miramar Parkway east of 441: Street closed due to flooding, depth unknown [22].
- w. Broward Resource Recovery Plant: Water inside of the ash landfill breached the surrounding dike. There was no discharge of water offsite, and the breach was repaired within one day. FDER kept on top of this [23].
- x. NW 39 Avenue from 4 Court to Seventh Street: Streets and yards flooded to 12 inches. Homes flooded to 4 inches [24].
