# 2000 JUNO PIER MONITORING REPORT

## Volume II - Lighting and Disorientation Report

# **2000 LIGHTING AND DISORIENTATION SURVEYS FOR SOUTH JUPITER AND JUNO BEACH INCLUDING THE JUNO BEACH FISHING PIER**

**Palm Beach County  
Department of Environmental  
Resources Management (ERM)**

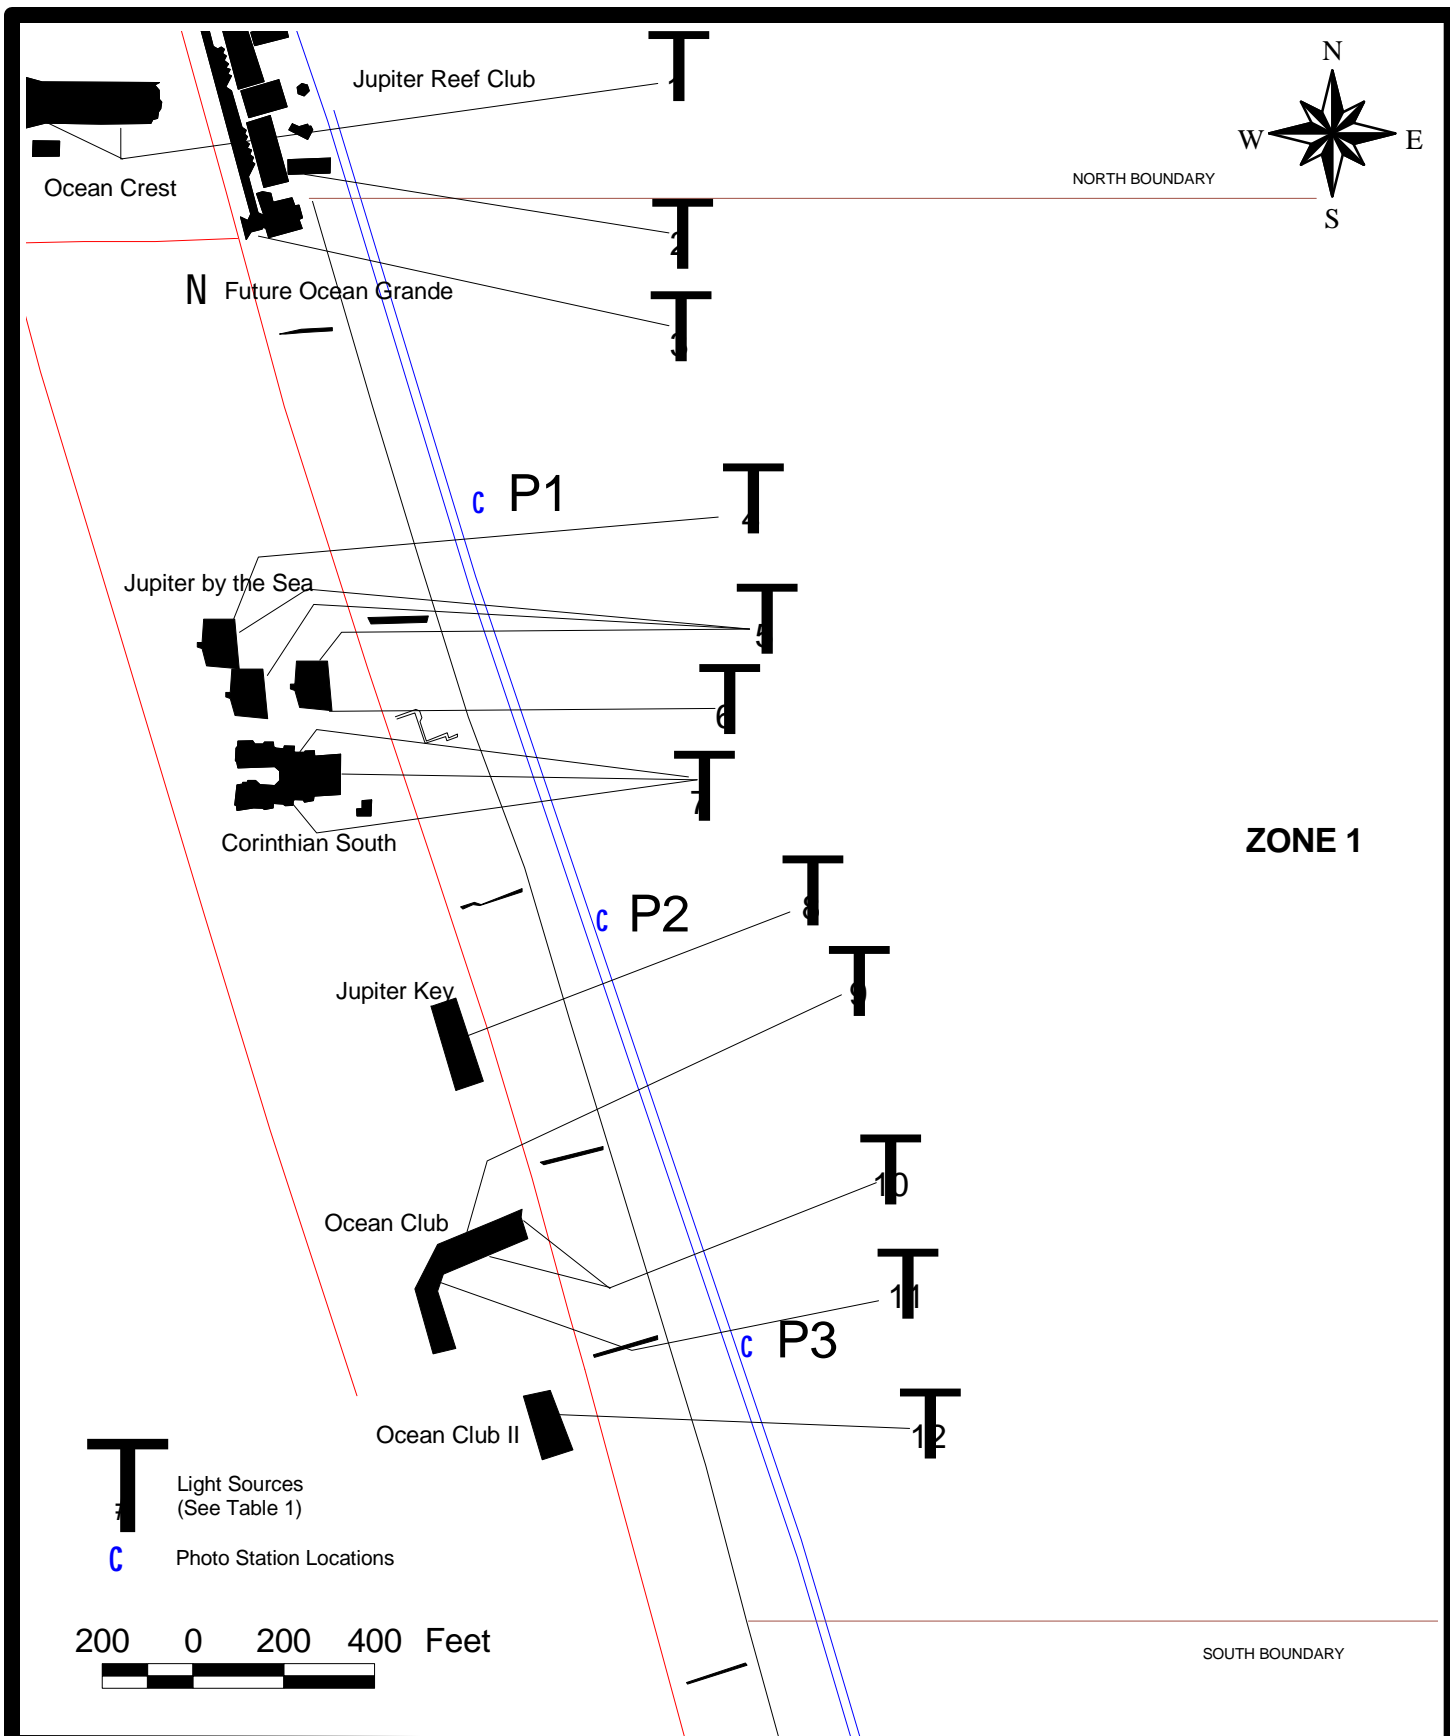
FIGURE 2.  
 LOCATIONS OF PHOTOSTATIONS AND LIGHT SOURCES.  
 ZONE 1, 2000

In the pier study area (Zones 1, 4, 5 and 8), approximately ninety light sources were visible from the beach (Table 1). The number of light sources visible from the beach was greatest in Zone 5 (n=46), followed by Zones 1 (n=22), 4 (n=15) and 8 (n=7) (Table 3). Figures 2, 5, 6 and 9 show the locations of the lights listed in Table 1. These data differ from 1999 results, which revealed that Zone 1 (n=28) had the greatest number of lights, followed by Zones 4 (n=22), 8 (n=6) and 5 (n=5).

The indirect glow observed on Ocean Crest (west of A1A) was exposed partially as a result of seagrape trimming activities conducted by the Town of Jupiter last year (prior to the 1999 survey and again in 2000) for most of the dunes in MLC Zones 1, 3 and 4. The seagrapes were lowered from 10-15' heights to 6-10' heights with considerable understory trimming at select locations. During 2000, one nest was disoriented in the northern end of Zone 1, resulting in approximately 30 disoriented hatchlings (Table 4). It is unclear from the information recorded on the disorientation report as to whether the Jupiter Reef Club parking lot lights or the glow on Ocean Crest that contributed to these disorientations.

The indirect glow observed at Jupiter by the Sea and Corinthian South was minimal relative to the direct interior lights, which were also identified as a problem the previous two year's surveys. The interior lights at Jupiter Key were only barely visible over the dune and were not visible from ground level.
