STORMWATER MASTER PLAN UPDATE #2

*Prepared for
Town of Miami Lakes, Florida*

*Prepared by
Kimley-Horn and Associates, Inc.*

April 2012
044533166

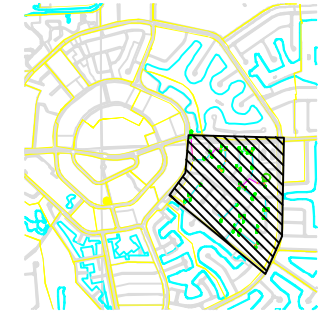
FIGURE 6
1 of 5

AREA 1 PROPOSED MODIFICATIONS

- ADD 1 MANHOLE
 - ADD 2 CATCH BASINS
 - ADD 40 LF OF 18" PIPE
 - ADD 200 LF OF 18" FRENCH DRAIN
- AREA 2 PROPOSED MODIFICATIONS**
- REPLACE 1 EXIST. C.B. W/ WEIR STRUCTURE
 - ADD 4 MANHOLE
 - ADD 6 CATCH BASINS
 - ADD 200 LF OF 18" PIPE
 - ADD 1000 LF OF 18" FRENCH DRAIN
- AREA 10 PROPOSED MODIFICATIONS**
- REPLACE 1 EXIST. C.B. W/ WEIR STRUCTURE
 - ADD 4 MANHOLE
 - ADD 7 CATCH BASINS
 - ADD 120 LF OF 18" PIPE
 - ADD 600 LF OF 18" FRENCH DRAIN

SUMMARY OF PROPOSED MODIFICATIONS

- REPLACE 2 EXIST. C.B. W/ WEIR STRUCTURE
- ADD 9 MANHOLE
- ADD 15 CATCH BASINS
- ADD 360 LF OF 18" PIPE
- ADD 1800 LF OF 18" FRENCH DRAIN

Existing and Future Conditions: Figure 6 shows existing conditions for the Lake Martha Sub-basin. The sub-basin consists of approximately 78.2 acres of existing detached single family development with approximately 11,000 linear feet of roadway including Dade Pine Avenue, Palmetto Palm Avenue, Mahogany Court, Maple Terrace, Cedar Court, Willow Lane, Bottle Brush Lane, Cassia Place, Queen Palm Terrace, Parkinsonia Drive, Orchid Drive and Tabuia Lane. The existing drainage system in this sub-basin consists of catch basins discharging either to Lake Martha or isolated sections of underground exfiltration trench. Roadside swales also provide some water quality pre-treatment and storage of roadway run-off. KHA observed several areas of flooding extending to the centerline of road within this sub-basin. The location of these deficiencies can be seen in Figure 6.

Recommended Drainage Improvements: Clean and flush all sediment and debris from existing catch basins and pipes and adjust catch basin elevations and locations to minimize accumulation of sediment and debris. Install the additional infrastructure depicted in Figure 6. Existing catch basins should be modified or reconstructed as required to provide sediment traps (sumps). Additional catch basins/ manholes, culverts and exfiltration trench are recommended to be constructed to interconnect the catch basins. Exfiltration trench and a new outfall to Lake Hilda are recommended to provide positive drainage. The outfall can be constructed in road right-of-way and cross through the park at the southeast corner of Ludlam Road and Miami Lakes Drive. The final catch basin prior to the outfall should be a control structure catch basin with a weir, pollution retardant baffle and a sedimentation sump.

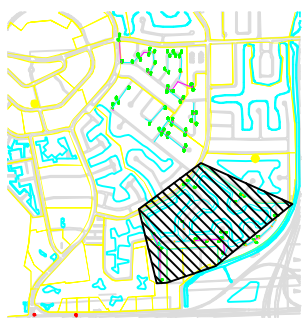
FIGURE 7
 2 of 4

- AREA 2 PROPOSED MODIFICATIONS**
- REPLACE 1 EXIST. C.B. W/ WEIR STRUCTURE
 - ADD 4 MANHOLE
 - ADD 5 CATCH BASINS
 - ADD 900 LF OF 18" PIPE
 - ADD 380 LF OF 18" FRENCH DRAIN
- AREA 3 PROPOSED MODIFICATIONS**
- REPLACE 1 EXIST. C.B. W/ WEIR STRUCTURE
 - ADD 1 MANHOLE
 - ADD 1 CATCH BASIN
 - ADD 150 LF OF 18" FRENCH DRAIN
- AREA 7 PROPOSED MODIFICATIONS**
- ADD 2 MANHOLE
 - ADD 2 CATCH BASINS
 - ADD 30 LF OF 18" PIPE
 - ADD 110 LF OF 18" FRENCH DRAIN

- SUMMARY OF PROPOSED MODIFICATIONS**
- REPLACE 2 EXIST. C.B. W/ WEIR STRUCTURE
 - ADD 7 MANHOLE
 - ADD 8 CATCH BASINS
 - ADD 930 LF OF 18" PIPE
 - ADD 640 LF OF 18" FRENCH DRAIN

Existing and Future Conditions: Figure 7 shows existing conditions for the Lake Martha Sub-basin. The sub-basin consists of approximately 69.1 acres of existing detached single family development with approximately 6,300 linear feet of roadway including Twin Sabal Drive, Sabal Drive, Poinciana Court and Leaning Pine Drive. The existing drainage system in this sub-basin consists of catch basins discharging either to Lake Sarah or to the smaller lake located northwest of Lake Sarah. Roadside swales and exfiltration trenches provide some water quality pre-treatment and storage of roadway run-off. KHA observed several areas of flooding extending to the centerline of road within this sub-basin. The location of these deficiencies can be seen in Figure 7.

Recommended Drainage Improvements: Clean and flush all sediment and debris from existing catch basins and pipes and adjust catch basin elevations and locations to minimize accumulation of sediment and debris. Install the additional infrastructure depicted in Figure 7. Existing catch basins should be modified or reconstructed as required to provide sediment traps (sumps). Based on the observed ponding, the existing drainage system appears to be under sized and does not appear to have sufficient capacity to meet the performance goals. Additional exfiltration trench is recommended to provide additional storage prior to positive drainage. The final catch basin prior to each outfall should be a control structure catch basin with a weir, pollution retardant baffle and a sedimentation sump.

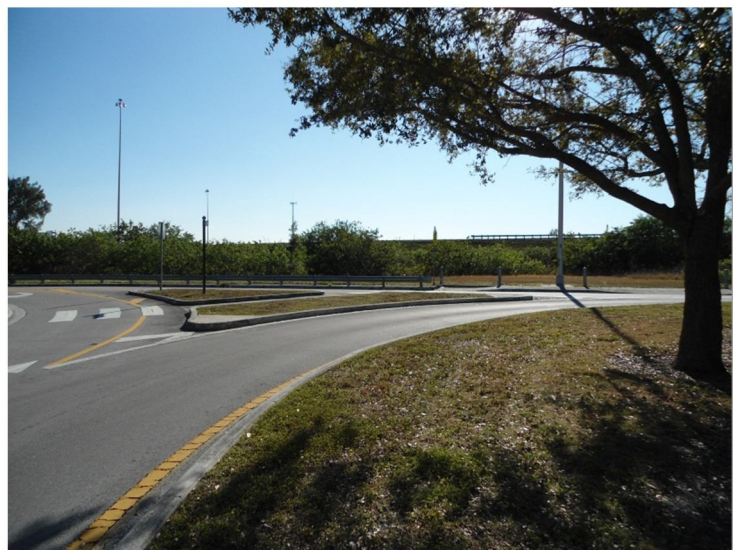
FIGURE 8
1 of 3

- REPLACE 8 EXIST. C.B.
- ADD 10 MANHOLES
- ADD 1 CONTROL STRUCTURE
- ADD 525 LF OF 15" PIPE
- ADD 625 LF OF 48" PIPE
- ADD 465 LF OF 48" FRENCH DRAIN
- ADD 685 LF OF 54" PIPE
- ADD 560 LF OF 54" FRENCH DRAIN

- AREA 1 PROPOSED MODIFICATIONS**
- REPLACE 2 EXIST. C.B.
 - ADD 2 MANHOLES
 - ADD 1 CONTROL STRUCTURE
 - ADD 100 LF OF 15" PIPE
 - ADD 300 LF OF 54" PIPE
 - ADD 255 LF OF 54" FRENCH DRAIN

- AREA 2 PROPOSED MODIFICATIONS**
- REPLACE 2 EXIST. C.B.
 - ADD 2 MANHOLES
 - ADD 100 LF OF 15" PIPE
 - ADD 385 LF OF 54" PIPE
 - ADD 305 LF OF 54" FRENCH DRAIN

- AREA 3 PROPOSED MODIFICATIONS**
- REPLACE 2 EXIST. C.B.
 - ADD 3 MANHOLES
 - ADD 150 LF OF 15" PIPE
 - ADD 375 LF OF 48" PIPE
 - ADD 270 LF OF 48" FRENCH DRAIN

- AREA 4 PROPOSED MODIFICATIONS**
- REPLACE 2 EXIST. C.B.
 - ADD 3 MANHOLES
 - ADD 175 LF OF 15" PIPE
 - ADD 250 LF OF 48" PIPE
 - ADD 195 LF OF 48" FRENCH DRAIN

**TOWN OF MIAMI LAKES
STORMWATER MASTER PLAN
WEST LAKES A SUB-BASIN**

Existing and Future Conditions: Figure 8 shows existing conditions for West Lakes A. The sub-basin consists of approximately 10.60 acres of four-lane road right-of-way with approximately 4,800 linear feet of roadway. The drainage system in this sub-basin consists of isolated catch basins connected to exfiltration trenches.

Recommended Drainage Improvements: Clean and flush all sediment and debris from existing catch basins and pipes and adjust catch basin elevations and locations to minimize accumulation of sediment and debris. Install the additional infrastructure depicted in Figure 8. Existing catch basins should be modified or reconstructed as required to provide sediment traps (sumps). In addition, additional French drain, catch basins, and/or manholes are proposed to provide water quality and water quantity treatment. The West Lakes A, B, C, D and E sub-basins are proposed be connected to the Graham Dairy Canal located south of West Lakes A. It is recommended that design phase for West Lakes A, B, C, D and E improvements be completed simultaneously so that the potential for a joint outfall can be explored as one of the key design alternatives for this area. Coordination with and approval from Miami-Dade County will be required for connection to the Graham Dairy Canal. The outfall and related control structure should be sized to accommodate flow from the entire area of the Town located south of NW 154th Street and west of NW 87th Avenue.

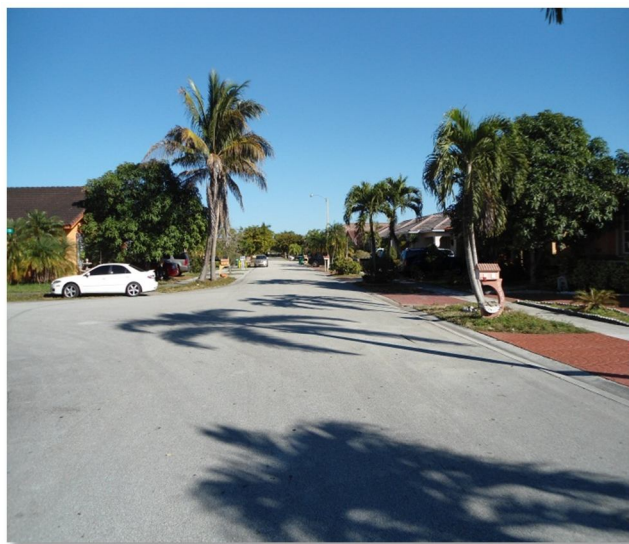
FIGURE 9
1 of 3

- AREA 1 PROPOSED MODIFICATIONS**
- REPLACE 2 EXIST. C.B.
 - ADD 2 MANHOLES
 - ADD 180 LF OF 15" PIPE
 - ADD 340 LF OF 30" PIPE
 - ADD 90 LF OF 30" FRENCH DRAIN
- AREA 2 PROPOSED MODIFICATIONS**
- REPLACE 2 EXIST. C.B.
 - ADD 1 MANHOLES
 - ADD 275 LF OF 15" PIPE
 - ADD 75 LF OF 15" FRENCH DRAIN

- AREA 3 PROPOSED MODIFICATIONS**
- REPLACE 2 EXIST. C.B.
 - ADD 1 MANHOLES
 - ADD 275 LF OF 15" PIPE
 - ADD 75 LF OF 15" FRENCH DRAIN
- AREA 4 PROPOSED MODIFICATIONS**
- REPLACE 2 EXIST. C.B.
 - ADD 1 MANHOLES
 - ADD 160 LF OF 15" PIPE
 - ADD 75 LF OF 15" FRENCH DRAIN

**TOWN OF MIAMI LAKES
STORMWATER MASTER PLAN
WEST LAKES B
SUB-BASIN**

Existing and Future Conditions: Figure 9 shows existing conditions for West Lakes B. The sub-basin consists of approximately 27.9 acres of single family residential development with approximately 7,600 linear feet of roadway. The drainage system in this sub-basin consists of isolated catch basins connected to exfiltration trenches.

Recommended Drainage Improvements: Clean and flush all sediment and debris from existing catch basins and pipes and adjust catch basin elevations and locations to minimize accumulation of sediment and debris. Install the additional infrastructure depicted in Figure 9. Existing catch basins should be modified or reconstructed as required to provide sediment traps (sumps). In addition, additional French drain, catch basins, and/or manholes are proposed to provide water quality and water quantity treatment. The West Lakes A, B, C, D and E sub-basins are proposed be connected to the Graham Dairy Canal located south of West Lakes A. It is recommended that design phase for West Lakes A, B, C, D and E improvements be completed simultaneously so that the potential for a joint outfall can be explored as one of the design alternatives. The outfall and related control structure should be sized to accommodate flow from the entire West Lakes area.

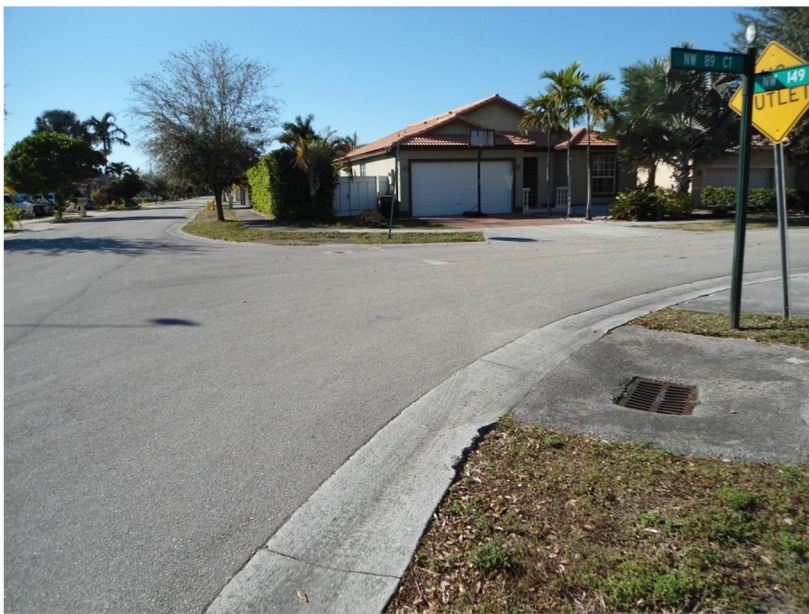
FIGURE 10

- AREA 4 PROPOSED MODIFICATIONS**
- REPLACE 6 EXIST. C.B.
 - ADD 1 MANHOLES
 - ADD 400 LF OF 15" PIPE
 - ADD 155 LF OF 15" FRENCH DRAIN

- AREA 5 PROPOSED MODIFICATIONS**
- REPLACE 6 EXIST. C.B.
 - ADD 1 MANHOLES
 - ADD 575 LF OF 15" PIPE
 - ADD 65 LF OF 15" FRENCH DRAIN

**TOWN OF MIAMI LAKES
STORMWATER MASTER PLAN
WEST LAKES C
SUB-BASIN**

Existing and Future Conditions: Figure 10 shows existing conditions for West Lakes C. The sub-basin consists of approximately 9.2 acres of single family residential with approximately 2,200 linear feet of roadway. The drainage system in this sub-basin consists of isolated catch basins connected to exfiltration trenches.

Recommended Drainage Improvements: Clean and flush all sediment and debris from existing catch basins and pipes and adjust catch basin elevations and locations to minimize accumulation of sediment and debris. Install the additional infrastructure depicted in Figure 10. Existing catch basins should be modified or reconstructed as required to provide sediment traps (sumps). In addition, additional French drain, catch basins, and/or manholes are proposed to provide water quality and water quantity treatment. The West Lakes A, B, C, D and E sub-basins are proposed be connected to the Graham Dairy Canal located south of West Lakes A. It is recommended that design phase for West Lakes A, B, C, D and E improvements be completed simultaneously so that the potential for a joint outfall can be explored as one of the design alternatives. The outfall and related control structure should be sized to accommodate flow from the entire area of the Town located south of NW 154th Street and west of NW 87th Avenue.

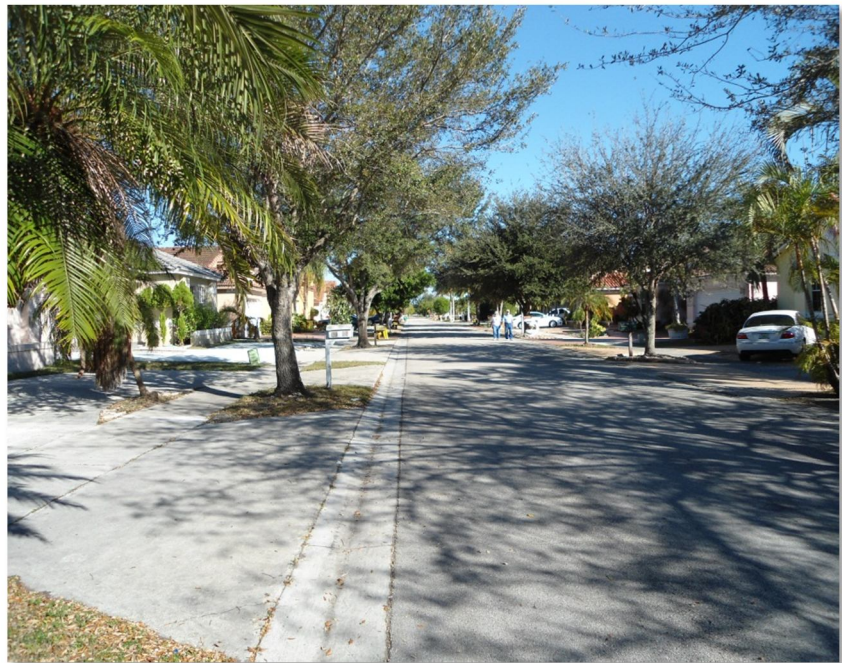
AREA 1 PROPOSED MODIFICATIONS

- REPLACE 2 EXIST. C.B.
- ADD 2 MANHOLES
- ADD 230 LF OF 15" PIPE
- ADD 100 LF OF 15" FRENCH DRAIN

SUMMARY OF PROPOSED MODIFICATIONS

- REPLACE 4 EXIST. C.B.
- ADD 3 MANHOLES
- ADD 770 LF OF 15" PIPE
- ADD 200 LF OF 15" FRENCH DRAIN

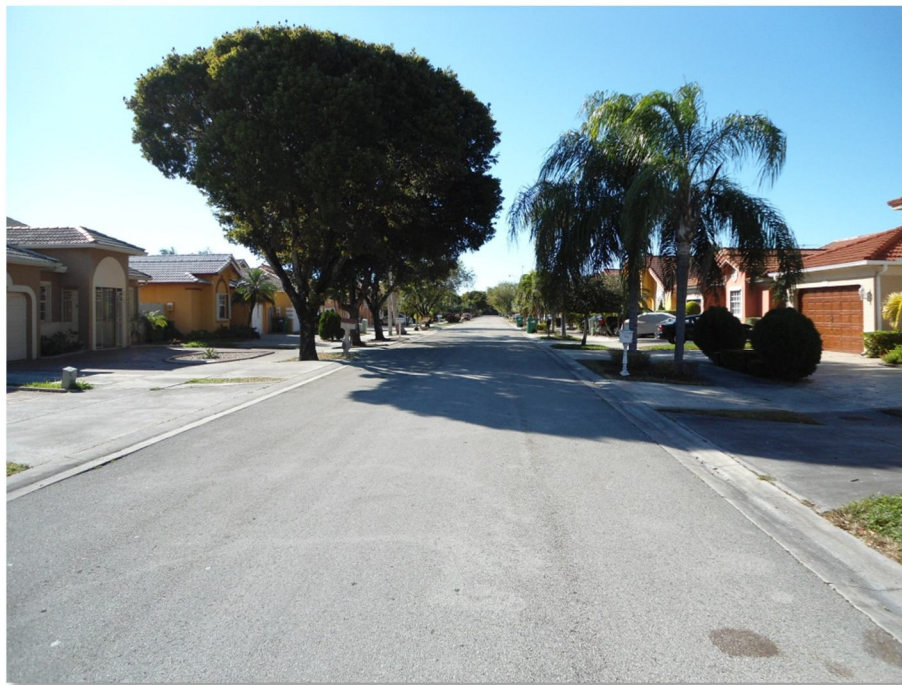
AREA 3 PROPOSED MODIFICATIONS

- ADD 1 MANHOLES
- ADD 50 LF OF 42" PIPE
- ADD 200 LF OF 42" FRENCH DRAIN

SUMMARY OF PROPOSED MODIFICATIONS

- REPLACE 7 EXIST. C.B.
- ADD 4 MANHOLES
- ADD 200 LF OF 15" PIPE
- ADD 810 LF OF 42" PIPE
- ADD 410 LF OF 42" FRENCH DRAIN

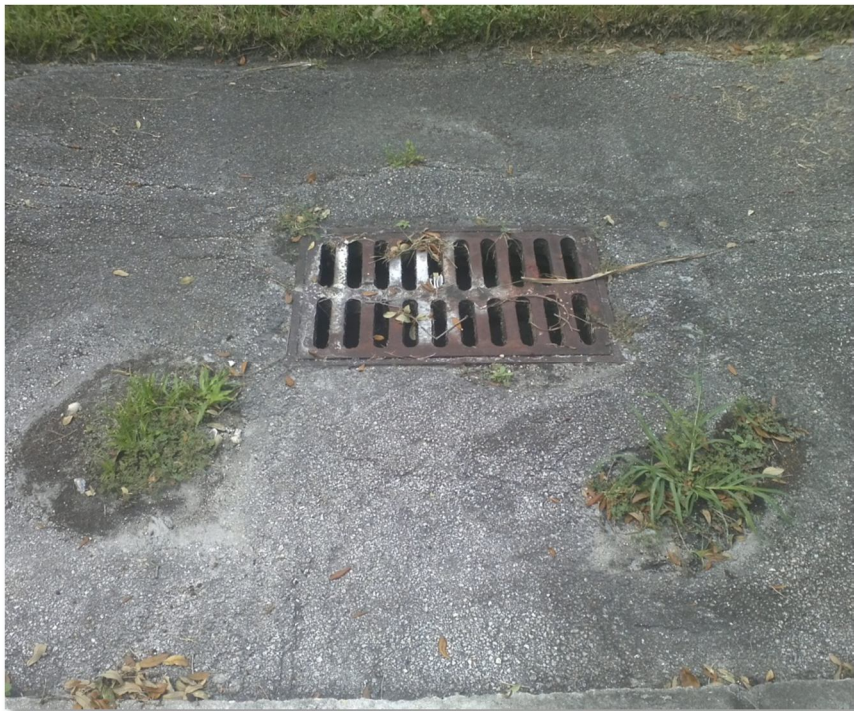
FIGURE 13

AREA 1 PROPOSED MODIFICATIONS

- REPLACE 4 EXIST. C.B.
- ADD 4 MANHOLES
- ADD 100 LF OF 18" PIPE
- ADD 620 LF OF 18" FRENCH DRAIN

Existing and Future Conditions: Figure 13 shows existing conditions for Royal Oaks A. The sub-basin consists of approximately 9.80 acres of existing detached single family development with approximately 2,200 linear feet of roadway. The drainage system in this sub-basin consists of isolated catch basins. Roadside swales also provide some water quality pre-treatment and storage of roadway run-off.

There are several unresolved resident complaints within this sub-basin. The location of these deficiencies can be seen in Figure 13. The sub-basin area was modeled together with the other sub-basins within the Royal Oaks area of the Town based on data collected as part of the stormwater master plan process.

Recommended Drainage Improvements: Clean and flush all sediment and debris from existing catch basins and pipes and adjust catch basin elevations and locations to minimize accumulation of sediment and debris. Install the additional infrastructure depicted in Figure 13. Existing catch basins should be modified or reconstructed as required to provide sediment traps (sumps). In addition, additional French drain, catch basins, and/or manholes are proposed to provide water quality and water quantity treatment. The Royal Oaks A, B, and C sub-basins could be connected to the NW 170th Street Canal located north of Royal Oaks C. For the purposes of this master plan, an outfall is not proposed. However, it is recommended that design phase for Royal Oaks A, B and C improvements be completed simultaneously so that the potential for a joint outfall can be explored as one of the design alternatives.

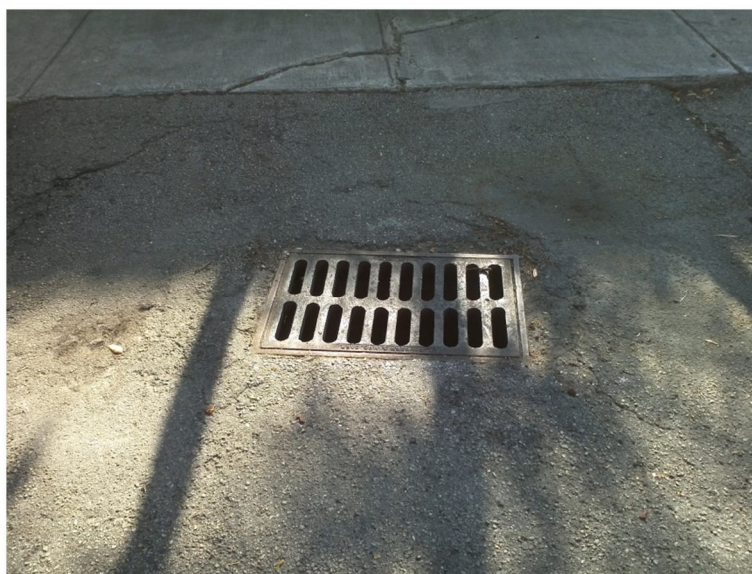
**TOWN OF MIAMI LAKES
 STORMWATER MASTER PLAN
 ROYAL OAKS B
 SUB-BASIN**

- REPLACE 12 EXIST. C.B.
- 350 SY OF ASPHALT
- ADD 17 MANHOLES
- ADD 1 CATCH BASIN
- ADD 325 LF 18" HDPE PIPE
- ADD 1265 LF 18" FRENCH DRAIN

- AREA 1 PROPOSED MODIFICATIONS**
- REPLACE 1 EXIST. C.B.
 - ADD 2 MANHOLES
 - ADD 25 LF OF 18" PIPE
 - ADD 80 LF OF 18" FRENCH DRAIN
- AREA 2 PROPOSED MODIFICATIONS**
- REPLACE 2 EXIST. C.B.
 - ADD 3 MANHOLES
 - ADD 50 LF OF 18" PIPE
 - ADD 285 LF OF 18" FRENCH DRAIN
- AREA 3 PROPOSED MODIFICATIONS**
- REPLACE 2 EXIST. C.B.
 - ADD 2 MANHOLES
 - ADD 50 LF OF 18" PIPE
 - ADD 215 LF OF 18" FRENCH DRAIN
- AREA 4 PROPOSED MODIFICATIONS**
- REPLACE 2 EXIST. C.B.
 - ADD 3 MANHOLES
 - ADD 50 LF OF 18" PIPE
 - ADD 300 LF OF 18" FRENCH DRAIN

- AREA 5 PROPOSED MODIFICATIONS**
- REPLACE 2 EXIST. C.B.
 - ADD 2 MANHOLES
 - ADD 50 LF OF 18" PIPE
 - ADD 150 LF OF 18" FRENCH DRAIN
- AREA 6 PROPOSED MODIFICATIONS**
- REPLACE 1 EXIST. C.B.
 - ADD 2 MANHOLES
 - ADD 30 LF OF 18" PIPE
 - ADD 45 LF OF 18" FRENCH DRAIN
- AREA 7 PROPOSED MODIFICATIONS**
- REPLACE 2 EXIST. C.B.
 - ADD 2 MANHOLES
 - ADD 55 LF OF 18" PIPE
 - ADD 150 LF OF 18" FRENCH DRAIN
- AREA 8 PROPOSED MODIFICATIONS**
- ADD 1 MANHOLE
 - ADD 1 CATCH BASIN
 - ADD 15 LF 18" HDPE PIPE
 - ADD 20 LF 18" FRENCH DRAIN

Existing and Future Conditions: Figure 14 shows existing conditions for Royal Oaks B. The sub-basin consists of approximately 18.7 acres of existing detached single family development with approximately 4,500 linear feet of roadway. The drainage system in this sub-basin consists of isolated catch basins. Roadside swales also provide some water quality pre-treatment and storage of roadway run-off.

There is one unresolved resident complaint within this sub-basin. The location of the deficiencies can be seen in Figure 14. The sub-basin area was modeled together with the other sub-basins within the Royal Oaks area of the Town based on data collected as part of the stormwater master plan process.

Recommended Drainage Improvements: Clean and flush all sediment and debris from existing catch basins and pipes and adjust catch basin elevations and locations to minimize accumulation of sediment and debris. Install the additional infrastructure depicted in Figure 14. Existing catch basins should be modified or reconstructed as required to provide sediment traps (sumps). In addition, additional French drain, catch basins, and/or manholes are proposed to provide water quality and water quantity treatment. The Royal Oaks A, B, and C sub-basins could be connected to the NW 170th Street Canal located north of Royal Oaks C. For the purposes of this master plan, an outfall is not proposed. However, it is recommended that design phase for Royal Oaks A, B and C improvements be completed simultaneously so that the potential for a joint outfall can be explored as one of the design alternatives.

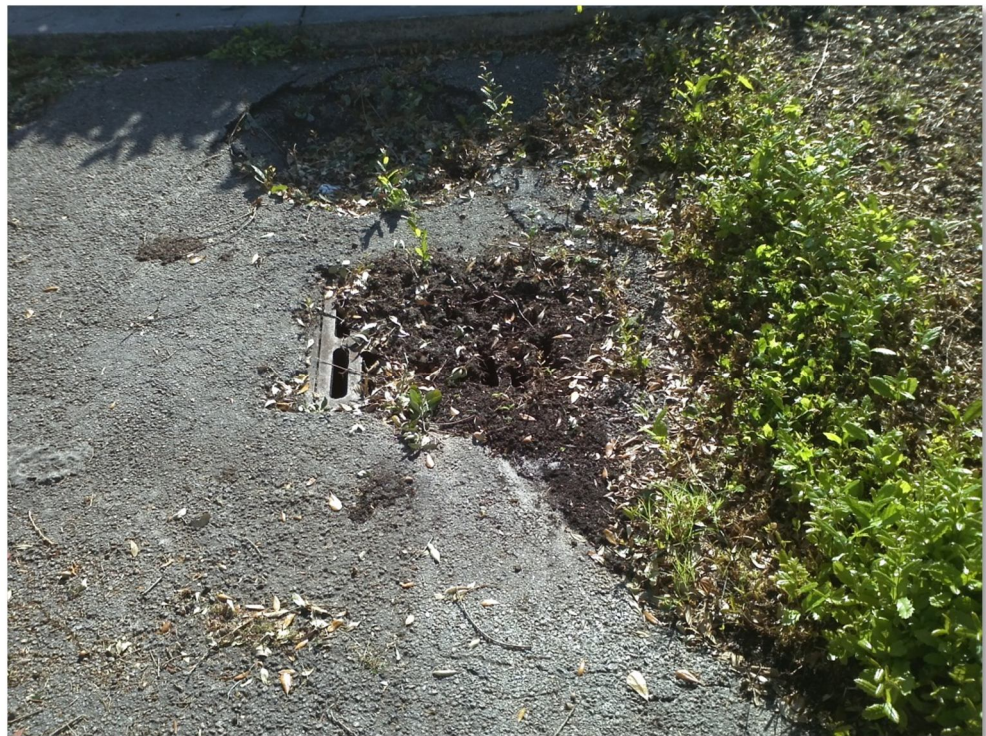
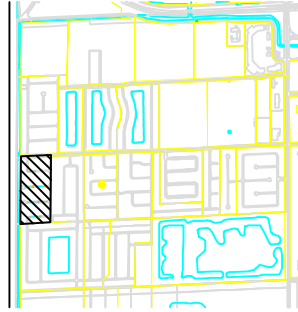
FIGURE 15

AREA 5 PROPOSED MODIFICATIONS

- ADD 3 MANHOLES
- ADD 2 CATCH BASINS
- ADD 60 LF OF 18" PIPE
- ADD 180 LF OF 18" FRENCH DRAIN

SUMMARY OF PROPOSED MODIFICATIONS

- REPLACE 10 EXIST. C.B.
- ADD 15 MANHOLES
- ADD 2 CATCH BASINS
- ADD 300 LF OF 18" PIPE
- ADD 1250 LF OF 18" FRENCH DRAIN

Existing and Future Conditions: Figure 15 shows existing conditions for Royal Oaks C. The sub-basin consists of approximately 17.3 acres of existing detached single family development with approximately 3,600 linear feet of roadway. The drainage system in this sub-basin consists of isolated catch basins. Roadside swales also provide some water quality pre-treatment and storage of roadway run-off.

There is one unresolved resident complaint within this sub-basin. The location of the deficiencies can be seen in Figure 15. The sub-basin area was modeled together with the other sub-basins within the Royal Oaks area of the Town based on data collected as part of the stormwater master plan process.

Recommended Drainage Improvements: Clean and flush all sediment and debris from existing catch basins and pipes and adjust catch basin elevations and locations to minimize accumulation of sediment and debris. Install the additional infrastructure depicted in Figure 15. Existing catch basins should be modified or reconstructed as required to provide sediment traps (sumps). In addition, additional French drain, catch basins, and/or manholes are proposed to provide water quality and water quantity treatment. The Royal Oaks A, B, and C sub-basins could be connected to the NW 170th Street Canal located north of Royal Oaks C. For the purposes of this master plan, an outfall is not proposed. However, it is recommended that design phase for Royal Oaks A, B and C improvements be completed simultaneously so that the potential for a joint outfall can be explored as one of the design alternatives.
