LAKE OKEECHOBEE WATER SUPPLY MANAGEMENT PLAN

July 1985

**Prepared By:
South Florida Water Management District**

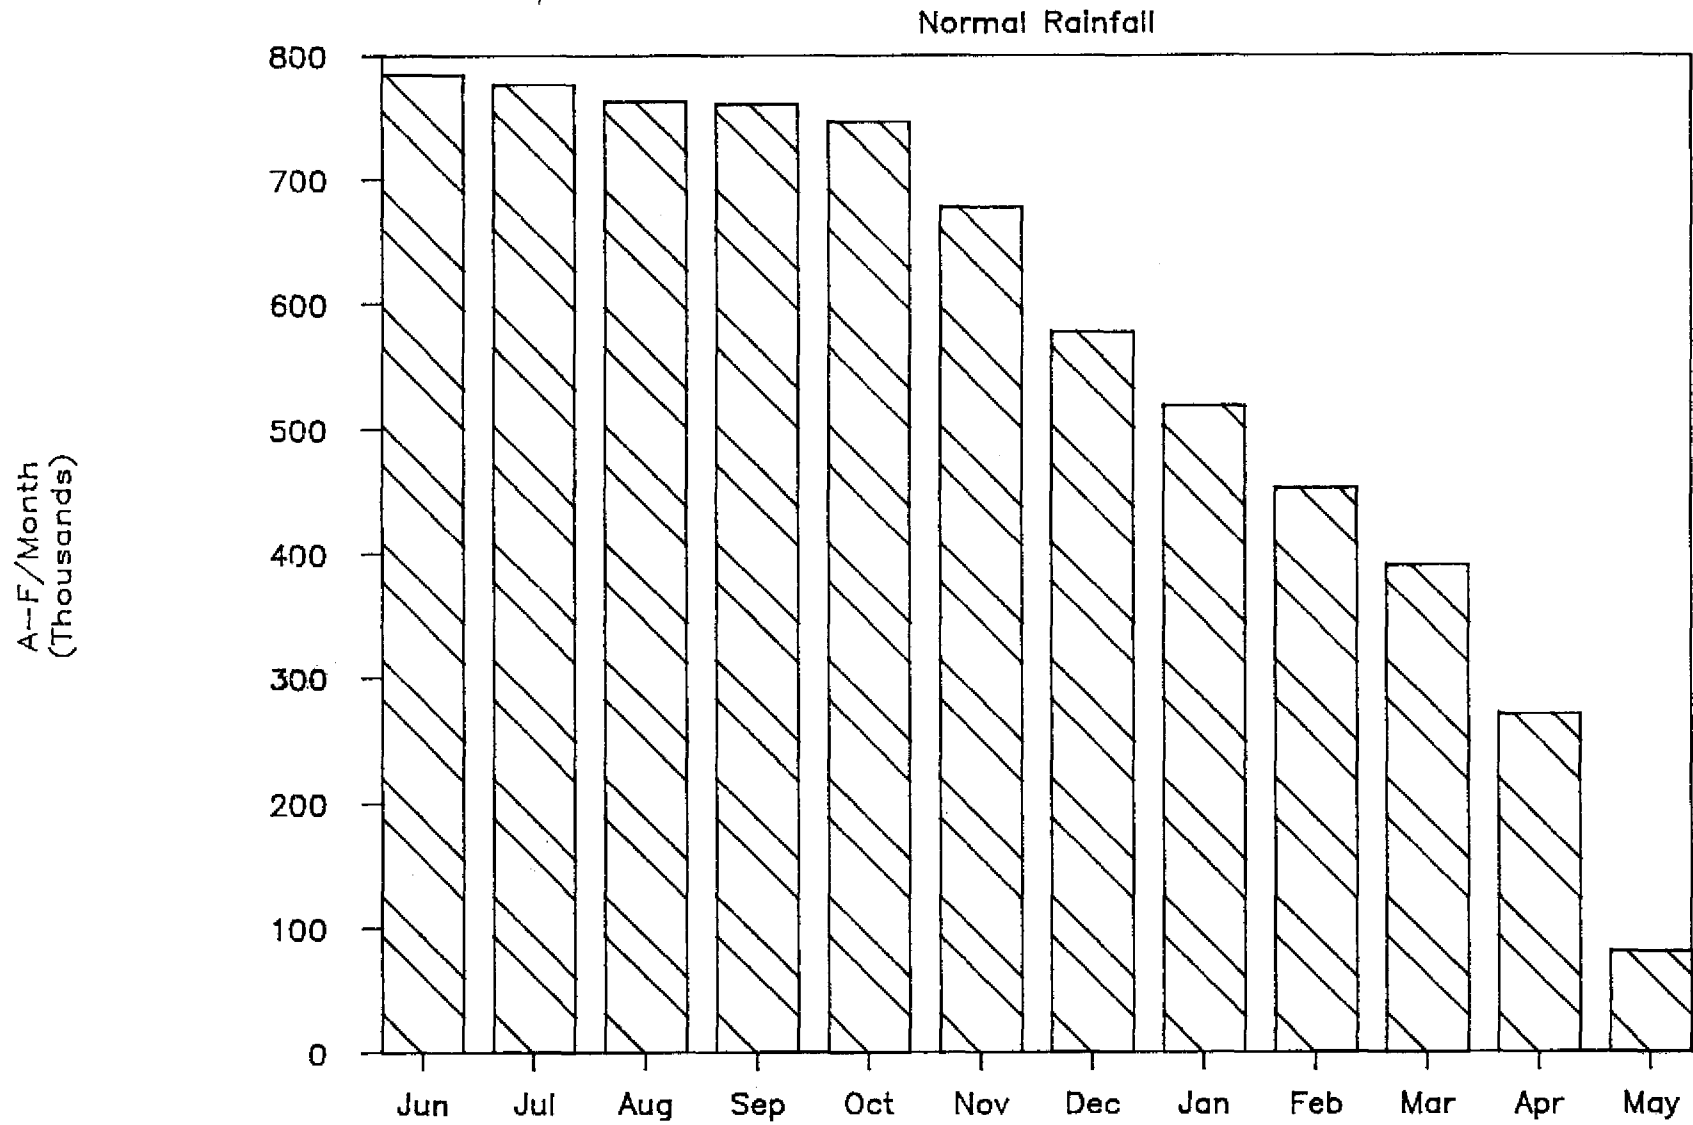
Figure 18 Lake Okeechobee Demands (Backsummed)

- 4. Backsum demands as estimated in 2 from end of dry season to desired month (TD_1).**

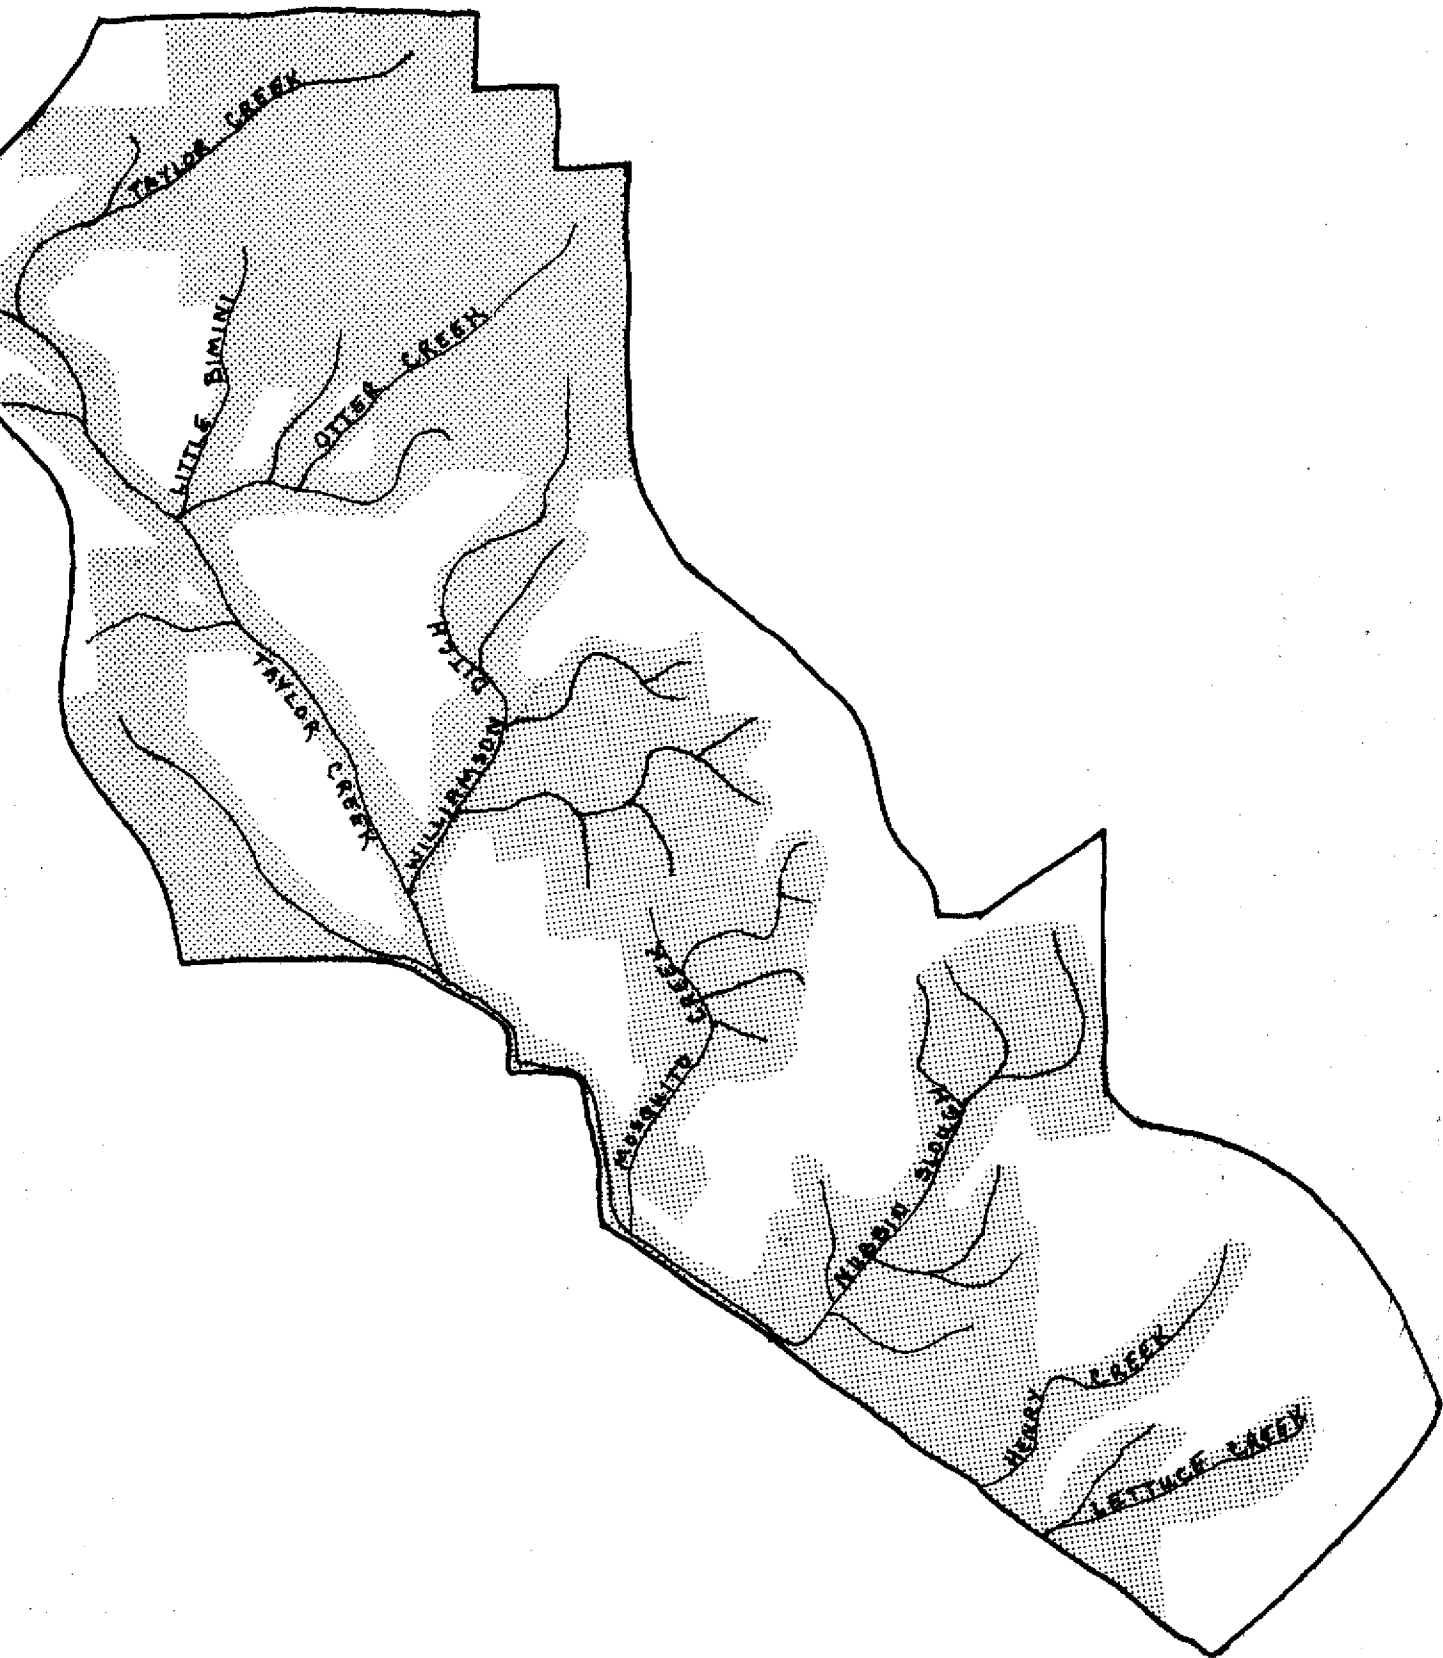
FIGURE 3. CRITICAL AREA IN TAYLOR CREEK-NUBBIN SLOUGH

critical acres under contract, and number of farms having critical acres in the watershed and the number of farms under contract. Figures 3 through 10 show the critical area in each watershed and Figures 11 through 17 show the location of contracted farms in each watershed.
