Final Report Contract RS-050962-A02

**Loaxahatchee Impoundment Landscape Assessment (LILA):
Tree Island Experiments and Management
May 1, 2005 to September 4, 2009**

Leonard J. Scinto, René Price, and Mike Ross.
Southeast Environmental Research Center and Department of Earth and Environment
Florida International University, Miami, FL 33199
(305)-348-1965 (ph), (305)-348-4096 (fax) scintol@fiu.edu

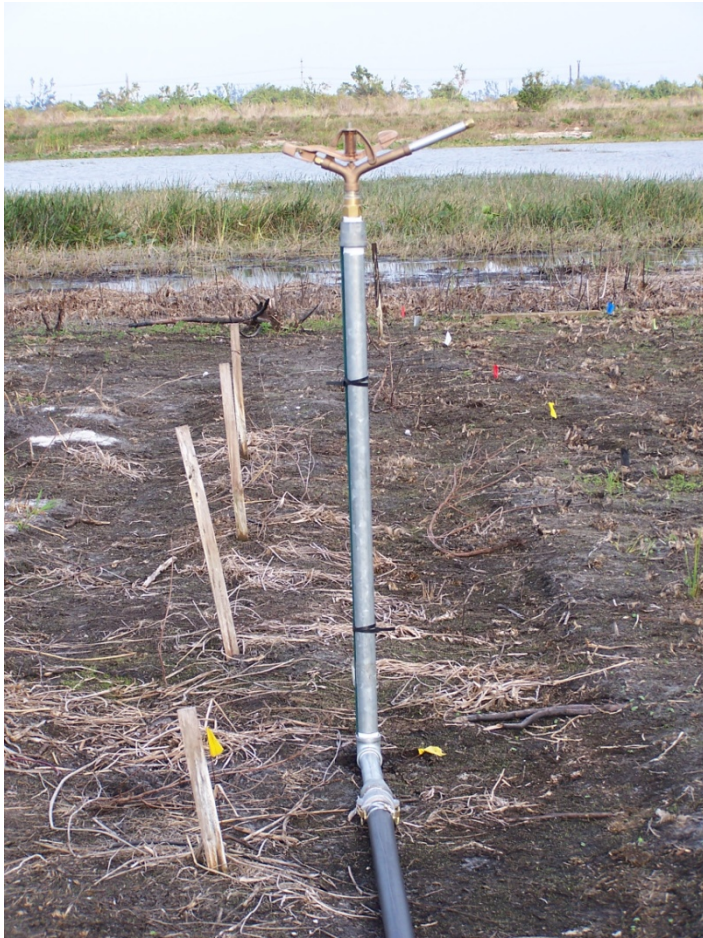
Figure 4.1 and 4.2. Irrigation system on one of the tree islands showing t-valve (top) that diverts water to each of the 2 standpipes and nozzles on each tree island (bottom) as required to partially satisfy Task 2a.

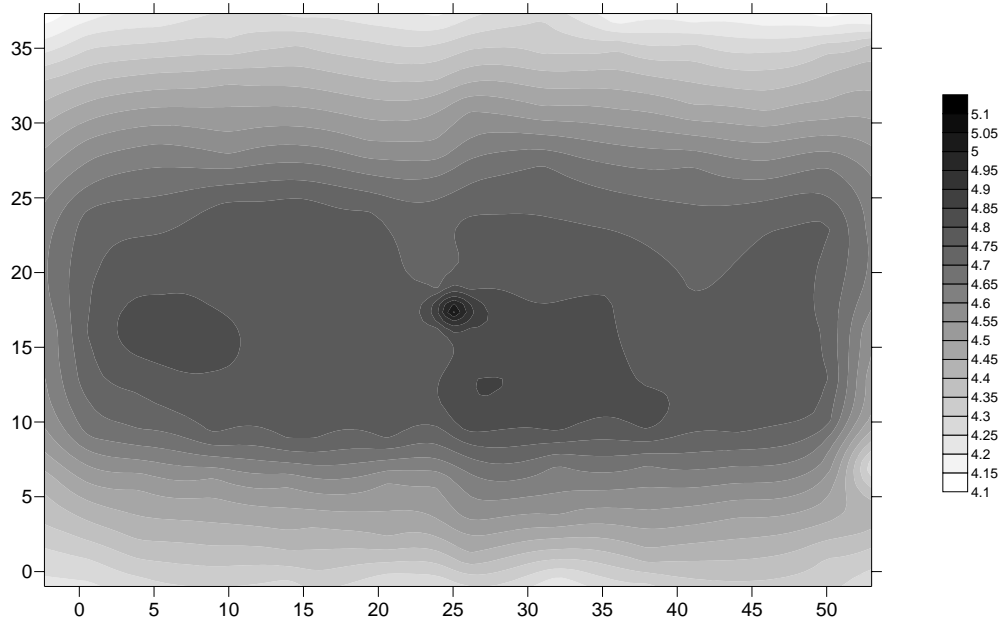
Figure 5.3. Elevation isopleths for the M2 West and M2 East tree islands in meters.

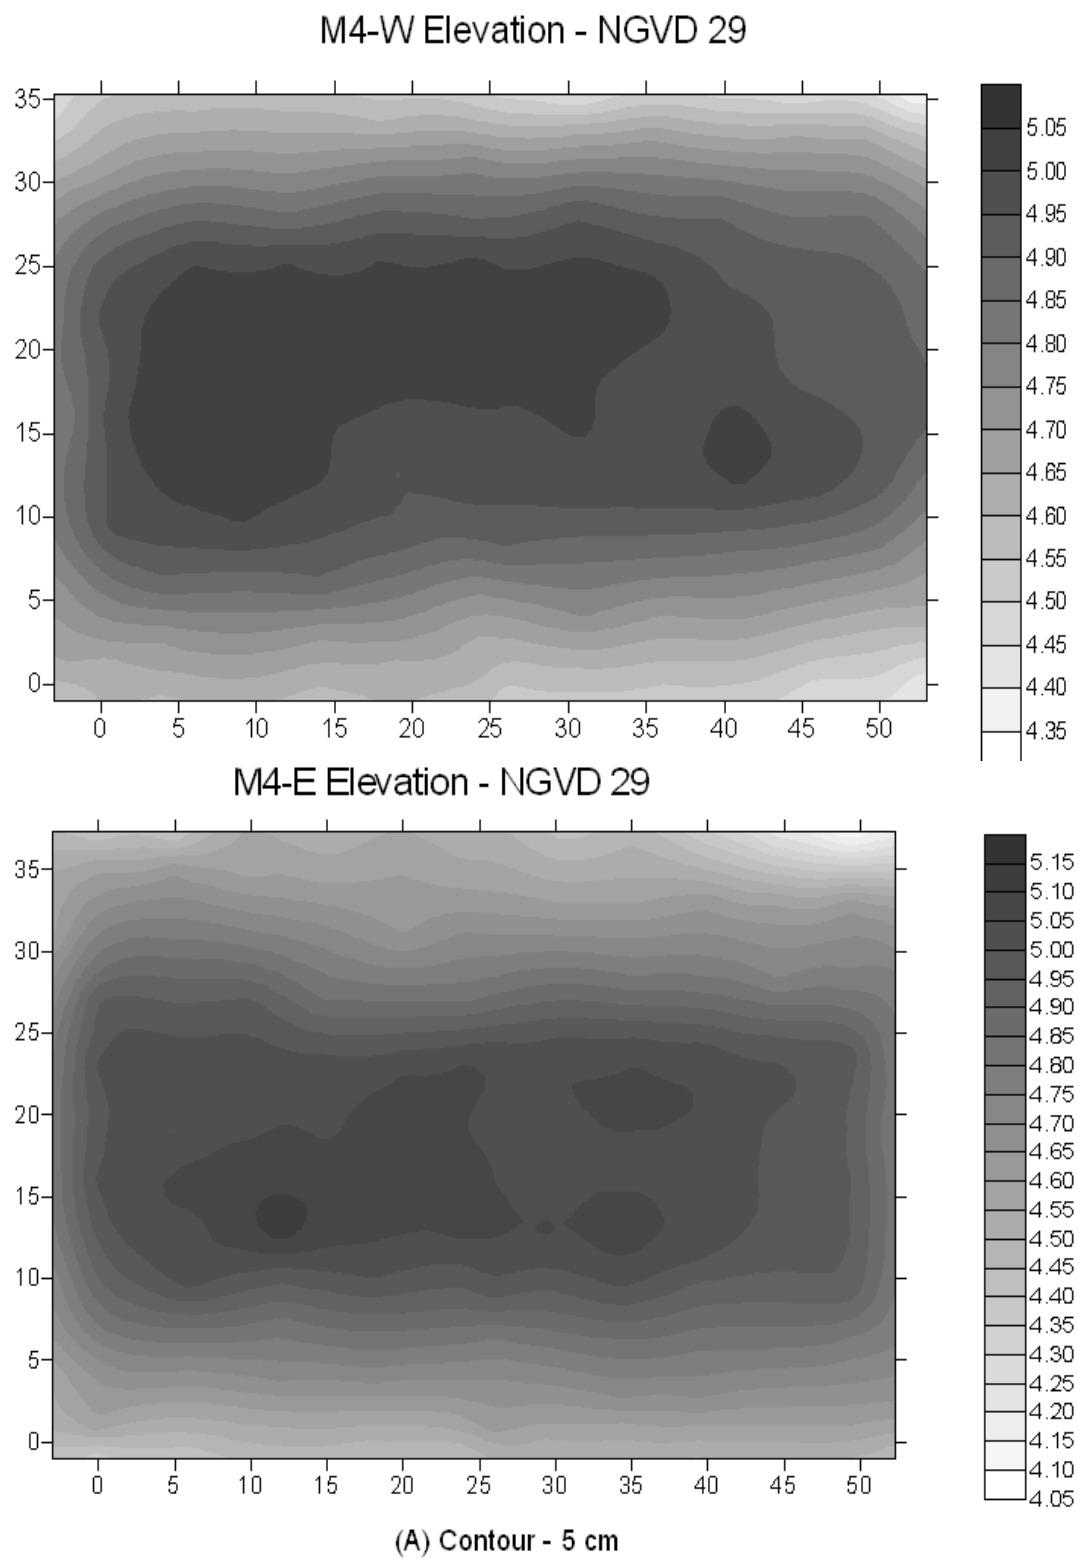
Figure 5.5. Elevation isopleths for the M4 West and M4 East tree islands in meters.

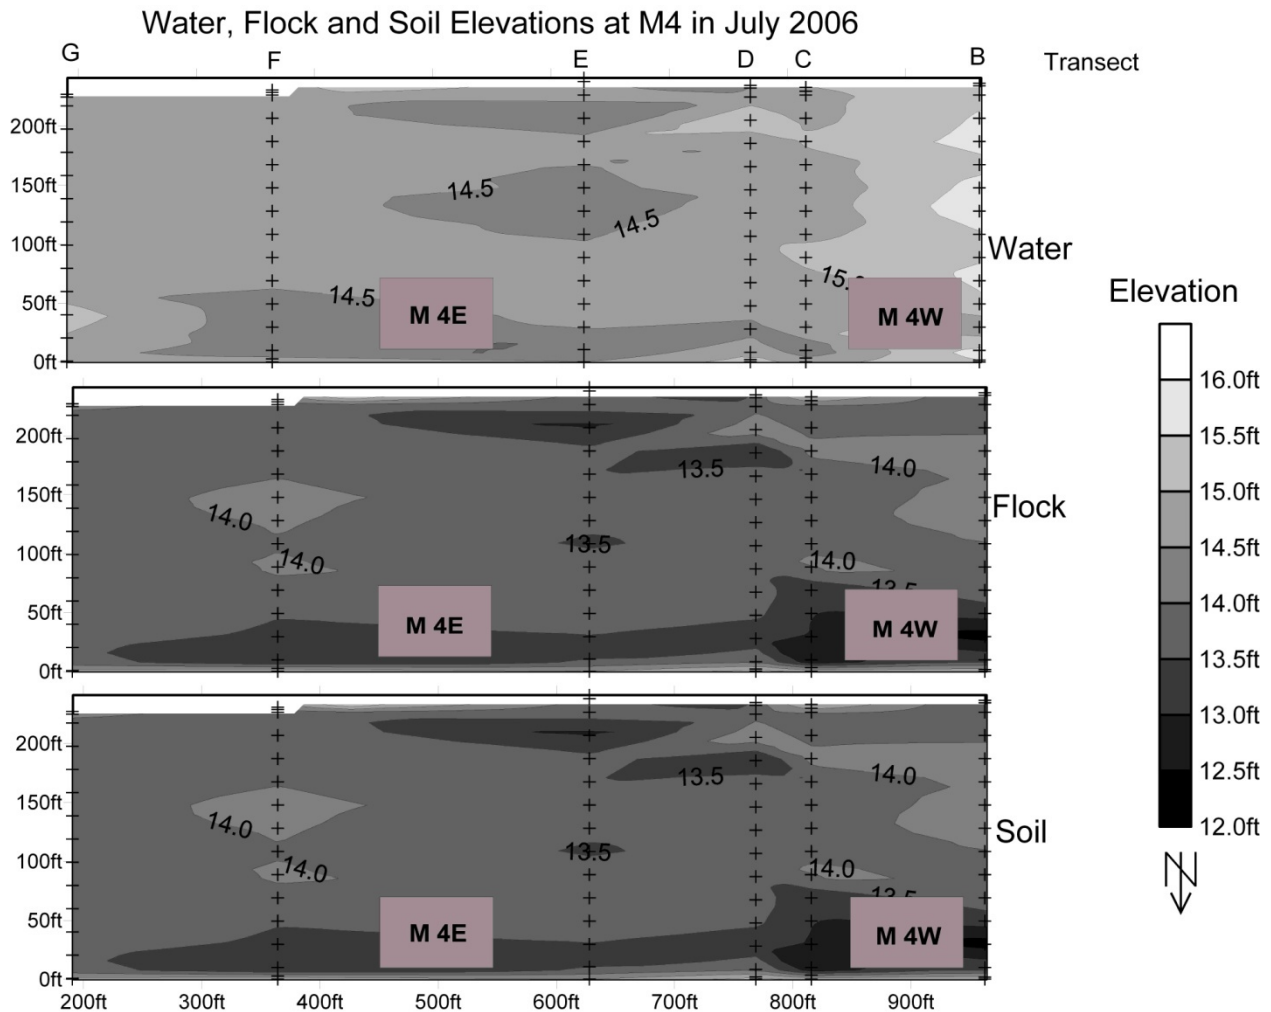
Figure 5.8. Elevations in feet of water level and top of flock and soil in M4 on July 2006.

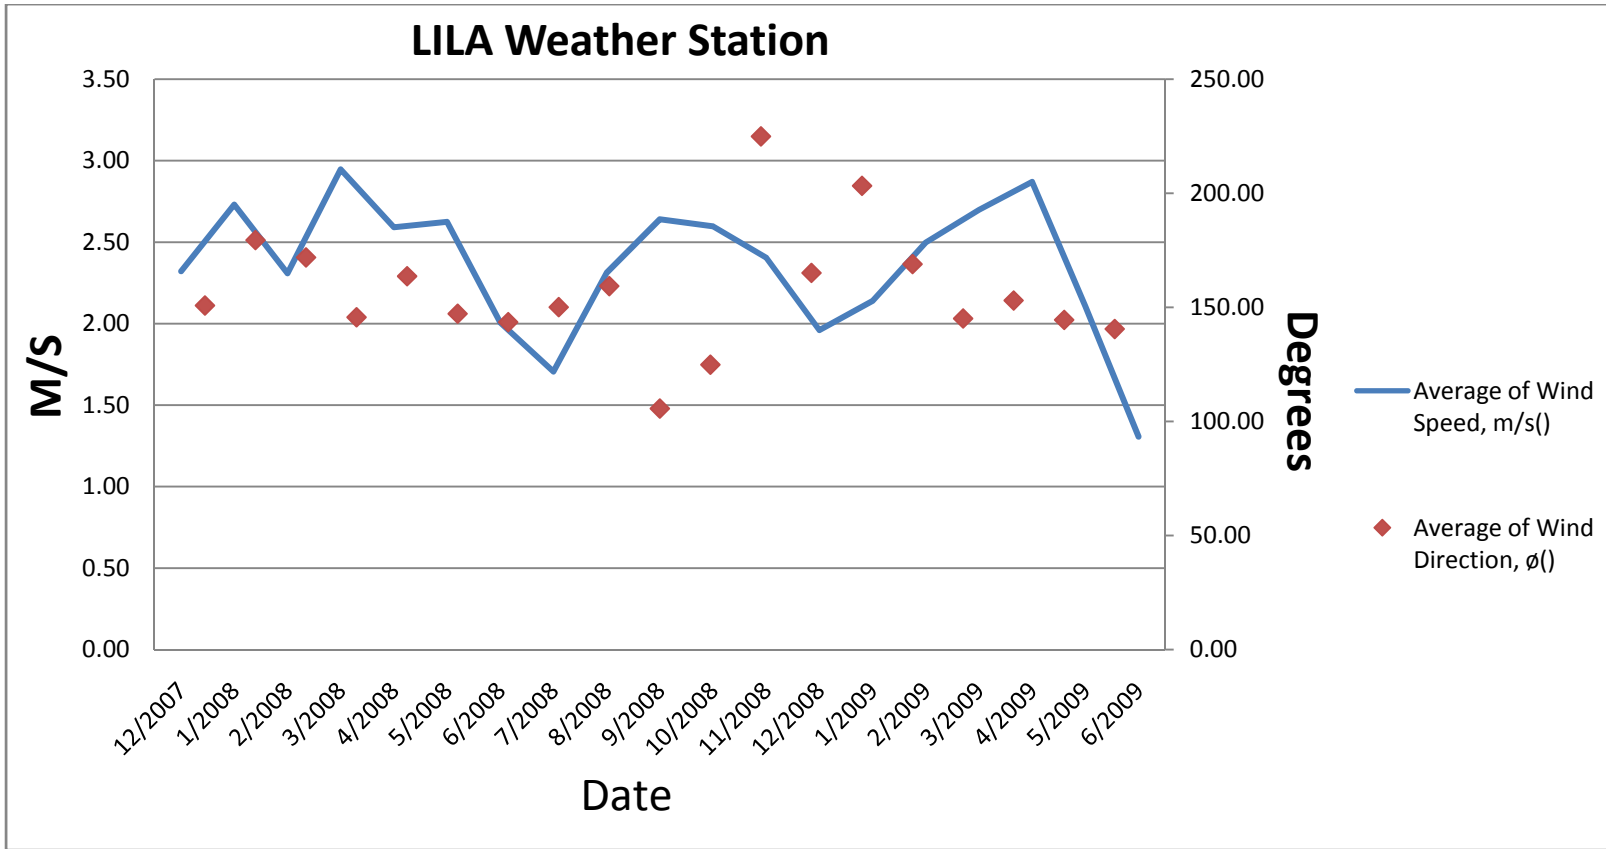
Figure 6.1.4.1. Wind speed and direction as recorded at the LILA M2W weather station.

Figure 6.1.4.1 is a graphical representation of two of these measurements, wind speed and direction.

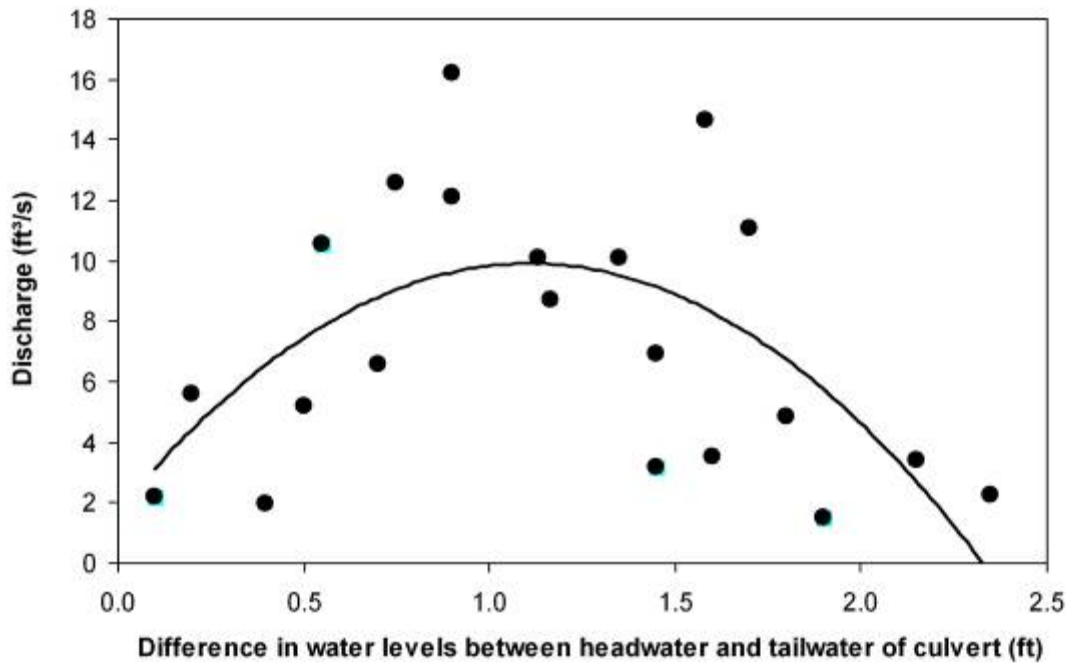
Figure 6.17. Discharge rates measured from culverts under varying water level conditions. Highest discharge through the culverts occurs when there is about a 0.3 +/- 0.05 m (1.0 +/- 0.2 ft) difference in the water levels on either side of the culvert.

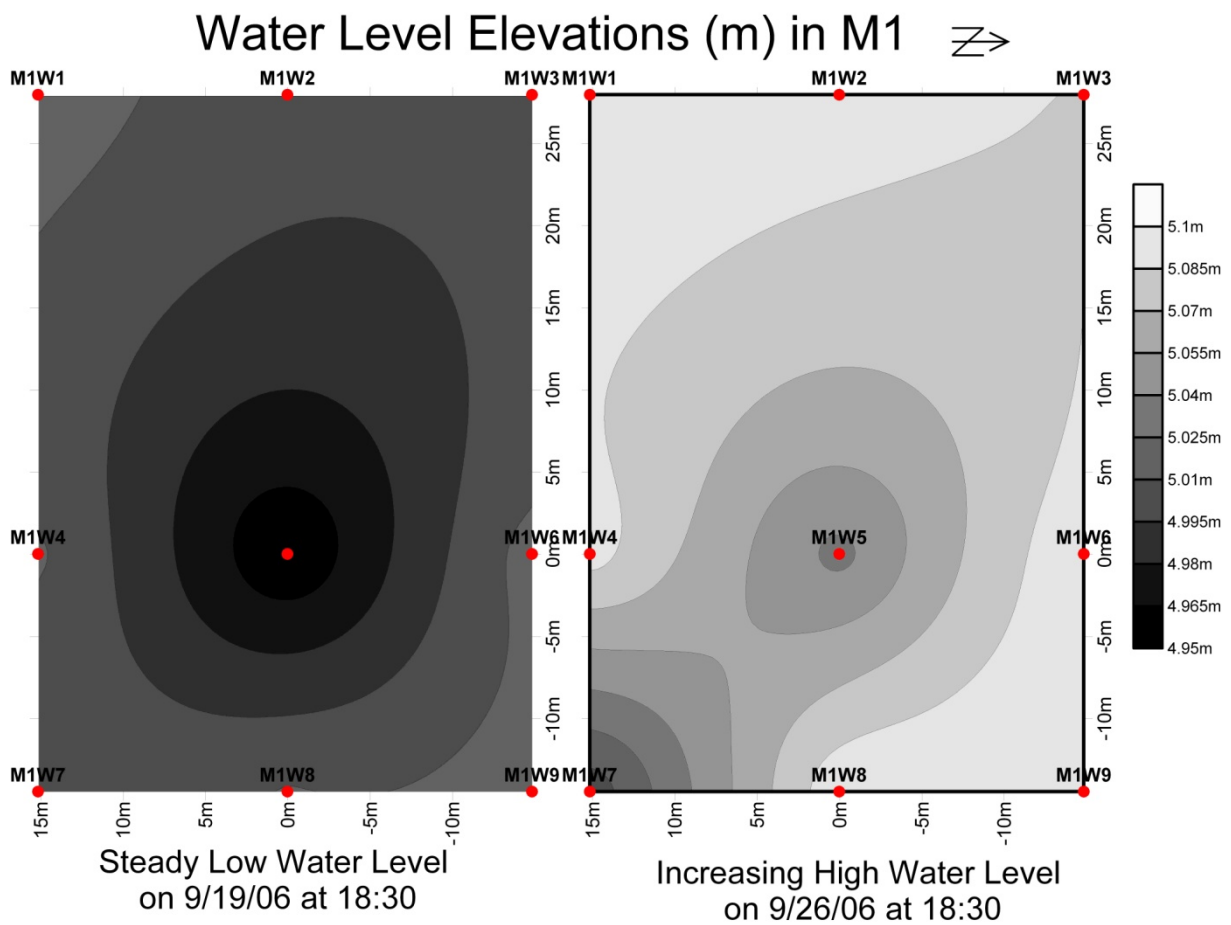
Figure. 6.3.1. Water level contours in tree island M1W as measured in all of the wells during low water levels (left plot) and high water levels (right plot) during September 2006.

The short-term test of the water levels in all of the wells in the M1 peat island, conducted in September 2006, indicated no clear difference in the water levels along the outside of the tree islands (Figure 6.3.1). When water levels were low (Figure 6.3.1 left), the water table in the center of the tree island was depressed. In that configuration, groundwater flow was from the edges to the center of the tree island. Depressed water level conditions still persisted in the center of the island, during rising water levels (Figure 6.3.1 right). Note that the contours depicted in Figure 6.3.1 include groundwater levels in the well points only, and do not include the surrounding surface water levels.

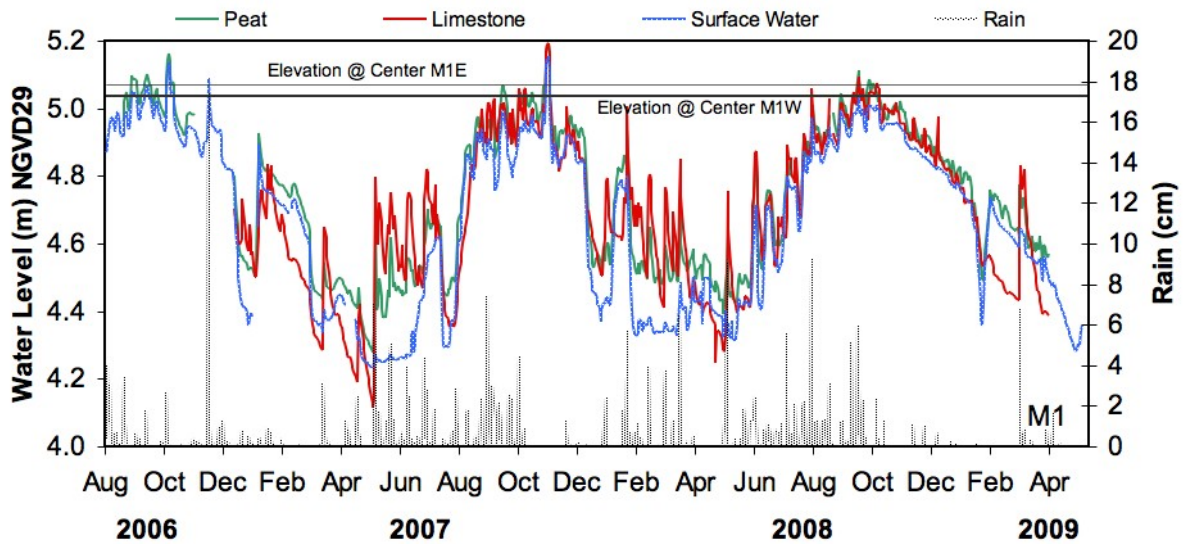
Figure 6.3.2. Daily average surface water levels (blue) and hourly average groundwater level for the center of the peat (green) and limestone (red) based tree islands in M1 from September 2006 to May 2009.

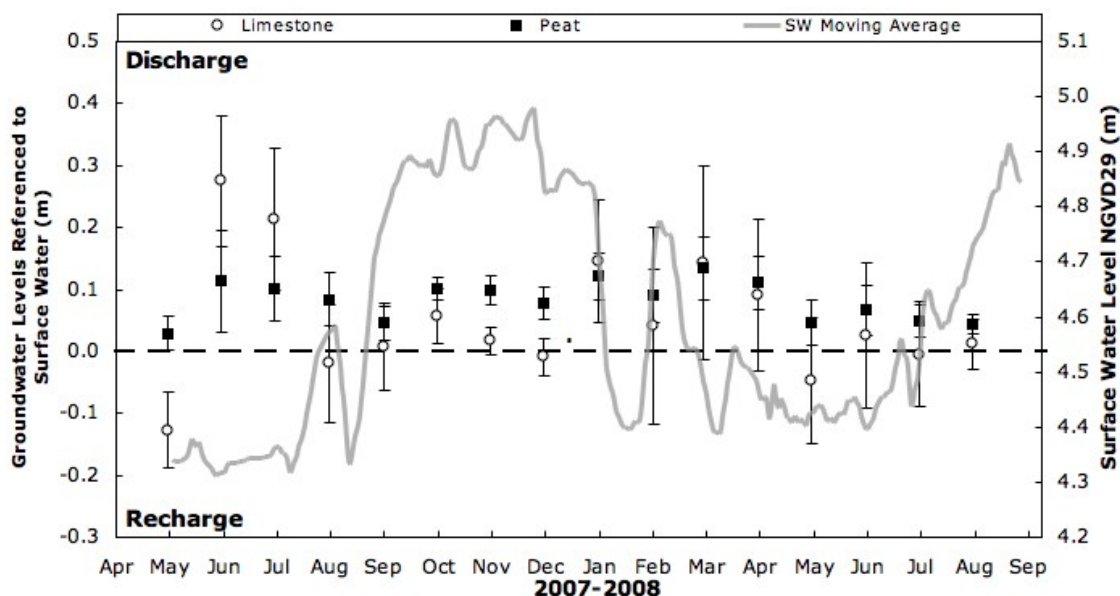
Figure 3. Mean-monthly referenced groundwater levels and standard deviation for the peat (black) and limestone (open) based tree islands compared to the mean daily surface water levels (gray) from May 2007 to August 2008.

Mean daily surface water level in the adjacent sloughs ranged from 4.29 m to 5.0 m (Figure 3). The high water period of September - January matches the seasonal pattern found in much of the Everglades, as does the low water period of March - July. Several interruptions (in the cycle of flooding and recession (e.g., August 2007, January and March 2008) were operational artifacts of short wildlife experiments at LILA.

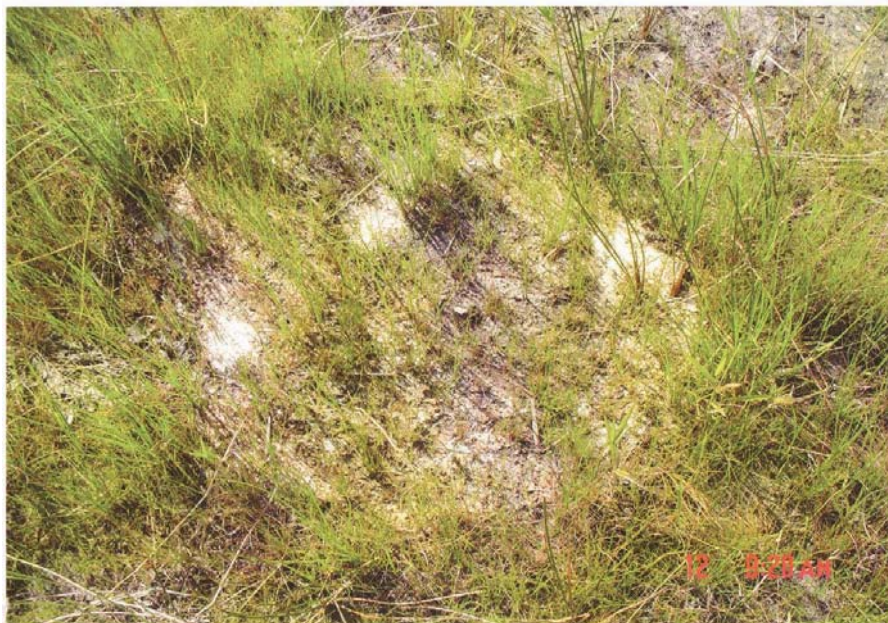
Figure 8.5. Degraded remains of a feldspar marker within a few months of placement. By six months these markers could not be located.
