Loaxahatchee Impoundment Landscape Assessment (LILA): Tree Island Experiments and Management; May 1, 2005 to September 4, 2009: Final Report

Final Report Contract RS-050962-A02

**Loaxahatchee Impoundment Landscape Assessment (LILA):
Tree Island Experiments and Management
May 1, 2005 to September 4, 2009**

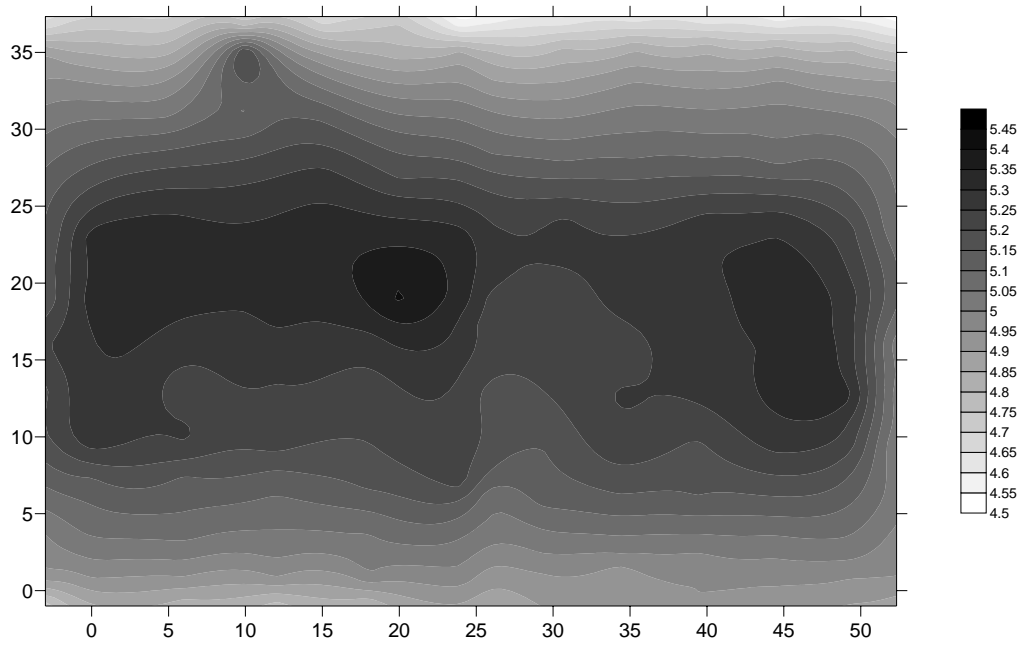
Figure 5.3. Elevation isopleths for the M2 West and M2 East tree islands in meters.

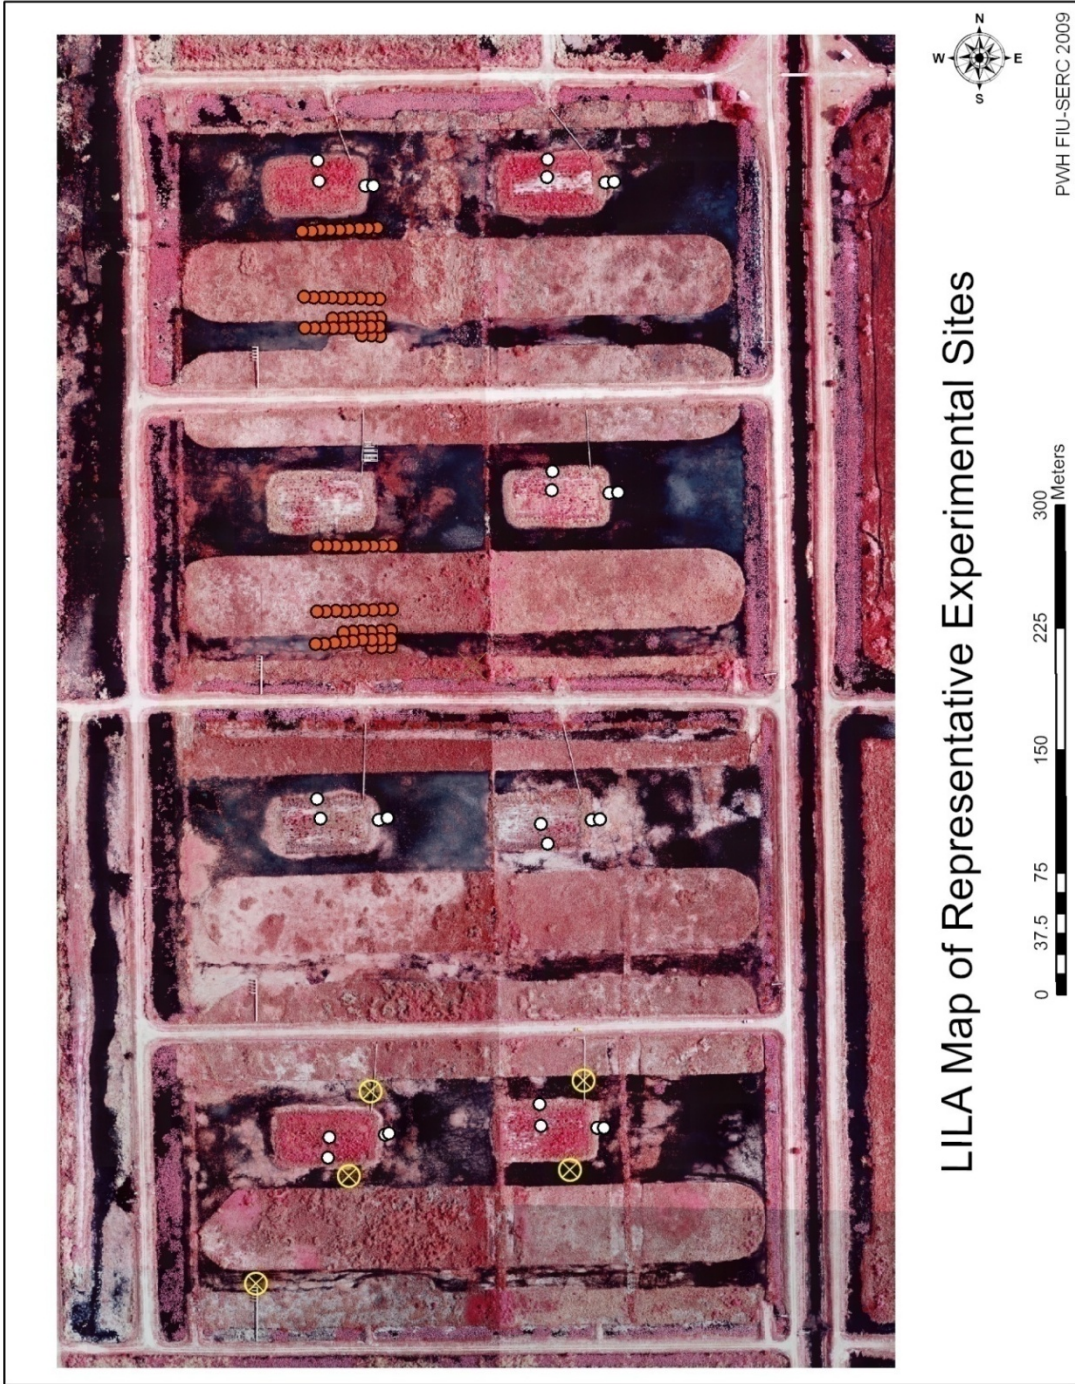
Figure 5.15. 2008 aerial photograph showing locations of the tree island SETs (white circles), the RAST plots (orange circles) and the locations of the 2008 M4 water velocity dye sampling points (yellow crossed circles).

The development of our GIS overlay database has made it possible to spatially locate field plots, major instrumentation, and other “sensitive” areas. This serves several purposes, including preventing others from walking on or otherwise degrading a research plot, identifying past manipulations e.g. transplanted vegetation plots, nutrient additions, to explain possible future anomalies, and ultimately to link data in a visual, spatial way. For instance, periodic measures of sedimentation and erosion table (SET) data can be linked as an attribute table allowing anyone to bring up past data by selecting the point on the GIS overlay. Figure 5.15 shows the 2008 aerial photograph with the spatial locations of three experiments; the tree island SETs (white circles), the RAST plots (orange circles) and the locations of the 2008 M4 water velocity dye sampling points (yellow crossed circles).

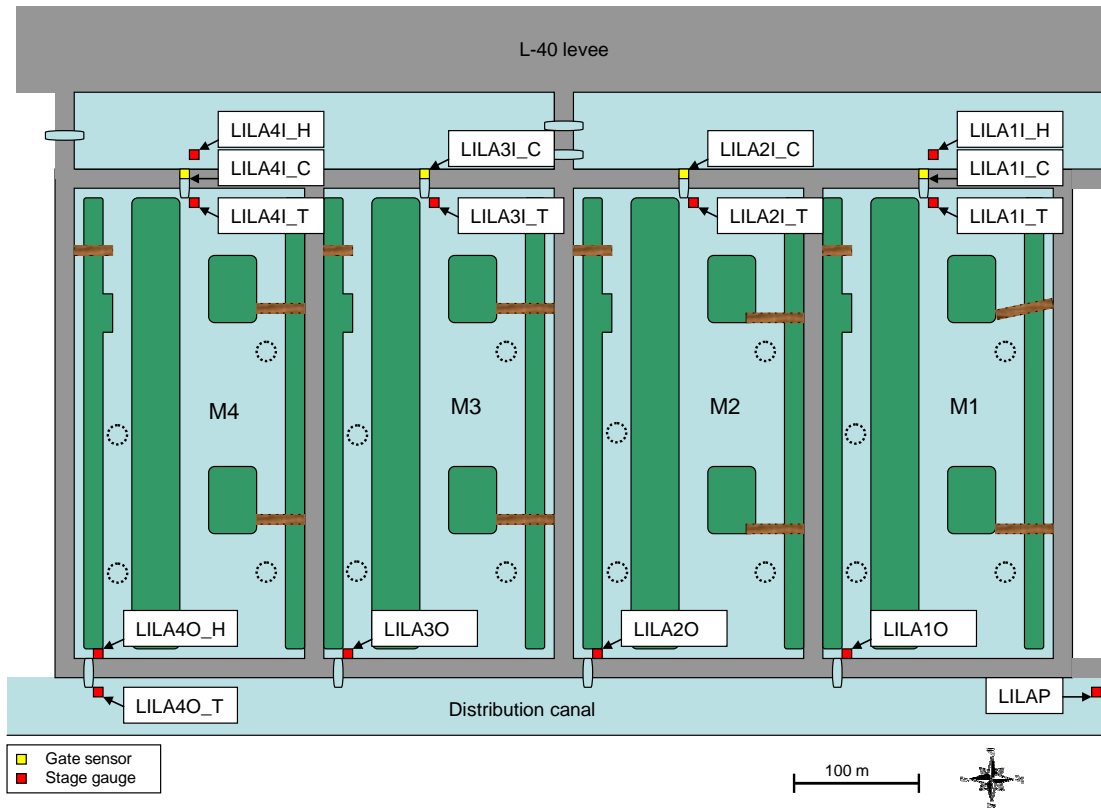
Figure 6.1 Location of all automated stage gauges (red squares) installed at LILA.

A 5-PSIG Level Troll 500 (In-Situ Inc.) pressure transducer was placed in the surface water slough just south of the center of island M1W on September 18, 2006, and then replaced on July, 20 2008 because of transducer failure. The pressure transducer was attached to a 3 ft-long vented cable. The vented cable allows for instantaneous equilibration of atmospheric pressure. Due to the extremely wet conditions at LILA, a number of precautions were taken to prevent moisture from entering the pressure transducer through the vented cable. A vented capsule of silica gel that attaches to the top of the vented cable is provided with each cable. This was augmented with a vented 250-mL plastic bottle filled with number 4 mesh drierite. The pressure transducer was suspended in a 2-inch PVC pipe using a stainless steel ring provided for this purpose from the manufacturer. The stainless steel ring is placed between a 2-inch (5.08 cm) PVC coupling and the PVC pipe to insure the pressure transducer remain stable. The PVC pipe was then attached to the metal bar in the slough next to M1 West with metal clamps. The PVC was covered with a 2-inch cap that was also vented to the atmosphere. The distance from the top of the PVC pipe to the bottom of the pressure transducer was measured to within 5 mm. The elevation of the top of the PCV pipe was determined using a Wild Nak-2 level and stadia rod which provided a 3mm level of accuracy. The elevation of the bottom of the pressure transducer in the surface water at M1 between 9/18/06 and 7/20/07 was 4.330 m (NGVD-29), and after 7/20/07 the elevation was 4.182 m (NGVD-29).

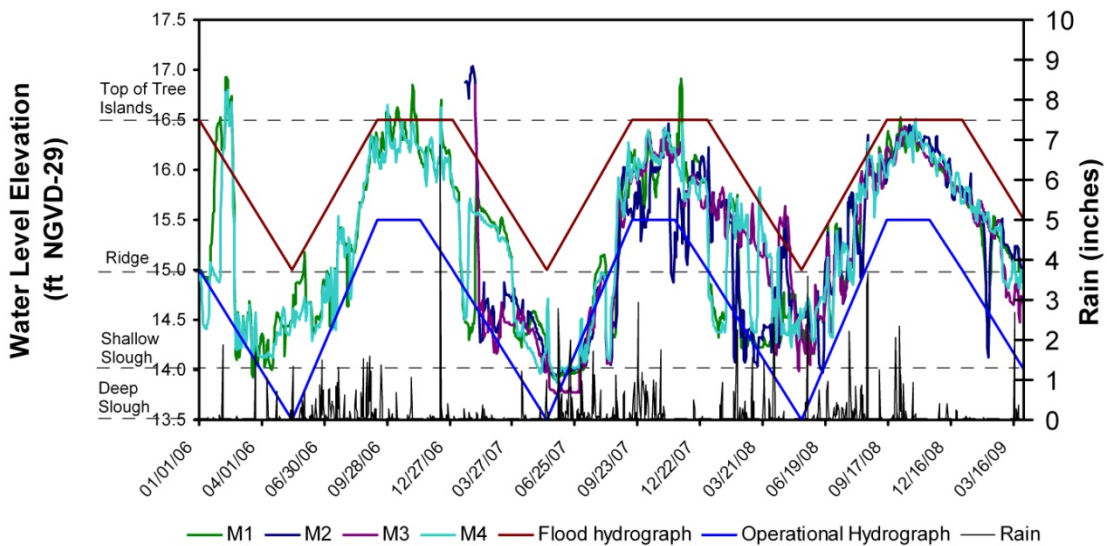
Figure 6.7. Surface water levels in M1 through M4 compared to the flood and operational hydrographs, and rainfall amounts from Jan. 1, 2006 until May 31, 2009.

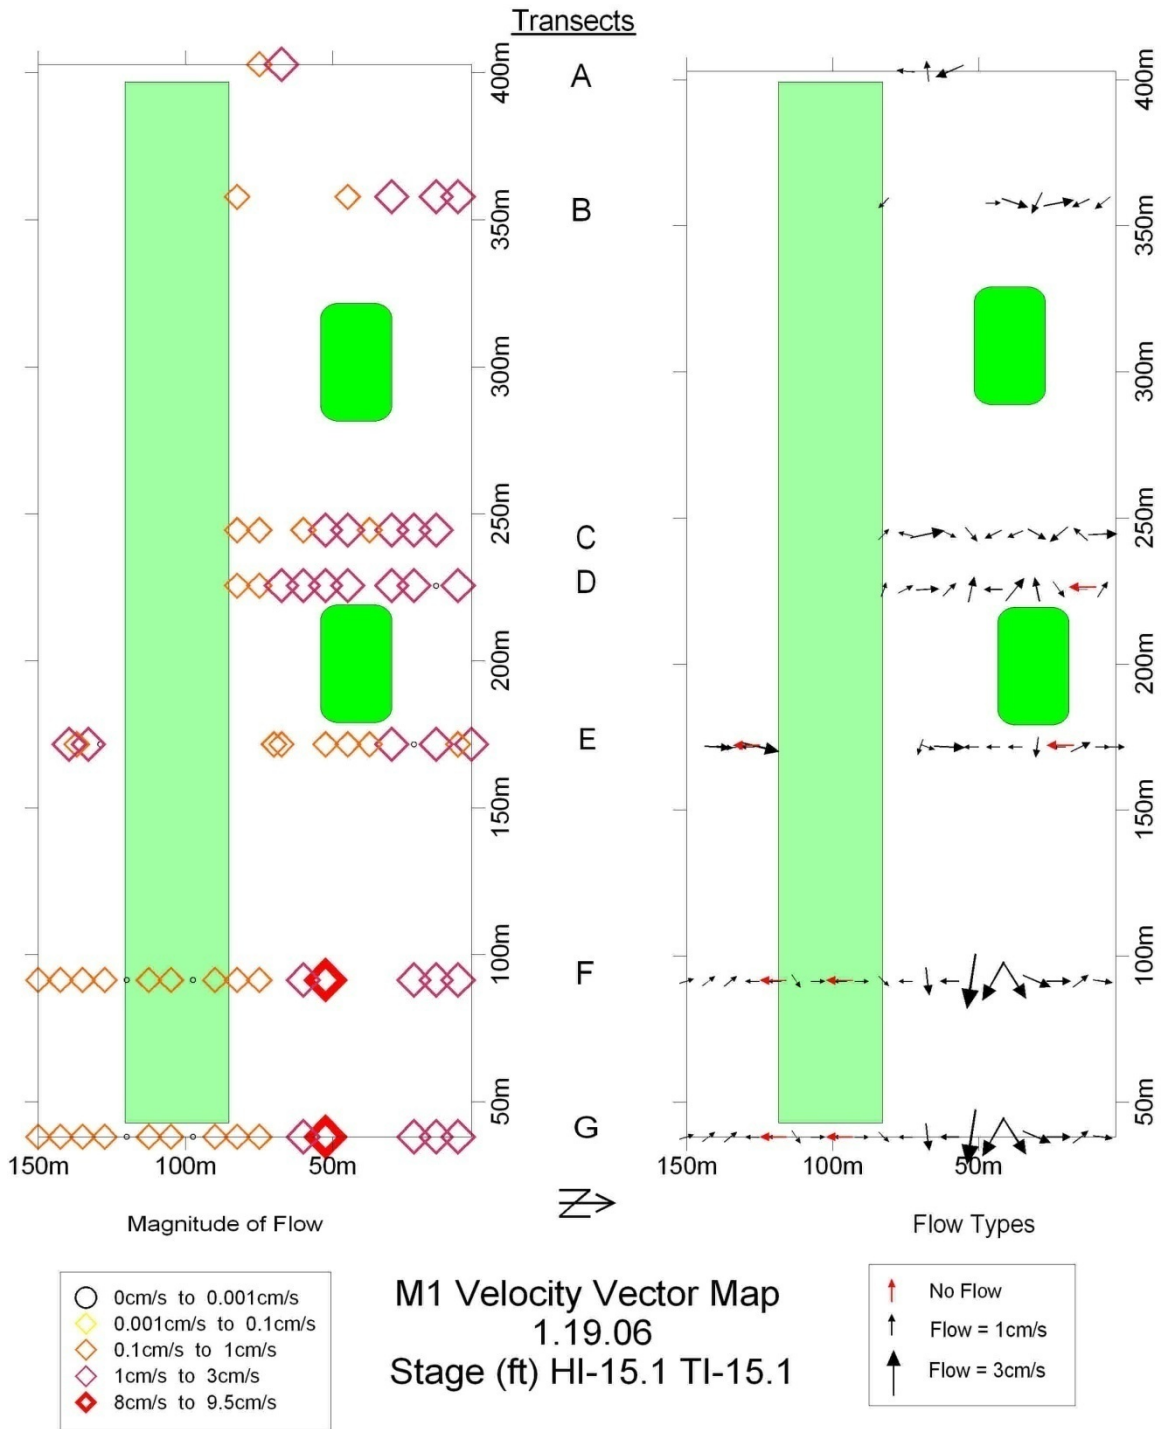
Figure 6.9. Velocity transects in M1 on January 19, 2006.

Plots of the flow velocity and discharge measurements for each sampling date are included in Figures 6.9 through 6.13. Only two velocity transects were completed in M2 on July 11, 2006 due to poor weather conditions, and therefore, the data obtained from that day were not included into the SURFER program. Histograms of the velocities obtained in each cell are included in Figure 6.14. Velocities obtained ranged from -4 cm/s to +4 cm/s. The highest flow rates tended to be near the eastern end of each cell. Low flow velocities with varying directions tended to occur close to the tree islands. In the sloughs, higher flow rates tended to be located in the center of the sloughs, away from the edges.

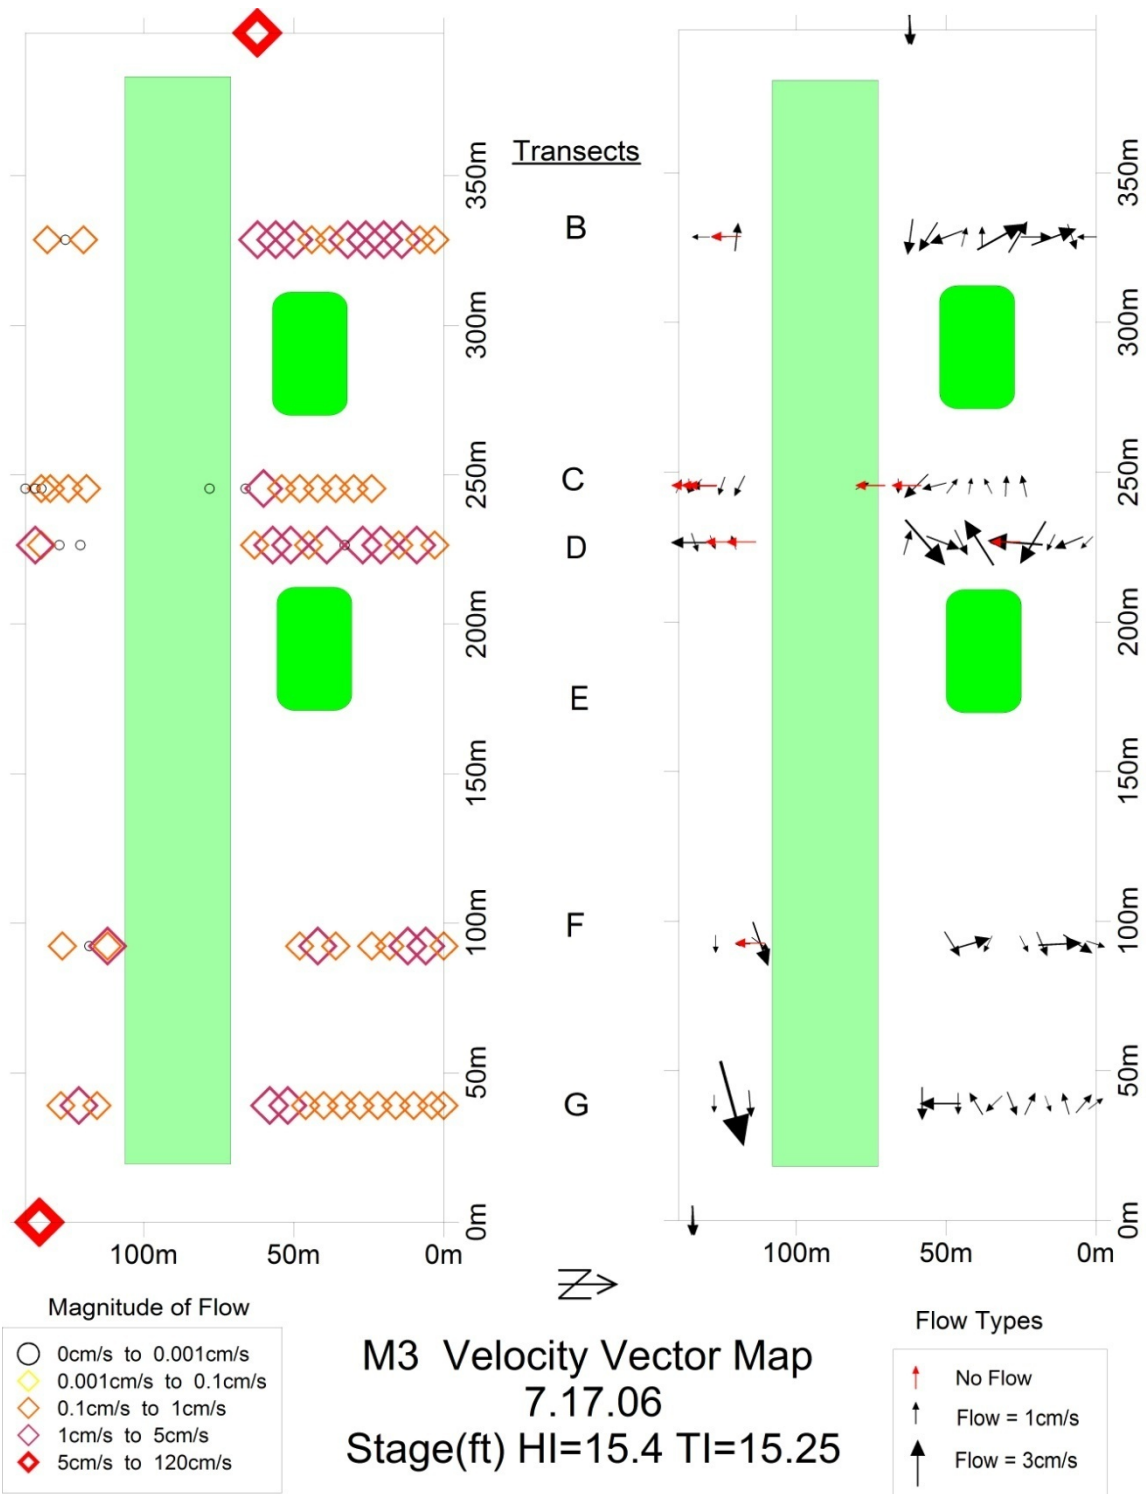
Figure 6.10. Velocity transects in M3 on July 17, 2006.

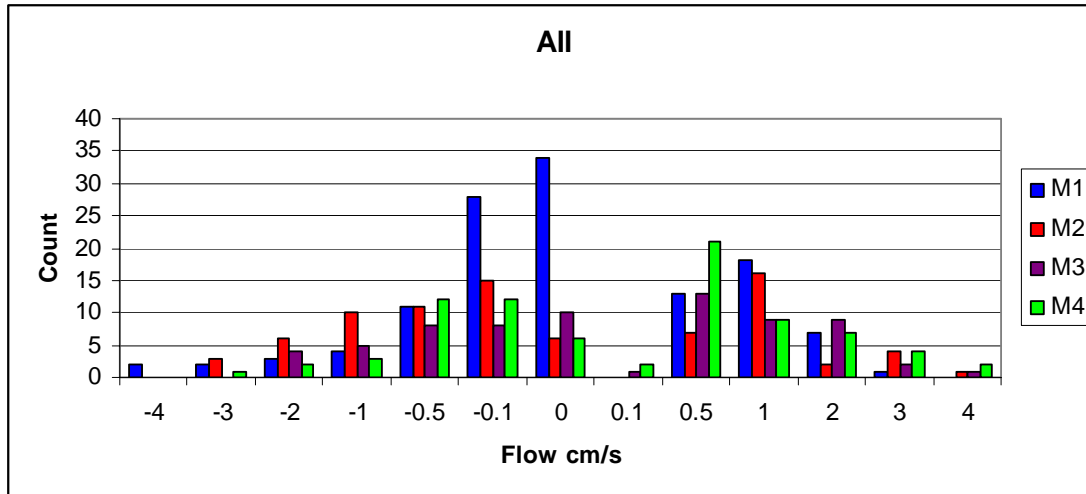
Figure 6.14. Histogram of all flow velocities measured along the transects in all cells.

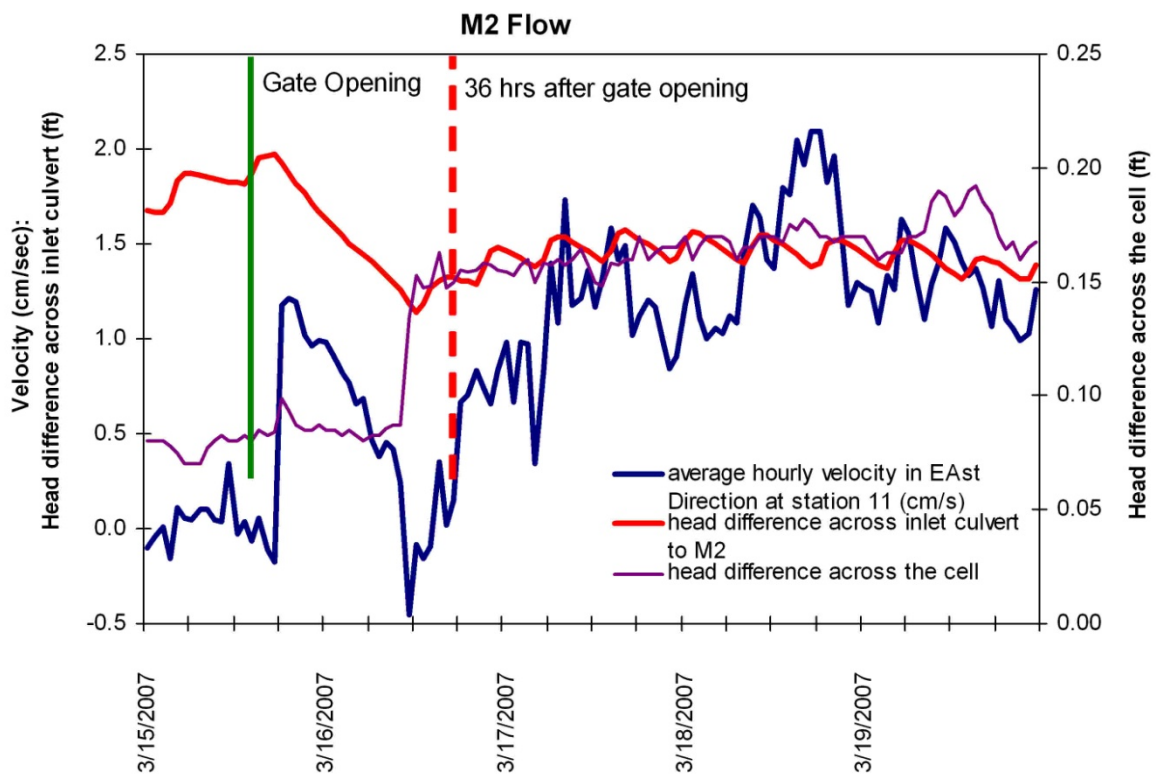
Figure 6.16. Graph of mean daily difference in head level across the inlet culvert and cell in M2, along with the mean daily flow velocity as measured by the downlooking SONTEK placed at location 11 on Figure 6.15.

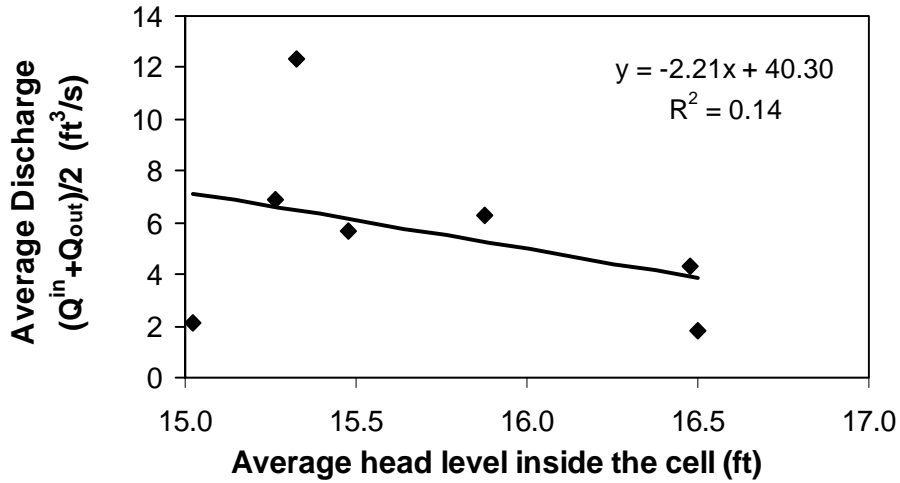
Figure 6.18a Average discharge from the outlet culvert compared with average head level inside of a cell.

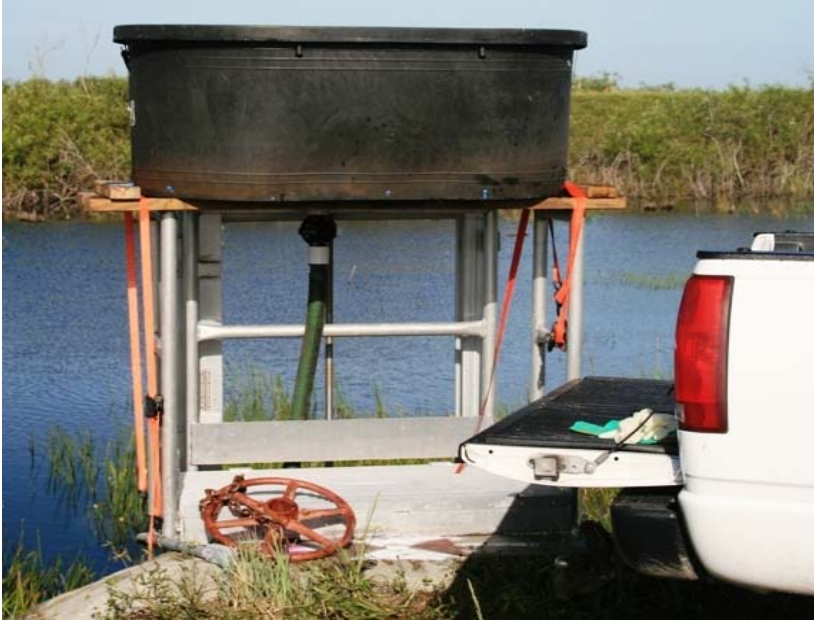
Figure. 6.2.5.2. Dye injector - note valve below mixing tank that allows for constant flow.

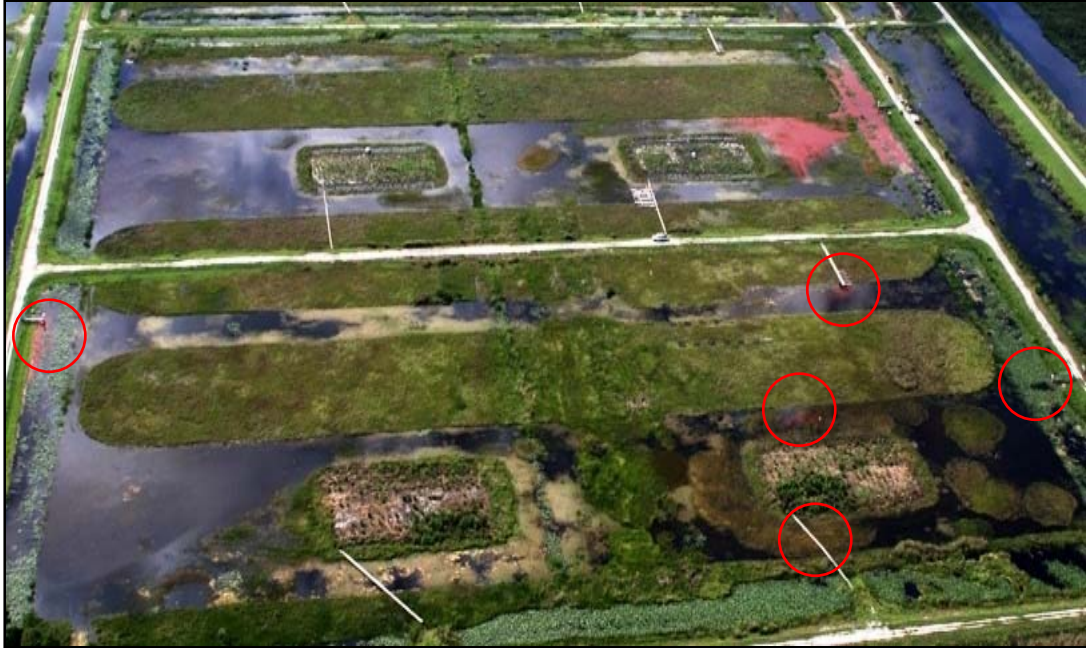
Figure 6.2.5.4. Comparison between flowing M2 (top of picture) and non-flowing M1 (lower), 1 hour after dye release.

A visual summary shows that there were distinct differences in water velocity in the flowing vs. the non-flowing cells as expected. This is a main treatment effect of the LILA project and is important to show (Figure 6.2.5.4, using M1 and M2 as examples – similar results were observed in M3 and M4, not shown). Treatments generally behaved similarly in both dye studies. That is, flowing cells showed dye movement while non-flowing cells showed some dispersion with time but no directed downstream movement. The flowing cells M2 and M4 also acted similarly with time (Figure 6.2.5.5) especially in the deep slough and around tree islands. The water level in M4 was at a stage about 6 inches higher than the water level in M2 which seemed to have the greatest effect on the water velocity in the shallow slough where the water seemed to move much further down the shallow slough in M4 vs. M2 (Figure 6.2.5.6). We originally thought that water velocity would more a function of cross channel morphology. That is the smaller volume and shallower depth of the shallow slough would cause relatively greater water velocities. However, it now appears that the vegetation influences flow to a larger extent than does channel depth or width. Additional effects of vegetation density on water flow should be studied.

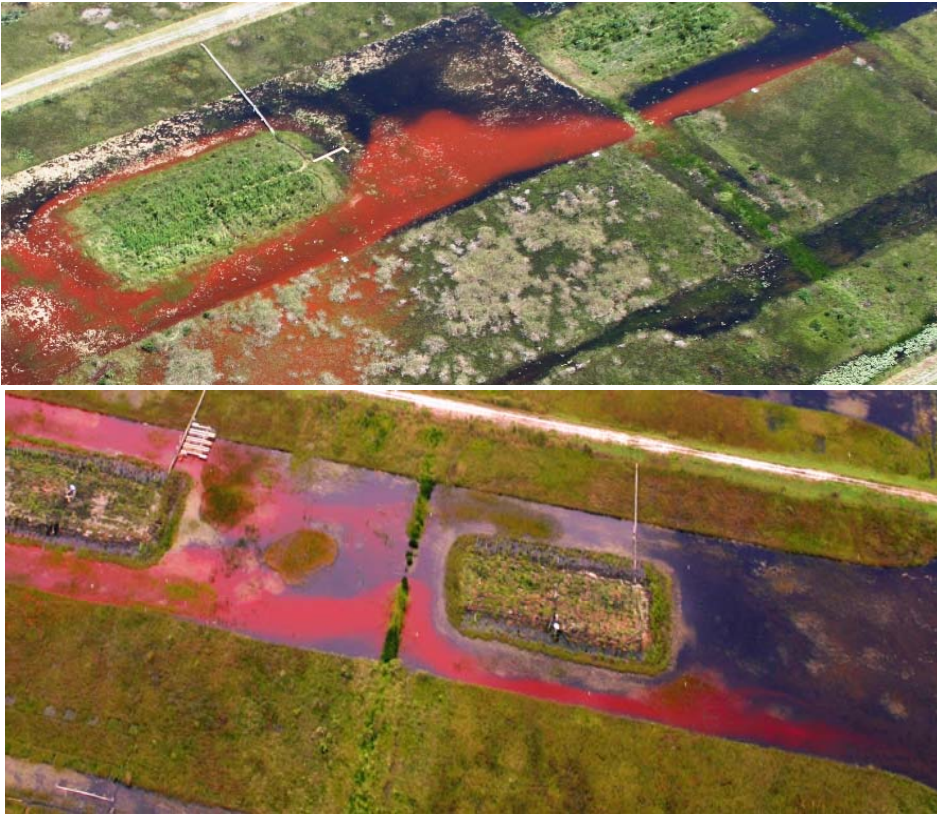
Figure 6.2.5.5. Photograph showing “similar” behavior in M2 (bottom) at 244 minutes into the dye study and M4 (top) at 224 minutes.

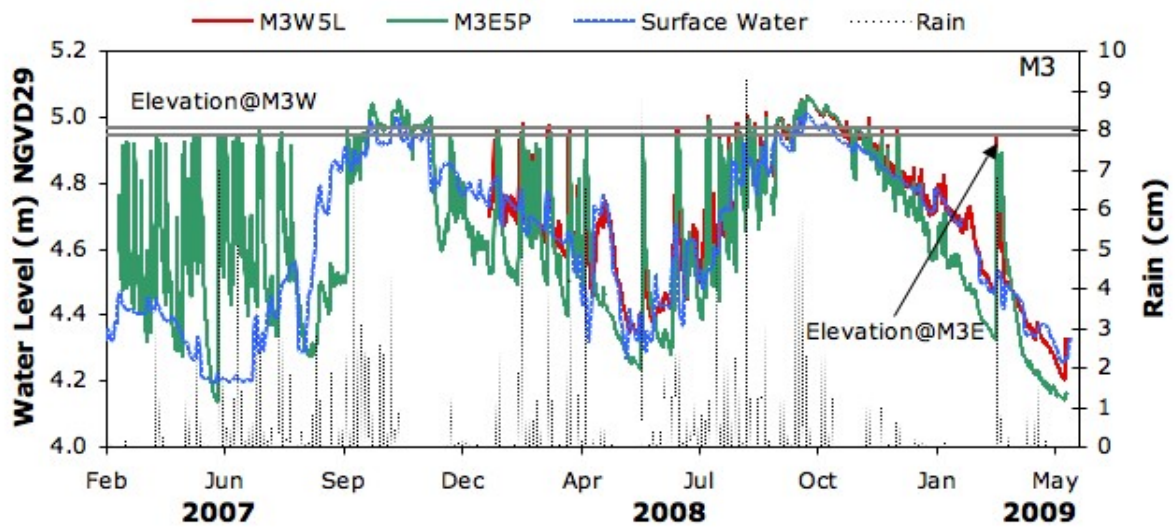
Figure 6.3.4. Daily average surface water levels (blue) and hourly average groundwater level for the center of the peat (green) and limestone (red) based tree islands in M3 from February 2007 to May 2009.

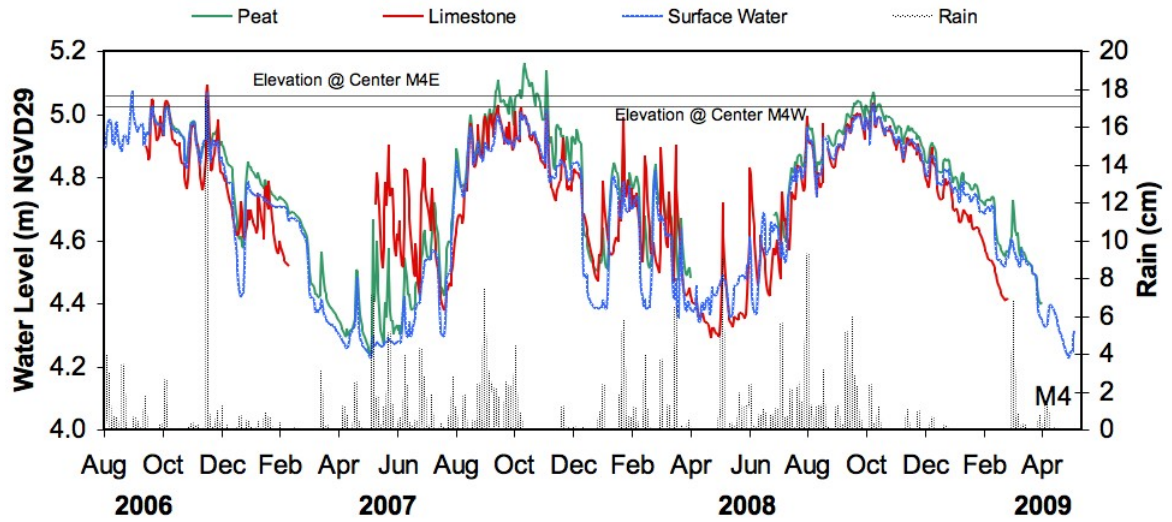
Figure 6.3.5. Daily average surface water levels (blue) and hourly average groundwater level for the center of the peat (green) and limestone (red) based tree islands in M3 from August 2006 to May 2009.

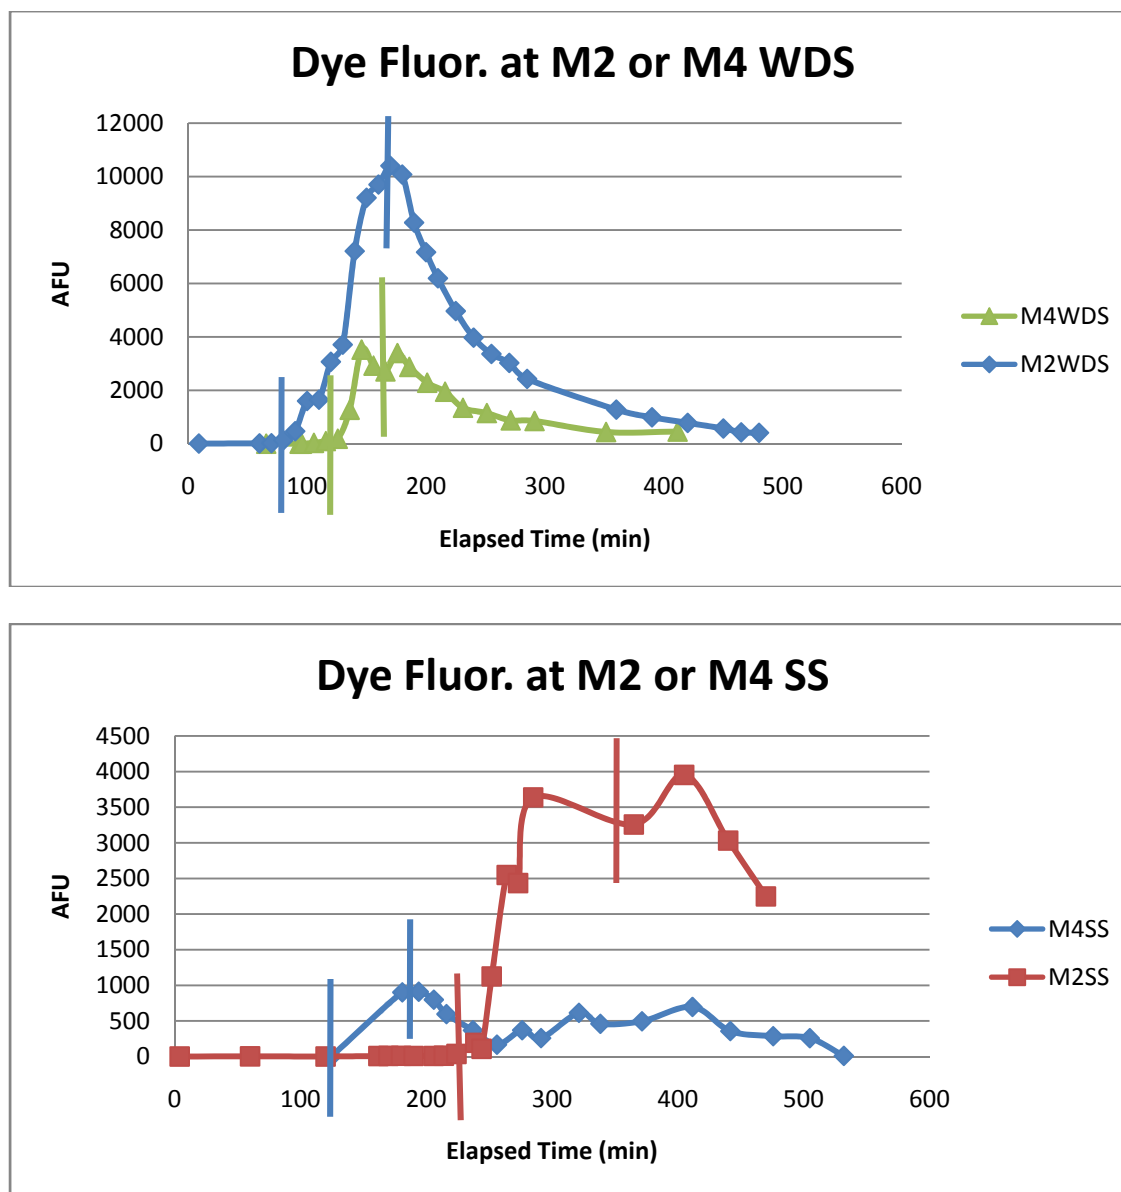
Figure 8.3. “Bell” shaped curves from M2 and M4 at the WDS and SS locations. First corresponding vertical line estimates the elapsed time of travel of a neutrally buoyant particle (T_e), the second vertical line is the elapsed time to the peak (T_p) of a dye or neutrally buoyant particle cloud. Estimates best fit to similar curves were used to derive values in Table 8.1.

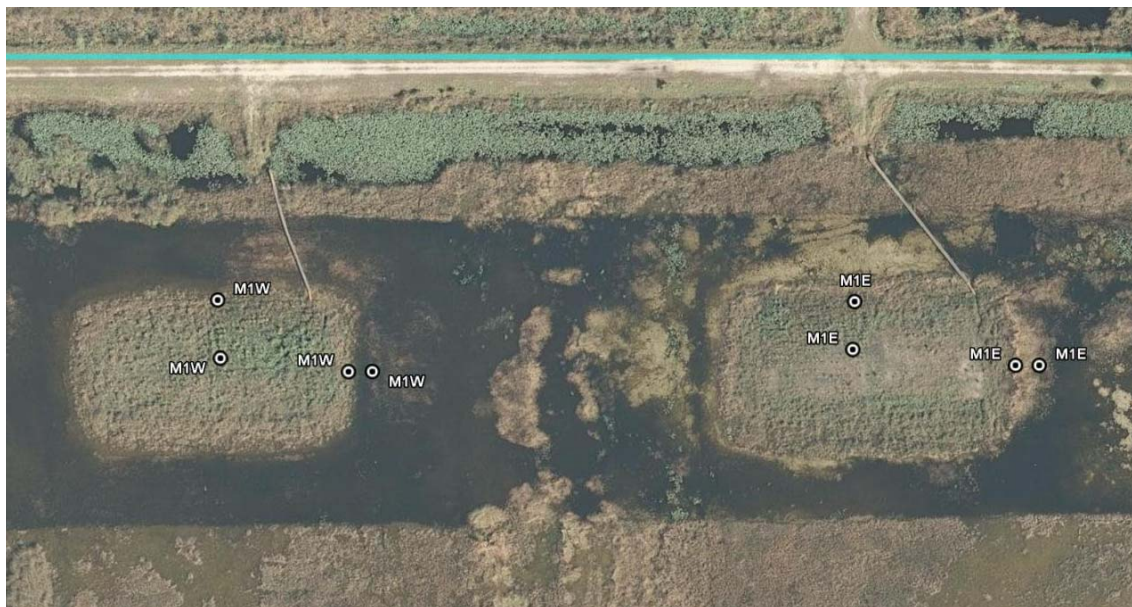
Figure 8.7. Georectified locations of SETs using M1 tree islands as an example. One SET is located on the “wet” side slope (upper in figure) and one is located on the highest elevation area of each tree island in the highest density plantings. Two other SETs are located in line with the tree island center at midslope and on the slough bottom of tree island tails.

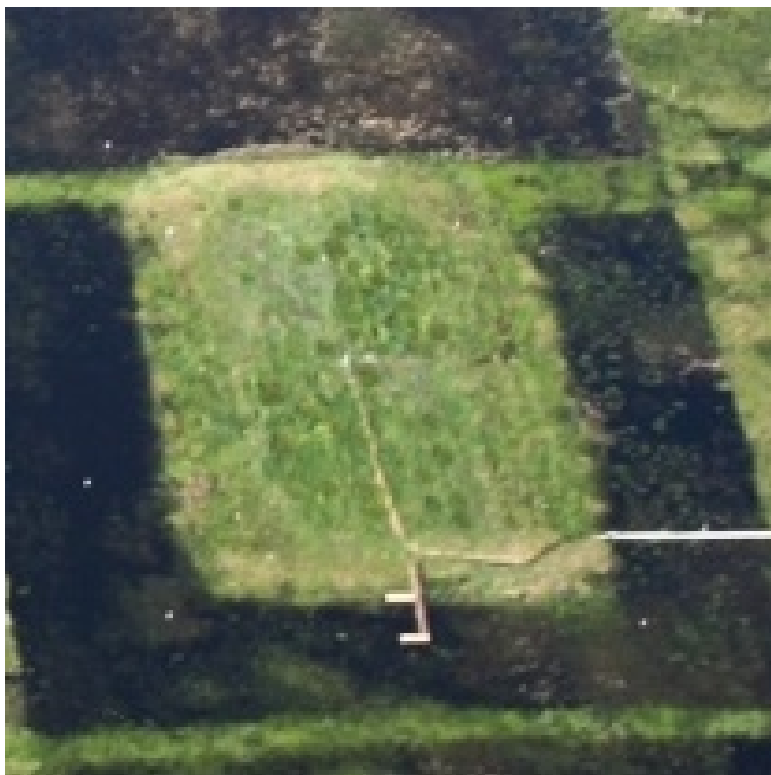
Figure 8.8. Aerial image showing SET boardwalks on one of the tree islands.
