FLORIDA MASTER SITE FILE
 Site Inventory Form

Site Name _____ Site No. _____
 Address of Site: 557 NE 92 St., Miami Shores, Fl 33138 Survey Date 8505 820 = =
 Instruction for locating on N side of NE 92 St. between NE 5 Ave., & 905 = =
NE 6 Ave. 813 = =
 Location: Miami Shores Sec. 2 57 16 & 17 868 = =
subdivision name block no. lot no.
 County: Dade 808 = =
 Owner of Site: Name: Thomas, Arthur W. ;
 Address: 557 NE 92 St., Miami Shores, Fl 33138

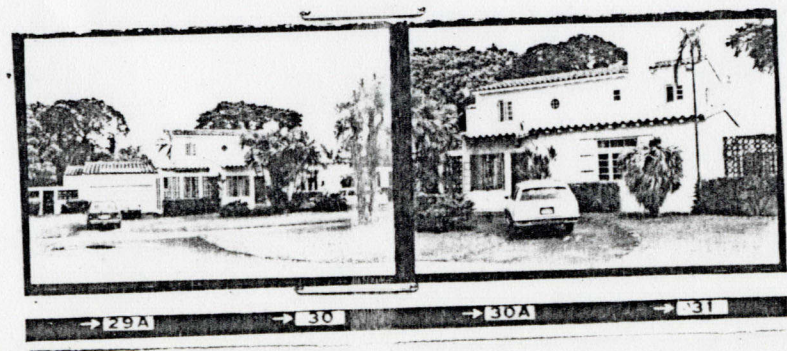
Contact Print

Structure is masonry vernacular with significant Mediterranean Revival influence. A front screened porch (S) now is enclosed with a variety of materials including aluminum casement windows. 2nd story front (S) facade has polygonal window in center. Ends of gables have horizontal weatherboard siding. The roof eaves have exposed brackets. Decorative hollow clay tile walls extend from E and W front corners, exaggerating the already significant lateral massing. Attached garage. Area to the immediate west is single-story professional offices, not threatening or impacting the residential neighborhood.
